# Evaluation of Precision Approach Path Indicator (PAPI)

Bret Castle

Prepared By  
FAA Technical Center  
Atlantic City Airport, N.J. 08405

April 1983  
Final Report

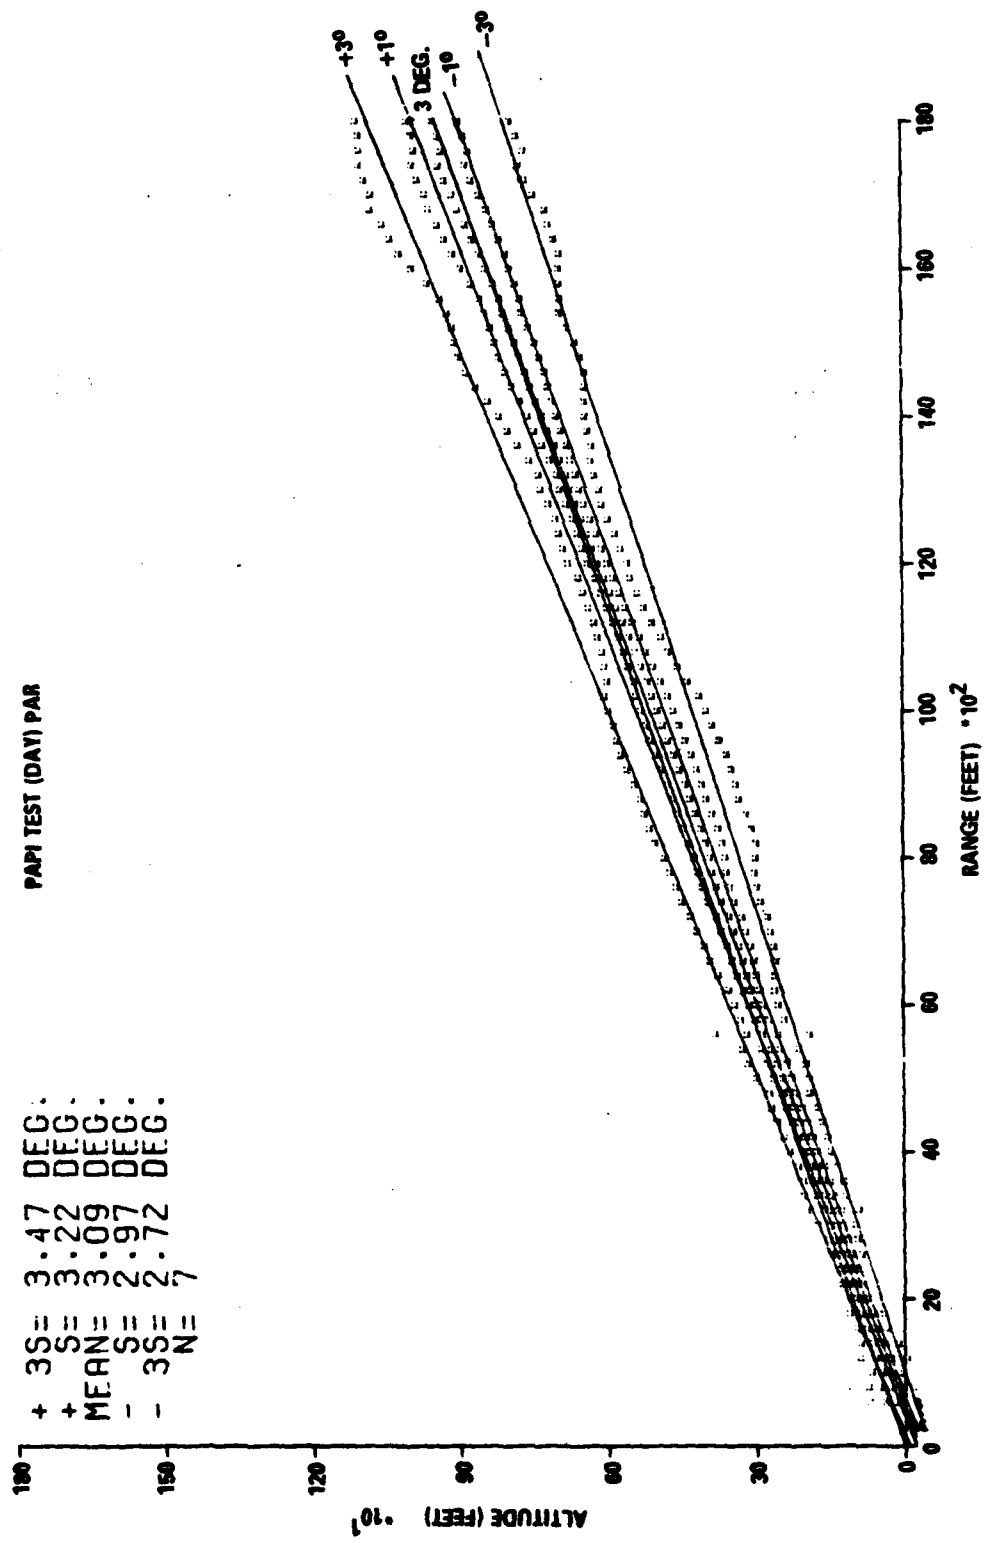
FIGURE D-5. PAPI STATISTICAL DAY PLOT

Attached as Appendix I is a compilation and summary of the data results of the questionnaires obtained from the test pilots during these tests. Also included are composite graphs, separated into daytime runs (figure 3) and nighttime runs (figure 4), showing the accuracy of the system as obtained by Radar tracking and reduced by our computer system. A statistical plot in figure 5

provides a graph that is broken down into 200 foot segments of range. Each range segment, when drawn together, provides a linear regression line. Lines representing the  $\pm 3 \sigma$  deviation indicate that 99.74 percent of all aircraft flying the PAPI would remain within this corridor. The data obtained is offered without comment for this data report. Further testing of this type is planned and will be included in the final report of PAPI.

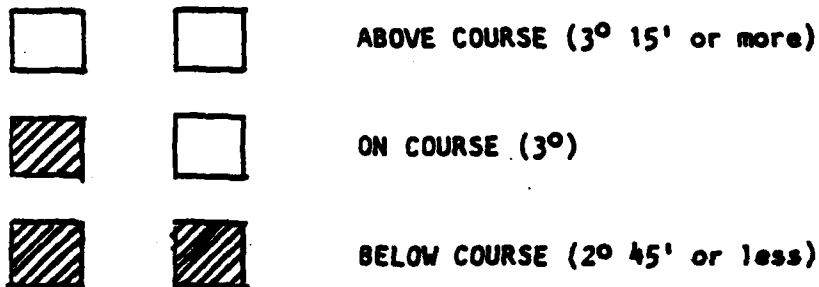
The tests now being conducted will provide data to determine whether a "Two Box" PAPI system can be successfully used on small airports with runways of 5,000 feet or less. The intended purpose of the "Two Box" PAPI is for use where it may not be necessary to have the five incremental paths provided by the full blown PAPI system. The arrangement of the units is similar to the full blown PAPI system except that only two boxes are used. The  $3^{\circ}$  glide-slope is midway between the angular setting of the pair of light units. The on-course signal is one red and one white light, the above course (greater than  $3^{\circ} 15'$ ) is two white lights, and the below course (less than  $2^{\circ} 45'$ ) is two red lights. These are depicted in the diagram below.

For this test, the units are located 1,000 feet down runway 4 on the right-hand side. Once you have accomplished a sufficient number of approaches to this system, please fill out the postflight questionnaire provided.
