AFOSR Grant Number 80-0130 AF-OSR-80-0/30
Annual Technical Report
March 1983

ANALYSIS OF LONG BONE AND VERTEBRAL FAILURE PATTERNS

Jo Ann C. Eurell, DVM, MS, PhD

THE EFFECTS OF VERTICAL IMPACTION ON THE SPINAL COLUMN OF BABOONS

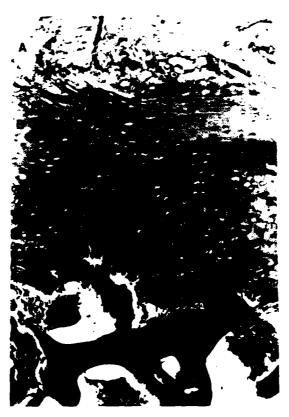
The cartilaginous endplate consisted of three morphologic regions (Fig. 3). Next to the trabecular bone were areas of strongly alcian

Figure 3. Normal growth plate of control animal G30. A=annulus fibrosus, B=outer zone, non-calcified, C=outer zone, calcified, D=inner zone, E=trabecular bone. 225X, hematoxylin and eosin stain.

blue staining cartilage. These areas were scattered along the bone-cartilage interface. Above the alcian blue regions was a zone of calcified cartilage. A basophilic line separated areas of contact of the calcified cartilage with the trabecular bone of the body. Irregular basophilic regions demarcating the calcified areas were observed. These regions corresponded to the granular appearance observed with SEM. Between the intervertebral disc and the calcified cartilage

was a third zone of cartilage with flattened cells and an eosinophilic matrix. This region blended with the disc above.

The morphologic regions of the cartilaginous end zone compare to those described in mice by Higuchi, et al (1982). The inner zone is narrowed as if the vertebrae of this animal were approaching skeletal maturity.

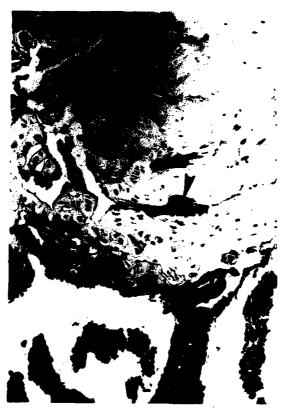
Six month post-impaction (G74, G84). Fragments of trabecular bone were observed in the intervertebral discs (G84 L_{1-2}) and conversely, intervertebral disc and end plate fragments were observed in the vertebral bodies (G84 L_{2-3}) of the upper lumbar levels. Also fragments of trabecular bone were sometimes observed embedded in the cartilaginous end plates (Fig. 4).

Figure 4. Fragment of trabecular bone embedded in the superior cartilaginous end plate of G84 L_3 . 385%, hematoxylin and eosin stain.

Six months post-impaction (G74,G84). Displaced fragments of trabecular bone, cartilaginous end plate, or disc material were probably the results of the impaction sequence. The impaction sequence was also most likely responsible for the fractures and separations of the cartilaginous end plates.

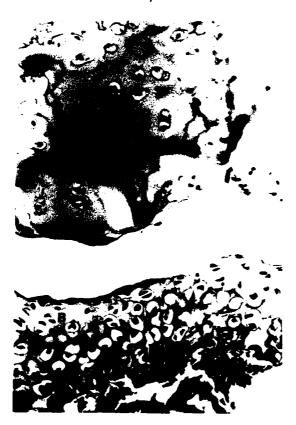
The cartilaginous end plates were usually separated from the underlying vertebral body. Three different junction patterns of the end plates and bodies were observed. The first pattern (Type I) was complete separation through the deep portion of the inner zone of the cartilage end plate with no apparent attempt at bridging (Fig. 5). This pattern seemed to occur posteriorly. The second pattern (Type II) resulted in separation through the upper portion of the inner zone (Fig. 6). Several flat

Figure 6. Type II junction of the cartilaginous end plate with the bone of the vertebral body. Note separation through the upper portion of the inner zone. A=cell nest of reactive cartilage, B=proliferative region of inner zone, C=hypertrophied region of inner zone. G84, L_{1-2} , 600X, hematoxylin and eosin stain.

proliferating chondrocytes overlying a zone of hypertrophied chondrocytes were present on the vertebral side of the separation. Either necrotic cartilage devoid of cells or reactive cartilage with cell nests of 8-10 cells was present on the disc side. The third pattern (type III) was bridging between the calcified outer zone and hypertrophied region of the inner zone by columns of chondrocytes (Fig. 7). The cartilage was intensely alcian blue positive, and it corresponded to bridging struts previously reported with SEM. Both of the later types of juction seemed to occur anteriorly.

The configuration of the type I and II junctions may be related to the path of the separtation. If the disruption courses through the deep hypertrophied region of the inner zone, the cells on the vertebral side

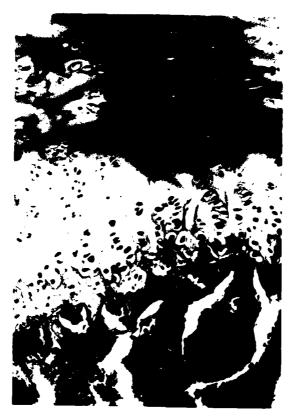
Figure 7. Type III junction of the cartilaginous end plate with the bone of the vertebral body. Columns of chondrocytes are present beneath the calcified outer zone. G74, L_{3-4} , 450%, hematoxylin and eosin stain.

The type III junction represents either a rejoining of the separated zones by cartilage proliferation or an area which was not damaged by the original impact. Further studies of immediate post-impaction animals is indicated to elucidate the nature of this junction.

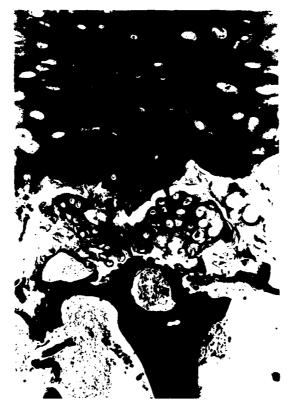
The cartilage in the inner zone region was disorganized (Fig. 8). The cells were arranged in clusters instead of columns and there were scattered localized areas of yellow or blue-staining fibrous tissue which separated the cell clumps.

Figure 8. End plate junction with underlying bone of 6 year post-impaction animal. Note chondrocyte clusters (arrow) separated by fibrous tissue. E34, T_{1-2} , 625X, alcian blue-van Gieson stain.

The separation of the end plate from the underlying vertebral body observed in the six month post-impaction animals is not present in the six year post-impaction animals, and therefore it may heal with time. The shape of the endplates is influenced by the progressive ossification of the vertebral body (Donisch and Trapp,1971). The initial damage to the plate may result in a defect in endochondral ossification. The disorganization of the cartilage at the junction region is probably a combination of changes related to growth plate closure and cartilage disruption due to the impaction sequence. The combination of damage to the end zone trabeculae induced by the incompressible nucleus pulposus and the possible disruption of bone growth due to the end plate damage may result overall in a very irregular vertebral end zone. This irregular end zone may contribute to some degree of joint instability.

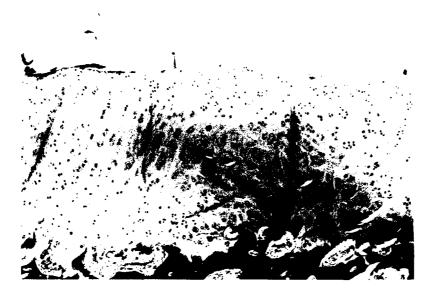
Six month post impaction (G-74, G84). Surface fibrillation and cracking of the articular cartilage was observed (Fig. 9). In some regions of the cartilage, the chondrocytes were clumped in nests of 4 to 8 cells. Alcian blue staining was diminished in the peripheral regions of the articular cartilage and around fibrillated areas.

Figure 9. Articular cartilage of facet joint from a 6 month post-impaction baboon. Note fibrillation and cracks. G74, 150X, hematoxylin and eosin stain.

<u>Light microscopy-posterior cartilage</u>. The surface fibrillation and cracking of the facet joint articular cartilage along with clumping of the chondrocytes and diminished alcian blue staining is indicative of cartilage degeneration.

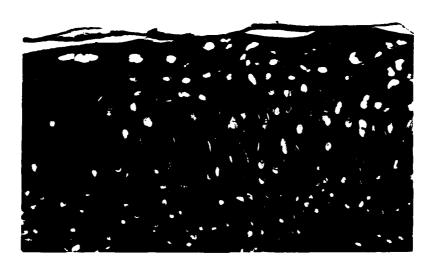
Six ,ears post-impaction (E34). In the central region of the articular surface, the hyaline cartilage was replaced by fibrocartilage (Fig. 10).

Figure 10. Articular cartilage of facet joint from a 6 year post-impaction baboon. The normal hyaline cartilage has converted to fibrocartilage. E34, L_5 , 500X, alcian blue-van Gieson stain.

Alcian blue staining was greatly diminished. The articular surface was fibrillated.

The changes seem to increase in severity with time as evidenced by the six year post-impaction sample in which more severe osteoarthrosis is present. The degenerative changes observed in the posterior articulations of the vertebral column are probably resultant of the preceeding intervertebral joint instability as proposed by Vernon-Roberts (1980).

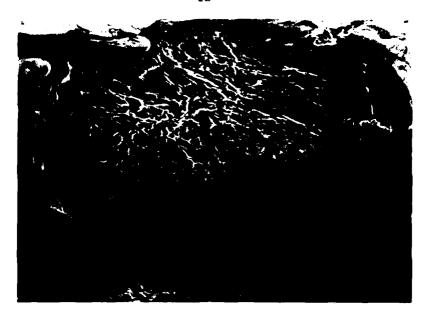
Six month post-impaction (G74, G84). The articular surface had a central zone of fibrillation (Fig. 12). A higher magnification of this fibrillation is shown in figure 13. Peripheral to this region were sever, cracks in the surface of the cartilage.

Figure 12. Articular cartilage of a facet joint from a six month post-impaction baboon. $\mathsf{G74}$, $\mathsf{14X}$.

Scanning electron microscopy - posterior column. The surface of the articular cartilage of the control animal was relatively smooth compared to the impacted animal joint surfaces. Fibrillation was evident on the articular surfaces of the joints from six month post-impaction animals and it had progressed to a more extensive, severe lesion of the cartilage in the six year post-impaction group. The fibrillation is indicative of osteoarthrosis and is thought to be related to the impaction process.

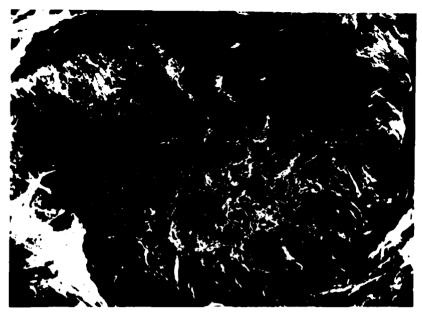
Six years post-impaction (E34). The articular surface was severely fibrillated, especially in the central portion (Fig. 14). A higher magnification of the fibrillated surface is shown in figure 15.

Figure 14. Articular cartilage of a facet joint from a 6 year post-impaction baboon. E34, $\rm L_6$ anterior, 10%.

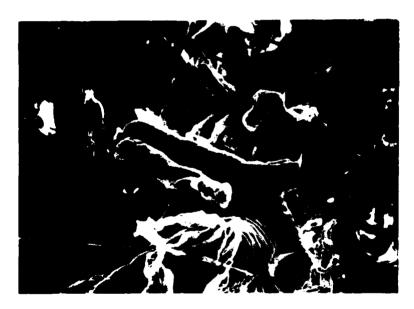
Figure 15. Higher magnification of fibrillated region shown in figure 14. E34, 325X.
