TECHNICAL REPORT GL-83-3

# CONCRETE BLOCK PAVEMENTS

Raymond S. Rollings

Geotechnical Laboratory

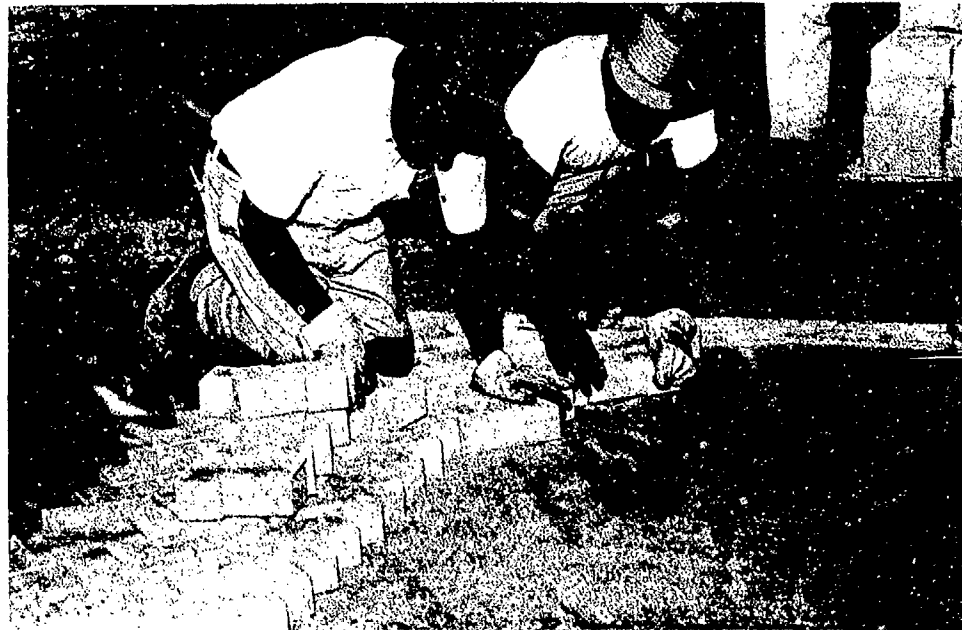
Figure 13. Placing concrete paving block (Z-blocks)

43. Paving blocks are set by hand as shown in Figure 13. A multitude of laying patterns are possible; several were illustrated earlier in Figure 3. Blocks are split to fit any cavities at edge of the pavement, around manholes, etc., where a whole block will not fit. A hydraulic block splitter is shown in Figure 14. Some work has been done to automate placing paving block, but such systems are not in general use now.

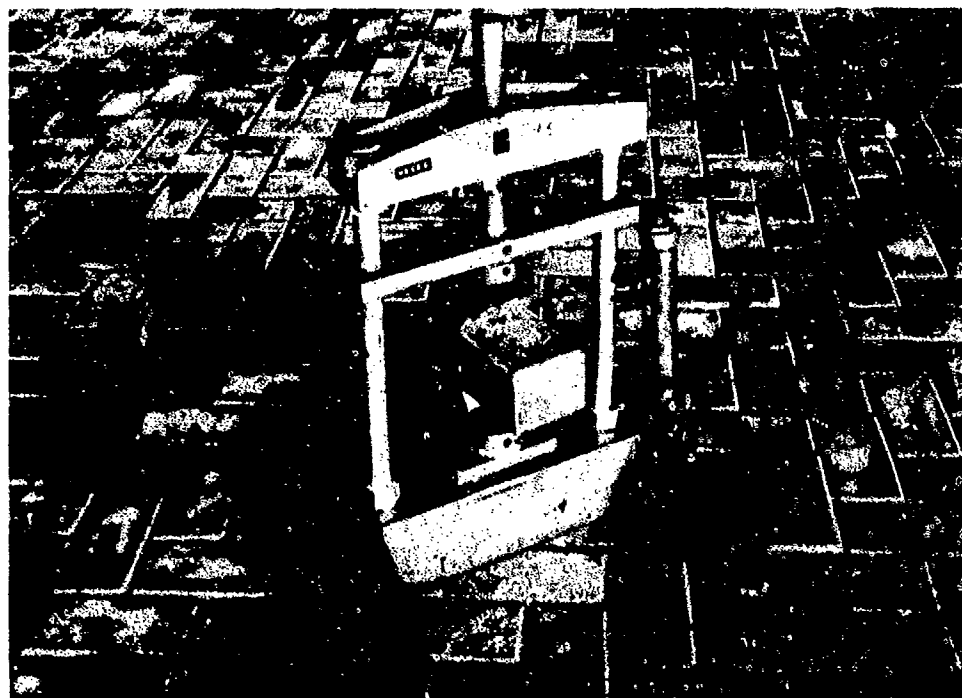
Figure 14. Hydraulic block splitter

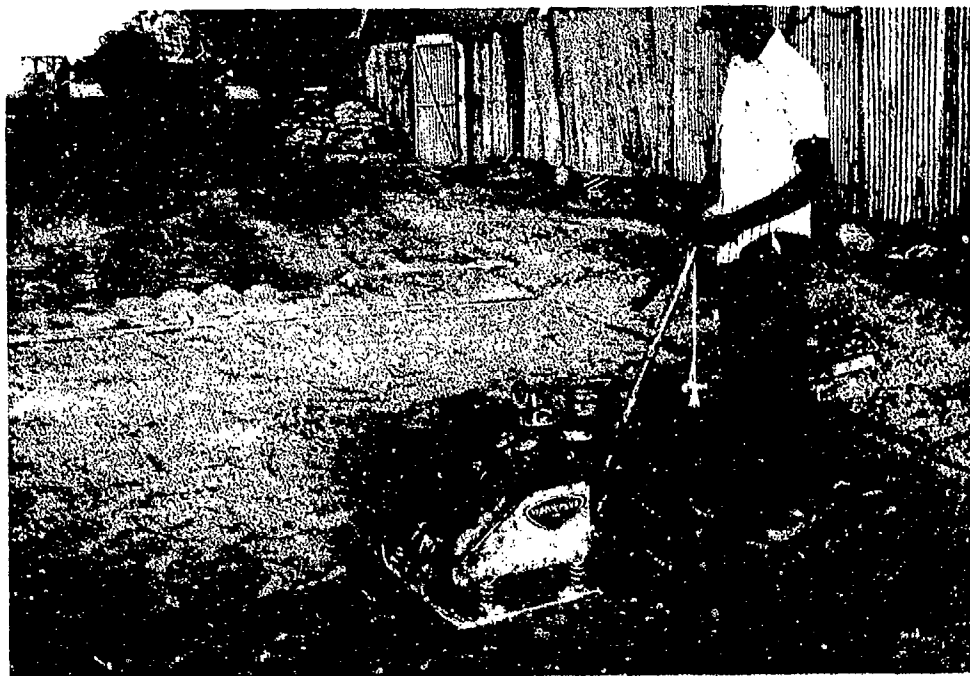
Figure 15. Vibrating sand into paving block joints,  
WES test section

44. The blocks are seated in the sand-laying course by vibrating them with a vibratory plate compactor. Sand is swept from the surface, and as shown in Figures 15 and 16, vibrated into the joints between the

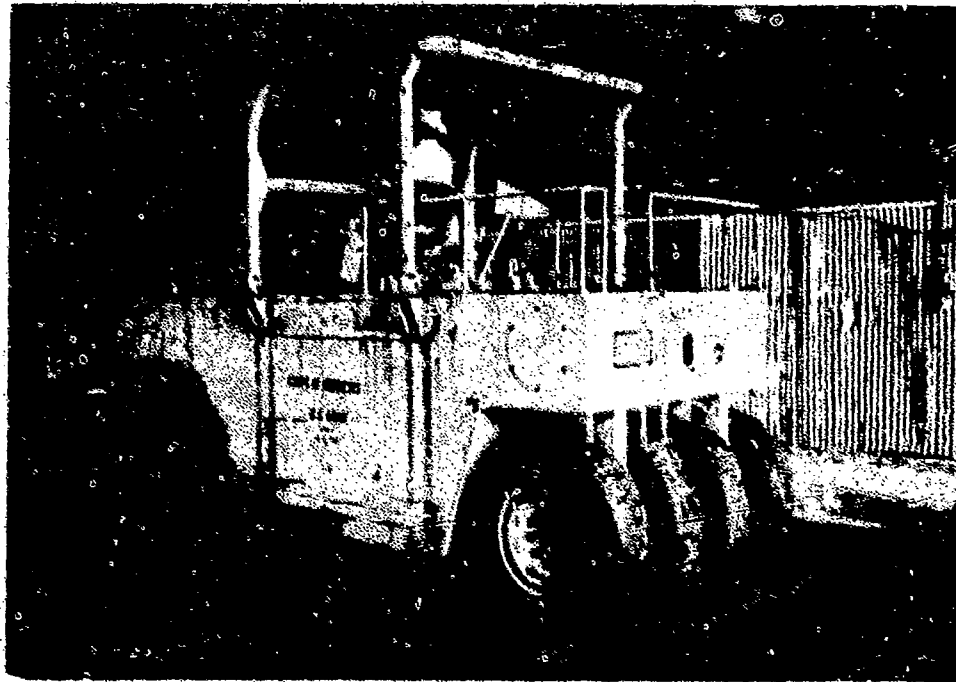
Figure 49. Rolling of heavy clay subgrade, 8 coverages, 65-psi tire pressure, 34 kips

131. The buckshot clay was spread and leveled in 6-in. lifts with a Caterpillar D-4D-tracked dozer. Each lift was compacted with 8 coverages of a self-propelled Ingram pneumatic roller (Figure 49). The

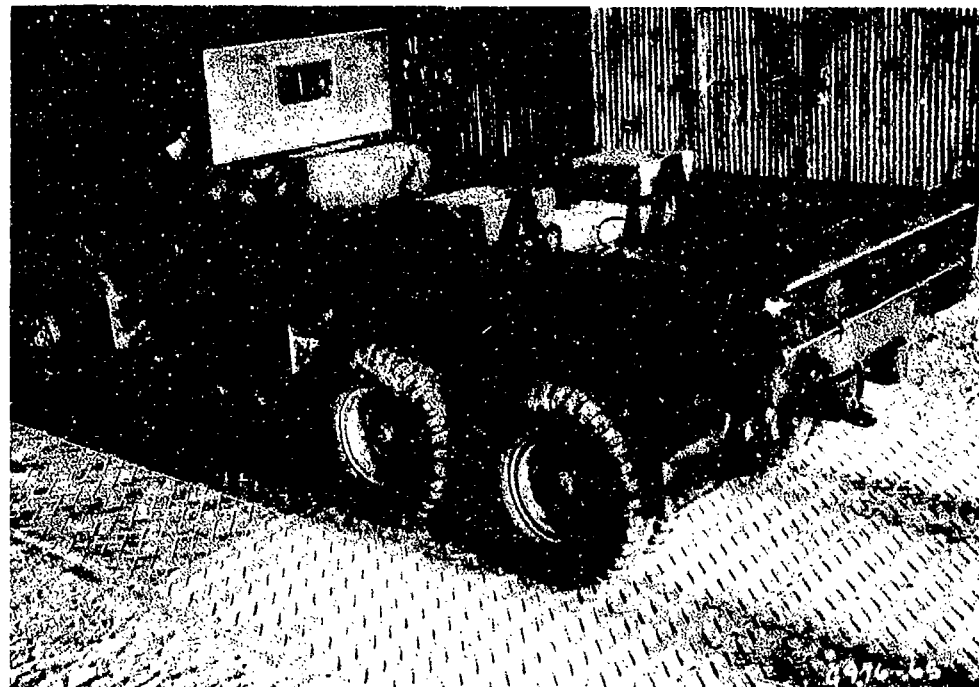
Figure 53. Traffic vehicle

134. Traffic loads were applied by the tandem-axle truck shown in Figure 53. All traffic was low speed and estimated not to exceed 5 mph. The truck was loaded with lead ingots until the load on the tandem axle was 25,000 lb. Wheel spacing for the tandem axle is shown in Figure 54. Using the Corps of Engineers equivalency factors in Figure 55 (Brown and Ahlvin 1961), one pass of the 25,000-lb dual-wheel, tandem-axle load is equivalent to one pass of a standard 18,000-lb, dual-wheel, single-axle load.

135. The rope visible in Figures 52 and 53 marks the outside left lane of traffic for the driver. No prescribed width or distribution of traffic was used in applying traffic. The traffic distribution came from the natural driving variation of the driver as he tried to drive with the wheels adjacent to the marking rope. This led to a narrow trafficked width of approximately 34 in. for each set of dual tires.

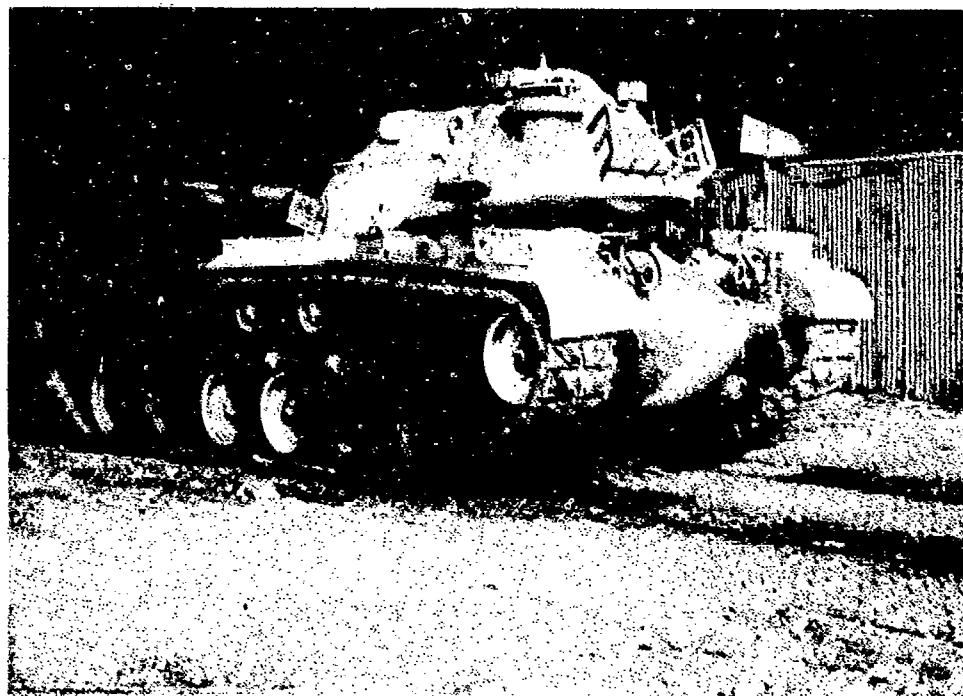
Figure 68. M-48 tank on item 2

140. After traffic with the truck, the M-48 tank in Figure 68 was turned repeatedly on the rectangular blocks in item 2. This tank was loaded with lead ingots for a total gross weight of 105,000 lb which is representative of a current U. S. Army M-60 tank. To make the turns, one track of the tank was locked while the other track drove the vehicle in circles. After repeated turns, blocks showed no signs of damage or shifting, and the test was halted.
