*HEAT TRANSFER AND EROSION IN THE ARES  
75 MM HIGH VELOCITY CANNON - VOL II*

Calspan Technical Report No. VL-5873-D-1

**Prepared For:  
ARES, INC.  
PORT CLINTON, OHIO**

**OCTOBER 1977  
PURCHASE ORDER NO. 1438**

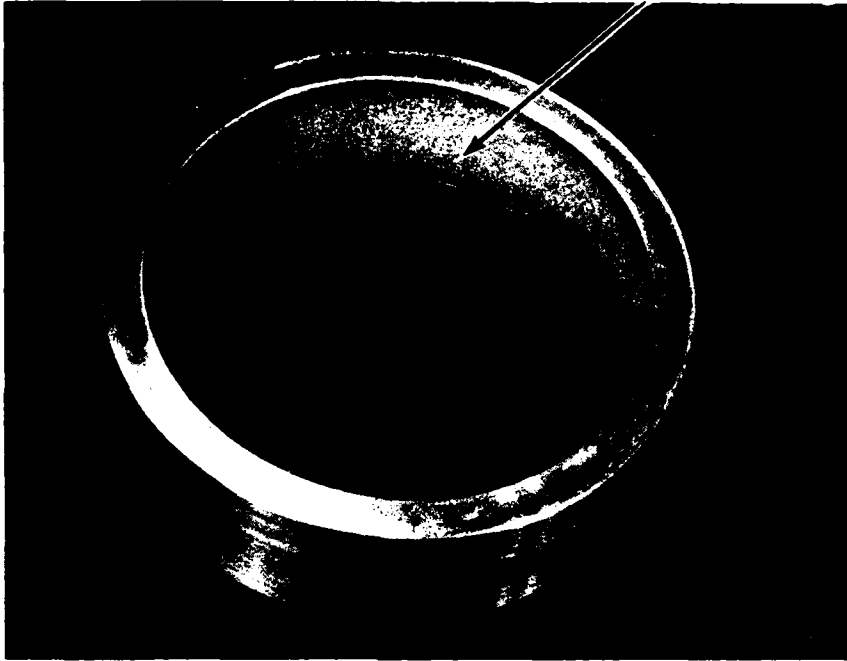
**SATIN  
SURFACE CONDITION**

**TYPICAL SOFT (LC) CHROME RING-  
AS PLATED**

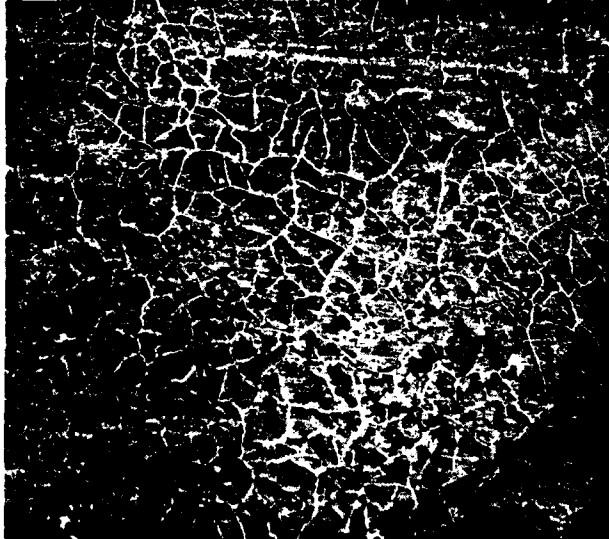
**SURFACE OF HARD CHROME PLATED EROSION SENSOR  
AFTER ONE SHOT  
(100X, SEM)**

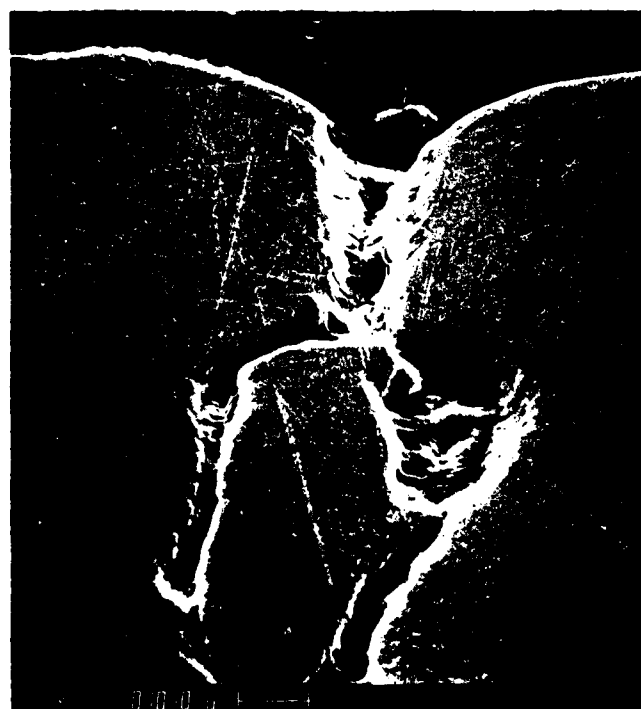
**Figure 32 SAME CRACK AS ABOVE AT 1000X. PROPELLANT GASES HAVE ERODED CRACK WIDTH TO 10-15  $\mu$  = 0.5 MIL**
