HYDRAZINE APU STARTER DEVELOPMENT(U) ROCKET RESEARCH
CORP REDMOND WASH D A PAHL JUN 83 RRC-83-R-905
AFWAL-TR-83-2039 F33615-78-C-2003

HYDRAZINE APU STARTER DEVELOPMENT

ROCKET RESEARCH COMPANY
YORK CENTER
REDMOND, WASHINGTON 98052

FINAL REPORT FOR PERIOD MARCH 1978 — MARCH 1983

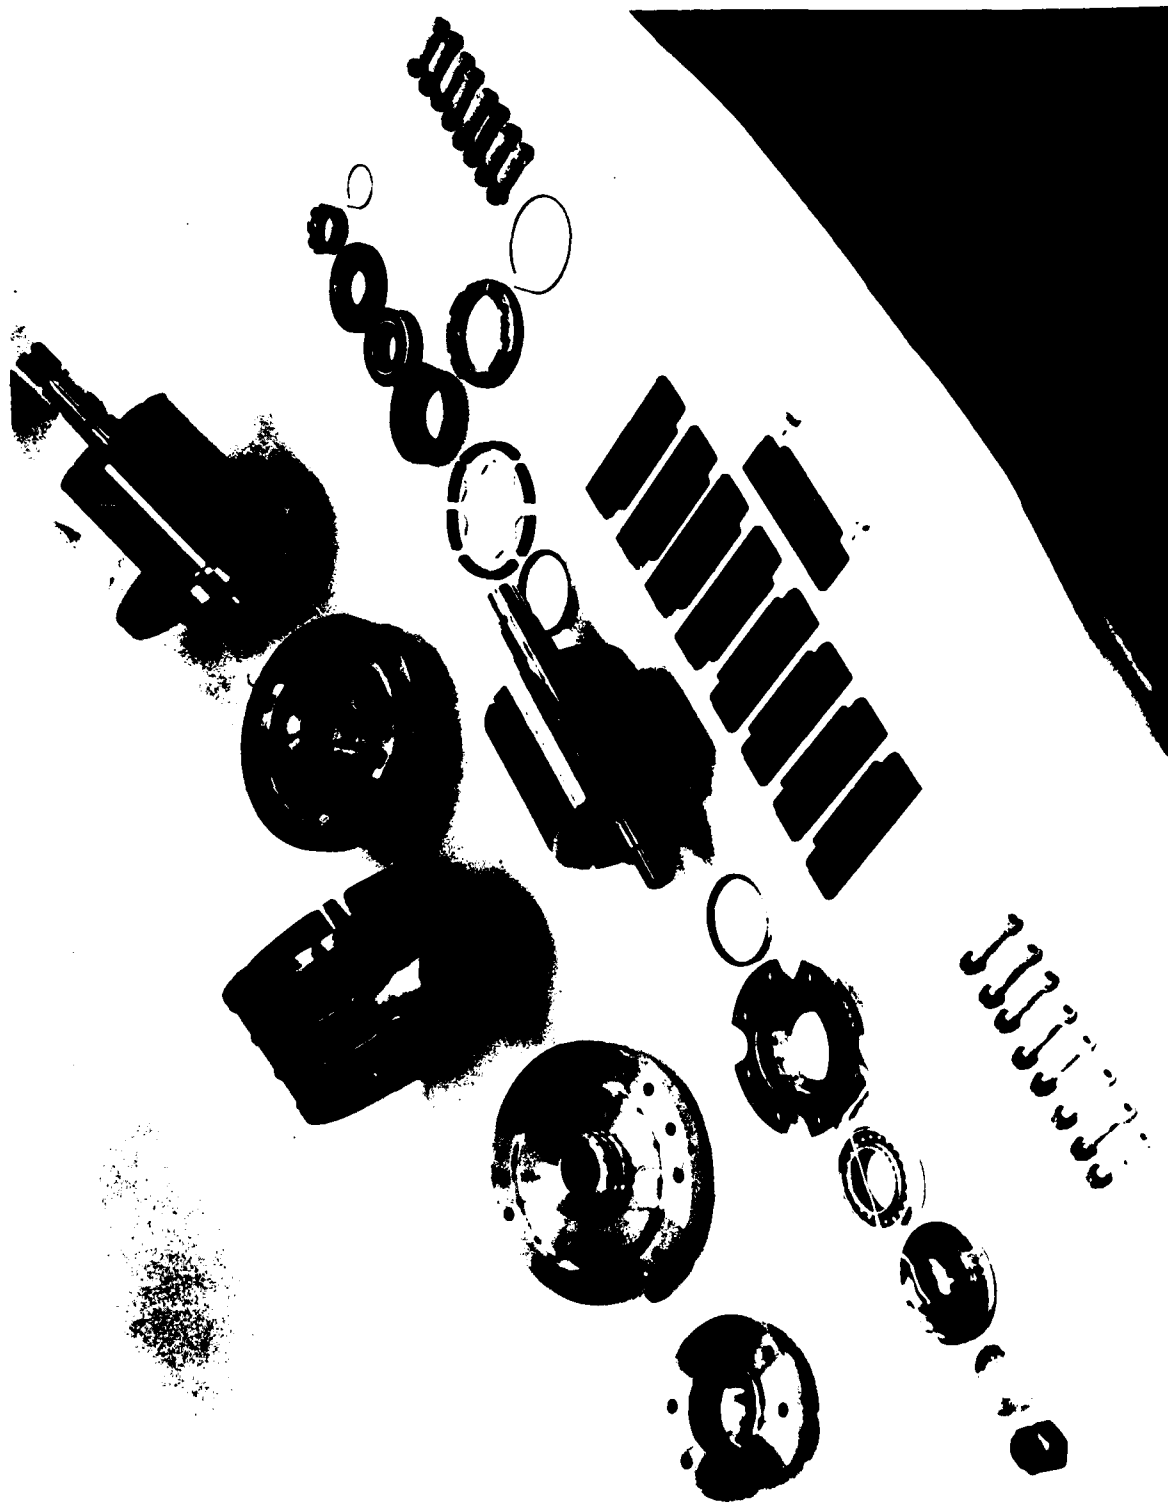
Figure 4. Vane Motor Piece Parts and Major Subassemblies (left view)

Output end plate
Rotor installed in end plate
