LASH SHIP PRETEST RESULTS OF THE JOINT
LOGISTICS-OVER-THE-SHORE (LOTS) TEST (U) OPERATIONS
RESEARCH INC SILVER SPRING MD H CASEY ET AL. 07 MAR 77
ORI-TR-1121 MDA903-75-C-0016

Rept. No. ORI-TR-1121

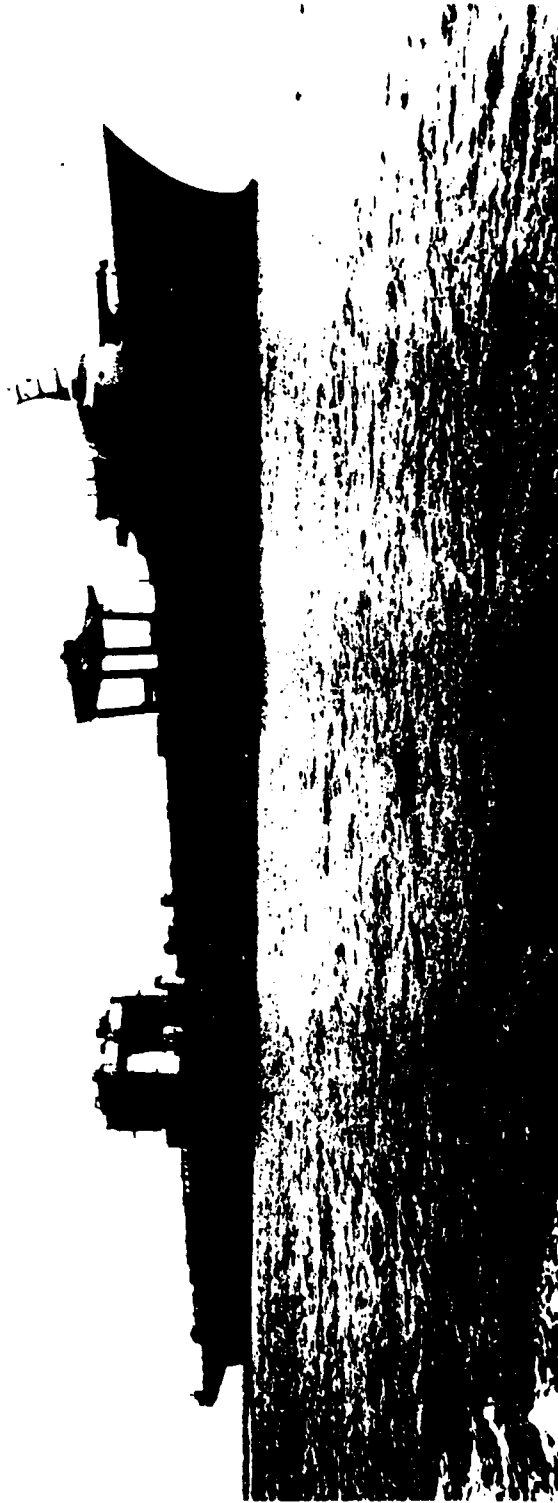
FIGURE 1. S.S. LASH ITALIA. The S.S. LASH ITALIA, a C881 Lighter-Aboard-Ship vessel, was chartered August 23-26, 1976, for the second in a series of LOTS pretests (the first pretest involved a conventional breakbulk ship). The LOTS pretest provided the Services the first opportunity to dedicate a LASH ship solely for military logistic operations and to operationally test the LCM8 lift beam.

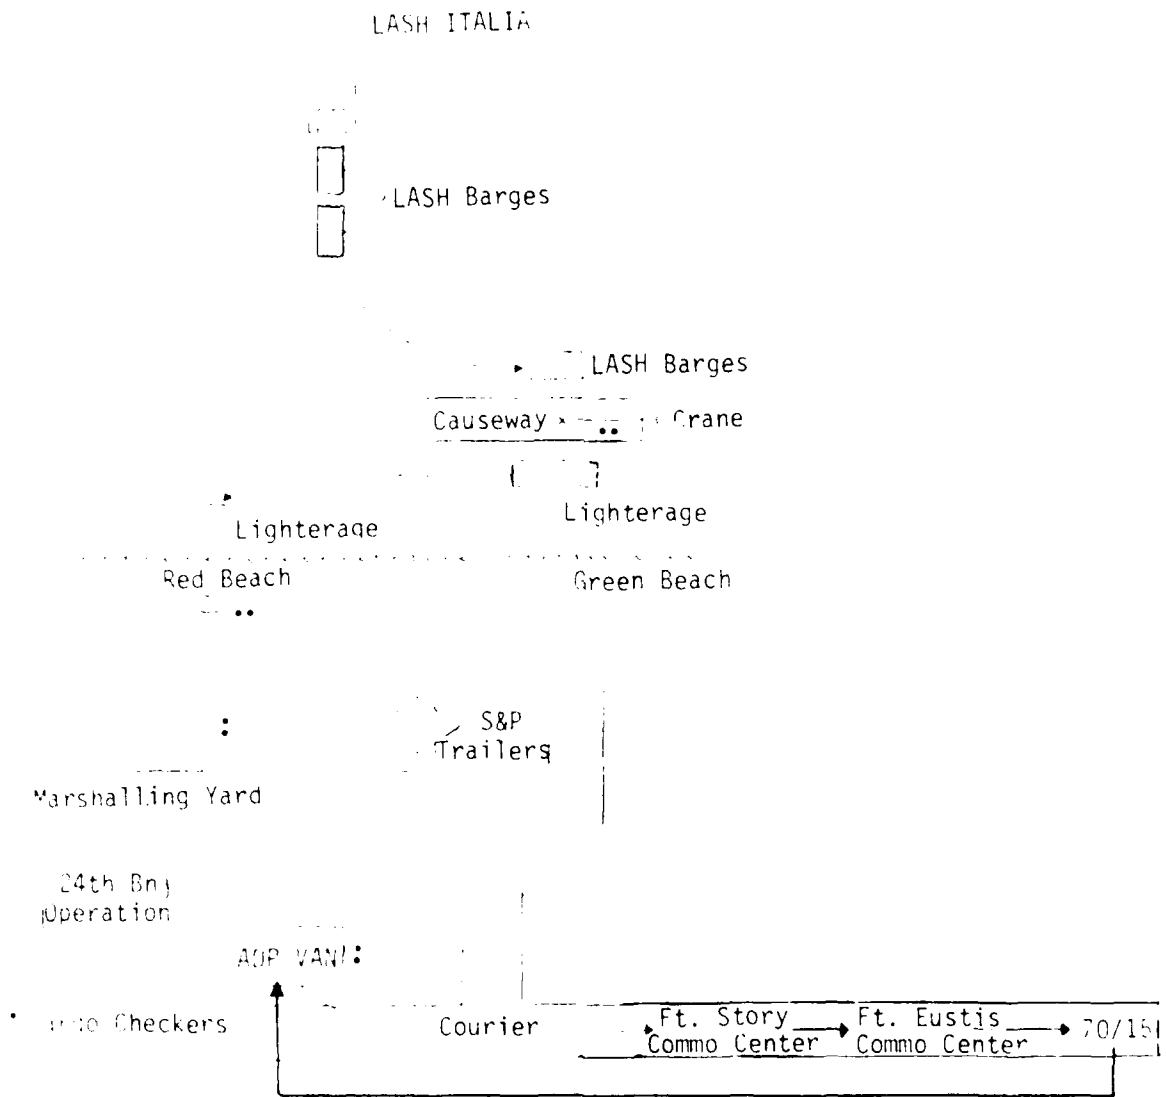
FIGURE 9. CARGO AND DOCUMENTATION FLOW

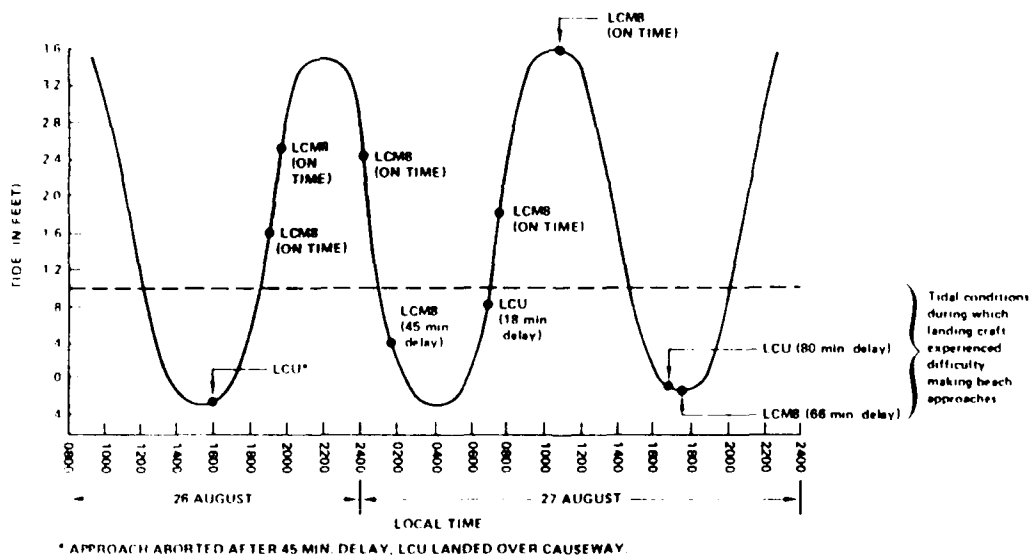
FIGURE 14. TIDAL CONDITIONS DURING LANDING CRAFT BEACH APPROACHES

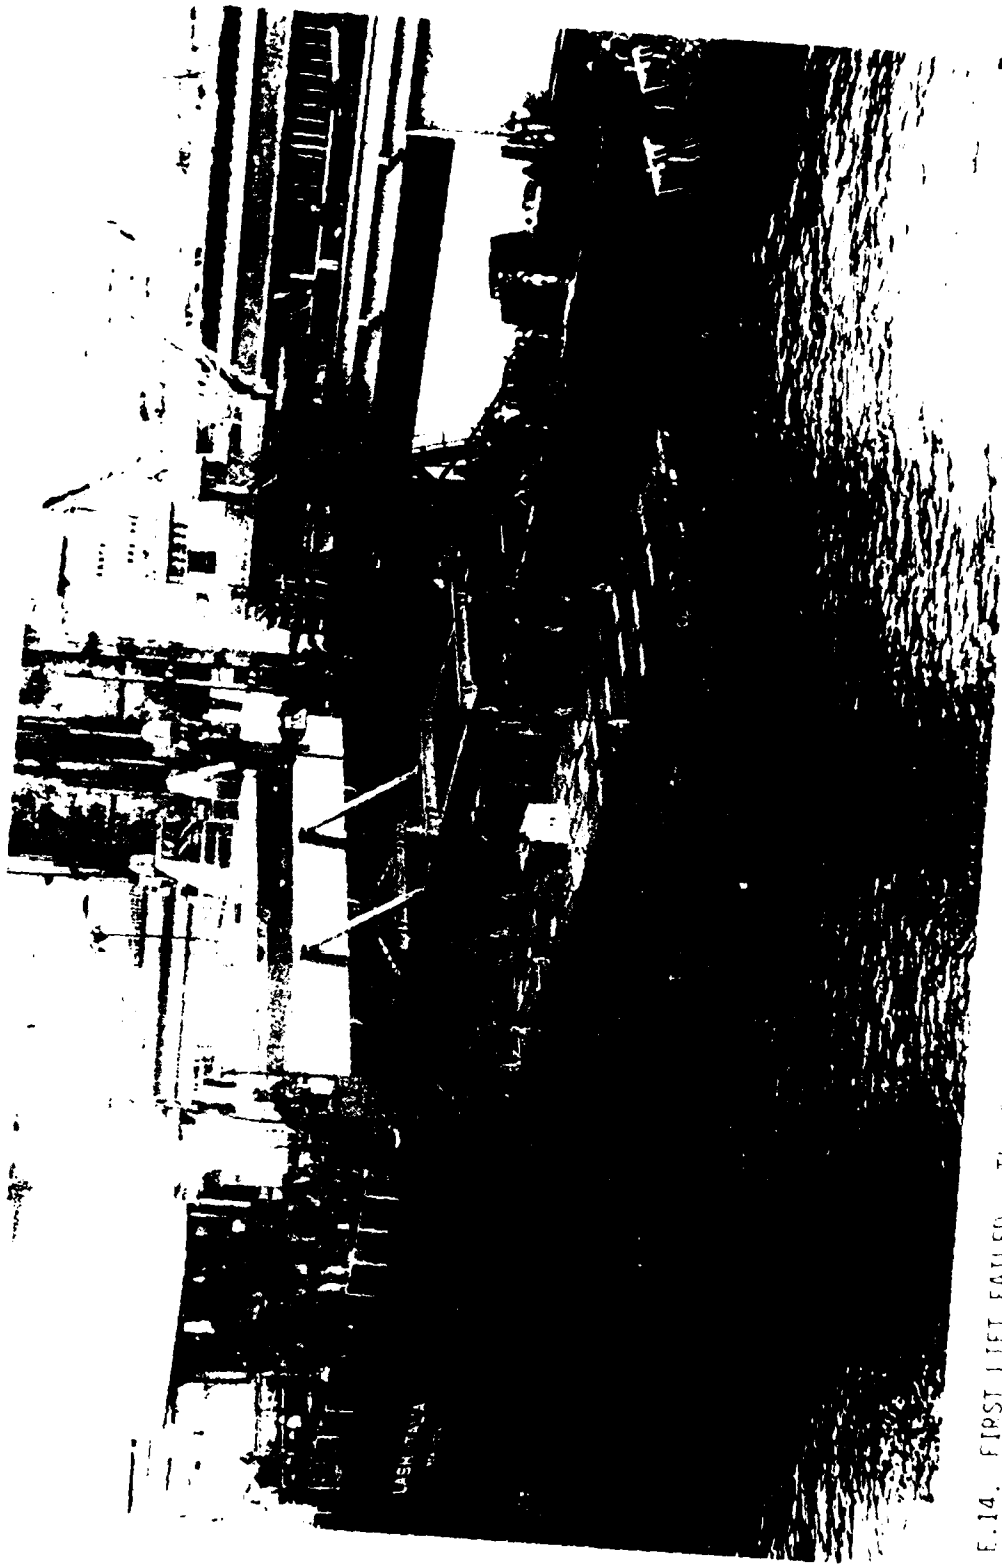
E.14. FIRST LIFT FAILED. The 3 x 25 causeway with 87.5 short tons aboard *U.S.S. Albatross* could not be safely hoisted by the lifting frame. In a second try, with all weights removed except for a 7-ton block as shown, the 3 x 25 causeway was hoisted aboard ship. The lift beam was then certified by the American Bureau of Shipping for lifting roadway sections.

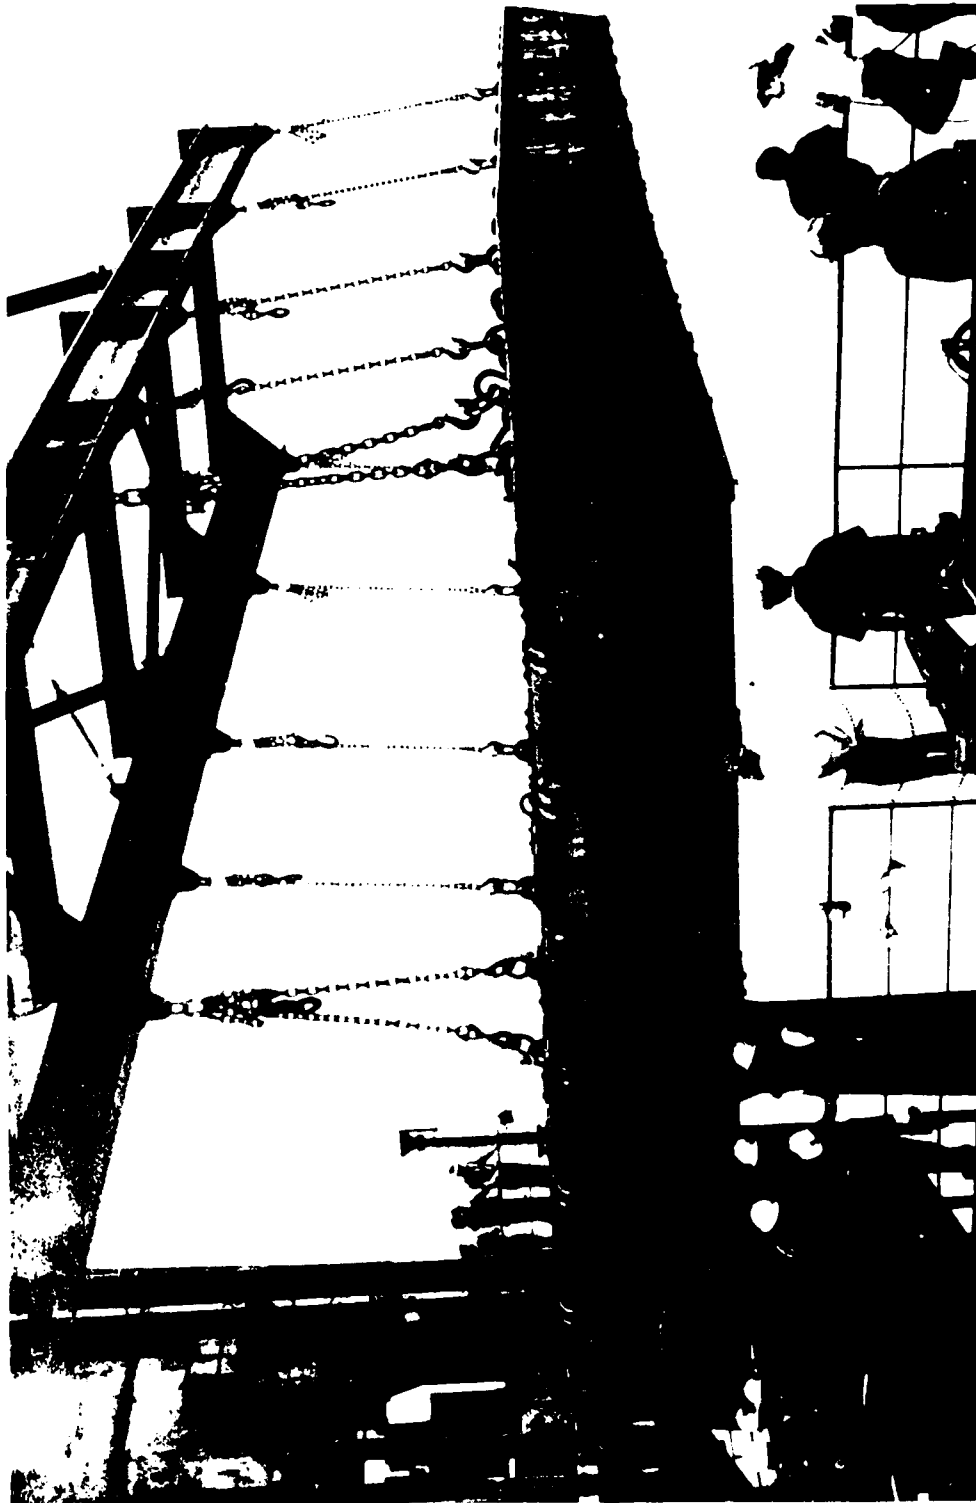
E.15. CAUSEWAY OFF-LOADING. Later, when the LASH ITALIA had been fully loaded, the ship moved to an anchorage off Green Beach, Ft. Story. After more than 7 hr spent trying to assemble the causeway lift frame to the LCM8 lift beam, the 3 x 15 causeway was finally off-loaded in about 49 minutes. Disassembly of the device required about 80 minutes. A new method of attaching the causeway lift frame has subsequently been adopted.
