AGARD CONFERENCE PROCEEDINGS No. 355

Characterization, Analysis and Significance of Defects in Composite Materials

Papers presented at the 56th Meeting of the Structures and Materials Panel
in London, United Kingdom on 12-14 April 1983.

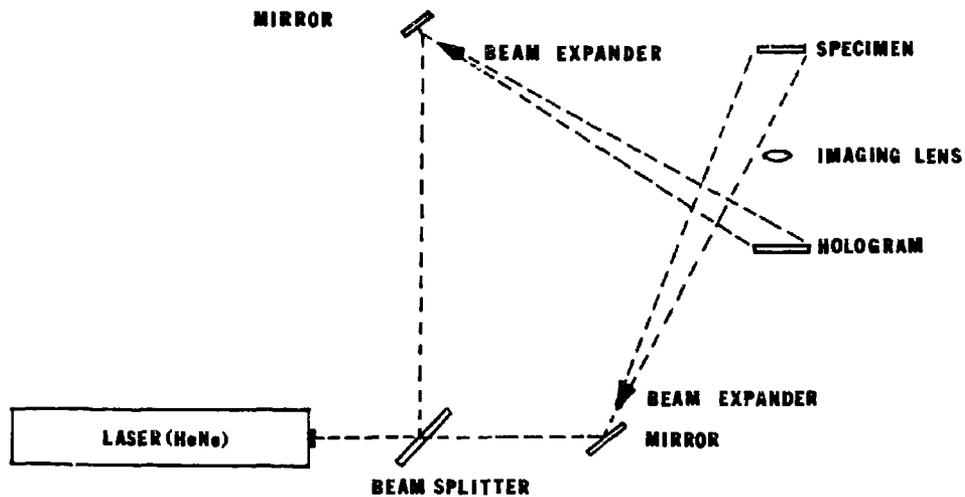
Fig. 14. Schematic diagram showing standard off-axis holographic setup.

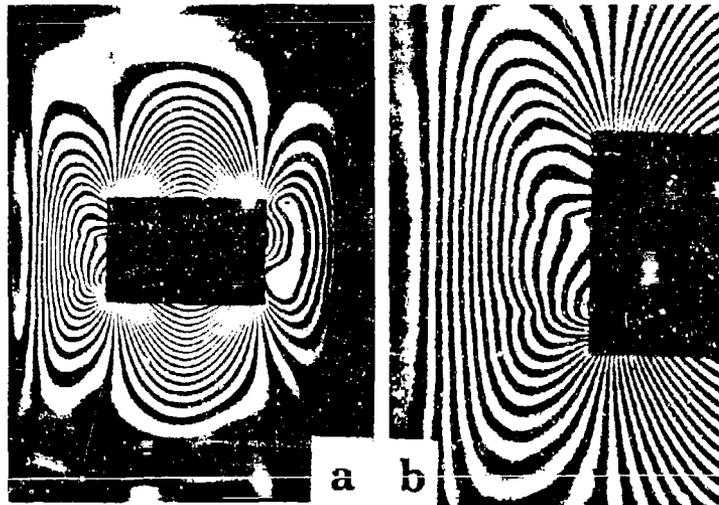
Fig. 15. Axial compressive loading induced holographic fringe pattern showing anomalies caused by manufacturing induced surface cracks in a fiberglass cylinder with a rectangular cutout.

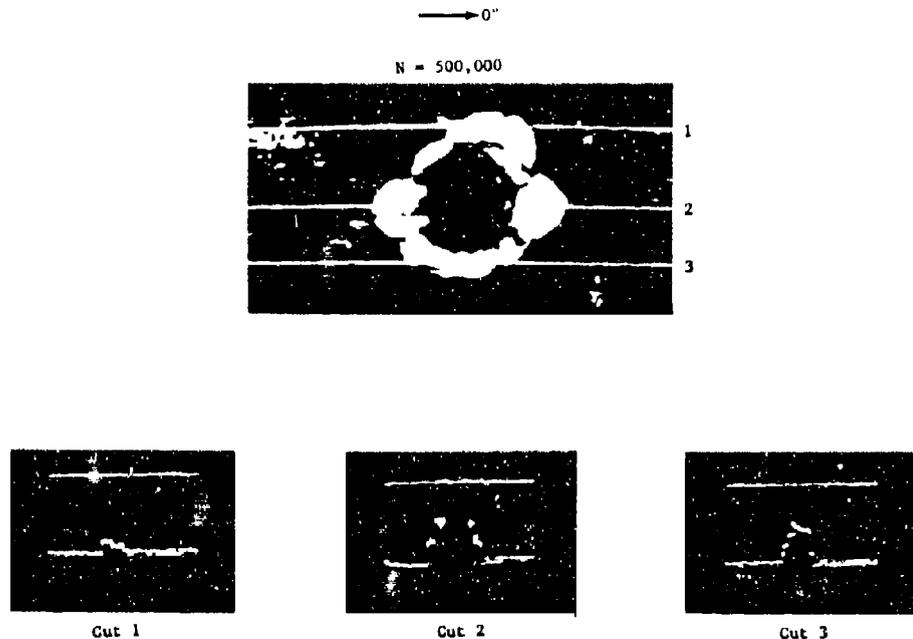
Fig. 19. C- and B-scans of 32-ply quasi-isotropic graphite-epoxy specimen with circular hole after 500000 cycles of fully reversed loading (Ref. 35).

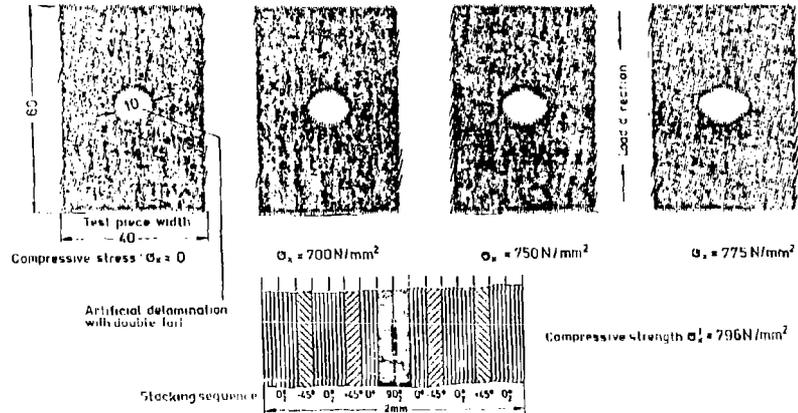
Fig. 8 Growth of artificial delamination under step-by-step compressive loading. Ultrasonic C-scans of a test specimen containing teflon circles implants

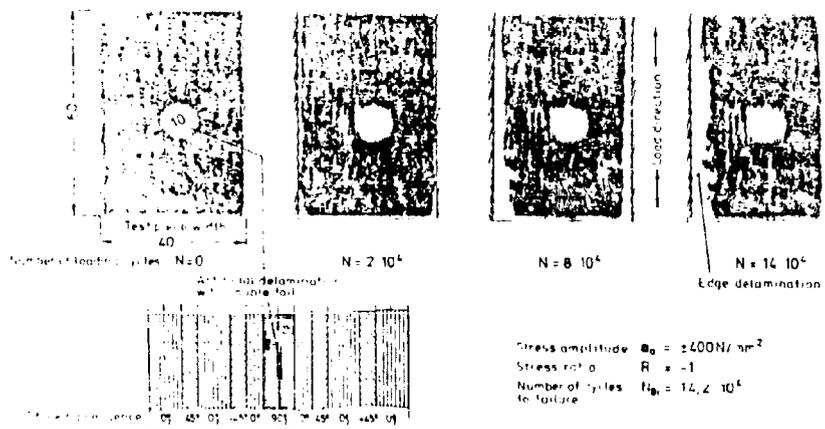
Fig. 10 Delamination states on increasing numbers of tension-compression loading cycles. Ultrasonic C-scans of a test specimen containing teflon circles implants

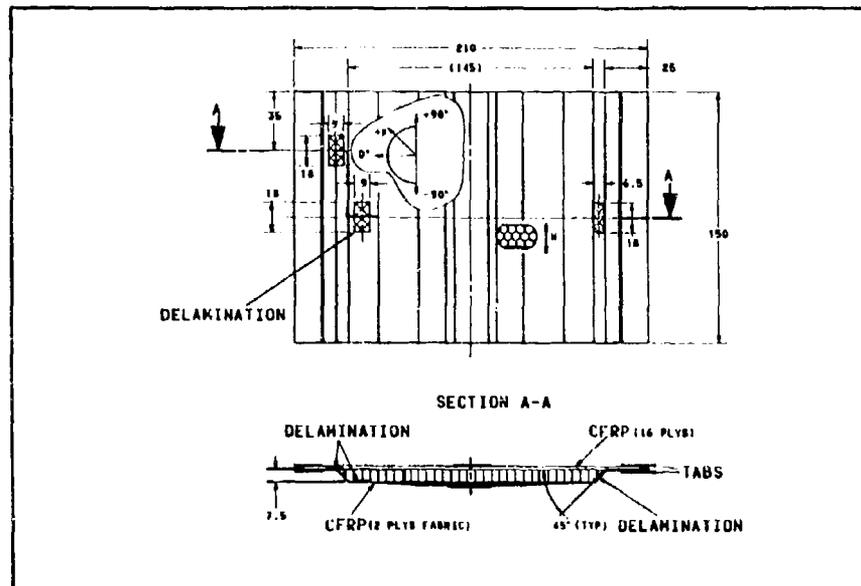
Fig. 1 Three point bending sandwich specimen with built-in delaminations

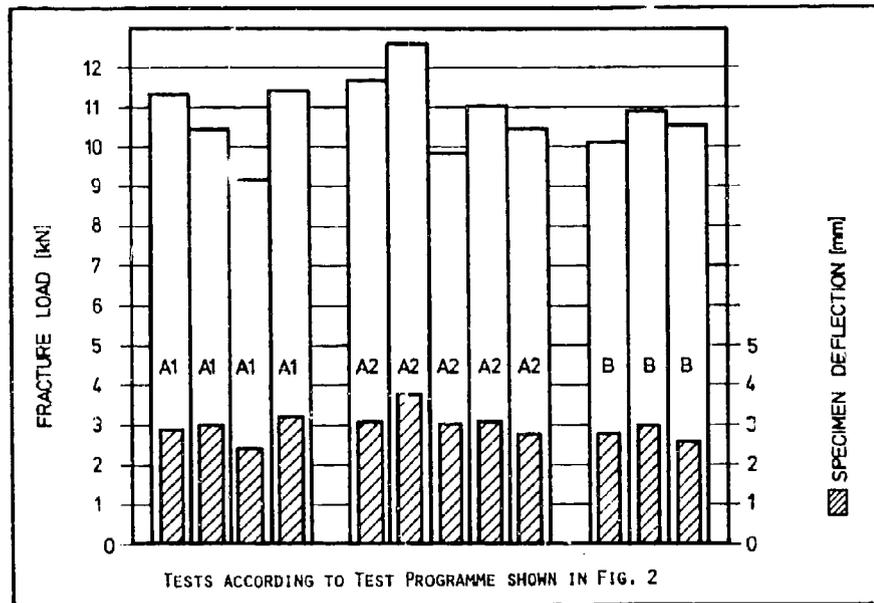
Fig. 3 Individual results of residual fracture load and specimen deflection of sandwich beam specimens

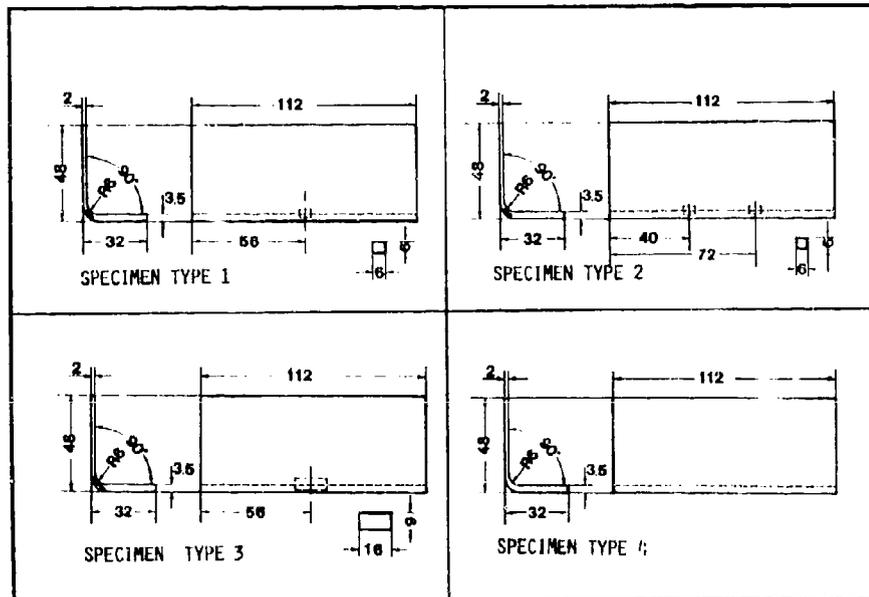
Fig. 4 Geometry, defect position and defect size of CFRP shear angles

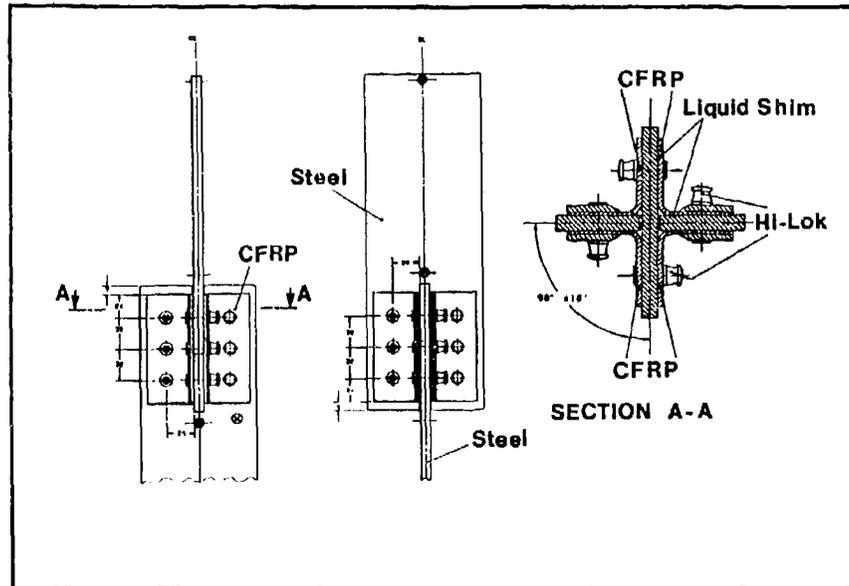
Fig. 5 Assembly drawing of shear angle specimens

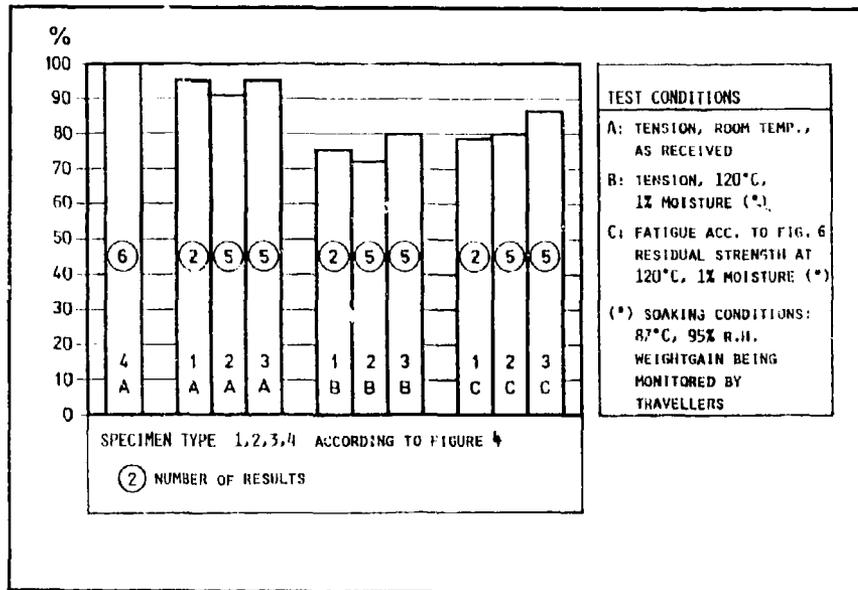
Fig. 7 Mean strength of shear angle specimen at various test conditions and three types of built-in delaminations

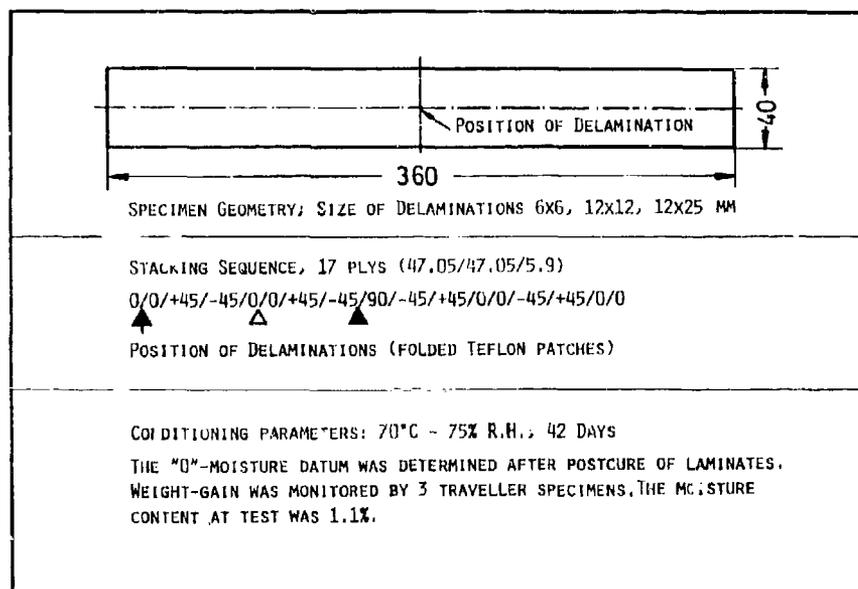
Fig. 8 Specimen geometry, lay-up, size and position of defects and conditioning of multidirectional compression specimens

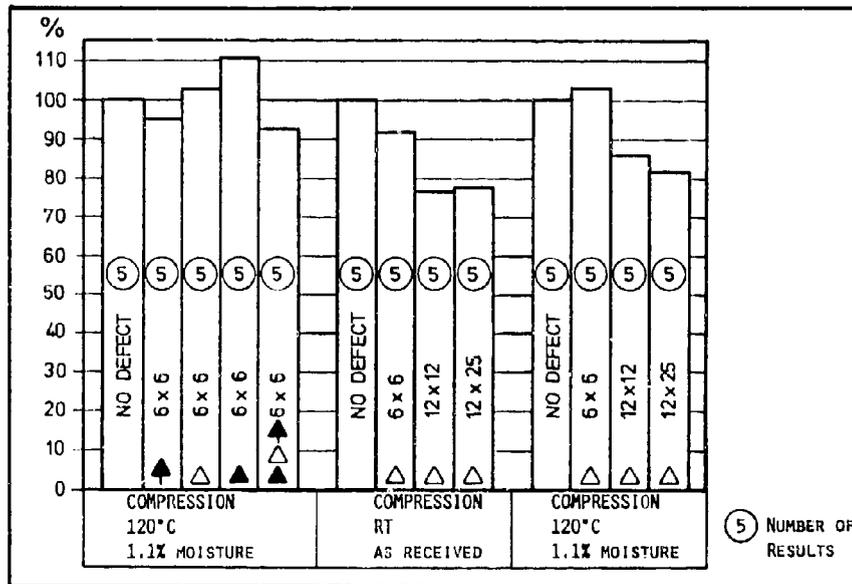
Fig. 9 Mean compression results as function of test conditions and delamination size and position

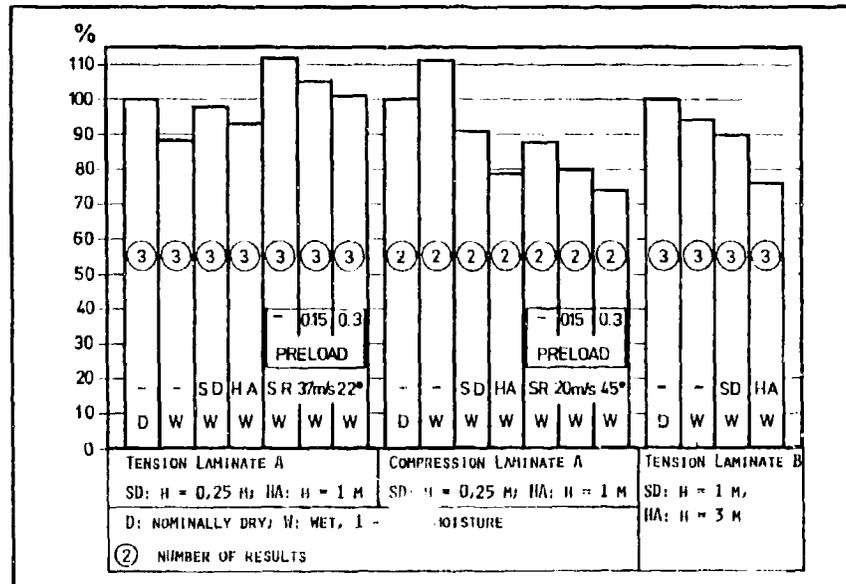
Fig. 13 Influence of low energy impact - mean test results at room temperature

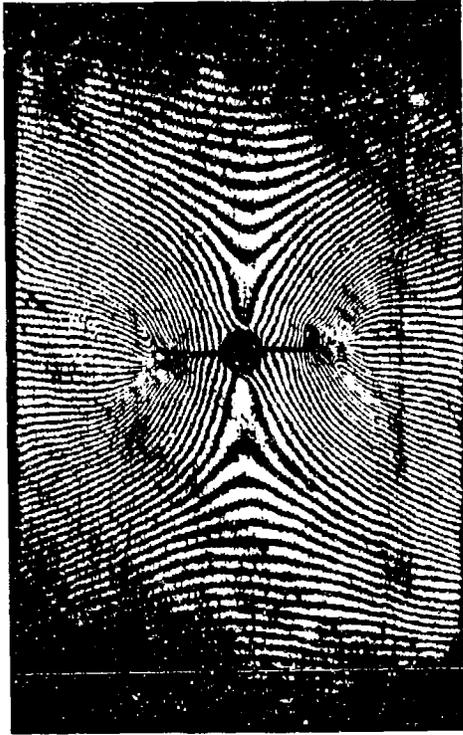
Fig 3 Laser moiré fringe pattern on a notched $(0^\circ, \pm 45^\circ)$ CFRP specimen under tension showing damage zones formed at the notch tips

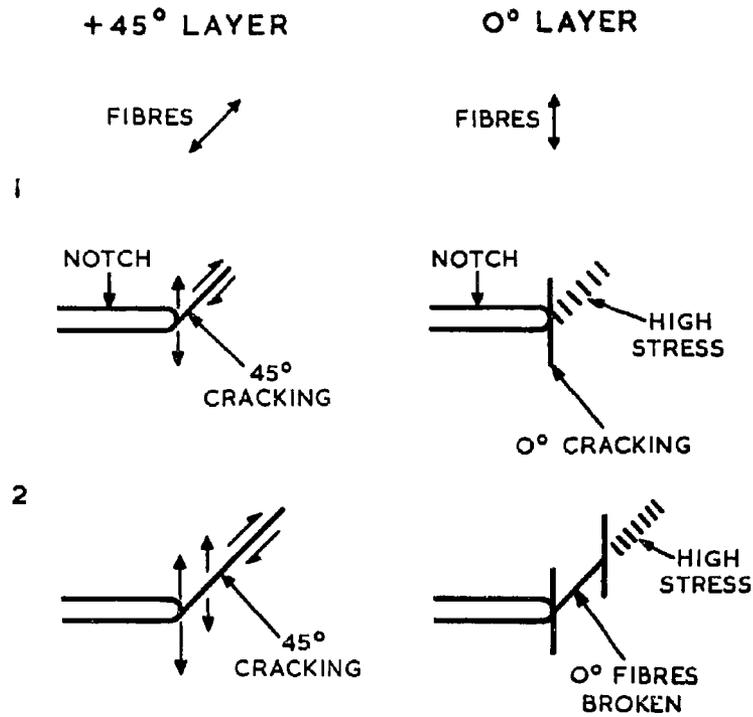
Fig 7 Layer interactions at notch tips in CFRP under tension showing the effect on the load-bearing 0° layers of 45° shear cracking

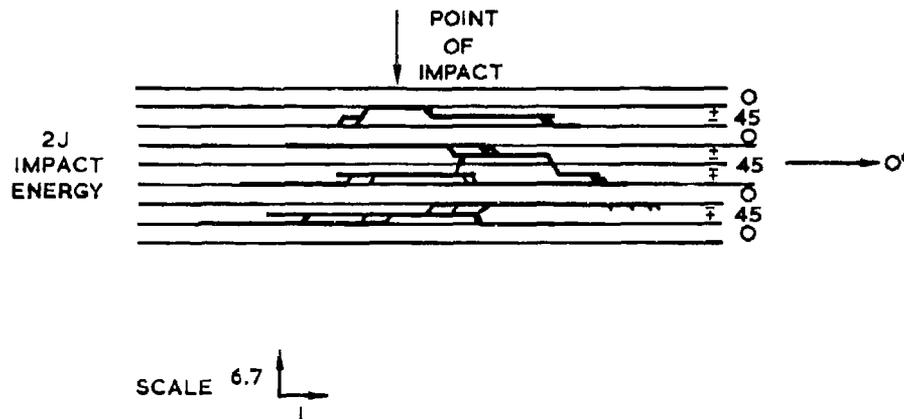
Fig 10 Scaled diagram showing delaminations observed microscopically in a polished cross-section of impacted $[(0^\circ_2, \pm 45^\circ)_2]_5$ CFRP

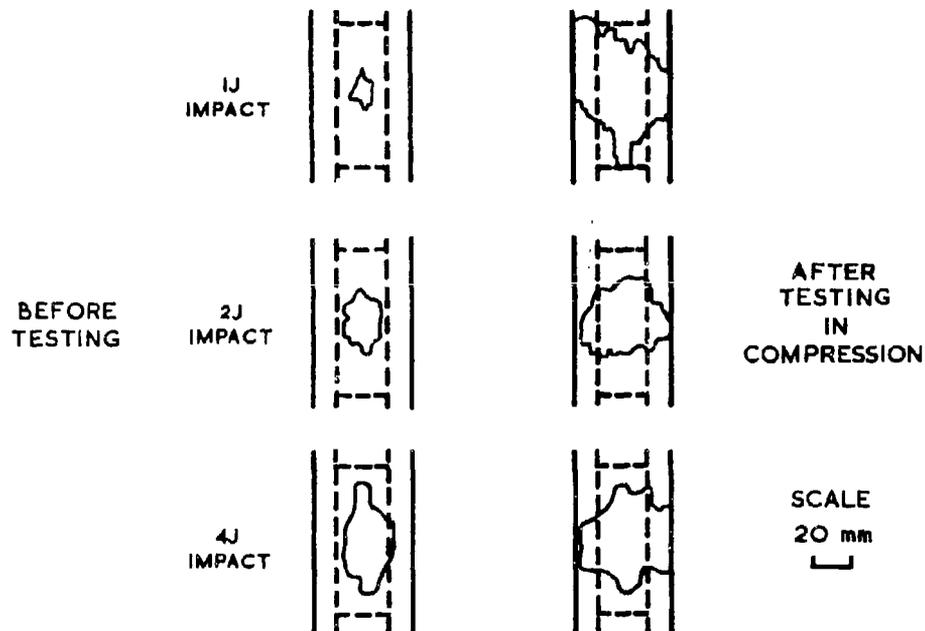
Fig 11 Delaminated areas in impacted specimens of $[(0^\circ_2, \pm 45^\circ)_2]_5$ CFRP before and after testing in compression (dashed lines indicate position of antibuckling guides along specimen edges)

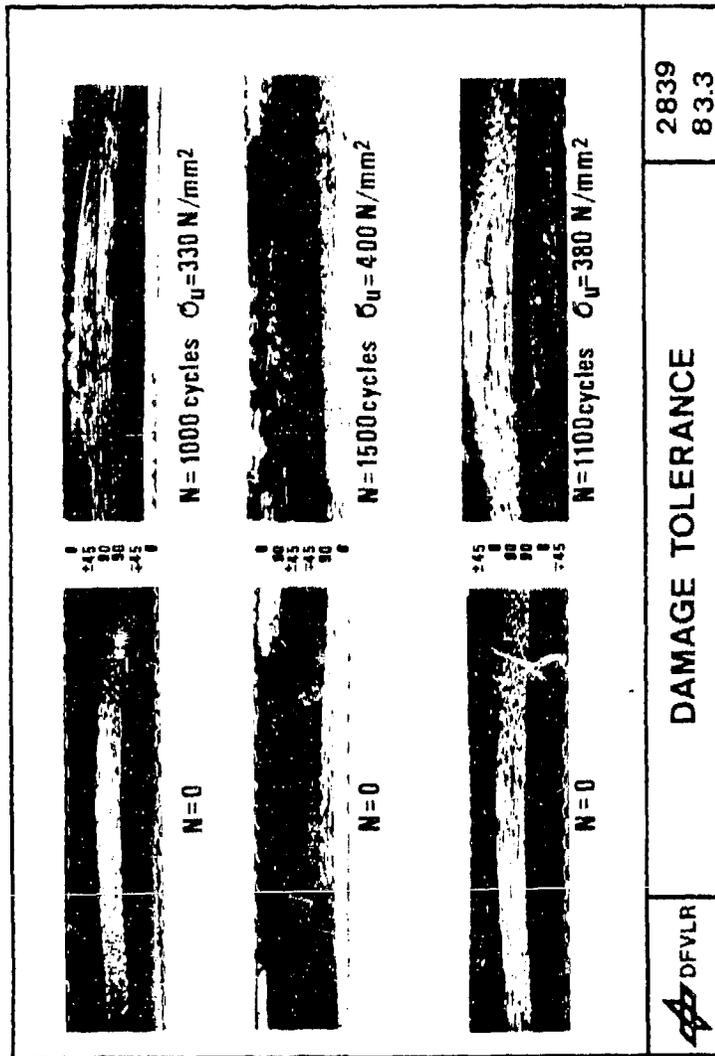
Fig. 5-Micrographs of specimens with idealized discontinuity before and after tensile fatigue loading

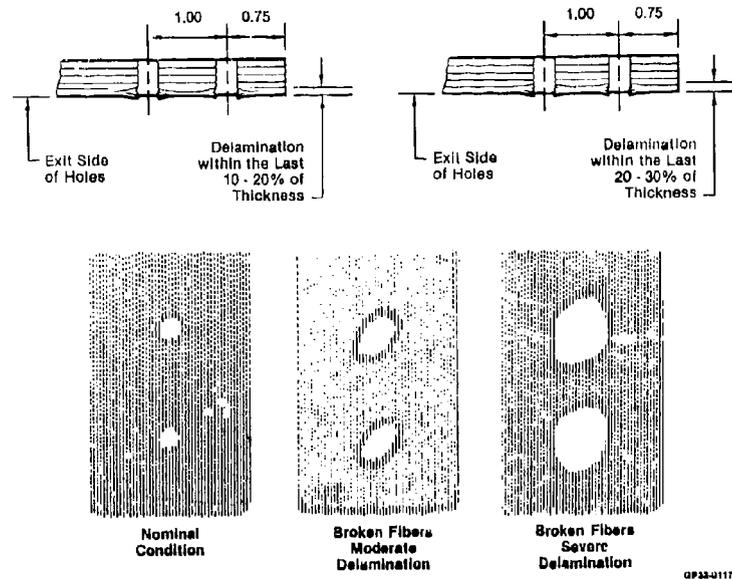
Figure 4. C-Scans of Laminates with Delaminations at Fastener Holes

Delaminations were detected visually and with ultrasonic C-scan. Delaminations were defined as "moderate" when they extended 10-20 percent (2-4 plies deep) into the laminate thickness on the exit side. Delaminations were defined as "severe" when they extended 20-30 percent (4-6 plies) of the laminate thickness on the exit side. Non-destructive C-scans in the area of the fastener holes with moderate and with severe delaminations are illustrated in Figure 4 and compared with a nominal condition.

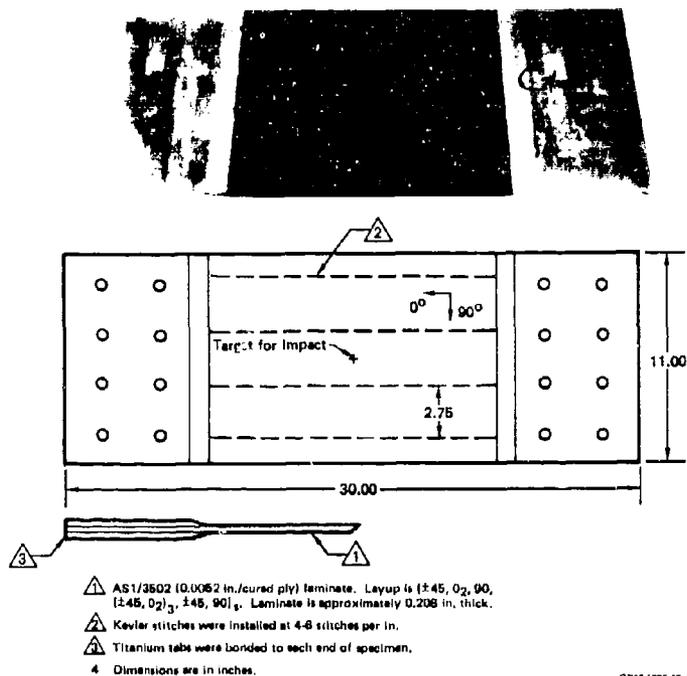
Figure 26. Specimen Configuration - Skins with Nonvisible Impact Damage

The specimen configuration is presented in Figure 26. Various impact energies were evaluated to determine the energy level representing the threshold between visible and nonvisible impact damage. A .50-inch diameter indenter was used while specimens were supported over a 3-by-3-inch opening. An 8-ft-lb energy level was determined to be the minimum level to produce visible surface damage. The 8 ft-lb energy level was also considered to be representative of expected damage from dropped tools and damage from runway stones. Resulting internal damage detected in ultrasonic inspection of the four specimens ranged from 1.2-inch to 1.5-inch diameter.

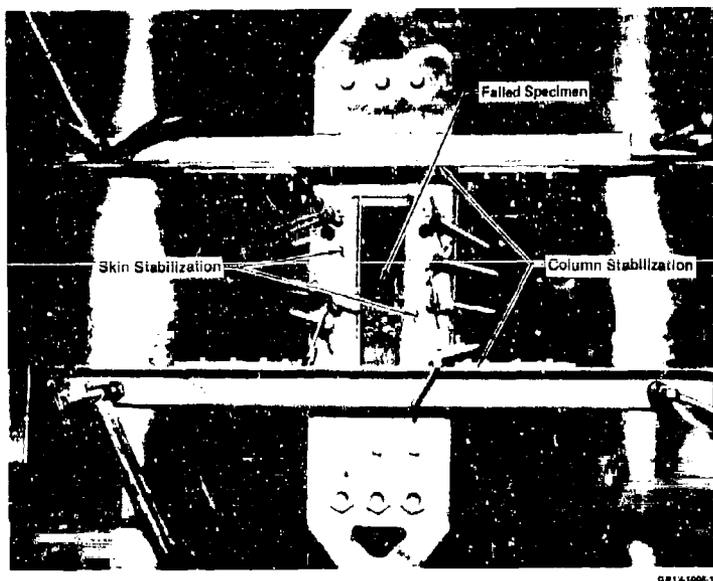
Figure 27. Structural Test Setup - Compressive Strength of Damaged Specimens

The setup for these compression tests is shown in Figure 27. Each end of the specimen was bolted to a loading adapter which fit within hydraulic grips in the upper and lower platens of the test machine. Back-to-back channels having access holes for instrumentation were clamped onto the specimen for skin stabilization. The area between the two central rows of stitches in the specimen contained the damage and was not stabilized by the channels. The column composed of the specimen with loading adapters on each end was supported at two locations by additional fixturing which was attached to the test machine. Strain data from back-to-back gages on the specimen indicated little bending. Measured strains in the stabilizing channels were negligible.

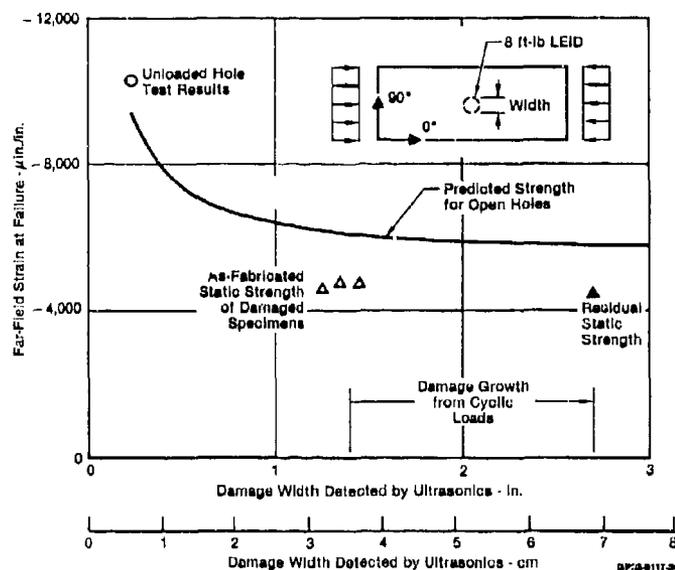
Figure 28. Residual Strength of Specimens with Nonvisible Impact Damage

These test results are summarized in Figure 28 in terms of far-field failure strains as a function of damage sizes detected in ultrasonic inspections. Test results for coupons with a .25-inch diameter hole are also shown in Figure 28. The predicted strengths, presented as a solid line, were determined using the methodology of Reference 1 and the material properties shown in Figure 29. These predictions correlate well with test results for specimens having a .25-inch diameter hole. Predictions for specimens containing impact damage were made for damage modeled as open round holes.

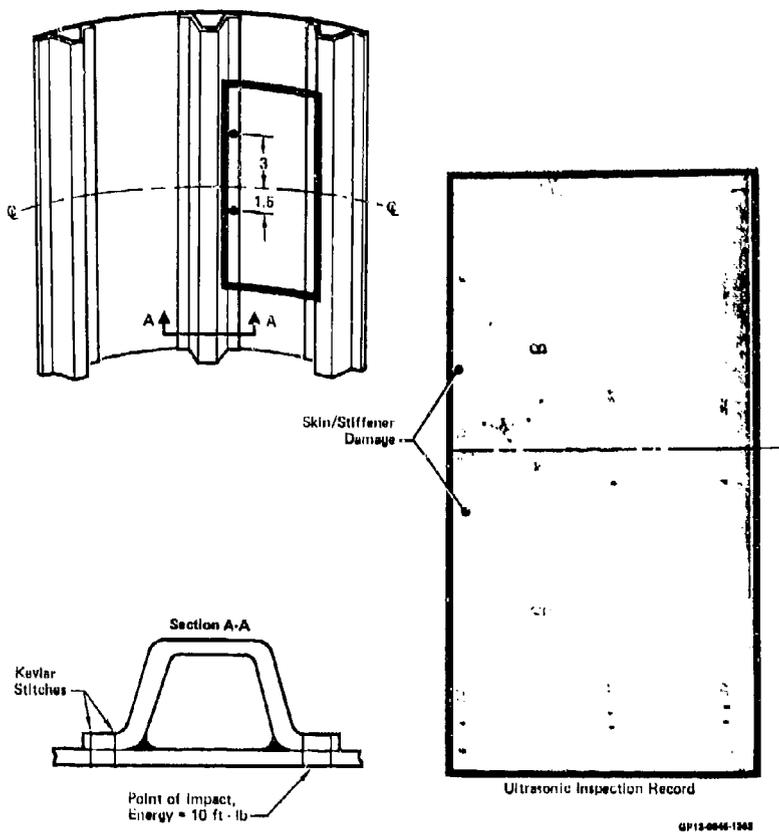
Figure 32. Damage Containment in Stitched Skin-to-Stiffener Joints

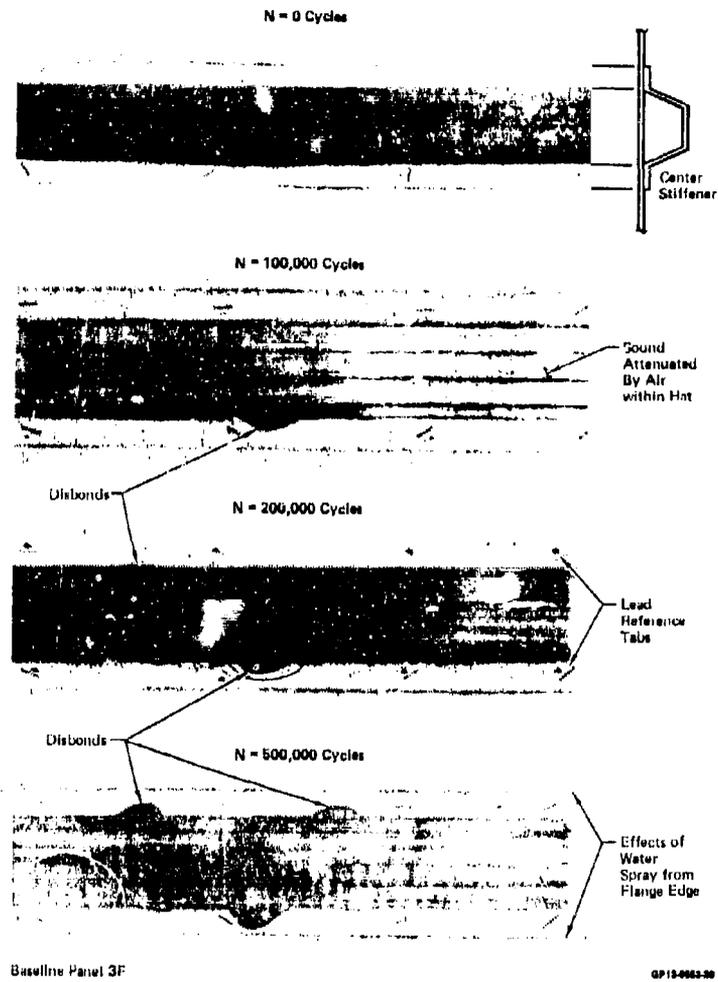
Figure 33. Growth of Disbands in Flange-to-Skin Joint

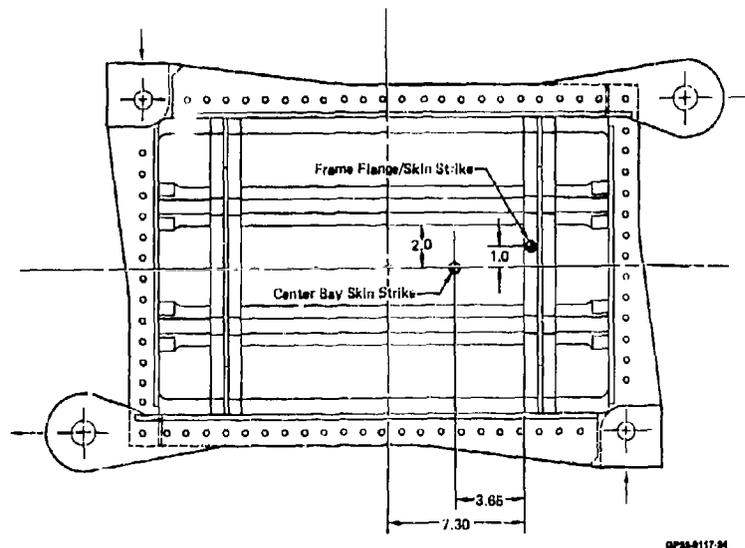
Figure 35. Shear Panel Configuration and Impact Damage Locations

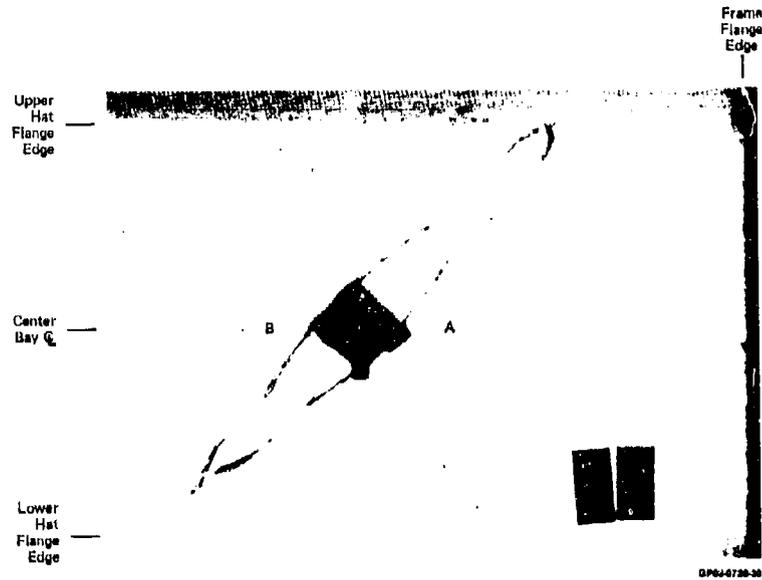
Figure 43. Radiographic Inspection of Initial Impact Damage

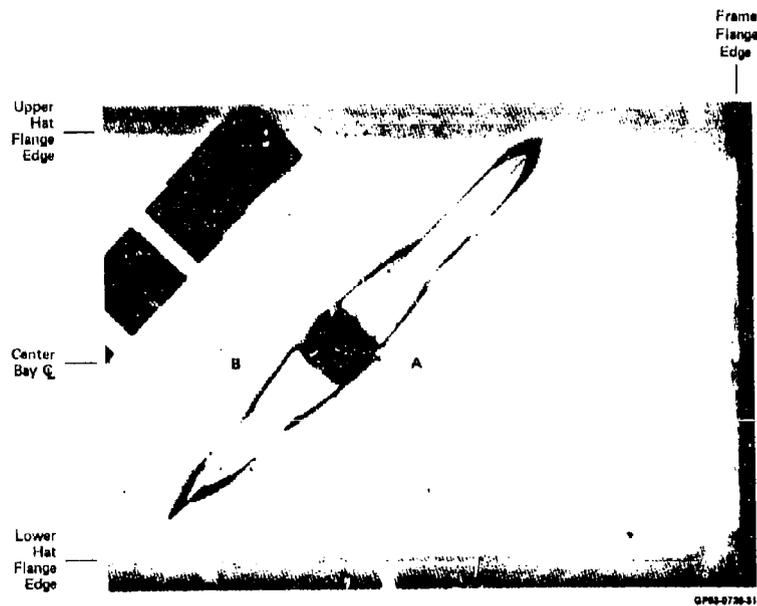
Figure 44. Radiographic Inspection of Impact Damage After 50,000 Cycles

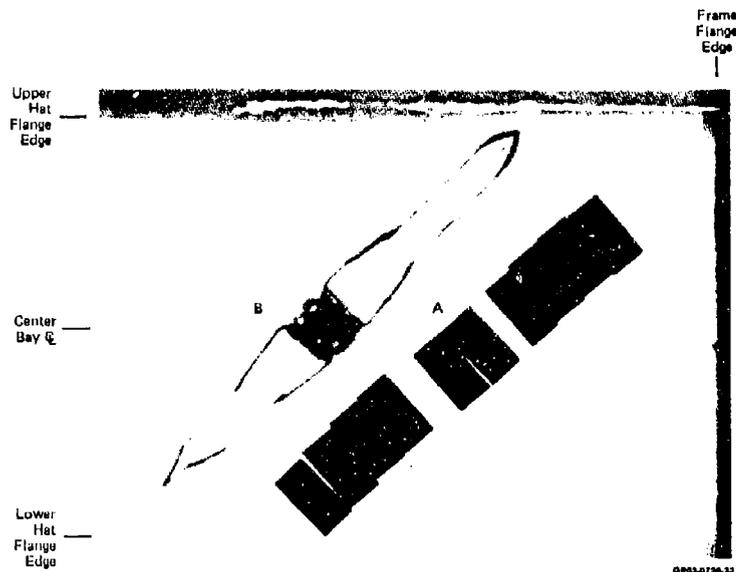
Figure 45. Radiographic Inspection of Impact Damage After 100,000 Cycles

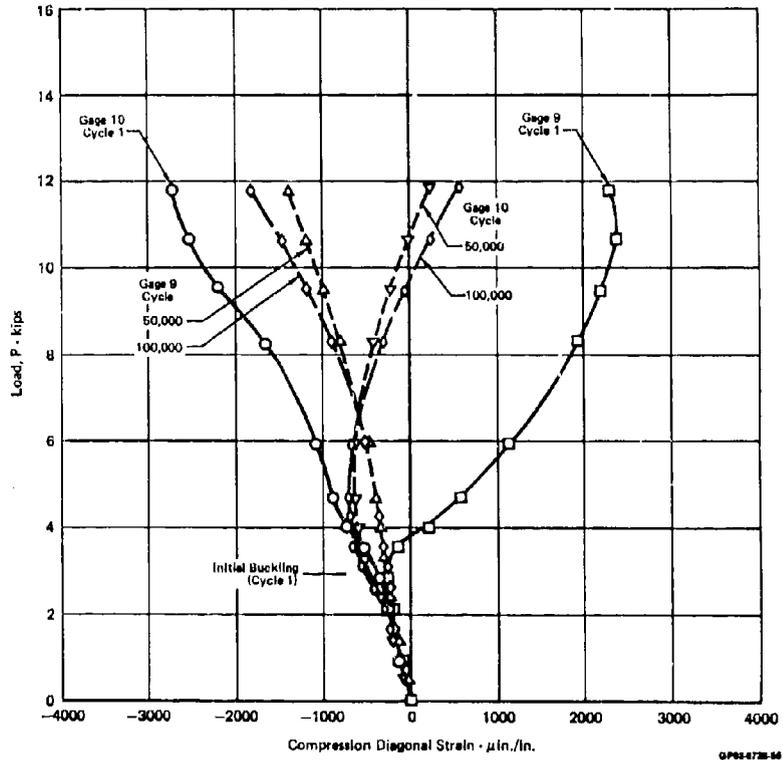
Figure 46. Mid-Panel Compression Diagonal Strains

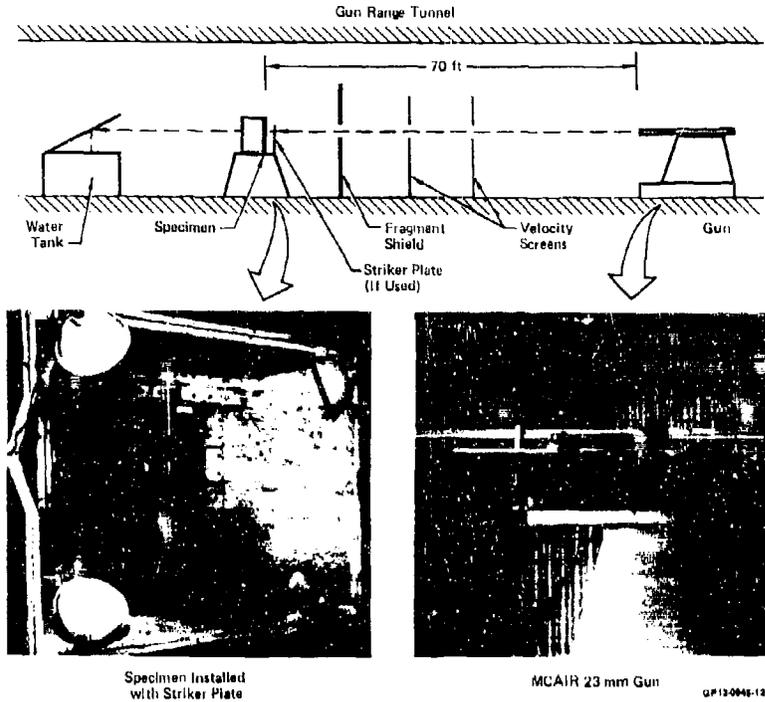
Figure 48. Ballistic Test Setup

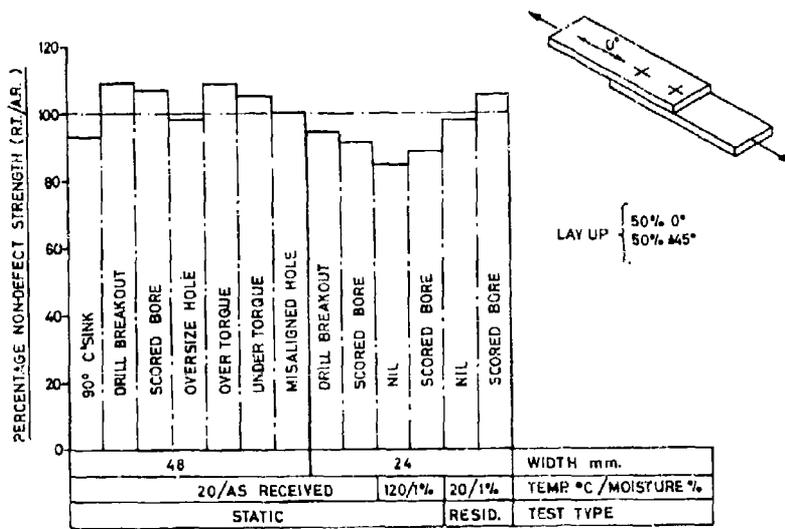
FIG. 3 BOLTED JOINT DEFECTS

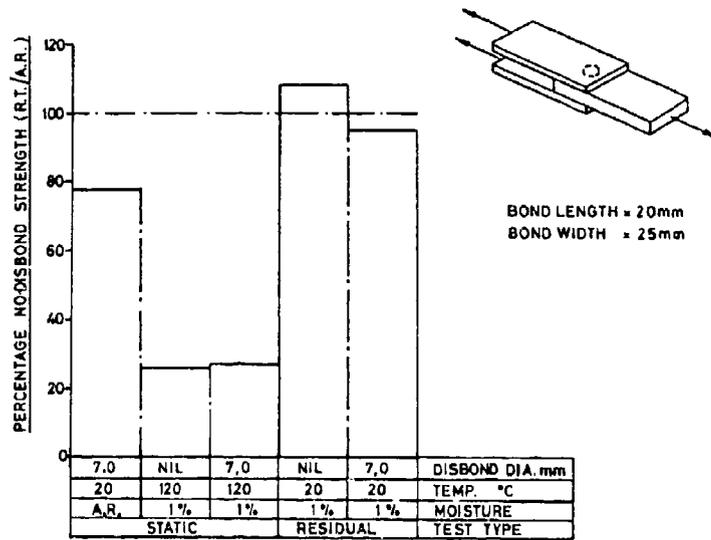
FIG. 4 BONDED JOINT DEFECTS

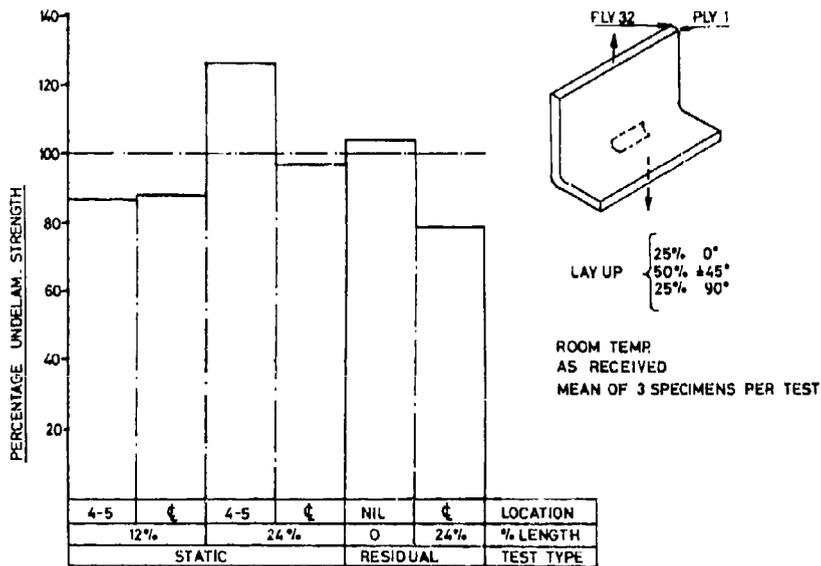
FIG. 5 TENSION CLEAT DELAMINATIONS

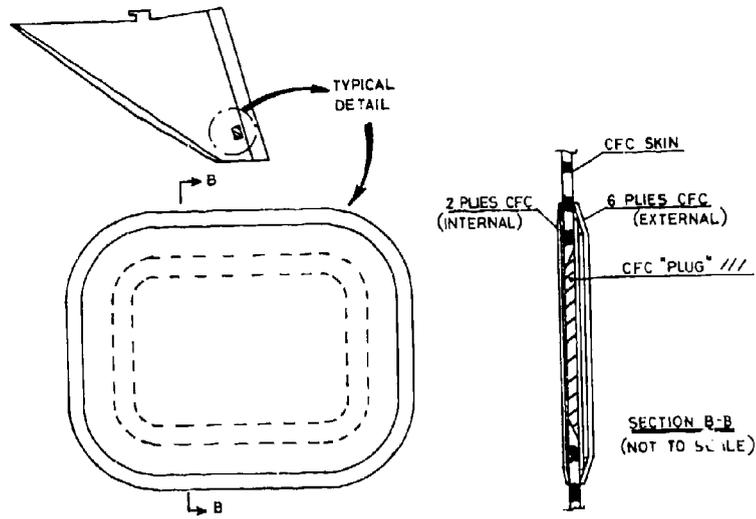
FIG. 14 TAILERON REPAIR

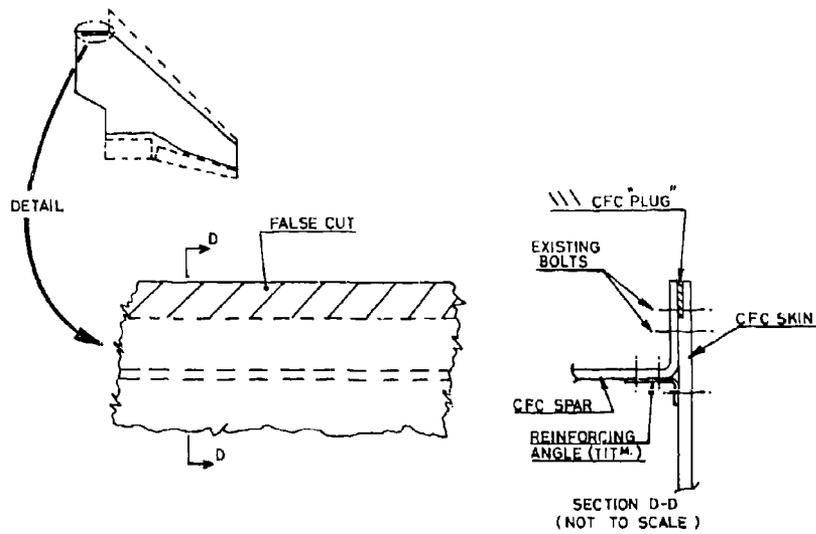
FIG. 17 FALSE CUT REPAIR

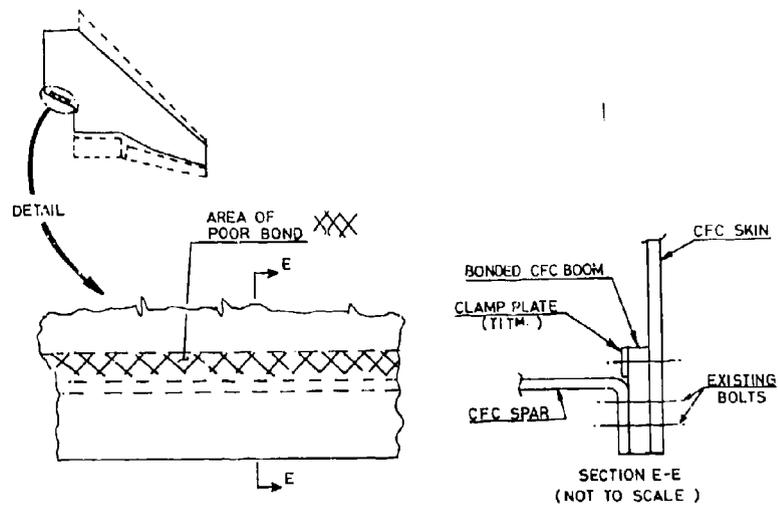
FIG. 18. POOR BOND REPAIR

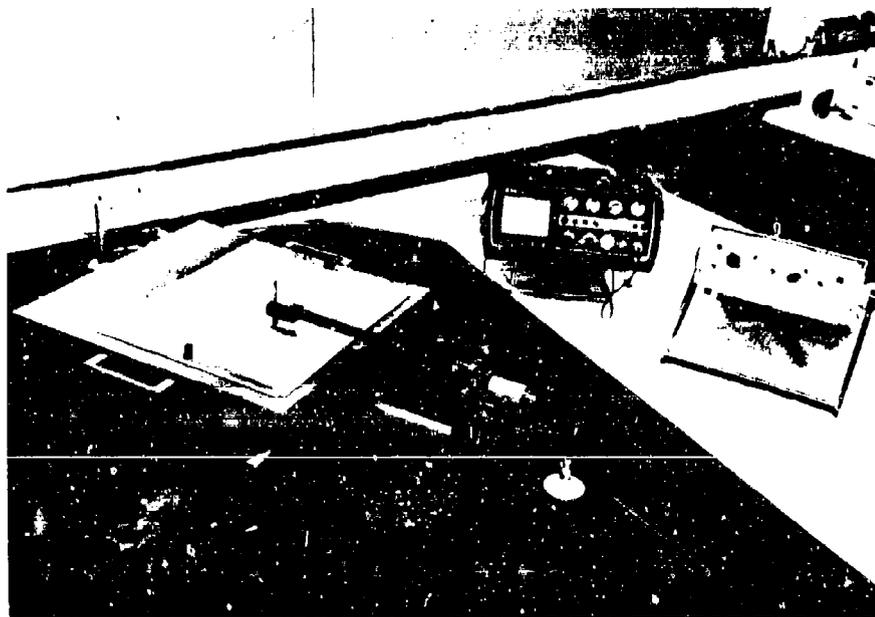
FIG. 19 PORTABLE C-SCAN UNIT
