ROLL-ON/ROLL-OFF (RO/RO) MERCHANT VESSEL OFFLOADING FACILITY TEST WITH THE CALM
WATER RAMP (CWR) (COTS CNO PROJECT 299, DT-IM-2)

by
Theodore G. Vaughters
James A. Aho

SYSTEMS DEVELOPMENT DEPARTMENT
RESEARCH AND DEVELOPMENT REPORT

May 1983

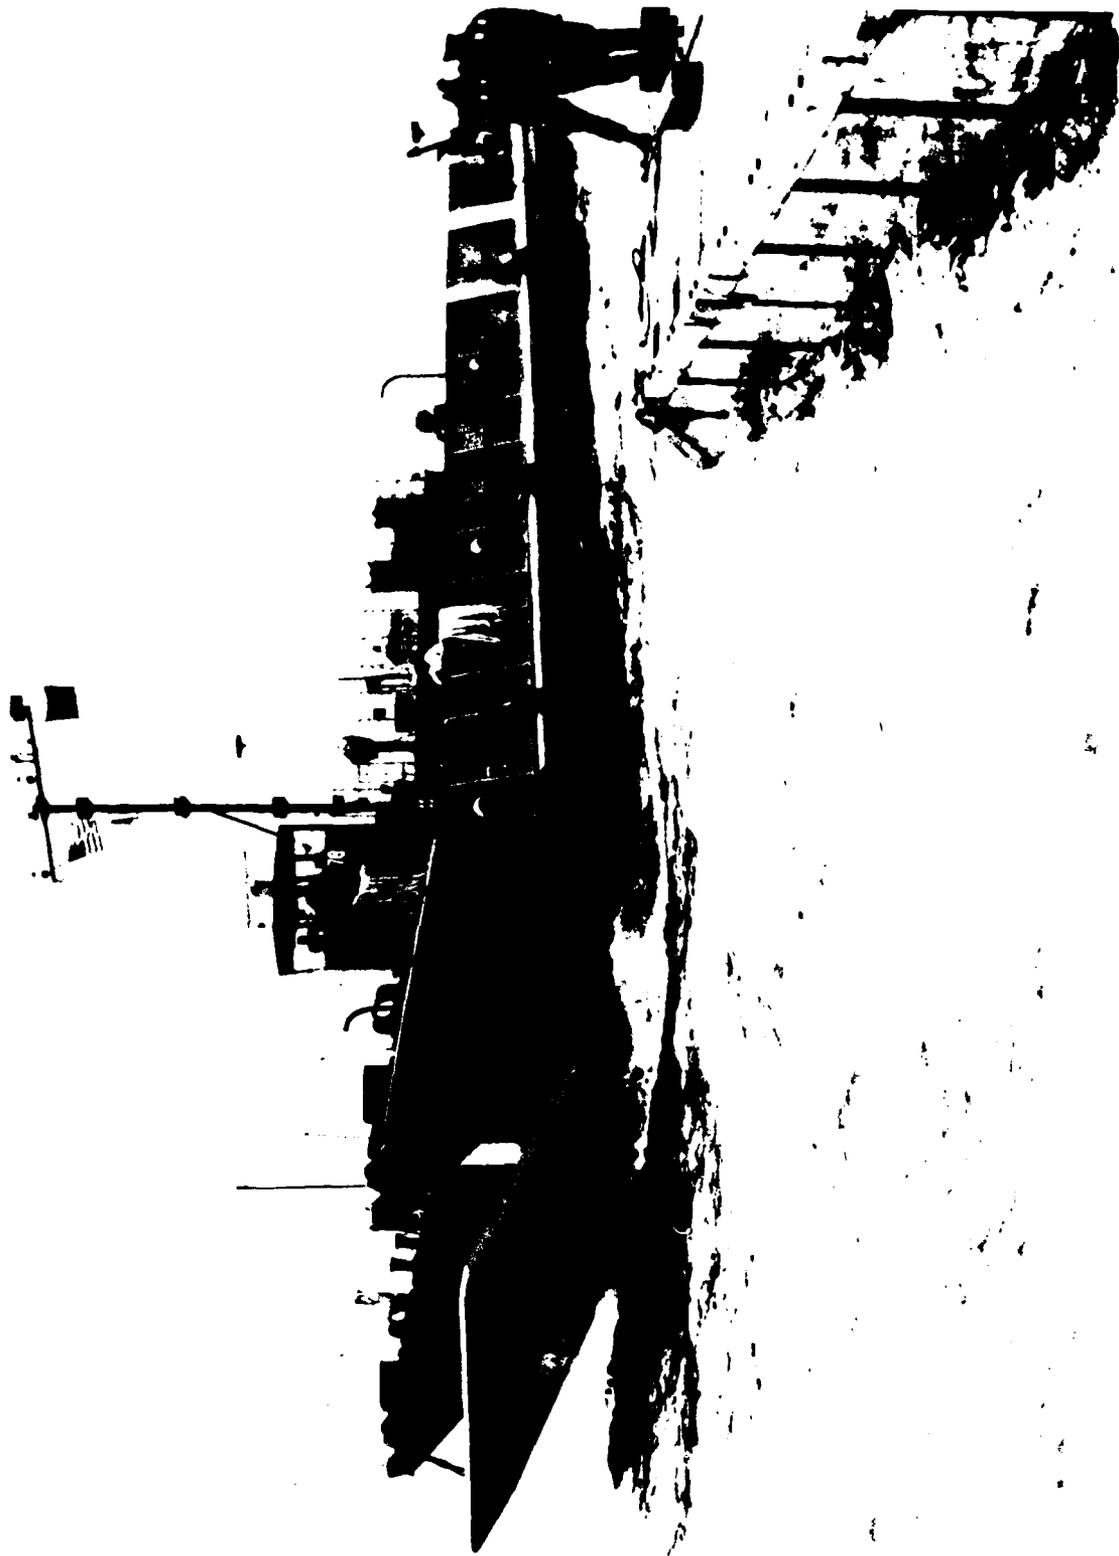
Figure 69 - ICU Attempting Marriage with B Section (View 1) (Day 2)

Figure 70 - LCU Attempting Marriage with R Section (View 2) (Day 2)

Figure 71 - LCU Attempting Marriage with B Section (View 3) (page 2)

Only one U.S. Army LCU was used during the two days of testing. On the first test day LCU marriages were made both with an alongside Causeway Ferry (see Figure 62) and without the ferry (see Figure 63) with no difficulty. On day 2 the LCU experienced difficulty maneuvering to a marriage both with and without an adjacent windward Causeway Ferry. Two tries totaling 12 min were required to complete the marriage with the adjacent Causeway Ferry (see Figures 64 through 68). When the Causeway Ferry was removed the LCU attempted six tries at marriage to the B section before giving up (see Figure 69 through 71).

The tests showed that LCU bow marriages to a B section alone are possible in Sea State 0 to 1 conditions, but virtually impossible in Sea State 2 conditions. Under the same basic sea conditions, an LCU bow marriage could be accomplished if a Causeway Ferry was attached to the windward side of the CPF. The Causeway Ferry formed a lee for the LCU and also provided a location to secure side mooring lines to the LCU.
