Special Report 83-15

Cold Regions Research &
Engineering Laboratory

Shoreline erosion and shore structure damage on the St. Marys River

1980 closed navigation season

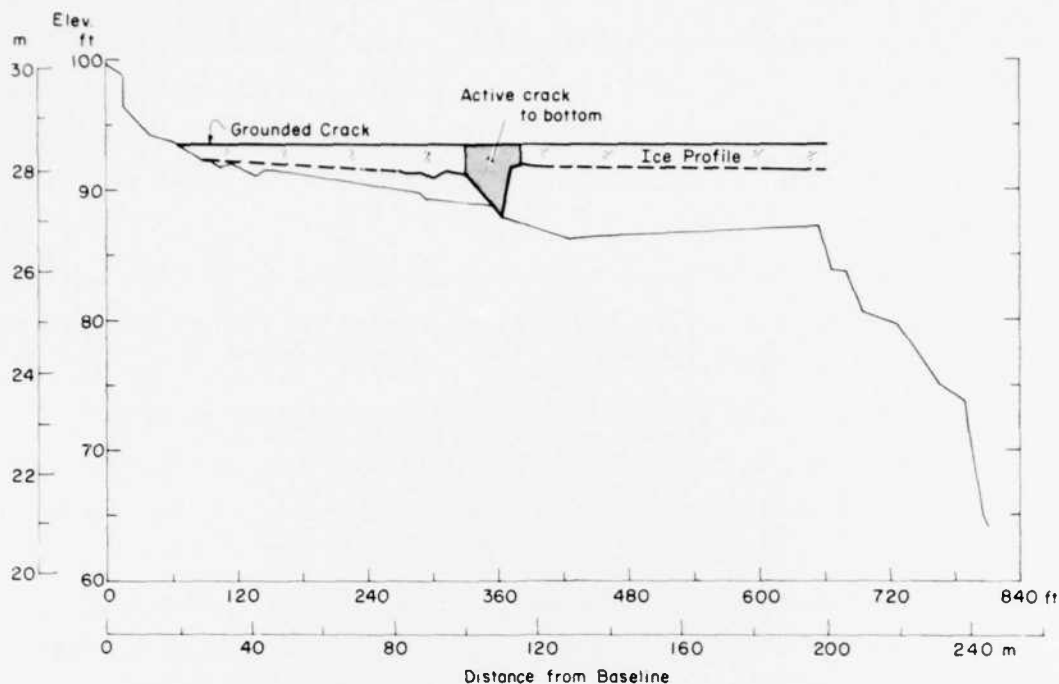
Figure 2. Active crack profile.

During winter the passage of the moving trough can cause the ice cover to become grounded in shallow water and nearshore areas, and nearshore cracks in the ice may develop running roughly parallel to the water-depth contours. With recurring moderate water-level fluctuations, these hinge cracks do not completely refreeze and can provide an ice-movement relief mechanism. Continuing vertical and horizontal movement of the ice cover may cause the accumulation of ice debris (which resembles pressure ridges) at these active cracks. Depending on the characteristics of crack formation, ice dams extending to the river bed may develop at the cracks (Fig. 2).

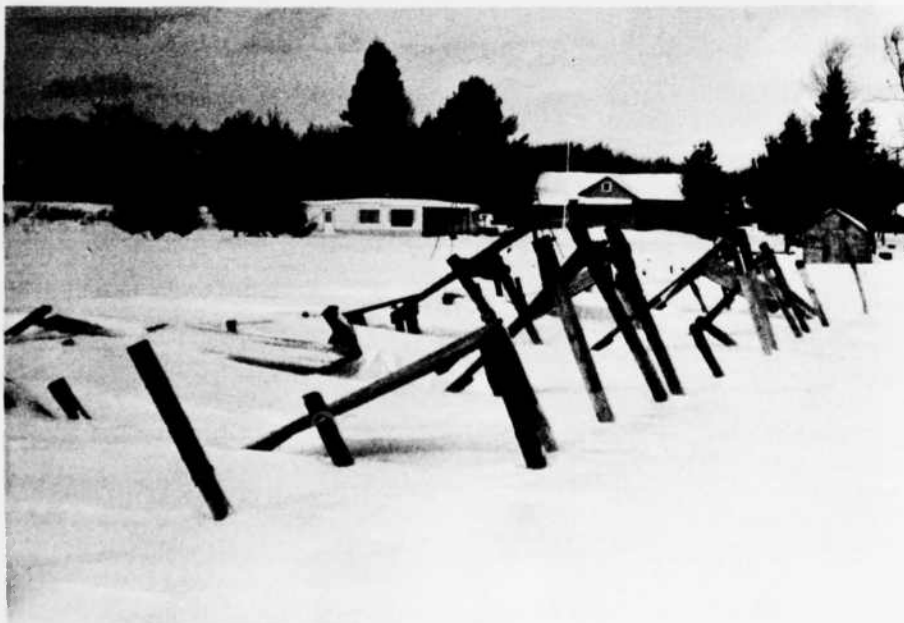
Figure 3. Series of finger piers damaged by ice jacking.

Typically the structures that suffer the most damage are light-duty, pile-supported piers such as those used on the St. Marys River for pleasure boats. Designed for summer activity, the support piles have very little skin resistance to upward forces. With a rise in water level, the buoyant ice sheet lifts the pile from the soil and the void under the pile fills with soil. When the water level drops, the weight of the ice is supported by the skin friction and point bearing of the pile. Since the pile is not

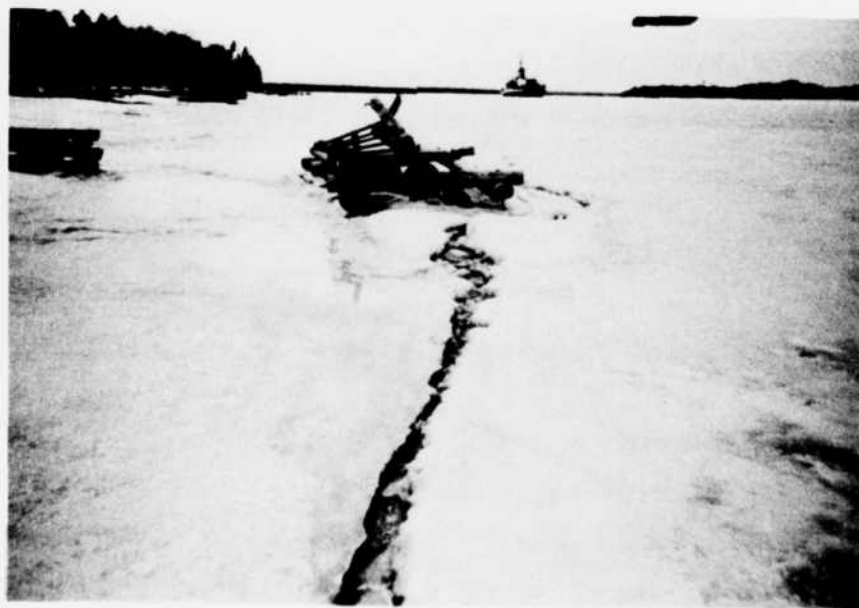
Figure 5. Active crack passing through dock.

With moderate water-level fluctuations of sufficient frequency, cracks in the ice sheet around structures may not refreeze and a permanently open, active crack may result. This may serve as a vertical-force release mechanism. Thus, winter navigation may actually reduce damage if the ships pass frequently enough and generate only small water-level fluctuations (a few inches). If the crack passes through a dock (Fig. 5), if the ships pass infrequently so that the cracks may refreeze, or if the fluctuations are larger, this protective mechanism is lost.

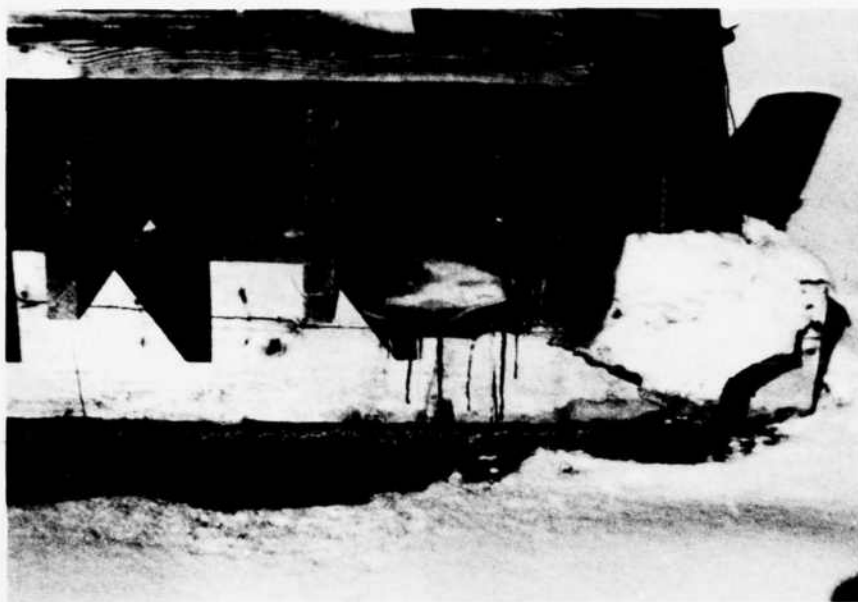
Figure 6. Horizontal member of dock in contact with ice cover.

horizontal members of a dock. Docks can also be damaged if the water level is high enough so that the ice surface touches the cross members; then the ice forces act directly on the structure (Fig. 6).

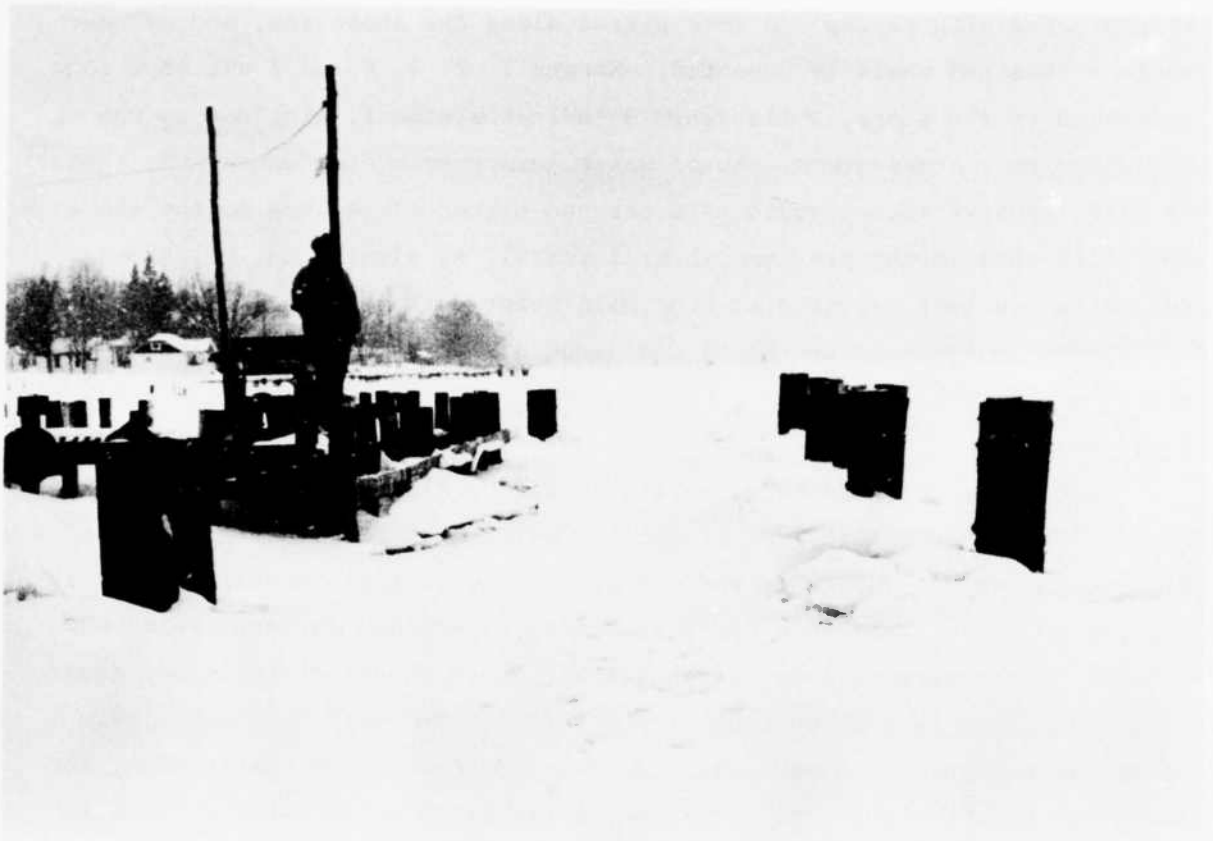
Figure 8. Dock at Six Mile Point.

Six Mile Point. Six Mile Point is an area of significant damage potential due to navigation, but the structures are constructed better than most along the St. Marys River. The docks at LaPeers Marine Gulf Station consist of a main dock perpendicular to the shoreline, with eight finger piers extending from it parallel to the shore. This structure is surrounded by 12 pile clusters (Fig. 8).

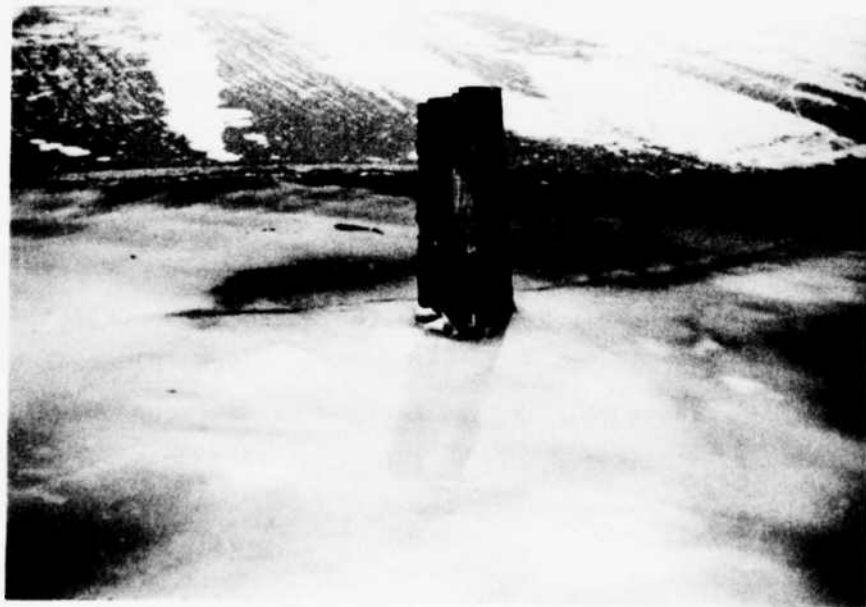
Figure 9. Active crack at pile cluster.

Figures 9 and 10 were taken on 11 January 1980 just after navigation ceased. Figure 9 shows the active crack that can develop between the pile clusters at this site; the crack isolates the docks from vertical forces due to water-level fluctuations (including ship-induced fluctuations). Figure 10 shows some ice rubble due to horizontal movement of a thin, early ice sheet. Thus, pile clusters can help to protect a dock against both horizontal and vertical movements of the ice sheet. A change in water levels will still influence the ice about the dock (Fig. 11), but the effective area of the ice that develops the vertical force on the dock is smaller and the group action reduces the uplift force on any single pile.

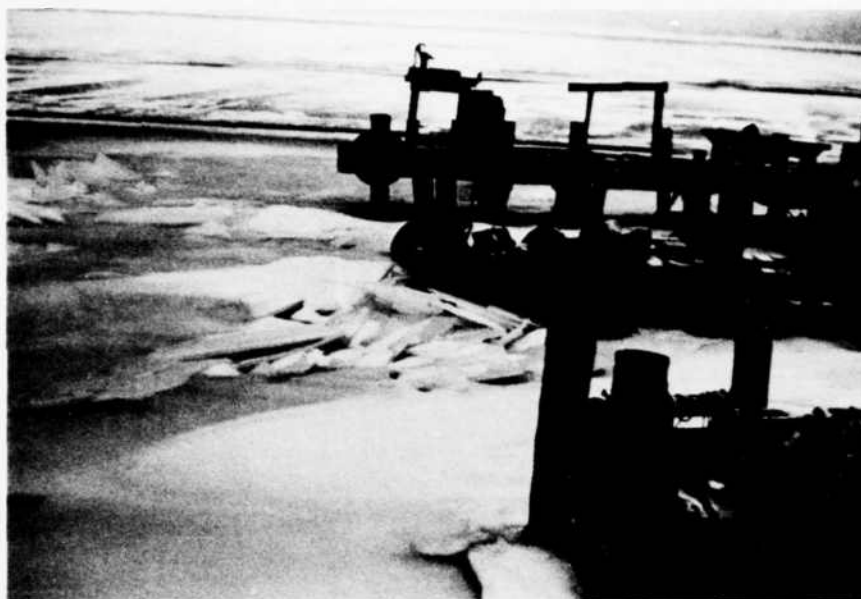
Figure 12. Horizontal movement of ice against dock.

Thin ice or small floes may still move horizontally against a dock (Fig. 12), but due to their limited size, forces are reduced. The docks at Six Mile Point were monitored throughout the closed navigation season, and although modes of ice action similar to those during periods with navigation were evident, no perceptible damage was observed.

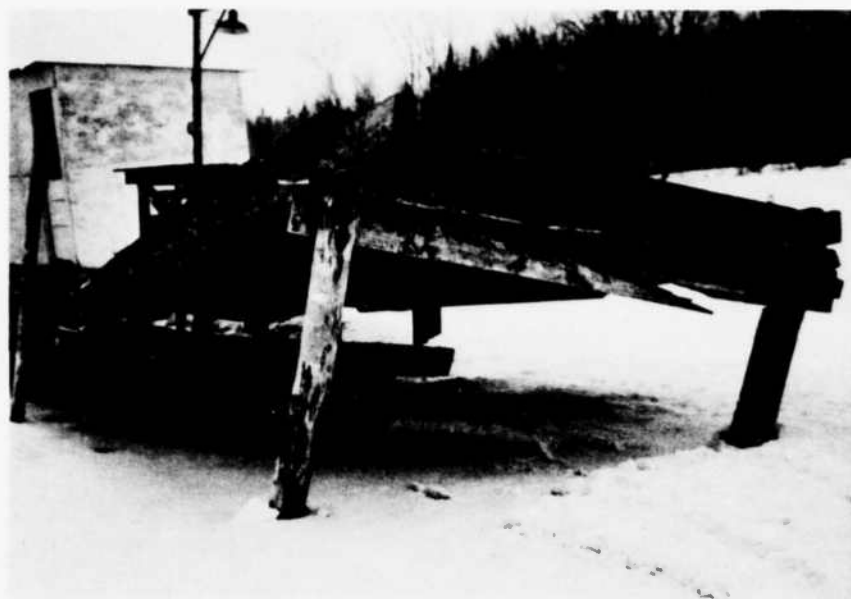
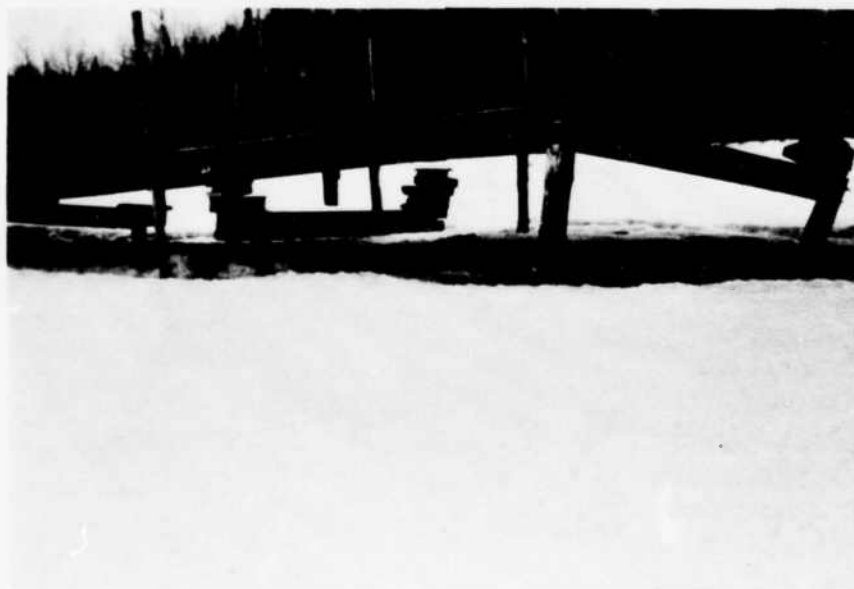
Dark Hole, Neebish Island. Another site monitored during the closed navigation season was the area known as the Dark Hole on Neebish Island. During previous years the Franklin Resort dock suffered significant damage due to uplifting forces (Figs. 13 and 14).

Figure 13. Franklin Resort Dock, end view (1976-77 winter).

Figure 14. Franklin Resort Dock, side view (1976-77 winter).

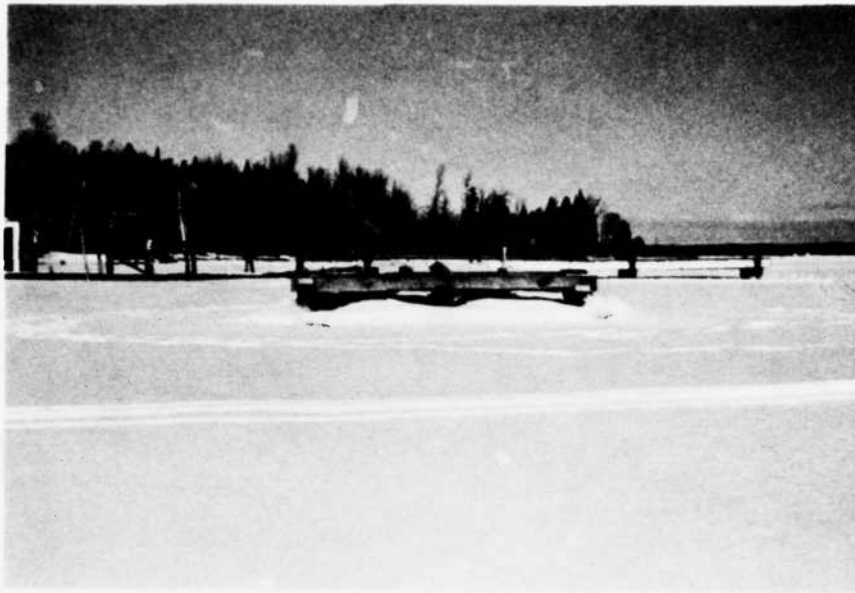
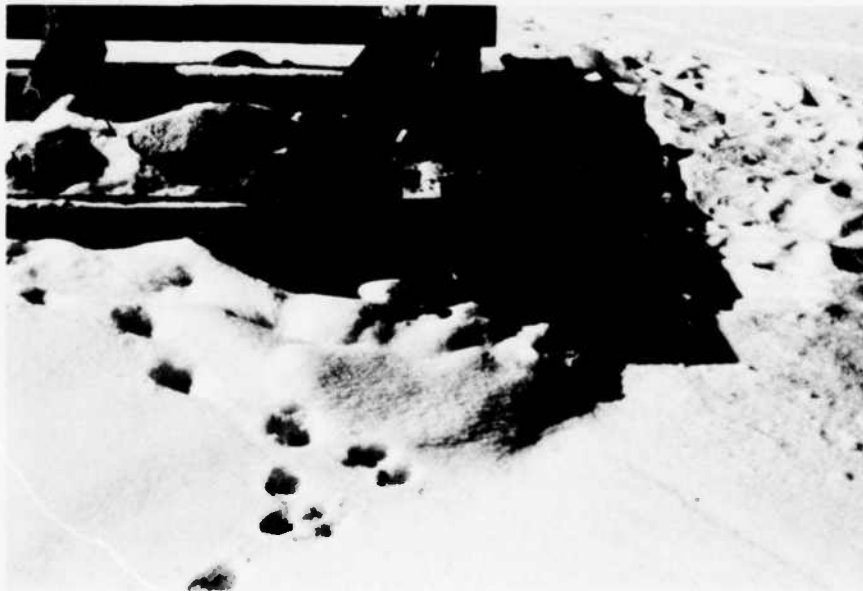
Prior to the 1978-79 winter navigation season, the Corps of Engineers had two demonstration docks installed at this site. One was a rock-filled timber crib (Figs. 15 and 16). The other was a pile-supported structure, with pile surfaces of various materials ranging from wood to plastic to steel (Fig. 17). Both of these structures stood up very well during both winters they were in place. The original Franklin Resort dock, which can be seen on the left side of Figure 15, was repaired and experienced no perceptible damage during the winter of 1980.

Figure 15. Dark Hole timber crib.

Figure 16. Timber crib close-up.

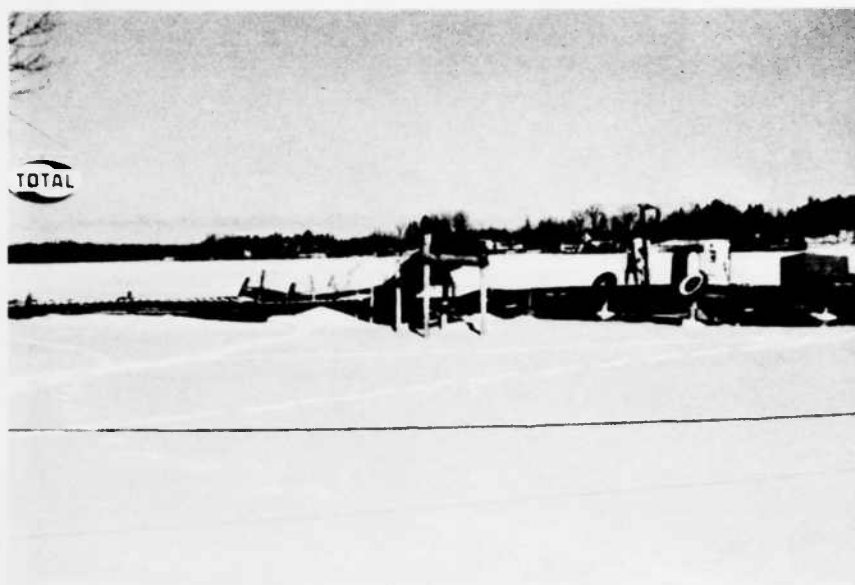
Figure 20. Little Neebish Resort at beginning of closed navigation season.

During the 1980 closed navigation season these cracks were not evident. Figure 20 shows conditions several weeks after the close of navigation. The dock shown in Figure 20 had been uplifted before the close of navigation and did not change during the closed period (Fig. 21).

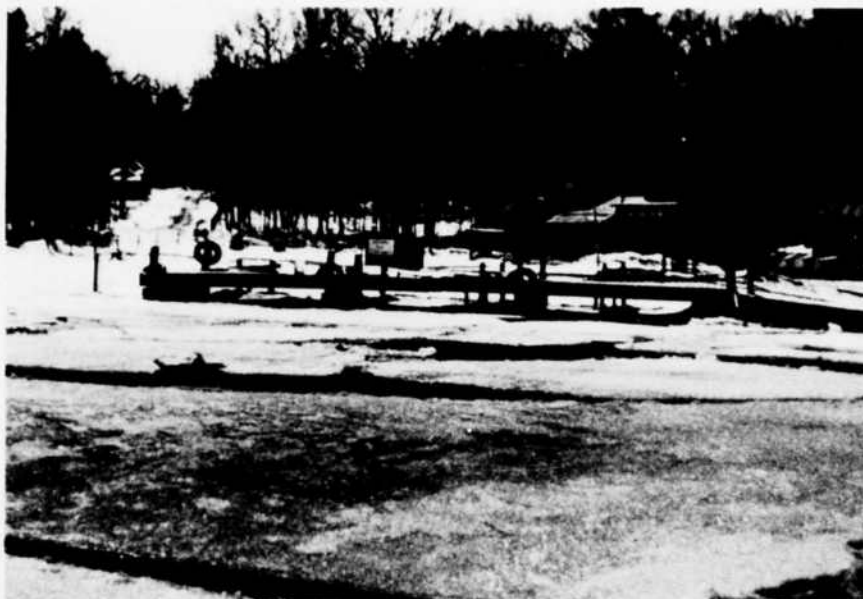
Figure 22. Little Neebish Resort during spring break-up. Note the large floating ice masses in the foreground.

Figure 22 shows the docks at the Little Neebish Resort during spring breakup. The left side of the structure in this picture is another Corps of Engineers structure, which is supported on piles of various composition. It sustained no perceptible damage throughout the winter. The large, floating ice masses were prevented from flowing against the docks by an area of intact shorefast ice upstream (Fig. 23).

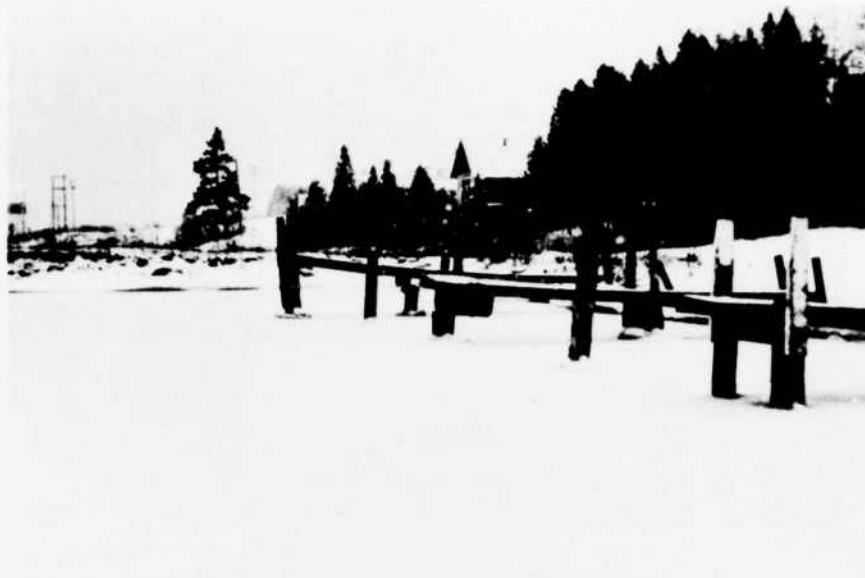
Figure 24. Small dock at Detour after close of navigation.

Detour. Figure 24 shows the condition of a series of small docks near the mainland Drummond Island Ferry dock on 25 February 1980. Some uplift is apparent, but as shown in Figure 25 taken on 15 March 1980 near the end of the closed navigation season, no further damage was apparent through the closed navigation period.

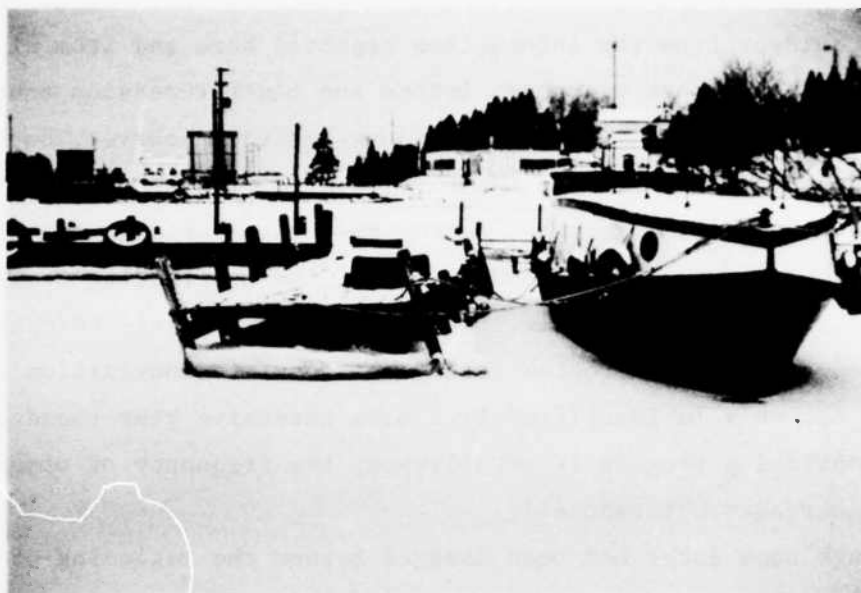
Figure 28. Damaged Lake Carriers dock with fishing boat.

of the dock. Figure 28 shows another portion of this same facility on 25 January 1980; this part had sustained some damage due to horizontal forces (possibly ice) prior to the closed navigation season. Figure 29 shows the same structure on 15 March 1980 near ice out with no further apparent damage.
