DOT/FAA/PM-83/29  
DOT-TSC-FAA-83-1

# Evaluation of Visibility Sensors at the Eglin Air Force Base Climatic Chamber

Transportation Systems Center  
Cambridge MA 02142

October 1983  
Final Report

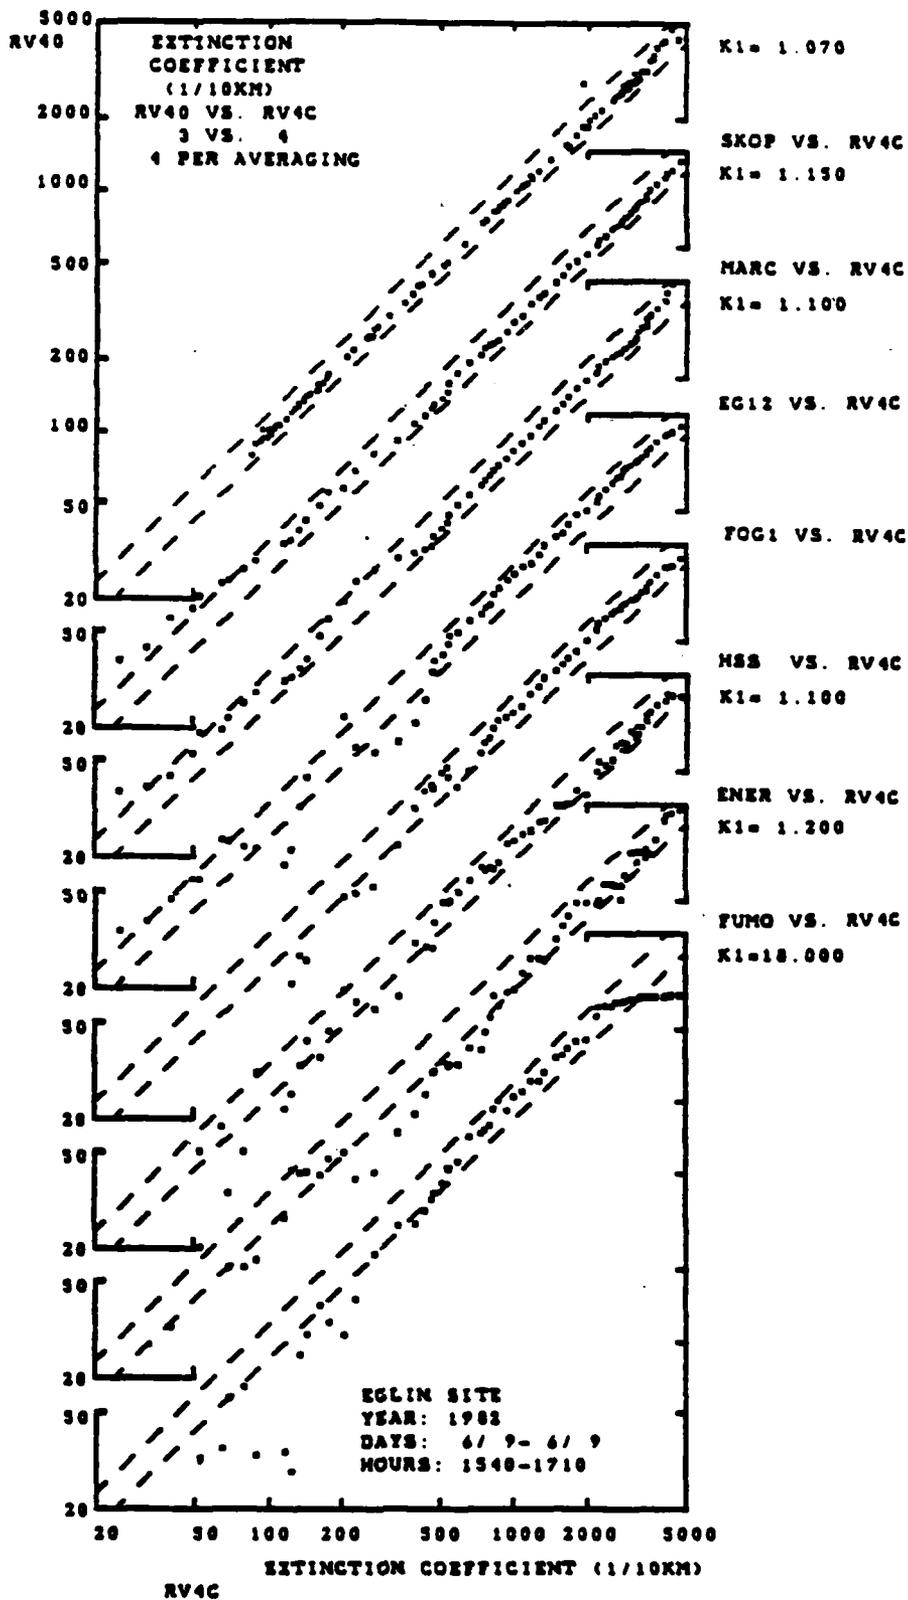
FIGURE 1-1. RESPONSE OF VISIBILITY SENSORS TO DENSE FOG.

All of the sensors tested were capable of measuring dense fogs. Some of them were found to require correction factors from their nominal calibration (see Table 1-1). The performance of the sensors under dense fog conditions is illustrated in Figure 1-1 which compares the corrected measurement of each test sensor with the measurement of the FAA laser RVR calibrator on a 40-foot baseline, which serves as a standard sensor. The sensor comparisons are made in terms of extinction coefficient. Table 1-2 shows how the graphed values of extinction coefficient are related to RVR. Different RVR values are obtained for day or night and for different runway light settings (e.g. L.S.3). The minus sign in front of an RVR value indicates that objects are more easily seen than the runway lights. Figure 1-1 is a composite of many scatter plots displaced vertically to allow comparisons between sensors. The diagonal dashed lines represent disagreements between the test sensor and the standard sensor of  $\pm 15$  percent. All plots except the top one are for the same fog event, which was selected for the most uniform conditions. A number of features can be noted in Figure 1-1. First, the transmissometers (top three plots) tend to give better agreement with the laser RVR calibrator than the forward-scatter meters since they average over much the same portion of the chamber. Second, the forward-scatter meters with small scattering volumes (bottom

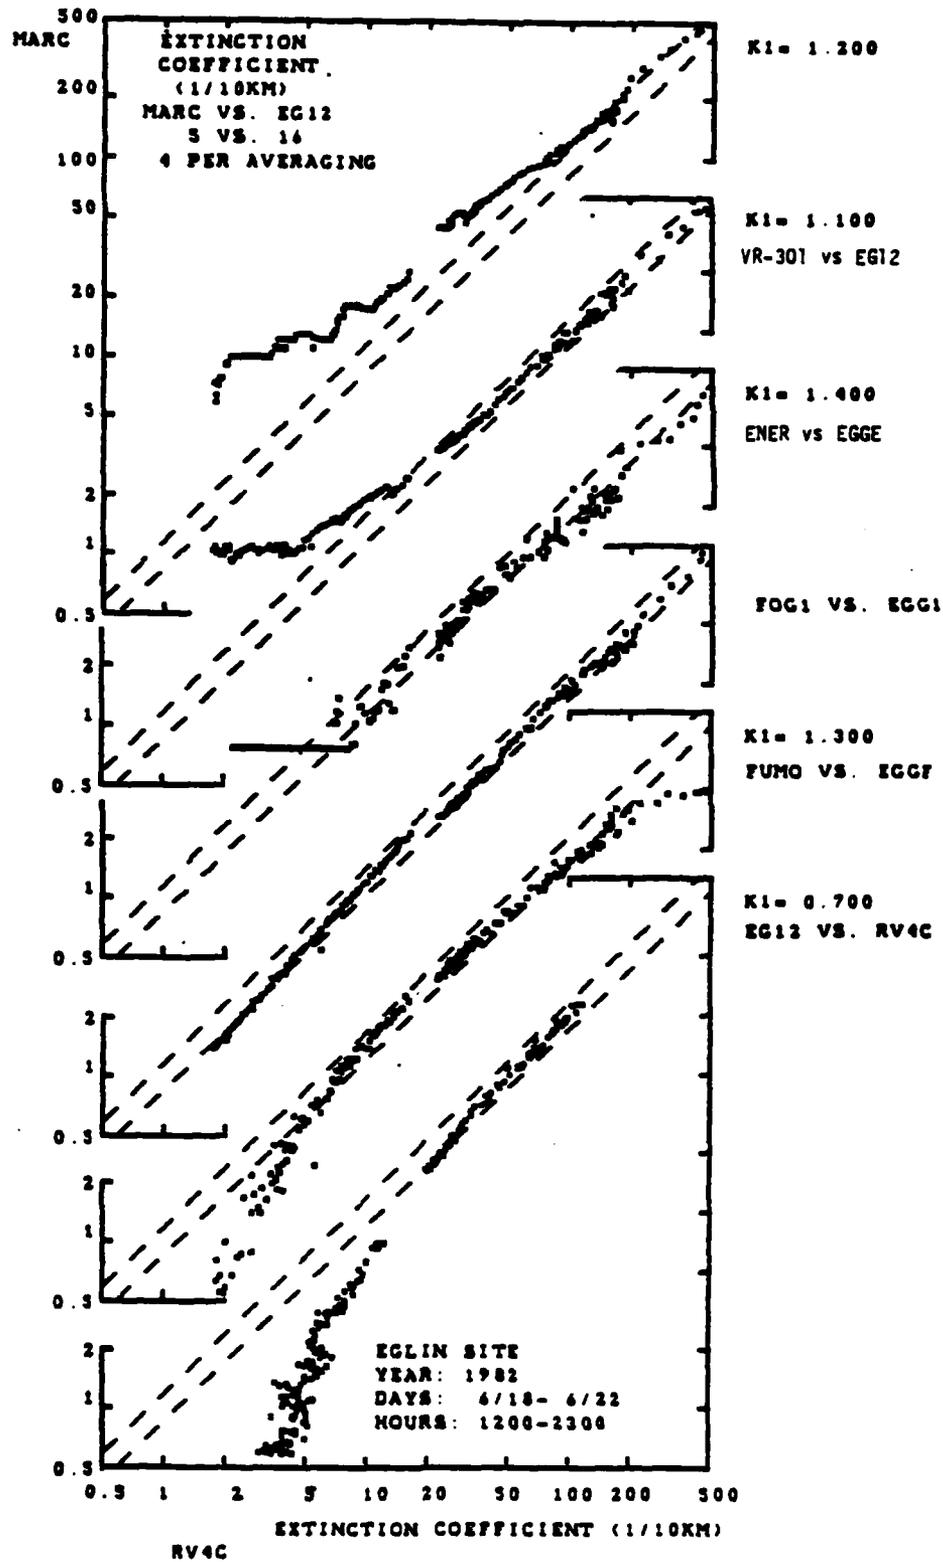
FIGURE 1-2. RESPONSE OF VISIBILITY SENSORS TO FOG/HAZE

Figure 1-2 compares the test sensors with a standard for two fog/haze events which covered different ranges of extinction coefficient (note the break in data below 20 units). Table 1-3 shows the runway visibility values (RVV) corresponding to the extinction coefficients in Figure 1-2. The haze corrections listed in Table 1-1 have been applied to the data in Figure 1-2. All comparisons except the bottom plot use the EG&G 207 forward-scatter meter as a standard. The bottom plot compares the EG&G 207 to the RVR calibrator; the curvature in this plot is caused by a slight error in the calibration of the calibrator. Similar calibration errors are also noted in the plots for three other sensors: Marconi MET-1 (top plot), HSS VR-301 (second plot from top), and to a lesser extent Fumosens III (second from bottom plot). The Ewertec EV-1000 (third plot from top) does not read below 4 units and therefore clips at that level. The EV-1000 shows considerably more scatter in the measurements than any of the other sensors.

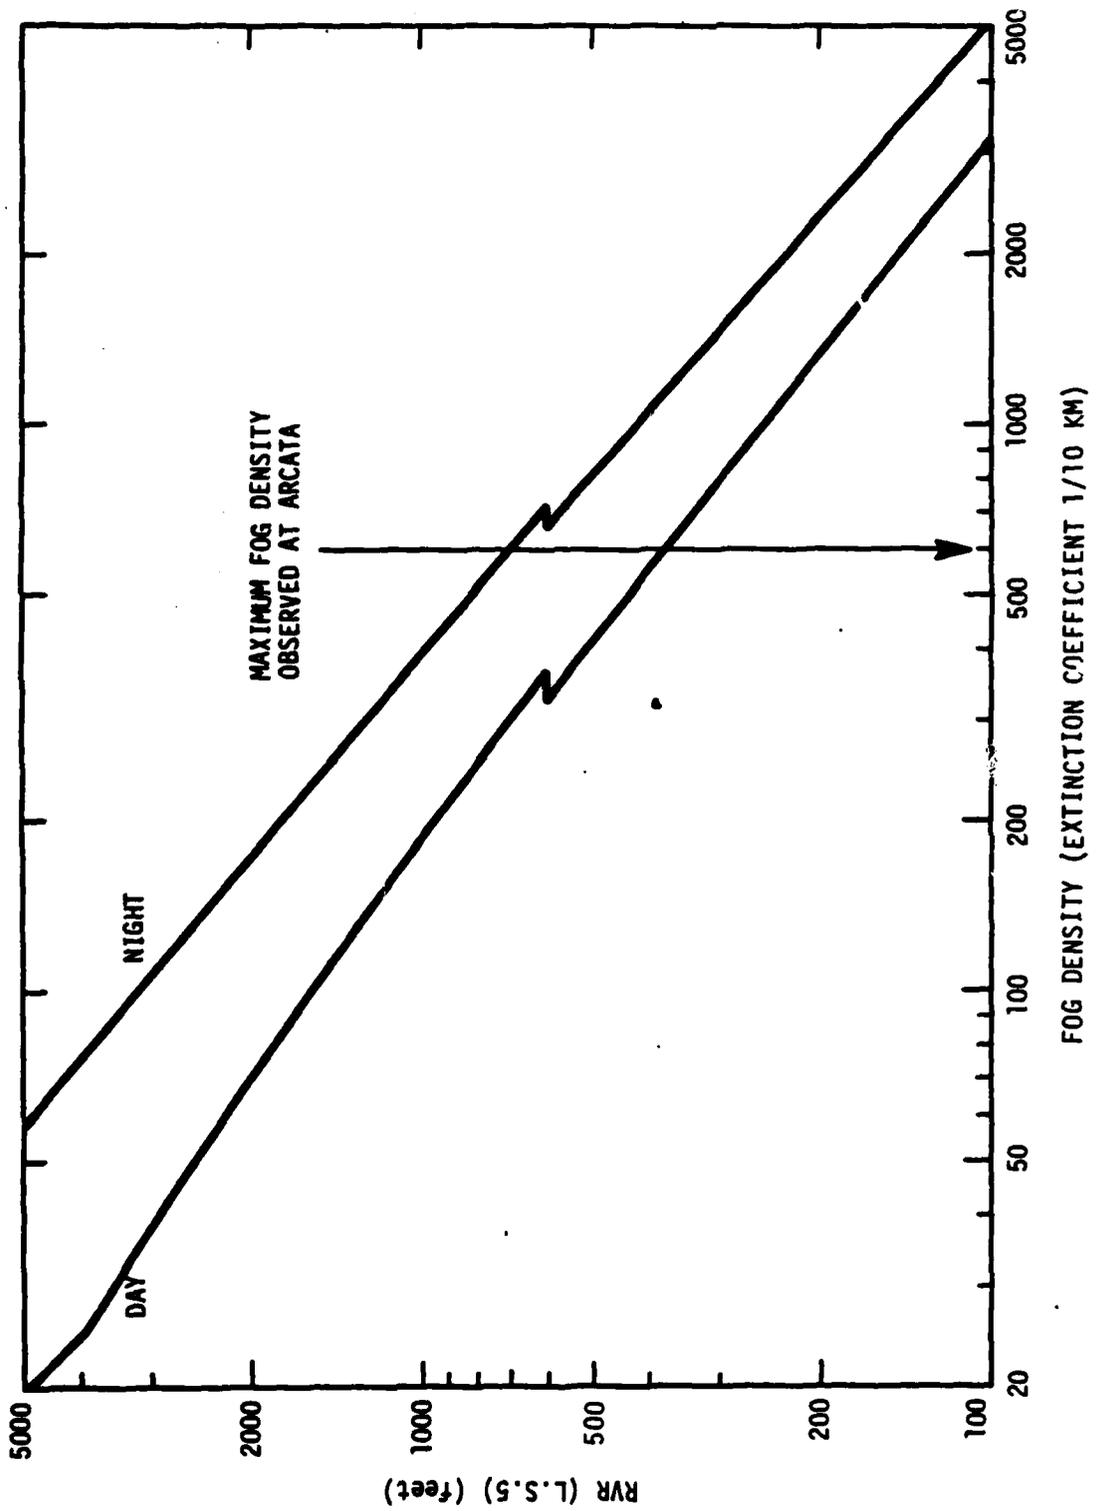
FIGURE 4-1. DEPENDENCE OF RUNWAY VISUAL RANGE (RVR) ON FOG DENSITY.

Runway Visual Range (RVR) is defined as the maximum distance for viewing the focused runway edge lights or the runway markings, whichever is easier to see. Figure 4-1 shows how RVR depends upon the extinction coefficient (here termed fog density) for runway light setting 5 (L.S. 5). The curves for day and night are shown. Table 1-2 relates RVR and extinction coefficient for other light settings.

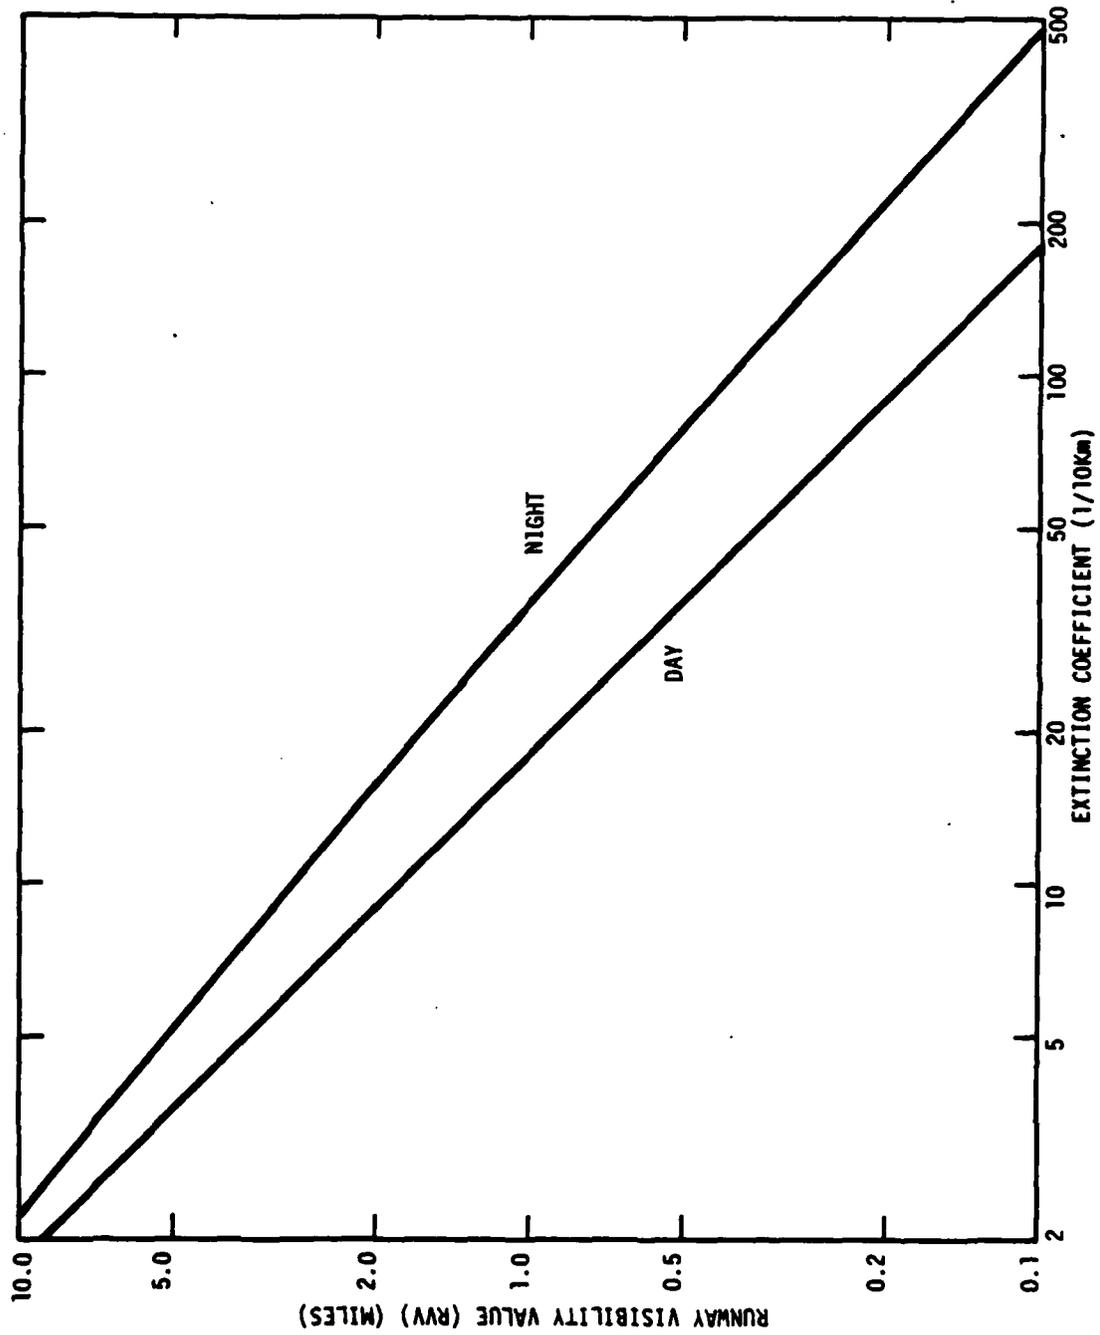
FIGURE 4-2. DEPENDENCE OF RUNWAY VISIBILITY VALUE (RVV) UPON EXTINCTION COEFFICIENT.

Runway Visibility Value (RVV) is defined as the maximum distance for viewing omnidirectional runway edge lights or the runway markings, whichever is easier to see. Figure 4-2 shows the dependence of day and night RVV on the extinction coefficient. The unit of extinction coefficient in Figures 4-1, 2 is 1/10 km. Table 1-3 presents numerical values relating RVV and extinction coefficient.

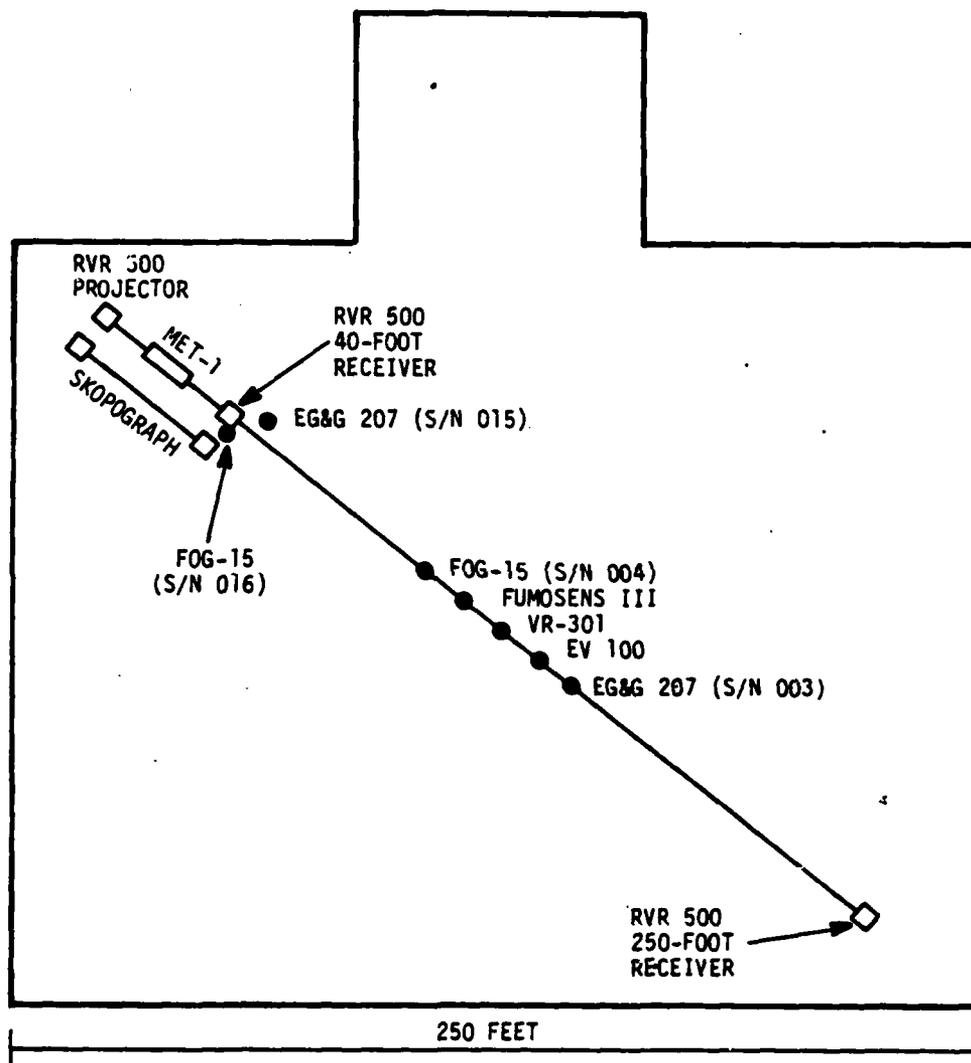
FIGURE 5-1. ORIGINAL SENSOR CONFIGURATION

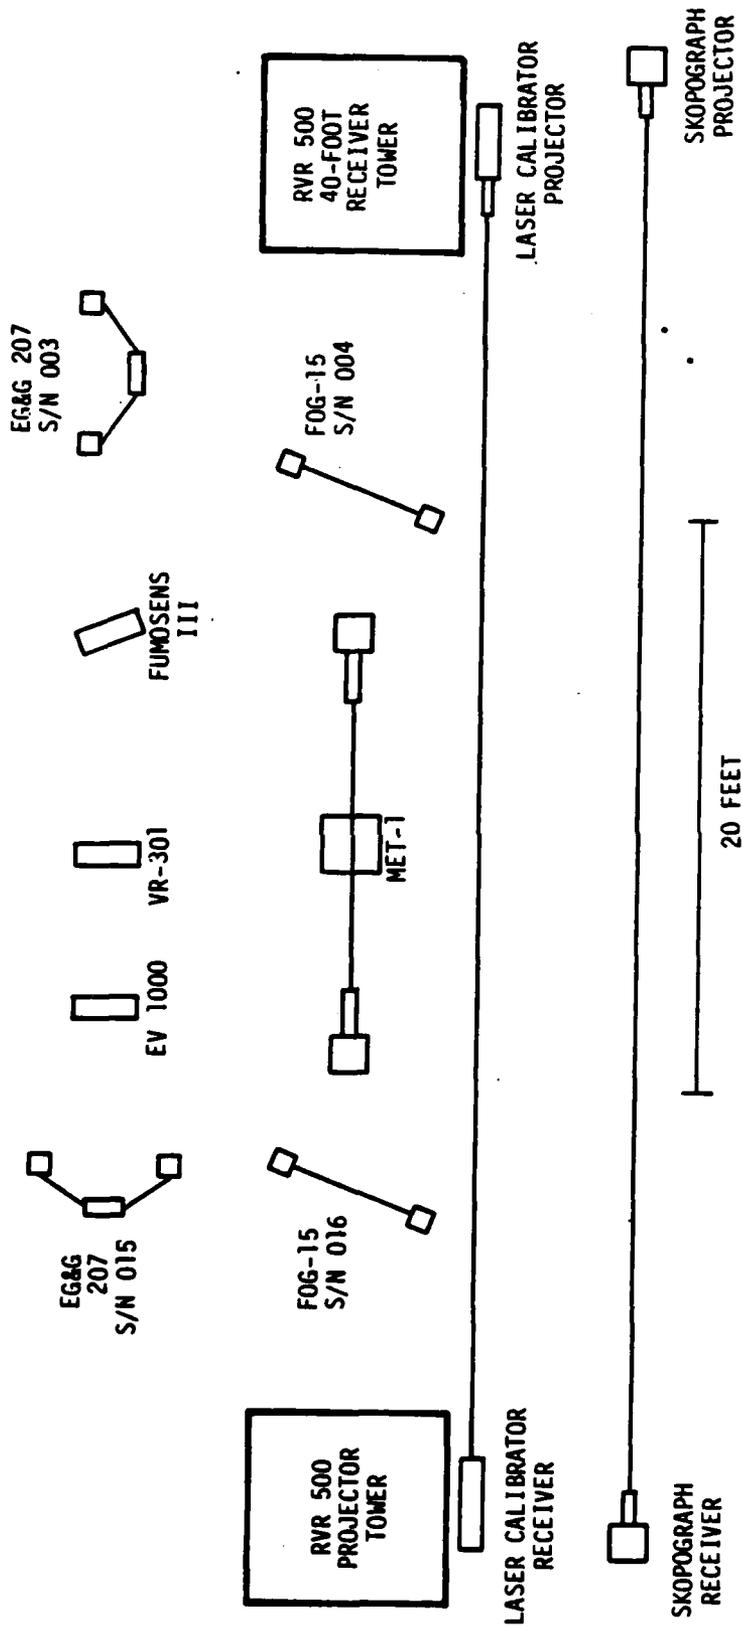
FIGURE 5-2. COMPACT SENSOR CONFIGURATION

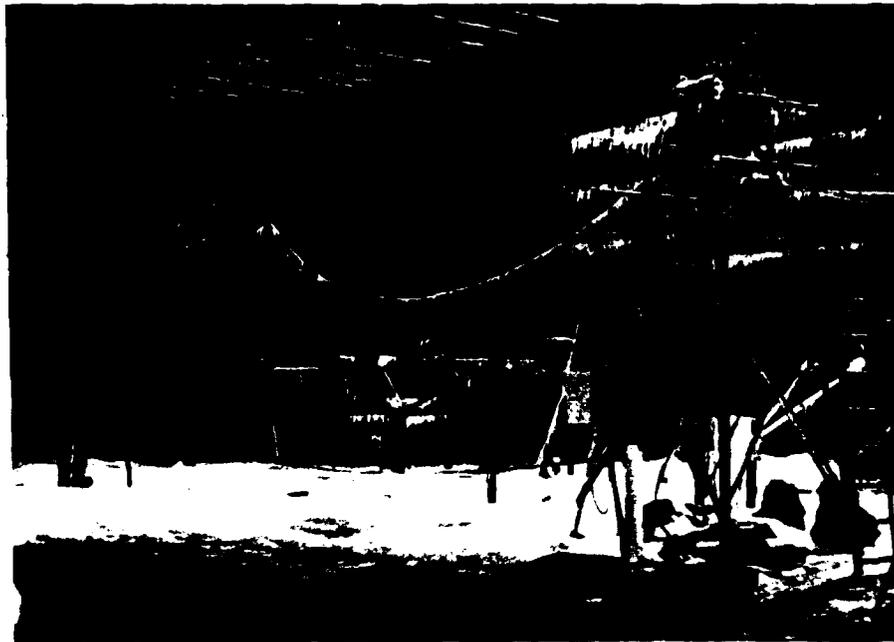
FIGURE 5-3. TASKER RVR 500 TRANSMISSOMETER:

(a) 14-FOOT TOWERS FOR 40-FOOT BASELINE, (b) PROJECTOR (Note RVR calibrator on right), (c) RECEIVER, (d) SNOW ON PROJECTOR GRID.

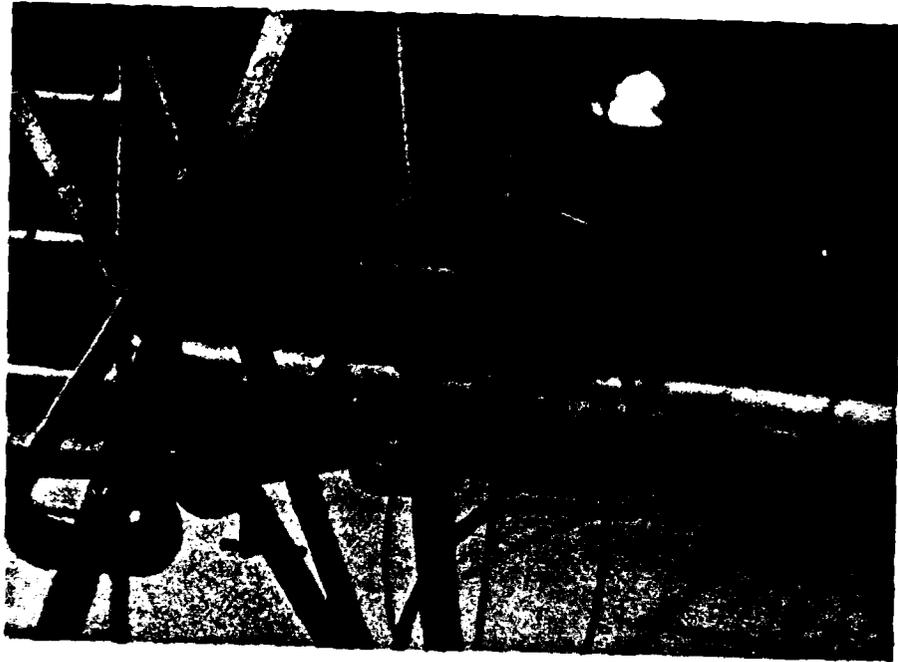
FIGURE 5-6. RVR LASER RVR CALIBRATOR WITH HOODS IN SNOW:  
(a) PROJECTOR, (b) RECEIVER.

The RVR Laser Calibrator (Figure 5-6) was modified to eliminate the problems encountered in standard units:

- 1) New receiver windows with no interference errors were installed. A ring of resistance heaters was added around the windows to keep them from fogging up.
- 2) Hoods were added to both projector and receiver to keep rain droplets off the windows.
- 3) The pulse output electronics were modified to eliminate instabilities due to glitches in the count-down circuitry. Two calibrators were operated at any given time while a third was available as a back up and source of spares.

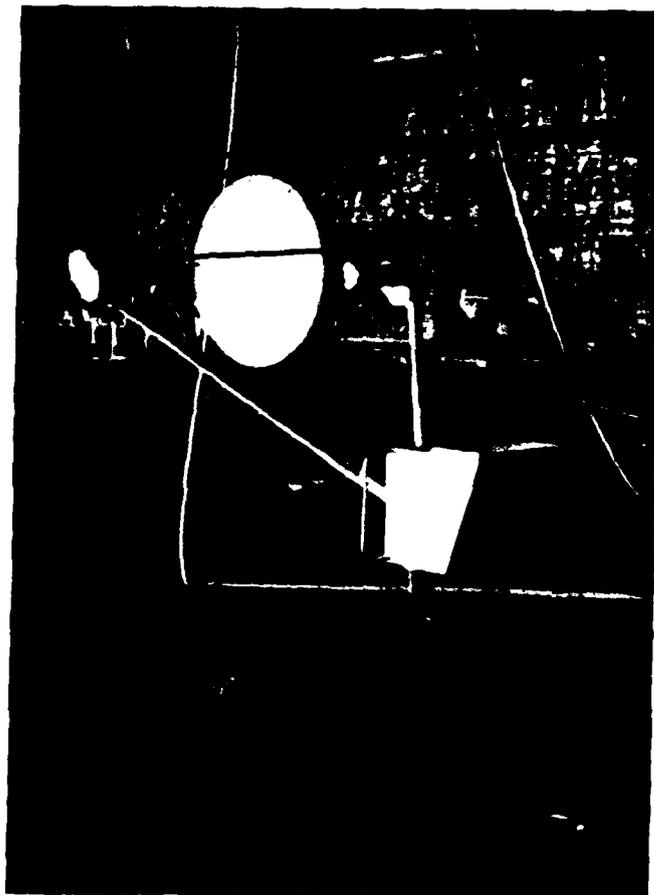
FIGURE 5-7. EG&G 207 FORWARD-SCATTER METER:  
(a) WITH CALIBRATOR INSTALLED, (b) IN SNOW.

Two EG&G 207 forward-scatter meter (FSM) units (Figure 5-7) were made available for the tests. A calibrated scatterer with an attenuator is used to set the EG&G to an absolute calibration level. The Air Force has made extensive use of the EG&G 207 FSM for research studies during the last decade.

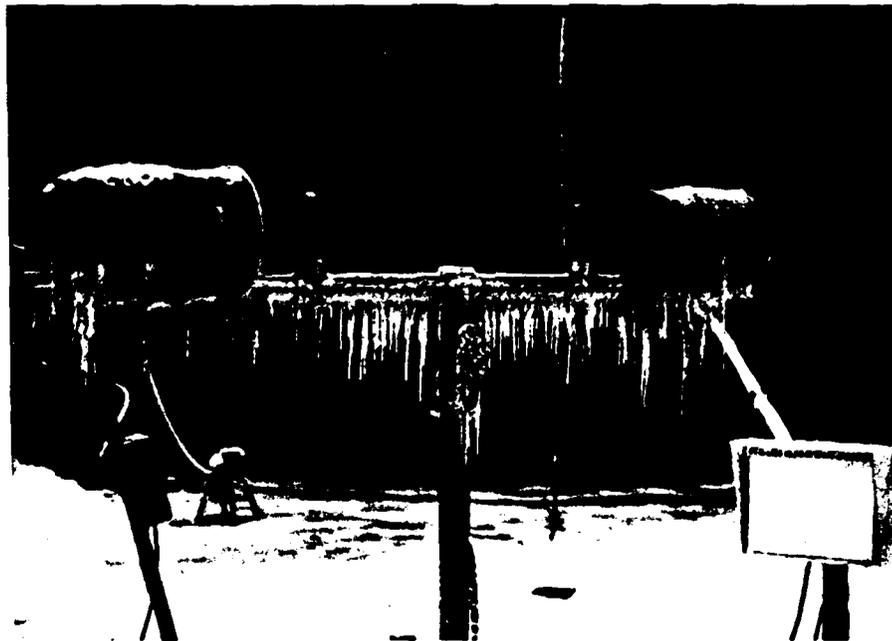
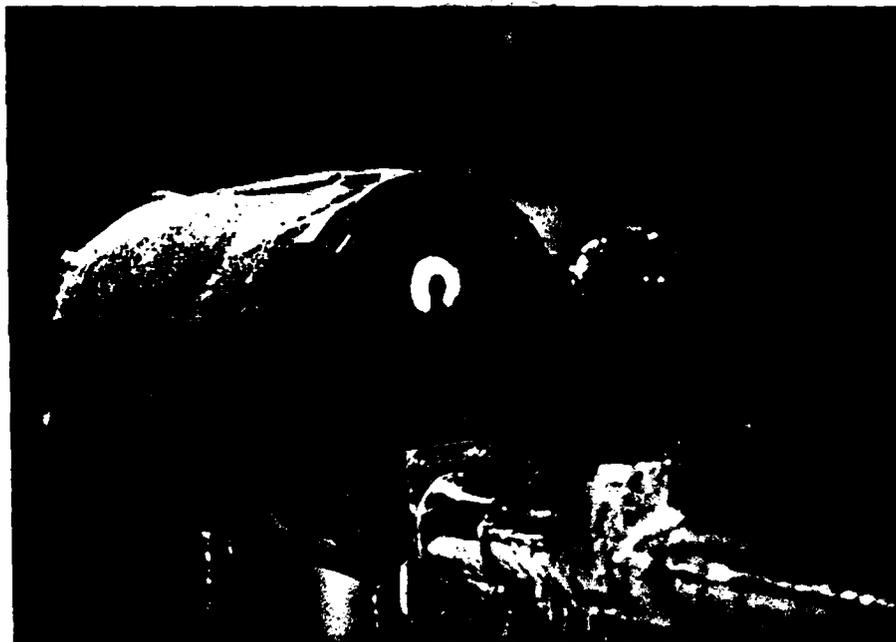
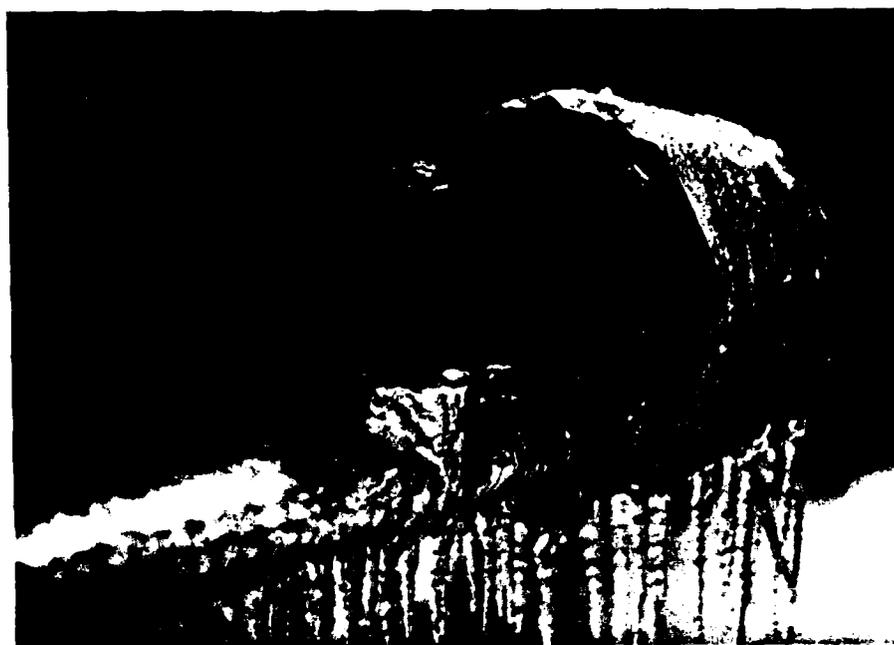
FIGURE 5-8. WRIGHT & WRIGHT FOG-15 FORWARD-SCATTER METER:  
(a) IN SNOW, (b) IN FREEZING RAIN, (c) PROJECTOR, (d) RECEIVER.

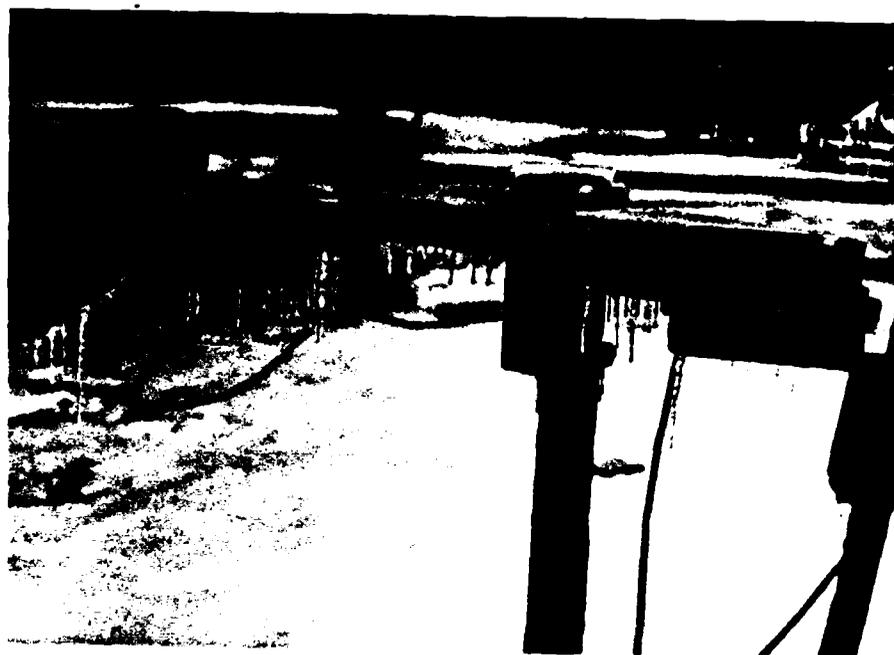
FIGURE 5-9. HSS VR-301 FORWARD-SCATTER METER:  
(a) BEAM BAFFLE ON LEFT, (b) SCATTERING GEOMETRY.

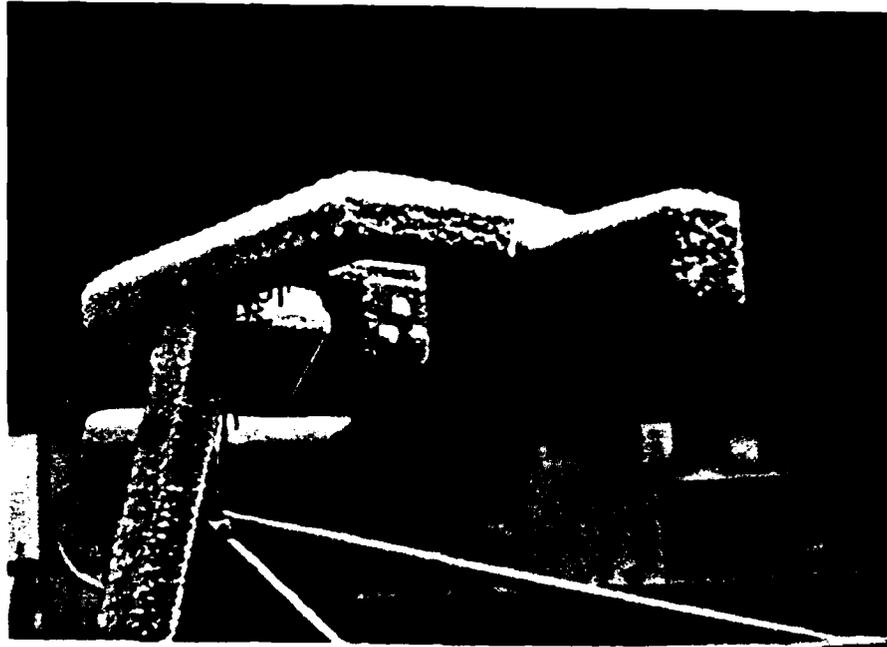
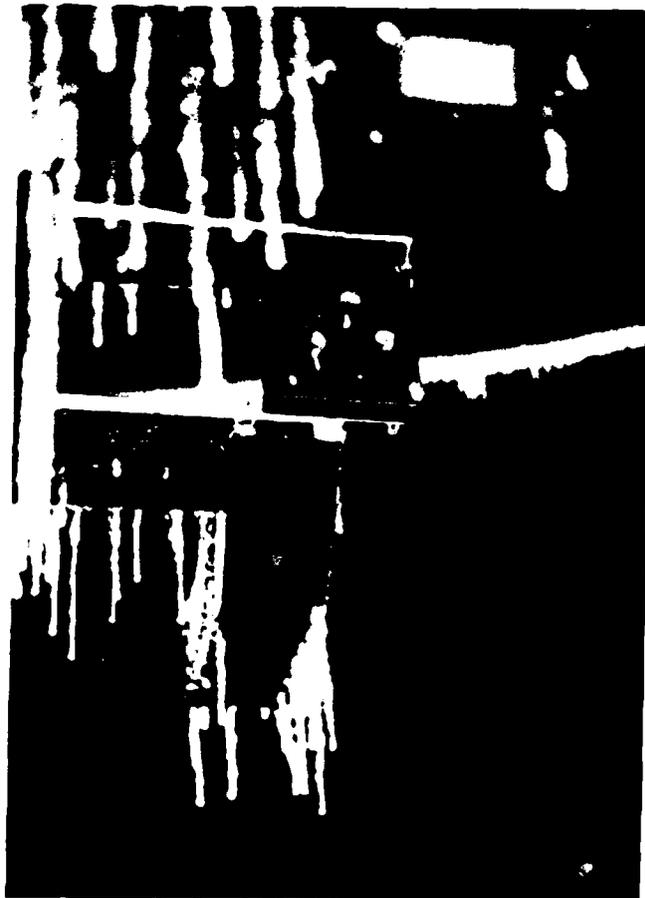
FIGURE 5-10. IMPULSPHYSICS FUMOSENS III FORWARD-SCATTER METER:  
(c) IN SNOW, (d) IN FREEZING RAIN.

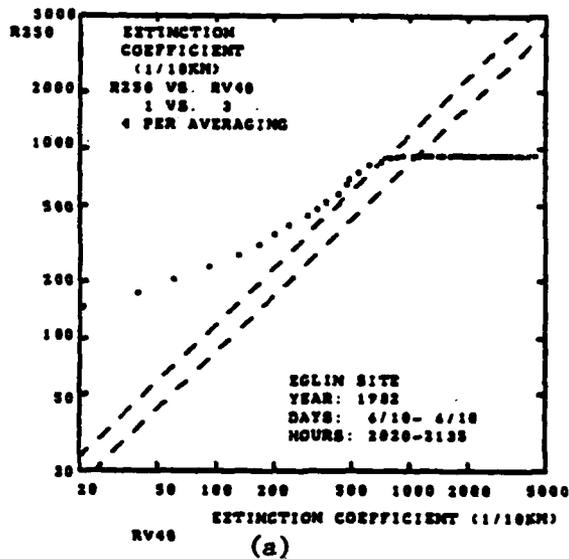
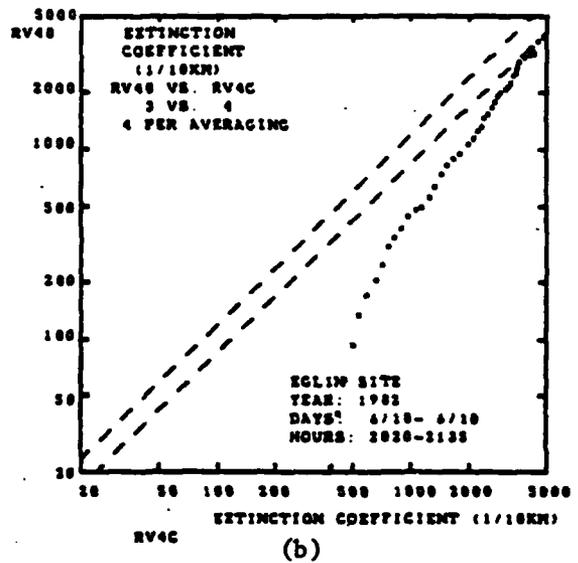
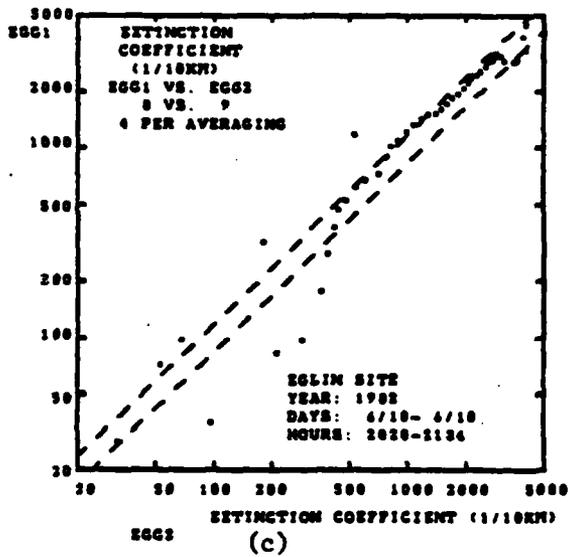
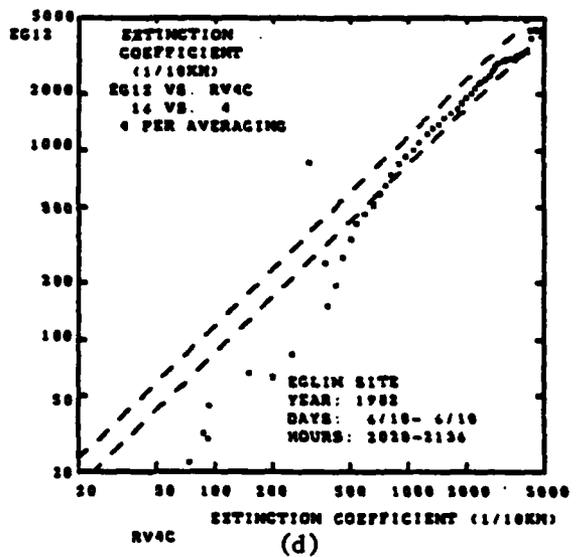
FIGURE 5-18. HOMOGENEITY OF THE COOLING FOG EVENT ON 6/10/82.

The character of cooling fogs is different from that of steam fogs. Because air is being circulated through the cooling coils, fog patches do not develop. The fog density varies more smoothly in time. On the other hand, the systematic variations in fog density are greater, presumably because of the consistent circulation pattern in the chamber. The final decay of the fog is also much more abrupt for cooling fogs as the cooling finally succeeds in driving the dewpoint below the temperature. It is clear that cooling fogs, while useful for close spaced sensors, are not a satisfactory method for achieving stable, uniform low fog densities.

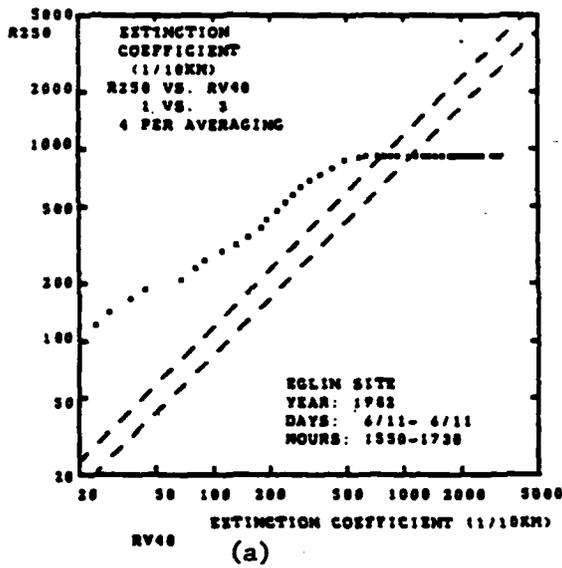
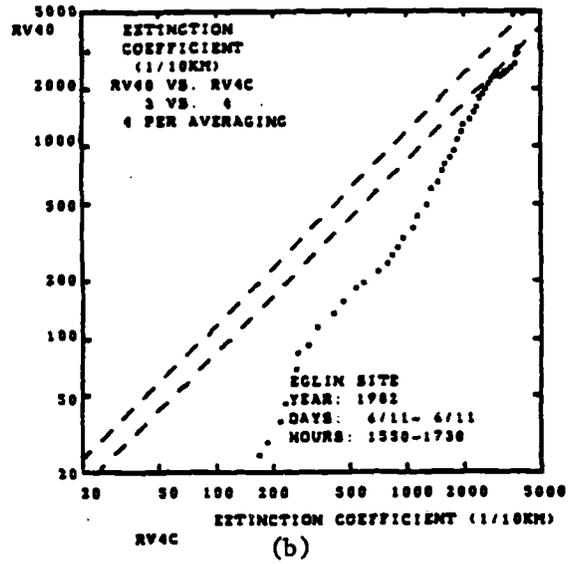
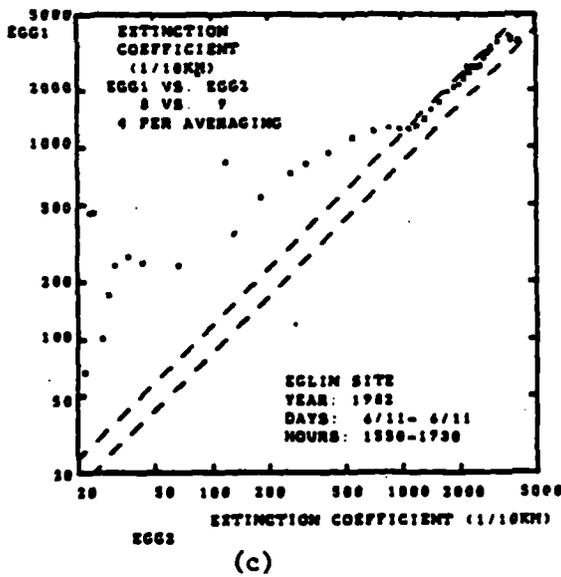
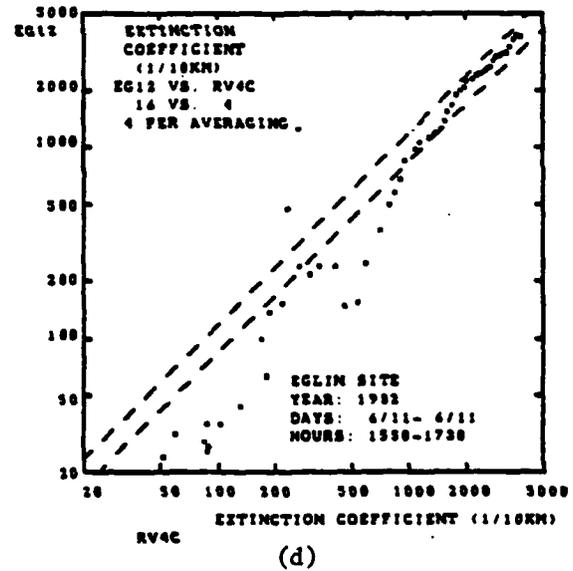
FIGURE 5-19. HOMOGENEITY OF THE COOLING FOG EVENT ON 6/11/82.

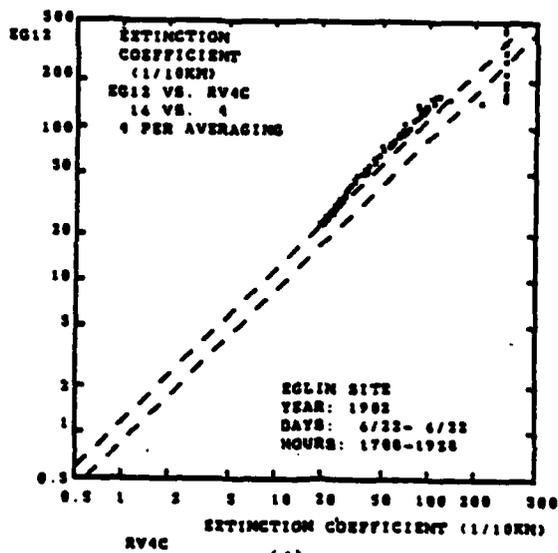
FIGURE 5-23. HOMOGENEITY OF THE FOG/HAZE EVENT ON 6/22/82: DECAY PERIOD. The RVR calibrator failed when the extinction coefficient was above 100 units in (b) and (d).

The last fog/haze event on 6/22 achieved the highest fog and haze extinction coefficients. Figure 5-20 shows the build-up period for this event. Approximately two hours were spent generating condensation nuclei and increasing the relative humidity. Figure 5-21 shows the decay period for the event. It shows less random variations. The snow machine output was cut back at intervals (17:13, 17:45, 18:22, 18:32) to gradually reduce the extinction coefficient. Figures 5-22 and 5-23 show the variation plots for the build-up and decay portions of the event respectively. The homogeneity is very good over a range of extinction coefficients which cannot be covered with steam or cooling fogs. The biggest variation noted is between the two RVR 500 baselines (Figures 5-22a and 5-23a) which indicate a difference between the two ends of the chamber. The build-up period (Figure 5-22) shows more scatter than the decay period (Figure 5-23).

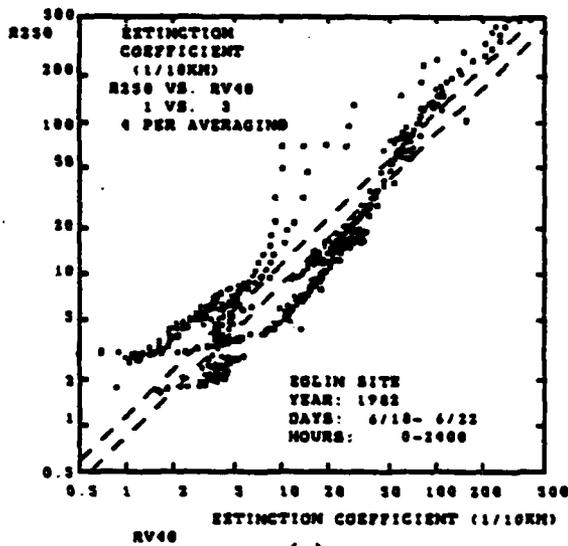
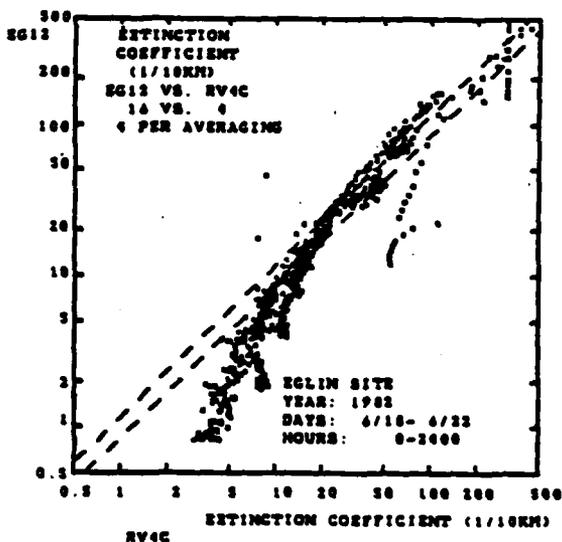
FIGURE 5-24. HOMOGENEITY OF ALL FOG/HAZE EVENTS. Note: the zig zag in (b) and (d) was caused by a transient in the RVR calibrator.

The decay portions of all the fog-haze events are combined in Figure 5-24. Many of these events reached lower extinction coefficients than

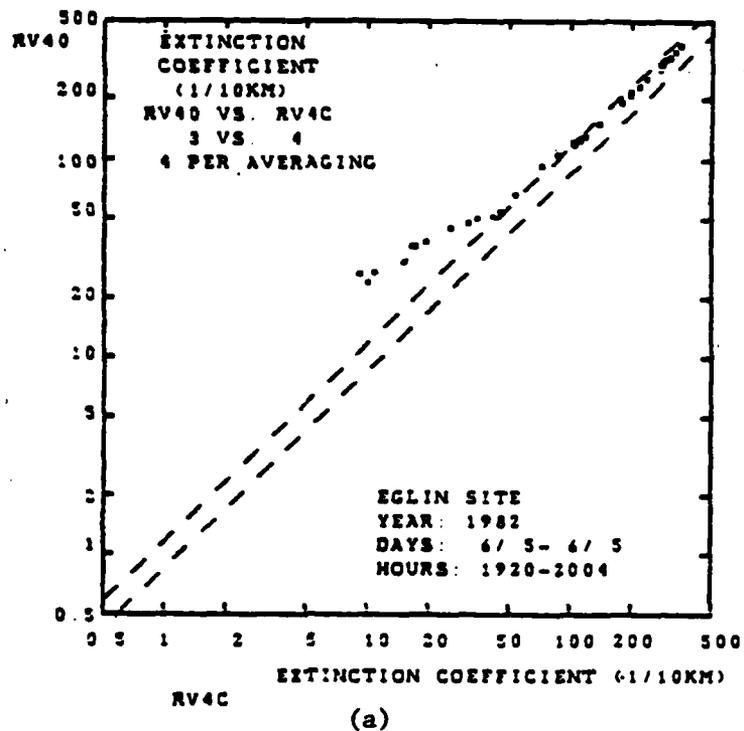
FIGURE 6-3. 40-FOOT RVR 500 VERSUS RVR CALIBRATOR SCATTER PLOTS FOR A COOLING FOG EVENT ON 6/5/82: (a) LOGARITHMIC, (b) LINEAR (SLOPE = 1.04. OFFSET = 8.5).

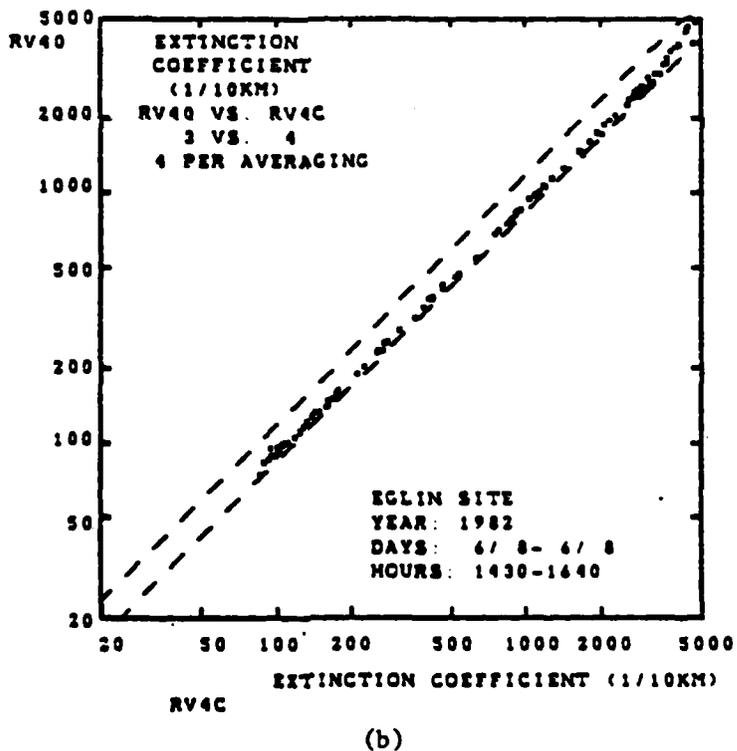
FIGURE 6-4. 40-FOOT RVR 500 VERSUS RVR CALIBRATOR FOR STEAM FOG EVENTS:  
(a) 6/7/82, (b) 6/8/82.

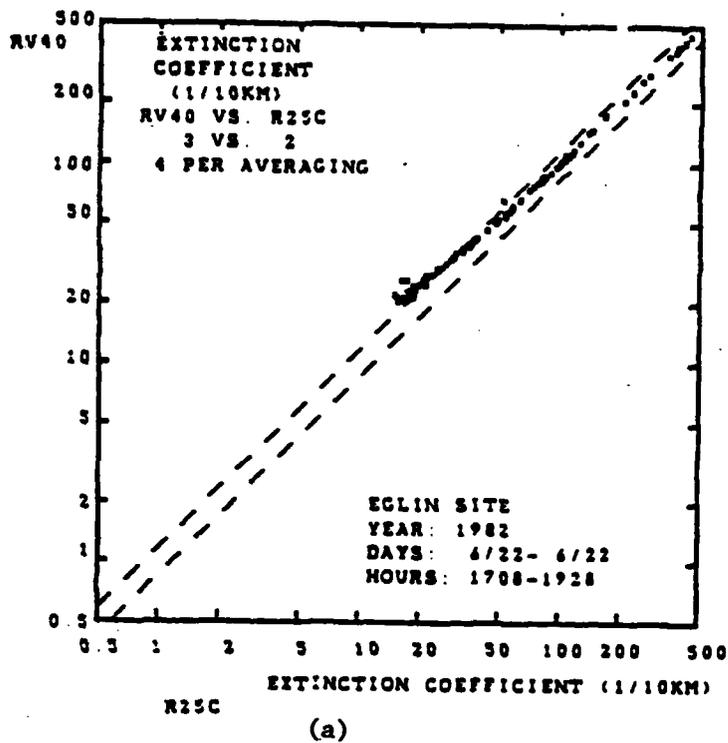
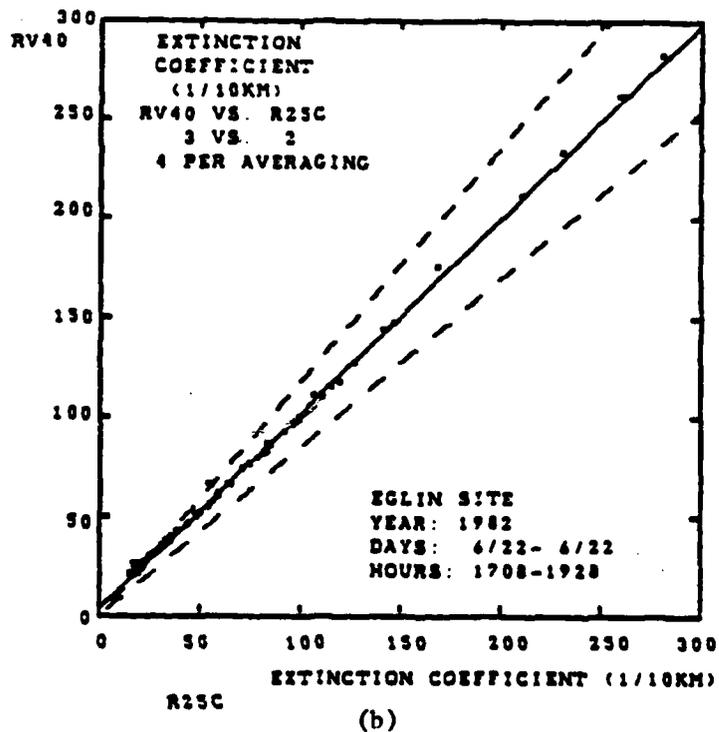
FIGURE 6-6. 40-FOOT RVR VERSUS (b) RVR CALIBRATOR SCATTER PLOTS FOR SNOW MACHINE FOG/HAZE ON 6/22/82: (a) LOGARITHMIC, (b) LINEAR (SLOPE = 0.98, OFFSET = 3.9).

a well defined curvature, a linear plot is also included to show that the curvature is caused by an offset in the extinction coefficient. The solid line in the linear plots is the least-square fit to the data points. The observed offsets of 13.2, 8.5, and 3.9 correspond to errors of 1.6, 1.0, and 0.5 percent respectively in the 100-percent calibration of the transmissometer. These values are consistent with the observed variation in 100-percent setting (see below). The offset could be caused by either or both instruments. The biggest offsets occurred on 6/5/82 which was a trial rather than an actual test day.

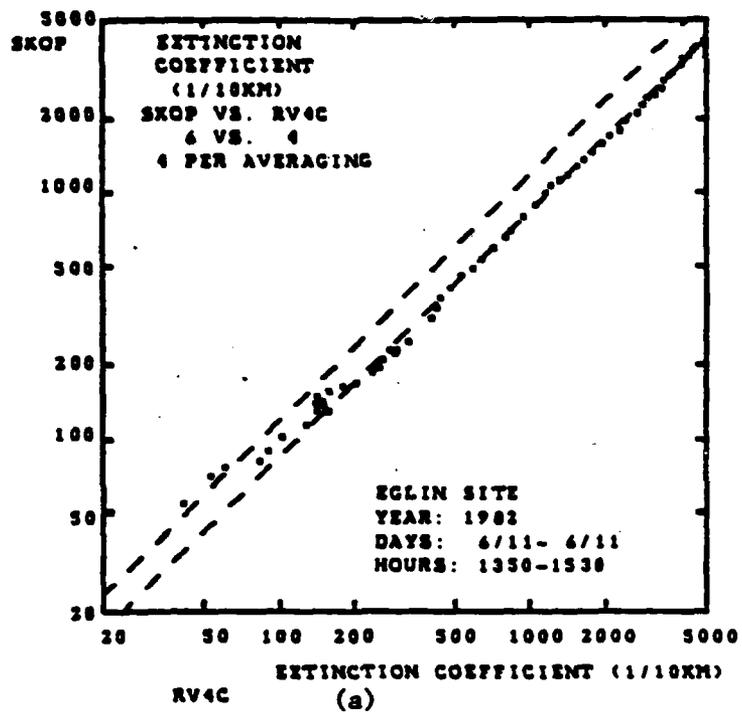
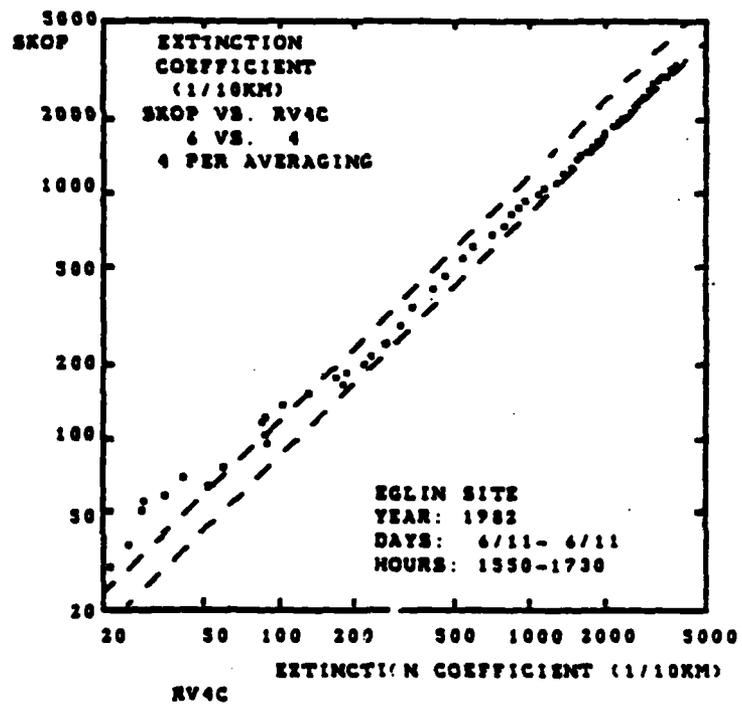
FIGURE 6-12. SKOPOGRAPH RESPONSE FOR TWO FOG EVENTS ON 6/11/82: (a) STEAM, (b) COOLING.

Figures 6-10 through 6-12 compare the Skopograph to the adjacent RVR calibrator for fog events. The correlation is excellent. There is a consistent offset, however, of about 15 percent toward lower extinction coefficients. A similar error (17 percent) was observed at Arcata on a 164-foot baseline. The observed errors are consistent with a forward-scattering error. Since both the beam size and the baseline were reduced in the Eglin tests, it is not unreasonable to have the same resultant error. If the 15 percent correction is made, the Skopograph
