DOT/FAA/PM-83/29  
DOT-TSC-FAA-83-1

# Evaluation of Visibility Sensors at the Eglin Air Force Base Climatic Chamber

Transportation Systems Center  
Cambridge MA 02142

October 1983  
Final Report

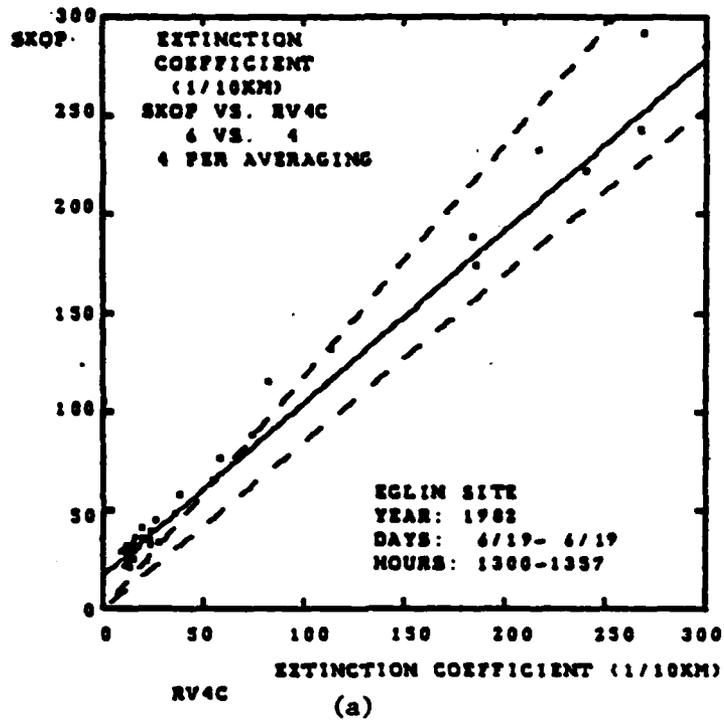
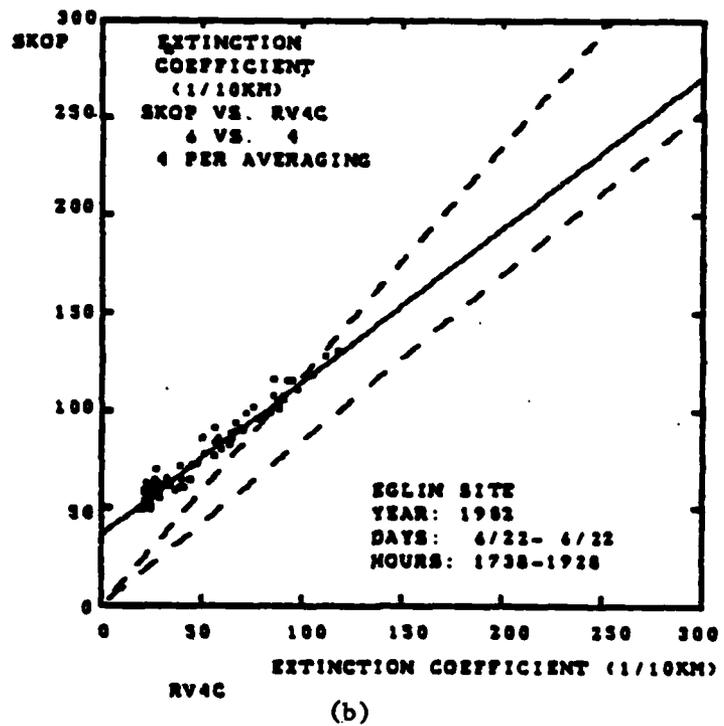
FIGURE 6-13. SKOPOGRAPH RESPONSE TO TWO FOG-HAZE EVENTS.

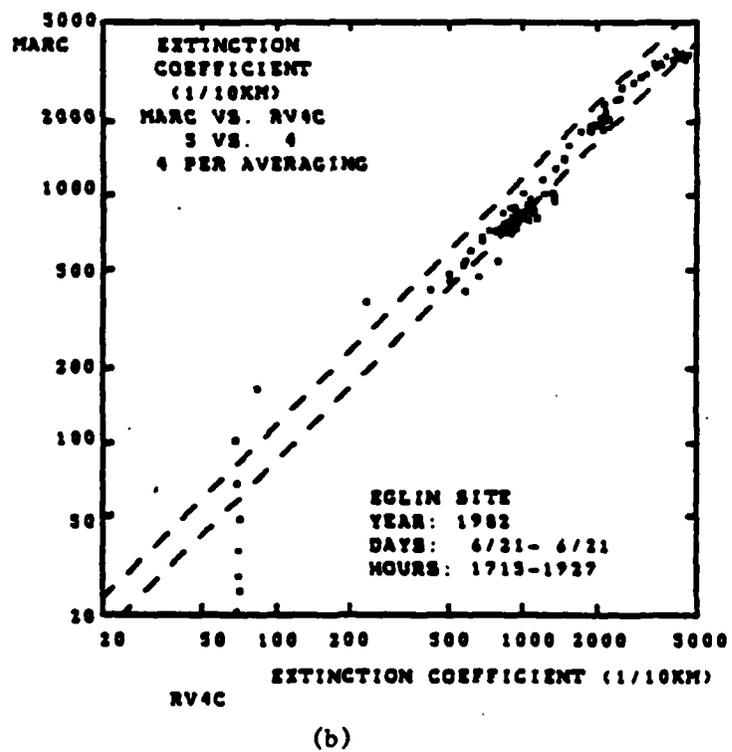
FIGURE 6-14. MARCONI RESPONSE TO TWO STEAM FOG EVENTS.

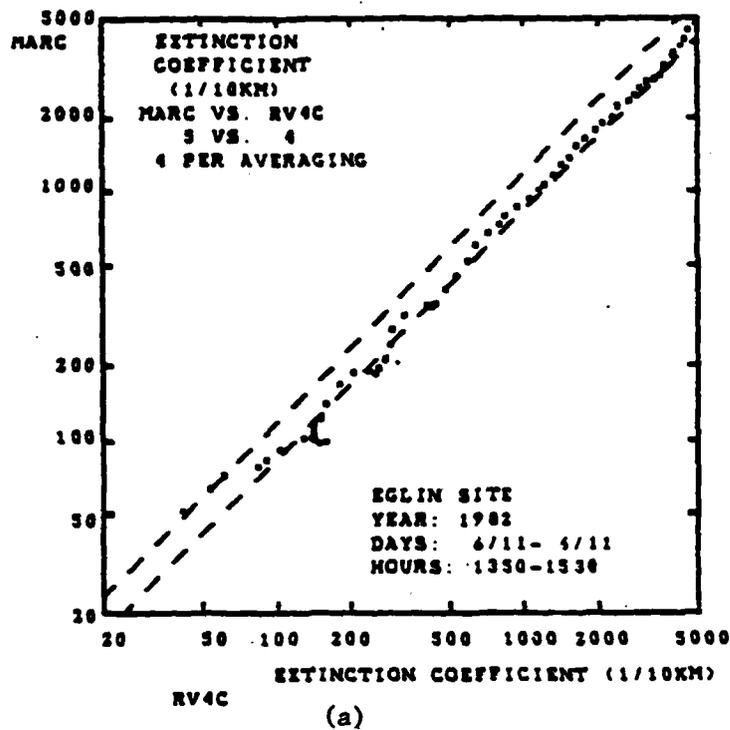
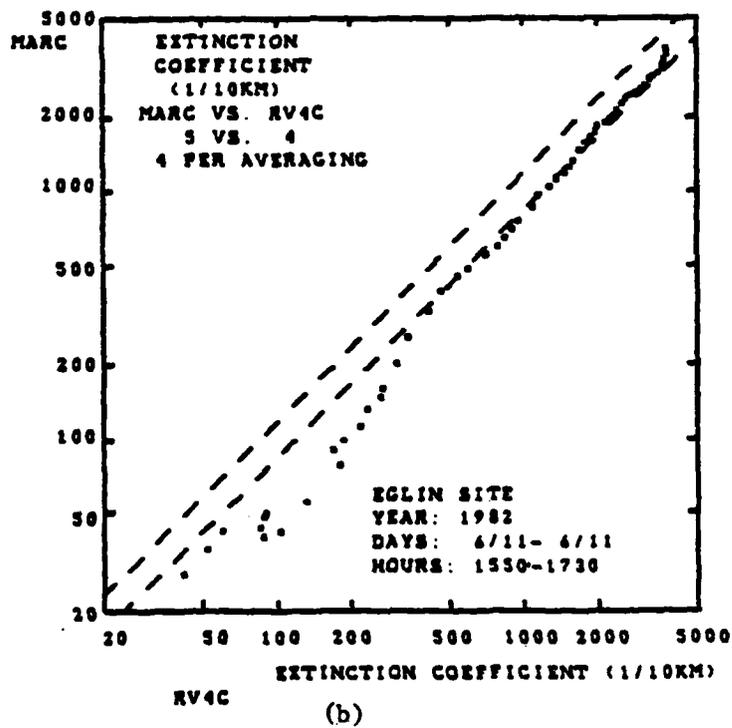
FIGURE 6-16. MARCONI MET-1 RESPONSE FOR TWO FOG EVENTS ON 6/11/82:  
(a) STEAM, (b) COOLING.

the response out to 6000 foot RVR ( $\sigma = 15$  in daytime) until after the cold temperature cycle which destroyed the stability of the 100-percent calibration. Offsets as large as  $\sigma = 15$  were observed after that time. Figure 6-17 compares the Marconi response to the RVR calibrator for two snow machine fog/haze events. The 6/19 event (6-17a) is consistent with the 10 percent correction noted for the fog events but the 6/22 event (6-17b) as well as the low extinction end of the 6/19 event shows a higher slope. Figure 6-18 compares the MET-1 to the average of the two EG&G 207 sensors for all the fog/haze events. The divergence of the various lines is caused by the shifts in 100-percent calibration.

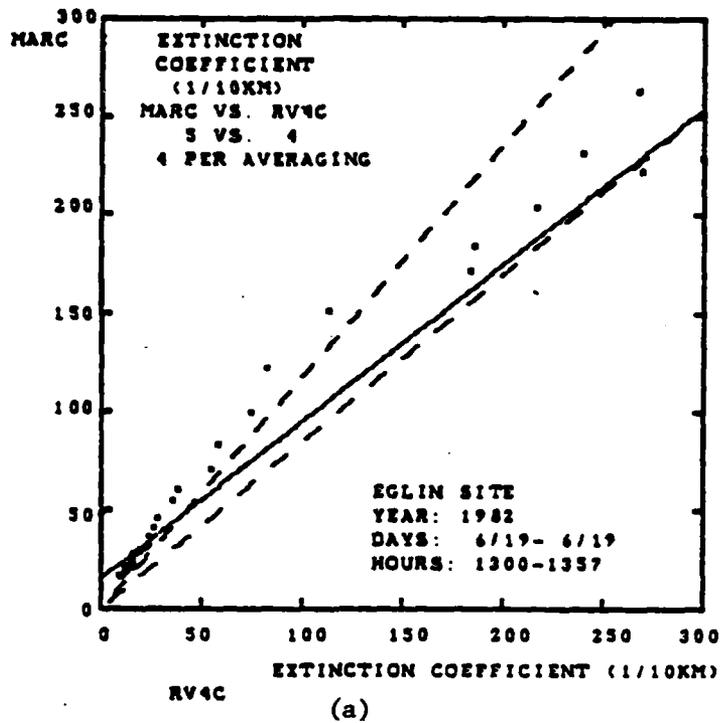
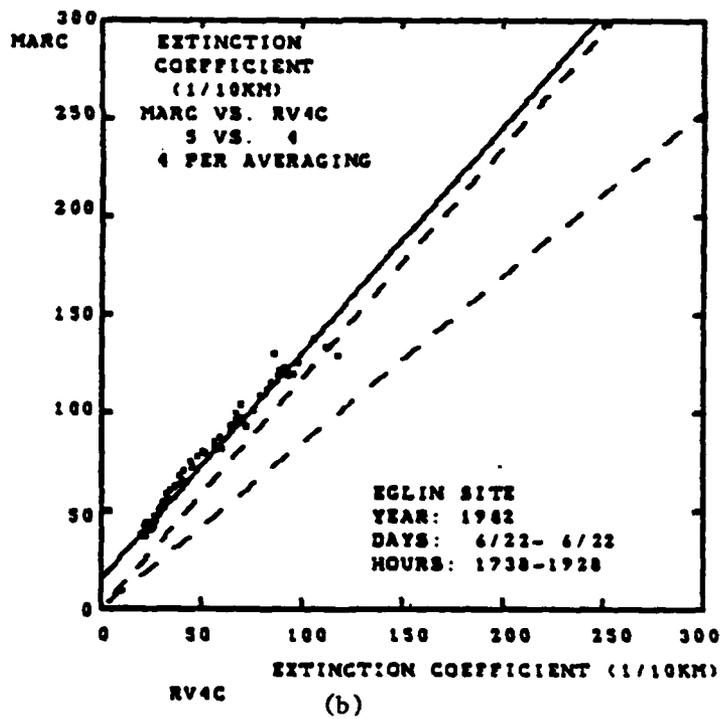
FIGURE 6-17. MARCONI MET-1 RESPONSE FOR TWO FOG-HAZE EVENTS.

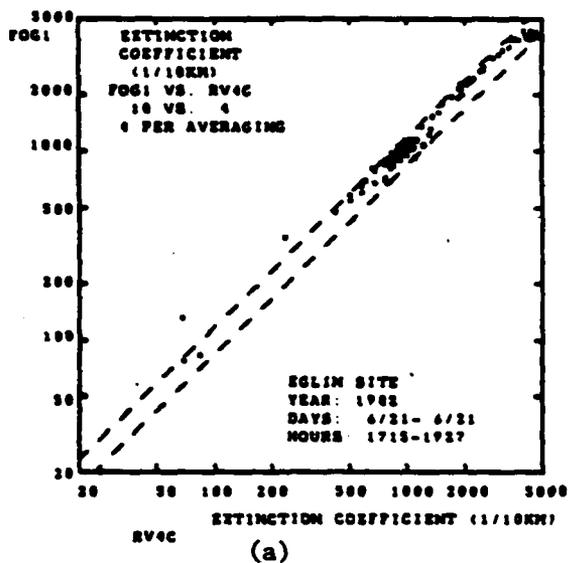
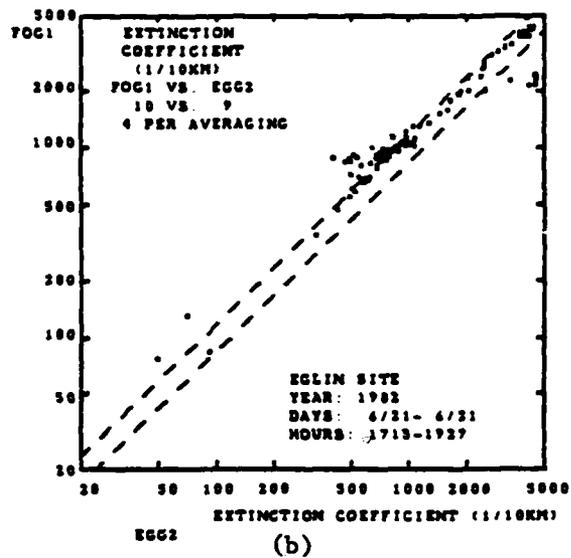
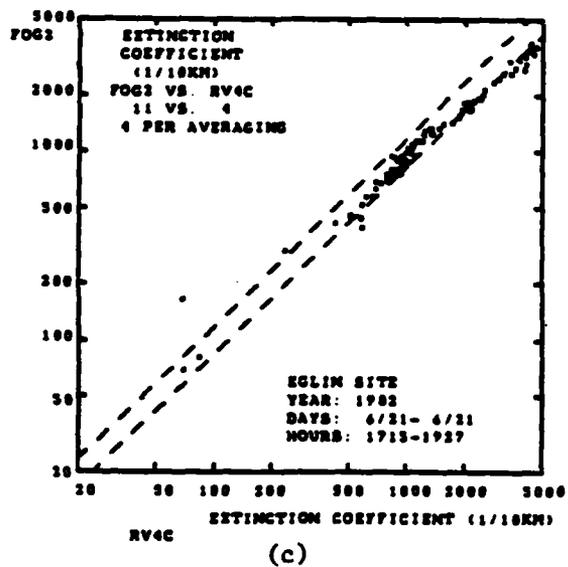
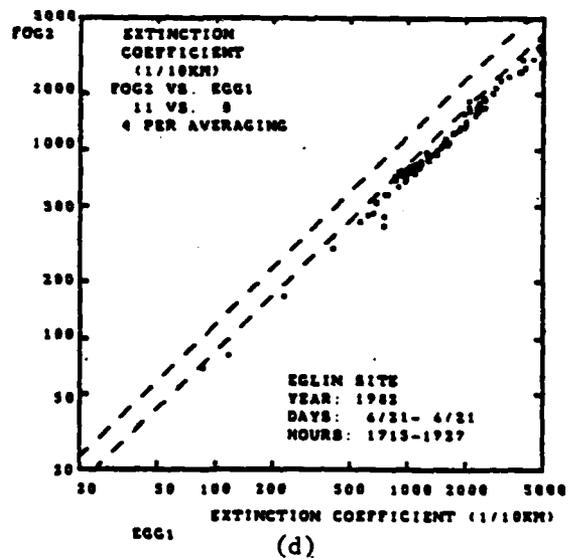
FIGURE 6-27. FOG-15 RESPONSE FOR THE STEAM FOG EVENT ON 6/21/82.

within the 15 percent limits of the pass/fail criterion above  $\sigma = 500$ . The possible saturation for FOG2 at high extinction coefficients, mentioned in Section 5.7.2, may be indicated in some of the plots (6-22c, 6-25c, 6-26c, and 6-27c). In these same Figures FOG2 also reads low compared to EGG1.

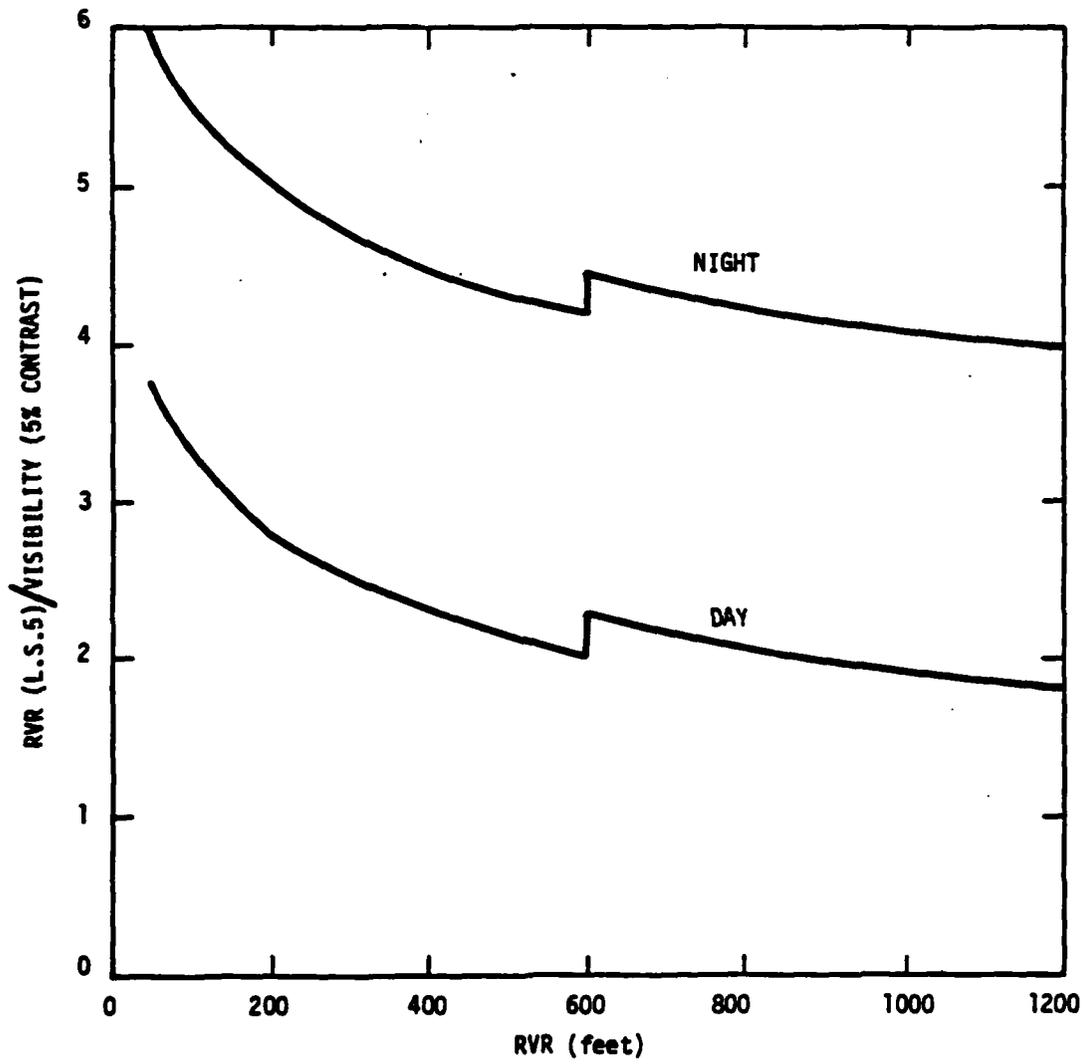
FIGURE 1. RATIO OF RVR (L.S.5) TO 5-PERCENT-CONTRAST VISIBILITY  
VERSUS RVR.

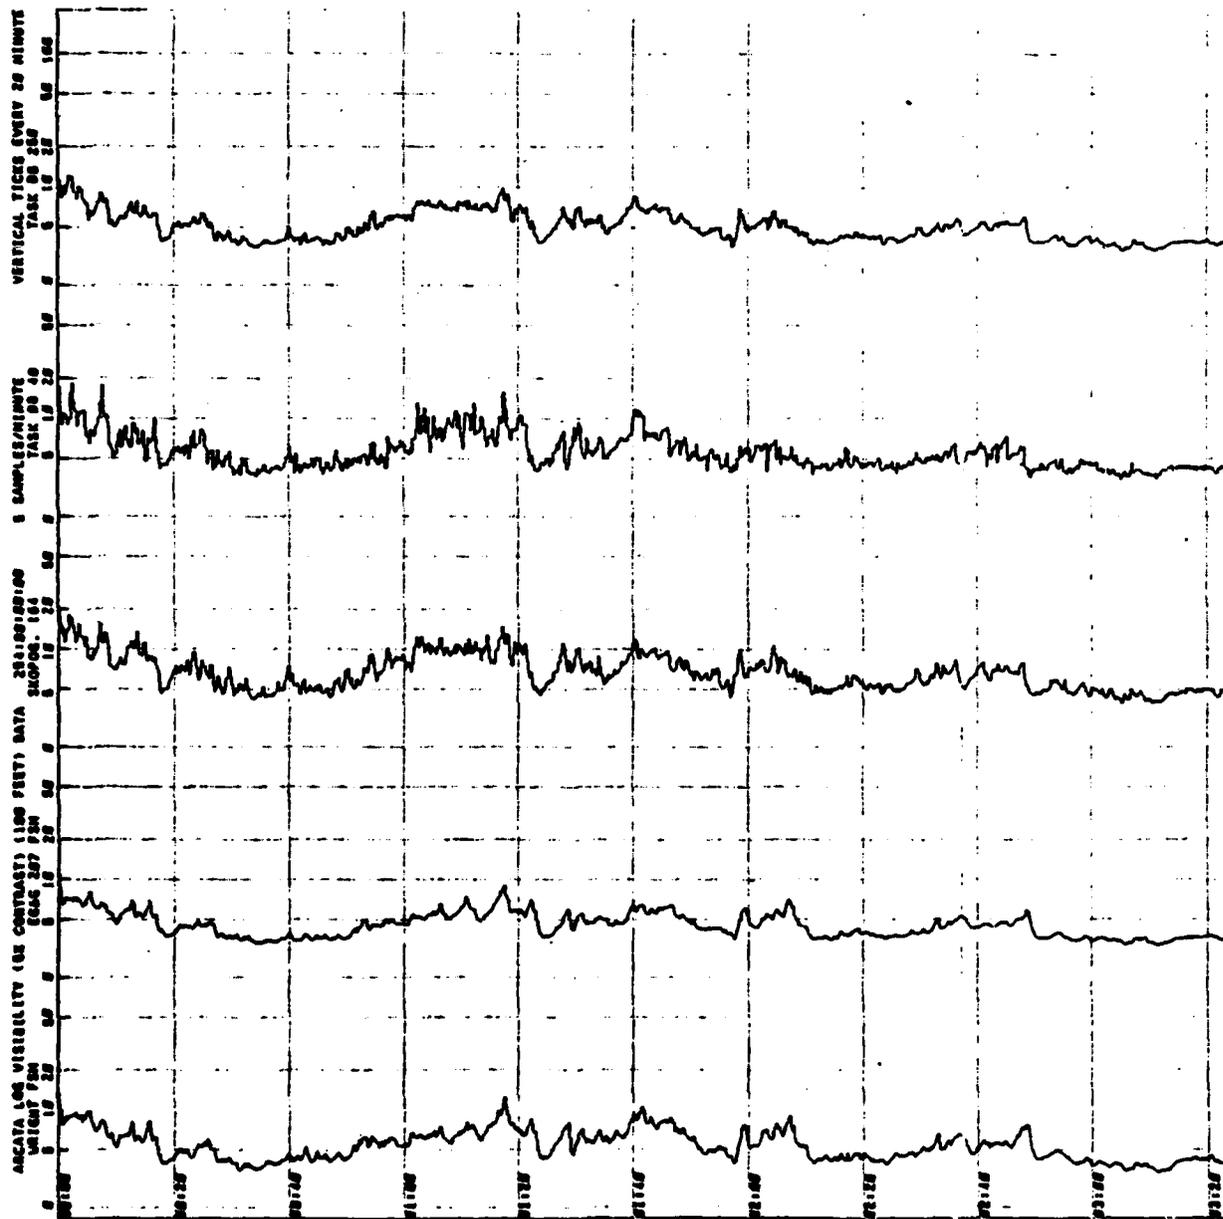
FIGURE 7. VISIBILITY TIME HISTORY FOR THE FIRST PART OF  
EVENT 2.

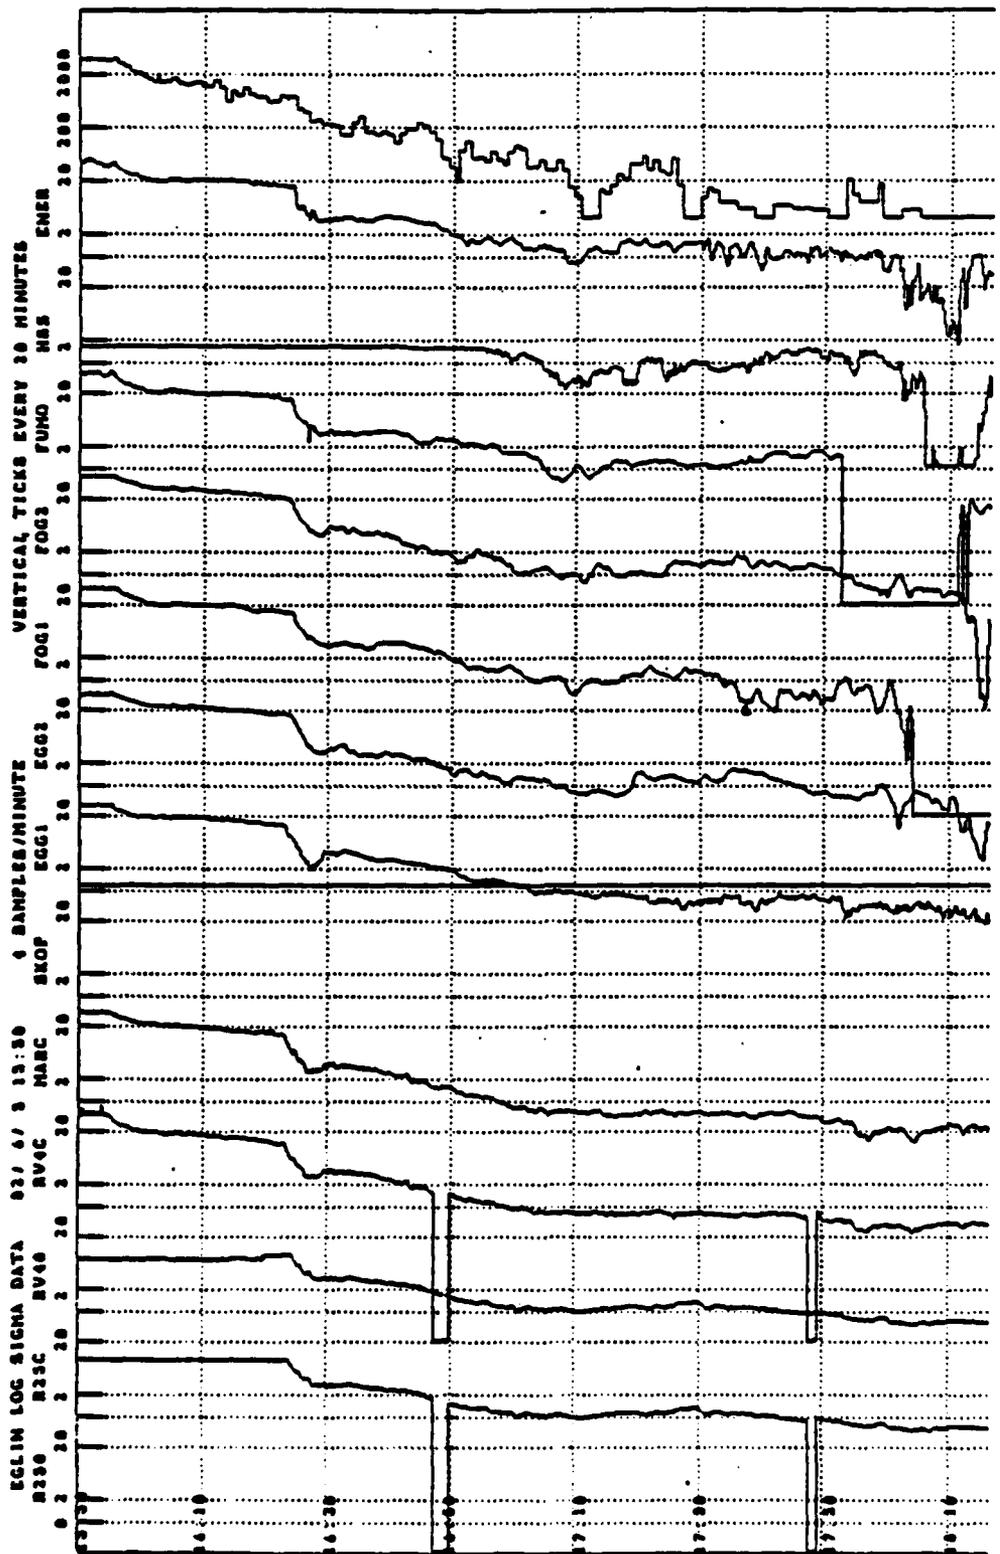
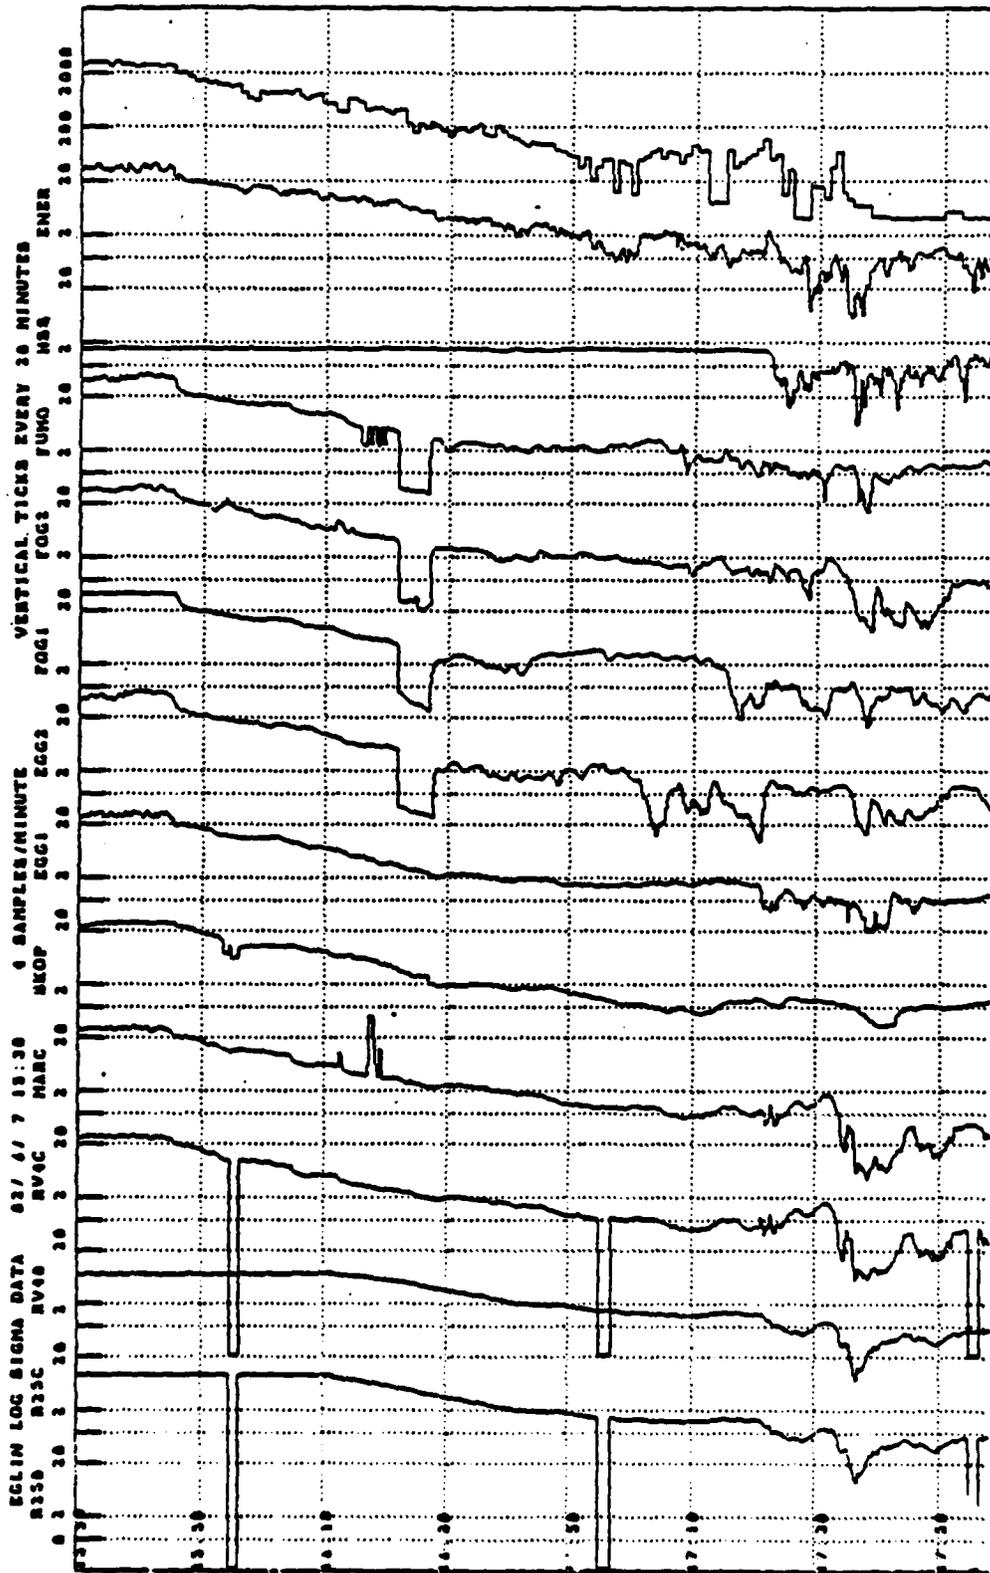
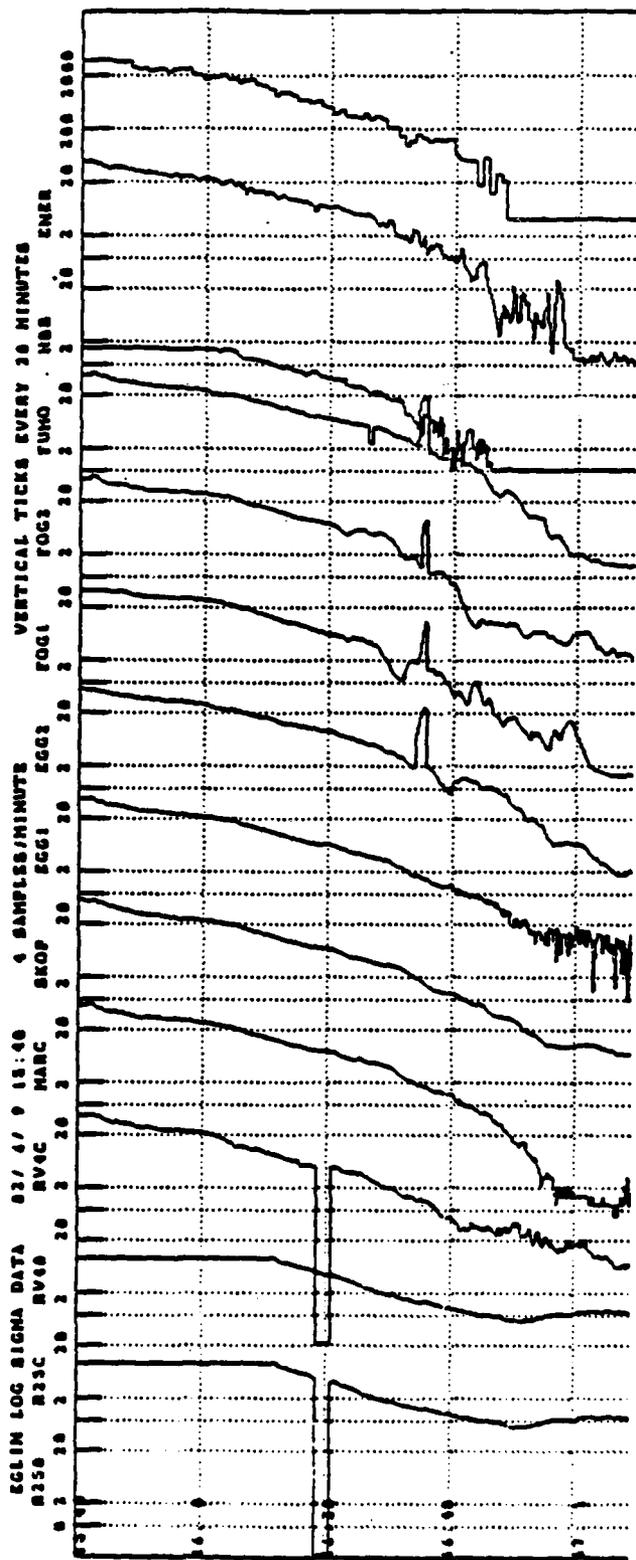
FIGURE C-1. STEAM FOG EVENTS.

This appendix contains stripcharts for all events not included in the body of the report. Figure C-1 contains the steam fog events (see also Figure 6-1). Figure C-2 contains cooling fog events. The nature of the event in Figure C-2a is uncertain since no log was kept of trial fogs. Figure C-3 contains snow-machine fog/haze events (see also Figure 5-19).

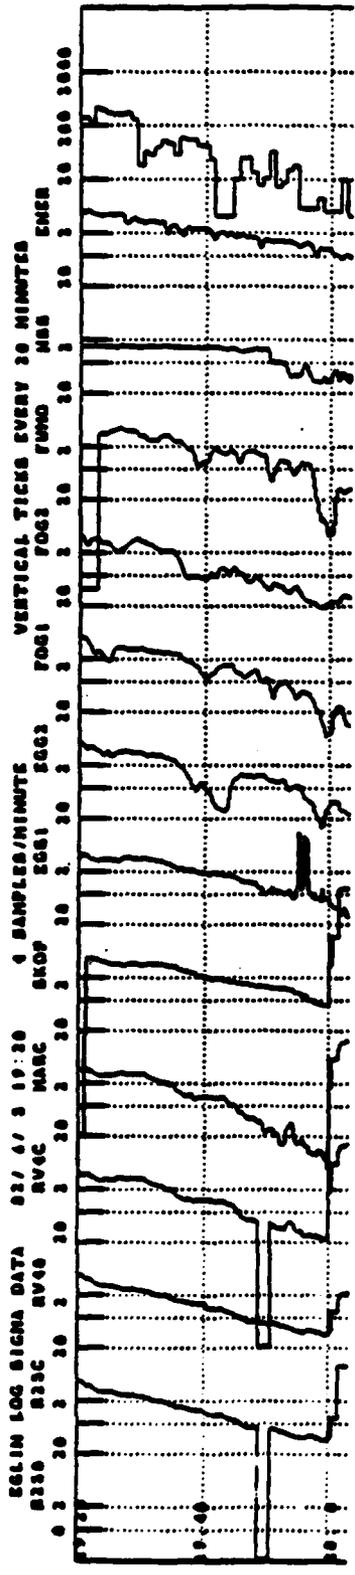
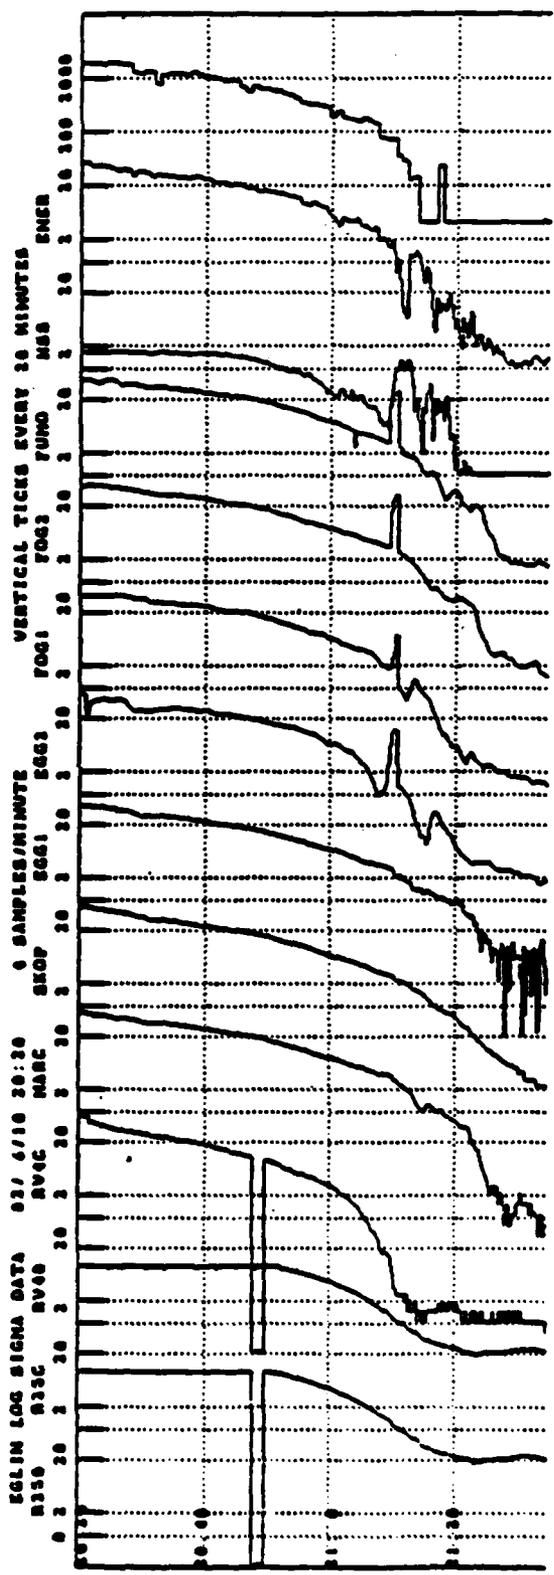
FIGURE C-2. COOLING FOG EVENTS

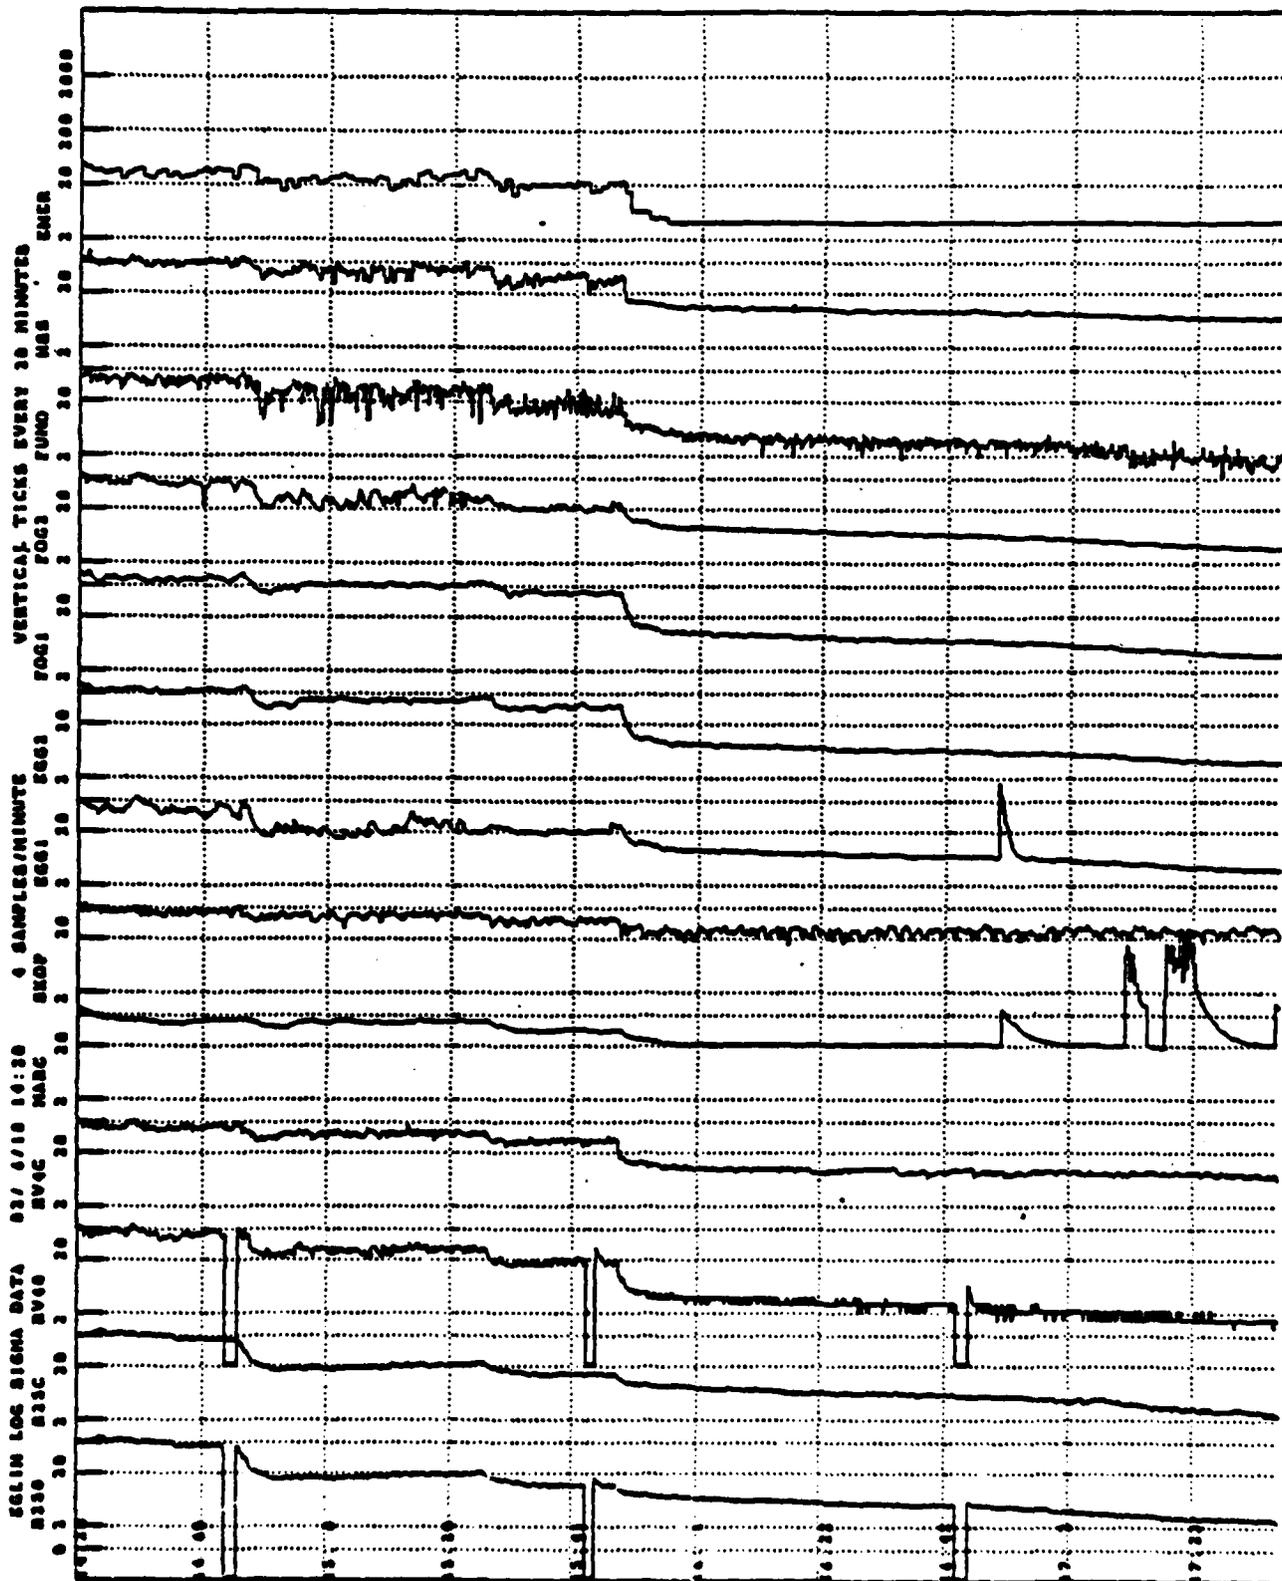
FIGURE C-3. FOG/HAZE EVENTS .
