THE ROLE OF HYDROGEN IN THE STRESS CORROSION FAILURE OF 1/1
HIGH STRENGTH AL... (U) IMPERIAL COLL OF SCIENCE AND
TECHNOLOGY LONDON (ENGLAND) M L YUEN ET AL. OCT 83

REPORT DOCUMENTATION PAGE		READ INSTRUCTIONS BEFORE COMPLETING FORM
1. REPORT NUMBER ADA136 212	2. GOVT ACCESSION NO.	3. RECIPIENT'S CATALOG NUMBER
4. TITLE (and Subtitle) The role of hydrogen in the stress corrosion failure of high strength Al-Zn-Mg alloys.		5. TYPE OF REPORT & PERIOD COVERED Annual Technical Report

1. INTRODUCTION

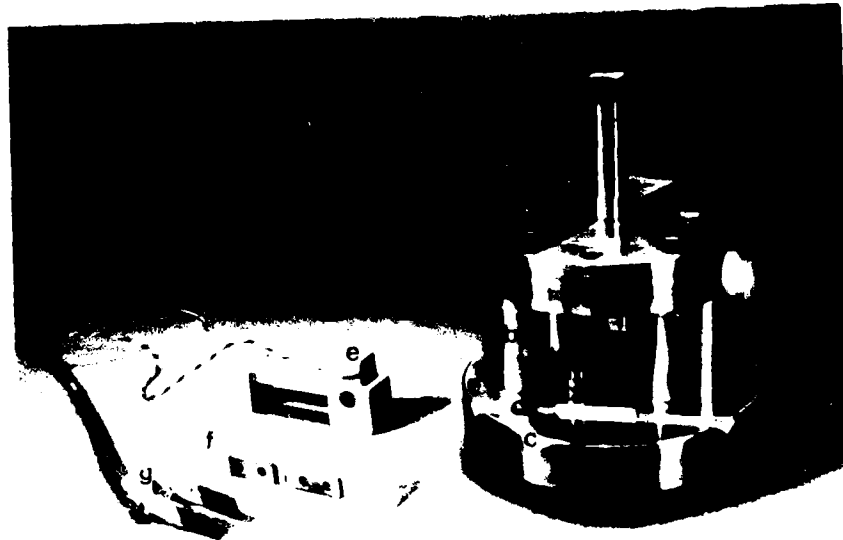
Fig. 3. Four point bending rig

a : top plate

b : spacers

c : bottom plate

cd : grooves and ceramic rods to support the specimen

ce : studs for positioning the specimen

d : bolt to apply a load on the specimen

e : load cell

f : a typical four point bending specimen with knife edges

g : dial indicator

An autoclave (1) and a 3-point bending rig (Fig. 3), have been built to carry out stress corrosion tests in a steam environment at

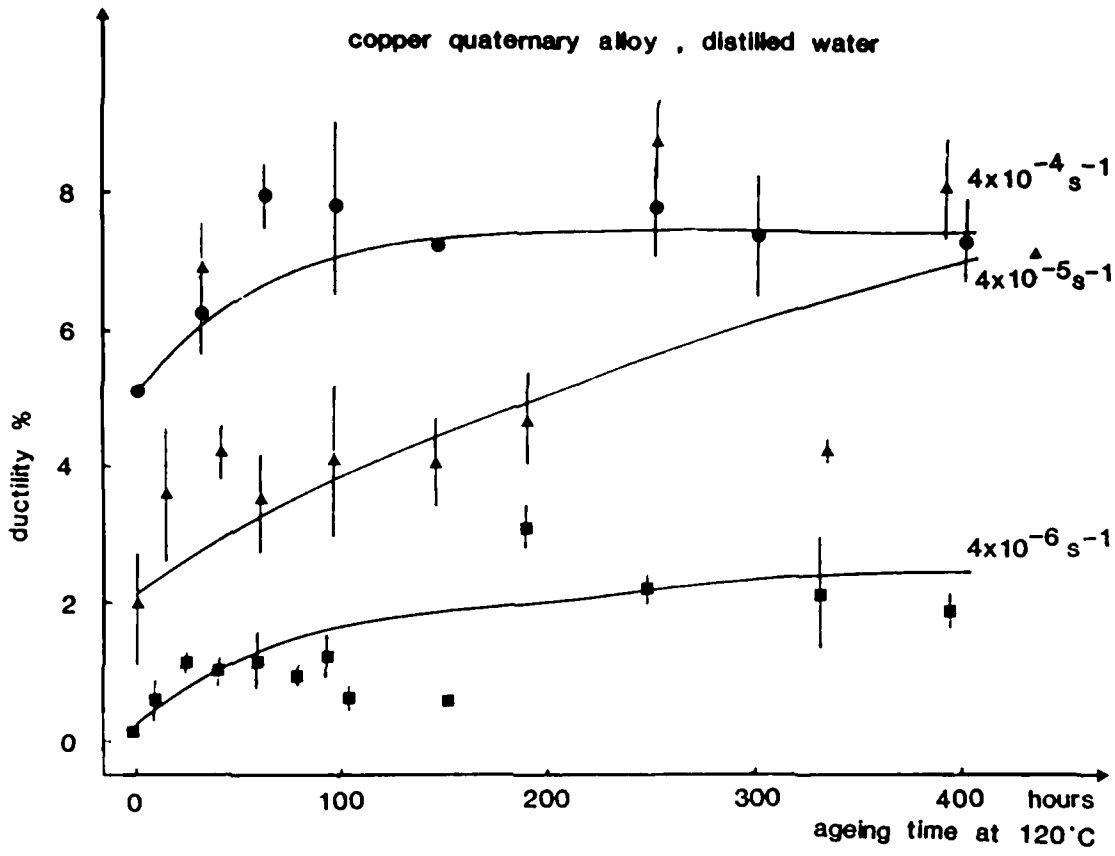
Fig.4a Variation of ductility with ageing time

In distilled water, the specimens underwent superficial corrosion and a large numbers of microcracks formed during loading. The presence of these led to considerable scatter in the apparent yield stress measurements but did not significantly affect fracture stress values (except for the slow strain rate saline environment tests). Since the fracture stress values were reproducible it is unlikely that the microcracks significantly affect the ductility values obtained which are presented in Figs. 4 a, b, for the distilled water environment and Figs. 5 a, b, for the saline environment. In both cases, ductility increases with increasing strain rate and increasing ageing time up to periods of the order of 10² hours at 120°C. The effect of the environment

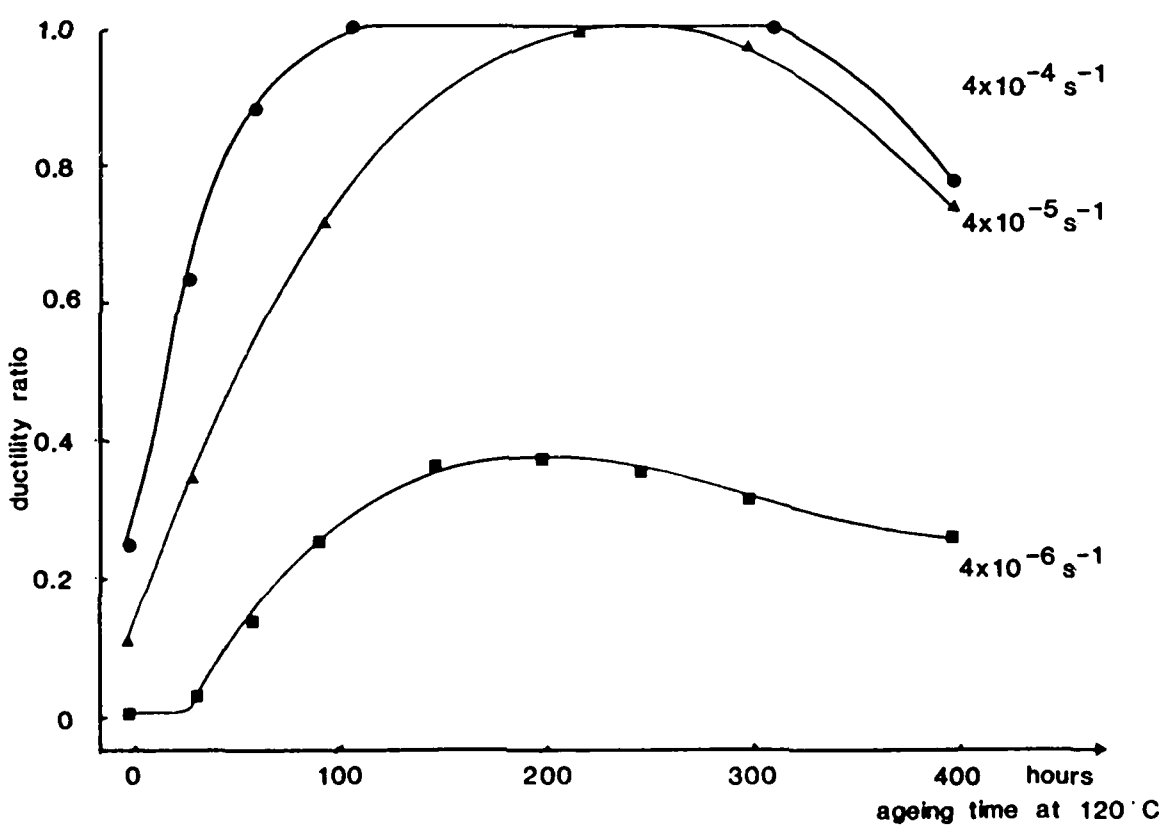
Fig.4b Variation of ductility ratio with ageing time
 Ductility ÷ ductility of fast strain rate dry samples

is most obviously demonstrated by plotting the ratio of the observed ductility to that obtained in similarly aged material tested dry at the fastest strain rate (7) (i.e., conditions under which environment influence is minimal). The results are presented in Fig. 4b and 5b and indicate that gross overageing, although marginally increasing the absolute level of ductility, decreases the resistance to embrittlement in aqueous media. Figs. 4 and 5 also demonstrate the deleterious effect of salt which reduces the ductility ratio by a factor of approximately two for all aged conditions and strain rates examined.

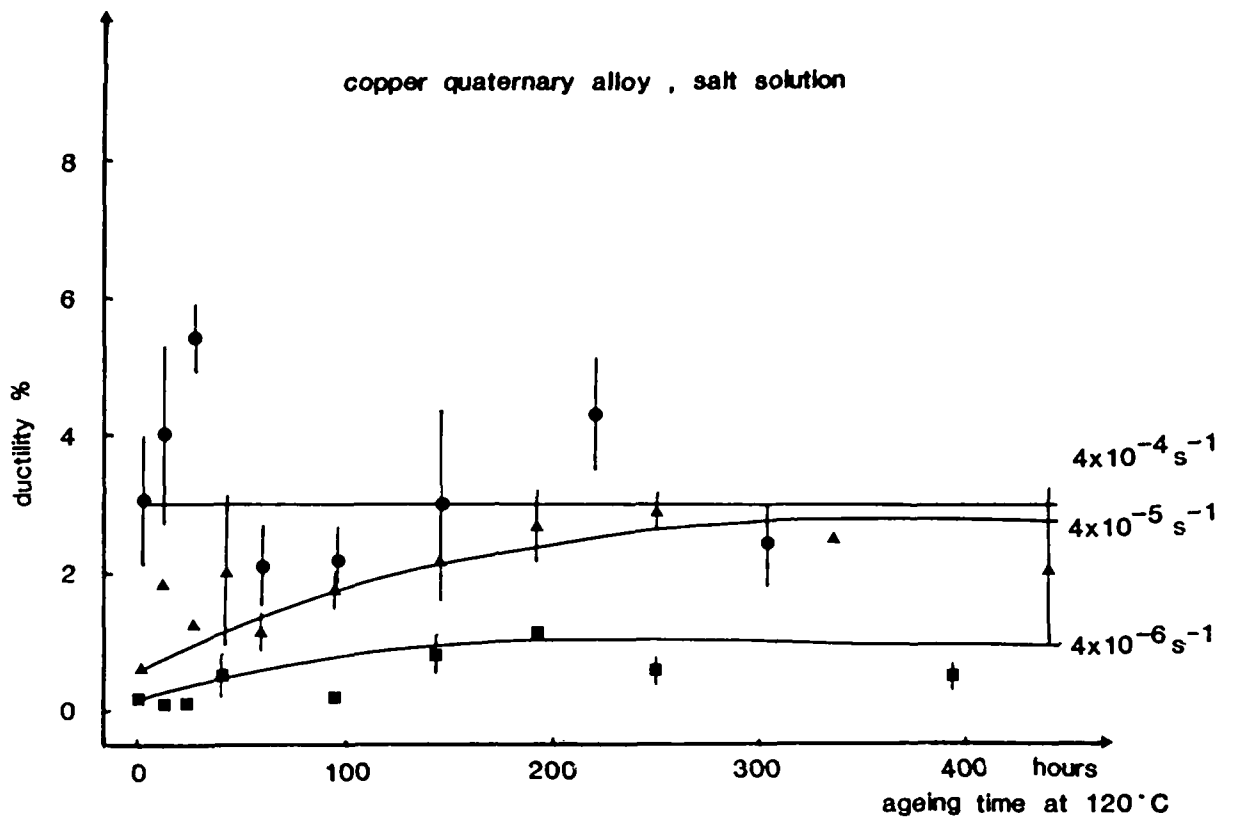
Fig. 5a Variation of ductility with ageing

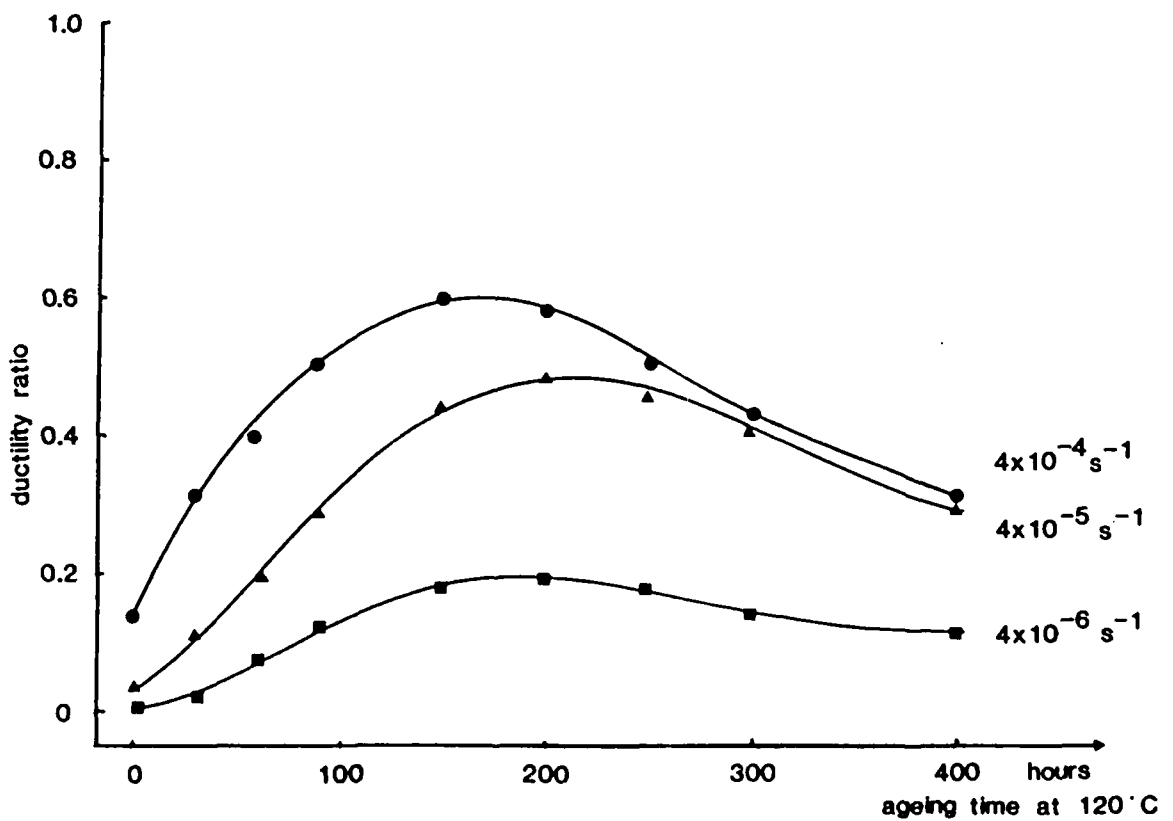
Fig. 5b Variation of ductility ratio with ageing
Ductility + ductility of fast strain rate dry samples

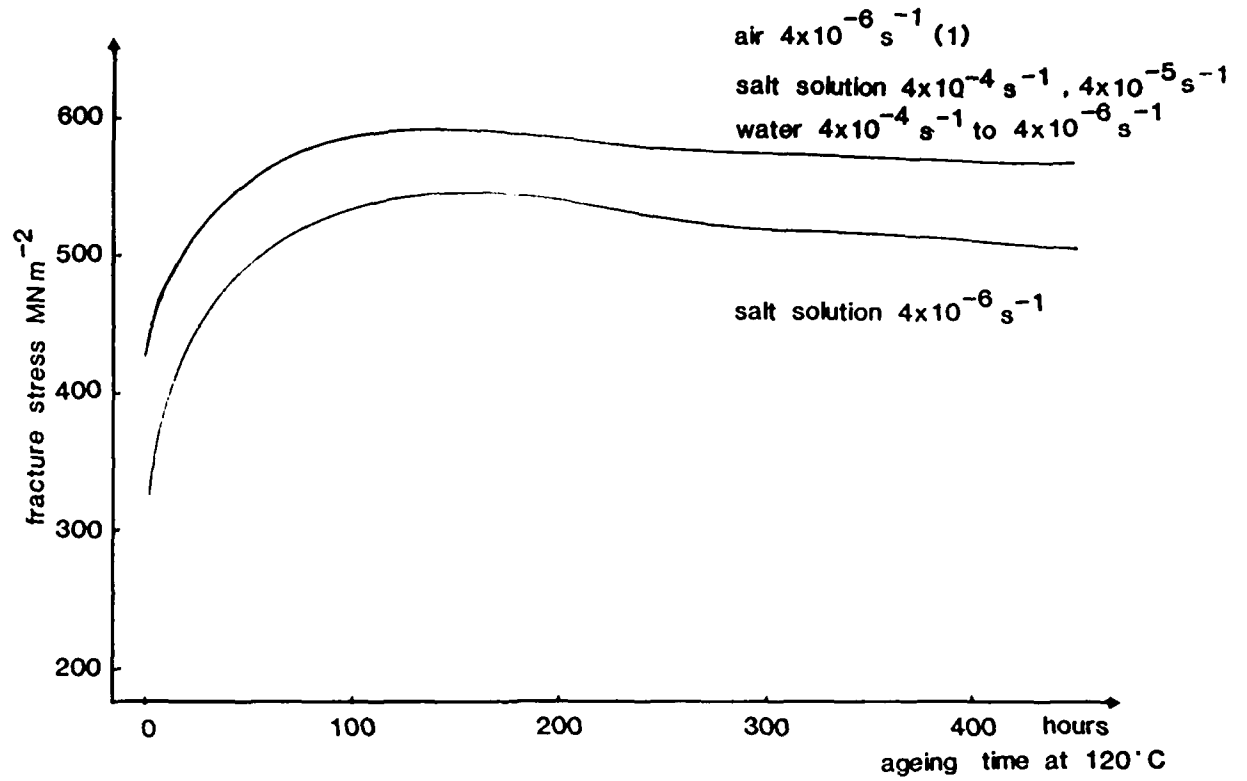
Fig.6 Variation of fracture stress with ageing
(scatter $\pm 10 \text{ MN m}^{-2}$)

As noted earlier fracture stress values were much less affected by environment and strain rate than was ductility. This is illustrated by Fig. 6 in which data for all tests, with the exception of the slow strain rate saline test, fall on the same curve as the fastest strain rate test in dry air.

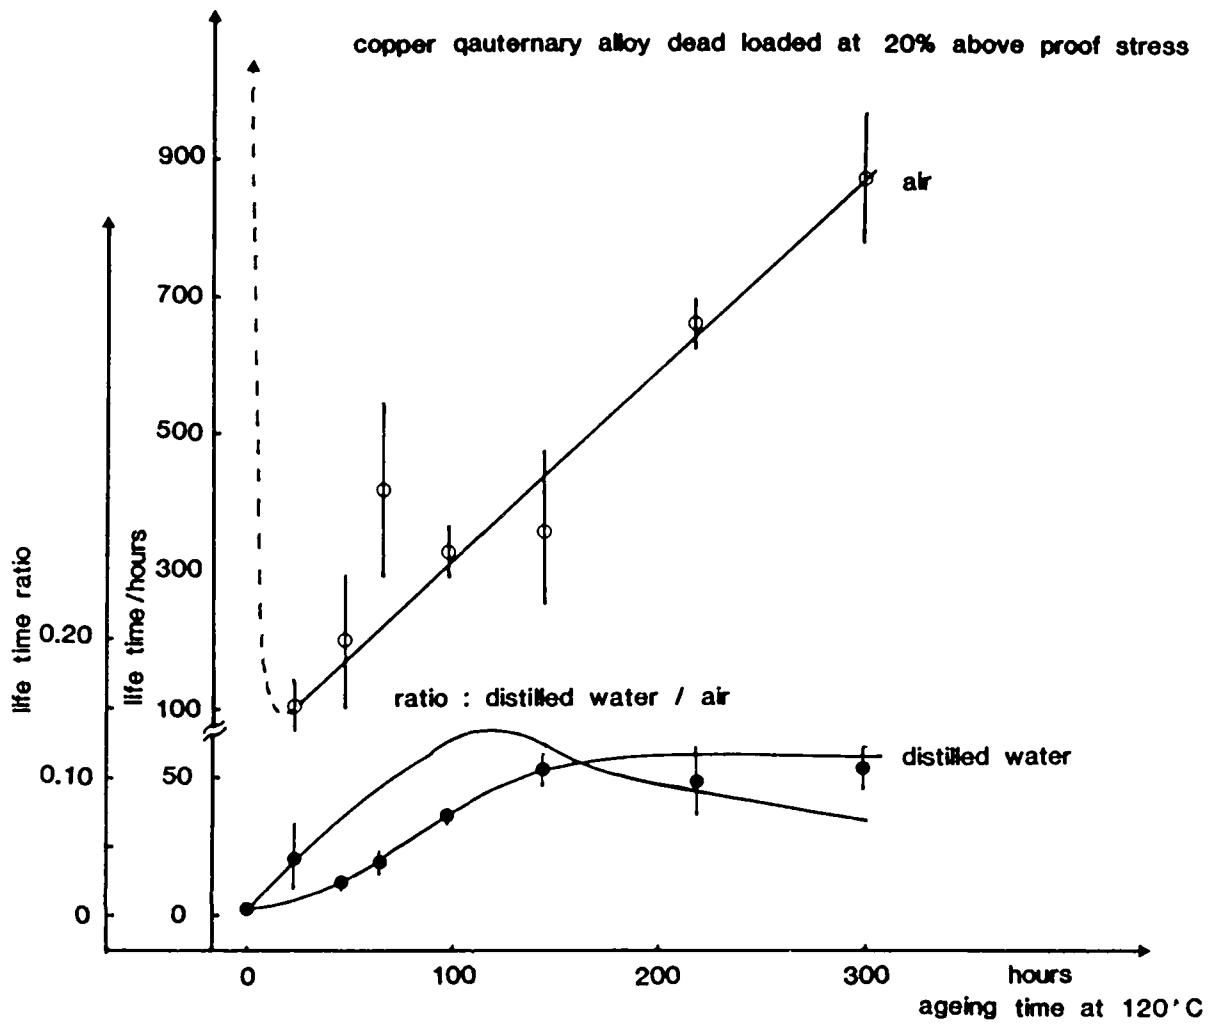
Fig. 8 Variation of life time and life time ratio with ageing

Beyond 24-30 hours of ageing at 120°C, the material has reached the age hardening plateau which extends to over 400 hours ageing. Beyond 30 hours of ageing, the samples were, therefore, loaded to the same stress level. Solution treated material has a life in excess of 1100 hours when tested in air: life drops sharply with artificial ageing down to the plateau and then rises continuously with increasing ageing time (Fig. 8).

This behaviour contrasts sharply with that of samples tested in water where even in the solution treated condition, life is minimal and increases much more slowly with ageing. The life time ratio expressed as the ratio of the life time in air to that in water shows a maximum at approximately 120 hours ageing and a shape very similar to that of the ductility ratio data for the slowest strain rate shown in Fig. 4b. Since the fractographic data indicate that the slow strain rate samples failed post yield the dead load results may be taken as equivalent to ultra low strain rate data.

However, fractography is considerably more complicated than the above correspondence would imply. The fracture surfaces were in general intergranular throughout the fracture path and were brittle in appearance. A small number of samples exhibited life times well below the values shown in Fig. 8. In all such cases, the fractography indicated that premature failure had initiated at surface flaws which produce a notch effect. The fracture contained clear evidence of tensile overload containing coarse dimples and/or transgranular facets with quasi cleavage or micro-dimples. Additionally all samples exhibited a thick hydrated oxide layer about 1 μ m in thickness covering the entire fracture surface. In some cases when part of the oxide had decohered, fracture matching showed that the missing segments were present on the corresponding area of the other fracture surface (plate 2 a, b). This implies that at least part of the oxide film developed before the fracture crack opened up. Many micro-cracks were also observed. The fractographic studies are summarised

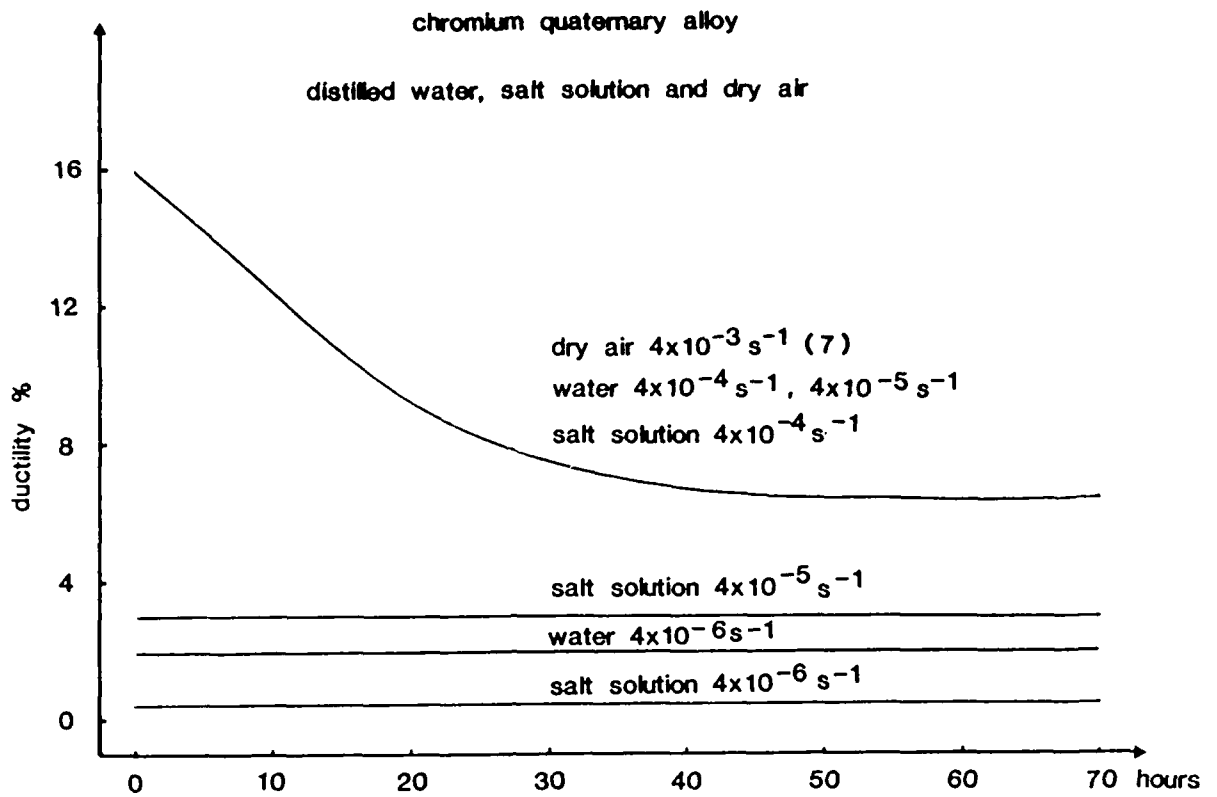
Fig.9a Variation of ductility with ageing

To avoid complication, experimental points are not shown.

The scatter is $\pm 2\%$ for the high ductility curve and $\pm 1\%$ for the lower ductility curves.

Tests have been performed on samples aged up to 70 hours at 120°C. There is no embrittlement when tested in distilled water at strain rates of $4 \times 10^{-4} \text{ s}^{-1}$ and $4 \times 10^{-5} \text{ s}^{-1}$ and in salt solution at $4 \times 10^{-4} \text{ s}^{-1}$. The ductility decreases as age hardening takes place and reaches a minimum value of about 7% after 40 hours ageing. At slower strain rates ductility is substantially reduced and is independent of the heat treatment condition. The ductility is plotted in Fig. 9a. The ratio of the ductility of this aqueous environment test to that of the fast strain rate dry sample (7) is plotted in Fig. 9b. Also included is the ratio of the ductility of the samples tested in air dried by silica gel at a strain rate of $4 \times 10^{-1} \text{ s}^{-1}$ to that of the fast strain rate dry samples.

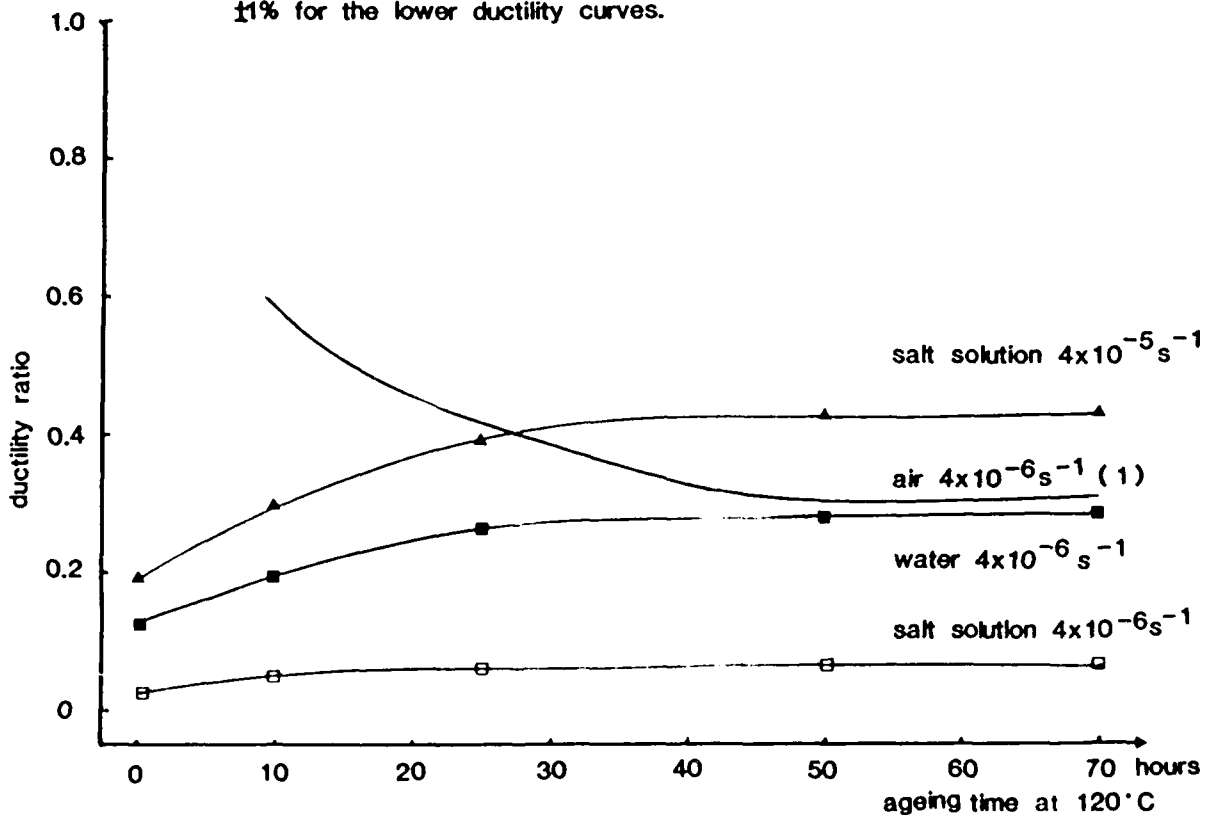
Fig. 9b Variation of ductility ratio with ageing

Ductility \div ductility of fast strain rate dry samples

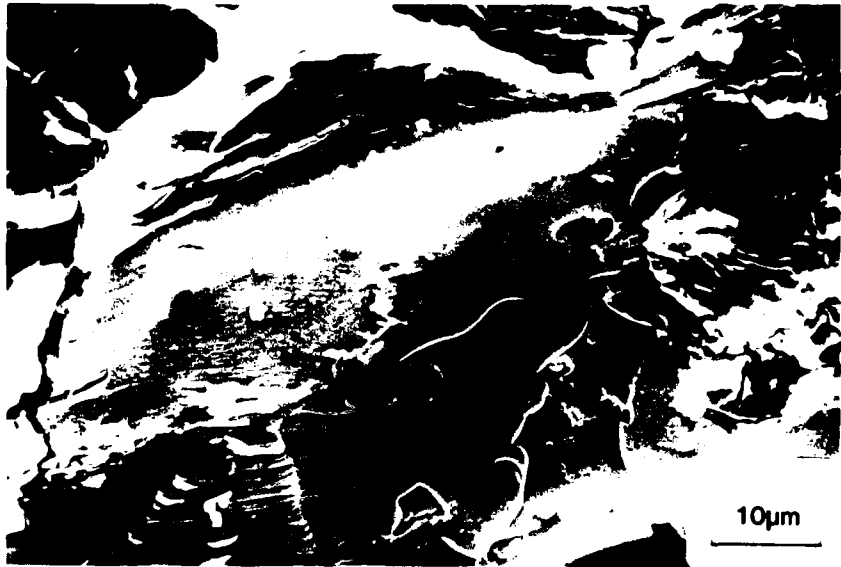
Plate 3 a, b.

Copper containing alloy, solution treated, overloaded after loading in air in excess of 1100 hours, showing the oxide film on the grain boundaries of the matching faces matches perfectly.

in Fig. 7. One dead load sample (copper containing variant in the solution treated condition) exposed to air for 1100 hours was deliberately overloaded to induce rapid fracture. Over 90% of the fracture surface was clearly formed during overload being ductile in nature. At one corner of the sample a small zone of brittle intergranular fracture was present. The fracture surface in this region was covered in a film which partially decohered from the surfaces and showed perfect matching on the two grain boundary surfaces (Plate 3 a, b). Clearly this oxide was present before the fracture crack opened up. The intergranular zone was surrounded by a narrow region of cleavage separating the ductile fracture from the intergranular regions. This zone is free of oxide and is presumably a hydrogen embrittled crack tip zone.

available does not imply, as suggested in other work (10), that the oxide forms along the grain boundaries prior to the passage of the crack. On the contrary, the deliberately overloaded air tested sample (plate 3 a, b) provides evidence only that the crack was filled with oxide prior to overload failure. If the small zone of intergranular fracture was caused by hydrogen penetration of the boundaries then a narrow crack would slowly grow into the metal which would have a hydrogen concentration profile in the boundaries and bulk of the metal ahead of the crack. The exposed boundaries are known to be highly reactive (1) and during the extremely long exposure time become covered in oxide which fills the narrow crack. Upon overload, this crack opens causing oxide to be torn and giving the observed matching on the fracture faces. The fast failure produces quasi cleavage in the hydrogen rich crack tip zone, as observed, and finally ductile failure of the environmentally unaffected metal.
