ENGINE-TRANSMISSION ANGULAR-CONTACT BALL THRUST BEARING
ENDURANCE TESTS(U) SOUTHWEST RESEARCH INST SAN ANTONIO
TX B B BABER NOV 83 SWRI-15-5607-814 DLA900-79-C-1266

Subject: Letter Report of the Engine-Transmission
Angular-Contact Ball Thrust Bearing Endurance
Tests Conducted Under Contract DLA900-79-C-1266,
P00019

Six (6) bearings, P/N 114DS-668-3, were to be endurance tested in pairs in a machine utilizing back-to-back loading of the bearing pairs under the subject contract. Each pair of bearings were run using a predetermined speed and load test schedule for 1,000 hours or failure, whichever occurred first. A description of the test program and the results obtained are included in the following paragraphs.

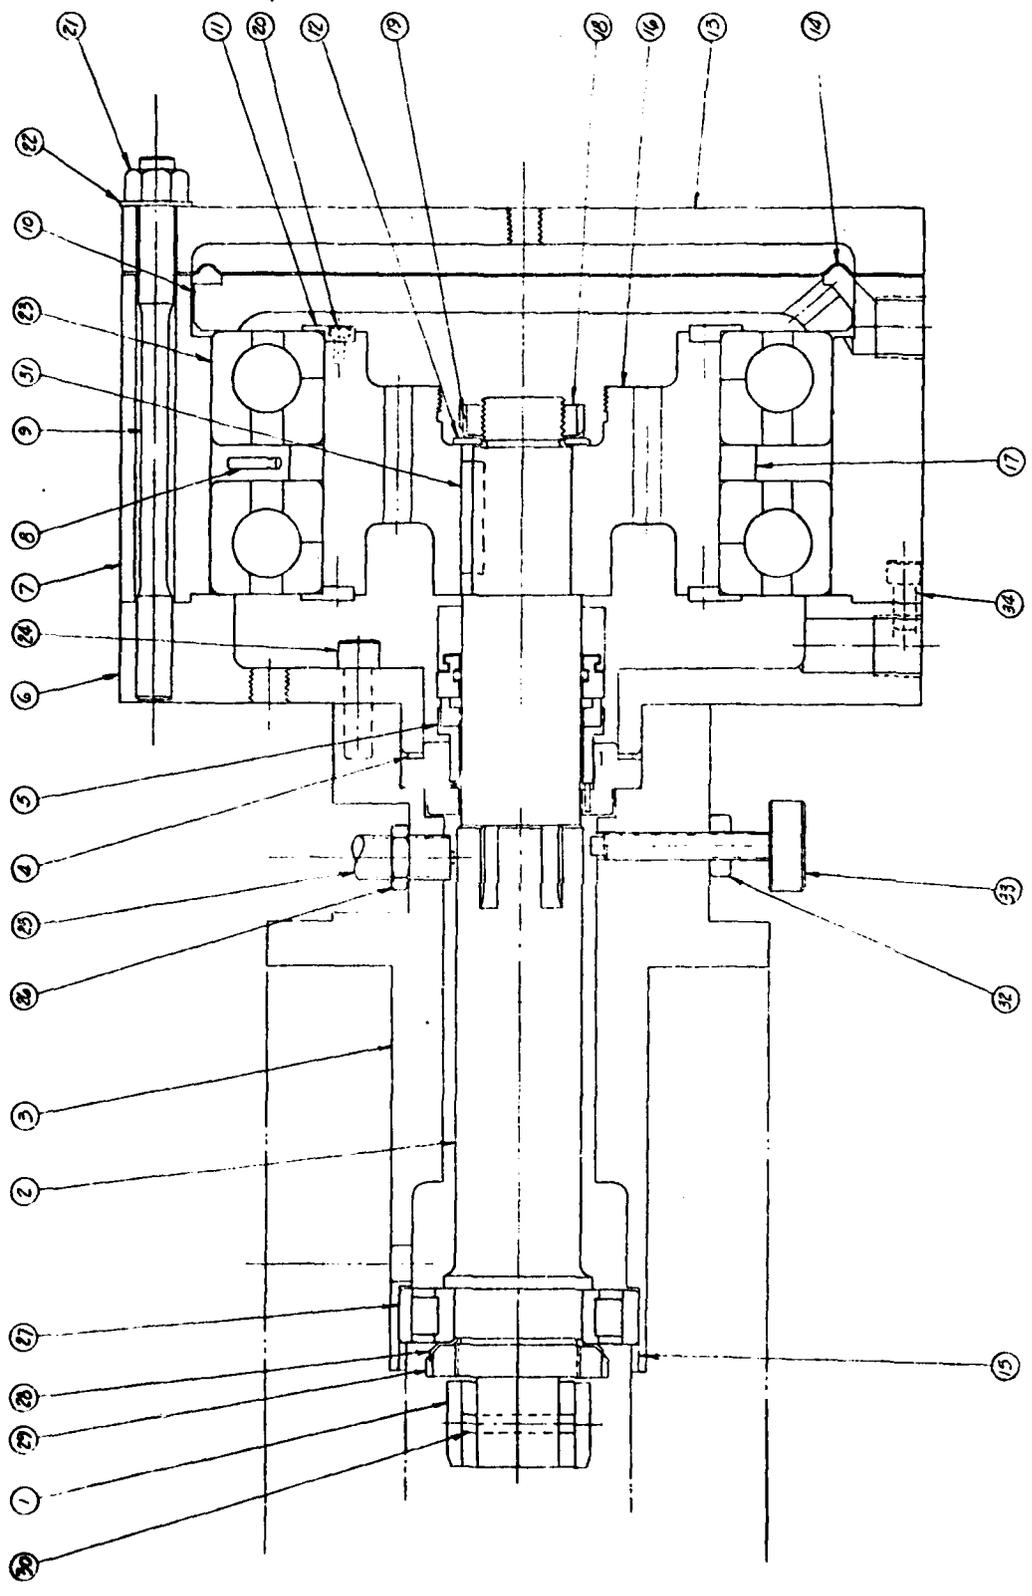
FIGURE 1. THRUST BEARING MACHINE

Test Procedure. The tests were conducted using a thrust bearing machine, shown in Figure 1 attached, especially modified to accept two of the special test bearings supplied. As shown in Figure 1, the two angular contact, ball test bearings (23) are loaded one against the other by means of a pneumatic pressure applied to the diaphragm (14) which is transmitted to the load plate (10). The load plate loads the outer race of the front bearing, through the balls of the front bearing to the rear inner race of the front bearing, through the spacer (17) to the front inner race of the rear bearing, through the balls of the rear bearing to the outer race of the rear bearing. The two retainers (11) are used only for retaining the test bearings to the shaft adapter (16) and are not load bearing members. The thrust load, applied as mentioned above, is taken by the support (6), through the studs (9) back to the cover (13). A small cylindrical roller bearing (27) supports the splined end of the machine shaft (2). Three adjusting screws (33), with locknuts (32), equally spaced around the shaft, are used to support the shaft when the test bearings are removed. A magnetic sensor (25), triggered by slots in the machine shaft, is used to determine machine speed during test.

Lubricant was supplied to the two test bearings at 45 ± 5 psig by eight test-oil jets (8) installed between the two test bearings (4 jets, installed 90° from each other, and directed towards each of the two bearings). All the oil supplied by the eight jets (approximately 4800 ml/min) passes through the test bearings. The test oil exits the machine through two scavenge ports, one located in front of the test bearings and the other located behind the test bearings. The test-oil sump temperature was controlled at $200 \pm 10^\circ\text{F}$. No provisions were made to control the test bearing temperatures; however, two thermocouples on each of the test bearing outer races provided a means of recording the operating temperature of each of the test bearings as well as providing an input to preset high-temperature safety controllers which shut the machine down in the event of a test bearing temperature excursion above a preset value. Machine speed was monitored by an rpm indicator which also includes over-and-under speed safety controls which shut the machine down in the event of an over-or-under preset speed indication. A vibration pickup and associated instrumentation, which processes the pickup signal, automatically shut the machine down in the event a pit or spall occurring on either of the test bearings causing the noise level, or vibration level, to increase above a preset background level. A temperature recorder was used to monitor the temperatures of the test-oil sump, test-oil in (to the thrust bearing machine), test-oil out (both front and rear scavenge lines), front test bearing outer race, and the rear test bearing outer race during test.

The drive stand used with the thrust bearing machine is powered by a 50-hp electric motor, through a variable speed Dynamatic coupling to the input shaft of a gearbox having a speed capability in excess of 16,000 rpm. Coupling of the thrust bearing machine to the drive stand is effected by an adapter block and splined coupling.

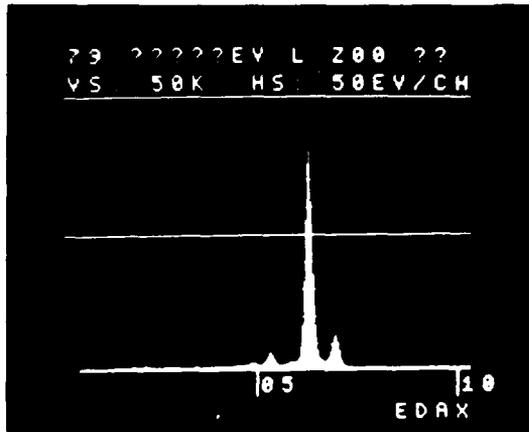
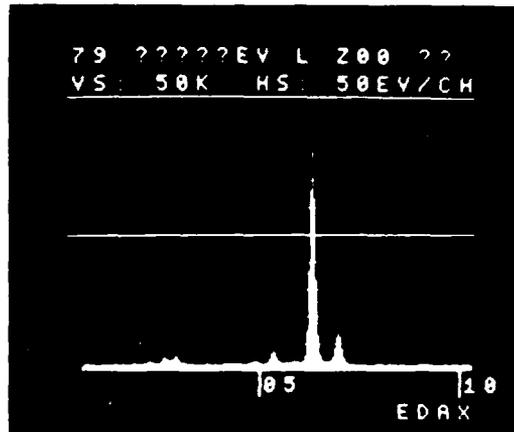
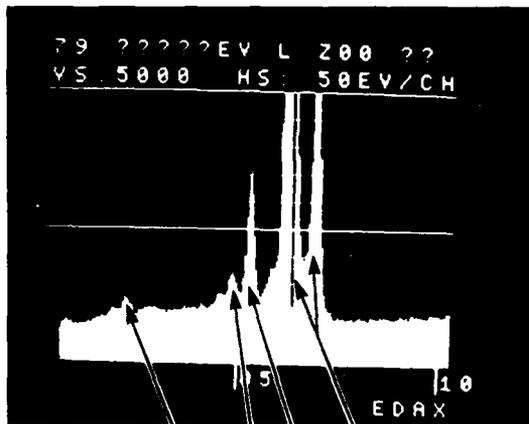
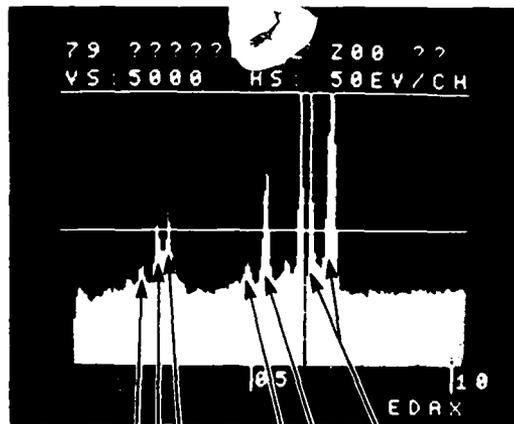
FIGURE 3. EDAX CHARTS OF SELECTED BALL AREAS

During the visual inspection of the test bearings after test, it was noted that there were several small silver colored spots approximately 1/16-in. to 1/8-in. in diameter on some of the balls and races of the test bearings, as shown in Figure 2. These spots which appeared on the balls and/or loaded portions of the races were readily discernible since they were not as discolored as other portions of the same balls and races. Inspection of typical bright spots and areas outside the bright spots on a selected ball using an Energy Dispersive X-Ray Analyzer (EDAX) gave the charts shown in Figure 3. Figure 3a represents a charting of the elements in an area outside of a bright spot. Figure 3b represents an area on a bright spot. Figures 3c and 3d are expanded scale representations of Figures 3a and 3b, respectively. It will be noted in Figure 3d that the

two peaks identified as Rhodium and Silver do not appear in Figure 3c. The only Silver known to be in the test system is in the plating on the cage of the test bearings. The Rhodium is believed to be perhaps a "flash plate" used prior to the silver plate. It appears that some of the silver plating material is removed from the cage by a wear process in the cage pockets. These silver wear particles or flakes get caught in a loaded zone between a ball and the race/or races of the bearing and are effectively randomly "pressure plated" on to either a ball or a race of the bearing. The silver particles or flakes then become a part of the mating surfaces in the loaded areas of the bearing. This additional material in the loaded areas increases the stress level in the area of the silver spots. The increased stress level in these silver spot areas will have a tendency to increase the chances of a spalling failure occurring in these areas as opposed to the areas of the bearings which do not have "foreign metals" in the loaded areas of the balls and races. The silver spots do not always induce spalls as evident from Figure 2. However, Figure 4 indicates a spall believed to be initiated by the presence of the silver spot. Figure 5 indicates two areas of incipient spallings, both occurring within a silver spot area.

3a. Surface Area Outside Bright Spot

3b. Surface Area Inside Bright Spot

3c. Iron
Chromium
Vanadium
Molybdenum

3d. Iron
Chromium
Vanadium
Silver
Rhodium
Molybdenum
