APPLICATIONS OF THE
SCANNING ELECTRON MICROSCOPE
TO CONCRETE FAILURE
(Axial, Biaxial, and Dynamic)

STEVENS INSTITUTE OF TECHNOLOGY
DEPARTMENT OF CIVIL AND OCEAN ENGINEERING
HOBOKEN, NEW JERSEY 07030

AFOSR-80-0256
FINAL

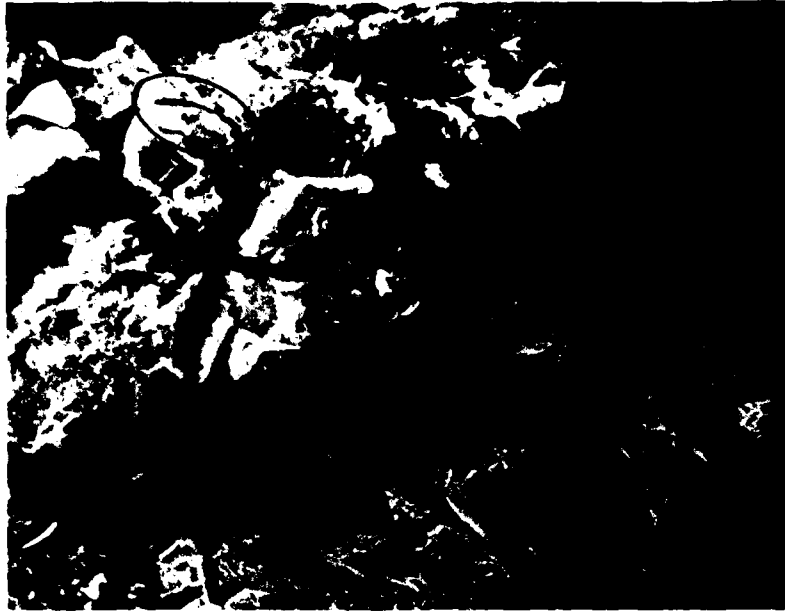
Fig. 7 - Crack map for reinforced limestone concrete (3000 psi) at 75% biaxial compression of the ultimate strength (50 X 1.25).

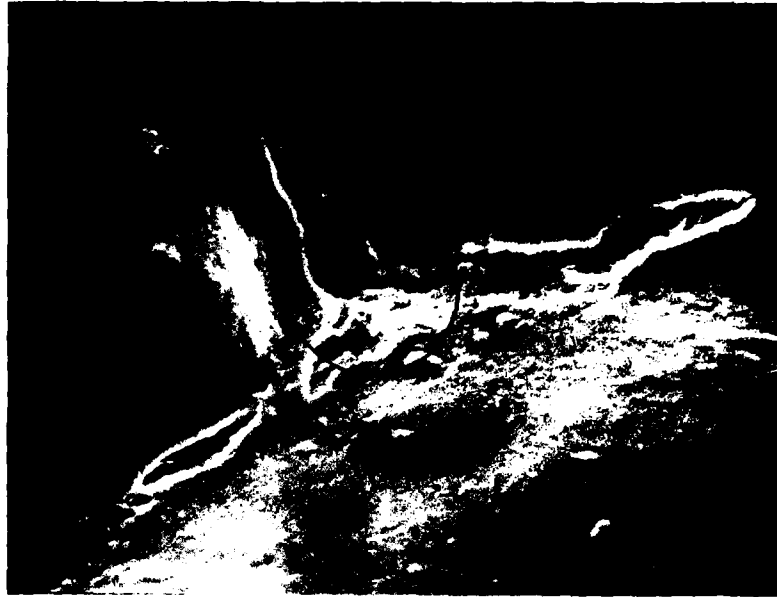
Fig. 9 - Crack map for reinforced limestone concrete (3000 psi) at 15% axial compression of the ultimate strength (5000 X 1.05).

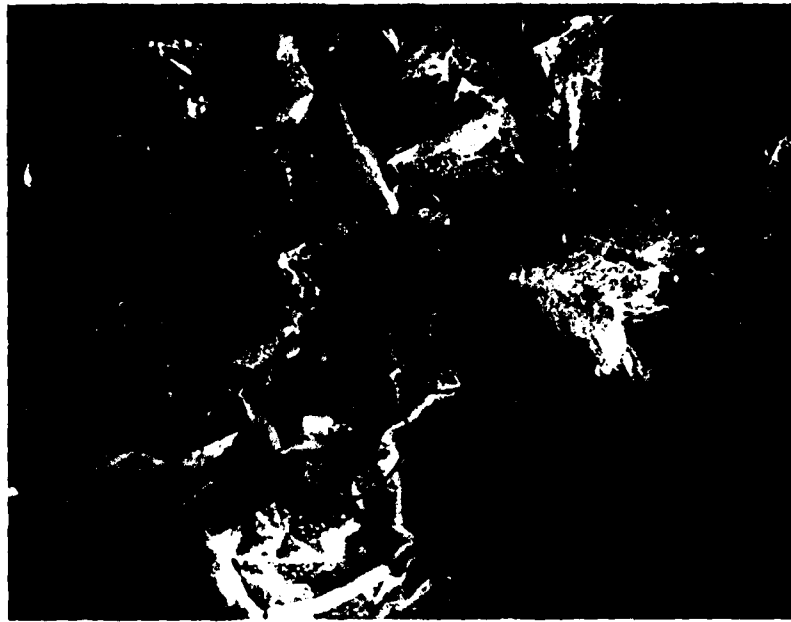
Fig. 20 - Crack map for plain limestone concrete (5000 psi) at 45% axial compression of the ultimate strength (200 X 1.50).
