Research
Paper
FPL 444

Longtime Performance of Trussed Rafters with Different Connection Systems

April 1984

Thomas Lee Wilkinson, Engineer
Forest Products Laboratory, Madison, Wis.

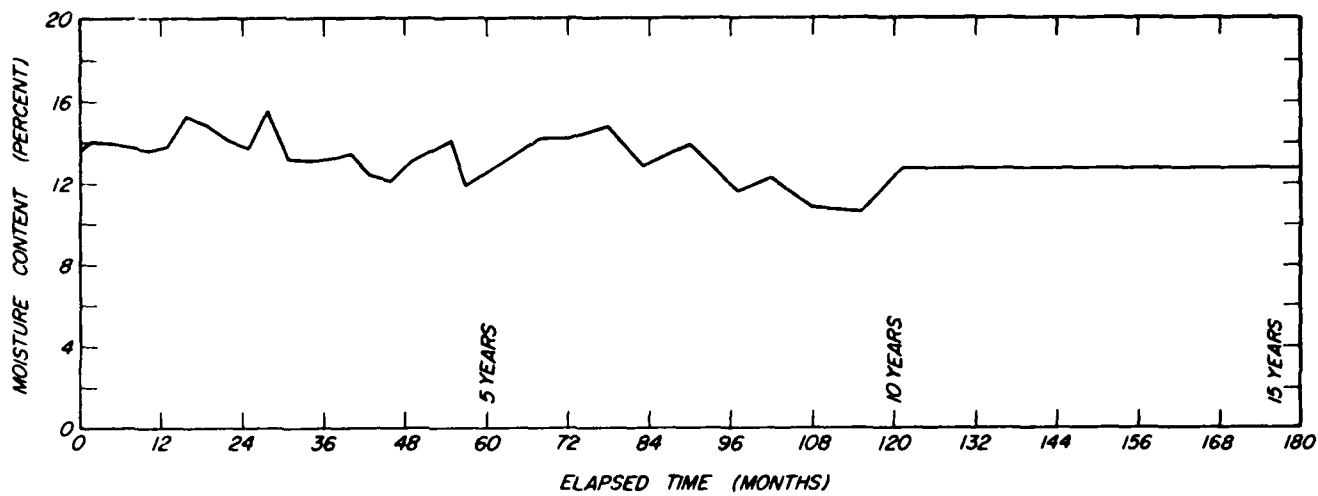
Figure 19.—Moisture content of wood samples placed with trussed rafters during longtime loading. (Samples were cut from overhang of trusses.) (M146374)

Average moisture contents of the wood samples placed with the trusses during longtime loading are presented in figure 19. Moisture content fluctuated during the 15 years of observation, but gradually decreased from about 14 percent to about 12 percent. The highest observed value was 15.5 percent and the lowest was 10.6 percent. The wood samples were not weighed during the last 5 years, but only at the time the trusses were unloaded. The samples had an average moisture content of 12.4 percent after 15 years. Moisture samples from the failed trusses had moisture contents of 10 to 11 percent after 15 years.

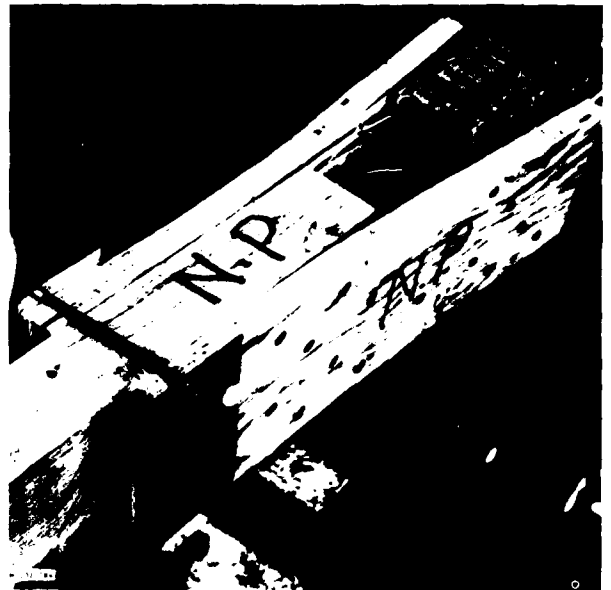
Figure 23.—Failure of control trussed rafter with nailed plywood gussets. Failure was at the lower chord splice. (M132784)

Most failures (21 of 28) occurred in bending in the upper chords as shown in figures 21 and 22. Other modes of failure were by failure of the joints (figs. 23, 24, 25, and 26) and by tension in the lower chord (fig. 27).
