12  
TECHNICAL REPORT HL-84-4

# OLD RIVER DIVERSION, MISSISSIPPI RIVER

## Report 3 BARGE BARRIER STUDY Hydraulic Model Investigation

Report 3 of a Series

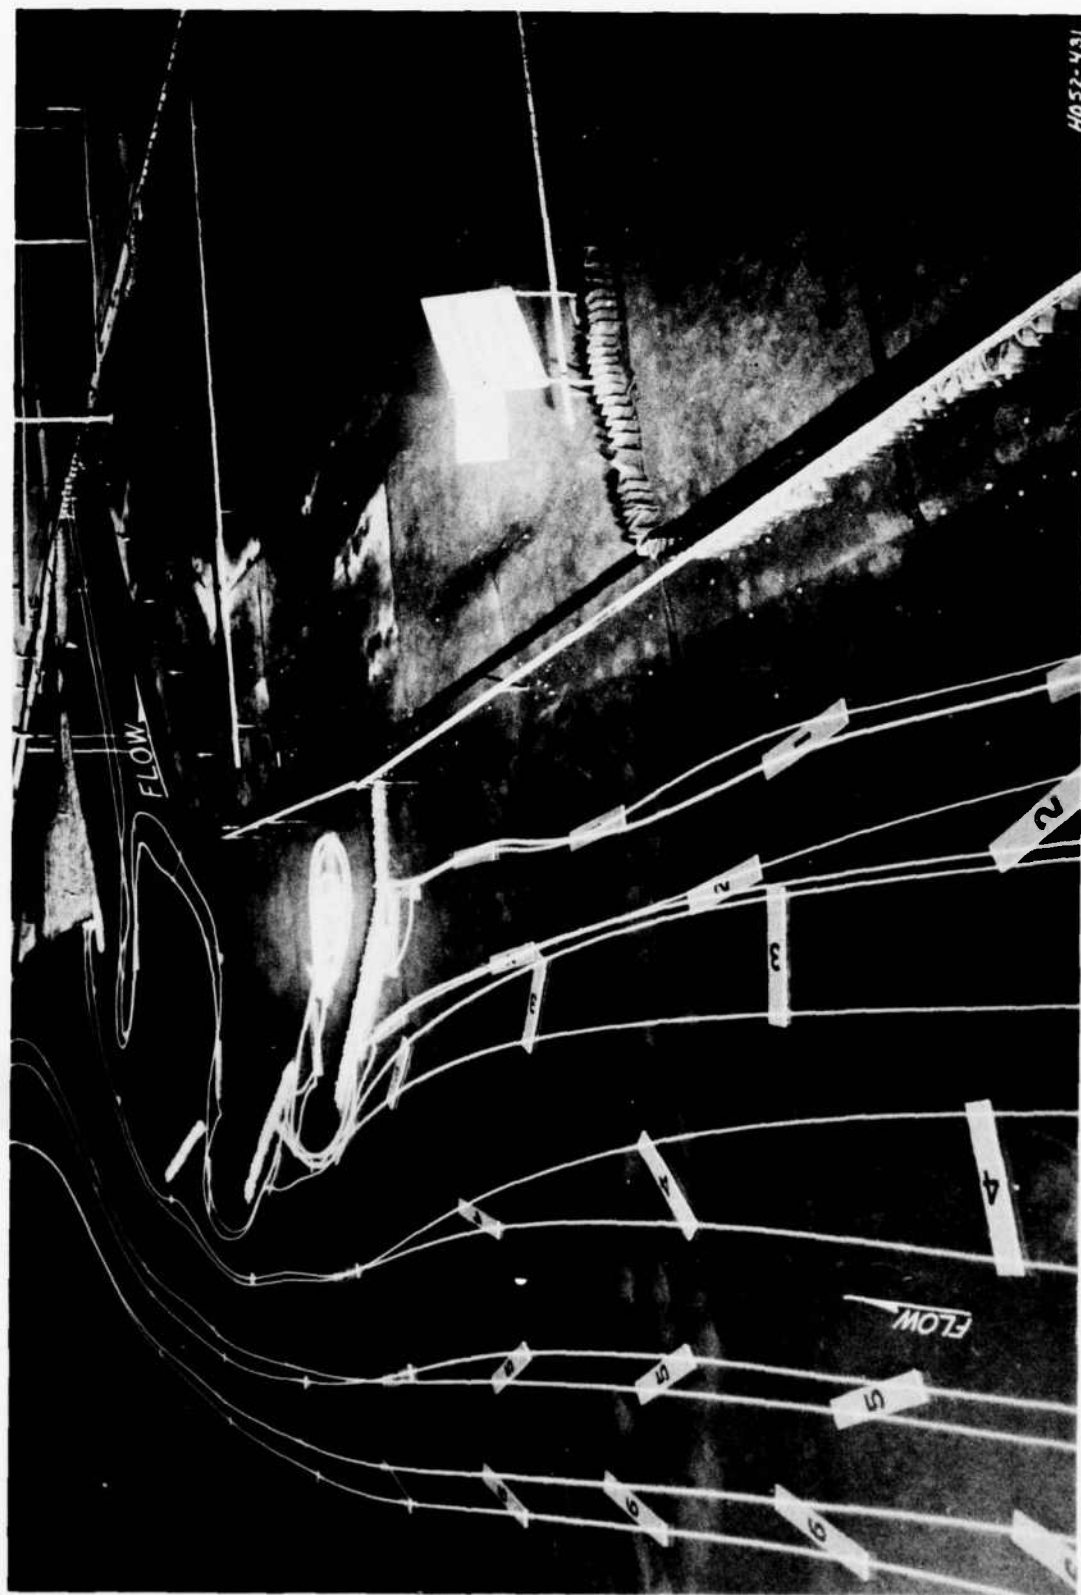
Photo 8. Vane dike barrier, 40-ft stage

15. Results. For the vane dike system, a 40-ft stage was tested instead of the 45-ft stage in the previous plan to obtain a wider spread in the stages tested. The probability of loose barges entering the inflow channel for the 40- and 50-ft stages was reduced to approximately 35 percent. Some of the barges entering the channel passed between the vane dikes and entered the inflow channel, while others were trapped in the turbulence behind the vane dikes long enough to be collected (Photo 8). If these barges trapped in the dike system were not captured, they could in time drift from the dike system into the inflow channel, thus increasing the number of incidences of barges entering the inflow channel. For the 60-ft stage with and without the overbank structure in operation, the probability of loose barges entering the inflow channel was reduced to approximately 20 percent. Barges drifting along the stream ends of the dikes were generally swept past the entrance, while barges floating over the dikes were grounded there or drifted between the dikes onto the overbank and ultimately into the low-sill or overbank structure (Photo 9). For river stages that would allow barges to float over the dikes, the probability of barges entering the inflow channel would be much higher than the 20 percent obtained during the tests of the two 60-ft stage conditions. Barges drifting across the overbank into the inflow channel occurred more often when the overbank structure was in operation.

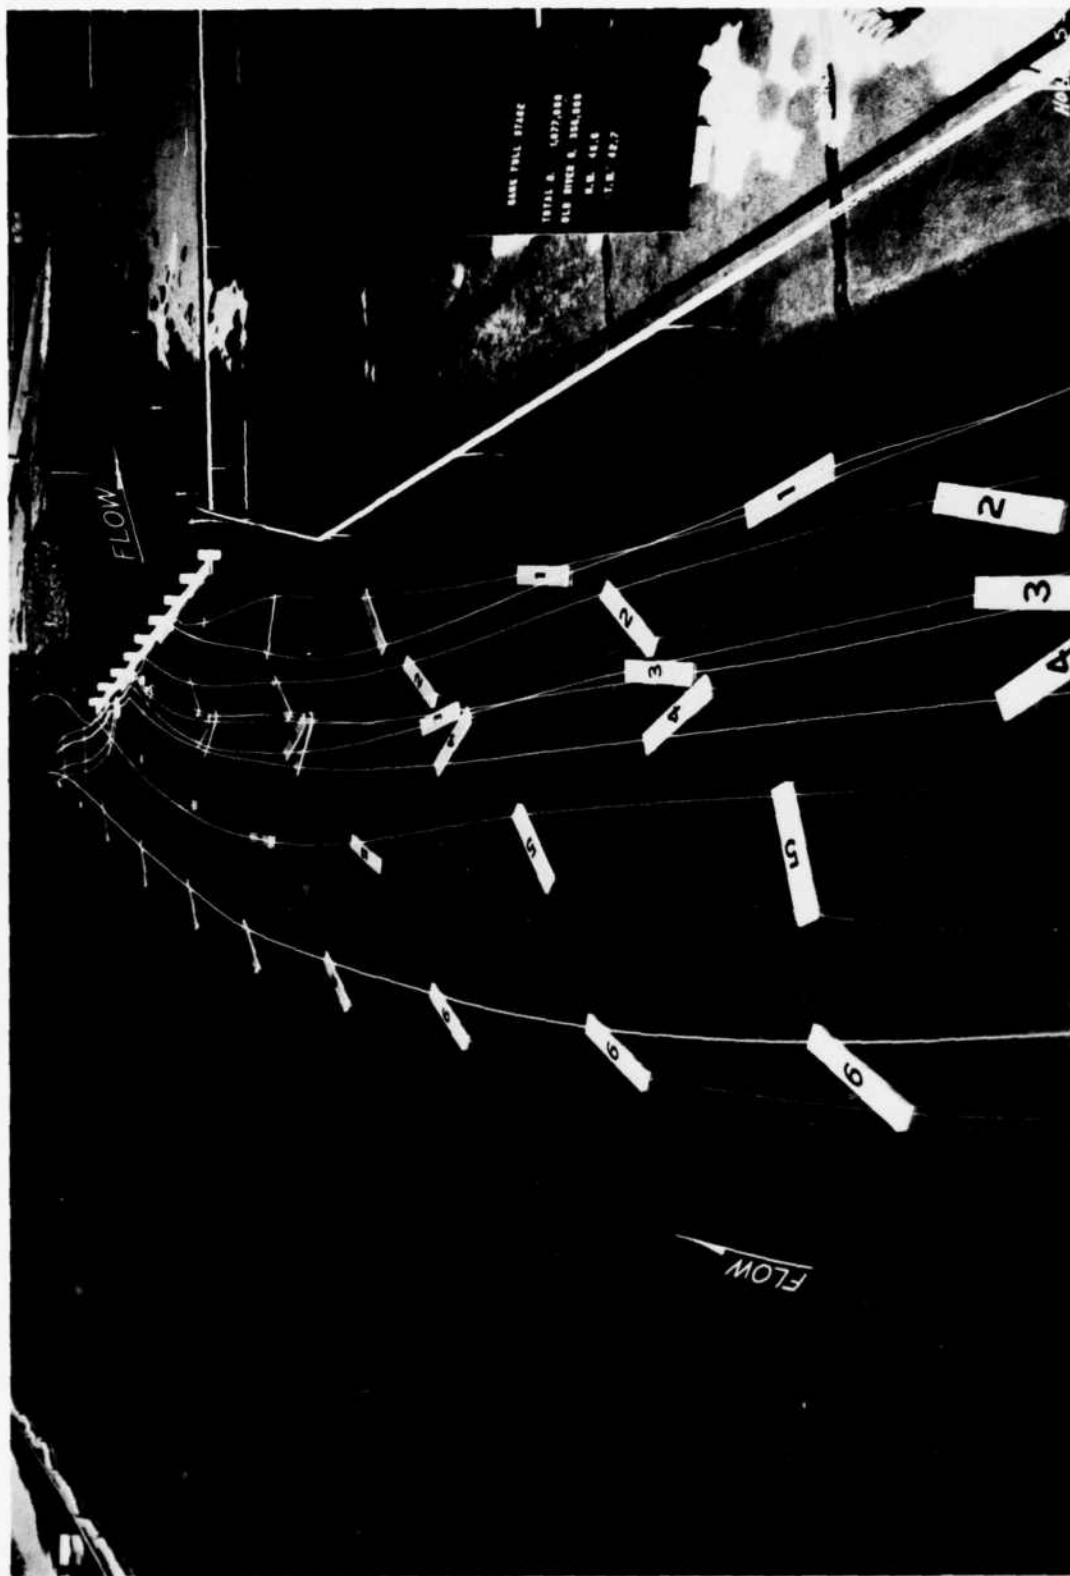
Photo 13. Pier-supported floating barge barrier, 46.6-ft (bank-full) stage

19. Results. Loose barge tests were conducted on the pier-supported barge barrier for low-sill structure headwater stages of 16, 24, 28, 32, 40, and 46.6 ft (bank-full), 1973 Flood, and Project Flood to evaluate the plan's effectiveness. For the bank-full and below stages, all of the loose barges were deflected past the entrance of the inflow channel (Photos 12 and 13). For the 1973 Flood and Project Flood, all of the loose barges drifting on the riverside of the barrier were deflected past the entrance, while those barges drifting along the right river bank line either hit the upstream end of the barrier or drifted onto the overbank upstream of the barrier. These barges tended to continue on into the inflow channel or become lodged on the overbank structure (Photo 14).
