MISCELLANEOUS PAPER GL-84-7

IMPROVED SURFACING MATERIALS FOR TRACKED VEHICULAR TRAFFIC

Geotechnical Laboratory

June 1984
Final Report

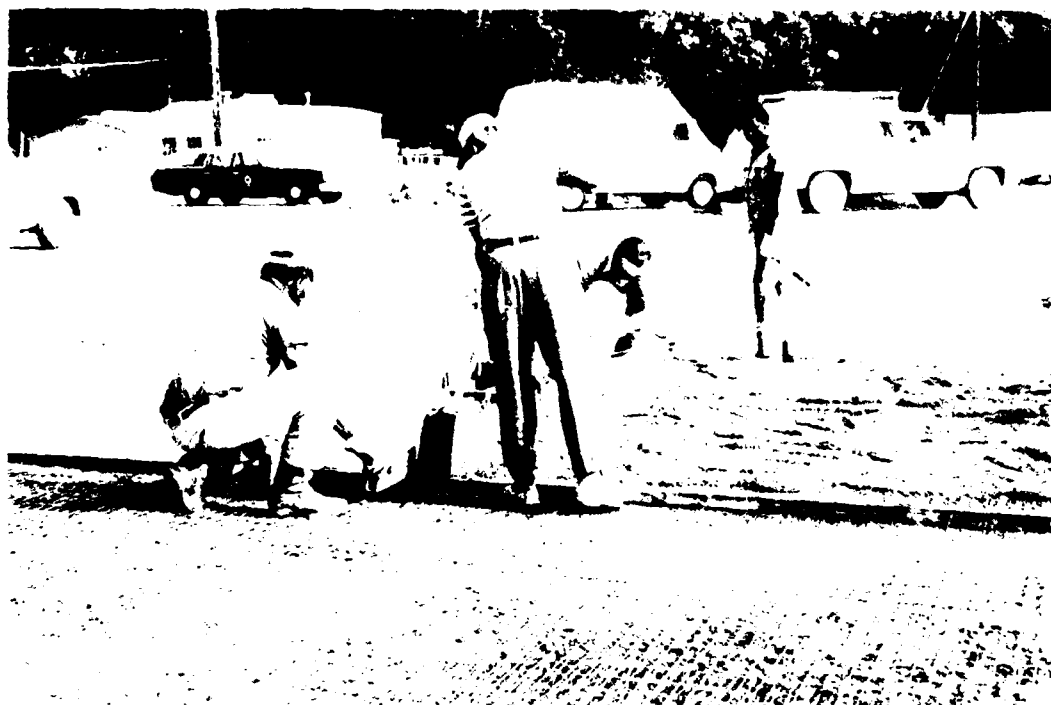
Photo 3. Placing concrete in item 1

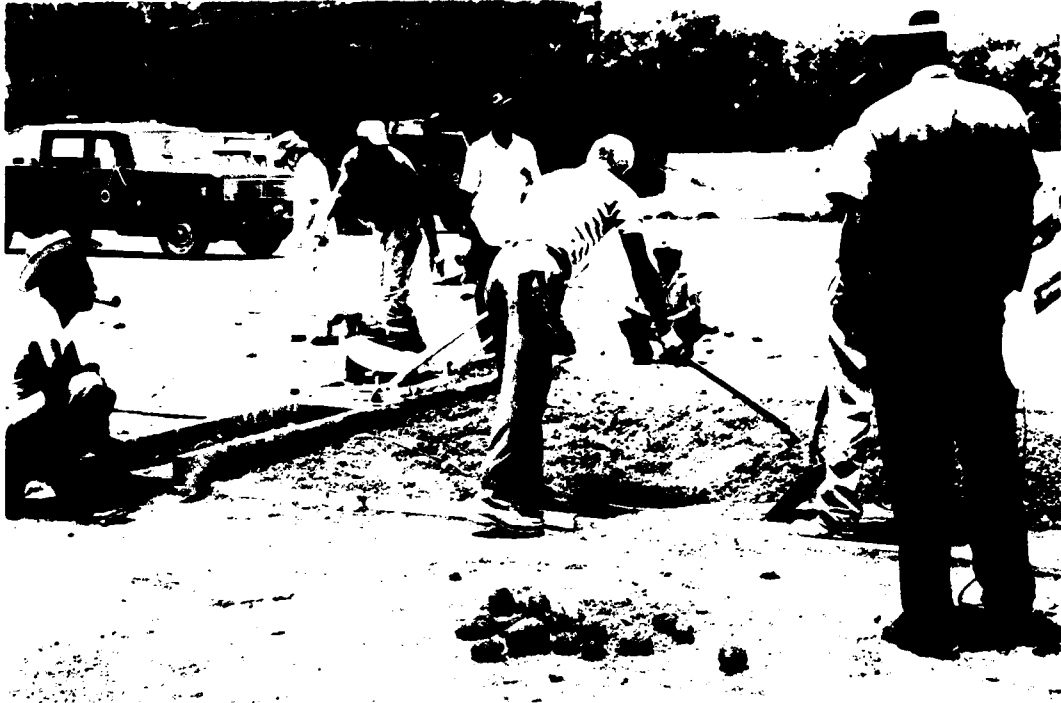
Photo 5. Placing fibrous concrete in item 3

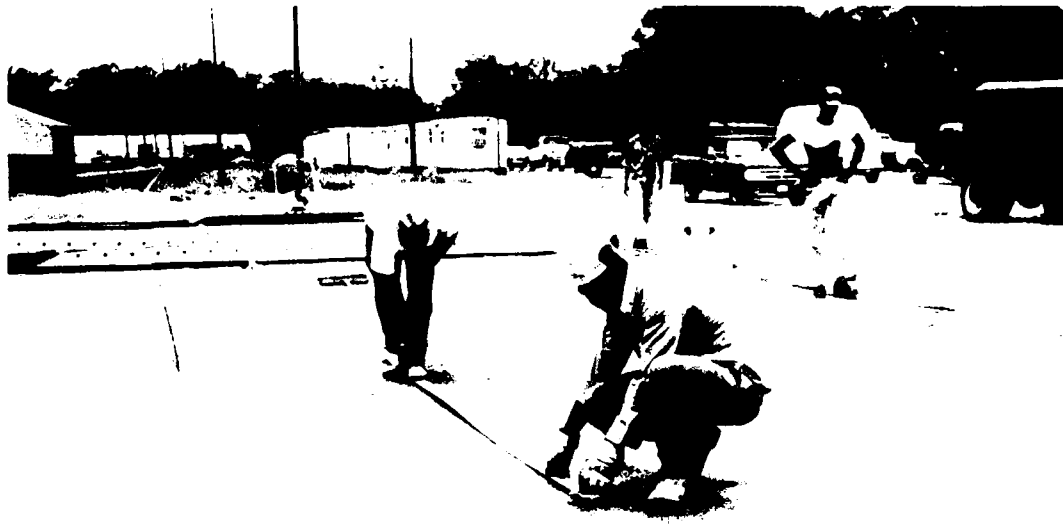
Photo 7. Forming weakened plane joints in items 1-10

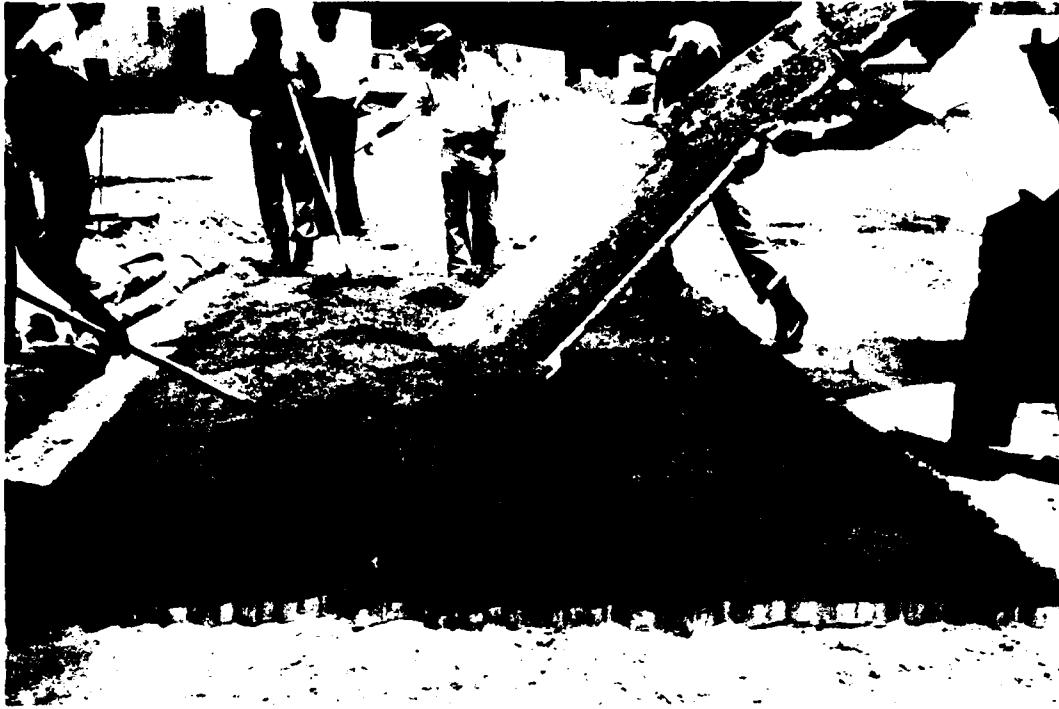
Photo 9. Placing concrete in grids by chute

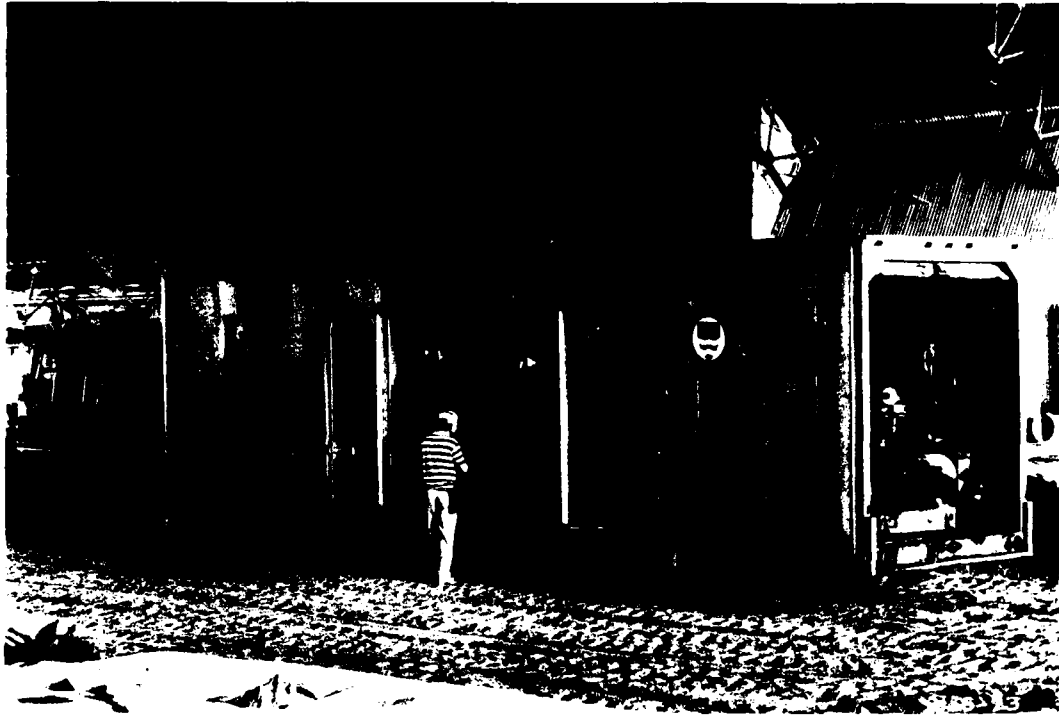
Photo 11. WES 16-kip vibrator

6. Results of dynamic load tests using the U. S. Army Engineer Waterways Experiment Station (WES) 16-kip vibrator (Photo 11) indicated dynamic stiffness modulus (DSM) values ranging from a low of 560 kips/in. to a high of 1020 kips/in. The average DSM was approximately 870 kips/in.

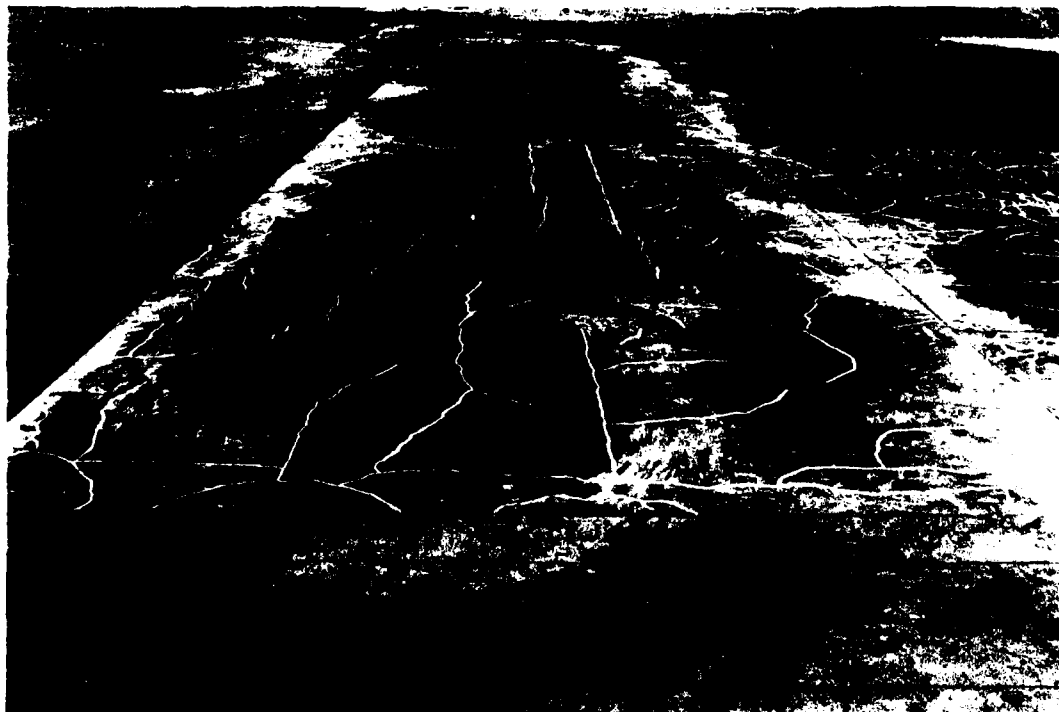
Photo 24. Item 1 after 2500 passes and
500 turning movements

- a. Item 1. Cracks occurred in two slabs prior to the start of traffic. During traffic, cracking occurred rapidly and the slabs had broken into an average of 11.5 pieces per slab at 1250 passes and 250 turns of the tank. There was very little additional cracking at 2500 passes and 500 turns (Photo 24), but the average number of pieces per slab increased to 28 after 5000 passes and 1000 turns (Photo 35).

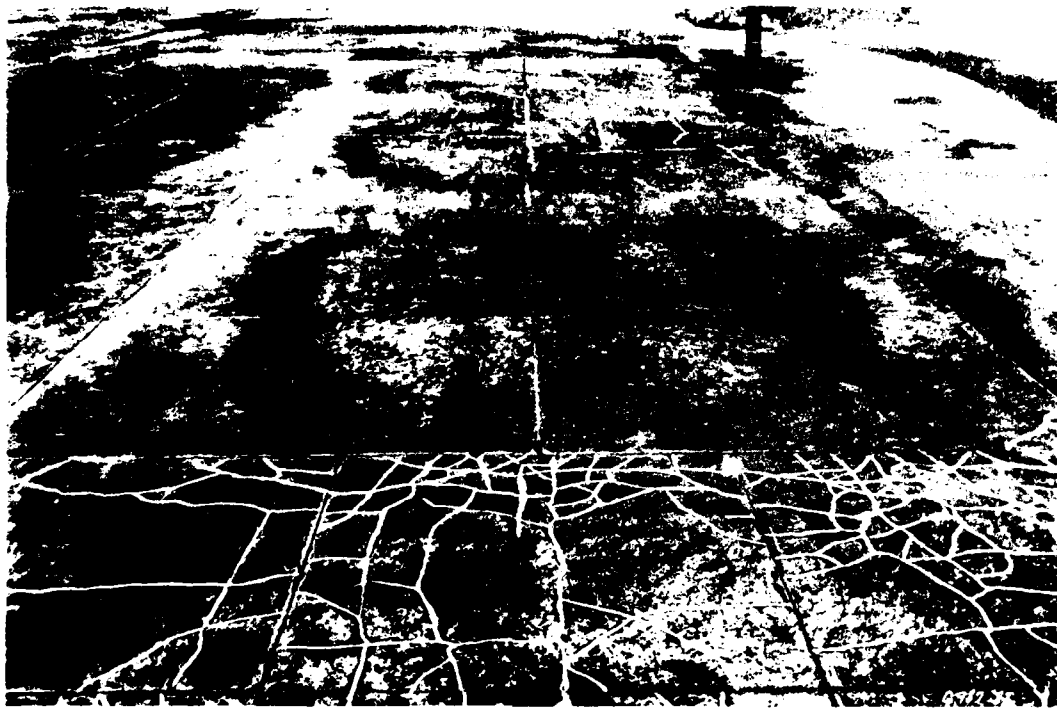
Photo 31. Item 8 after 2500 passes and
500 turning movements

- h. Item 8. This fibrous concrete test item contained no cracks prior to traffic, but had broken into an average of 2.5 pieces per slab and was therefore approaching initial failure as the traffic reached 5000 passes and 1000 turns (Photos 31 and 42).

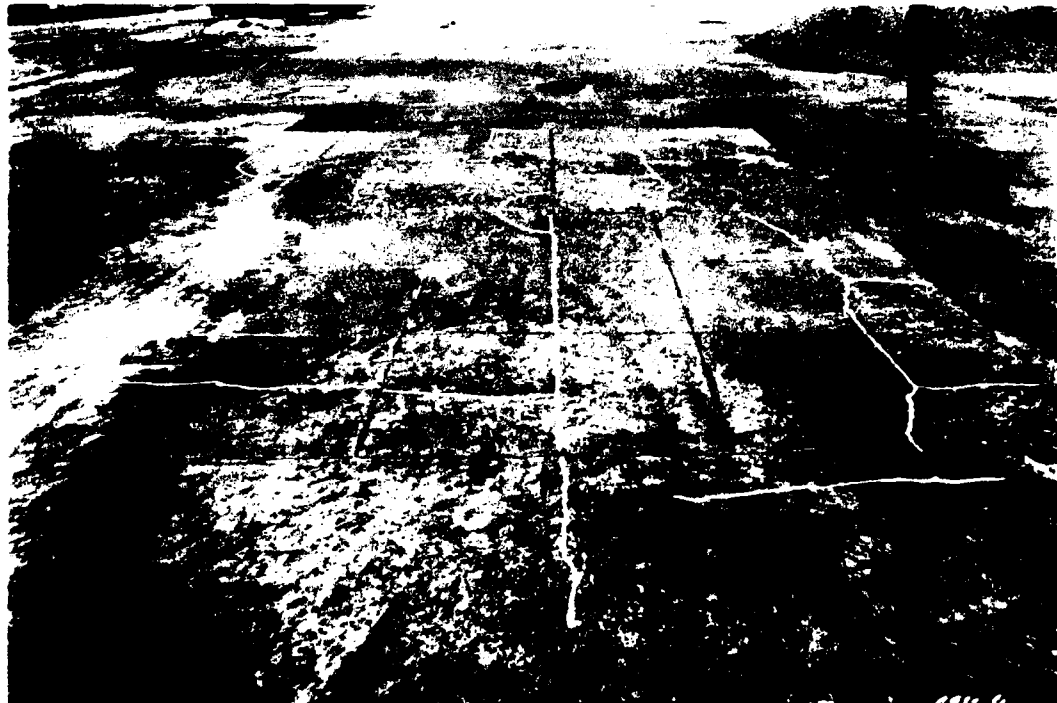
Photo 32. Item 9 after 2500 passes and
500 turning movements

- i. Item 9. The center slabs of this test item developed sympathy cracks for the full length of the test item prior to traffic. As the traffic increased from 2500 passes and 500 turns to 5000 passes and 1000 turns, two slabs showed no cracking although the average number of pieces per slab increased from 2.2 to 3.6 which was slightly past initial failure (Photos 32 and 43).

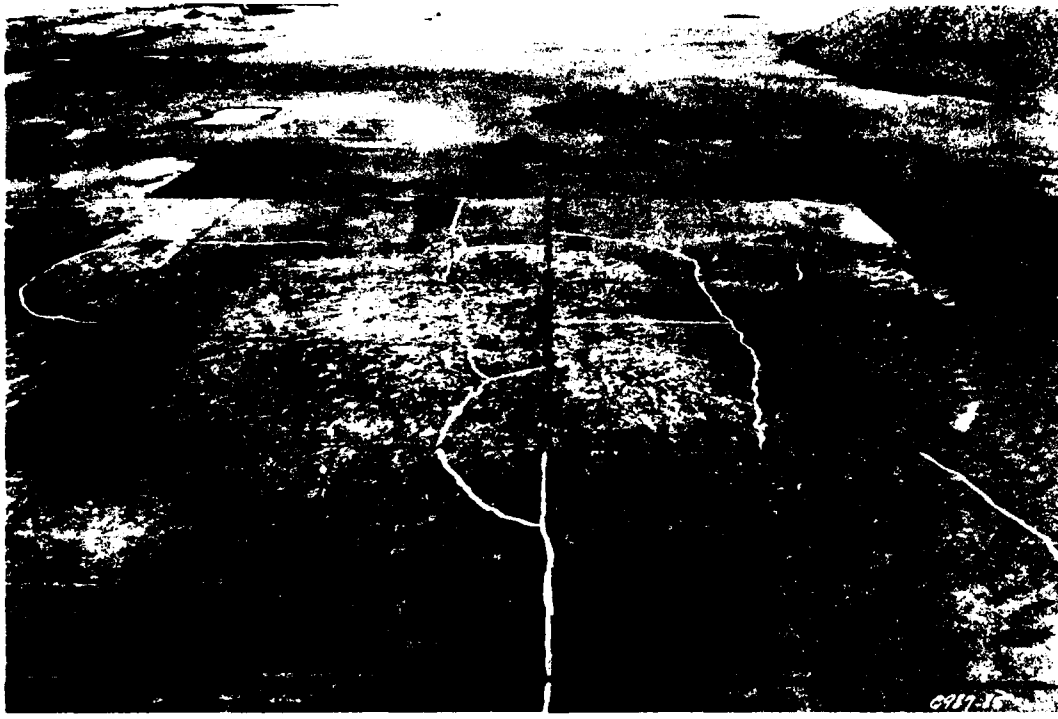
Photo 33. Item 10 after 2500 passes and
500 turning movements

- j. Item 10. All four slabs of item 10 had at least one crack after 1250 passes and 250 turns of the tank. The slabs were broken into an average of three pieces per slab at 2500 passes and 500 turns which indicated that initial failure had occurred (Photo 33). There was an average of 7.0 pieces after 5000 passes and 1000 turns (Photo 44).

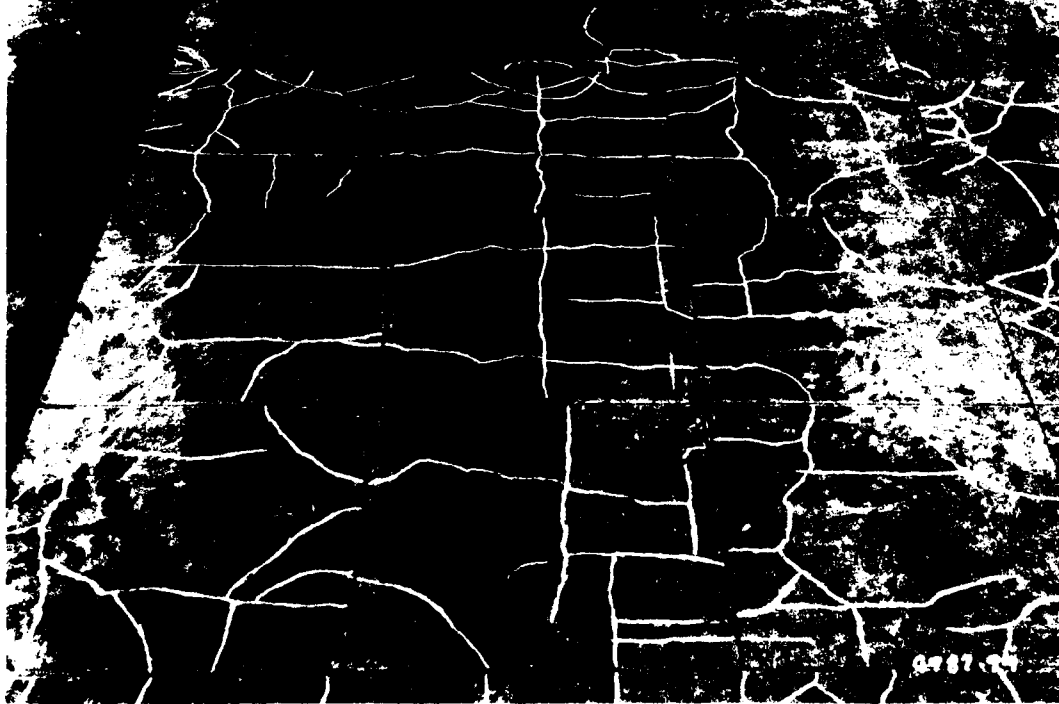
Photo 36. Item 2 after traffic tests were completed

- b. Item 2. Two slabs of item 2 had cracked prior to traffic. Cracking increased in the slabs with traffic (Photo 25), and the average number of pieces per slab was 11.4 after 5000 passes and 1000 turns (Photo 36).

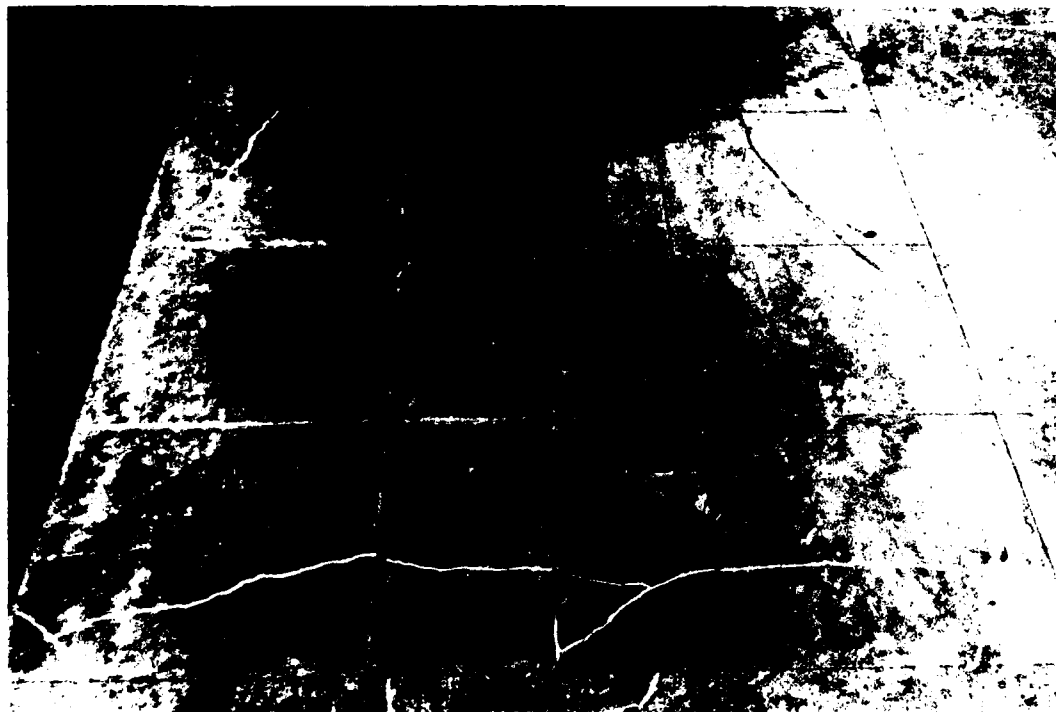
Photo 38. Item 4 after traffic tests were completed

- d. Item 4. The reinforced concrete in item 4 performed well. One slab had cracked prior to traffic. The other slabs contained a minimum number of cracks after 2,500 passes and 500 turns but soon broke into an average of 1.8 pieces per slab after 5000 passes and 1000 turns (Photo 38). The item therefore did not reach initial failure.

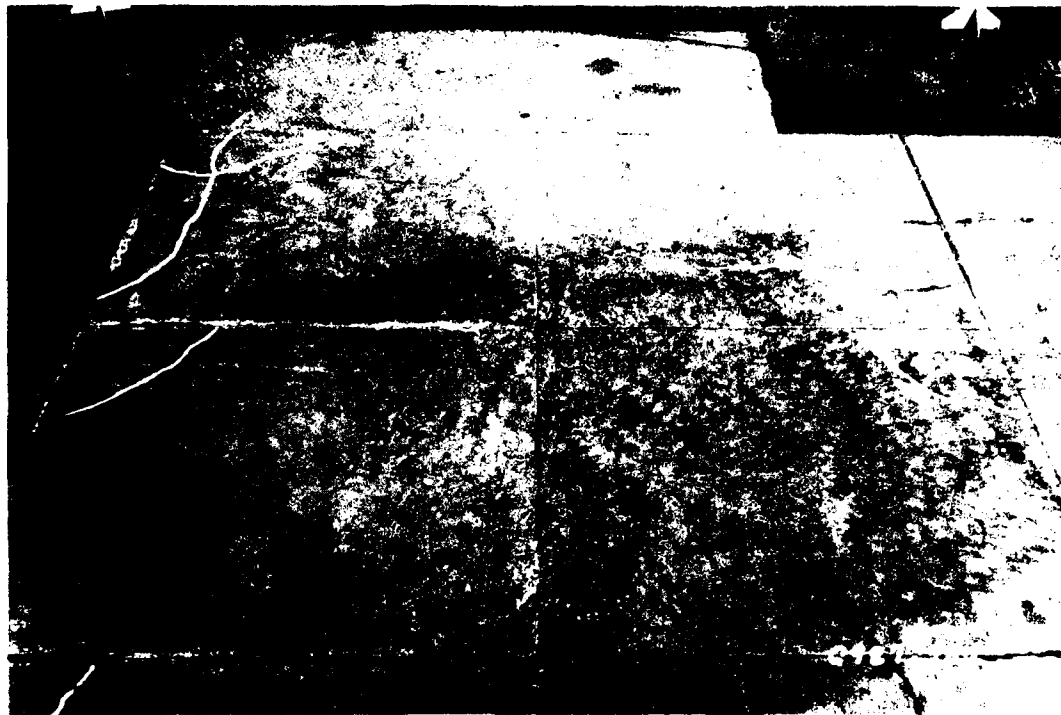
Photo 39. Item 5 after traffic tests were completed

- e. Item 5. There was no cracking prior to traffic. This item reached the initial failure condition (35 pieces per slab) after 2500 passes and 250 turns of the tank (Photo 28) and remained in this same condition with no significant increase in cracking after 5000 passes and 500 turns (Photo 39).

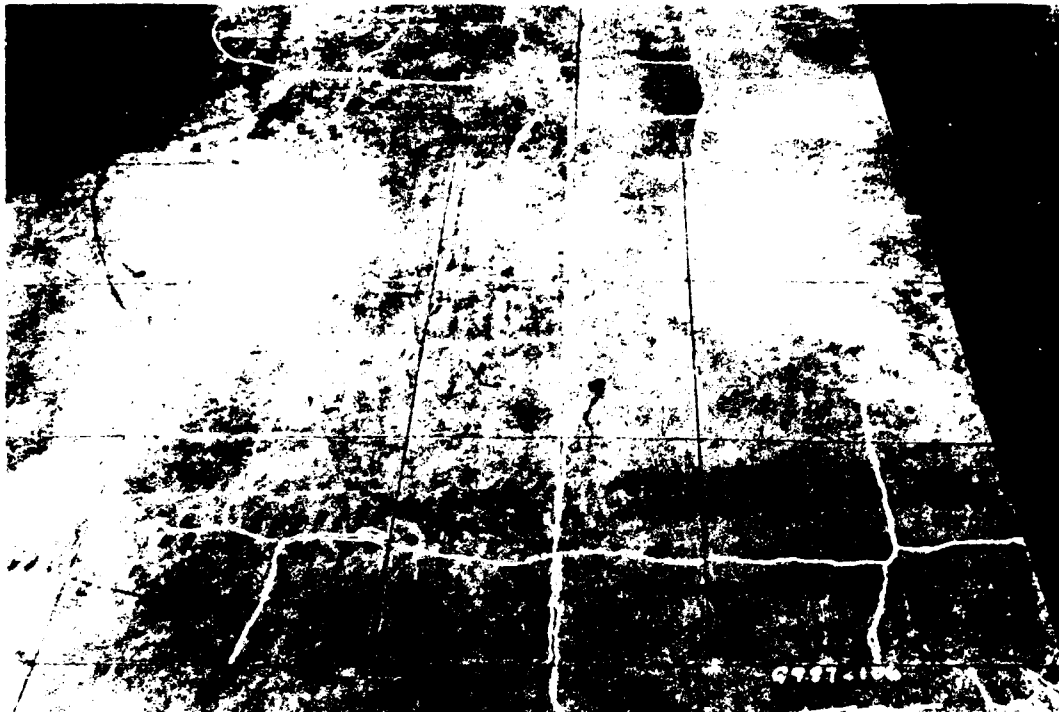
Photo 43. Item 9 after traffic tests were completed

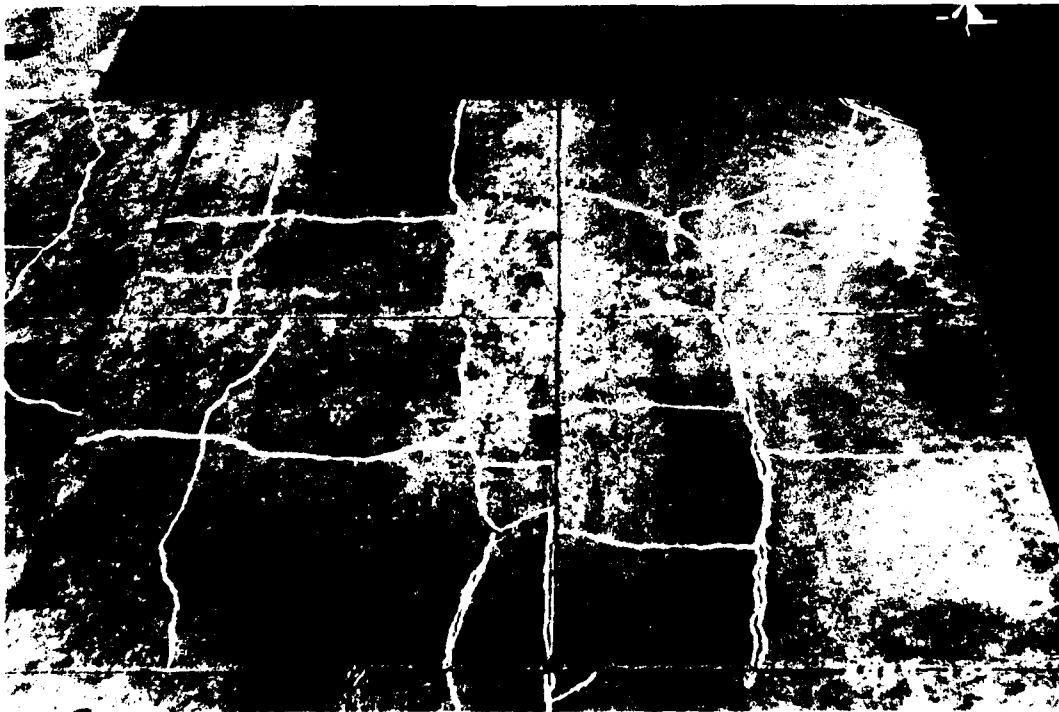
Photo 44. Item 10 after traffic tests were completed
