POQUONOCK RIVER BASIN
GROTON , CONNECTICUT

POQUONOCK DAM
CT 00231

PHASE I INSPECTION REPORT
NATIONAL DAM INSPECTION PROGRAM

DEPARTMENT OF THE ARMY
NEW ENGLAND DIVISION , CORPS OF ENGINEERS
WALTHAM , MASS. 02154

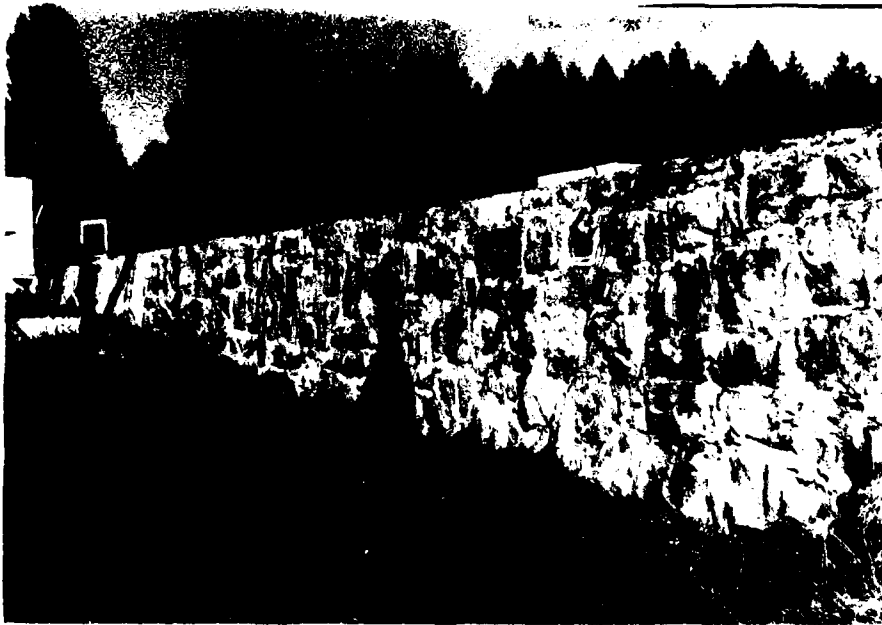
From an examination of the ashlar wall forming the downstream face of the dam, both open and mortar-filled joints were noted (Appendix C, Photo No. 1). It could not be determined whether the wall was originally laid up with mortared or unmortared joints, whether it is of massive cemented masonry construction, or whether it is simply a "stonewall" facing with uncemented joints, the latter having been common practice at the turn of the century. Seepage through the ashlar wall was minimal, with moist stone seeps in evidence in about four locations to the right of the spillway and along the face below the spillway (Appendix C, Photo No. 2).

1. Downstream face of dam right of spillway.
