Special Report 84-26

Cold Regions Research &
Engineering Laboratory

Secondary stress within the structural frame of DYE-3: 1978-1983

H. Ueda, W. Tobiasson, D. Fisk, D. Keller and C. Korhonen

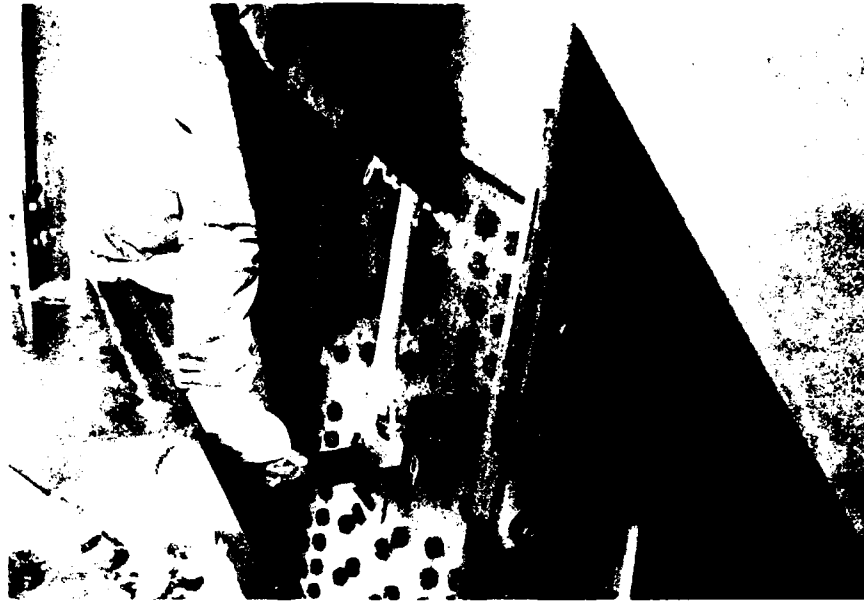
Figure 7. Loosening an unloaded sway bolt.

Details of how the sway bolts are checked are described by Tobiasson et al. (1974). Initially, the tester places a wrench on each bolt. Those bolts that are easily turned (i.e., those sustaining little or no load) are backed off (Fig. 7). Working with one loaded sway bolt at a time, the tester then places a hydraulic ram alongside the loaded sway bolt (Fig. 8). Before the tester backs off a loaded sway bolt, a dial extensometer is placed on the opposite side of the column to monitor the relative movement between the column and the collar (Fig. 9). Pressure is increased in the ram until the loaded sway bolt is unloaded. The now unloaded bolt is backed off (Fig. 10) and hydraulic pressure on the ram is then slowly released until the system is returned to its original position as indicated by the dial extensometer. The hydraulic pressure recorded at this time is considered to represent the sway bolt load. Finally, the load is transferred from the ram back to the bolt and the system is returned to its original position, within 0.001 in. In this fashion the lateral interacting loads between the building and columns and the trusses and columns is determined.

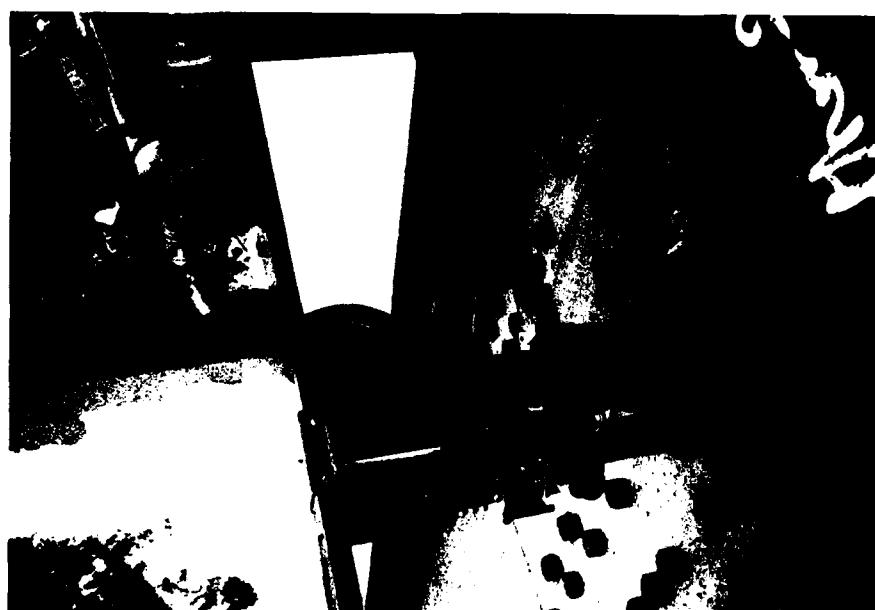
Figure 8. Ram placement.

a. Adjacent to sway bolt in the building.

b. Adjacent to truss collar sway bolt.

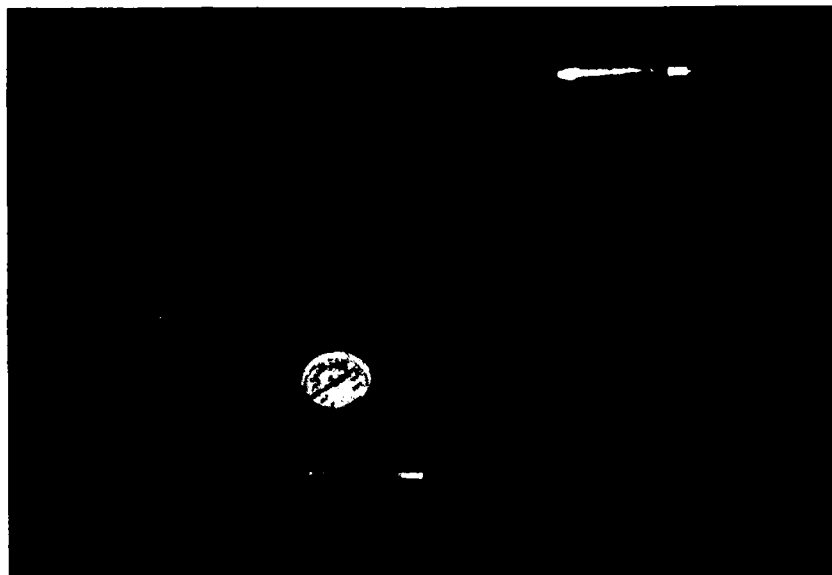
Figure 10. Backing off the "loaded" sway bolt once its load has been transferred to the ram.

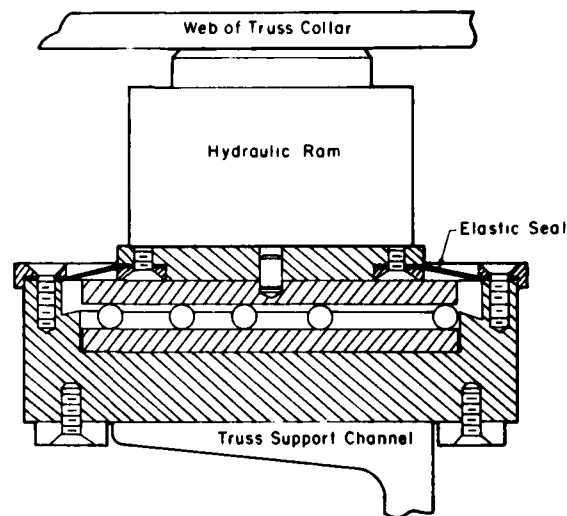
Figure 12. Cross section of friction-reducing roller devices.

In 1981, an attempt was made to reduce friction there during sway bolt readings by supporting the four corners of each level-3 collar on friction-reducing roller devices (Fig. 12 and 13) designed by Ueda and Tobiasson. Unfortunately, the center portion of each level-3 collar, which rests on two beams (Fig. 5), did not lift when the rollers were inserted at the four cor-

ners because of high flexibility in the collar assembly; therefore, considerable frictional resistance was still present between the column halves.

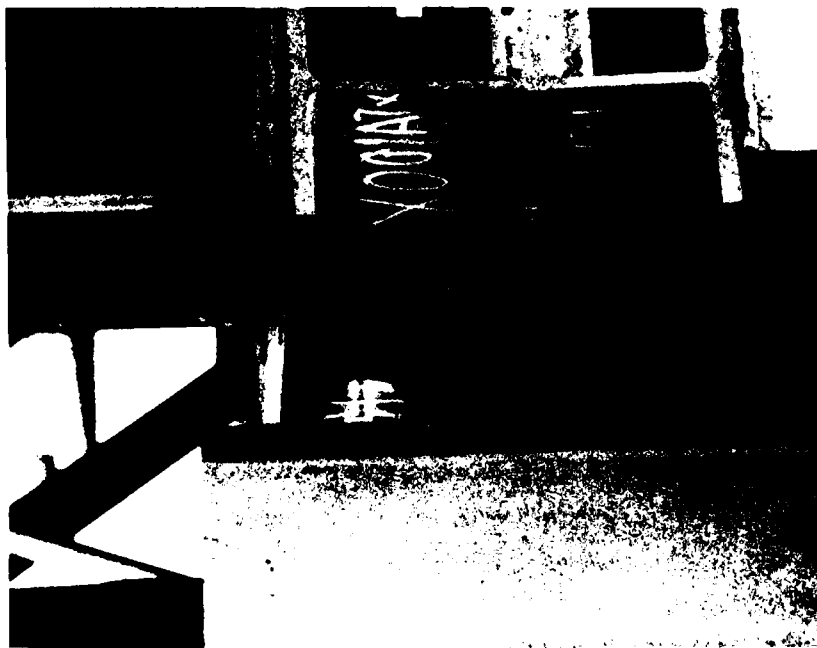
Figure 13. Friction-reducing roller device in place.

Two sets of level-3 sway bolt readings are presented in Appendix A, 1981 Measurements, one with and one without the rollers installed. The rollers did not change level-3 sway bolt loads much. An unsuccessful attempt was made in 1982 to insert Teflon sheets between all bearing surfaces of the level-3 collars, but again the center portion of the collars could not be lifted. Consequently, loads measured on the level-3 collars are only a rough indication of the actual loads there. Level-1 and level-2 collar loads were measured more accurately. When the building and trusses are raised in 1984, low-friction bearing surfaces will be provided for the truss system. Teflon and stainless steel sheets will be inserted between the contact surfaces at these points, using a design developed cooperatively

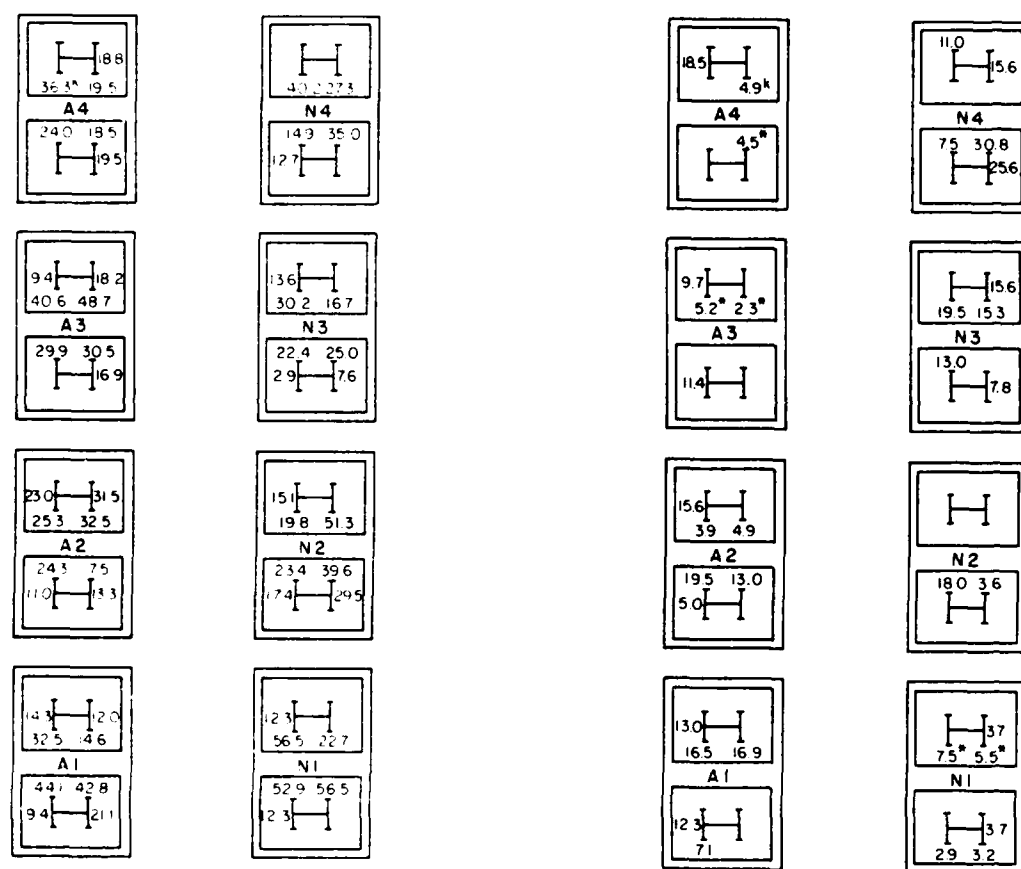
Figure A1. Individual sway bolt load measurements (in kips [1000 lb], * = load displacement measurement).

a. Building level.

b. Level 1.

c. Level 2.

d. Level 3.

Sway bolt measurements taken in 1978, 1981, 1982 and 1983 as well as column bending moments determined from these measurements are presented in

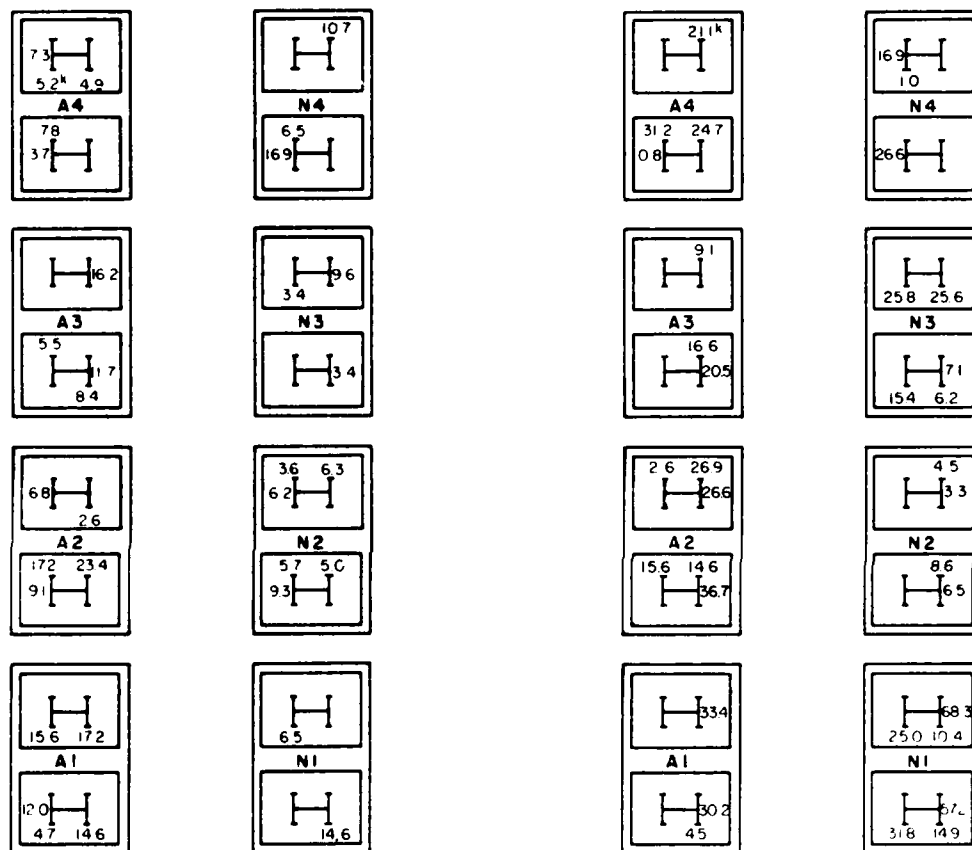
Figure A2. Individual sway bolt load measurements (in kips [1000 lb]).

a. Building level. b. Level 1.

e. Level 3, without friction-reducing devices.
