REPORT ON RESULTS OF THE CONVENTIONAL BREAKBULK SHIP  
PRETEST OF THE JOINT..(U) ORI INC ROCKVILLE MD  
H CASEY ET AL. 29 OCT 76 ORI-TR-1037 MDA903-75-C-0016

The principal test items were the Army's two newly acquired container handling cranes (140-ton and 300-ton capacities), and Army LCM8 landing craft and Navy 3 X 15 floating causeway. The cranes were disassembled so that the weight of each major component was less than 60 long tons, the maximum capacity of heavy-lift booms on the majority of cargo ships. The causeway weight exceeded this capacity by only 0.3 long tons. The risk of making that lift would normally be acceptable under emergency conditions.

Both cranes suffered minor boom damage primarily from swaying into hatch coamings during discharge. Training deficiencies were noted as well as the effects of off-shore sandbars and currents on the ability of boat crews to land equipment on the beach.

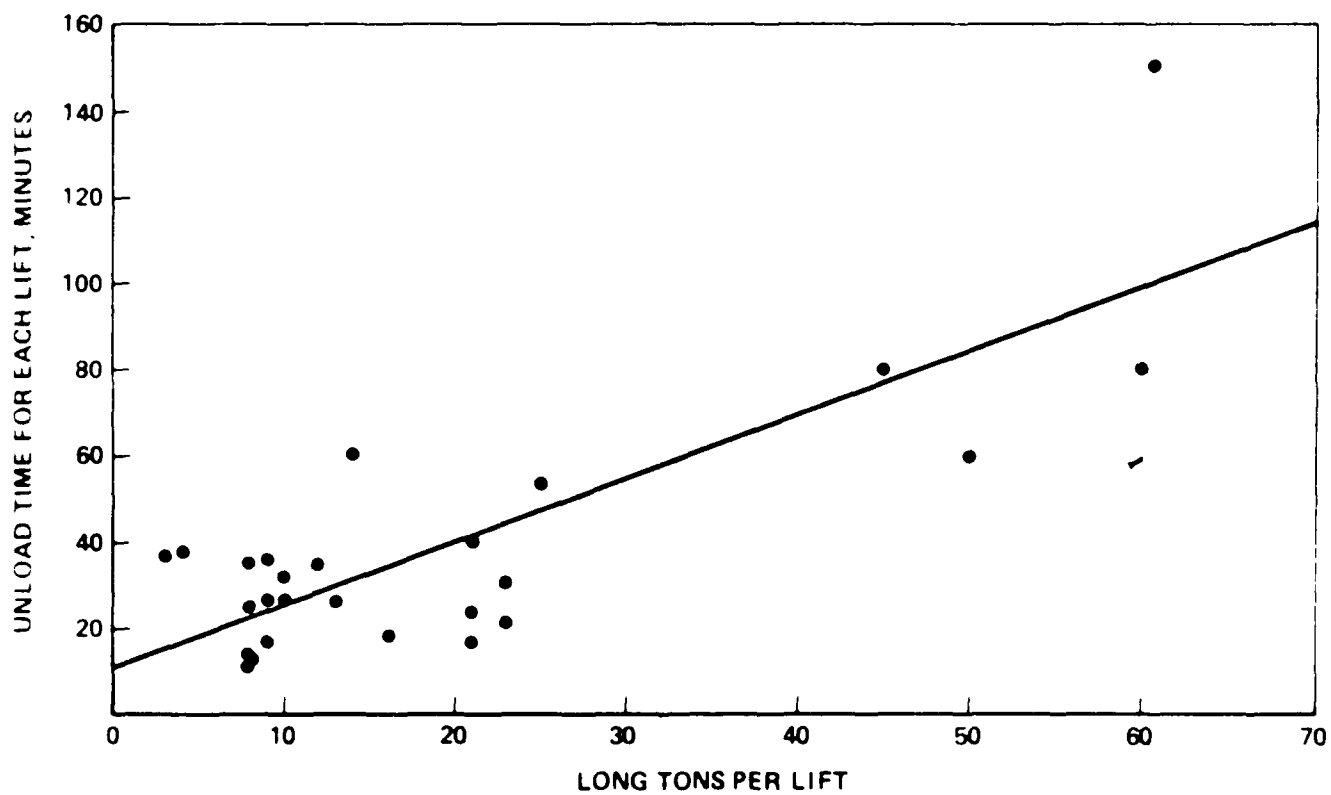
FIGURE 9. RELATION BETWEEN UNLOADING TIME AND LONG TONS  
(Chart is for 26 lifts)

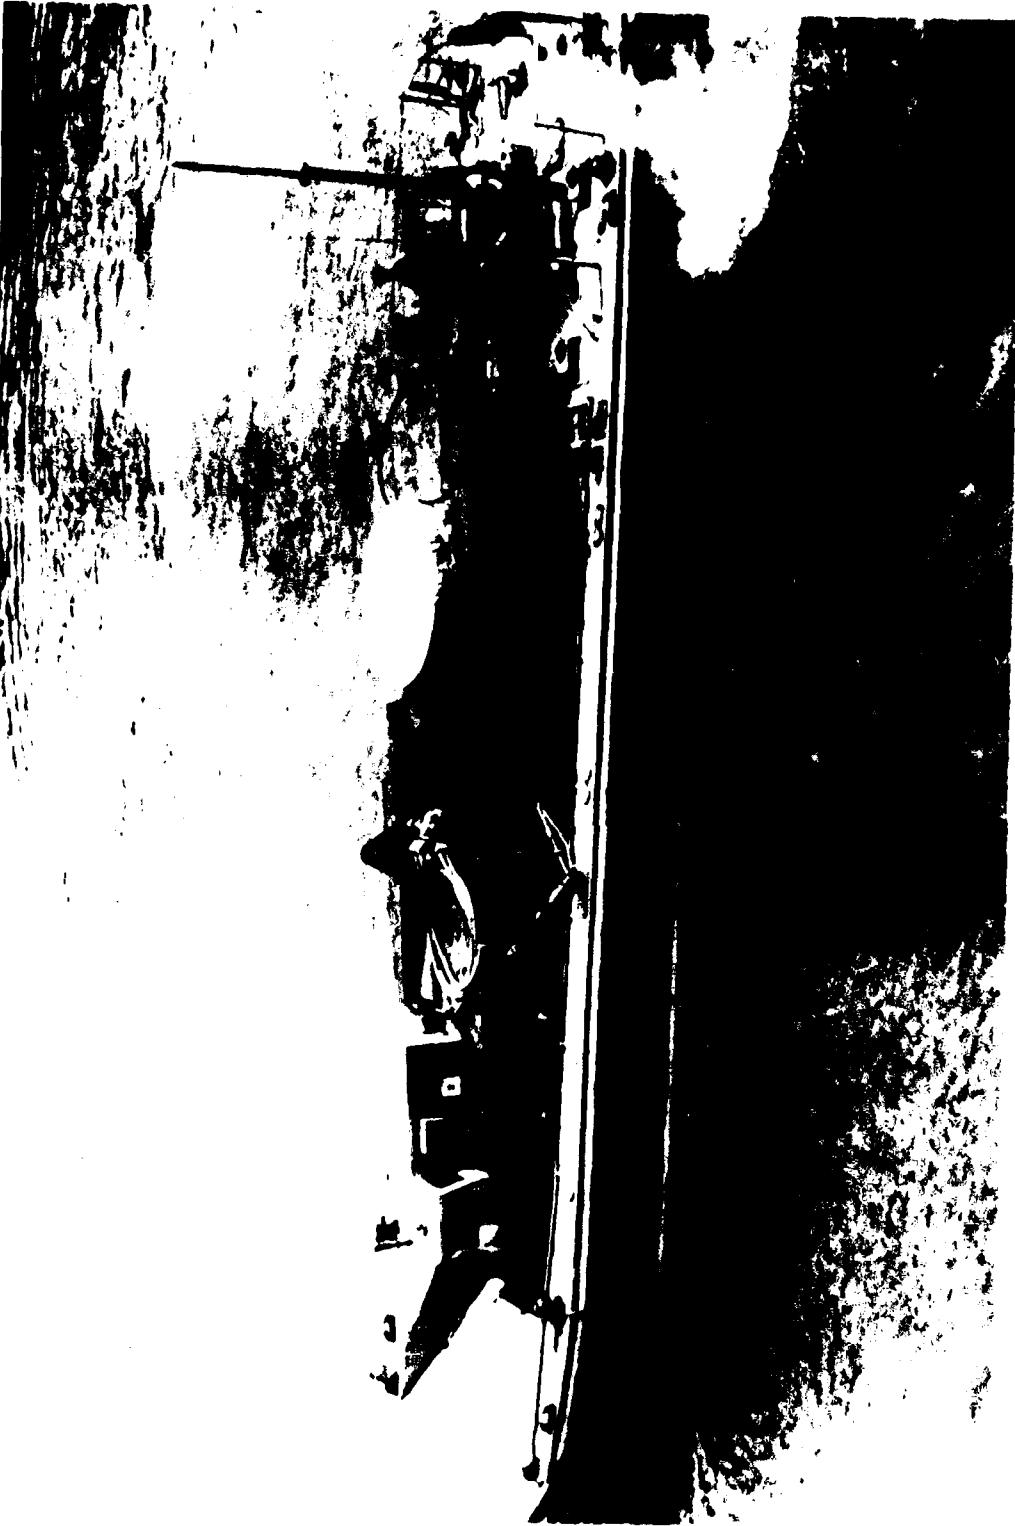
FIGURE A.6. CARRIER LOADED IN LCM8. In order to deploy and off-load a 300-ton crane it was necessary to have a lighter that could carry it ashore. The LCM8 has the capability to carry the weight but there was less than an inch clearance between the LCM8 well and the carrier, too little to normally off-load the carrier from the ship without incurring damage. Above the carrier is shown riding on specially designed ramps that permit loading it on a slant in the well of the LCM8. This added about 4 feet of clearance and made the LCM8 ride in the water more safely.

The Joint Test Directorate tasked the study of the fit of the carrier in the LCM8 to the J.J. Henry Co., Inc. As a result of this tasking a design for a ramp was provided and fabrication was ordered by the Joint Test Directorate. (See Figure 1, the LCM8 with ramp and 6250 crane carrier.) The second problem, seaworthiness of the LCM8 with the carrier, was partially confirmed when the carrier was backed into the LCM8 without the specially fabricated ramp and test runs were made on the James River. These runs resulted in no ventilation of the LCM8's propeller nor was the craft excessively down in the bow. However, the LCM8 did have a noticeable starboard list because the carrier was not centered longitudinally. Also the LCM8 did ride with its main deck parallel with the water when it normally rides with its bow quite high.

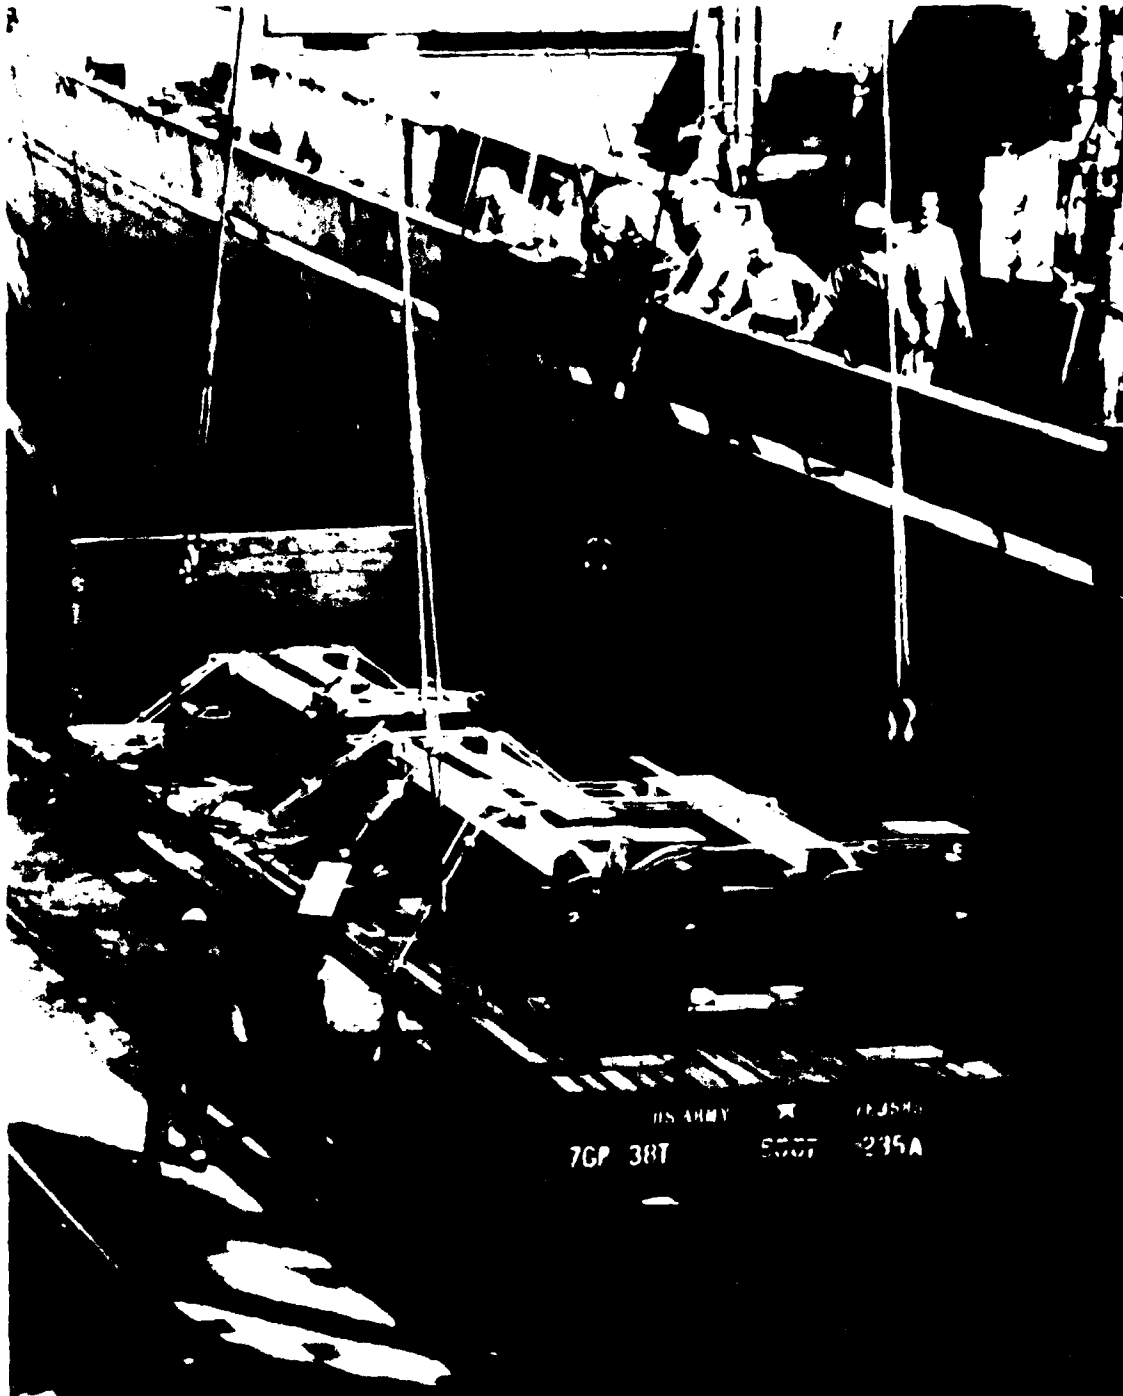
FIGURE A-8. OUTRIGGER BEAMS LOADED. Outrigger beams mobile-loaded on an M127 trailer are being loaded aboard the AMERICAN COURIER's Hold No. 4. Contract stevedores were used to load the ship. Army and Navy stevedores were used to discharge it while at anchorage off Ft. Story, Virginia.

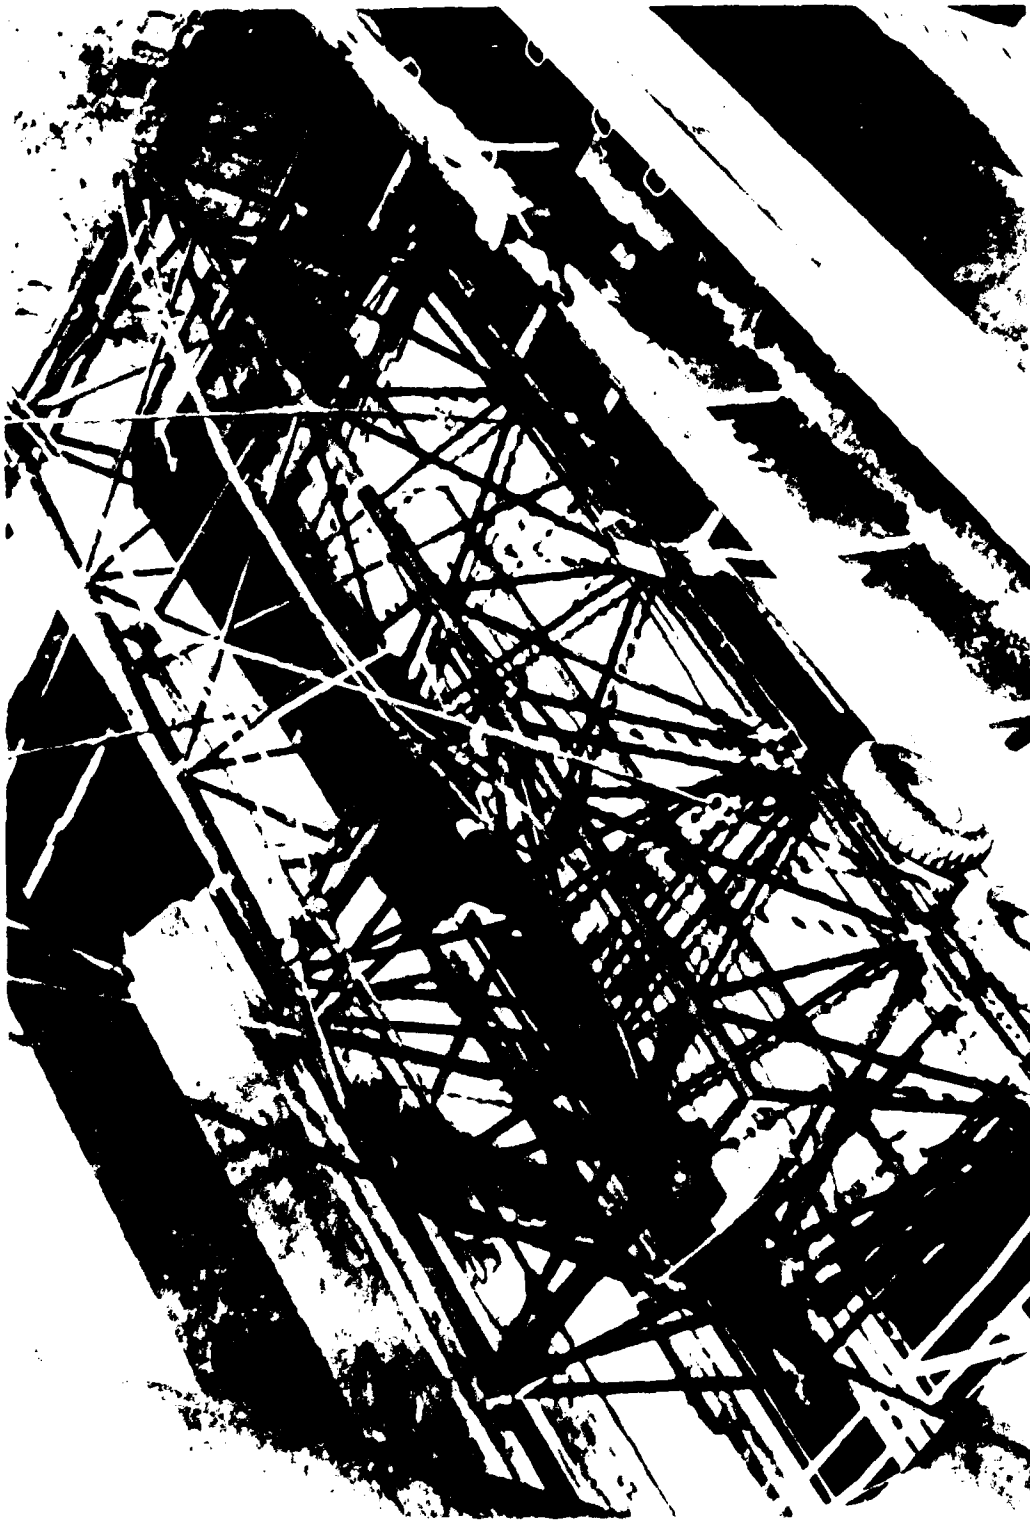
FIGURE A.9. CLOSE FIT. Mobile-loaded 10- and 20-foot boom sections for the 300-ton crane are lowered into midships No. 4 hold. The hatch squares through which vehicles had to be lowered were 16 feet x 42.5 feet and required careful handling to prevent loads from banging into the coaming.

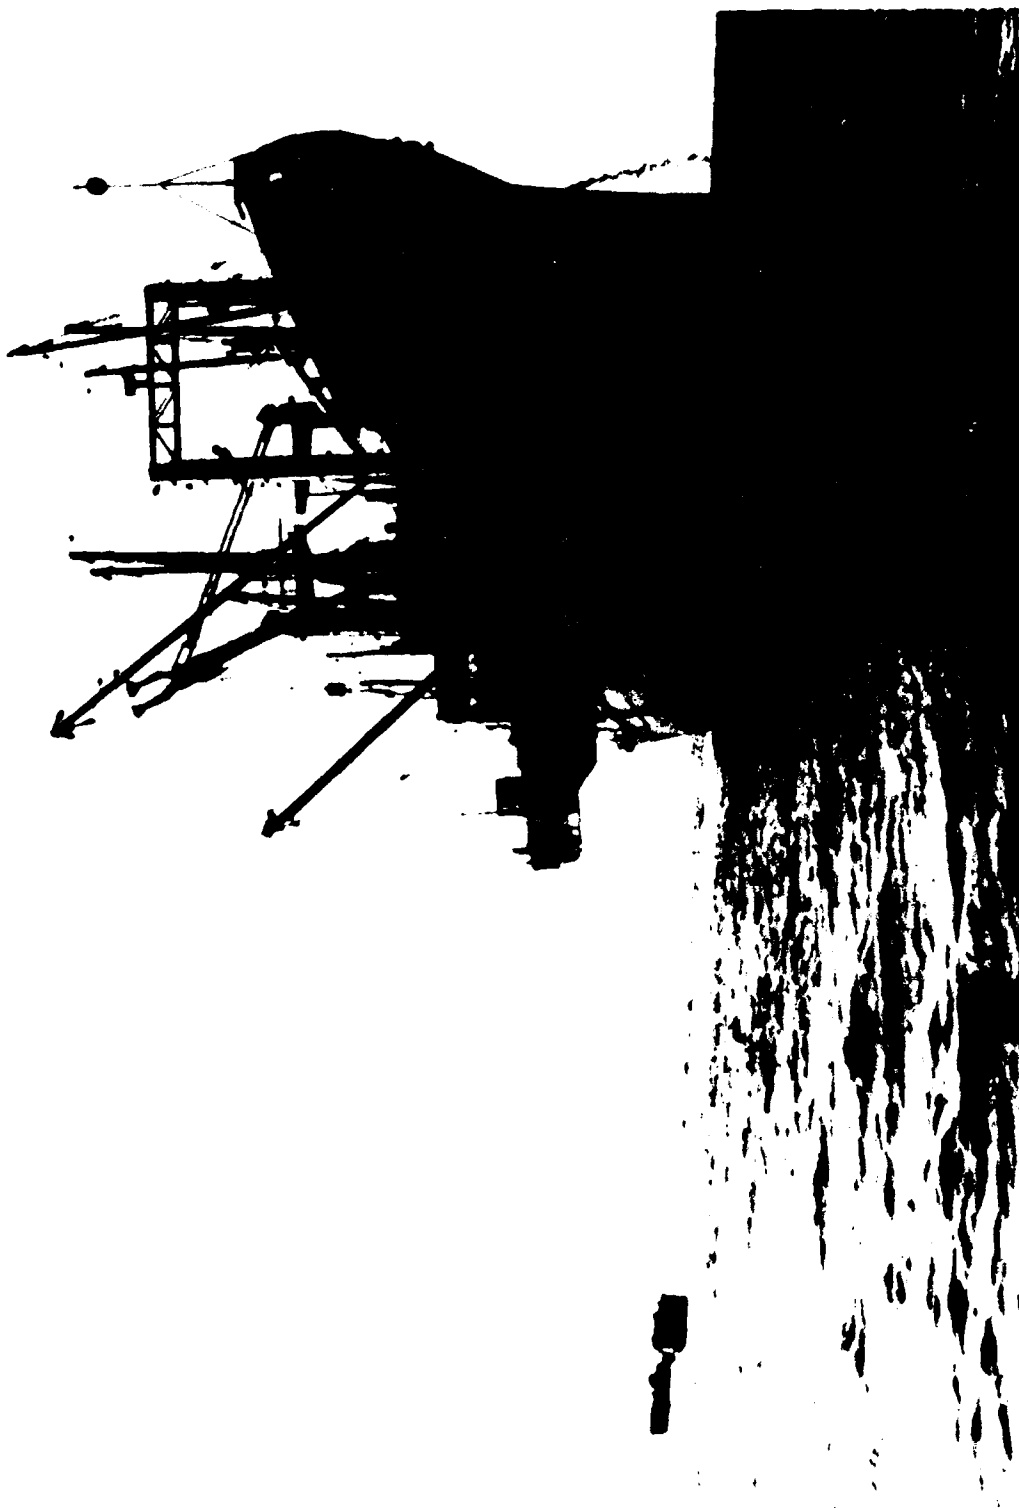
FIGURE A.17. OFF-LOADING BEGINS. Once at anchorage the first item to be off-loaded was the LCM8. Because it was the first item, military stevedores proceeded very cautiously. The ship's cargo handling gear had no difficulties. The load cell attached to the heavy-lift boom block indicated forces of about 66 long tons. This included weights of the LCM8 (estimated at about 58 long tons), the boom's hook, the load cell itself, the sling, and inertial forces.

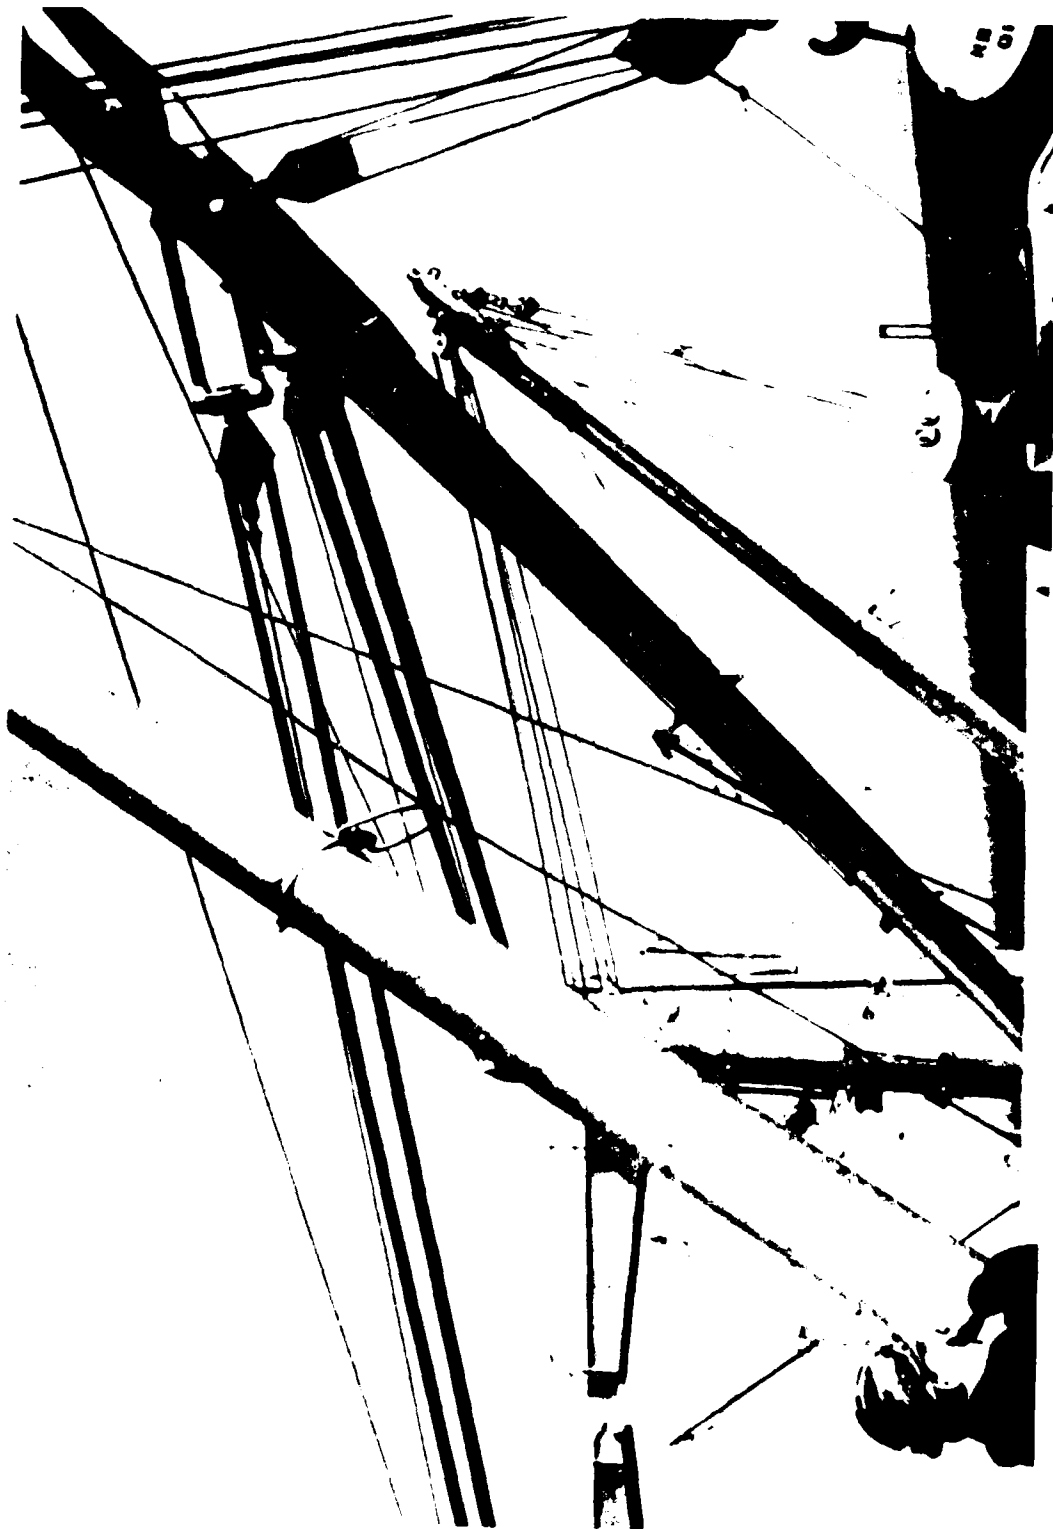
FIGURE A.24. CAUSEWAY CAUSES LIST, BLOCK NEARLY TOPPED. The very lengthy sling legs and the length of the 3 x 15 causeway made for very slow ship unloading when the causeway was discharged. The ship listed about 5 degrees to the starboard (exaggerated in the photo above) as the causeway was rotated so that it was parallel to the ship. A powered tag line was used to help the causeway clear the side of the ship. Because the sling legs were very long, the block was nearly topped.

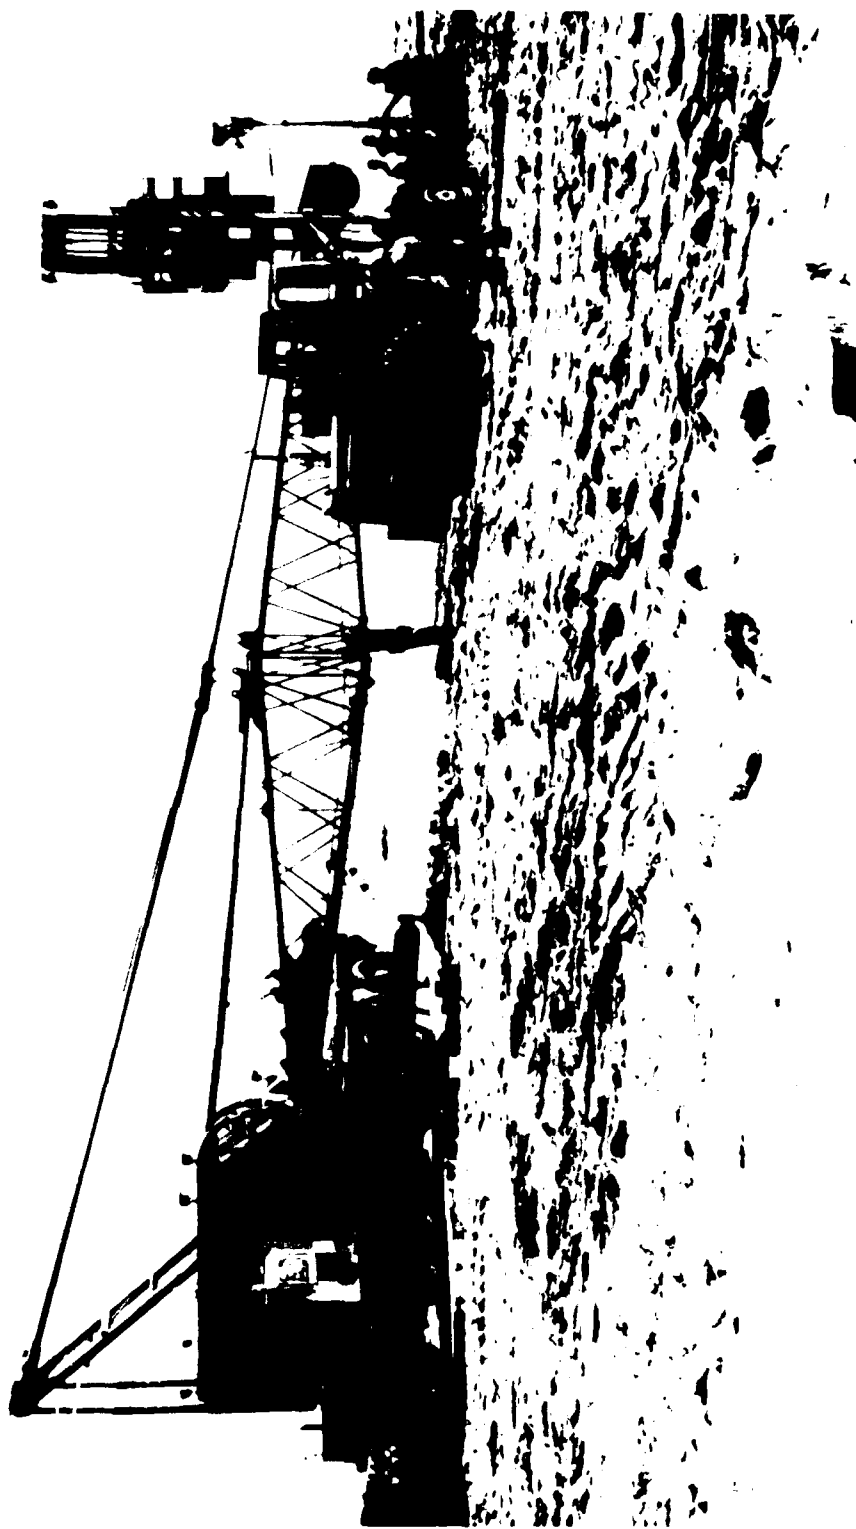
FIGURE A.30. BOOM TIP ADDED. A heavy-lift forklift is used to help assemble the 140-ton crane's boom tip. Once this step was completed, the crane's counterweight could be added.

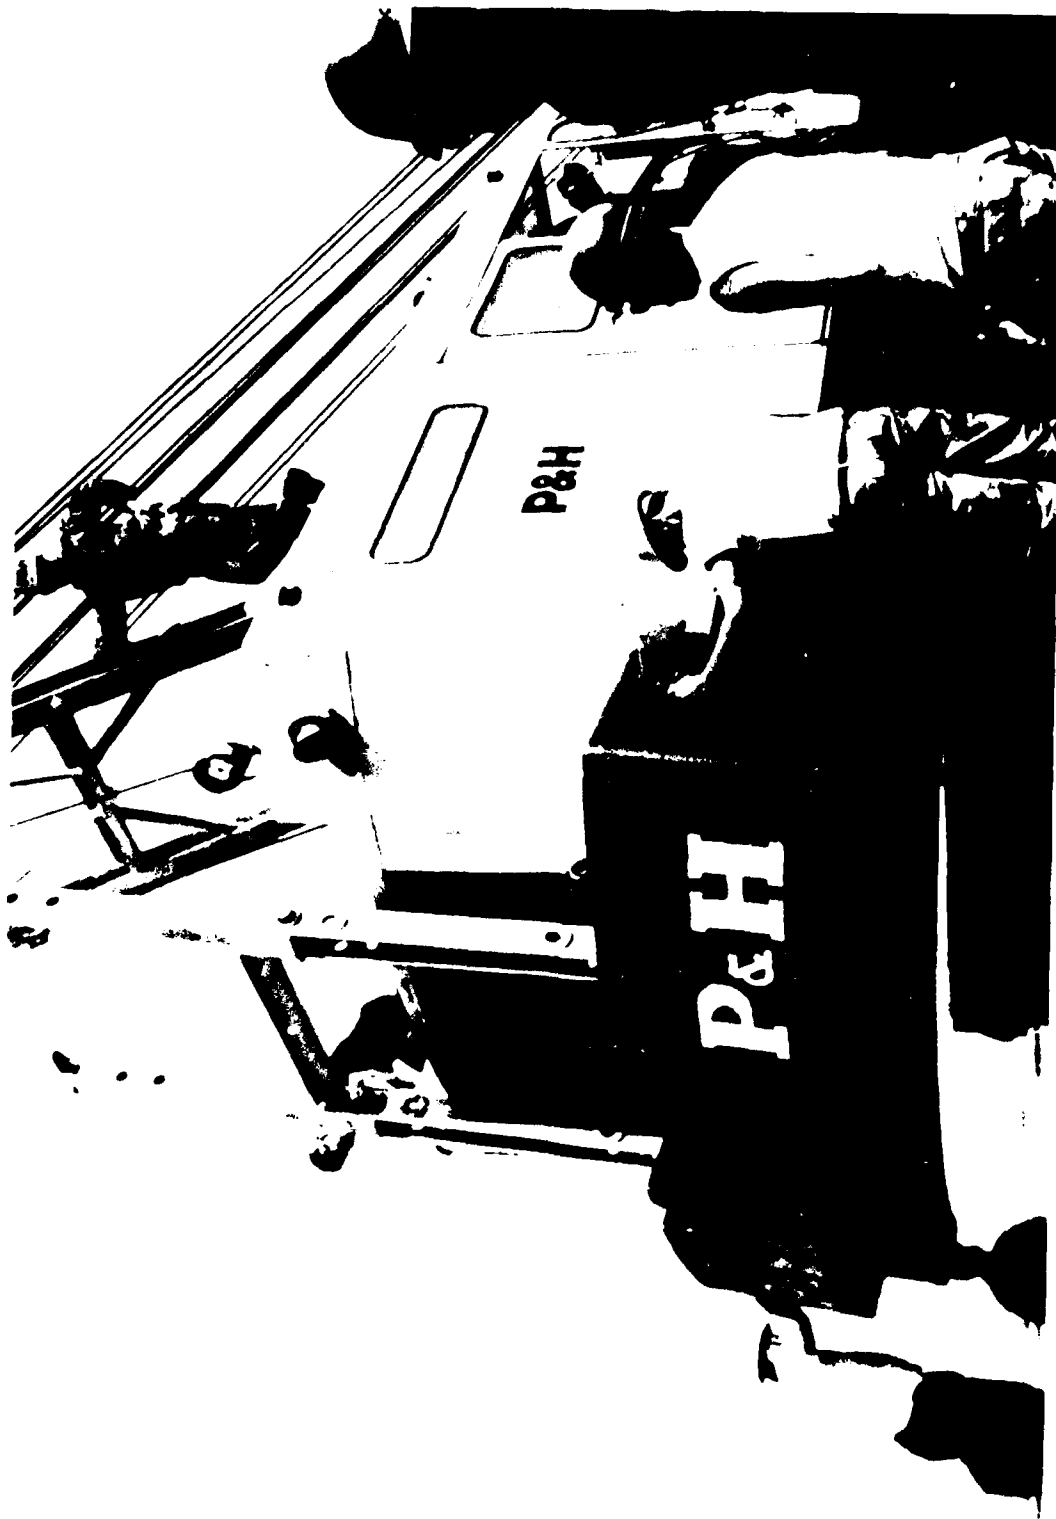
FIGURE A.31. COUNTERWEIGHT ASSEMBLED. With the use of its gantry the crane is able to assemble its 62,000-pound counterweight.

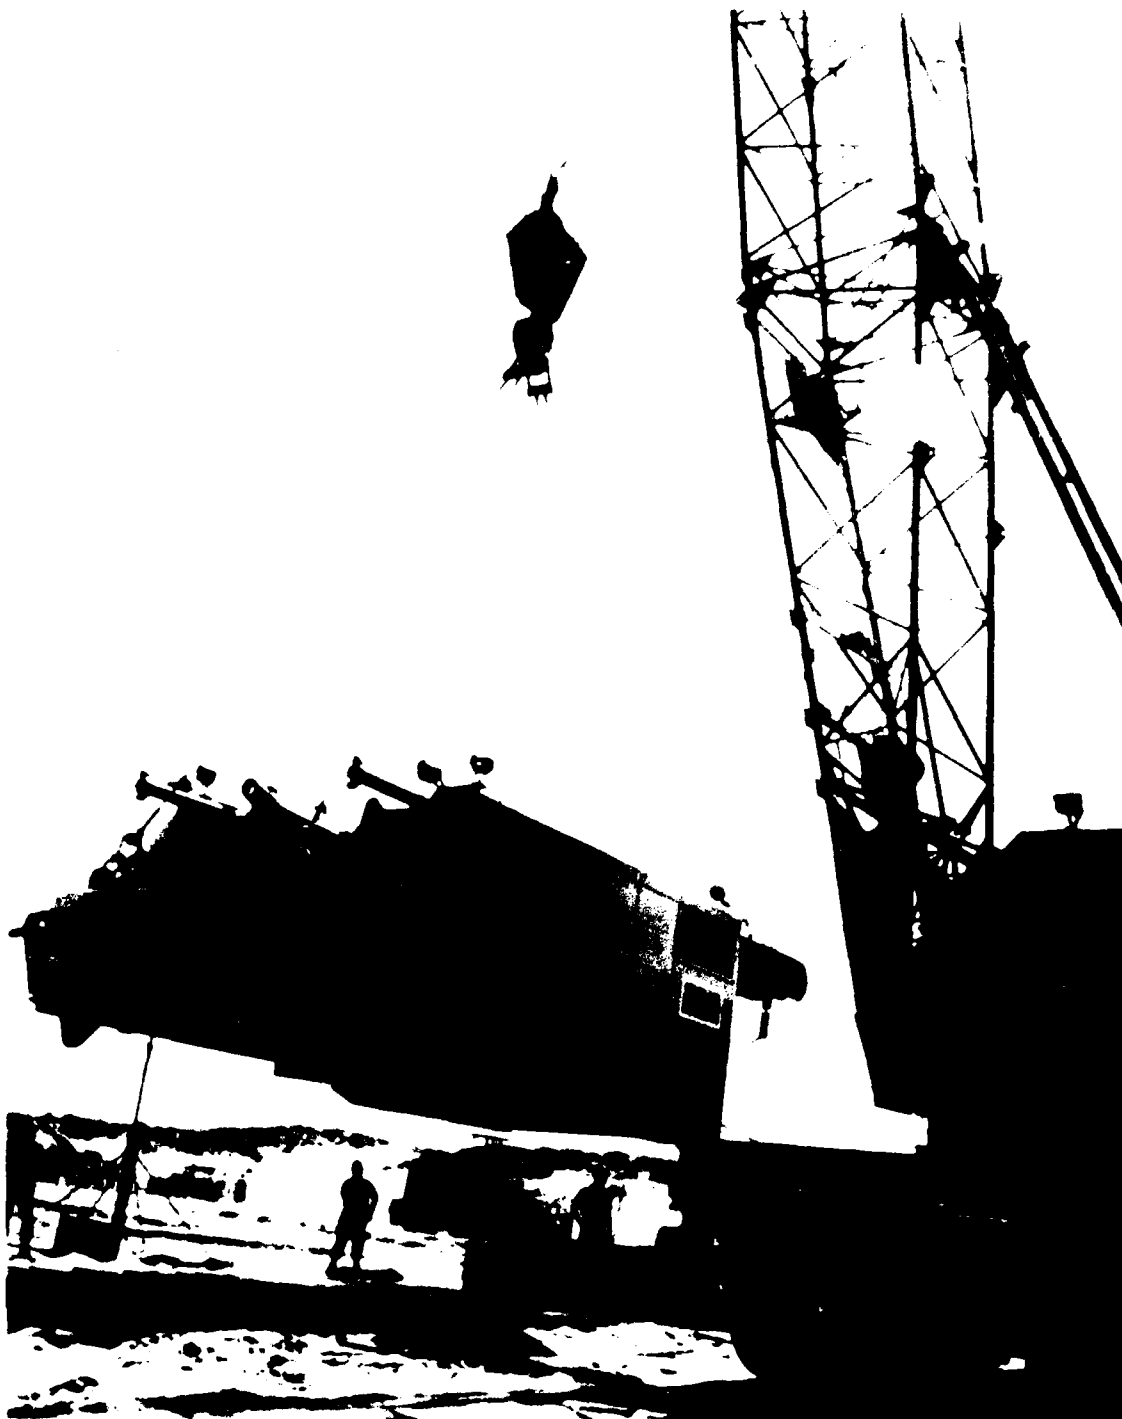
FIGURE A.34. 6250 ASSEMBLY BEGINS. Once the 300-ton crane upper was in position, assembly began. The 140-ton crane had little difficulty on the beach hoisting the upper.

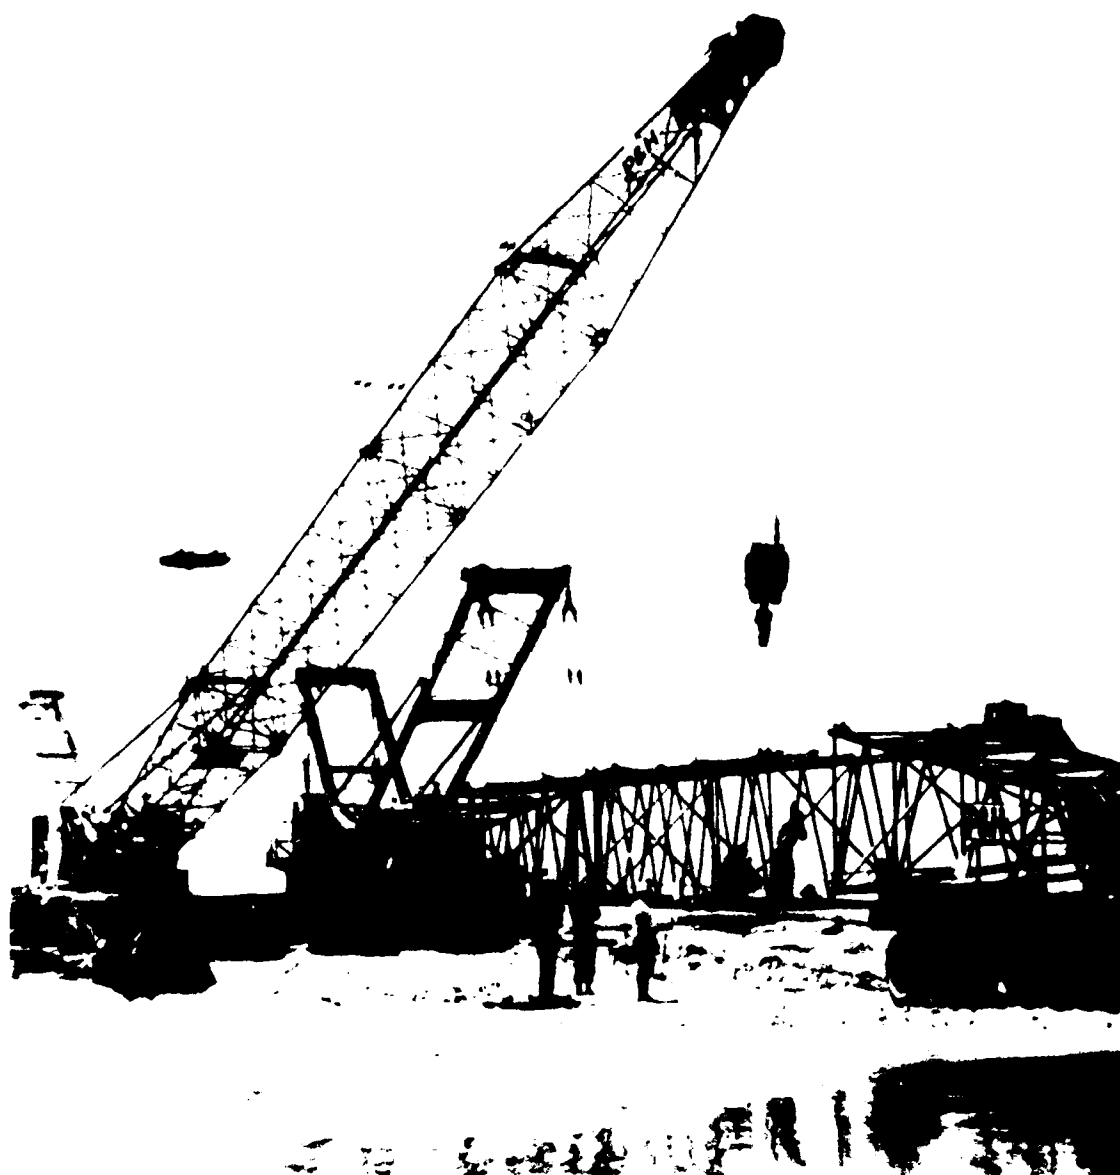
FIGURE A.37. BOOM SECTIONS ASSEMBLED. With the counterweights in place, the 140-ton crane was used to help assemble the boom for the 300-ton crane. Assembly of the 300-ton crane required a total of 20 hours and 10 minutes. This included assembly of the outriggers, counterweights, mast, two 30-foot boom sections, the boom base and tip, and the operator's module.
