HEAVY-LIFT BREAKBULK SHIP PRETEST RESULTS OF
THE JOINT LOGISTICS-OVER-THE-SHORE (LOTS)
TEST AND EVALUATION PROGRAM

25 JULY 1977

PREPARED UNDER
CONTRACT NUMBER MDA-903-75-C-0016
FOR THE OFFICE OF THE SECRETARY OF DEFENSE
DEPUTY DIRECTOR (TEST AND EVALUATION)
OFFICE OF THE DIRECTOR, DEFENSE RESEARCH AND ENGINEERING
WASHINGTON, D.C. 20310

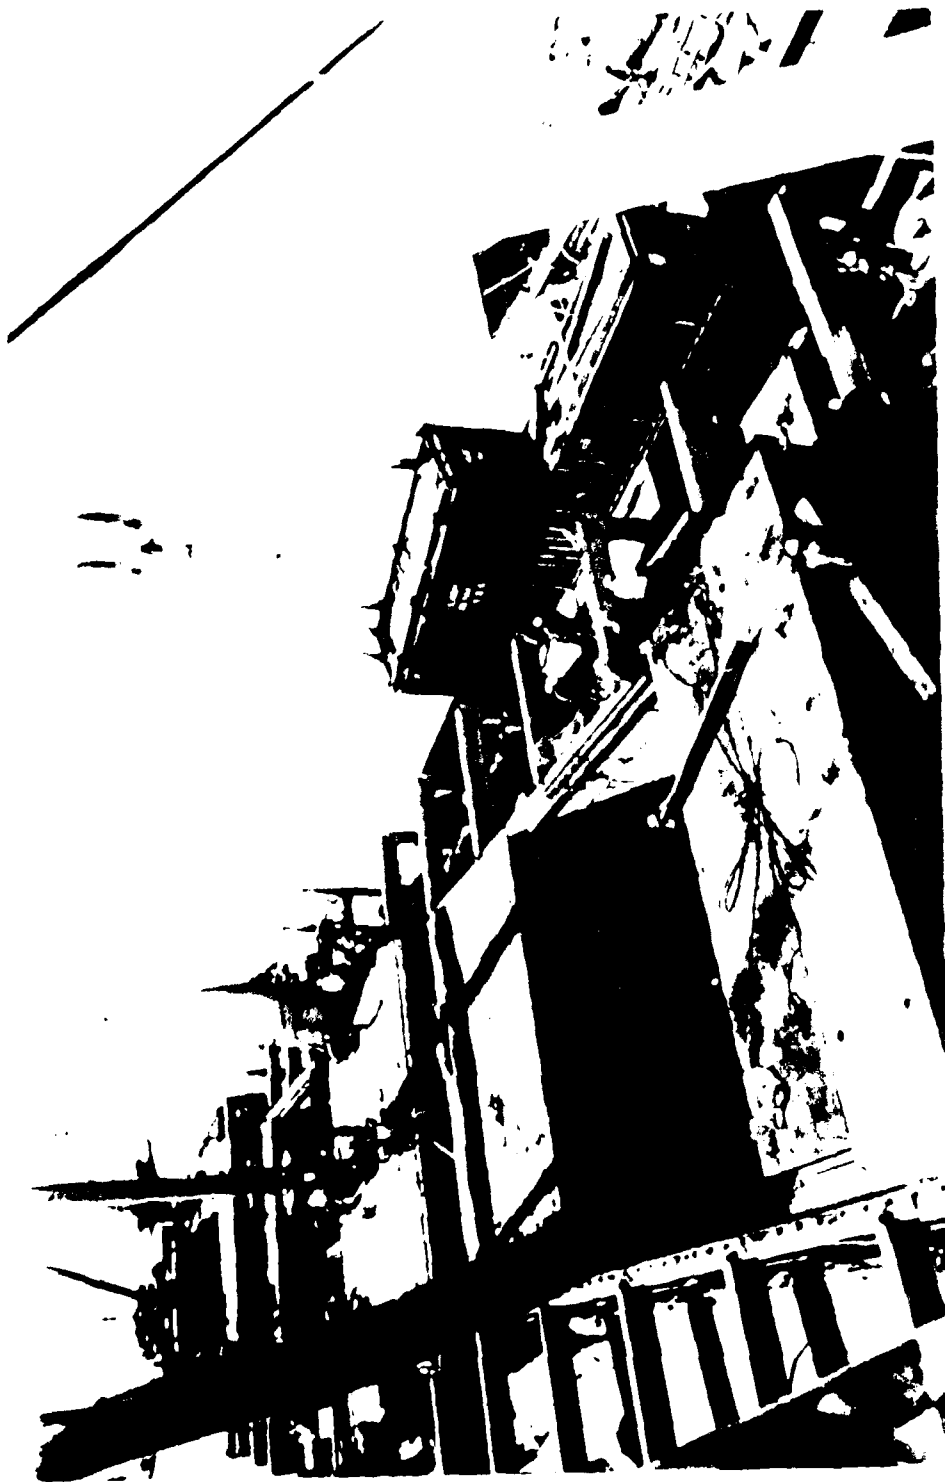
FIGURE 3.4. 40-FT CONTAINER. One 40-ft container was included in the load to provide data and experience in handling a 40-ft container which weighed 14,700 lbs.

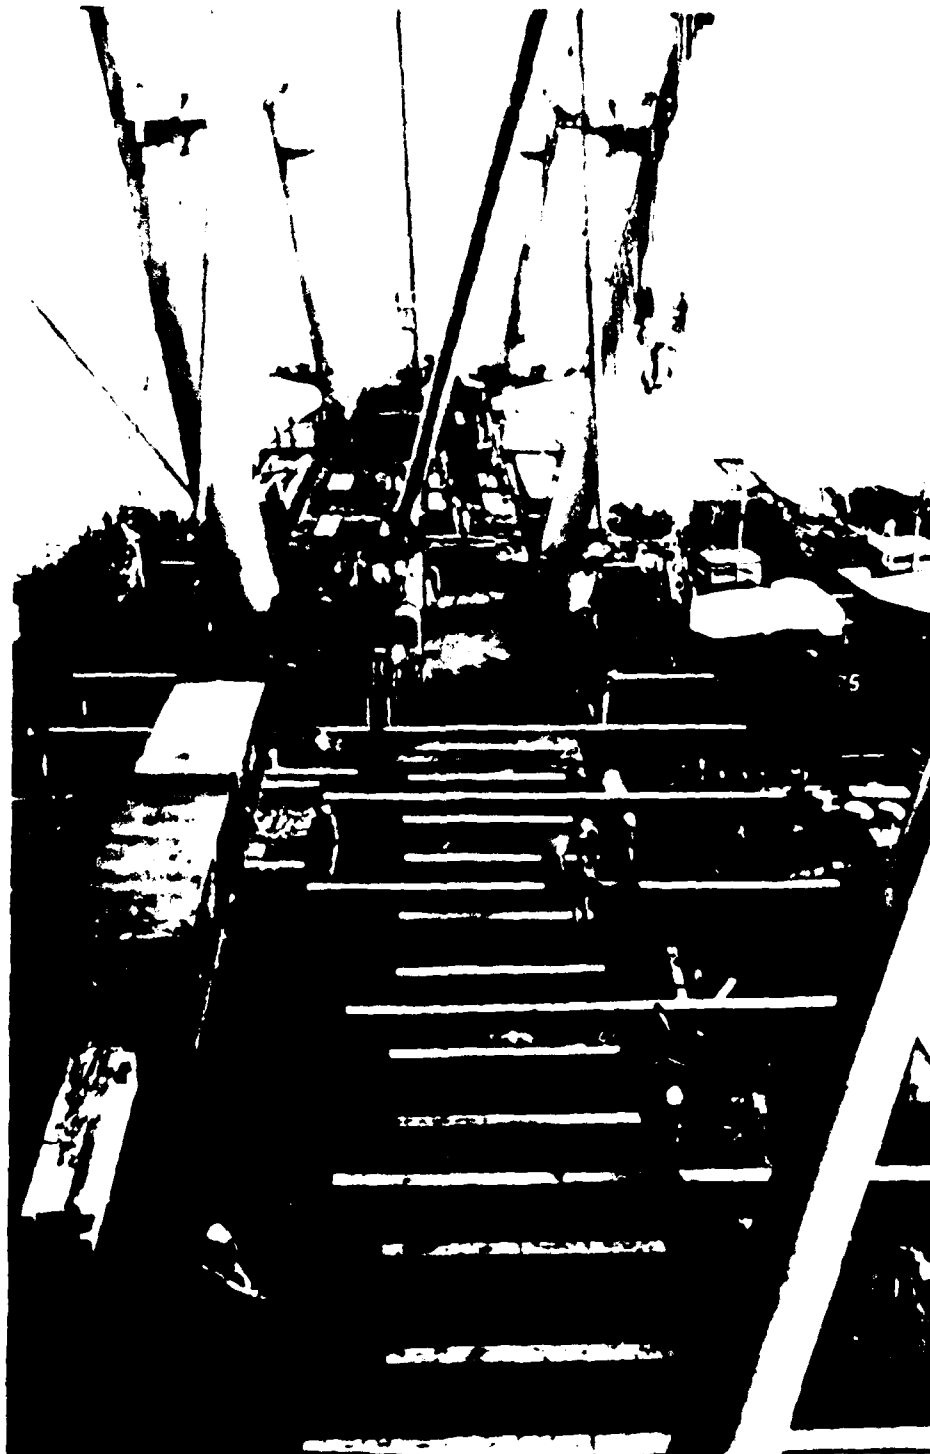
FIGURE 1.5. DECK PREPARED. Lunnage was laid on deck in preparation for the heaviest lift made in the LIFT pretest program, a 140t-class Army L₁. Each of the two heavy-lift ships (the only heavy-lift ships currently in the U.S. flag fleet) can carry four of these large landing craft. A 164t-class L₁ could not be lifted because neither the ship nor the Navy had the necessary sling.

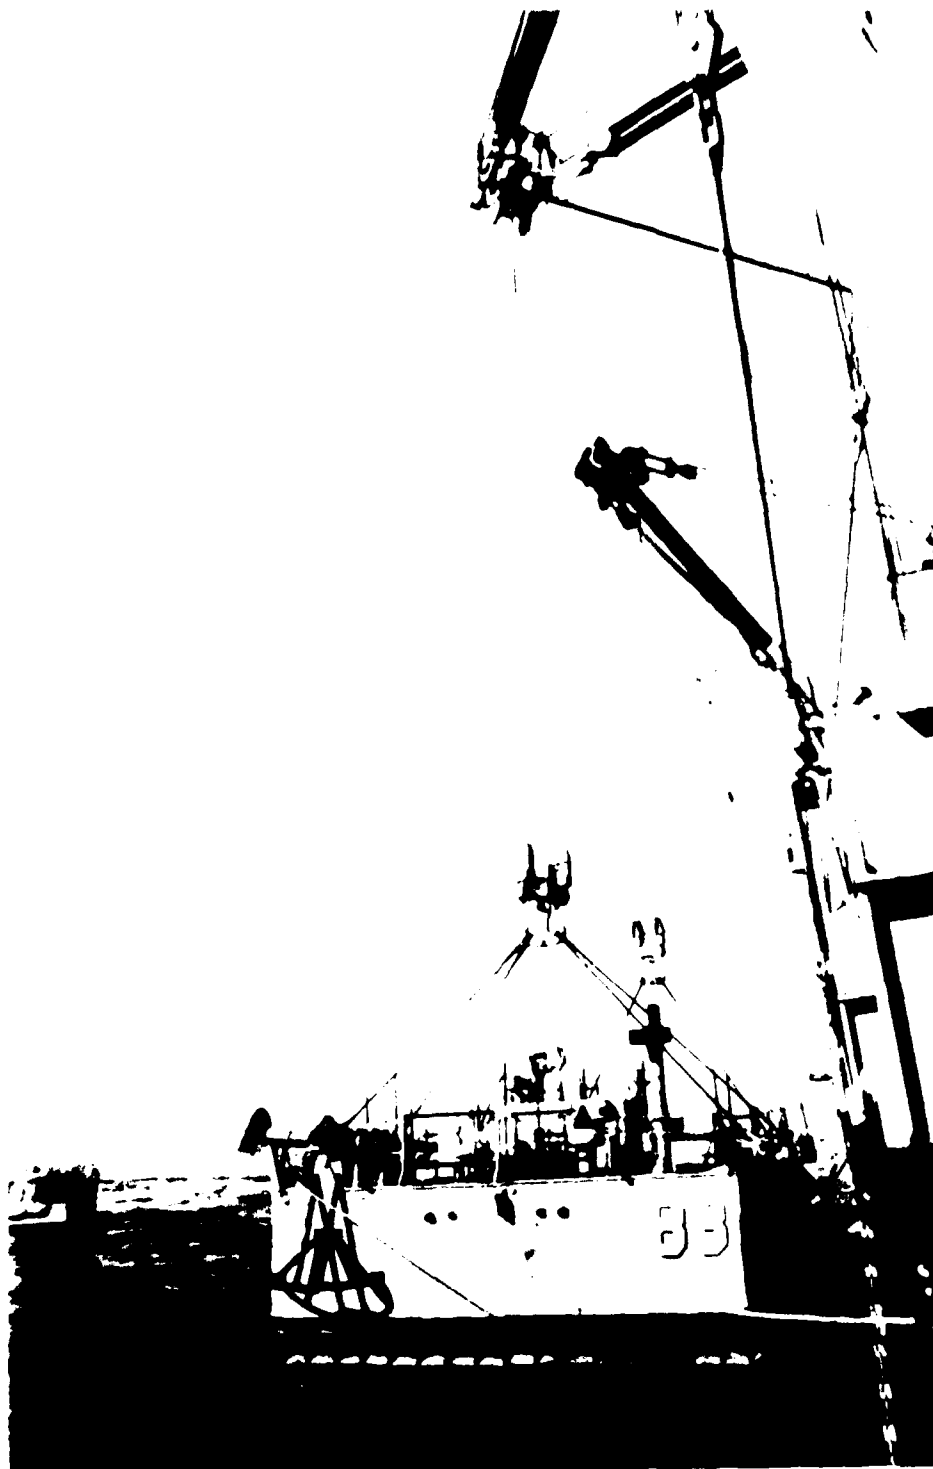
FIGURE 1-6. BOOM MARRIAGE. To lift the 180-long ton LCU, a boom marriage of two 100-ton capacity booms was made. This gives the ship a 200-ton capacity, although reportedly the ship has lifted and carried a 250-ton tug.

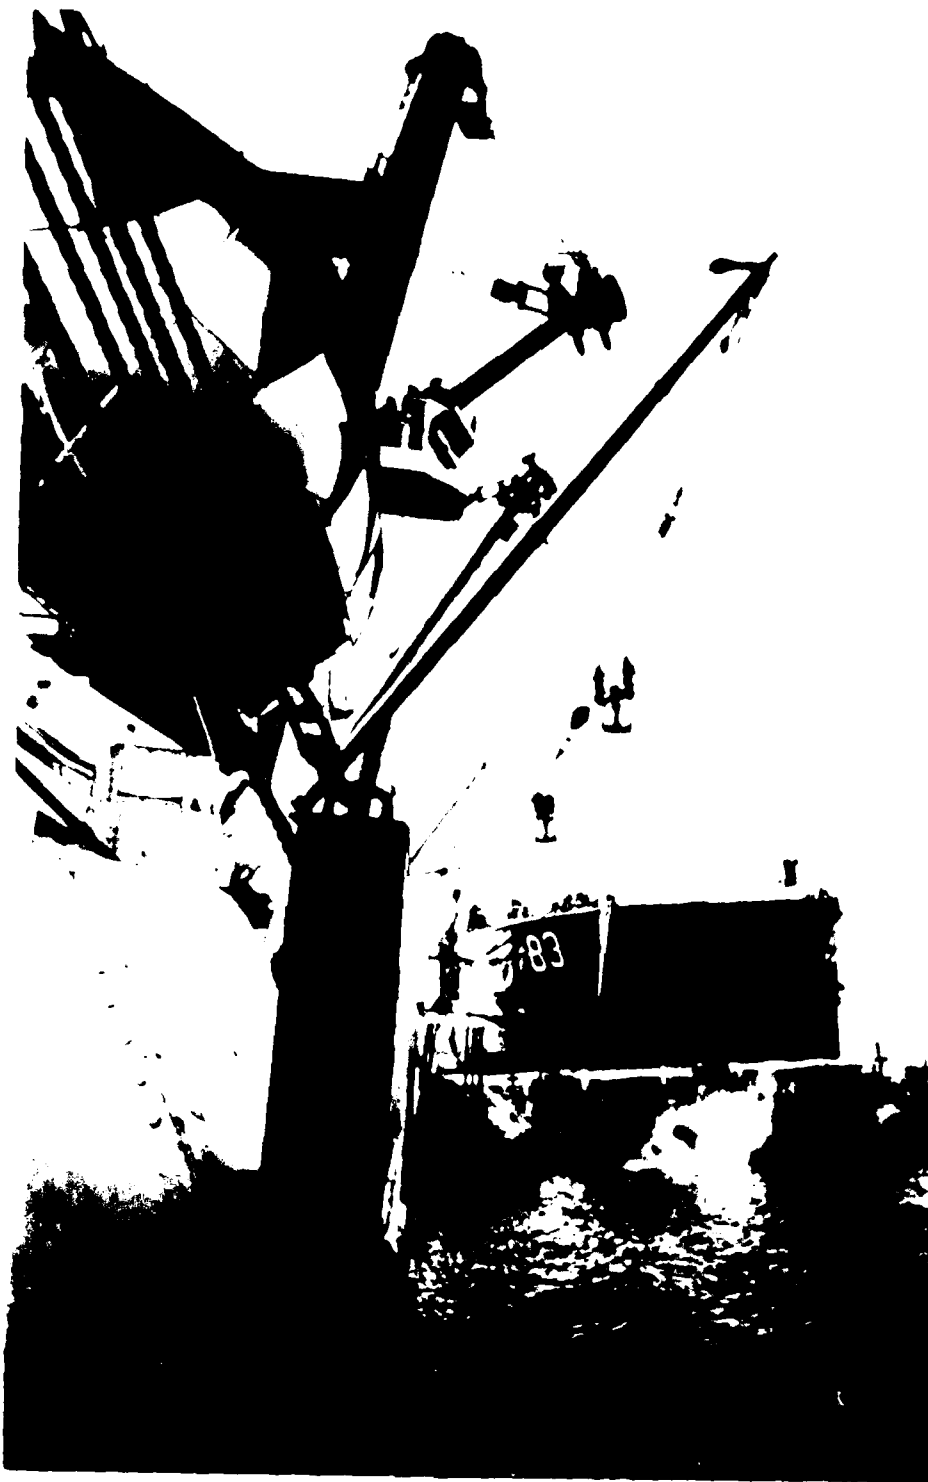
FIGURE 1. LIFTED WITH EASE. The LCU lift, although infrequently accomplished, was made with relative ease. Military personnel acted as stevedores but the ship's company operated all machinery and directed the technical aspects of the lift.

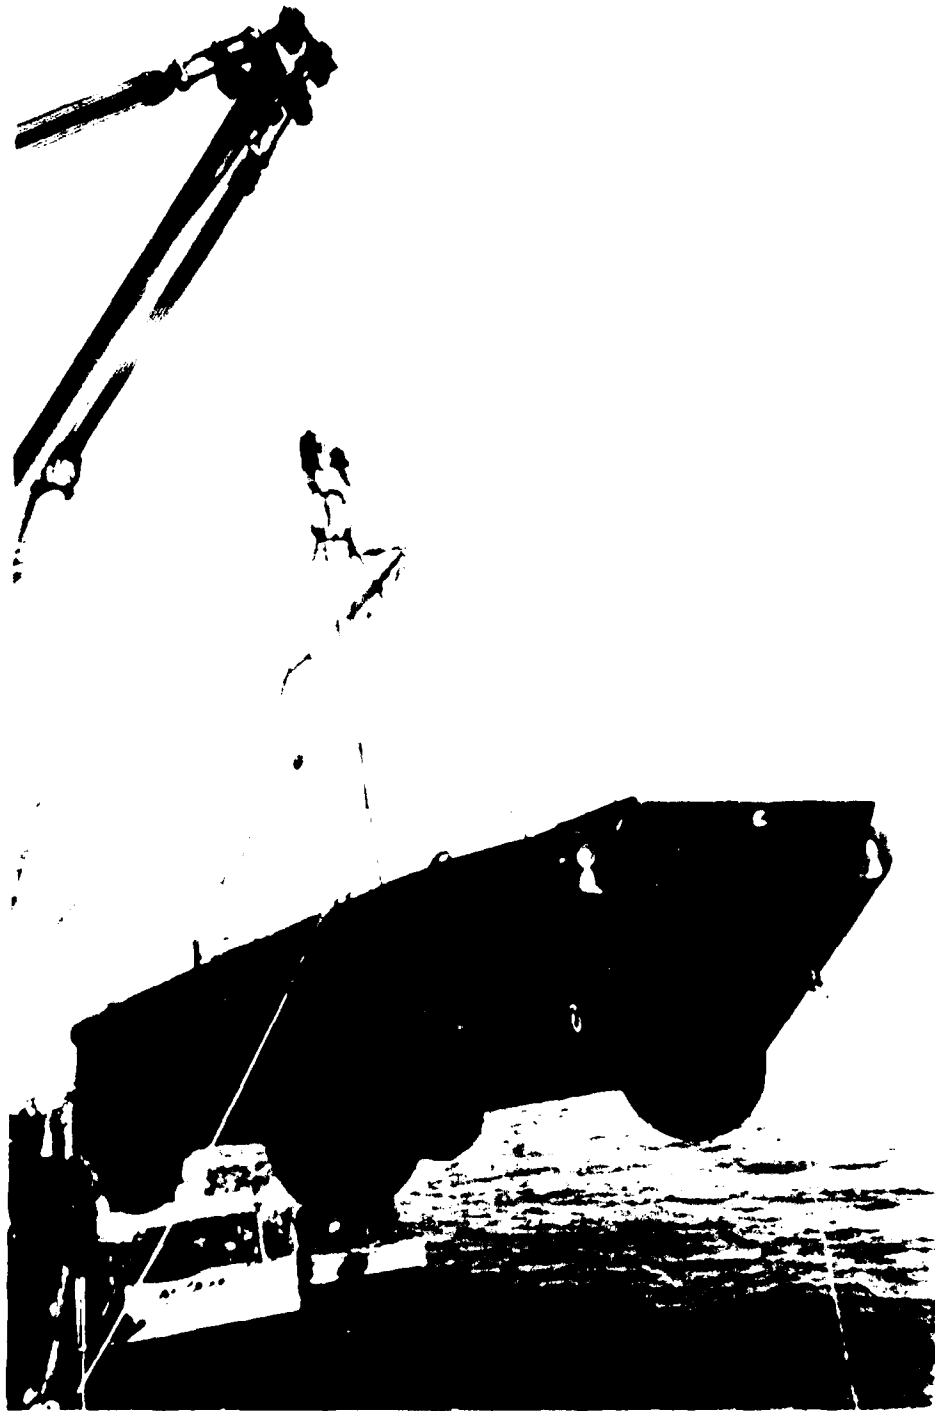
FIGURE 1. Aerial view of the MV-19. Approximately one-third of the 16-minute test time was spent hoisting the MV-19 and another the amphibious landing was completed in the remaining time.

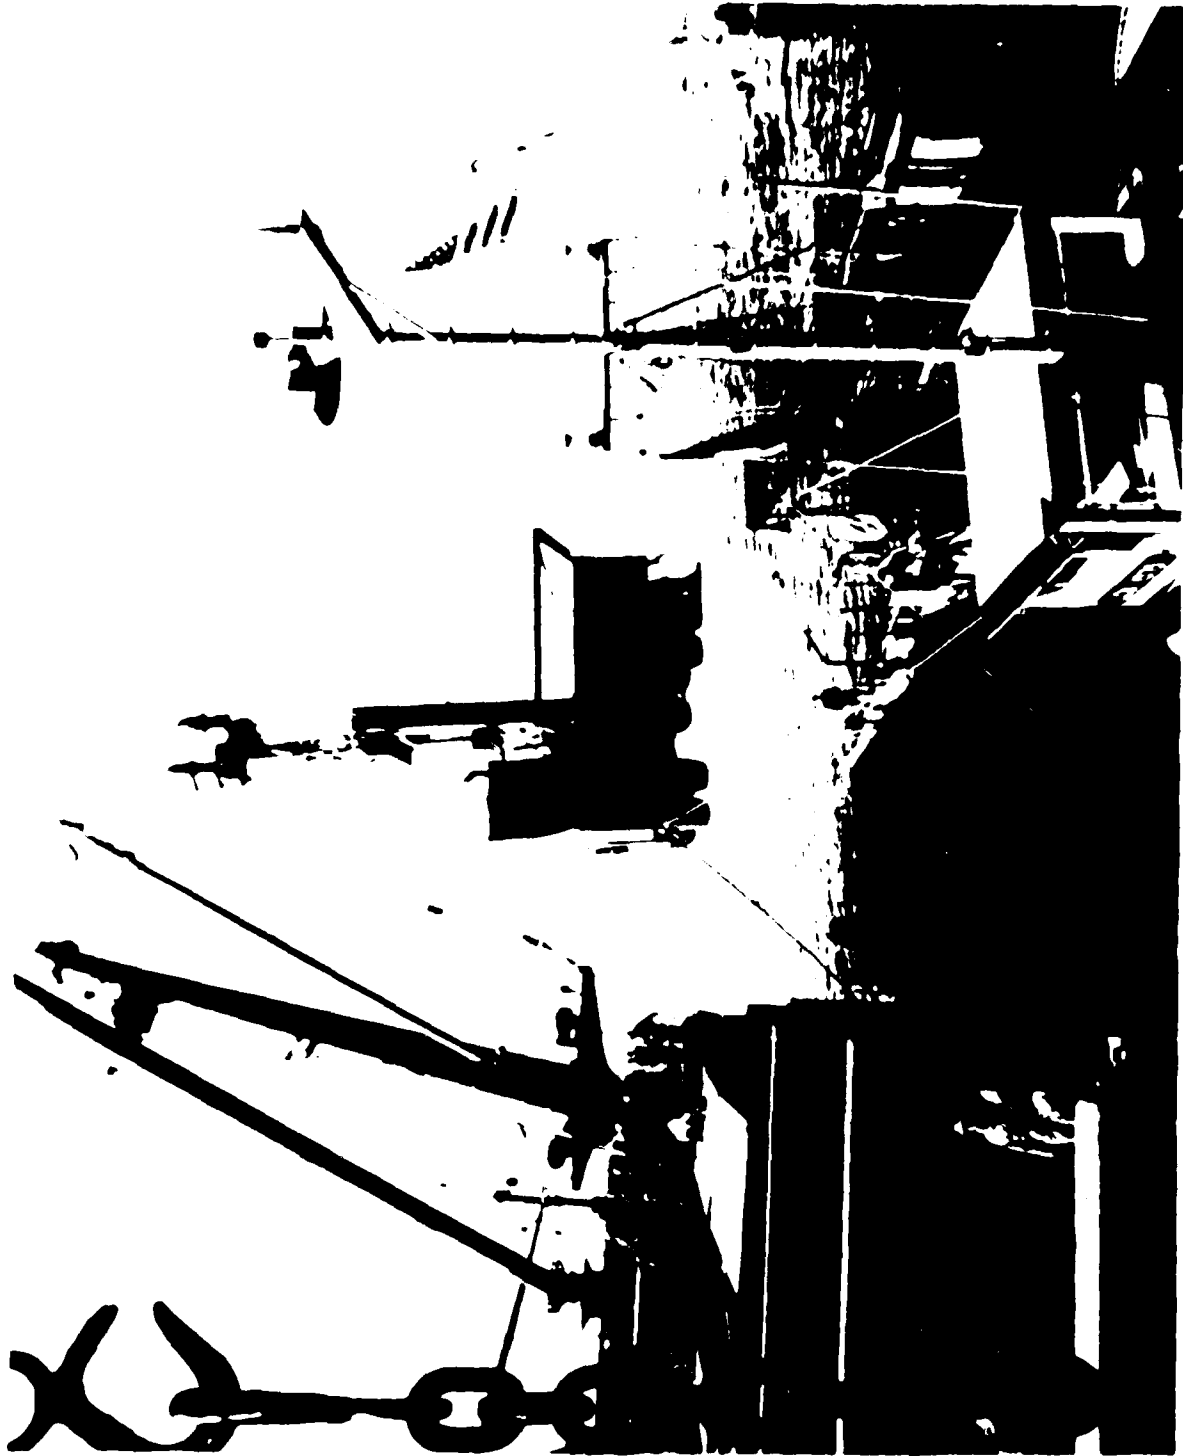
FIGURE D.29. SIDELOADER EASY LIFT. Compared to the other equipment embarked the sideloader went aboard relatively easily. It weighs 64 long tons and is 41 ft long, 12.5 ft wide, and 11.7 ft high.

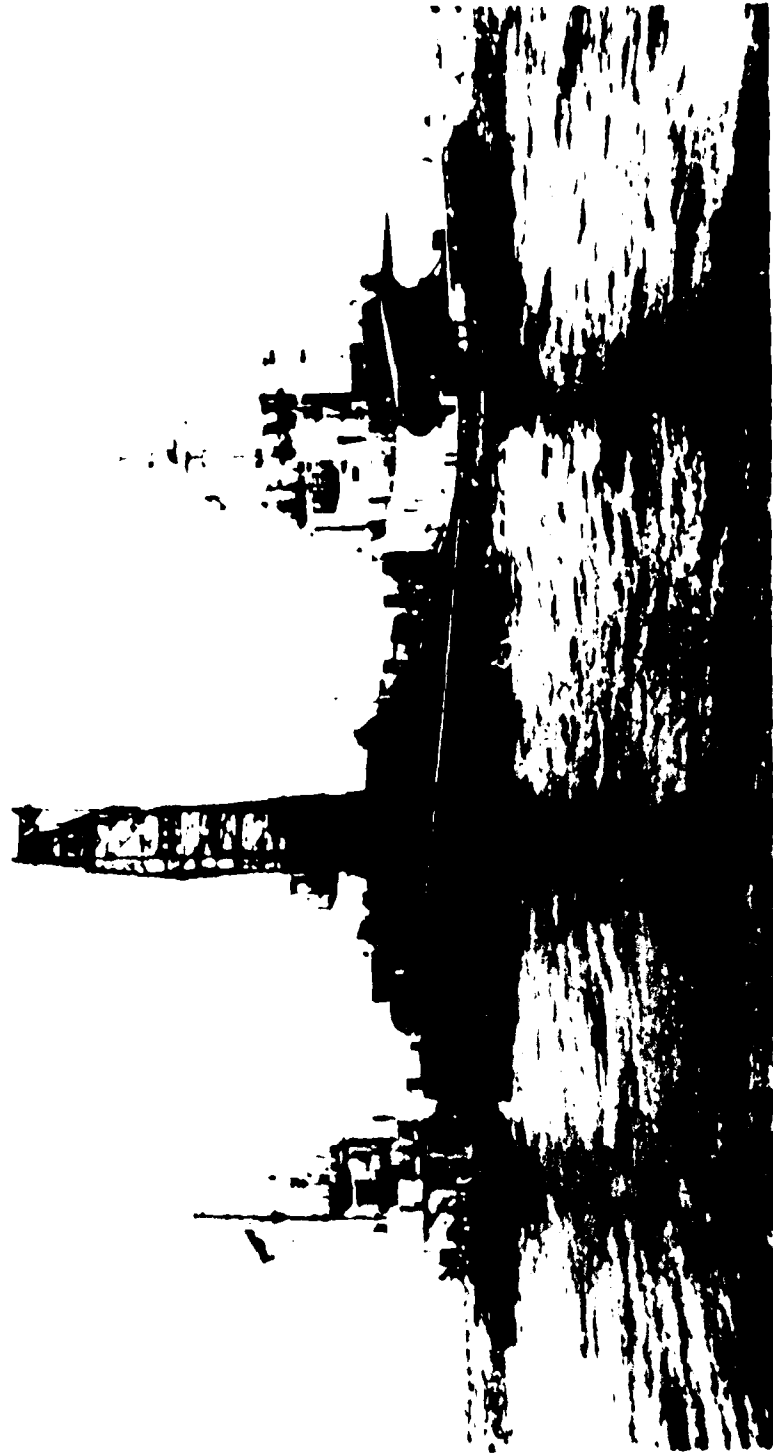
FIGURE D.34. TCOF TOWED TO PRETEST SITE. Once the deployment cargo had been off-loaded, the TCOF was positioned alongside the ship so that containers could be off-loaded and throughput events could begin.

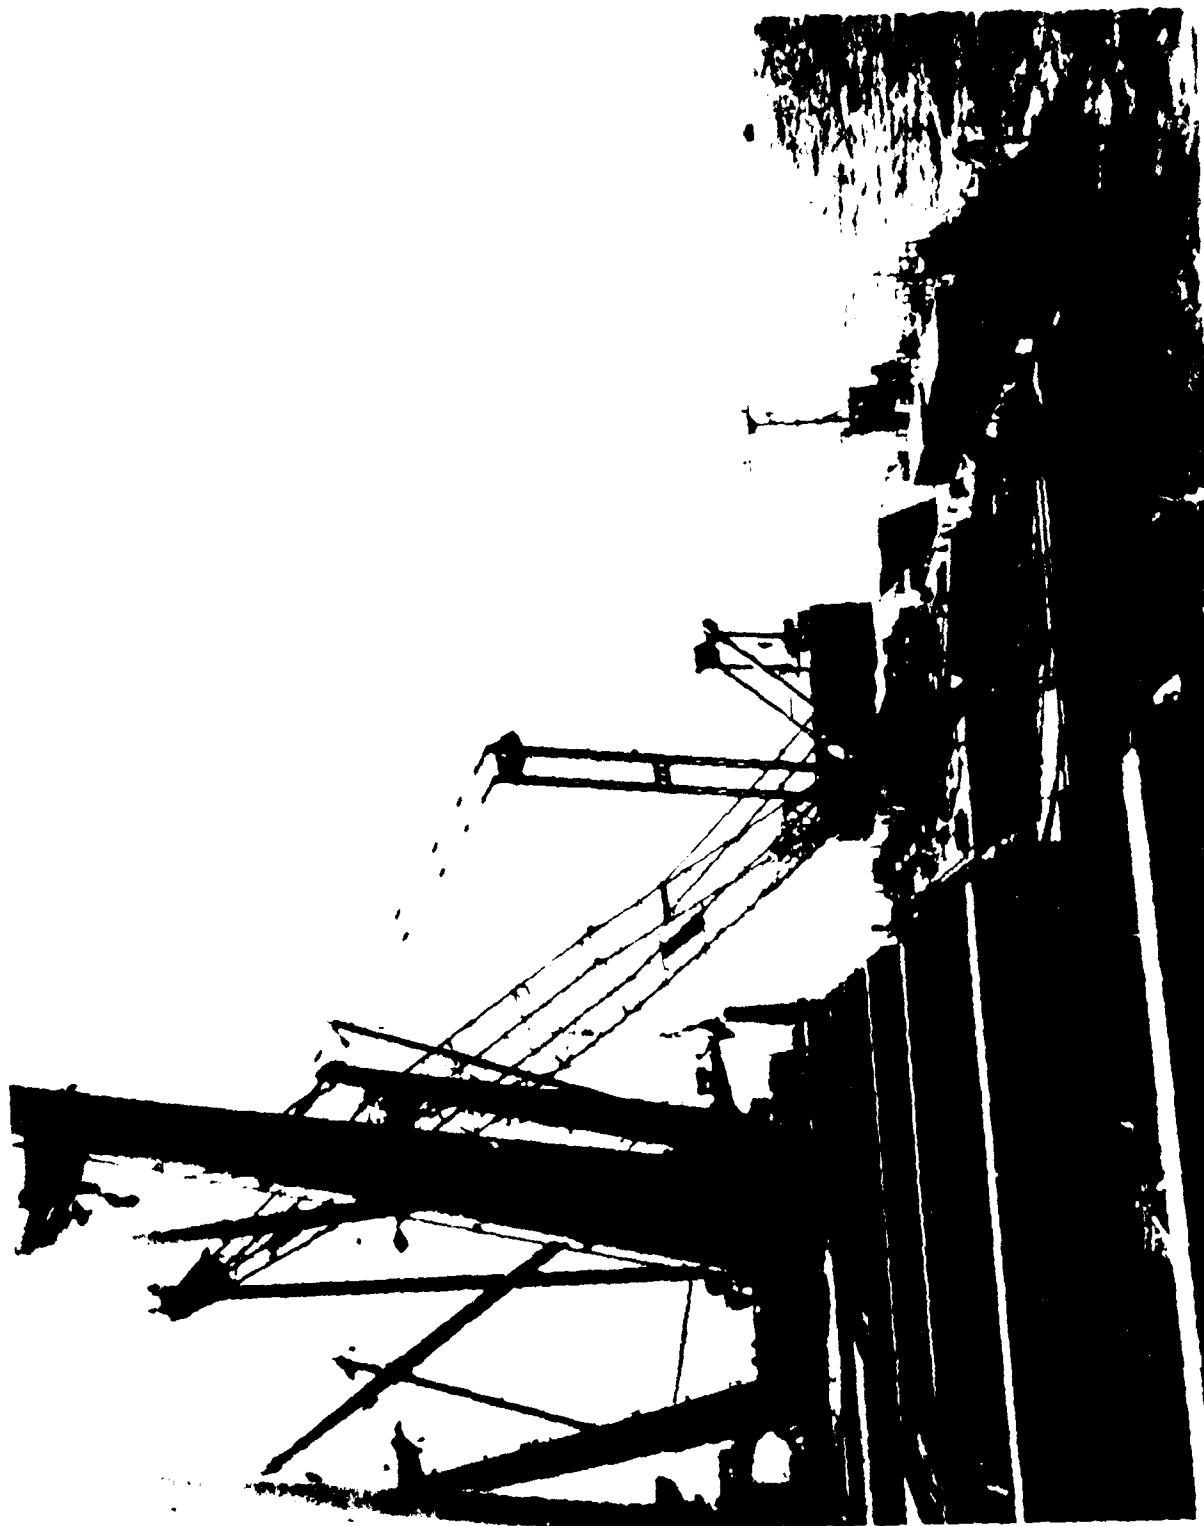
FIGURE 2-40. BOW TORSION. Once the container was attached the crane had to top up as well as raise the hook in order to clear the ship's booms and kingposts. This adds delays to cycle times that would not be typical of operations on the clear deck of a container ship.

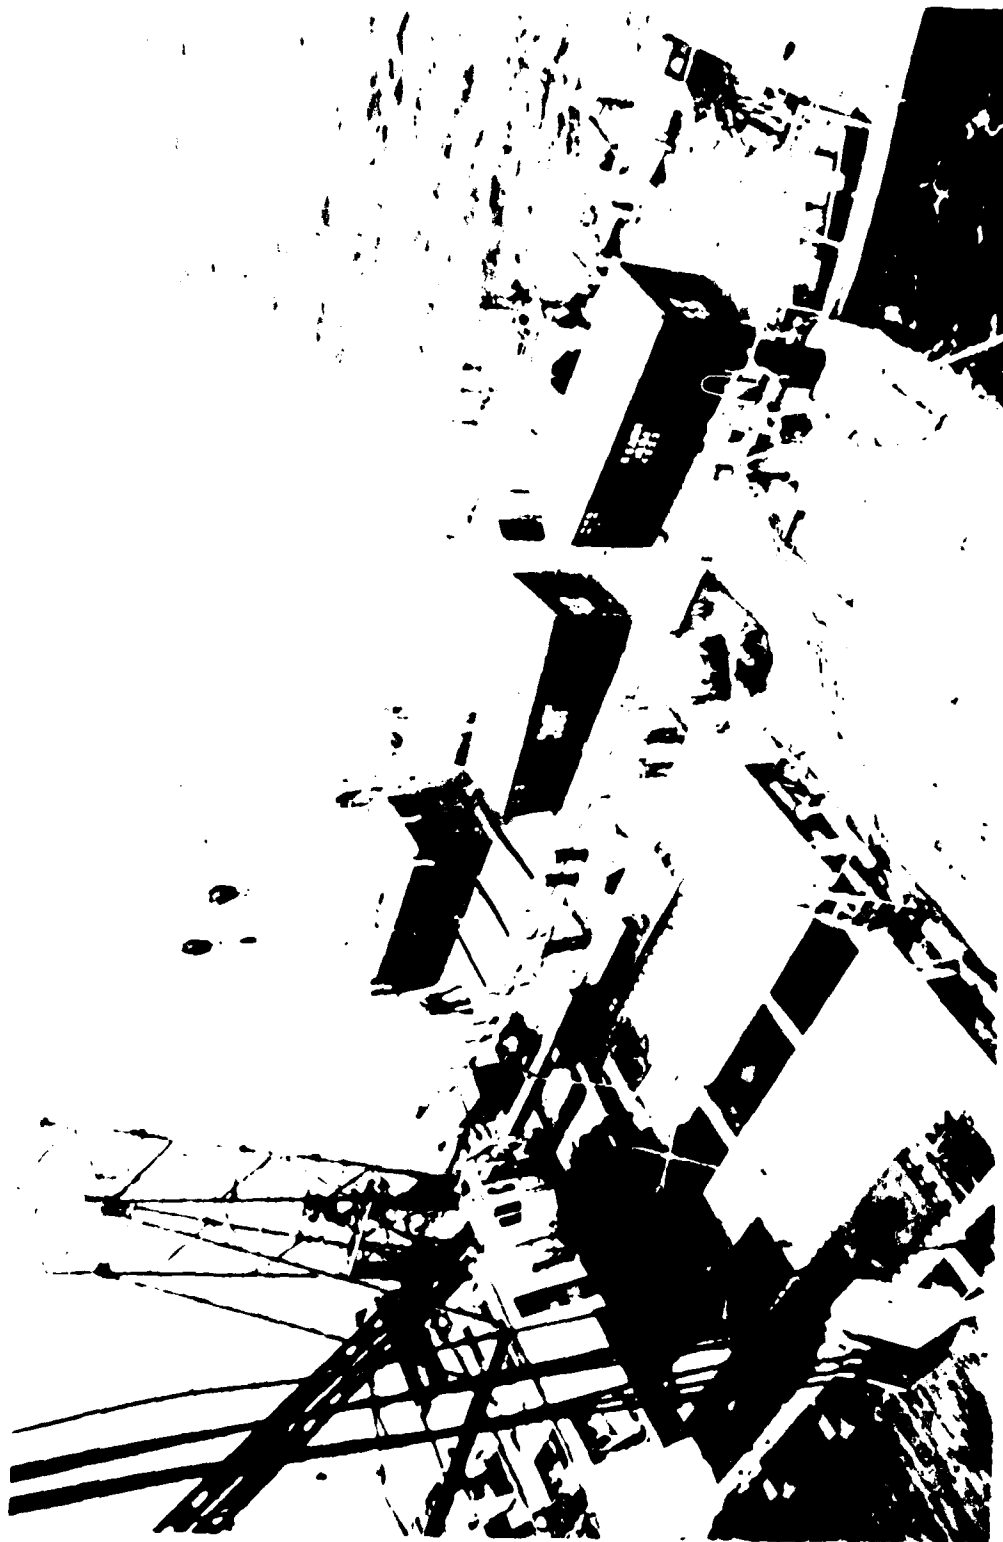
FIGURE D.42. LCU LIGHTLY LOADED. Normally an LCU would be loaded with four containers but because of the limited number of containers available, capacity loading was not practiced.

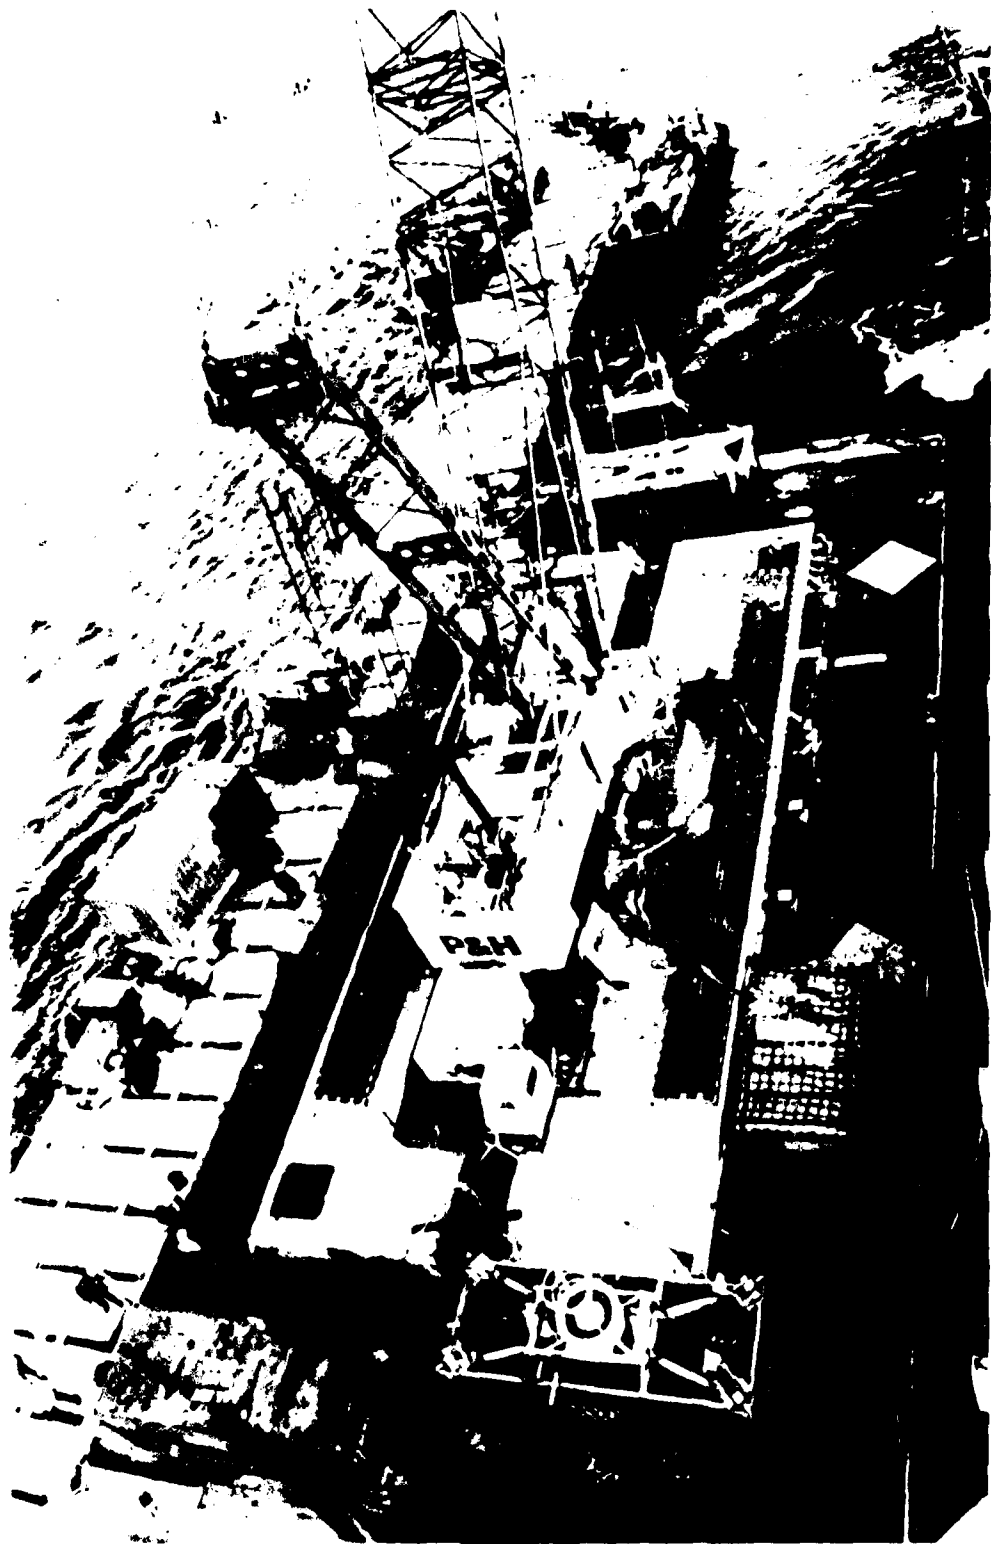
FIGURE D.43. MOBILE LOADING TIME-CONSUMING. One method of minimizing handling at the beach is to place trailers on a causeway ferry and load the trailers shipside. However, because of the motion of the seas and the need for close alignment during loading, it required approximately an hour to load just two of three trailers and it became apparent that the method was too time consuming.

The operation in which the causeway was loaded with containers placed with trailers on the beach athwartship was in the overall more efficient than the operation in which the containers were placed on military chassis. This was because much greater accuracy was required to land the containers on the military chassis, which proved to be difficult and time consuming.

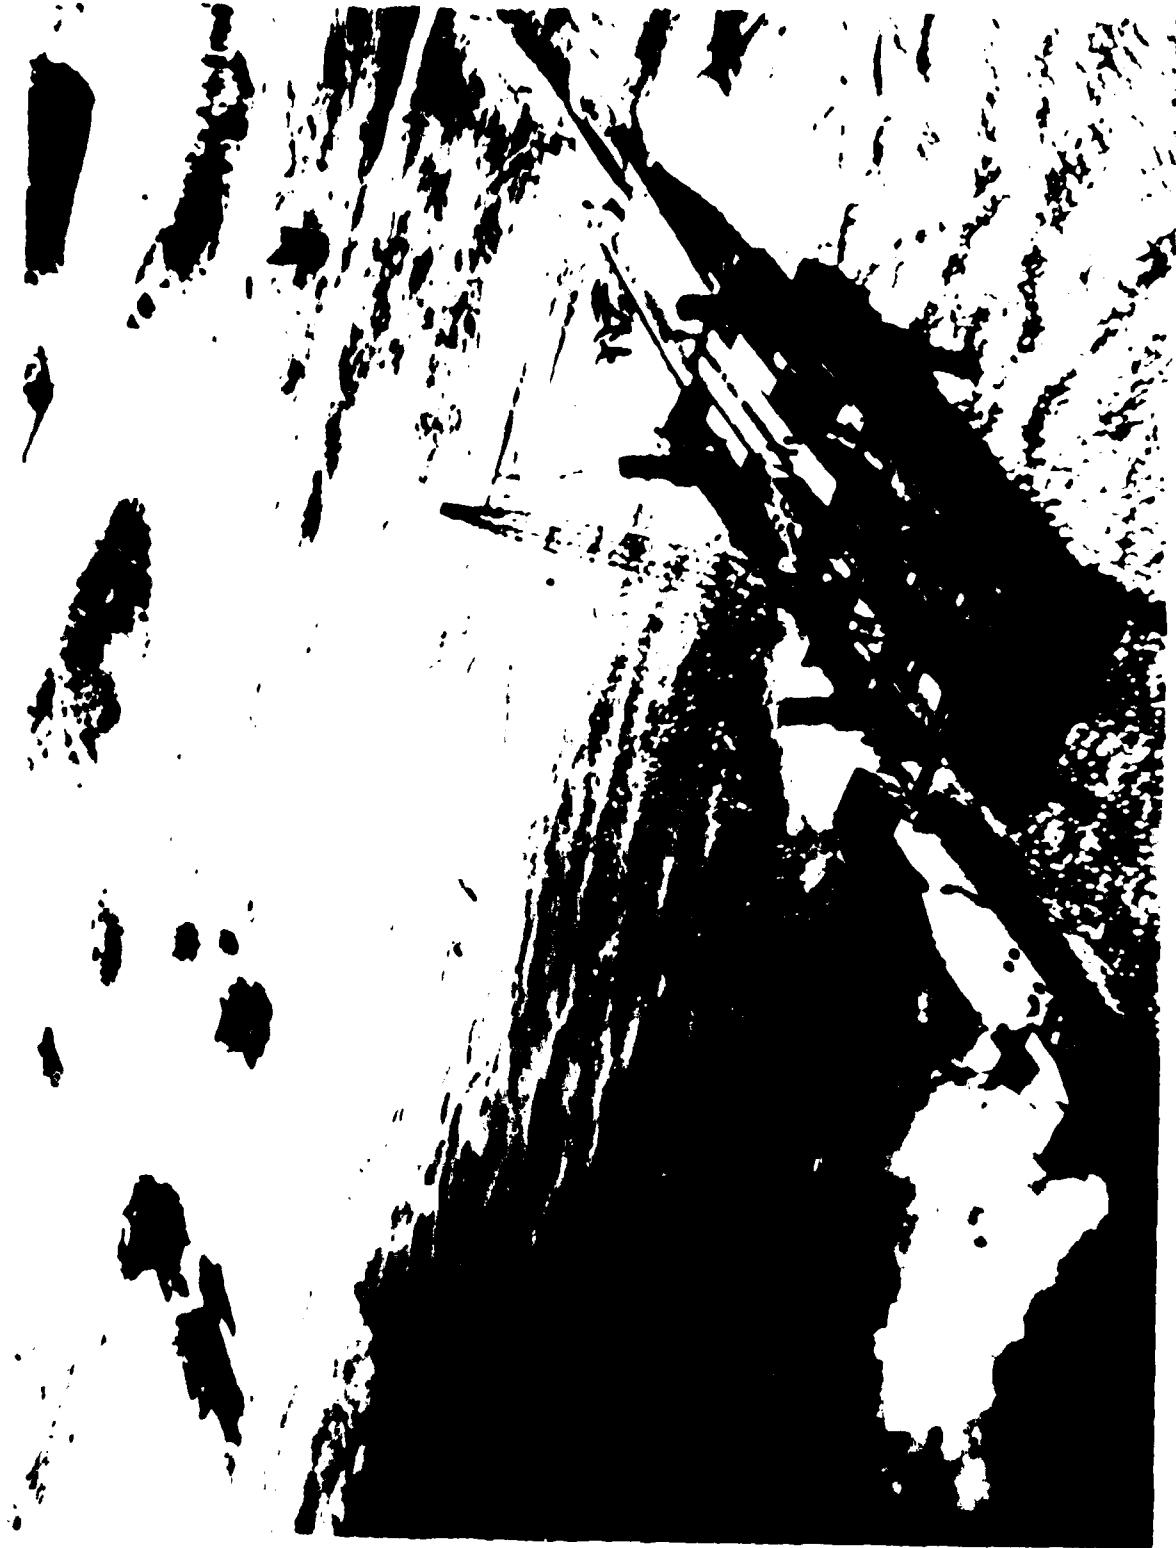
FIGURE D.48. LCU RETRACTS. An LCU is shown above retracting from the DeLong pier after unloading at high tide.

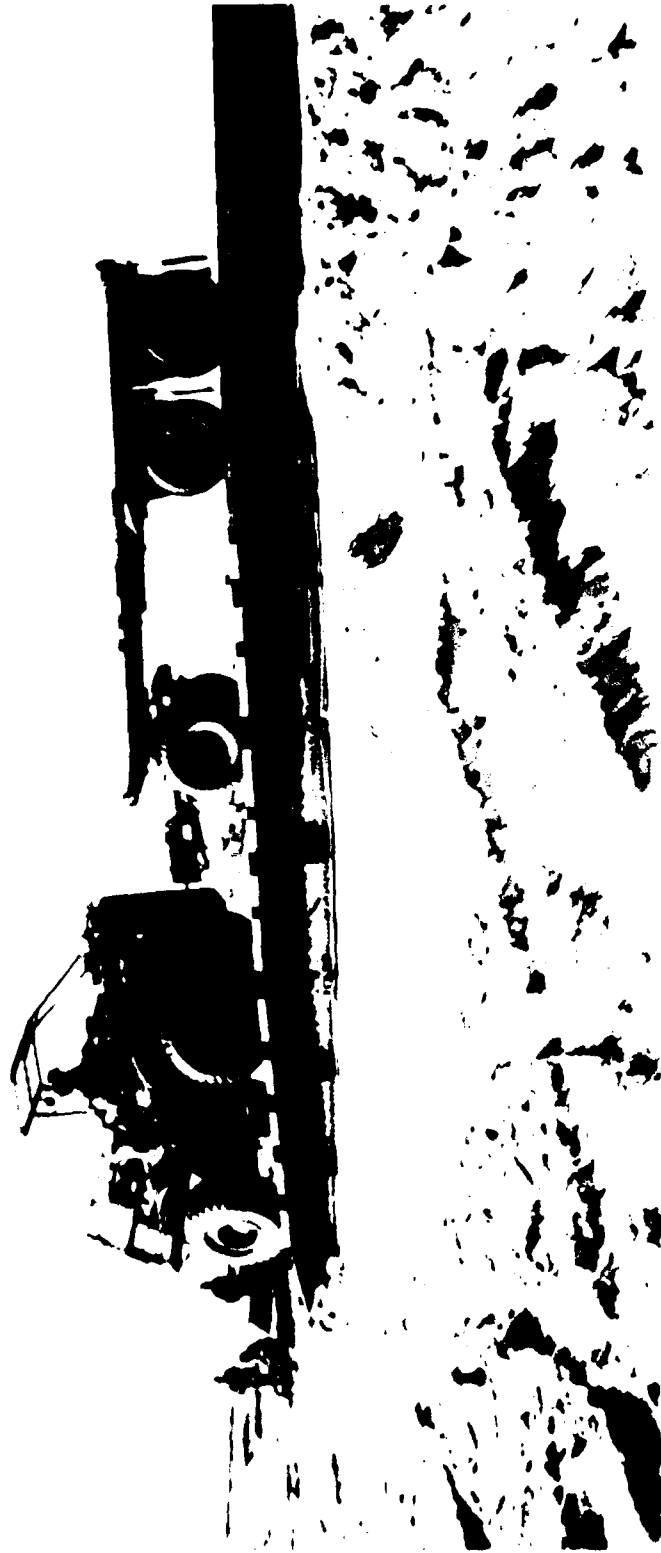
FIGURE 50. FAW 44-BEEM. Truck drivers experienced difficulty backing their trailers up the ramp so a rough terrain forklift, which has articulated steering, was tried. The above 44B ramp connects onto the 44B ramp. The 44B ramp was subsequently replaced by a sand ramp.

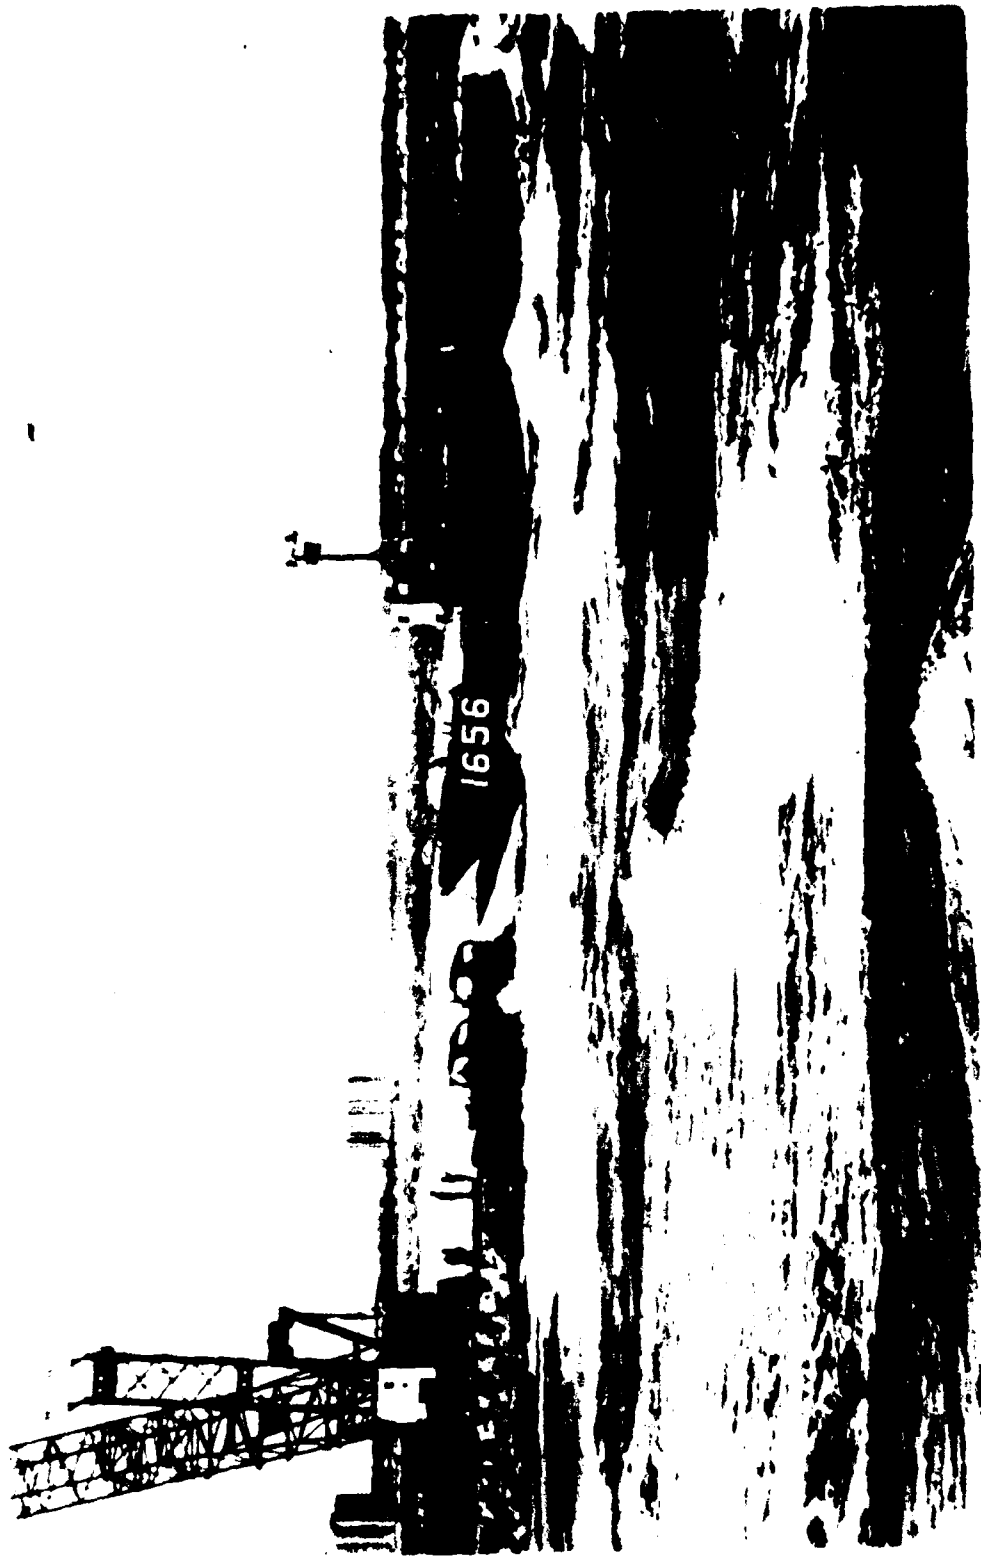
D-65

FIGURE D.65. ROUGH WEATHER EXPERIENCED. Another problem was encountered when the surf and winds increased. The sand ramp upon which the crane had been placed began to erode and had to be repaired at high tide by dozers.
