USAAEFA PROJECT NO. 83-15

PRELIMINARY AIRWORTHINESS EVALUATION OF THE OH - 58C WITH 3 - AXIS STABILITY CONTROL AUGMENTATION SYSTEM AND IMPROVED TAIL ROTOR SYSTEM

OCTOBER 1983

FINAL REPORT

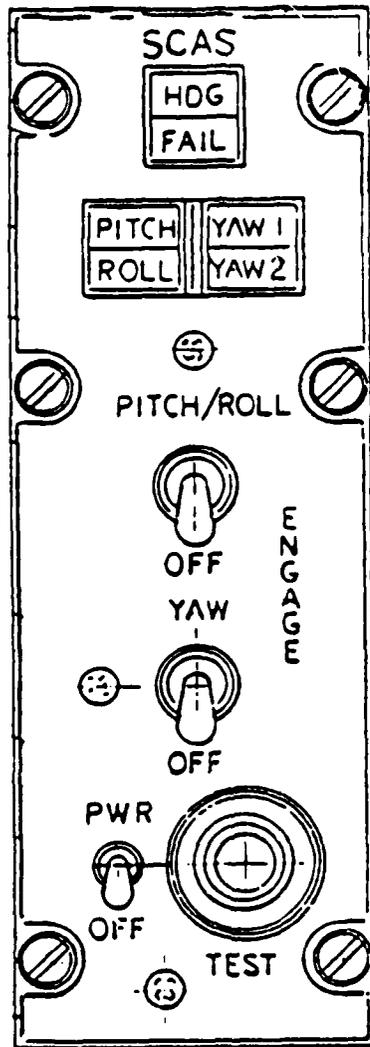
Figure 3. SCAS Control Panel

9. The SCAS control panel is shown in figure 3. The panel includes a power switch, a pushbutton test switch, two magnetically held engage switches, and 6 fail annunciators. The HDG

fail annunciator is not used and will not be visible to the pilot.

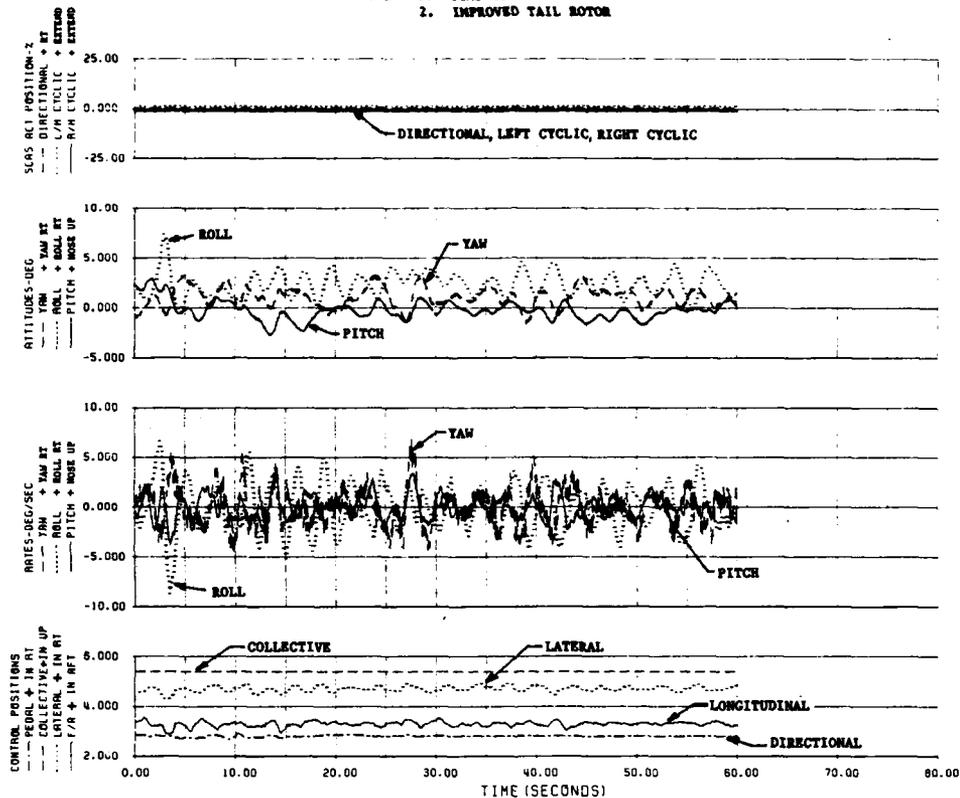
FIGURE 24
 GUST RESPONSE IN LIGHT TURBULENCE
 OH-58C USA S/N 68-16850

AVERAGE GROSS WEIGHT (LB)	AVG CG LOCATION		TRIM DENSITY ALTITUDE (FT)	AVG OAT (°C)	TRIM ROTOR SPEED (RPM)	TRIM CALIBRATED AIRSPEED (KIAS)	TRIM FLIGHT CONDITION
	LONG (FS)	LAT (BL)					
3040	111.8 (AFT)	0.3 (F)	2600	23.0	353	90	LEVEL

NOTES: 1. SCAS ON
 2. DEPROVED TAIL ROTOR

18. The short-term dynamic stability characteristics of the OH-58C aircraft with 3-axis digital SCAS and improved tail rotor were evaluated at the test conditions shown in table 1. Gust response characteristics were simulated in all control axes by single axis 1 inch control pulse inputs which were held for 0.5 seconds and by releases from steady heading sideslips. The short-term dynamic stability characteristics observed in all axes were deadbeat. The aircraft was also flown both SCAS OFF and SCAS ON in light turbulence as shown in figures 23 and 24, respectively. Increased short-term rate damping provided by the SCAS reduced the aircraft gust response and significantly reduced pilot workload to maintain steady flight.

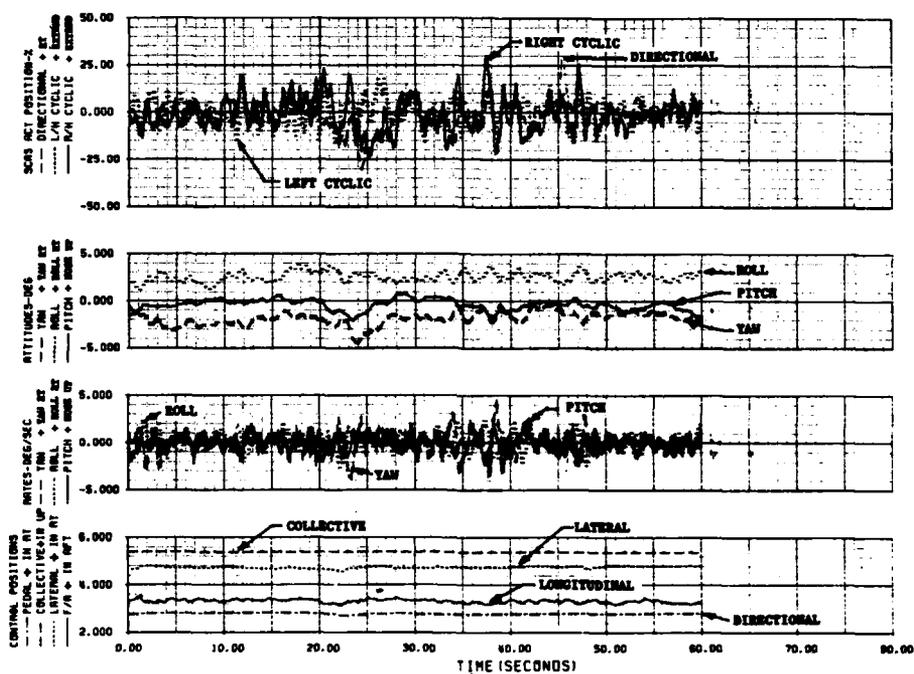
FIGURE 25
 LONGITUDINAL LONG TERM RESPONSE
 OH-58C USA S/N 68-16850

AVERAGE GROSS WEIGHT (LB)	AVG CG LOCATION		TRIM DENSITY ALTITUDE (FT)	AVG OAT (°C)	TRIM ROTOR SPEED (RPM)	TRIM CALIBRATED AIRSPEED (KCAS)	TRIM FLIGHT CONDITION
	LONG (FS)	LAT (BL)					
2920	111.8 (AFT)	0.3 RT	6000	19.0	354	60	335 SHP CLIMB

- NOTES: 1. SCAS OFF
 2. IMPROVED TAIL ROTOR

20. During high power, low airspeed climbs the standard OH-58C exhibits a divergent long period oscillation in the longitudinal axis similar to the SCAS OFF response of the test aircraft shown in figure 25, appendix E. Figure 26 is a time history of the longitudinal long period oscillation observed SCAS ON. The

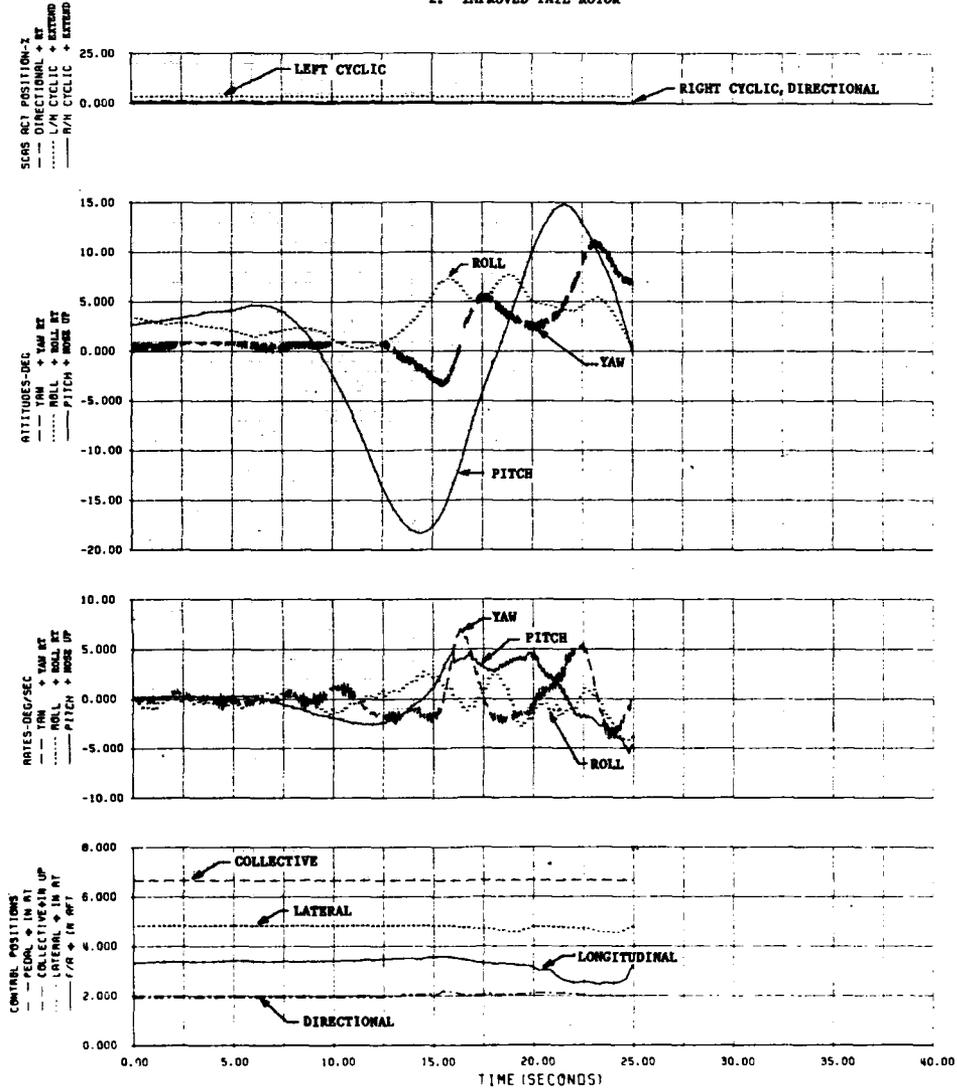
FIGURE 26
 LONGITUDINAL LONG TERM RESPONSE
 CR-52C WEA 8/8 68-16830

AVERAGE GROSS WEIGHT (LB)	AVG CG LOCATION LONG (IN) LAT (IN)	TRIM IDENTITY ALTITUDE (FT)	AVG QAT (°C)	TRIM SPEED (MPH)	TRIM CALIBRATION AIRSPEED (KIAS)	TRIM FLIGHT CONDITION
2920	111.8 (AFT) 0.3 BT	4500	20.5	174	60	335 MPH CLIMB

NOTES: 1. SCAS ON
 2. DEFUSED TAIL ROTOR

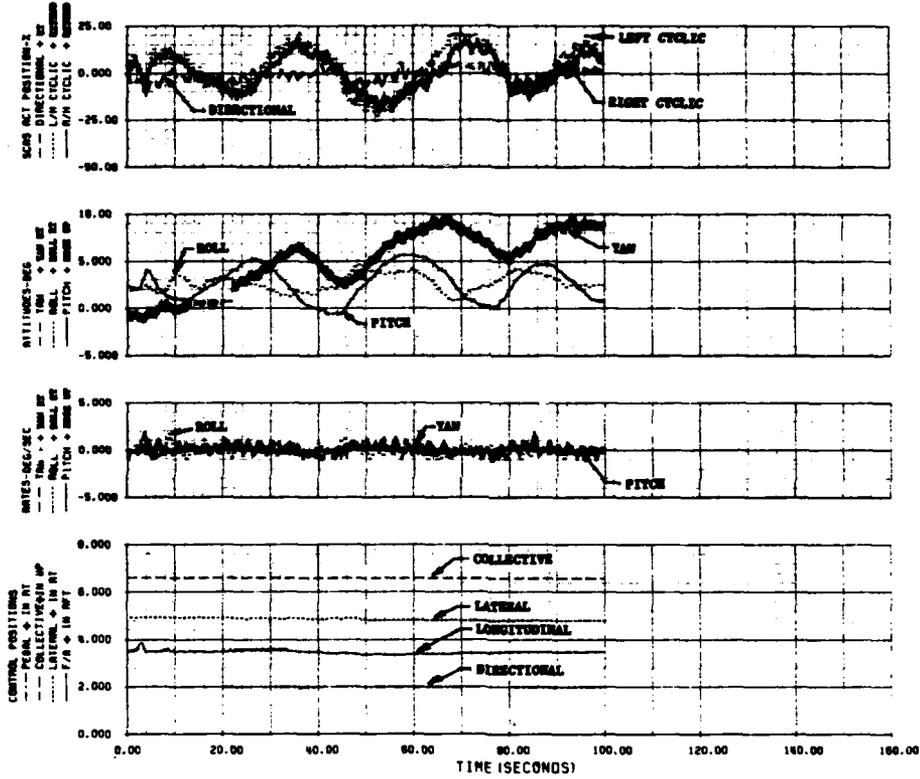
**FIGURE 27
LONGITUDINAL CONTROLLABILITY
OH-58C USA S/N 68-16850**

AVG DENSITY (LBS/FT³) 0.0028	AVG CG LOCATION LONG (FT) 111.8 (AFT)	LAT (DEG) 0.4 RT	AVG DENSITY ALTITUDE (FT) 1658	AVG OAT (DEG C) 21.8	AVG ROTOR SPEED (RPM) 354	TRIM CALIBRATED AIRSPEED (KCAS) 0	TRIM FLIGHT CONDITION HOVER
---	---	--------------------------------	--	--	---	---	---

NOTES: 1. SCAS ON
2. IMPROVED TAIL ROTOR

22. The longitudinal controllability characteristics were evaluated at a hover and at 90 KCAS (figs. 27 and 28, app E). The longitudinal controllability characteristics SCAS ON were qualitatively similar to the standard aircraft (no SCAS) except that no dig in (continuously increasing normal load factor with constant longitudinal control position) tendency was observed. A dig-in characteristic was documented on the standard OH-58C (ref 13, app A). Longitudinal control power and response were approximately the same as the no SCAS aircraft. The sensitivity of the longitudinal control was approximately double that of the standard OH-58C but was not objectionable. The longitudinal controllability characteristics of the OH-58C equipped with the 3-axis SCAS and improved tail rotor are significantly improved and are satisfactory.

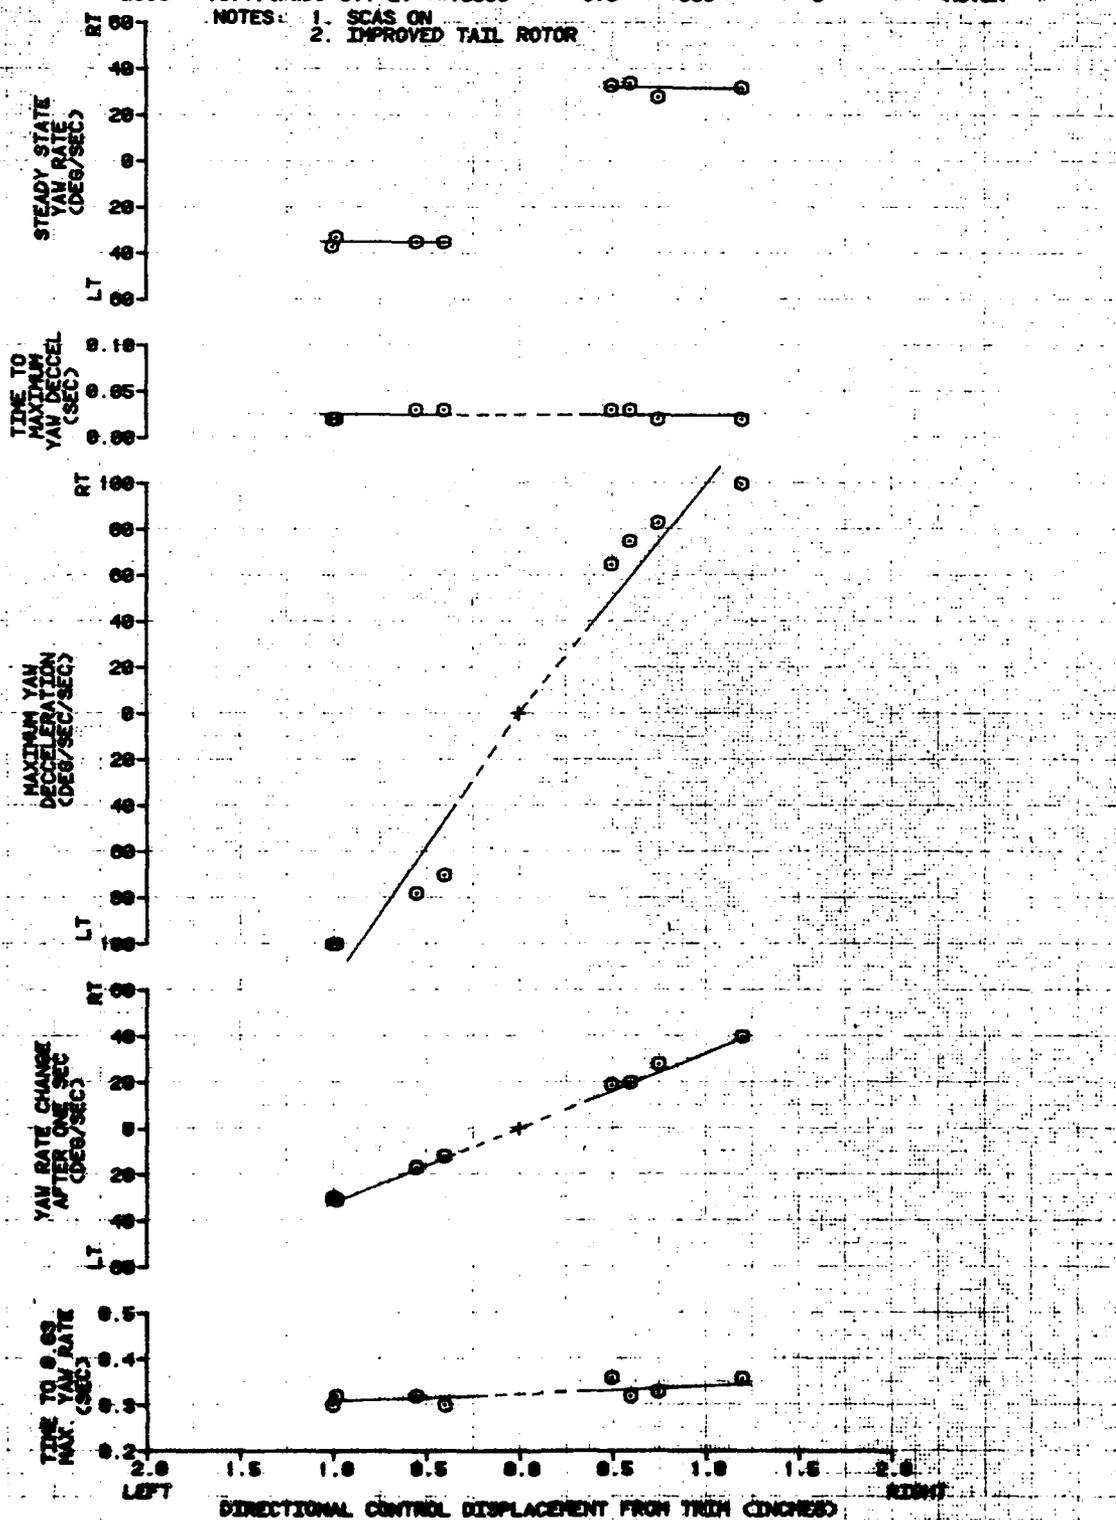
FIGURE 38
 DIRECTIONAL CONTROLLABILITY
 FROM A STEADY YAW RATE
 ON-500 USA S/N 68-10060

NOTES: 1. SCAS ON
 2. IMPROVED TAIL ROTOR

25. Directional controllability was also evaluated in terms of recovery from steady yaw rates (figs. 35 through 38, app E). These maneuvers were documented only for the improved tail rotor with the final yaw SCAS gains. The aircraft was stabilized in a steady yaw in one direction, then incrementally greater opposite step directional control inputs were introduced with the aid of a control fixture. Moderate (approximately 30 degrees per second) and high (approximately 45 degrees per second) yaw rates were used for trim conditions. In all cases the aircraft yaw rate changed in the proper direction with no hesitation. The directional controllability characteristics in steady yaw rates of the OH-58C equipped with a 3-axis SCAS and improved tail rotor are satisfactory.
