FOLLOW-ON PRODUCTION TEST

CARTRIDGE, 105-MM, HEAT-T-MP, M456A2

(CORROSION INVESTIGATION),

U. S. ARMY COMBAT SYSTEMS TEST ACTIVITY
ABERDEEN PROVING GROUND, MD 21005-5059

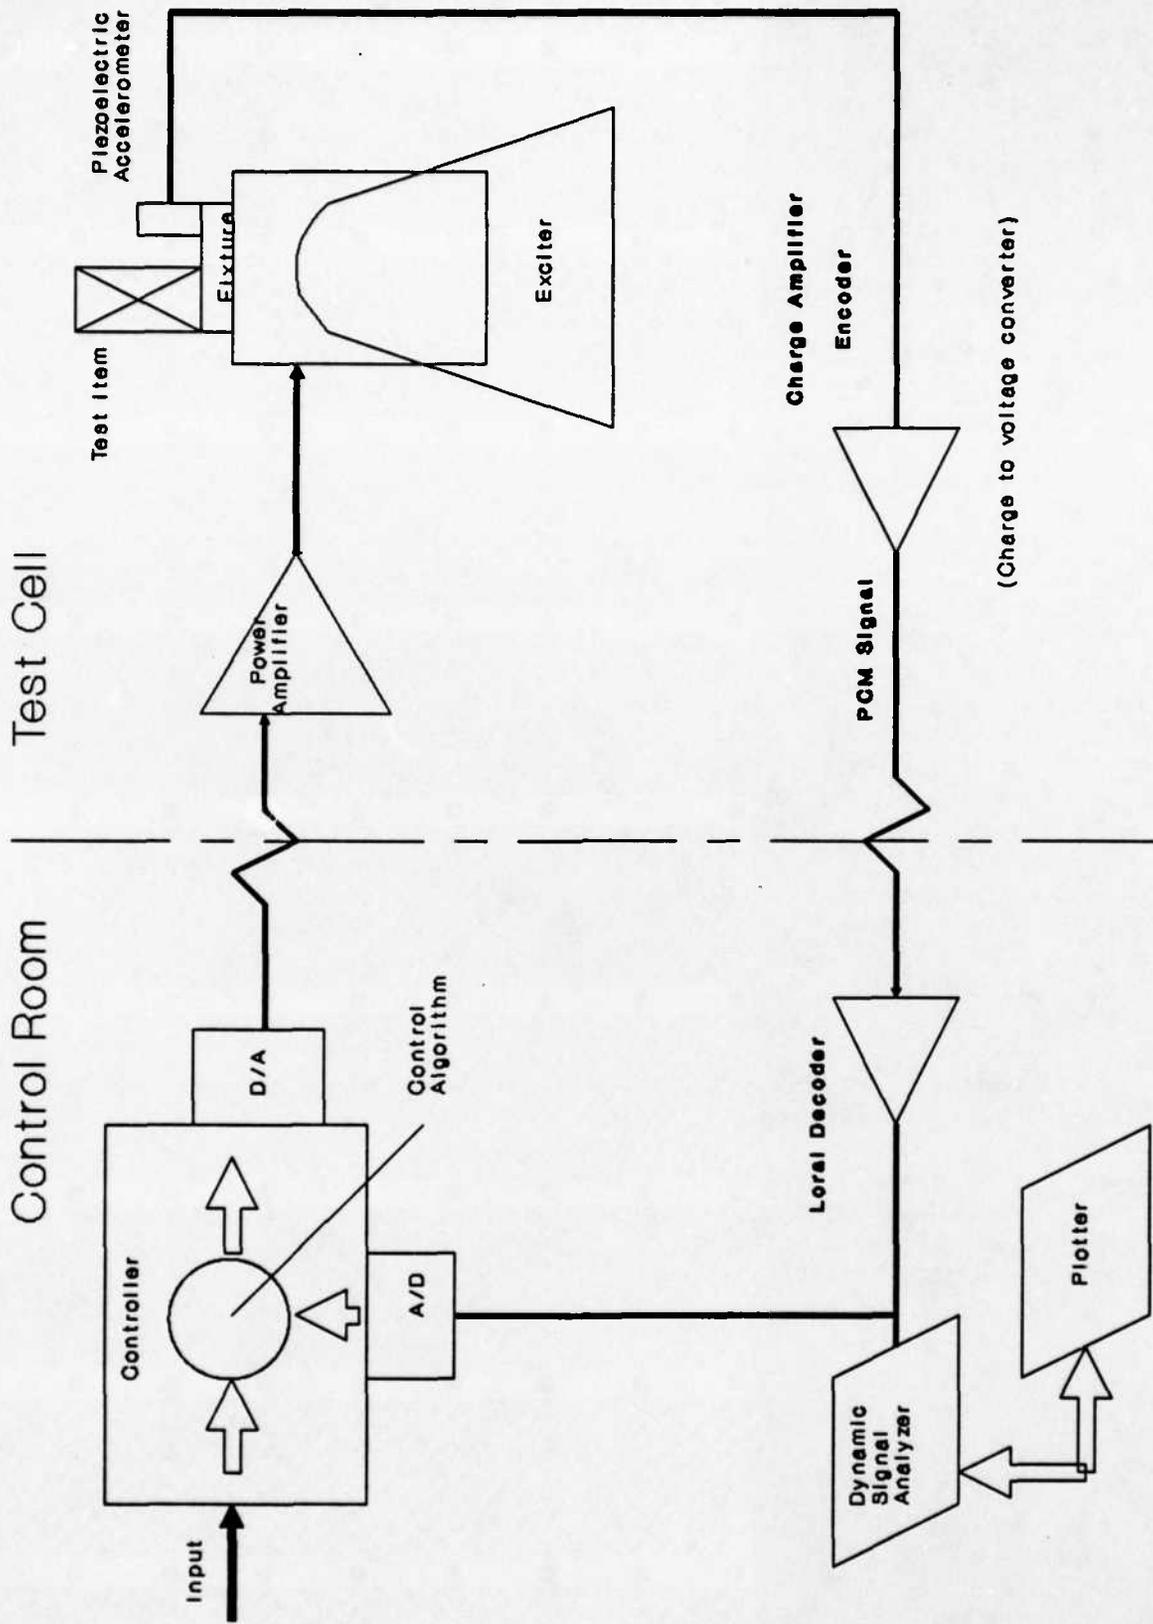
Figure A-4. Simplified block diagram of vibration control system.

The control of the vibration exciter, based on the acceleration measurement, was continuously maintained within ± 3 dB of the specified requirements by the digital vibration controller. If an error was to occur, or the computer controller could not maintain control within the limits of the specified spectrum acceleration levels, the computer would halt the test until the problem was corrected. Figure A-5 contains a simplified block diagram of the vibration control system.

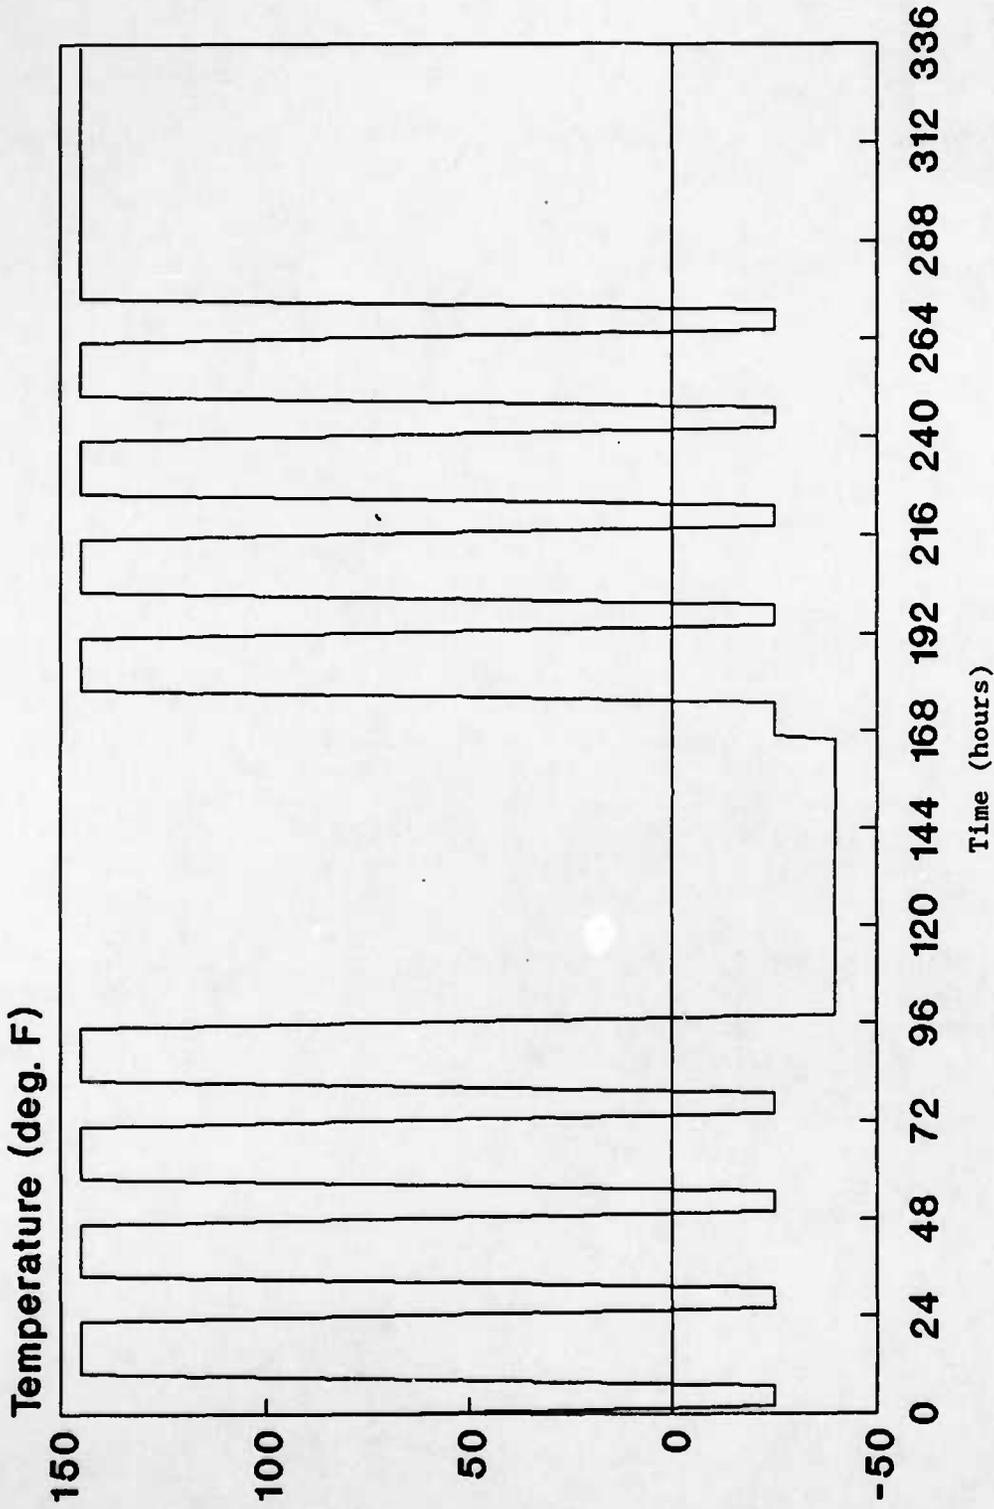
Figure A-20. Temperature/humidity cycle.

1. Above 21 °C (70 °F) the humidity was gradually increased from 75 to 95 percent.
2. Humidity was maintained at 95% when temperatures were 63 °C (145 °F).
3. Time tolerances were 15 minutes for all periods of temperature change.
4. Below 21 °C (70 °F) the humidity was turned off (humidity within chamber was uncontrolled below 21 °C).

The relative humidity was controlled (fig. A-20) during those portions of the cycle that were above 21 °C (70 °F). The relative humidity and temperature were programmed to gradually increase from 75 to 95 percent and 21 to 63 °C, respectively. The relative humidity was maintained at 95 ± 5 percent when the internal chamber temperature was 63 °C. When the internal chamber temperature decreased from 63 to 21 °C, the relative humidity also gradually decreased from 95 to 75 percent. At this point, the chamber humidification system was turned off and the humidity within the chamber was uncontrolled while the chamber temperature was below 21 °C.

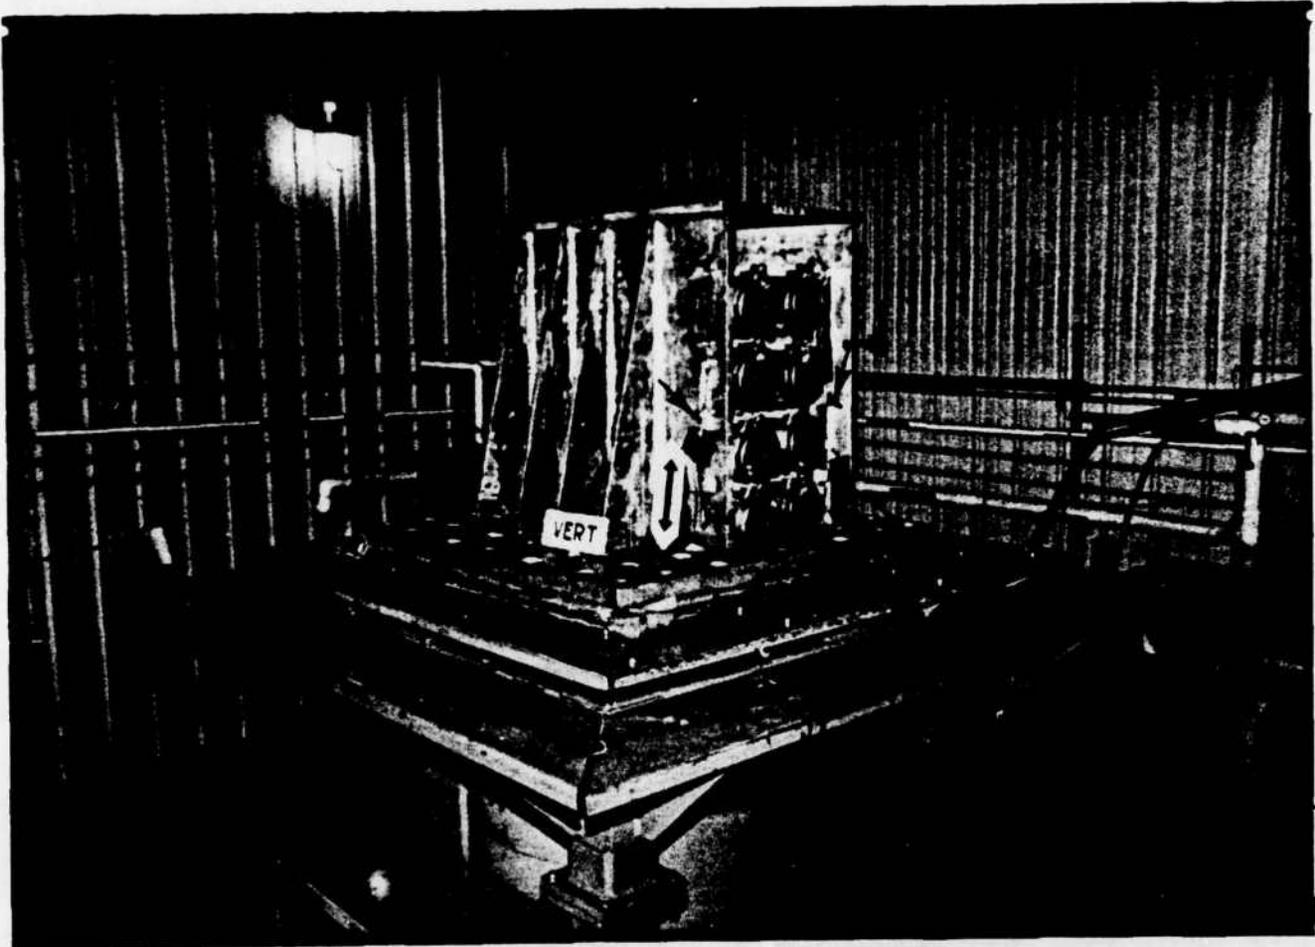
Figure B-1. General view of the vertical installed-equipment (rack) test setup. Arrow indicates visible control accelerometer location.

b. Test Setup. The unpackaged cartridges were placed in the 8-tube hull rack for the M1 tank and subjected to the rack vibration simulation in each of their three orthogonal axes (vertical, transverse, and longitudinal). The bare cartridges were placed horizontally in an M1 hull rack that had been removed from the hull of a tank and mounted into an aluminum fixture in the same manner and orientation as it is mounted in the vehicle. The test cartridges were placed in the lowest tube location within the rack. The number of test cartridges for each load varied according to the flow chart in Figure 1-1. Testing was conducted on top of the vibration table for the vertical axis and on the slip-table for the transverse and longitudinal axes. For vibration in the vertical direction (fig. B-1), the longitudinal axis of the cartridges was perpendicular to the axis of applied force. For the longitudinal vibration, (fig. B-2), the longitudinal axis of the cartridges was parallel to the axis of applied force. For the transverse axis (fig. B-3), the longitudinal axis of the cartridges was again perpendicular to the axis of the applied force.

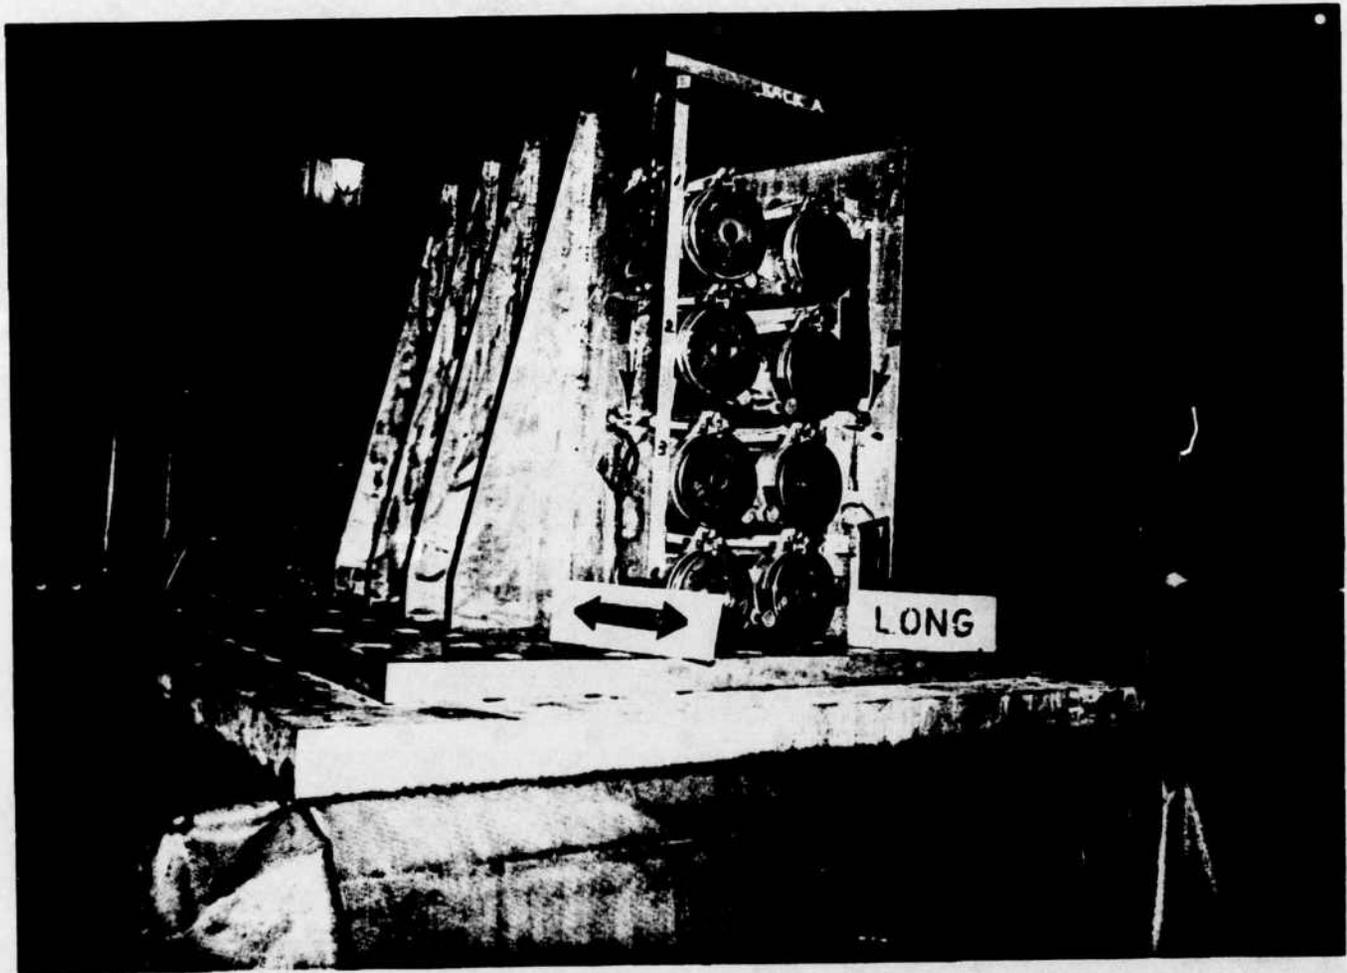
Figure B-2. General view of the longitudinal installed-equipment (rack) test setup. Arrows indicates visible control accelerometer location.

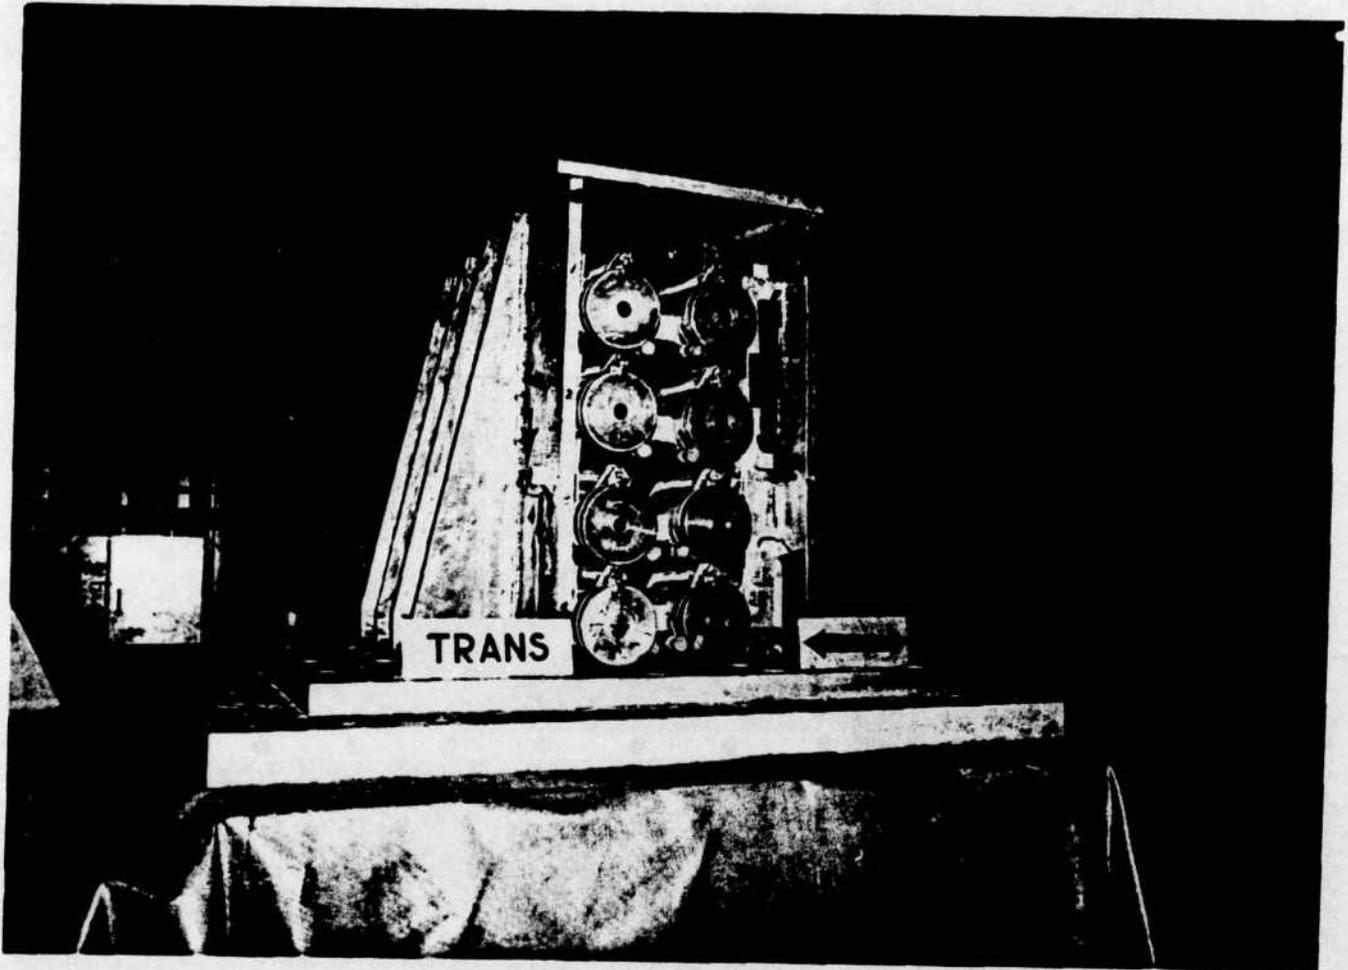
Figure B-3. General view of the transverse installed-equipment (rack) test setup. Arrows indicates visible control accelerometer location.

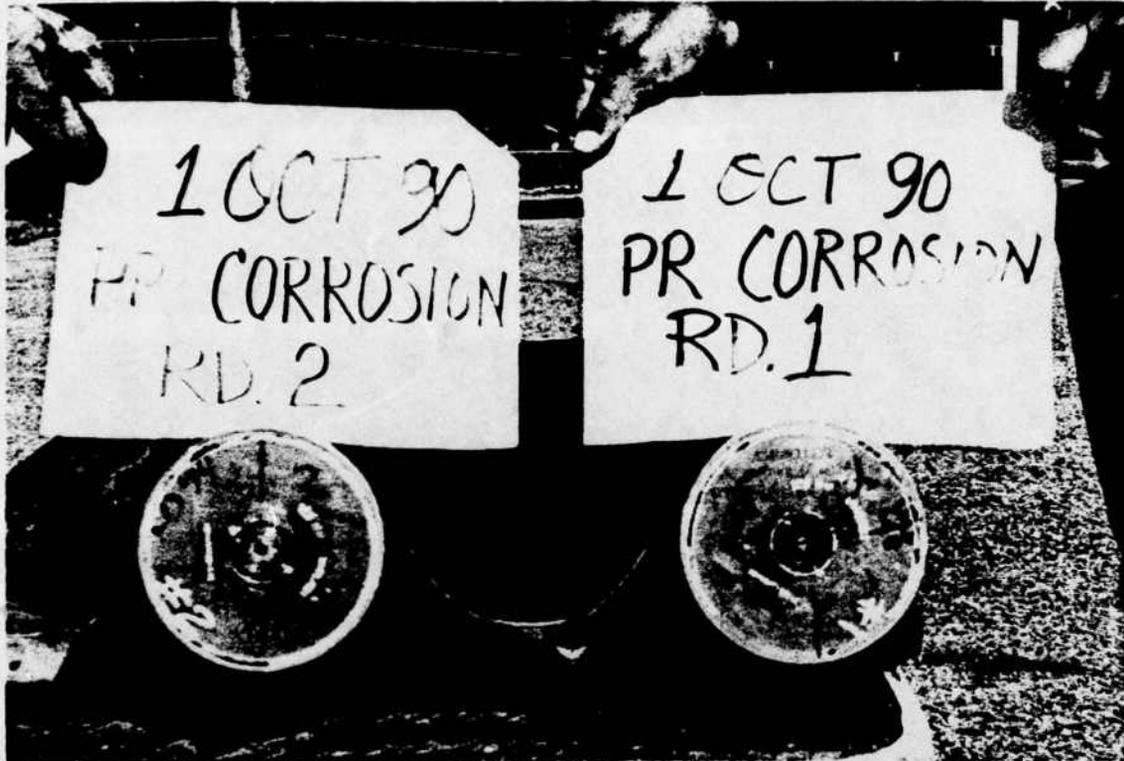
Figure B-4. M456A2 test cartridge No. 1 and 2 after environmental tests with no corrosion buildup.

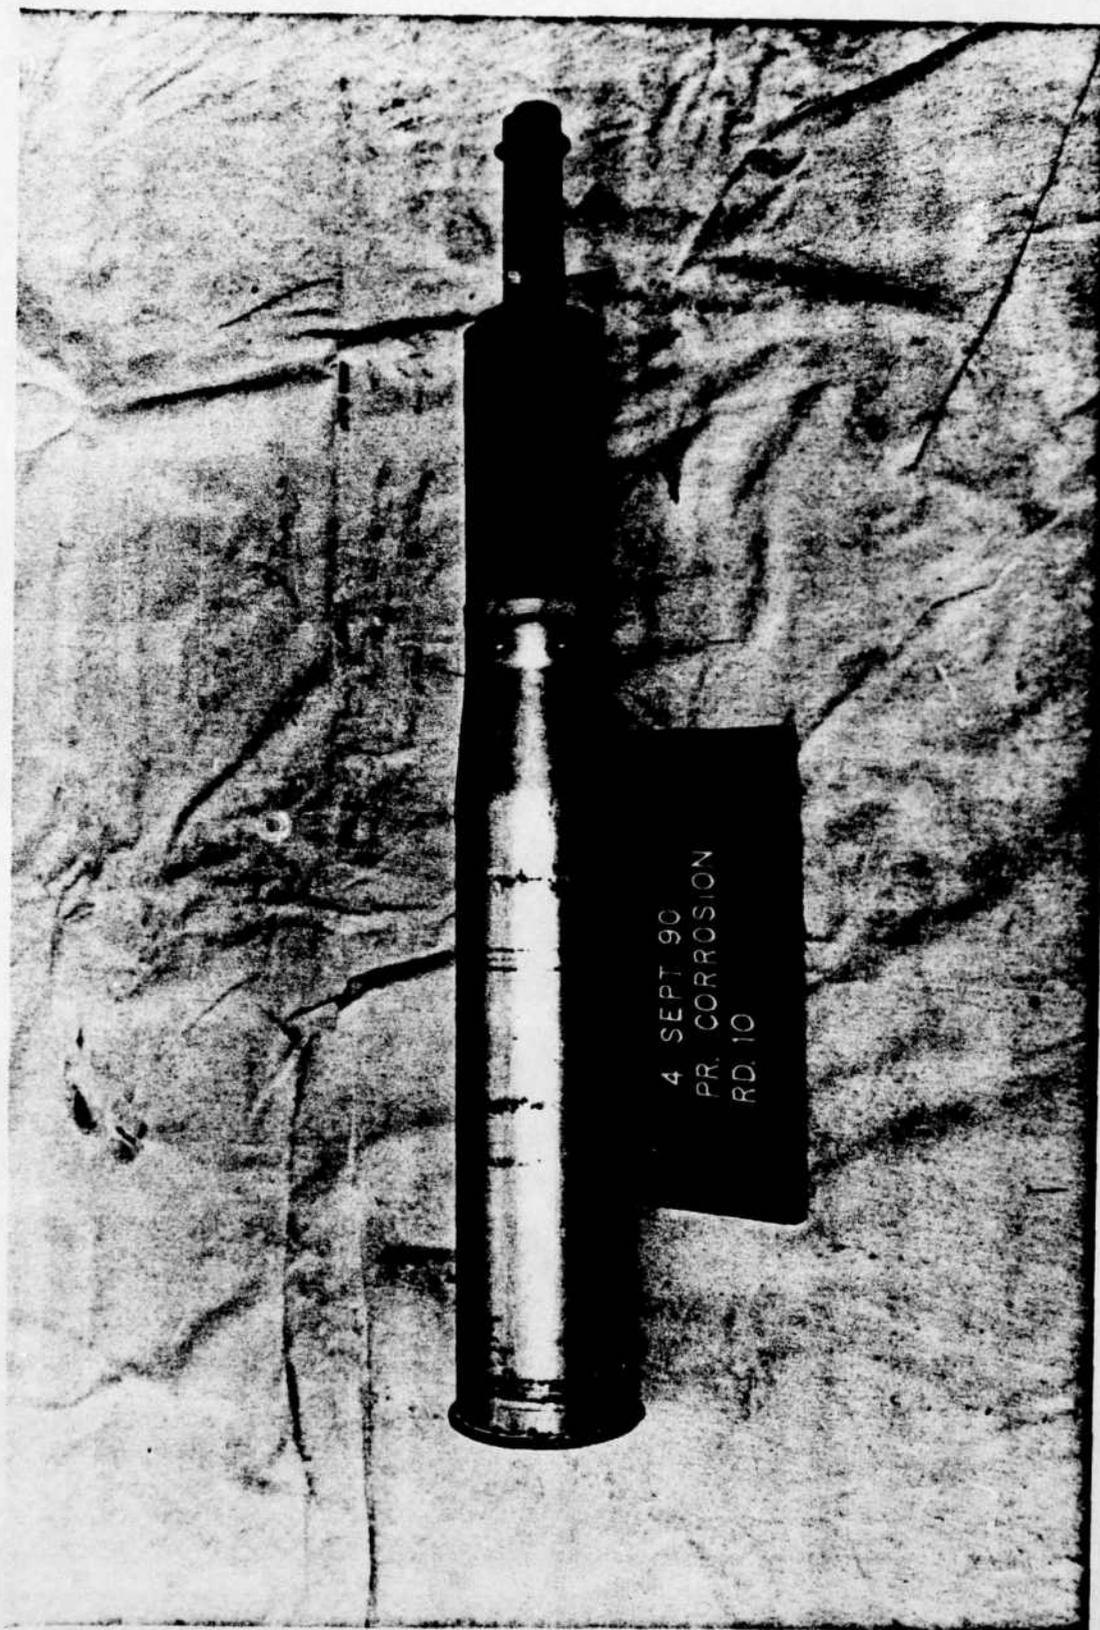
At the completion of the first 24-hour drying period, moderate oxidation and salt deposits were found on the exterior surfaces of the cartridges. The oxidation and salt deposits on the exterior surfaces of the cartridges were more extensive following the second 24-hour drying period.

Figure B-6. M456A2 test cartridge No. 10 after all environmental tests were completed and showing corrosion buildup.

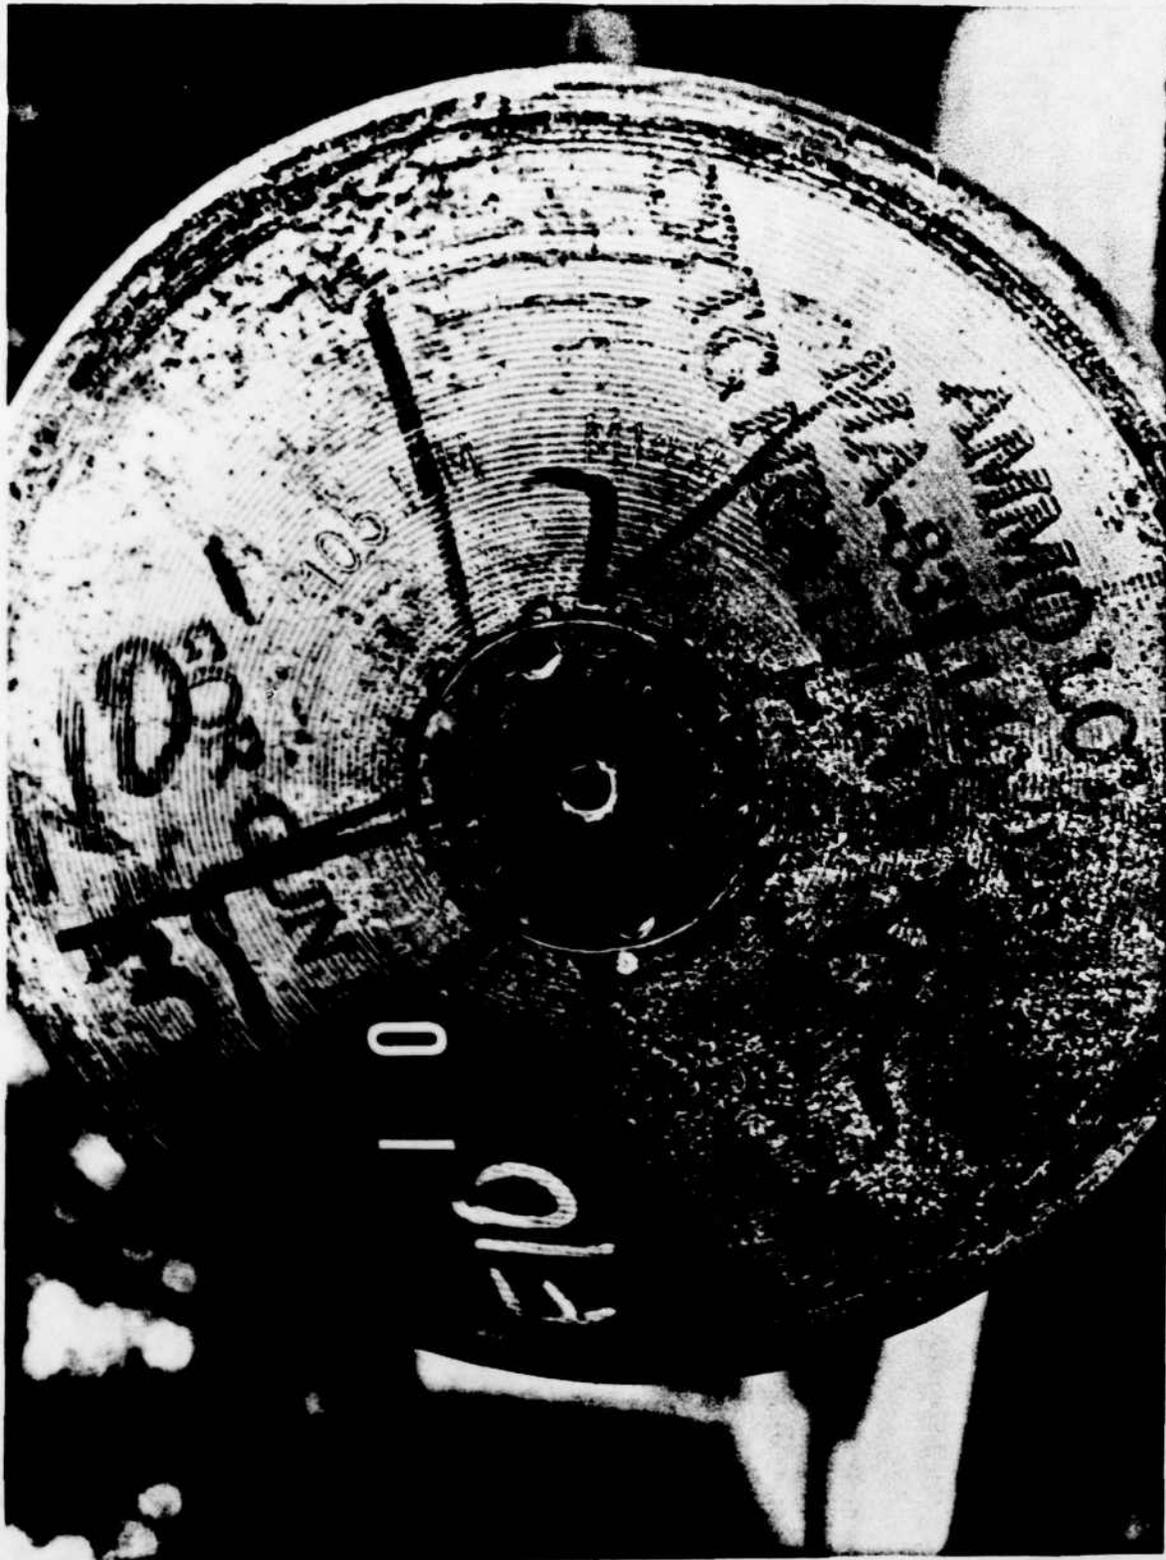
NOTE: CARTRIDGE NUMBERS 5 AND 6 HAD MOST CORROSION BUILD UP AROUND THE PRIMER.

Figure B-7. Test cartridge No. 10 from the primer end of the case showing corrosion buildup around the primer.

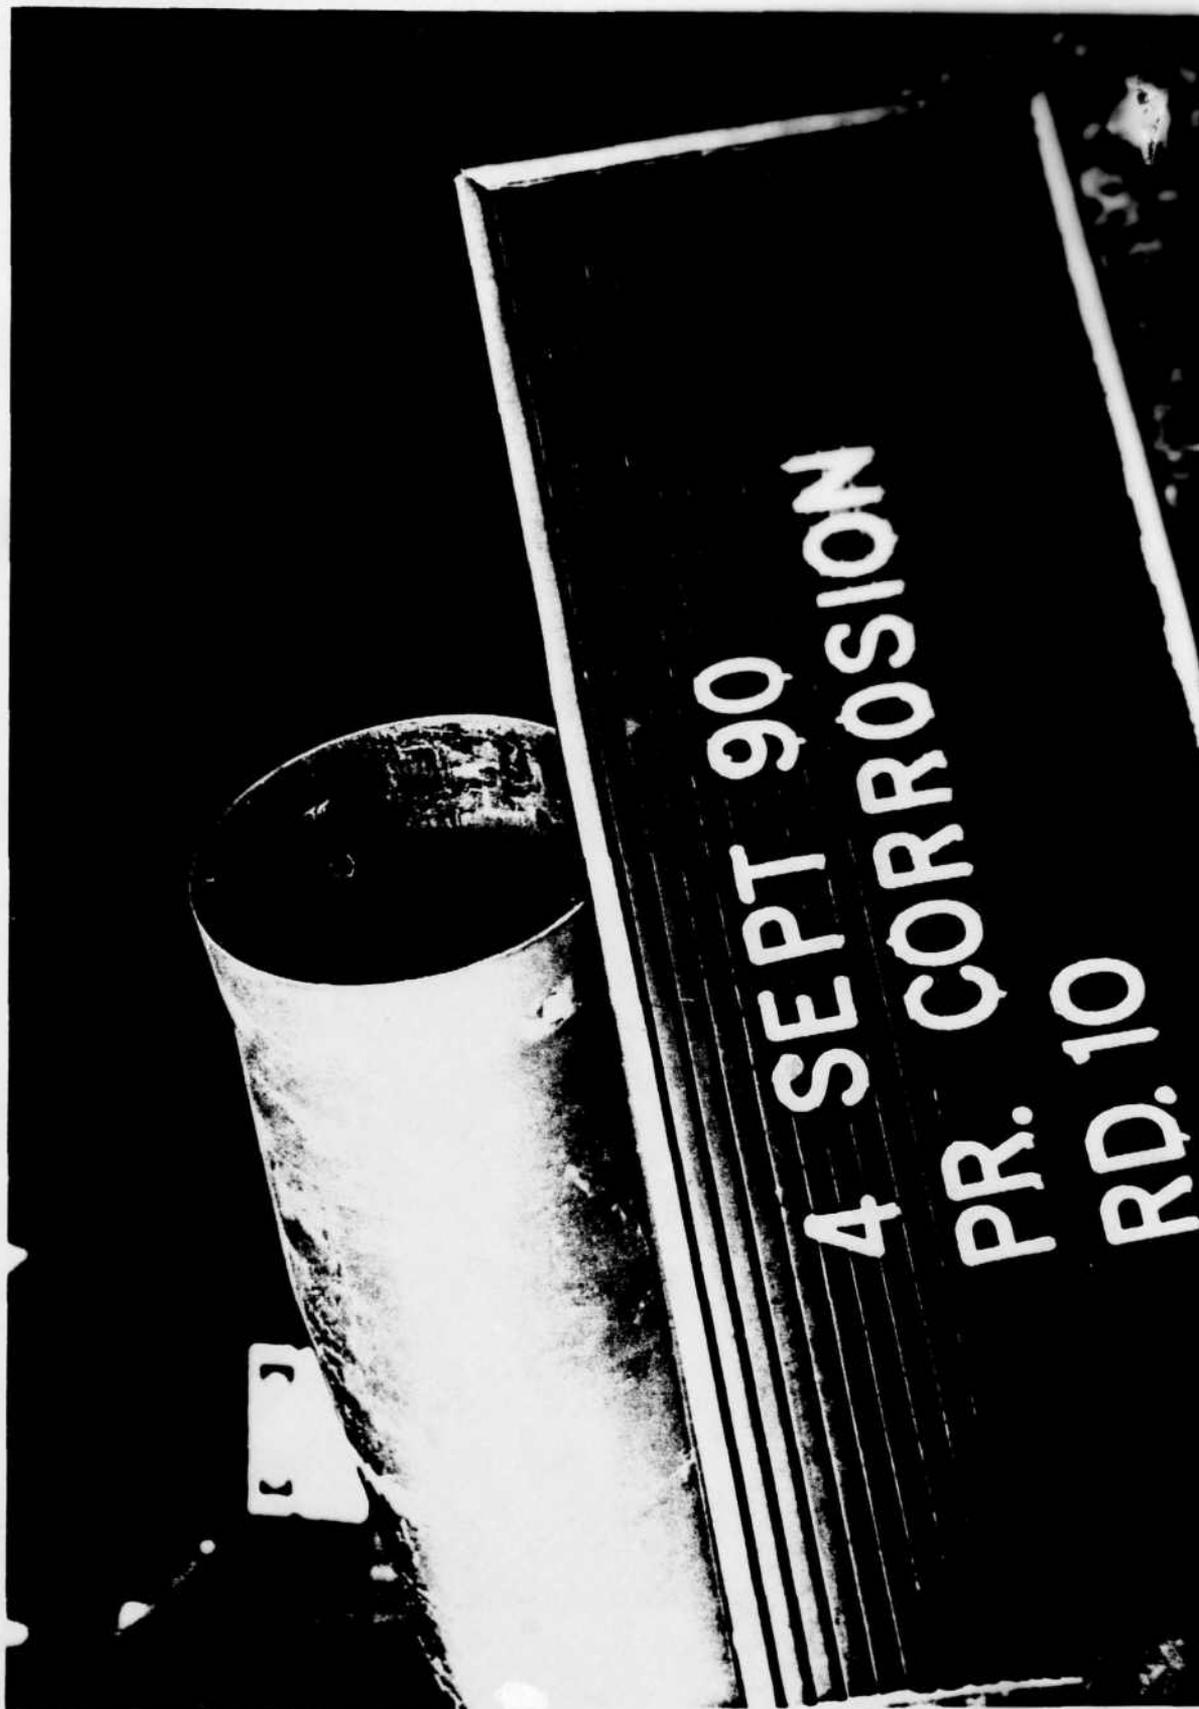
Figure B-8. Test cartridge No. 10 showing corrosion on the internal lip of the case after disassembly.
