NASA
Technical
Paper
2441

Effect of Low-Velocity or Ballistic Impact Damage on the Strength of Thin Composite and Aluminum Shear Panels

Gary L. Farley

*Structures Laboratory
USAAVSCOM Research and Technology Laboratories
Langley Research Center
Hampton, Virginia*

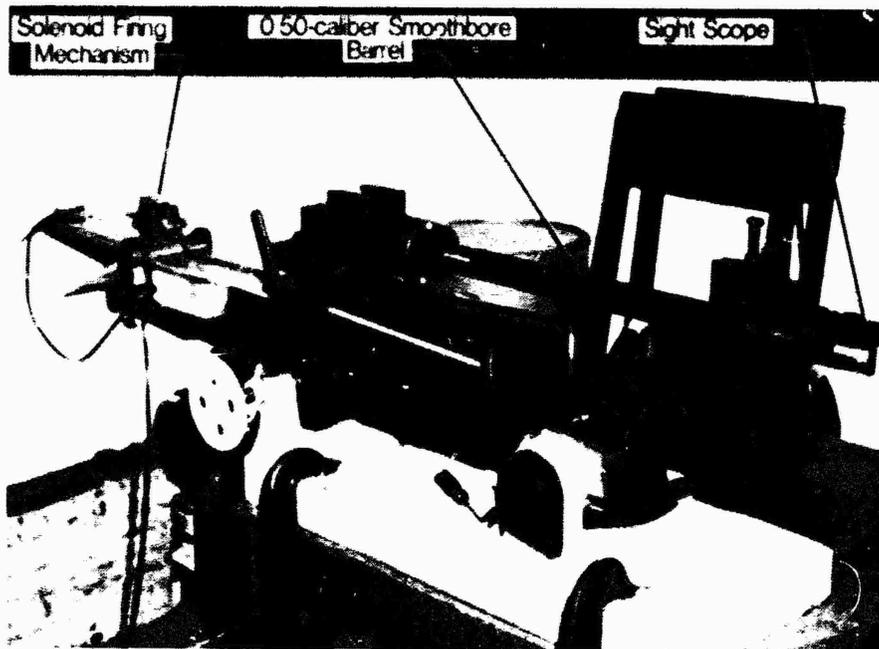
L-85-33

Figure 6. Photo of 0.50-caliber, 76.2-cm (30.0-in.) smoothbore barrel mounted on test stand.

The ballistic impact test apparatus is depicted in figures 6-9. A 0.50-caliber smoothbore test weapon, figure 6, was located approximately 6.5 m (21.3 ft) from the test panel, figures 7-9. Tumbling of the projectile was produced by chamfering the end of the barrel. Chamfering the end of the barrel causes a pressure imbalance on the projectile. Based upon previous tests with this apparatus, a 6.5 m (21.3 ft) distance between the weapon and test panel would produce a $\frac{1}{4}$ turn, 90° impact of the projectile. Precise control of tumbling was not achievable once the barrel of the weapon increased in temperature as a result of repeated firing. Projectile speed was determined by recording the time required for the projectile to pass through the two velocity screens, as shown in figure 8. The projectile triggered an electric photocell on each velocity screen. The screens were located 1.5 m (5.0 ft) apart.

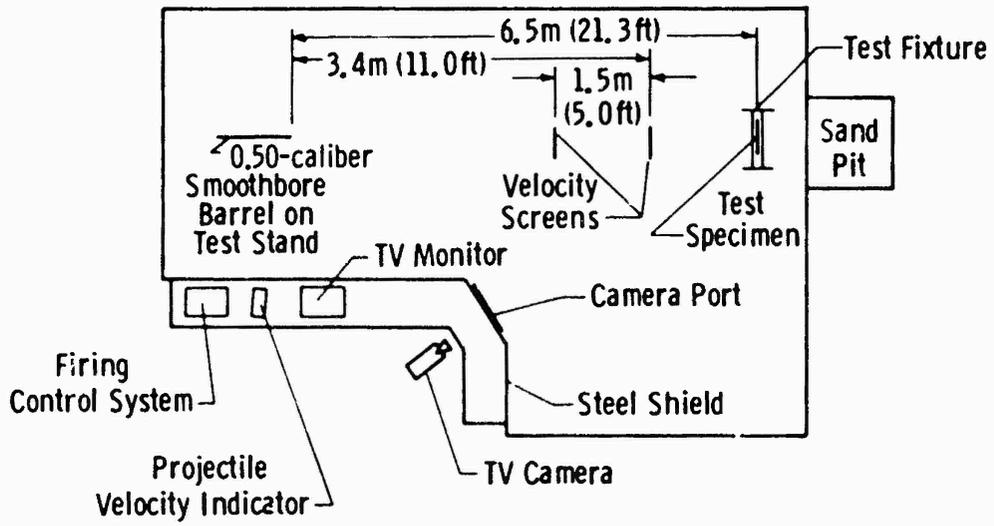
Figure 7. Ballistic impact test firing range with test specimen.

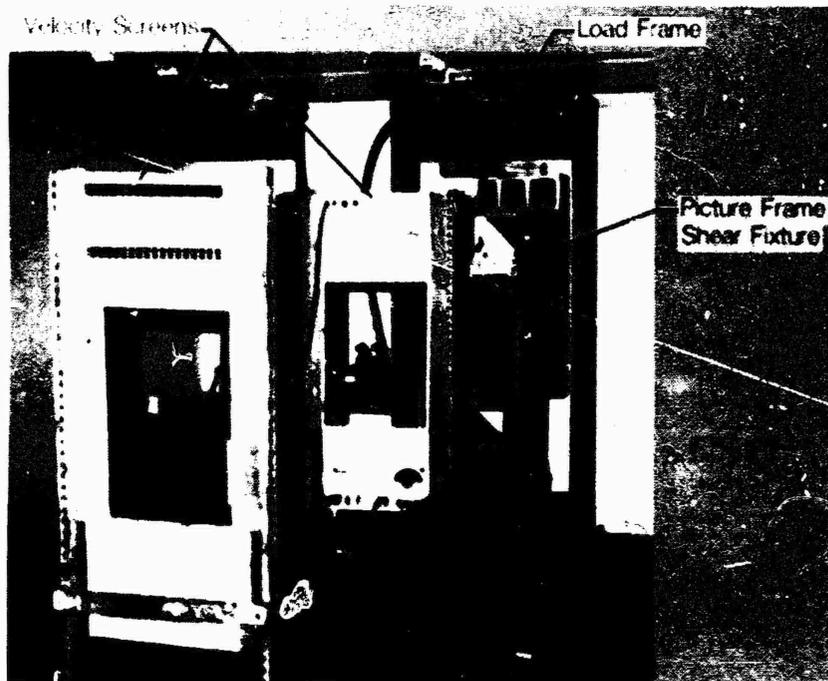
L-85-34

Figure 8. Ballistic impact test apparatus with velocity screens.

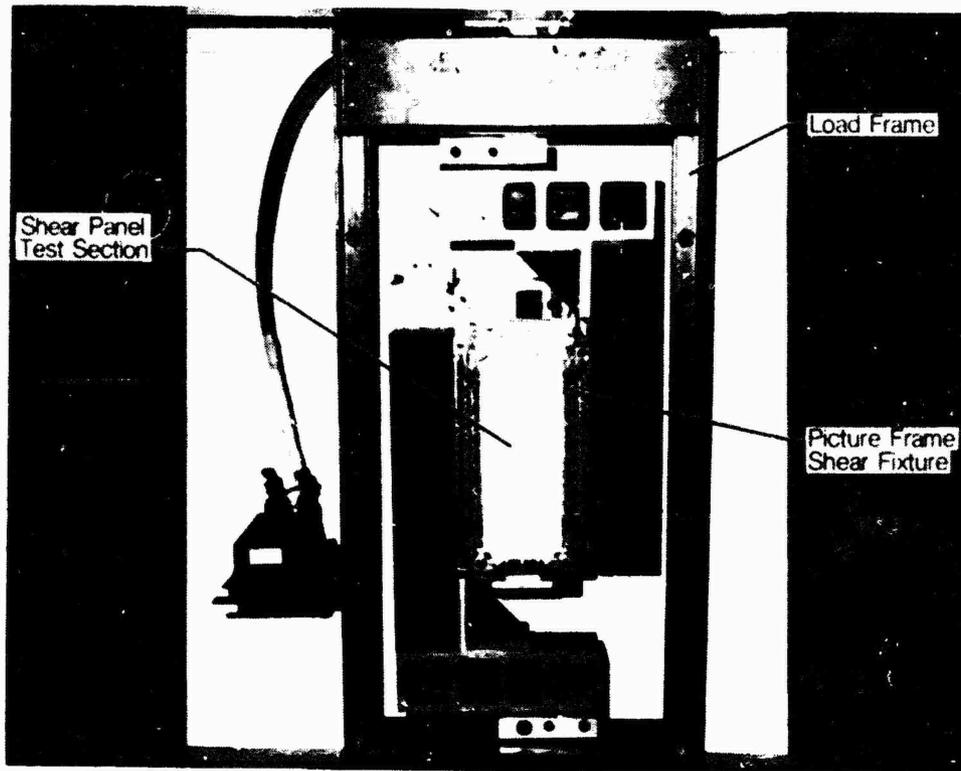
L-85-35

Figure 9. Shear fixture in ballistic impact load frame.

Shear panel test specimens were assembled in the shear test fixture and portable load frame, figure 9. This assembly was positioned in front of a sand-filled pit to trap the spent 0.50-caliber projectile. Load was applied to the specimen through a hydraulically actuated displacement control load train. An impact speed of 671 m/sec (2200 ft/sec) was selected for all tests. The speed was chosen on the basis of the visual damage from 14 preliminary panel tests. In these preliminary tests, impact speeds were varied between 457 m/sec (1500 ft/sec) and 884 m/sec (2900 ft/sec). A speed of 671 m/sec (2200 ft/sec) is the expected projectile speed after traveling 366 m (1200 ft) from a weapon with a barrel 76 cm (30 in.) in length. The 366-m (1200-ft) distance is within the normal accuracy range of a 0.50-caliber weapon. The point of aim for impact was the center of the panel. Because the projectile was tumbled, precise control of the impact point was not obtainable. The actual impact point was within 5.0 cm (2.0 in.) of the aim point.

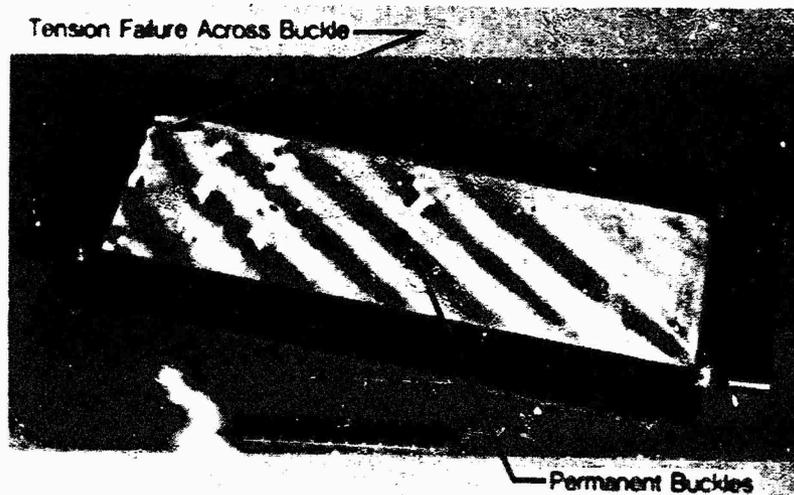
L-85-36

Figure 10. Failed aluminum diagonal tension field shear panel.

Classical diagonal tension fields (refs. 10 and 11) were exhibited by the thin composite and aluminum panels tested, figure 10, in this study. Once the diagonal tension field is established in the panel, the panel strength is a function of the material strength parallel to the tension field (buckles). Forces normal to the buckles are small relative to the forces parallel to the tension field. Typical failure modes of thin shear panels were tension failures perpendicular to the buckle direction.

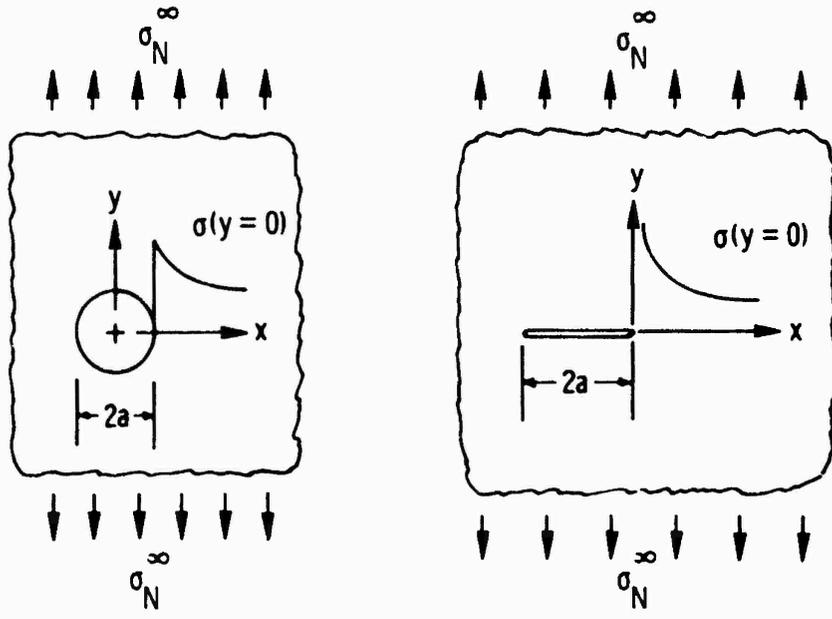
(a) Hole in an infinite plate. (b) Crack in an infinite plate.

Figure 11. Stress distribution about a hole and a crack in infinite plates.

The point stress failure criterion (ref. 9) for an infinite orthotropic plate with a hole of radius a , as depicted in figure 11, is given by

and $\xi = a/(a + D_0)$. The applied far-field stress and the stress at $x = a + D_0$, $y = 0$ are σ_N^∞ and σ_0 , respectively. The longitudinal and transverse extensional moduli, shear modulus, and Poisson's ratio are E_x , E_y , G_{xy} , ν_{xy} , respectively. Similarly, the point stress criterion for an infinite orthotropic plate with a crack of half length a (see fig. 11) is given

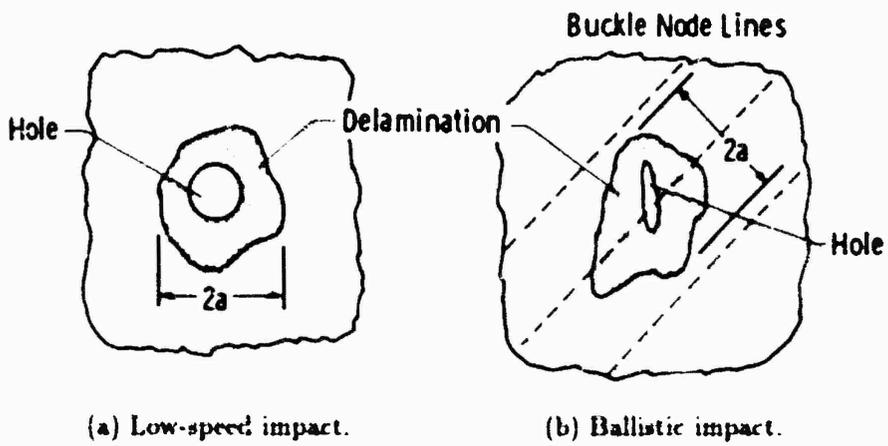
(a) Low-speed impact. (b) Ballistic impact.

Figure 12. Hole diameter and crack length ($2a$) in impacted panels.

Predicted values from equations (1) and (2) were compared with the low-velocity and ballistic impact tests of the composite panels, respectively. For the nonpenetrating impacts, the hole radius was taken as half the distance across the visually detected damaged region. Hole radius, a , for the penetrating low-velocity impacts includes the penetration and any delamination damage around the penetration. (See fig. 12.) The crack length, $2a$, for the ballistic impact tests was taken as the length of the damaged region perpendicular to the diagonal tension field (buckles). (See fig. 12.)

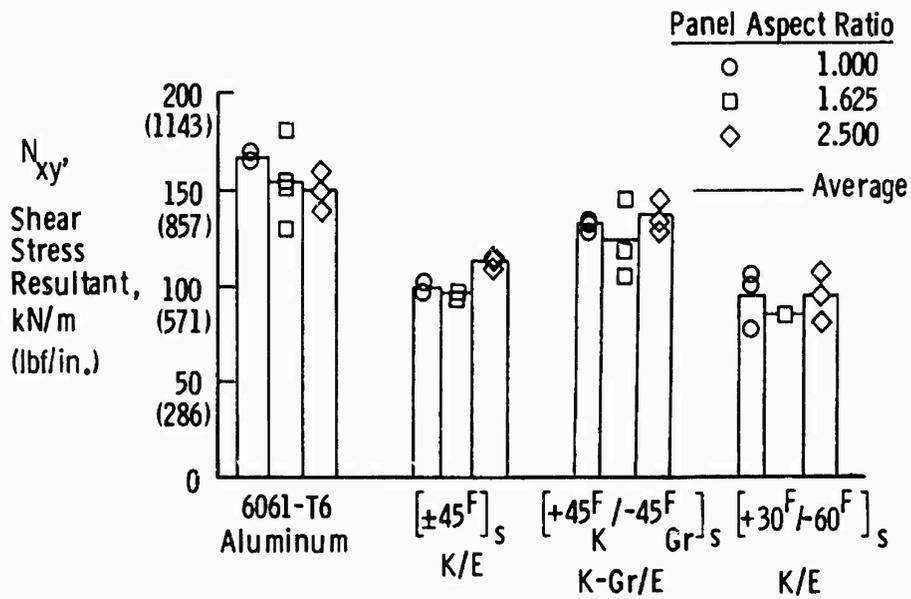
Figure 13. Ultimate shear stress resultants of undamaged panel tests.

Shear strength tests on undamaged composite and aluminum panels were conducted as previously described. Ultimate shear stress resultants for each panel are listed in table V and plotted in figure 13. The ultimate shear stress resultant is calculated by dividing the applied edge failure load by the length of the panel. The average ultimate shear stress resultants for panels with all three aspect ratios for each of the four material configurations were calculated and compared with values obtained for damaged panels. Average ultimate shear stress resultants for panels with a particular aspect ratio varied less than 15 percent from values obtained for panels of the same material with other aspect ratios. There are no distinguishable trends with respect to panel ultimate shear stress resultant and aspect ratio. All panels except the $[+30^\circ/-60^\circ]_s$ K/E panels exhibited tension failures across a buckle similar to those reported in reference 10. The $[+30^\circ/-60^\circ]_s$ K/E panels exhibited a combined tension and shear failure. The combined failure mode of the $[+30^\circ/-60^\circ]_s$ K/E is attributed to the nonalignment of fibers with the diagonal tension forces.

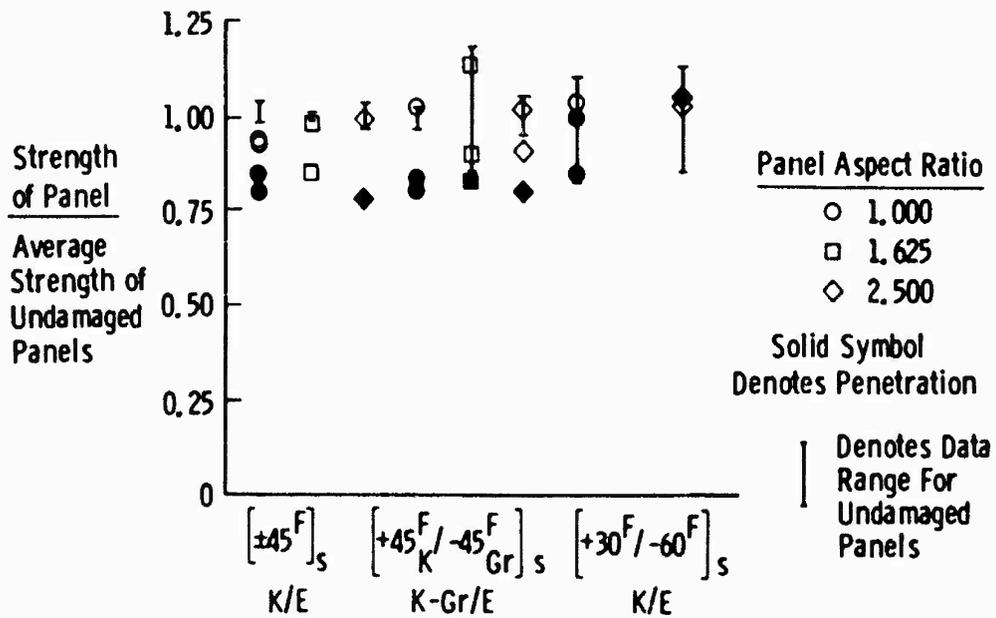
Figure 14. Residual strength ratio of panels impacted at low speed.

residual strength ratio (i.e., the strength of the damaged panel divided by the average strength of the undamaged panels) is plotted in figure 14.

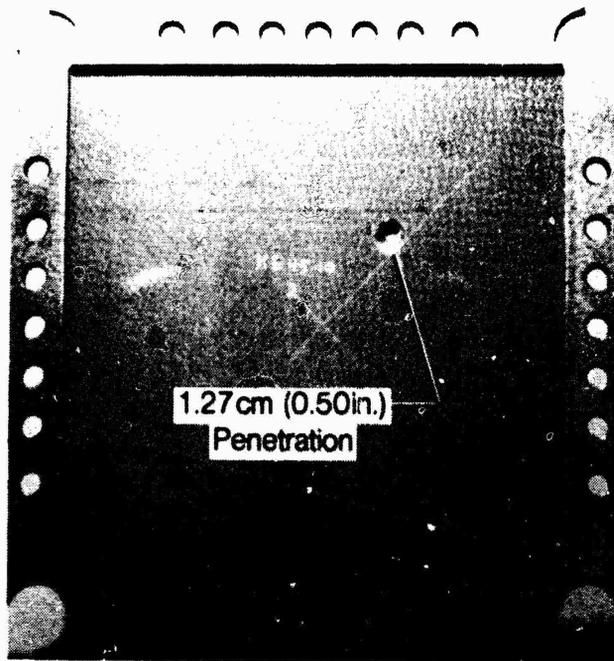
L-85-38

Figure 16. $[\pm 45^\circ]$, K/E shear panel impacted at 67 m/sec (220 ft/sec).

Typical strength reductions from penetrating impacts were 15 to 20 percent of the undamaged-panel strength. Visual and C-scan-defined damage areas were comparable. As shown in figures 16 and 17, typical entrance and exit side damage was between 1.27 cm (0.50 in.) and 1.91 cm (0.75 in.) across for both K/E and K-Gr/E panels. Exit side damage consisted of frayed Kevlar fibers about the penetration with delamination around the perimeter of the penetration. Entrance side damage consisted of the hole with little or no perimeter delamination. The Gr/E plies in the hybrid laminates were cleanly penetrated by the aluminum sphere. All panels were tested to measure residual strength. They exhibited the characteristic tension failure with failure initiating at the hole and propagating to the edge of the panel. (See fig. 18.)

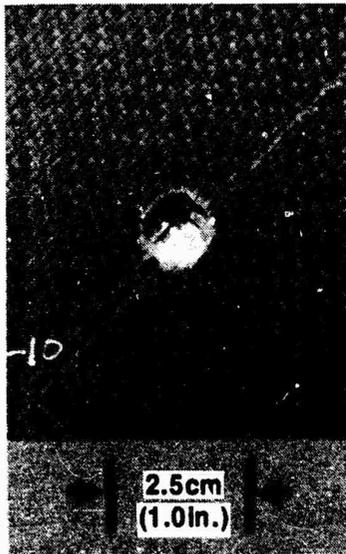
(a) Impacted side.

(b) Exit side.

Figure 17. Damaged region of $[+45_K^F / -45_{Gr}^F]$, K-Gr/E shear panel impacted at 67 m/sec (220 ft/sec). L-85-39

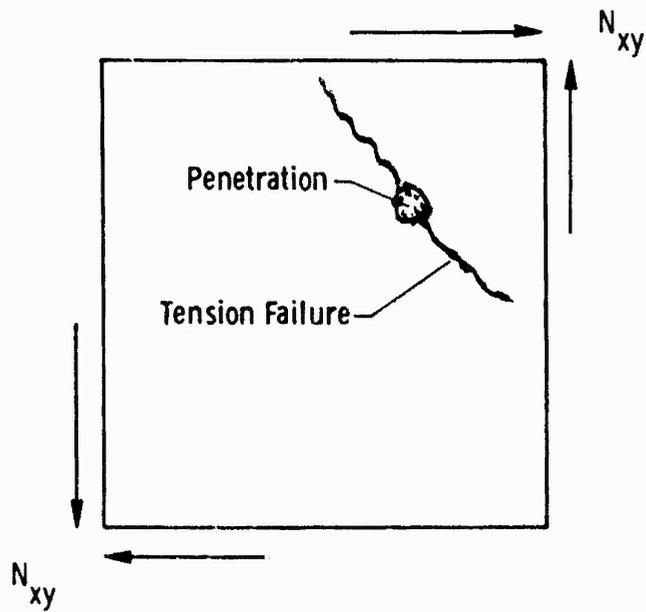
Figure 18. Typical failure mode of $[\pm 45^F]$, K/E shear panels impacted at 67 m/sec (220 ft/sec).

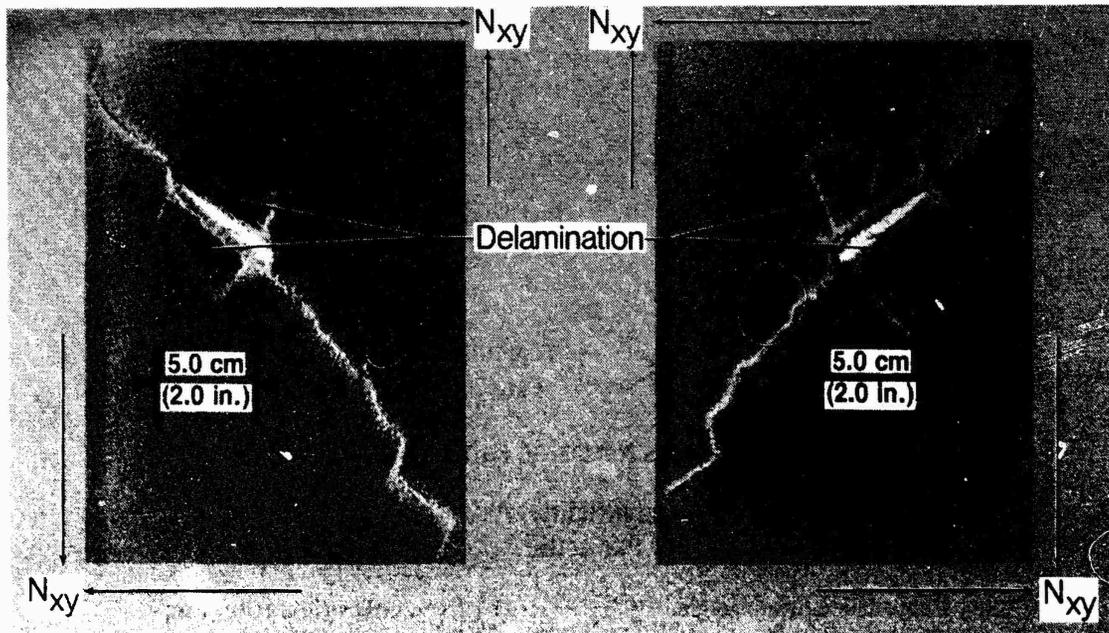
L-85-40

(a) Impacted side.

(b) Exit side.

Figure 19. Typical damaged region of ballistically impacted $[\pm 45^\circ]$, K/E shear panel. Panel failed upon impact; hole size corresponds to projectile tumble angle of 90° .

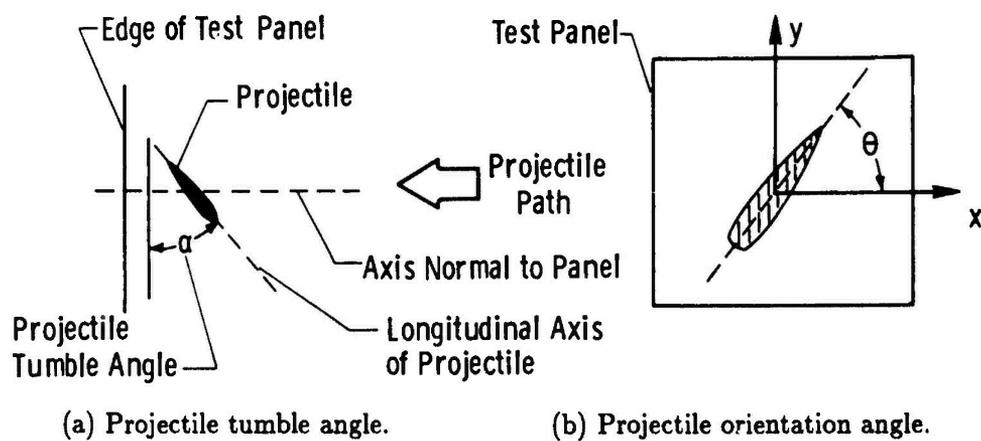
Figure 21. Ballistic projectile tumble and orientation definition.

Precise control of the projectile tumble and orientation angles was not achievable. Tables VII-IX list the projectile tumble and orientation angles for the ballistically impacted panel tests. The projectile tumble angle (α), as shown in figure 21, is the enclosed angle between the longitudinal axis of the projectile and the normal axis (through the thickness) of the panel. Projectile orientation angle (θ), see figure 21, is the angle between the longitudinal axis of the projectile and the inplane horizontal axis of the panel. Figure 22 shows the effect of tumble angle on the crack length ($2a$). As the crack length ($2a$) approaches the diameter of the projectile, the projectile tumble angle approaches zero. Figure 23 shows the effect of projectile orientation angle on the crack length ($2a$). The smallest crack length ($2a$) occurs for orientation angles between 30° and 65° ; this is consistent with the definition of the crack length ($2a$). Data scatter and the coupling effects between projectile tumble angle and orientation angle hinder the discerning of other characteristics. The results of the low-velocity and ballistic impact tests suggest that nontumbled ballistic impacts ($\alpha = 0^\circ$) would cause no greater damage than an equivalent diameter spherical projectile that penetrated the panel at a lower speed.

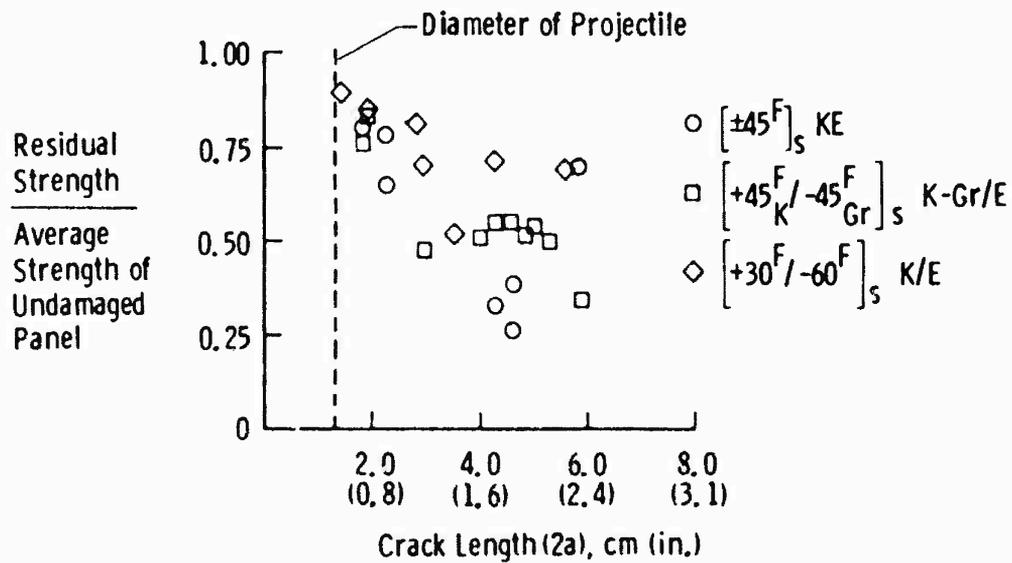
Figure 24. Effect of crack length on residual strength of ballistically impacted panels.

Figure 24 presents data on the effect of crack length ($2a$) on residual panel strength. As the crack length ($2a$) decreases, the residual strength increases. When the crack length approaches the diameter of the projectile, the residual strength is approximately equal to the residual strength of those panels that were subjected to penetrating low-velocity impacts.

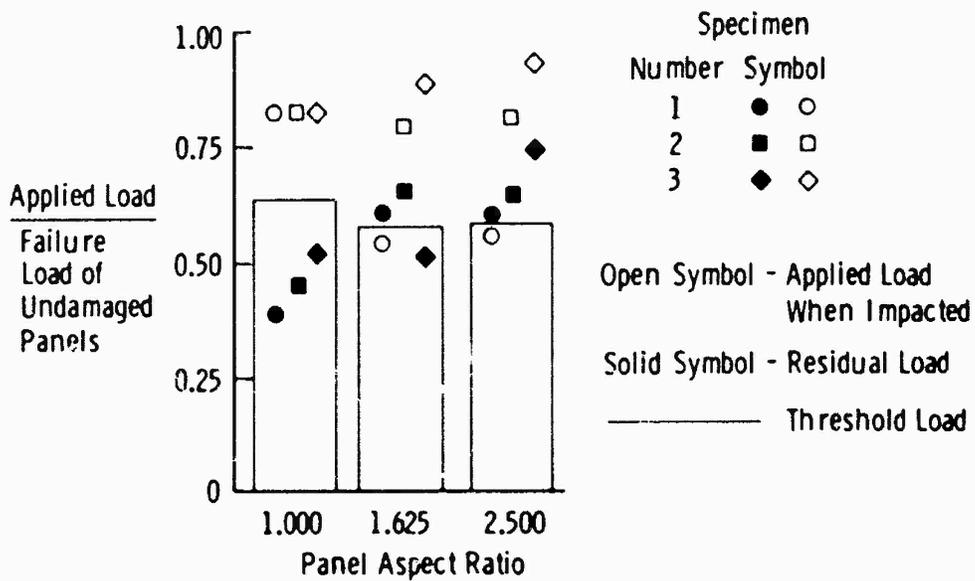
Figure 26. Load ratios of ballistically impacted aluminum panels.

The residual strengths of ballistically impacted aluminum shear panels are plotted in figure 26. The average residual strengths, listed in table XI, were 0.45, 0.60, and 0.67 of the strength of the undamaged aluminum panels for panels having aspect ratios of 1.000, 1.625, and 2.500, respectively, with an overall average of 0.57. The average residual strengths increased with panel aspect ratio. The average crack lengths of panels having different aspect ratios were similar, and the extent of damage was similar. Therefore, the percent of damaged area of the panel should decrease with increased aspect ratio, and the residual strength should increase.

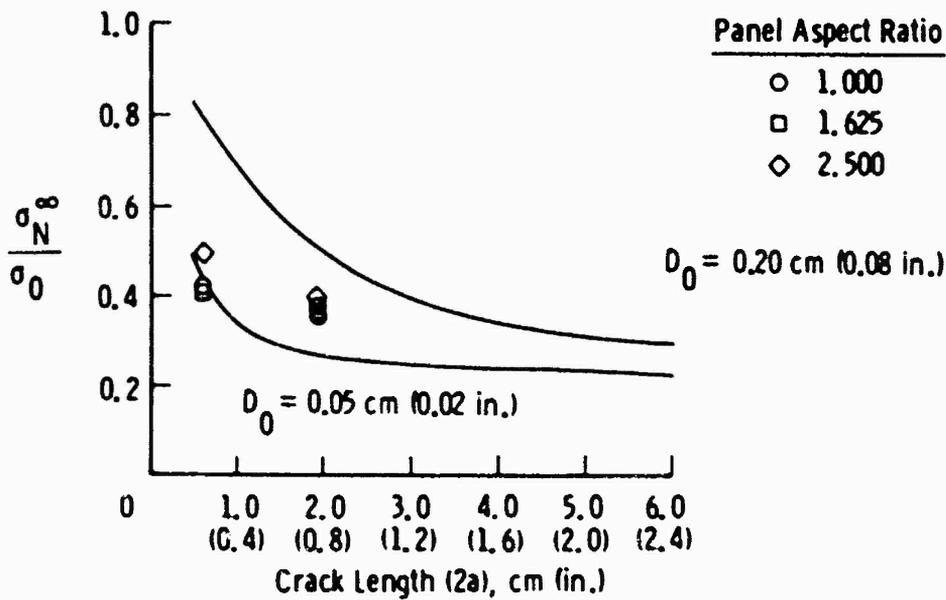
Figure 34. Point stress criteria for $[\pm 45^\circ]$ K/E shear panel impacted at low velocity.

from reference 11, where t is panel thickness and N_{xy} is the applied edge shear stress resultant when the panel failed. The undamaged material strength, σ_0 , was determined from coupon tests. As shown in figures 34-36, typical values of D_0 that correlate with the test data were between 0.05 cm (0.02 in.) and 0.20 cm (0.08 in.). These results are in agreement with the results from tension tests in reference 12.

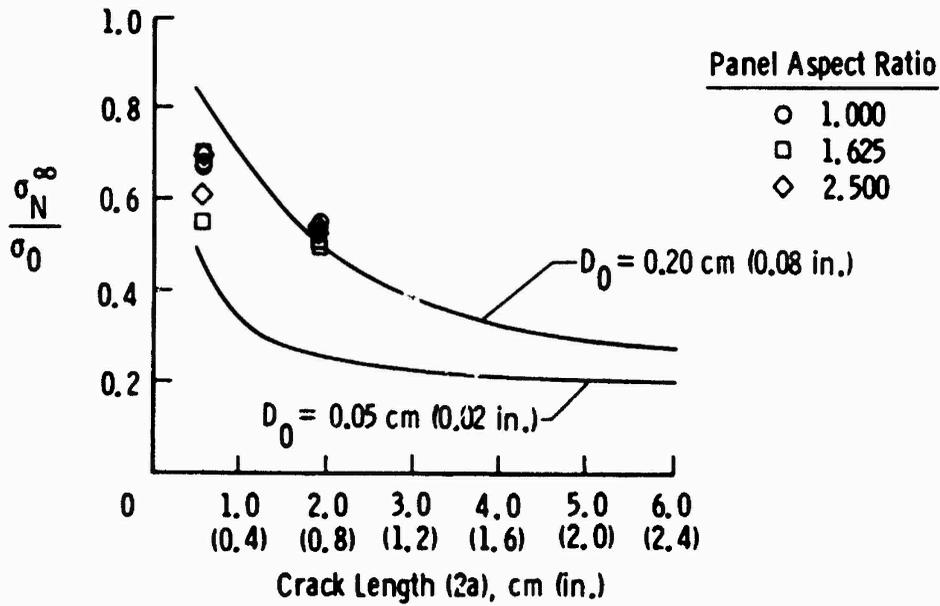
Figure 35. Point stress criteria for $[+45^{\circ}_x / -45^{\circ}_y]$, K-Gr/E shear panel impacted at low velocity.

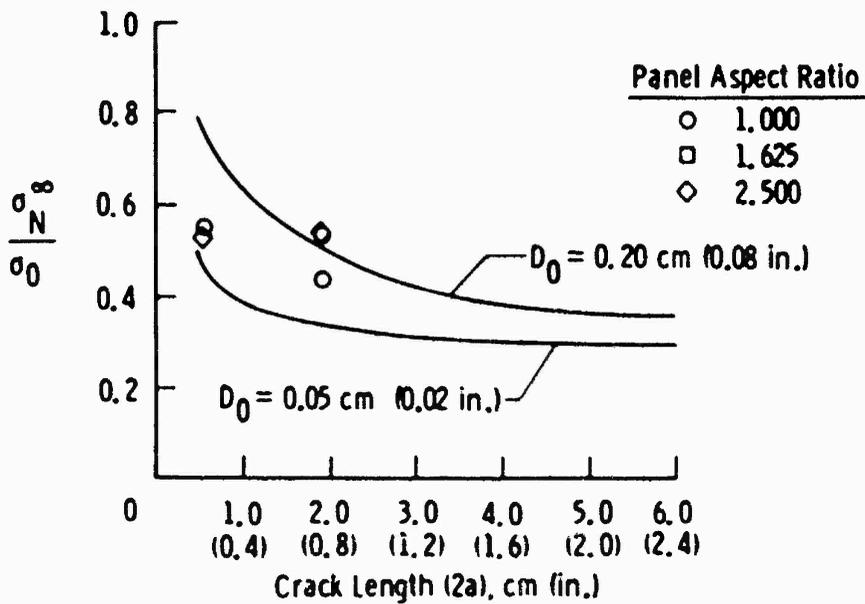
Figure 36. Point stress criteria for $[+30^{\circ}_x / -60^{\circ}_y]$, K/E shear panel impacted at low velocity.
