USAAEFA PROJECT NO. 83-22

**LIMITED ARTIFICIAL AND NATURAL ICING TESTS
OF THE EXTERNAL STORES SUPPORT SYSTEM
(ESSS) INSTALLED ON A UH - 60A AIRCRAFT**

**JUNE 1984
FINAL REPORT**

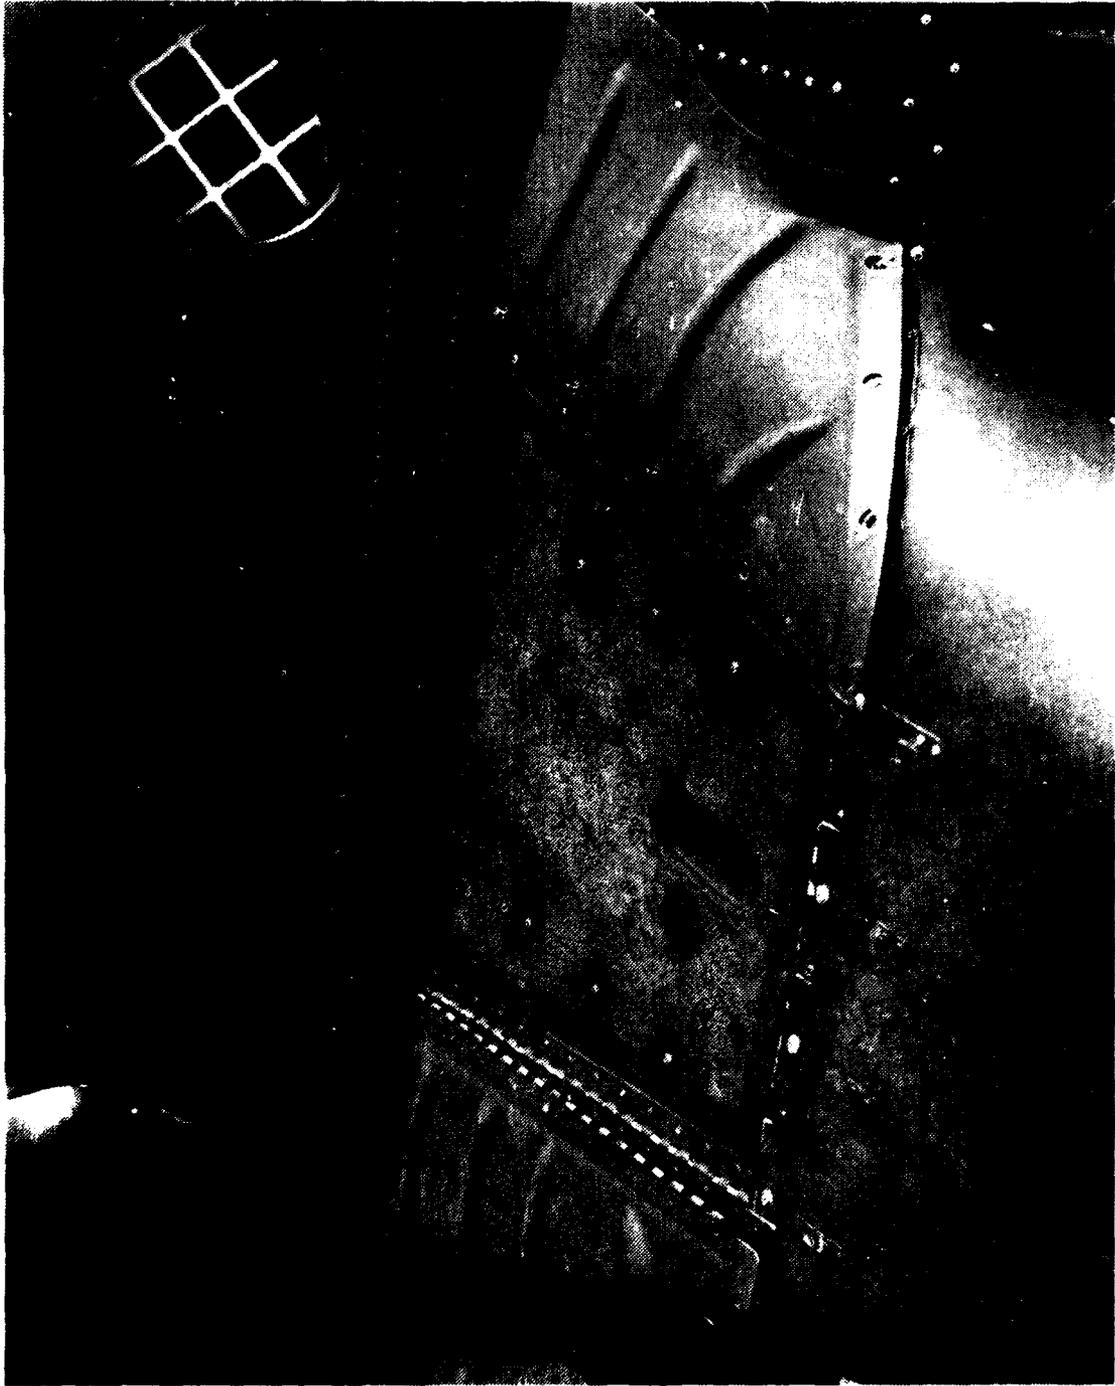
Photo 2. Production Wing Root Fairing

15. The ice accretion and shedding characteristics of the fixed provision fairings were evaluated at the specific test conditions shown in table 1, appendix F. Artificial and natural icing condition flights were conducted with the aircraft configured with fixed provision fairings. All icing flights were conducted with the prototype wing root fairings except for two flights where the right prototype wing root fairings (smooth surface) were replaced with production wing root fairings (ribbed surface). A detailed description of these fairings with photos is contained in appendix B. Photos 6 and 7, appendix G, document typical ice accretions on the right (production) fairing and left (prototype) fairing, respectively. These photos show small ice accretions (approximately 1/2 inch thick) on the wing root fairings and a larger buildup of ice (approximately 3 inches thick) on the outboard portions of the fixed provision fairings. The area directly in front of the engine inlet accumulated only a small quantity of ice, and no engine or aircraft damage was documented when these formations shed. The ice accretion and shedding characteristics of the fixed provision fairings (combined with either the prototype or production wing root fairings) were satisfactory.

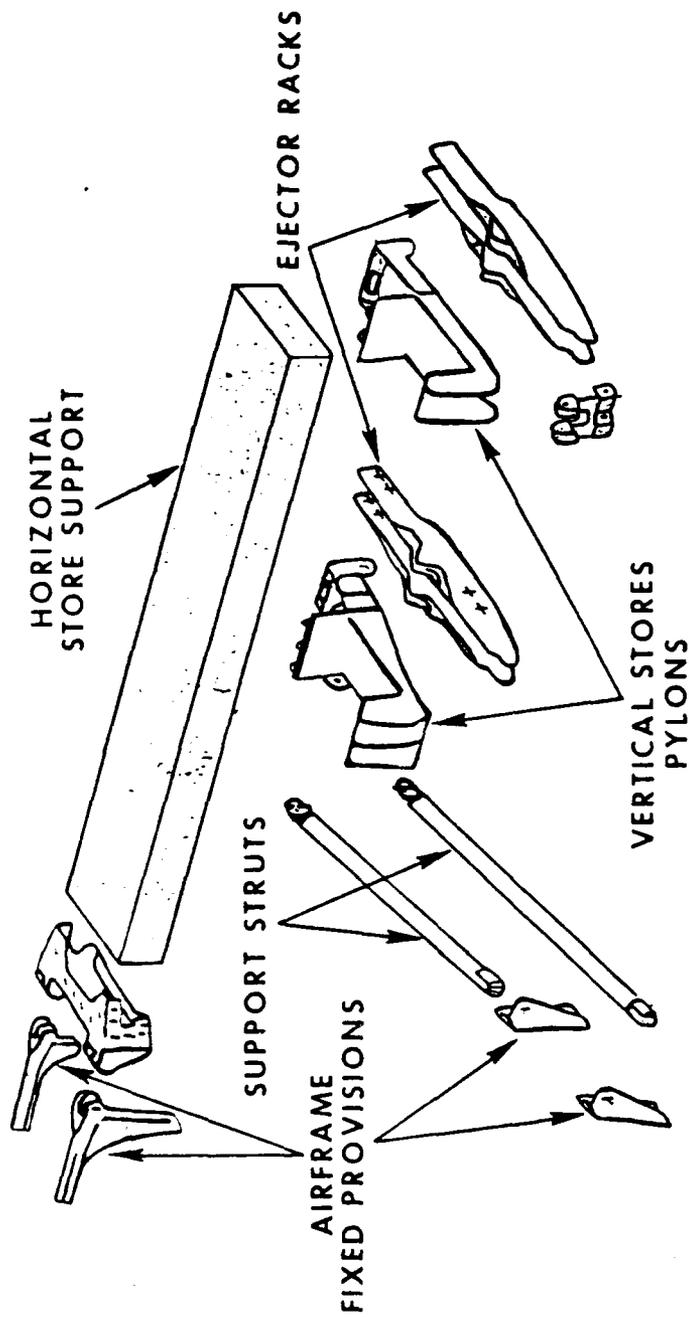
Figure 1. ESSS Structural Components

3. The ESSS is a modification of the UH-60A helicopter designed to provide the capability for performing extended range missions and self-deployment. The test aircraft, UH-60A USA Serial Number 79-23352, is a twin-turbine single main rotor helicopter capable of day or night operations in visual or instrument meteorological conditions (IMC). The main and tail rotors are both four-bladed with a capability of manual main rotor blade and tail rotor pylon folding. A horizontal stabilator is located on the tail rotor pylon. The deicing kit installed incorporates a main and tail rotor deicing system and an ice detection system as well as anti-ice provisions for the main rotor droop stops, the pilot and copilot windshields, pitot-static tubes and their support struts, engines, and engine inlets (ref 2, app A). The ESSS for the UH-60A consists of airframe fixed provisions and external stores subsystems. The airframe fixed provisions include permanent structural modifications, attachment points, fuel and pneumatic lines and electrical harnesses. The external stores subsystem is comprised of a horizontal stores support, two support struts, and two vertical stores pylons for each side of the aircraft.

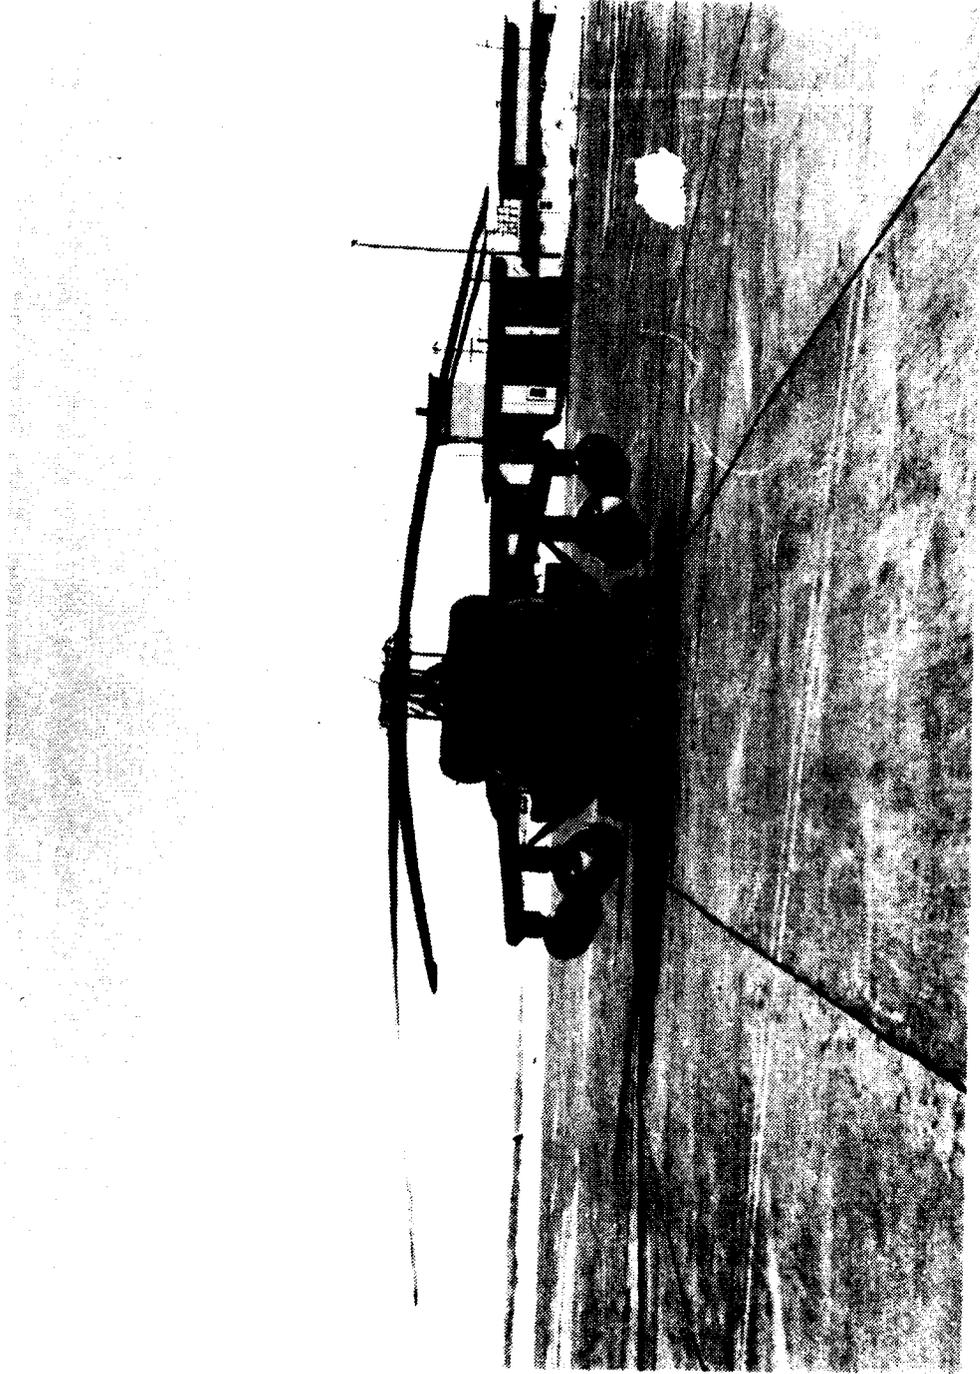
Photo 3. ESSS Four-Tank Configuration, Front View

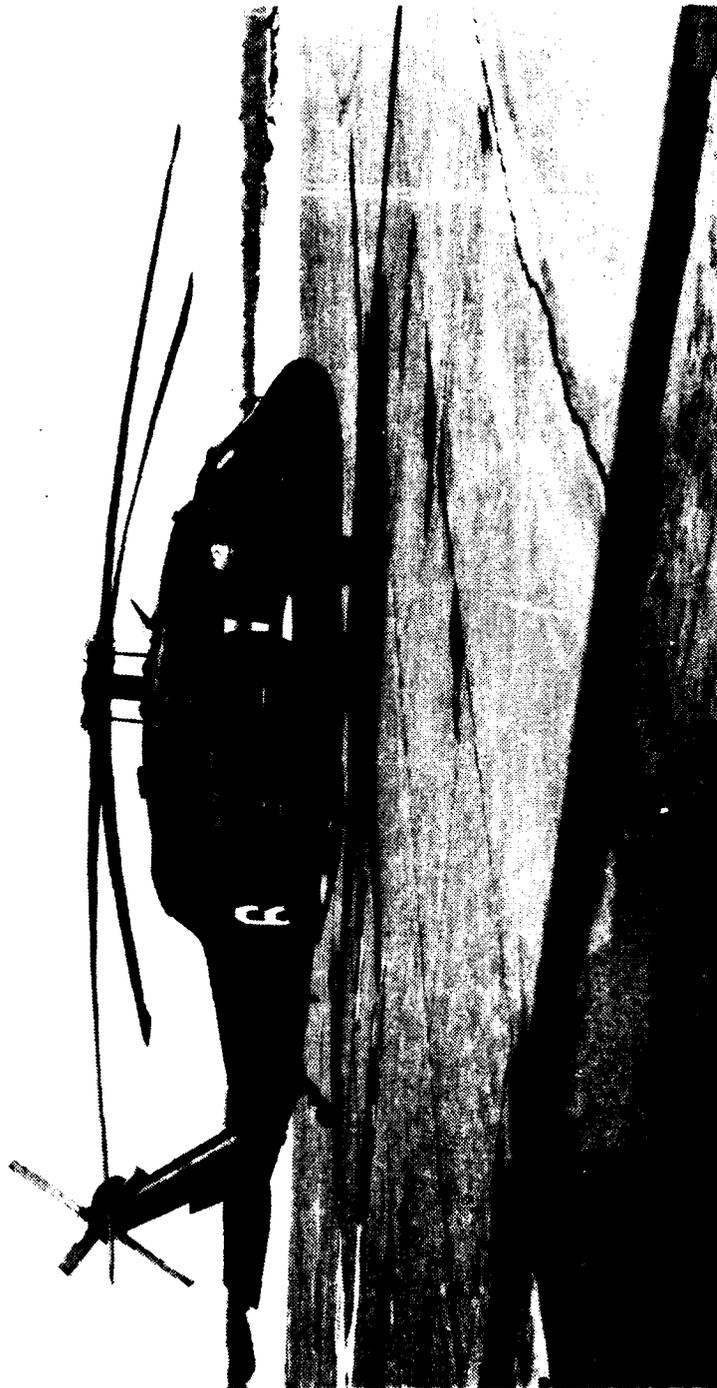
Photo 4. ESSS Four-Tank Configuration, Right Front View

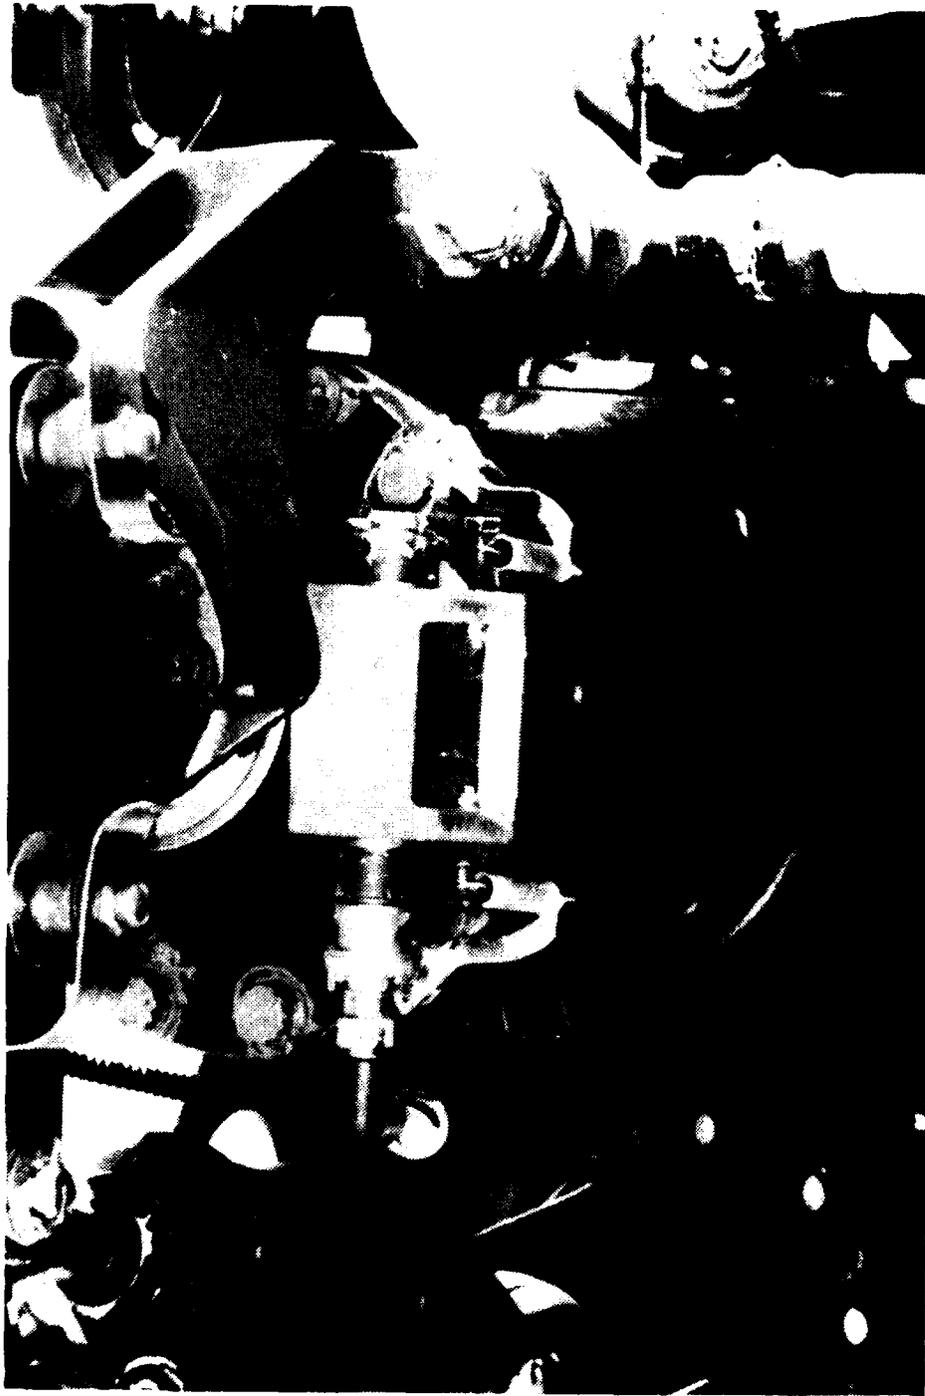
Photo 5. Improved Droop Stop Installation

9. The anti-ice systems installed on the test aircraft were identical to the systems previously tested (ref 3, app A) except for the improved main rotor droop stops (P/N 70105-08151-045, photo 4, app B). All anti-ice systems were activated prior to entering the icing environment and were operational for all icing flights. Observed anti-ice system operational characteristics were identical to previous tests except as noted in the following paragraphs. The inadequate anti-ice provisions on the pitot-static struts as installed with the improved airspeed system fairings or wedges was identified as a shortcoming.

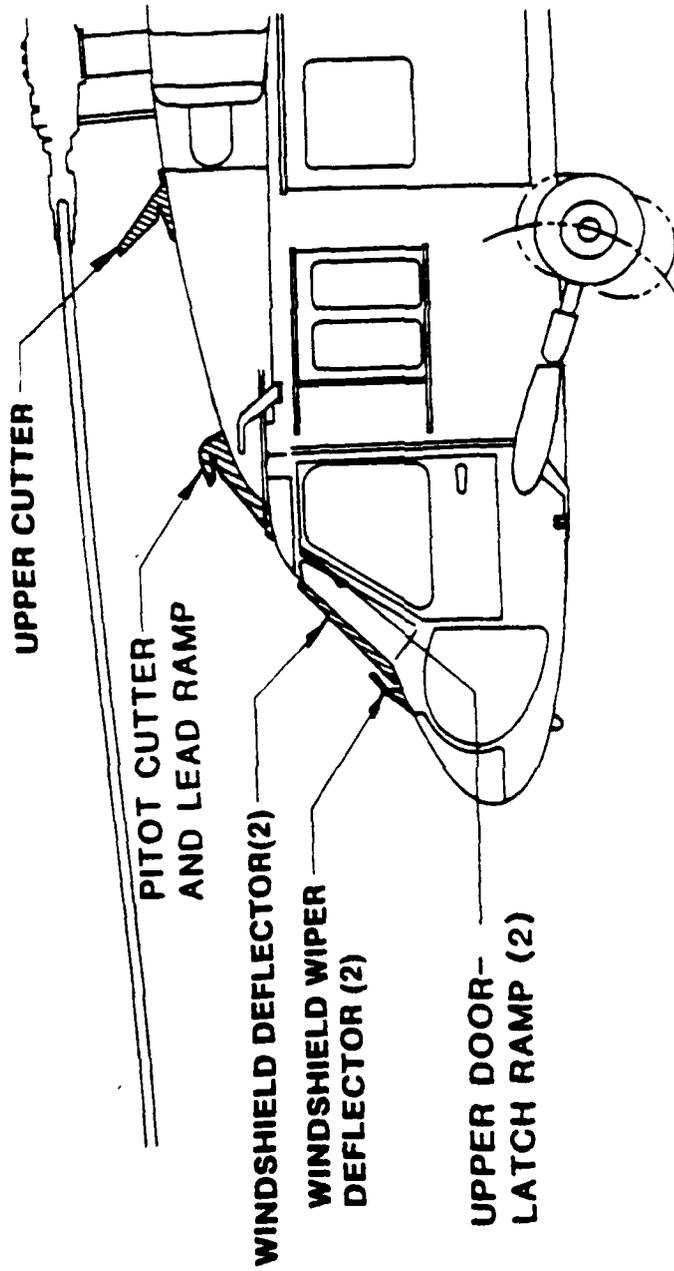
8. A partial non-structural WSPS was installed for icing test purposes (fig. 2). The installation included upper fuselage components considered to have an icing hazard potential and

Figure 2. Wire Strike Protection System Icing Test Installation

was made in accordance with drawing X7006-26780. The major components included the upper cutter (photo 9), pitot cutter and lead ramp (photo 10), two windshield wiper deflectors, two windshield deflectors, and two upper door latch ramps (photo 11).

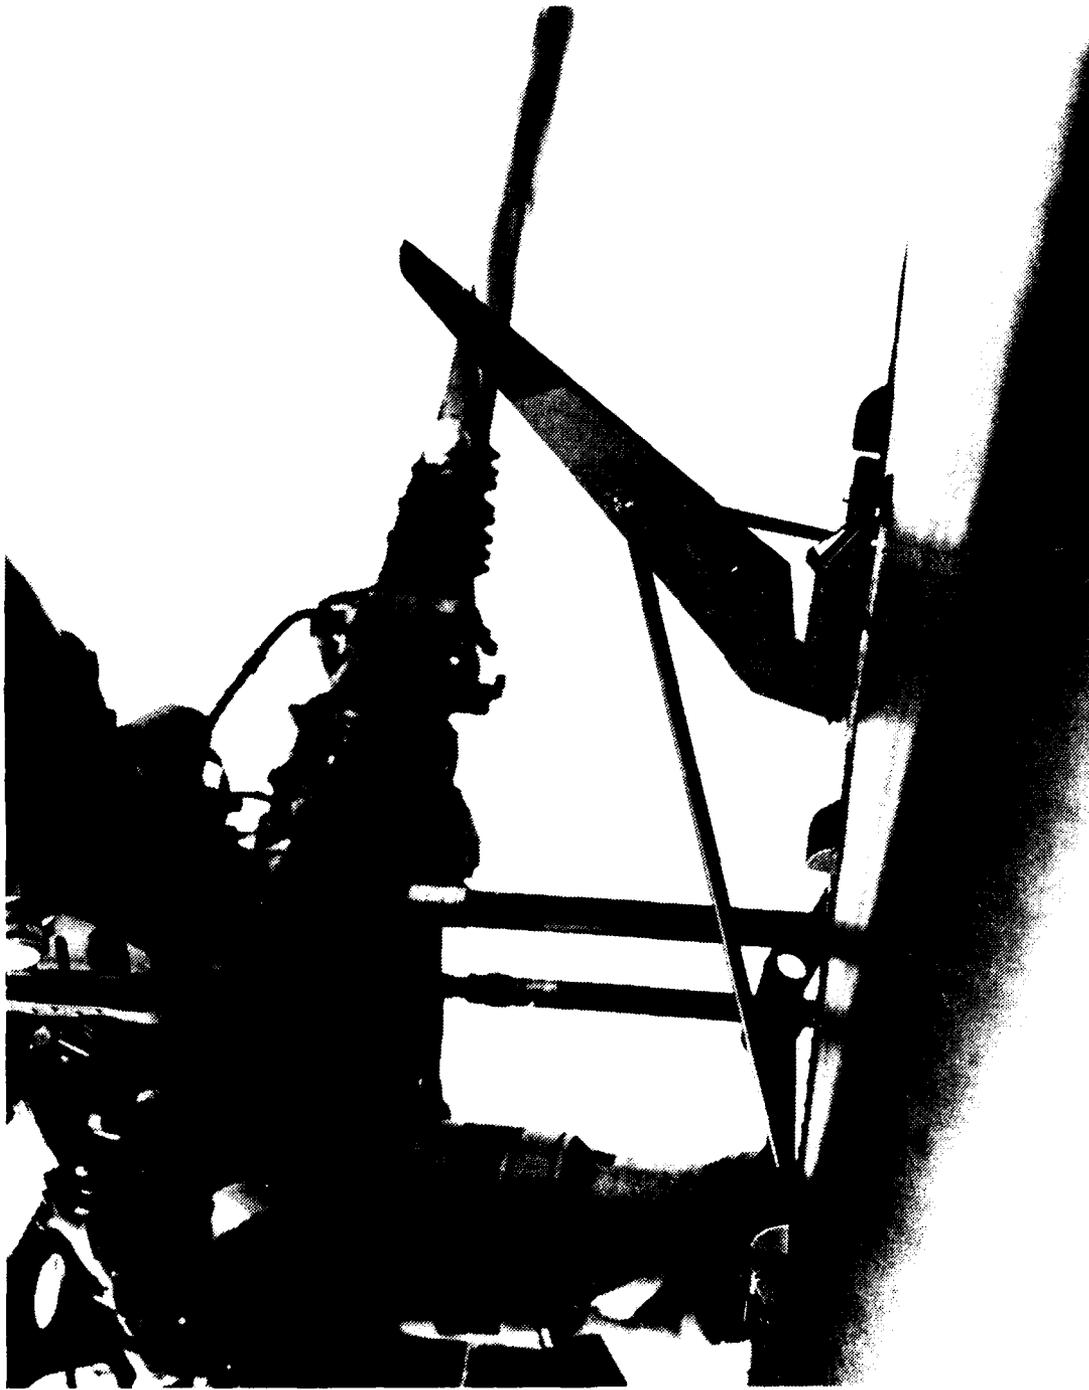
Photo 9. WSPS Upper Cutter

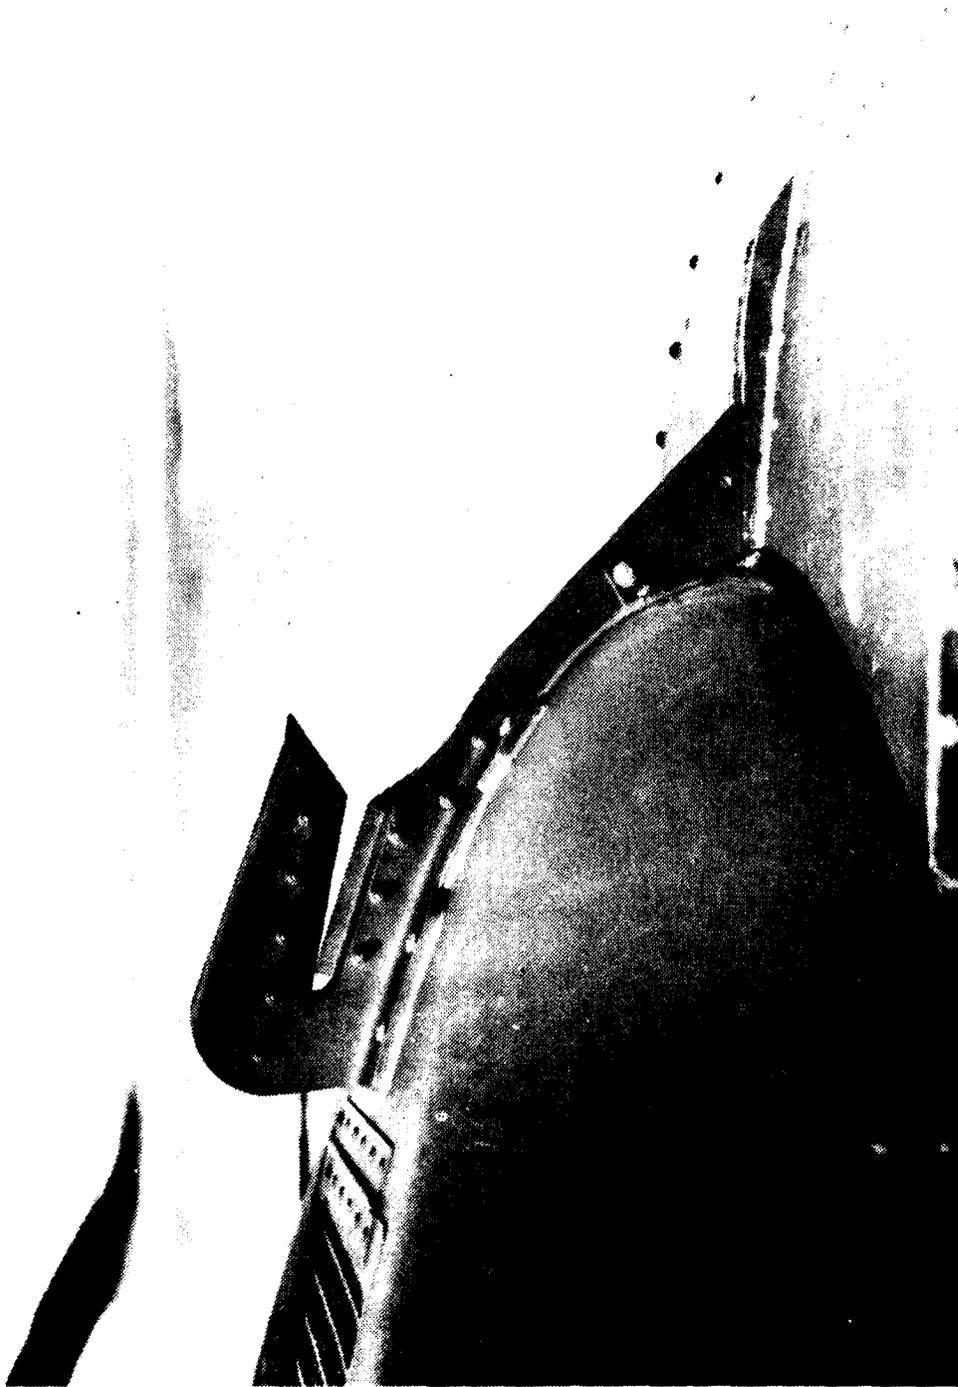
Photo 10. WSPS Pitot Cutter and Lead Ramp

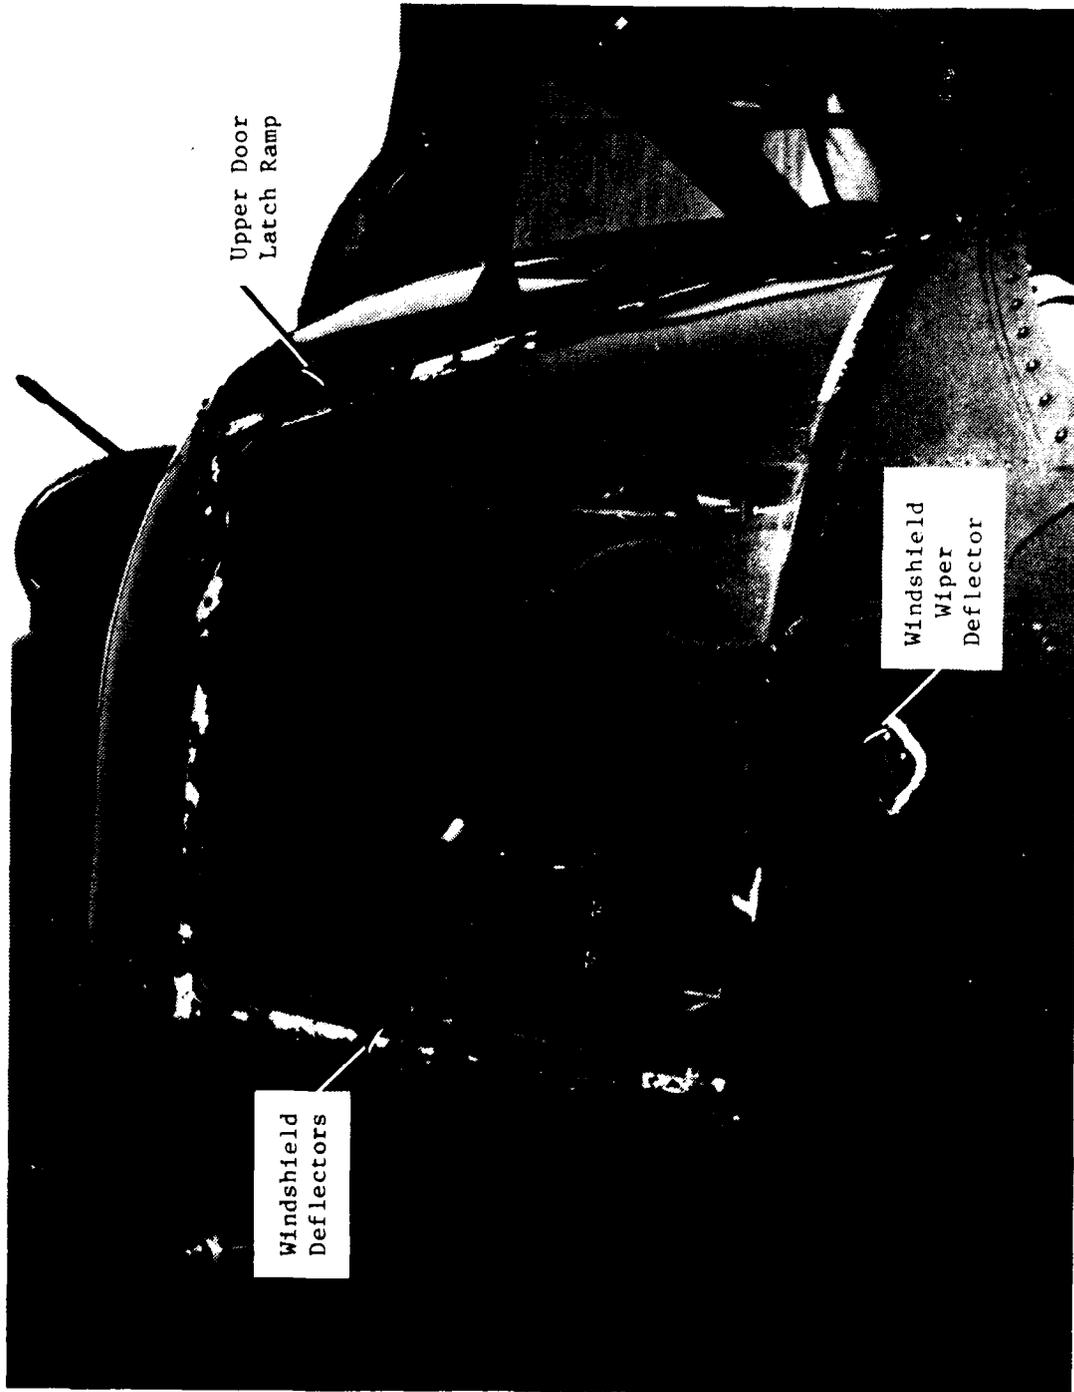
Upper Door
Latch Ramp

Windshield
Wiper
Deflector

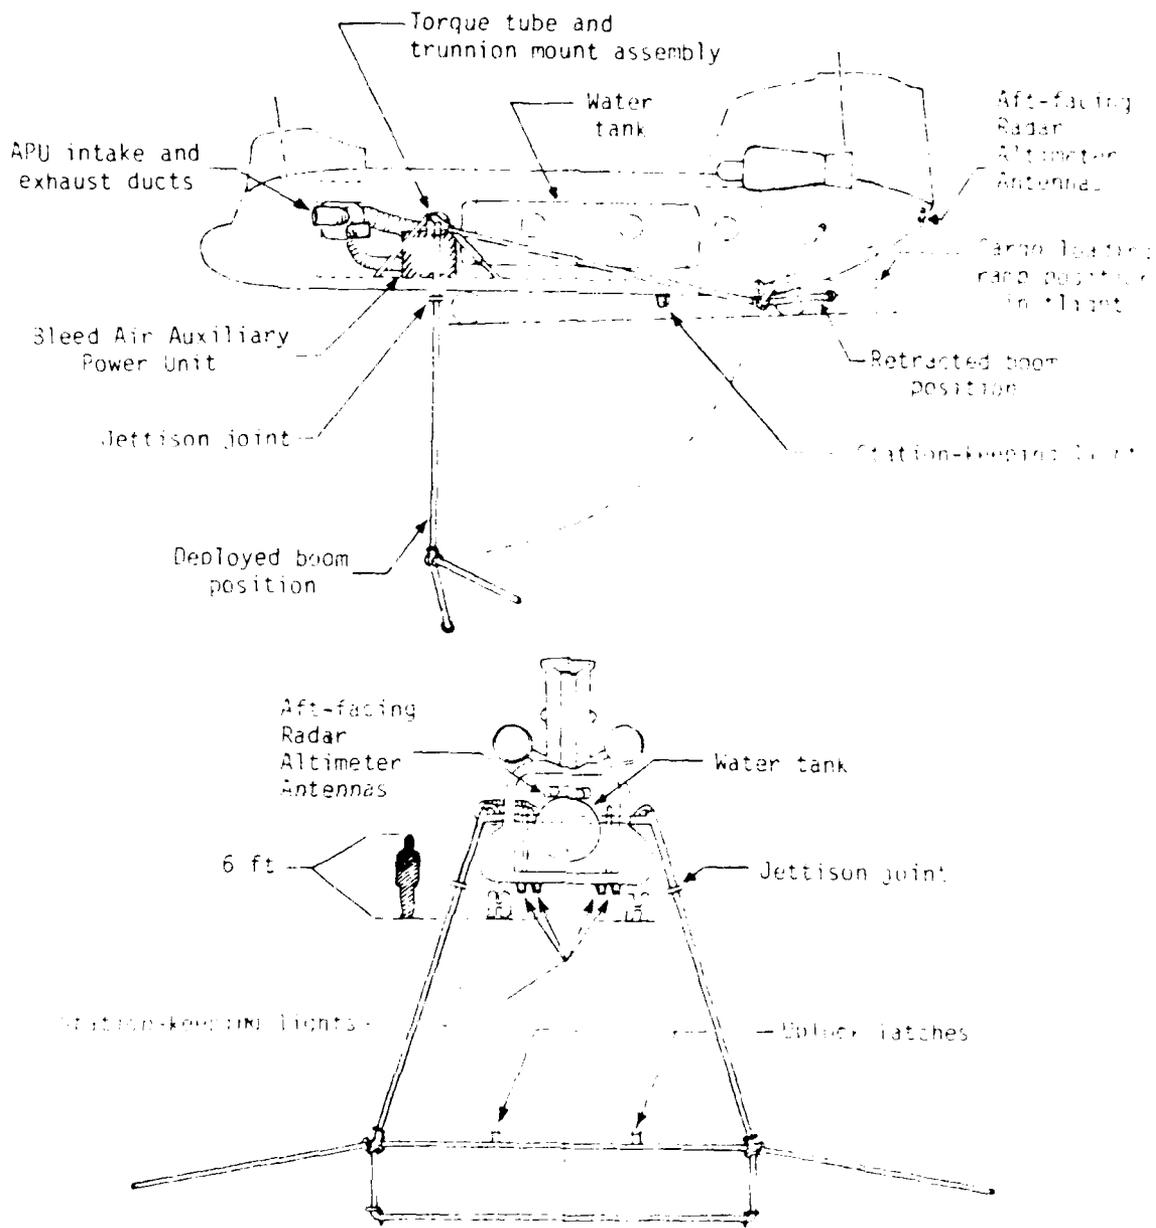
3. At the 150 foot standoff distance used for icing tests, the size of the visible spray cloud is approximately 8 feet high by 36 feet wide. Water flow rates to provide a desired liquid water content (LWC) are established based on a theoretically derived formula assuming no evaporation. The spray cloud is then sampled to determine the actual LWC by a fixed wing, chase/calibration aircraft equipped with particle-measuring devices. The flow rate is adjusted and the cloud sampled until the desired average LWC is attained.

Figure 1. Helicopter Icing Spray System
Side and Rear View Schematic

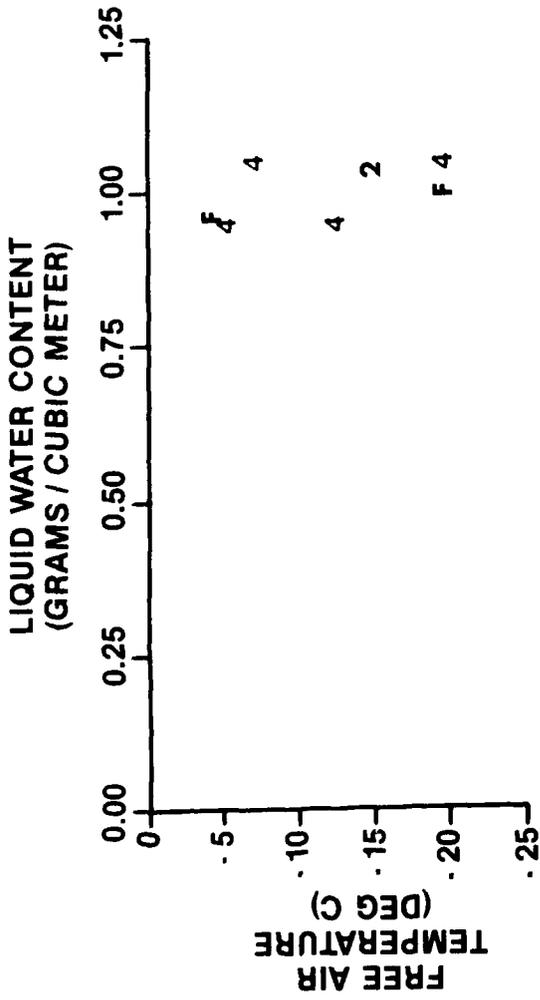
- NOTE:
- 2. ESSS, 2-TANK CONFIGURATION
 AVERAGE GROSS WEIGHT = 13,300 lb
 AVERAGE LONGITUDINAL CG LOCATION = FS 359.5
 AVERAGE DENSITY ALTITUDE = 80 FT
 - 4. ESSS, 4-TANK CONFIGURATION
 AVERAGE GROSS WEIGHT = 14,940 lb
 AVERAGE LONGITUDINAL CG LOCATION = FS 355.8 (MID)
 AVERAGE DENSITY ALTITUDE = 4870
 - F. FIXED DPROVISIONS
 AVERAGE GROSS WEIGHT = 12,250 lb
 AVERAGE LONGITUDINAL CG LOCATION = FS 362.6 (AFT)
 AVERAGE DENSITY ALTITUDE = 4200 FT

Figure 1
 Artificial Icing Test Conditions

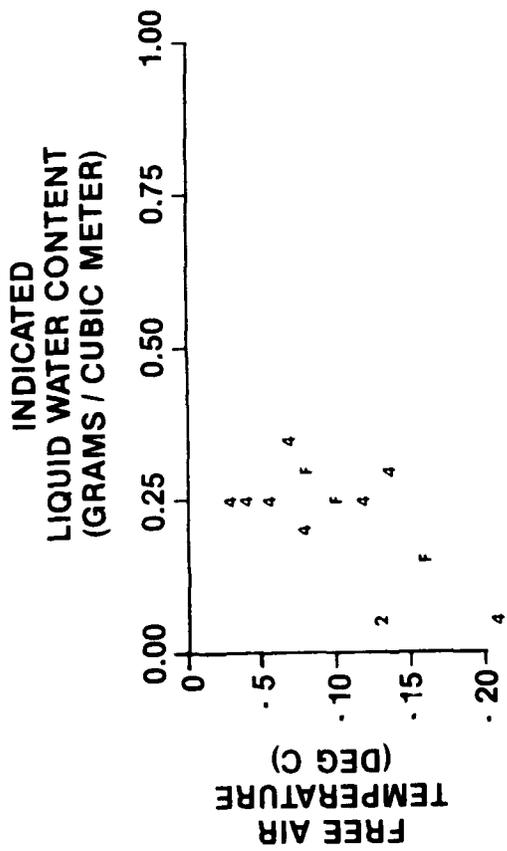
NOTE: 2. ESSS, 2-TANK CONFIGURATION
 AVERAGE GROSS WEIGHT = 15,700 lb
 AVERAGE LONGITUDINAL CG LOCATION = FS 356.4 (MID)
 AVERAGE DENSITY ALTITUDE = 5100 FT

4. ESSS, 4-TANK CONFIGURATION
 AVERAGE GROSS WEIGHT = 16,190 lb
 AVERAGE LONGITUDINAL CG LOCATION = FS 353.5 (MID)
 AVERAGE DENSITY ALTITUDE = 3880

Figure 2
 Natural Icing Test Conditions

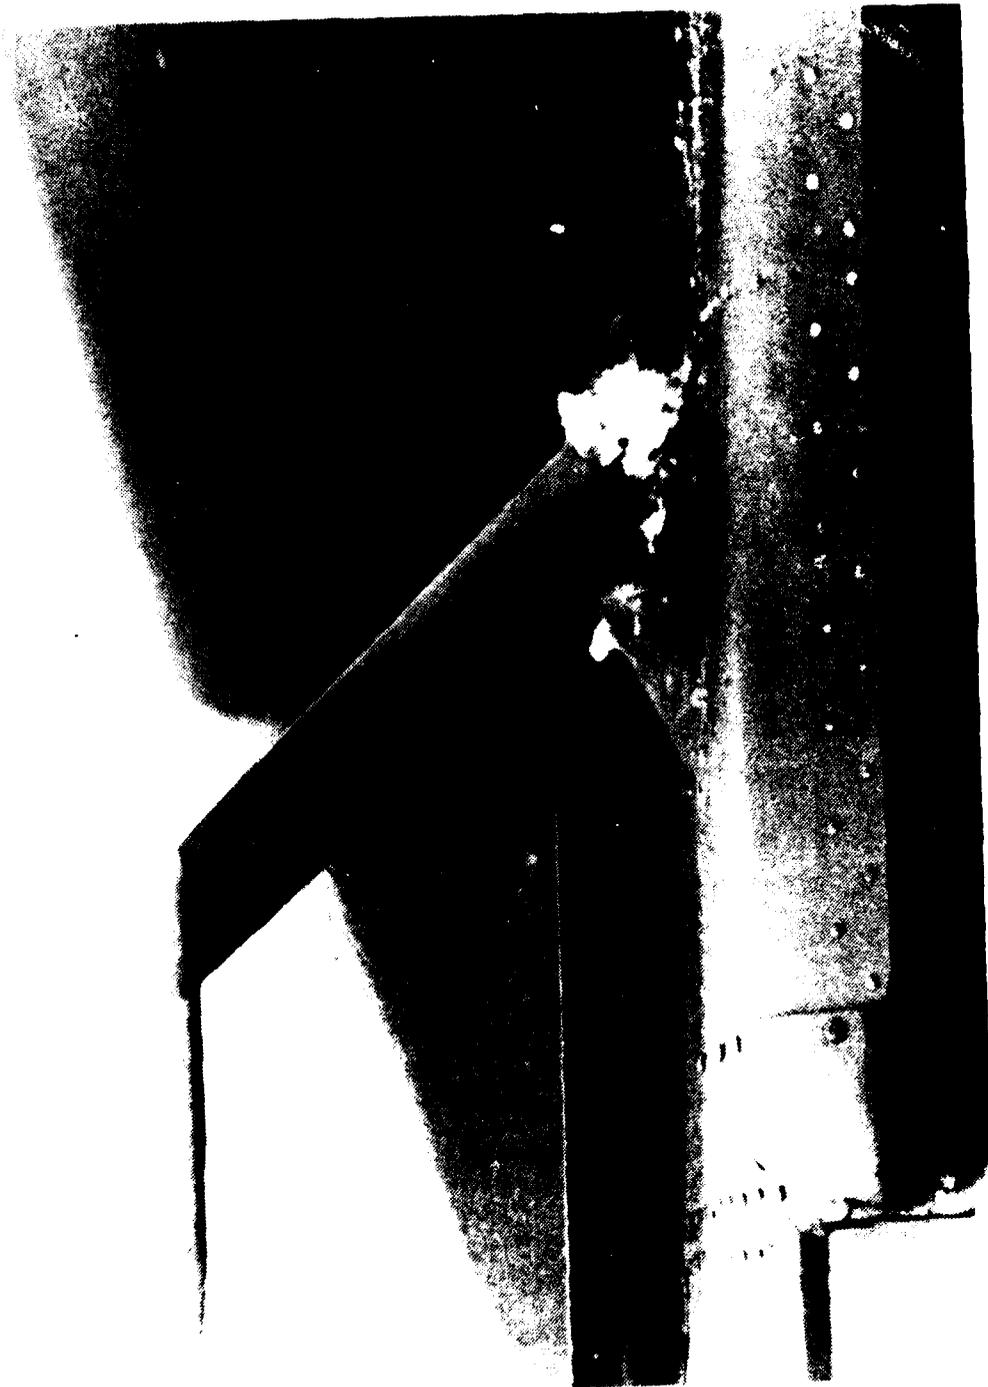
Photo 1. Pitot-Static Tube Strut Ice Accretion

Conditions: Environment - Natural
Configuration - 4-Tank
Flight - 17

Avg FAT - -7.0°C
Avg LWC - 0.36 gm/m^3
Time in Cloud - 168 minutes

10. Pitot-static tube strut anti-ice characteristics were evaluated throughout these tests. Specific test conditions are presented in table 1, appendix F. The test aircraft was equipped with the improved airspeed system (para 7, app B). The pitot-static tube is fully anti-iced, while only the leading edge of the support strut is anti-iced. The improved airspeed system was tested with an aerodynamic fairing and with wedges installed (photos 7 and 8, app B). Large ice accretions were observed to form on the unheated aft, outboard, lower portions of both pitot-static tube struts at most of the conditions tested (artificial and natural). An example of these ice formations is shown in photo 1, appendix G. These ice accretions were larger with increased icing exposure (liquid water content (LWC) or time) and were characterized by clear globular formations. These characteristics are typical of runback ice formations indicating that the pitot-static tube strut anti-ice capabilities were exceeded. The location of the ice formation, directly in front of the engine inlet, increases the probability of engine FOD, although none was noted during 23.6 hours of icing condition flight. Since previous testing on UH-60 aircraft without the improved airspeed system installation fairing or wedge did not encounter this problem, it is expected that the size and shape of the improved airspeed system installation fairing or wedge was responsible for these ice formations. The inadequate anti-ice provisions on the pitot-static tube support struts as installed with the improved airspeed system fairings or wedges is a shortcoming. The inadequate anti-ice capabilities of the pitot-static tube support struts should be improved prior to release into icing conditions of any UH-60 aircraft configured with the improved airspeed system.

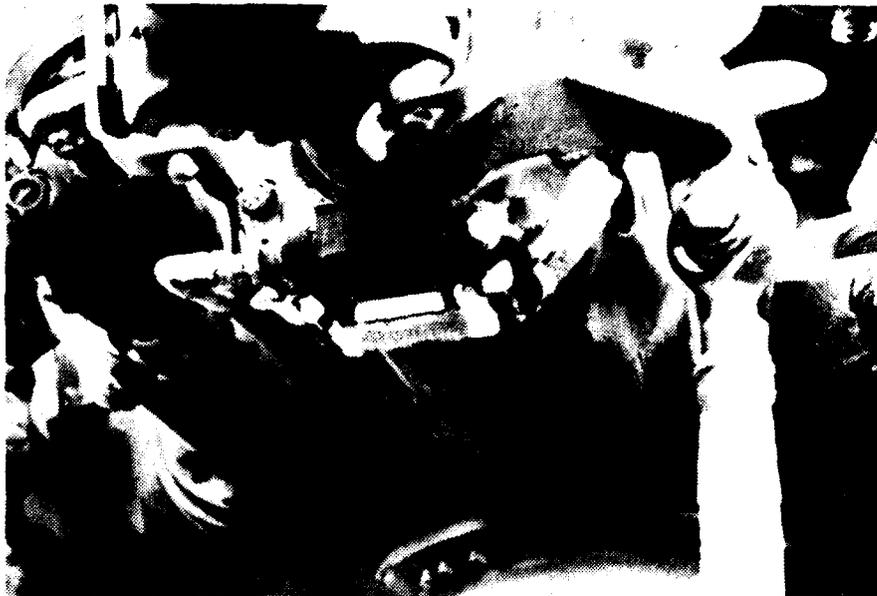
Photo 2. Improved Droop Stop Ice Accretion

Conditions:	Environment - Natural	Avg FAT - -12.0°C
	Configuration - 4-Tank	Avg LWC - 0.25 gm/m^3
	Flight - 3	Time in Cloud - 62 minutes

11. The anti-ice characteristics of the improved droop stops were evaluated at the specific test conditions shown in table 1, appendix F. The improved droop stops (P/N 70105-08151-045, photo 2, app G) installed on the test aircraft were electrically anti-iced and differed slightly in design from the droop stops previously tested (ref 3, app A). Following all tests, the improved anti-iced droop stops returned to the retracted position, fully seated, and incurred no damage. The improved anti-iced droop stops operated satisfactorily through moderate icing conditions.

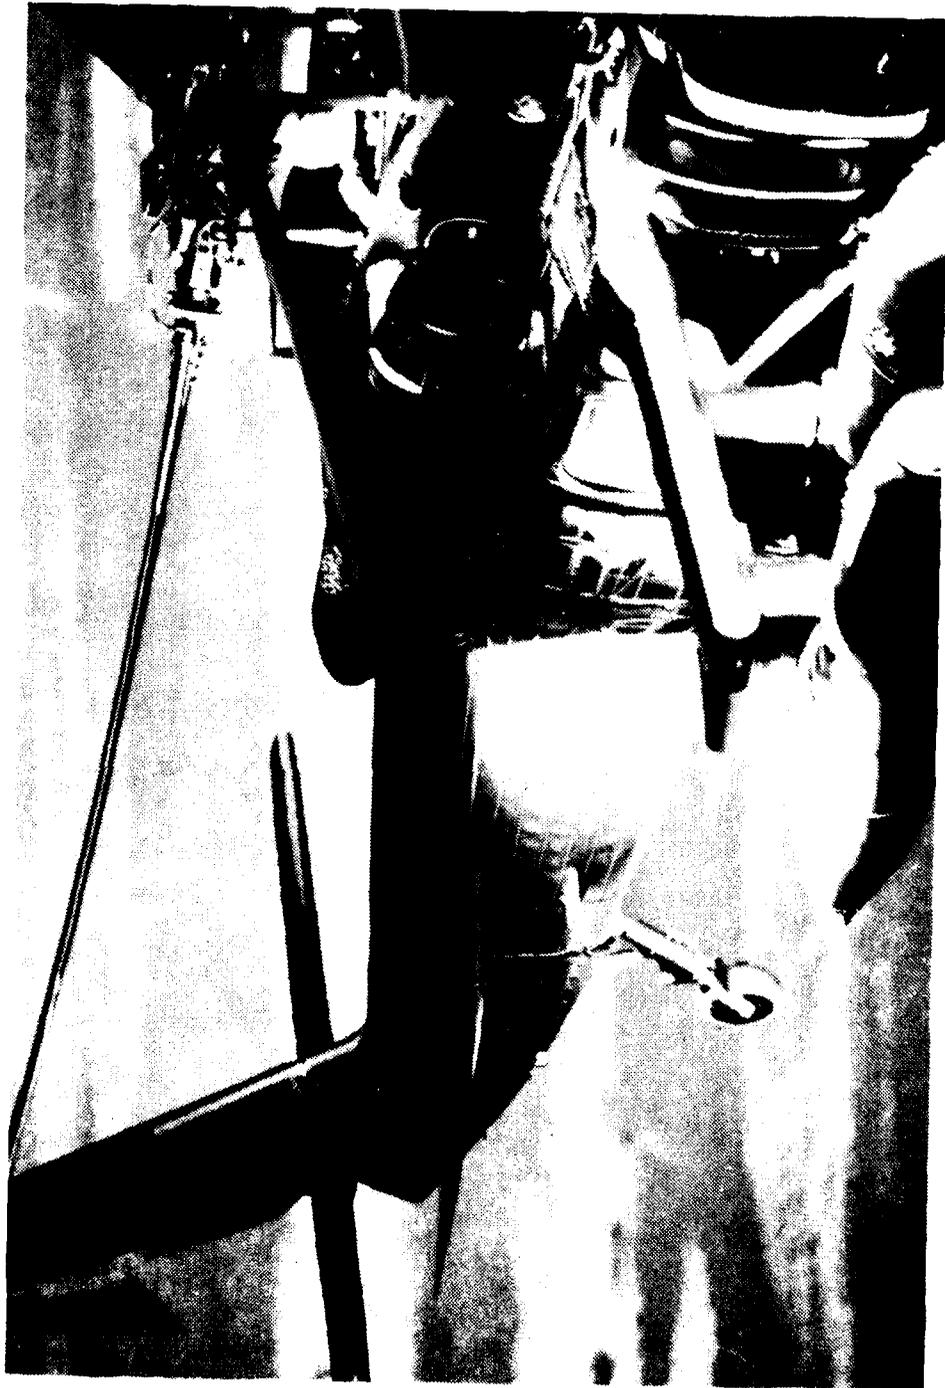
Photo 4. Typical Four External Fuel Tank Ice Accretion (Aft Fuselage)

Conditions: Environment - Artificial Avg FAT - 20.0°C
Configuration - 4-Tank Avg LWC - 1.05 gm/m³
Flight - 5 Time in Cloud - 45 minutes

16. The ice accretion and shedding characteristics of the UH-60A helicopter configured with an ESSS and external fuel tanks were evaluated at the specific test conditions shown in table 1, appendix F. Thirteen of the eighteen icing flights were conducted with the ESSS wing and fuel tanks installed. Eleven flights were flown with four external fuel tanks installed and two were conducted with the two-230 gallon outboard tanks installed. A typical ice accretion is shown in photo 8, appendix G. The ESS installed on the test aircraft was an operable external fuel system and fuel was transferred during icing condition flight with ice accretions on the tanks and supports. As much as four inches of ice was accreted on the stagnation regions of the horizontal and vertical supports, and the nose of the fuel tanks. Larger accretions (approximately six inches thick) were observed on the wing struts due to their higher catch efficiency. On several occasions the aircraft descended below the freezing level and these ice formations were shed. These ice sheds were observed from the chase aircraft and documented on video tape. In all cases the shed ice particles passed well clear of rotating components. No evidence of aircraft damage due to shedding of these ice accretions was documented. The ice accretion and shedding characteristics of the ESSS with either two (230 gallon) or four (two-230 gallon and two-450 gallon) external fuel tanks installed were satisfactory.

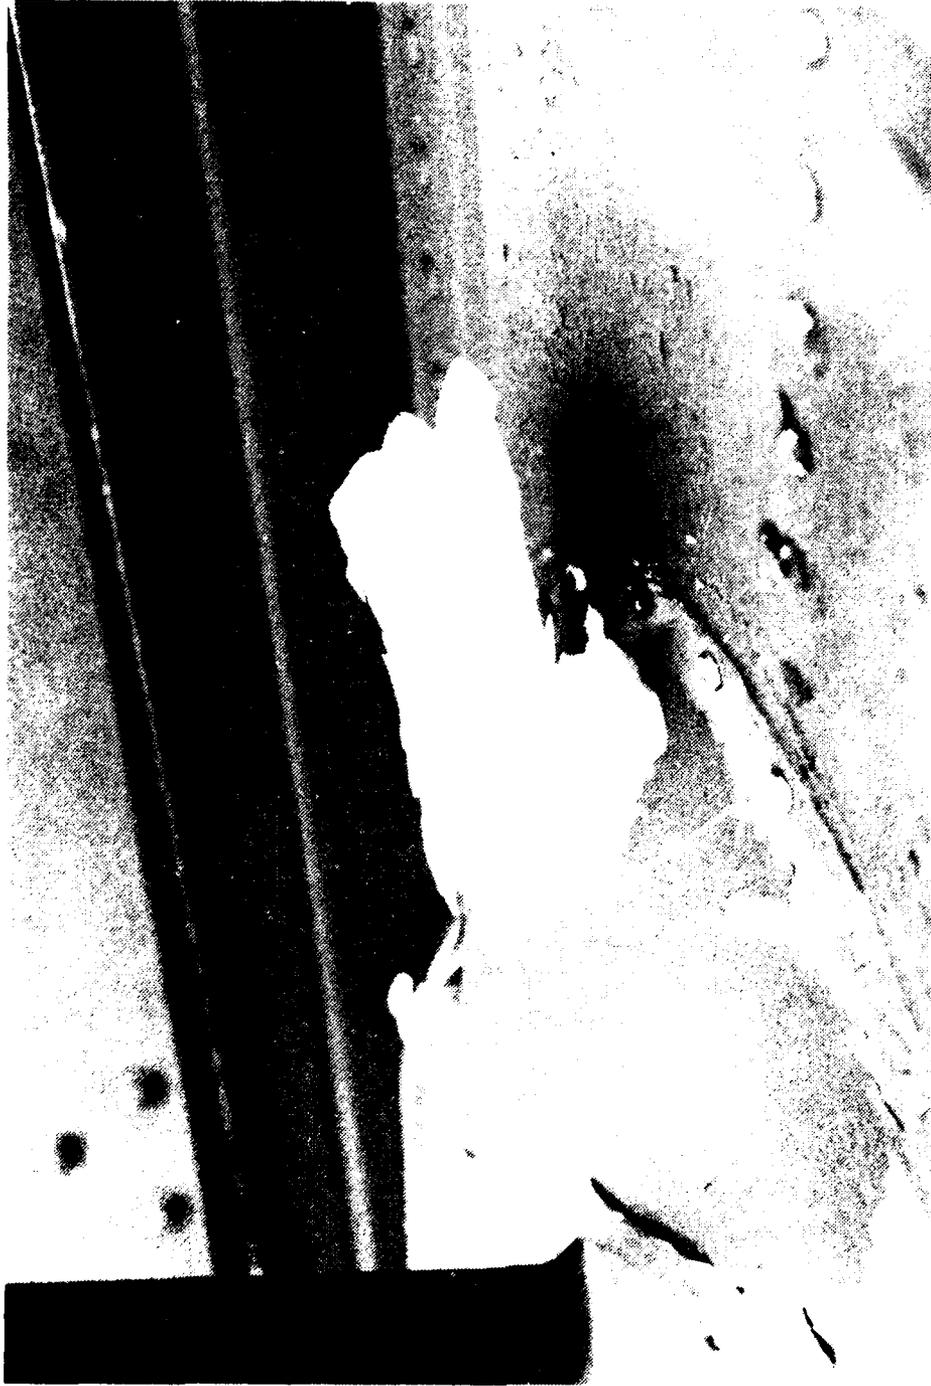
Photo 5. Pitot-Static Probe Mount Fairing Ice Accretion

Conditions: Environment - Natural Avg FAT - -8.0°C
Configuration - 4-Tank Avg LWC - 0.20 gm/m^3
Flight - 11 Time in Cloud - 150 minutes

14. The ice accretion and shedding characteristics of the improved airspeed system pitot-static tube mounts were evaluated at the specific conditions shown in table 1, appendix F. A fairing was installed around the base plate of the standard UH-60A pitot-static tube support as a result of the improved airspeed system modification. Details of the fairings installation is contained in appendix B. An example of an ice accretion on these fairings is shown in photo 5, appendix G. This in-flight photo shows the relative position of this accretion to the engine inlet. Although a few instances of natural ice accretion shedding were observed, no engine FOD was noted. An alternate metal wedge pitot-static strut installation was tested with similar results. The large ice accretion and location of the formation relative to the engine inlet combined to increase the probability of engine FOD. The large ice accretions on the forward portion of the improved airspeed system pitot-static tube support strut fairings or wedges is a shortcoming. The pitot-static tube support strut mounting should be redesigned to minimize or eliminate ice accretion prior to release into icing conditions of any UH-60 aircraft configured with the improved airspeed system.

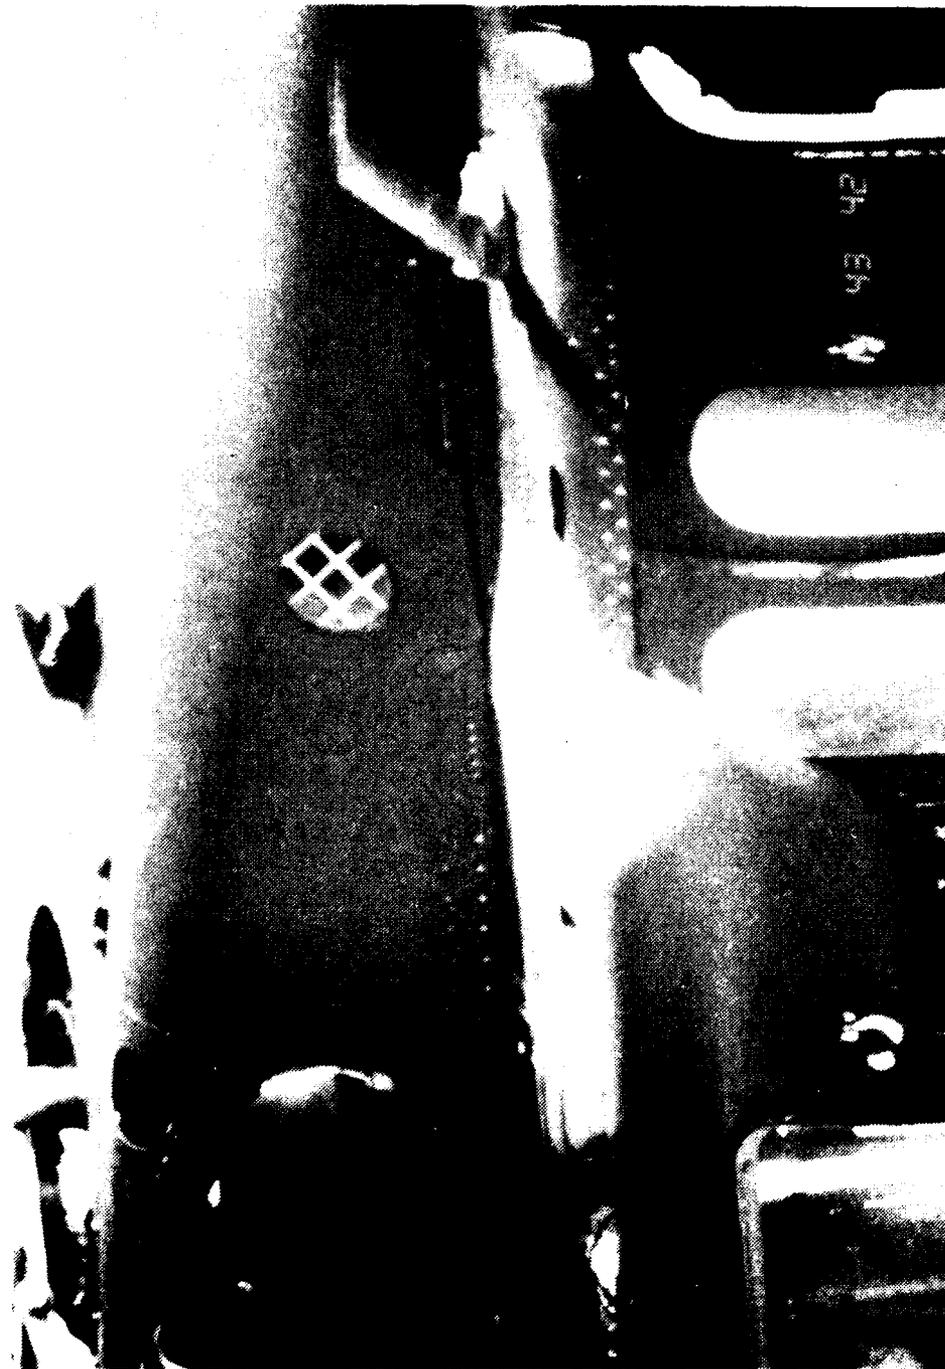
Photo 6. Production Wing Root Fairing Ice Accretion;

Conditions: Environment - Natural Avg FAT - -8.0°C
Configuration - Fixed Provisions Avg LWC - 0.30 gm/m^3
Flight - 16 Time in Cloud - 132 minutes
