USAAEFA PROJECT NO. 83-22

**LIMITED ARTIFICIAL AND NATURAL ICING TESTS
OF THE EXTERNAL STORES SUPPORT SYSTEM
(ESSS) INSTALLED ON A UH - 60A AIRCRAFT**

**JUNE 1984
FINAL REPORT**

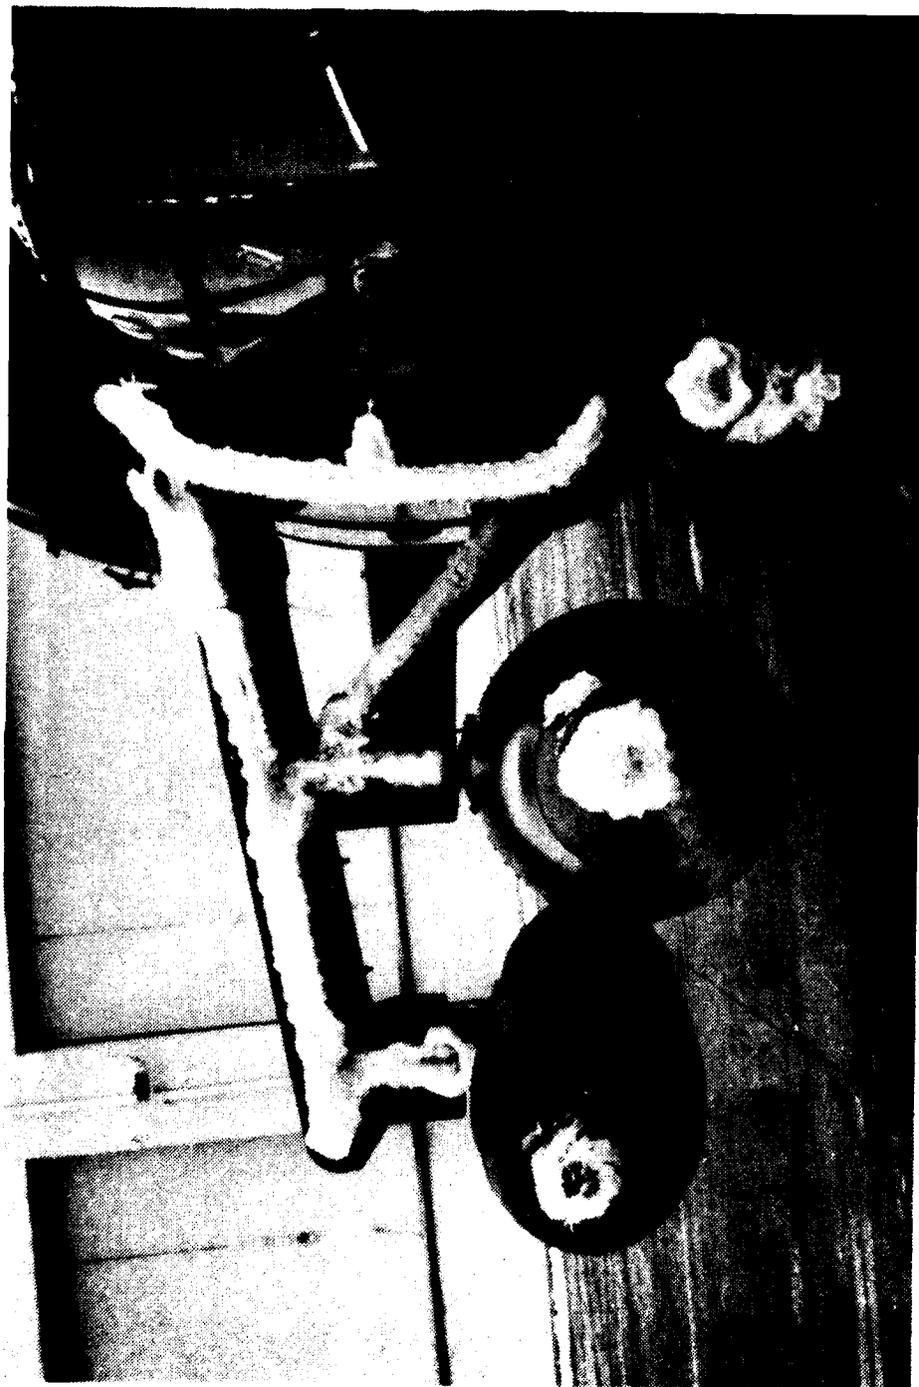
Photo 8. Four Tank ESSS Typical Ice Accretion

Conditions: Environment - Natural
Configuration - 4-Tank
Flight - 10

Avg FAT - -5.5°C
Avg LWC - 0.25 gm/m^3
Time in Cloud - 142 minutes

16. The ice accretion and shedding characteristics of the UH-60A helicopter configured with an ESSS and external fuel tanks were evaluated at the specific test conditions shown in table 1, appendix F. Thirteen of the eighteen icing flights were conducted with the ESSS wing and fuel tanks installed. Eleven flights were flown with four external fuel tanks installed and two were conducted with the two-230 gallon outboard tanks installed. A typical ice accretion is shown in photo 8, appendix G. The ESS installed on the test aircraft was an operable external fuel system and fuel was transferred during icing condition flight with ice accretions on the tanks and supports. As much as four inches of ice was accreted on the stagnation regions of the horizontal and vertical supports, and the nose of the fuel tanks. Larger accretions (approximately six inches thick) were observed on the wing struts due to their higher catch efficiency. On several occasions the aircraft descended below the freezing level and these ice formations were shed. These ice sheds were observed from the chase aircraft and documented on video tape. In all cases the shed ice particles passed well clear of rotating components. No evidence of aircraft damage due to shedding of these ice accretions was documented. The ice accretion and shedding characteristics of the ESSS with either two (230 gallon) or four (two-230 gallon and two-450 gallon) external fuel tanks installed were satisfactory.

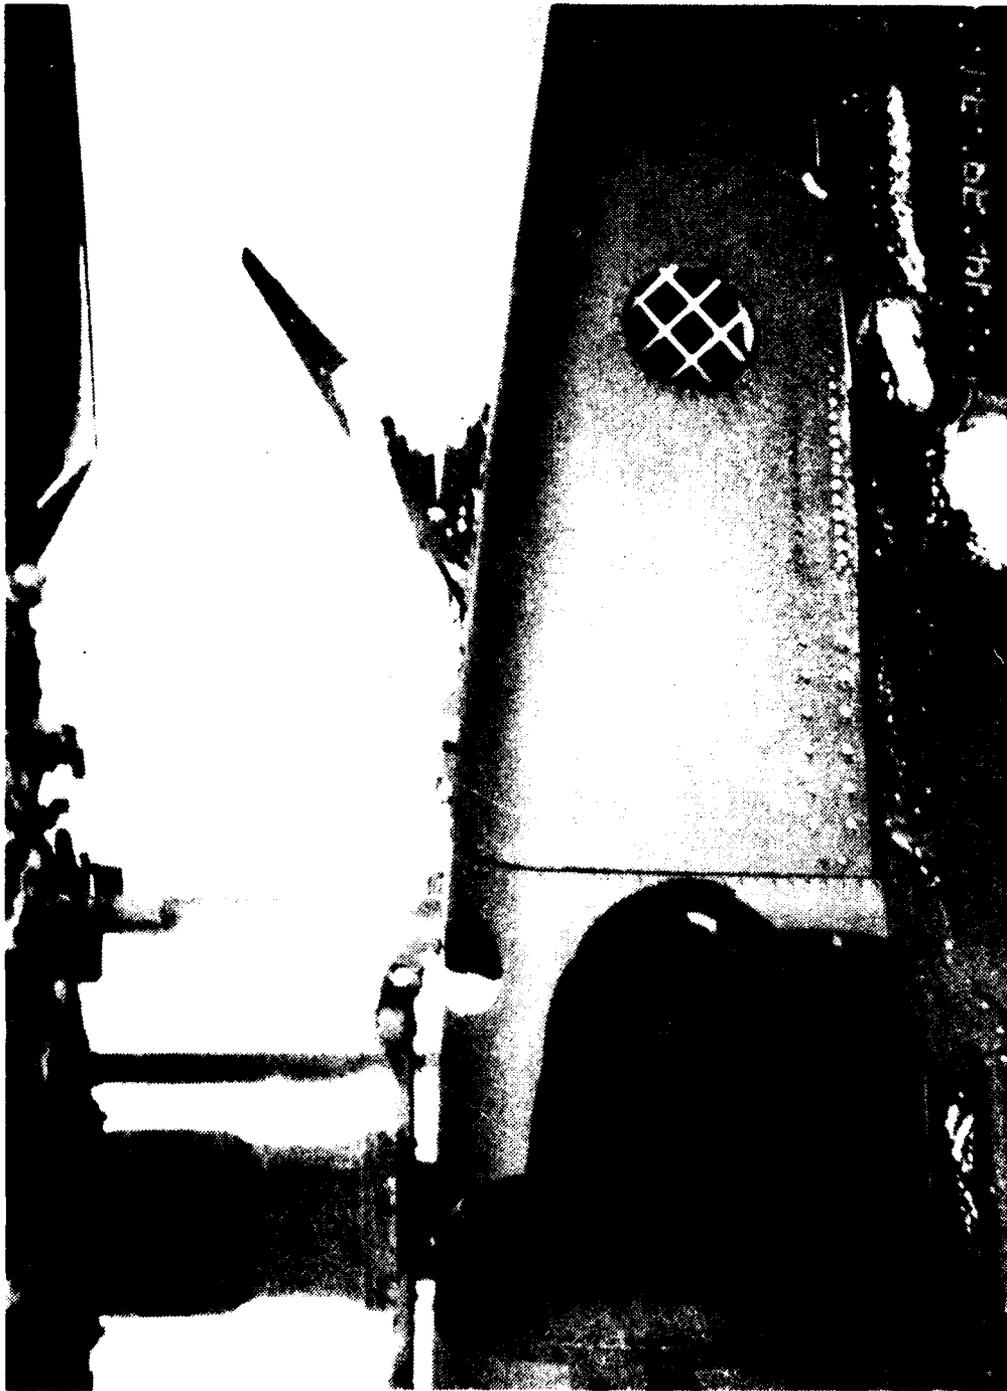
Photo 11. Upper Wire Cutter Ice Accretion

Conditions: Environment - Natural
Configuration - 4-Tank
Flight - 11

Avg FAT - -8.0°C
Avg LWC - 0.20 gm/m^3
Time in Cloud - 150 minutes

18. Ice accretion and shedding characteristics of selected portions of a prototype WSPS were evaluated at the specific test conditions listed in table 1, appendix F. Two upper wire cutters and several wire deflectors were installed. The test installation included only the components considered to have an icing hazard potential. A full description of these WSPS selected components is contained in appendix B. A typical ice accretion can be seen in the large scale aircraft photograph (photo 3, app G). Close-up pictures of the WSPS peculiar accretions are shown in photos 11 through 14, appendix G. Large ice accretions (as much as five inches in thickness) were observed both from the chase aircraft and as residual ice formations after landing. On several occasions observers reported large pieces of ice departing these components and striking various fixed and rotating components of the test aircraft. Ice from the upper wire cutter was seen striking the pitch change links of the main rotor blades and fragmenting into the main and tail rotors. The location of these components near the aircraft centerline and forward of the rotating components contribute to the potential for FOD. Following several flights, in which the ice was naturally shed from the WSPS components, main and/or tail rotor blade damage was noted on the post-flight inspection. One such FOD occurrence (flight 17, average OAT of -7.0°C , average LWC of 0.36 gm/m^3) resulted in dents to three main rotor blade lower skin surfaces. One dent (0.086 inches deep at approximately two-thirds span) was cause for blade rejection. Another dent found on the tail rotor red blade skin approached blade paddle replacement criteria. Lesser damage to other main and tail rotor blades and tip caps were documented throughout these tests. No damage to the main rotor pitch change links was noted. The large ice accretions on the WSPS components which subsequently shed and cause FOD damage to the aircraft is a shortcoming. A design effort should be undertaken to minimize the ice accretion and/or ice shedding FOD associated with the WSPS prior to issuing a clearance for flight in icing conditions for aircraft so equipped.
