Structures Technical Memorandum 399

**A REVIEW OF AUSTRALIAN INVESTIGATIONS ON
AERONAUTICAL FATIGUE DURING THE PERIOD
APRIL 1983 TO MARCH 1985**

This document was prepared for presentation to the 19th Conference of the International Committee on Aeronautical Fatigue scheduled to be held in Pisa, Italy on May 20 and 21, 1985. It is being distributed within Australia as an ARL Technical Memorandum.

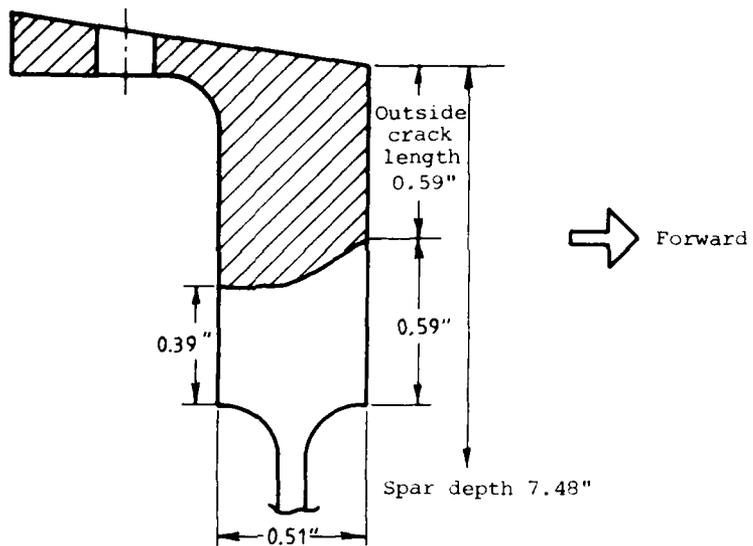
FIG. 9.1 CROSS-SECTION OF NOMAD STUB WING
UPPER-SPAR-CAP CRACK (B.L.476)

To the beginning of 1985 a total of 165,843 simulated flights have been achieved. The fatigue test was temporarily halted in December, 1982 due to a critical failure of the stub wing front spar upper cap, Fig. 9.1. After an 18 month down-time, the Nomad fatigue test programme was resumed in May, 1984. The original stub-wing assembly was completely removed and replaced by a new test specimen at 137,986 test hours. The new stub-wing structure incorporates some potentially fatigue sensitive parts from the previous test specimen (rear spar, strut pick-up fittings, etc) and a new front spar.

The stub wing spar cap residual strength test was followed by fractographic investigation of the fracture face. Figures 9.1 and 9.4 show the starboard failure location, and the fractographically derived crack propagation data. The fracture surface was badly damaged during the test, and the crack propagation data include some gaps. These uncertainties may be resolved by a fractographic examination to be made of the port side spar crack, and the crack in the same location in the second stub-wing.

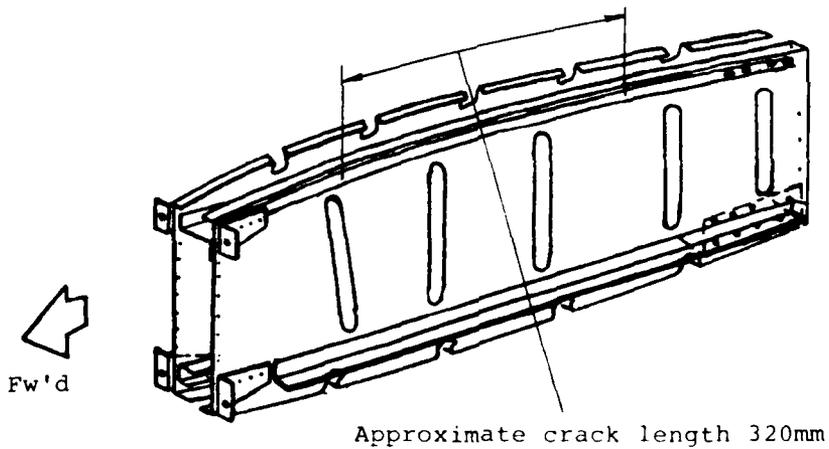
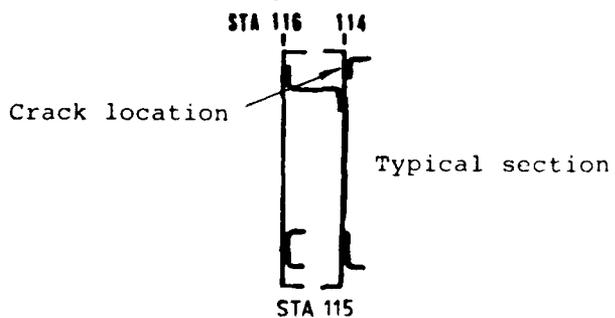
FIG. 9.2 NOMAD WING RIB ASSEMBLY SHOWING LOCATION OF CRACKING
ON FATIGUE TEST

The test continues to reveal some unexpected failures. For example, a major crack was identified in the main wing rib at STA.114, Fig. 9.2. The rib will shortly be replaced. A critical crack has also developed in the front spar upper cap of the new stub wing. The crack location is identical to the previous failure location, but the times to crack initiation differ by a factor of five, Fig. 9.3. This failure could have significant implication for the service life of Nomad aircraft. However, it is envisaged that

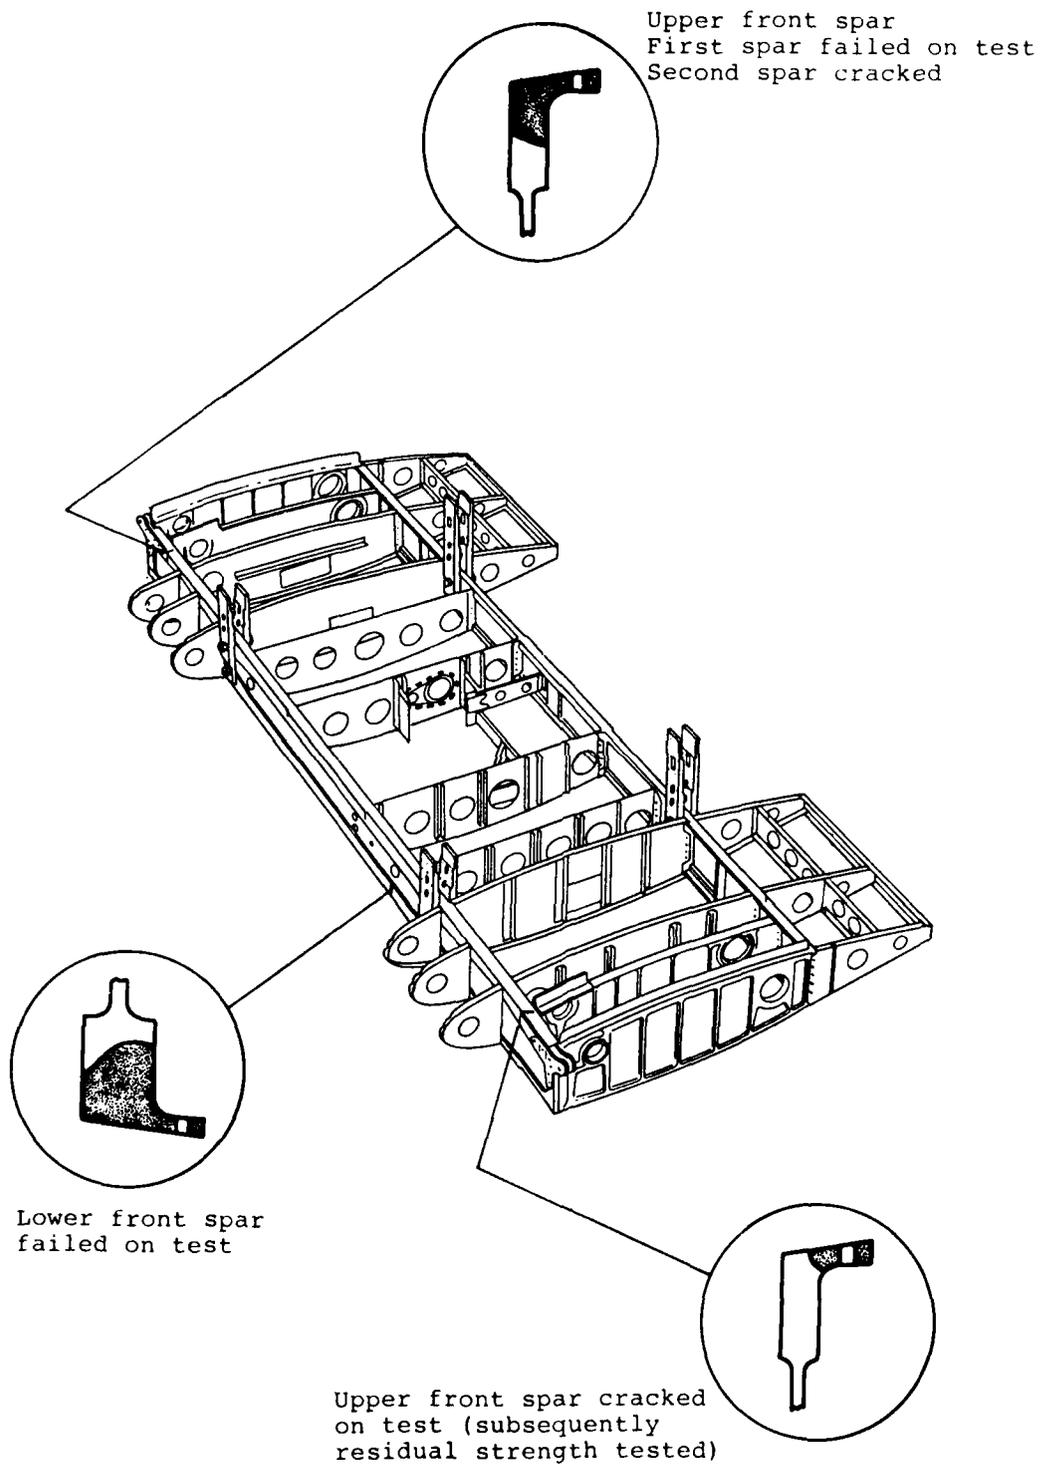
FIG. 9.3 NOMAD STUB WING SHOWING LOCATIONS OF MAJOR FATIGUE TEST FAILURES

Although the total number of identified cracks to date is 163 /3/, and most of these cracks are of relatively minor significance, some major or critical cracks have also occurred. A brief summary of the major cracks and failures is provided in Table 9.1. The fatigue test is also providing an ideal opportunity to develop and evaluate possible repair schemes and inspection techniques. For example, a redesigned lower wing skin has survived 54,000 flights without any cracking, whereas the first crack in the original skin was already noted at 4,500 flight hours /4/.

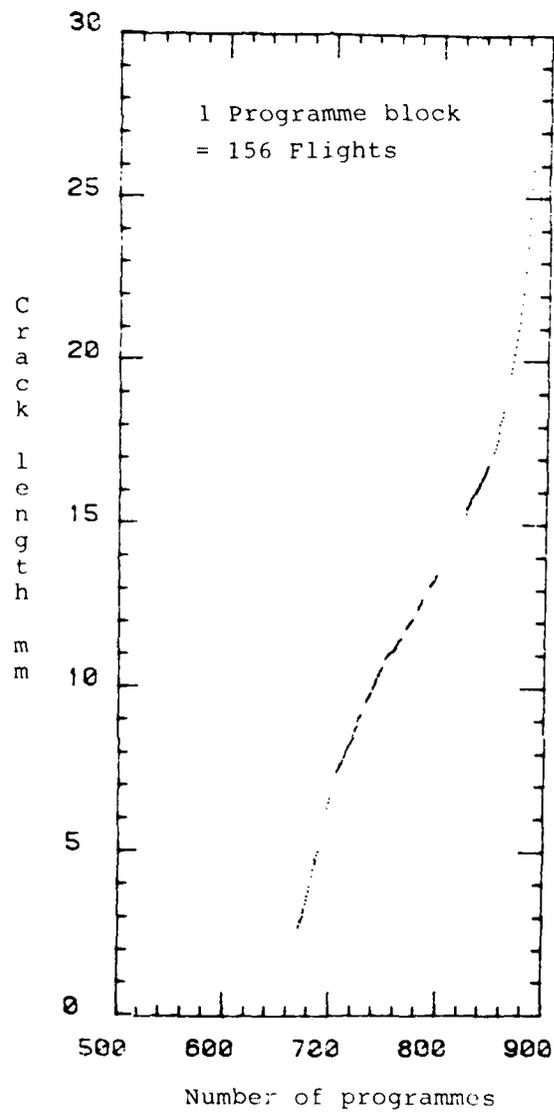
FIG. 9.4 RADIAL CRACK DEPTH VERSUS THE NUMBER OF PROGRAMME BLOCKS FOR THE NONAD STUB WING FRONT SPAR UPPER CAP FAILURE AT B.L. 47.6

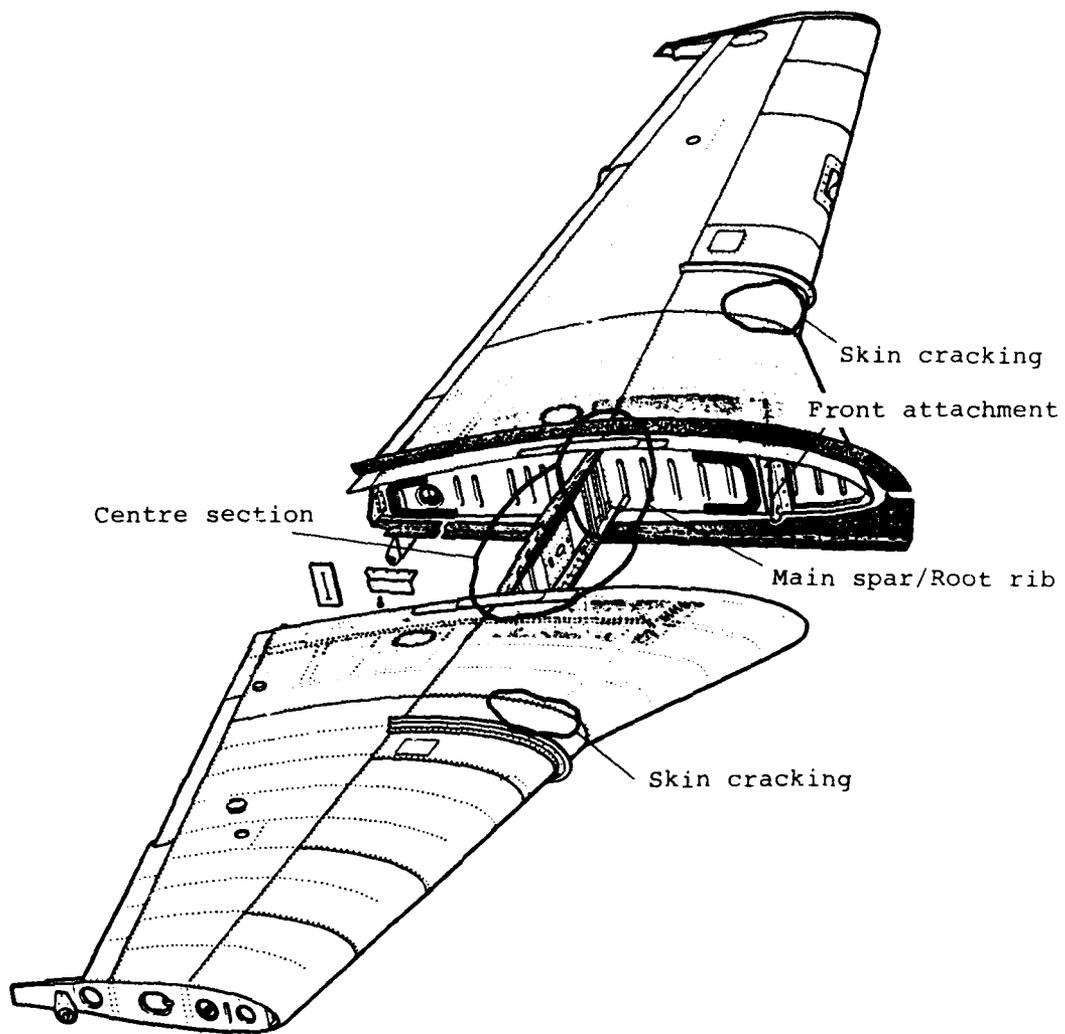
FIG. 9.6 CT4-A MAIN PLANE ASSEMBLY

The test highlighted four main fatigue prone areas. All were in the mainplane assembly shown in Fig. 9.6. The 5000 hour major inspection revealed considerable fatigue damage in the port wing forward attachment area. It was found by fractographic analysis that the two lowest bolts of the attachment bracket failed at approximately 2500 hours. There was also fatigue cracking in the inter-rib diaphragms and corner stiffening brackets as depicted in Fig. 9.7. The corresponding area in the starboard wing was free of damage and did not fail in this manner until 17,000 hours whereas the port side required frequent bolt replacement throughout the test.

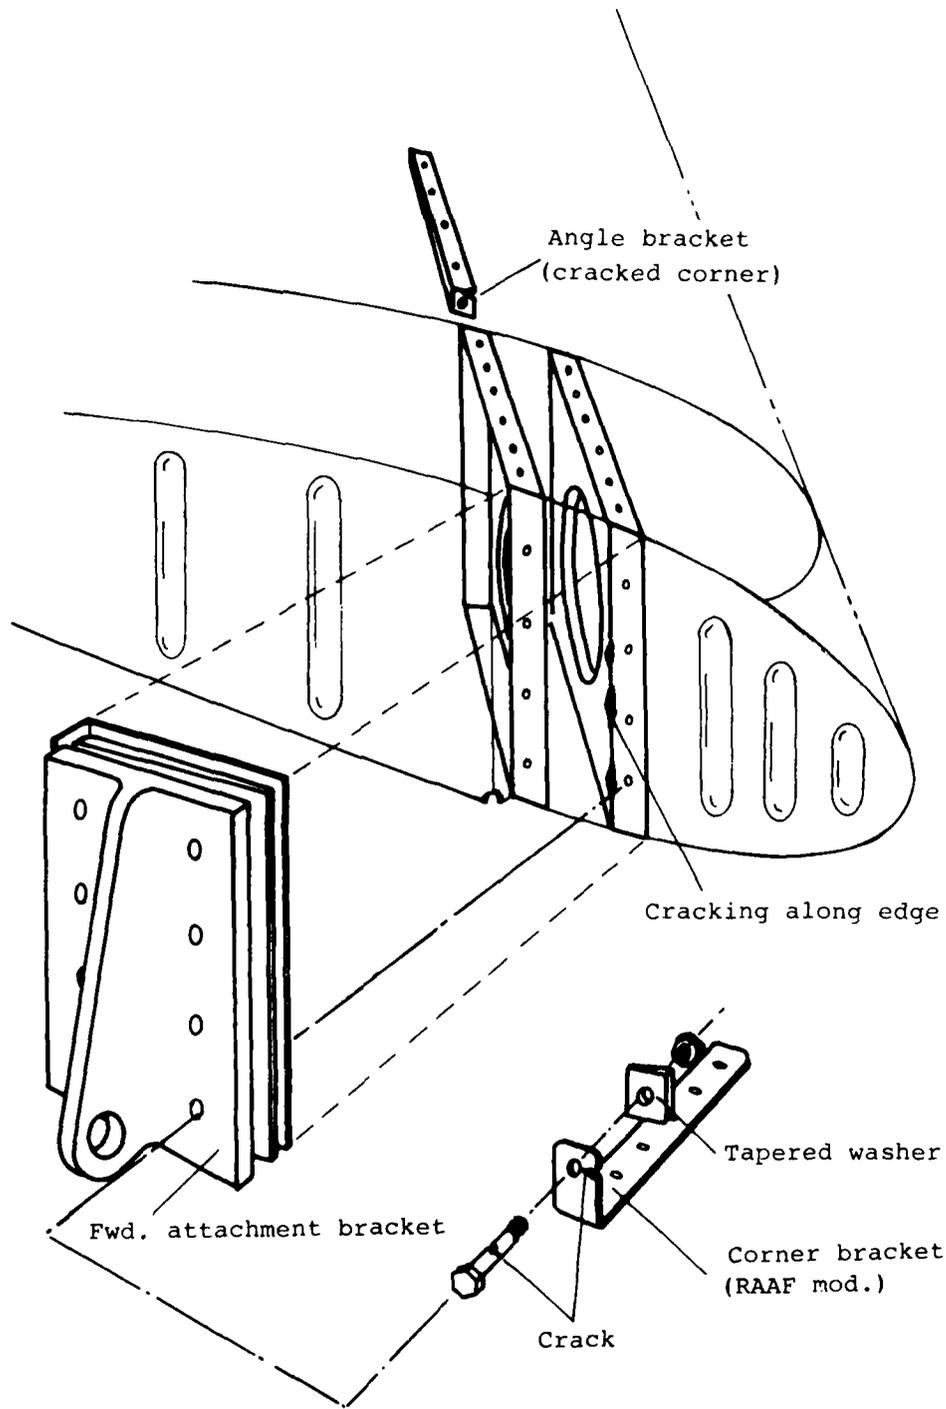
FIG. 9.7 CT4-A FORWARD WING ATTACHMENT DETAILS SHOWING DAMAGE AT 5000 HRS.

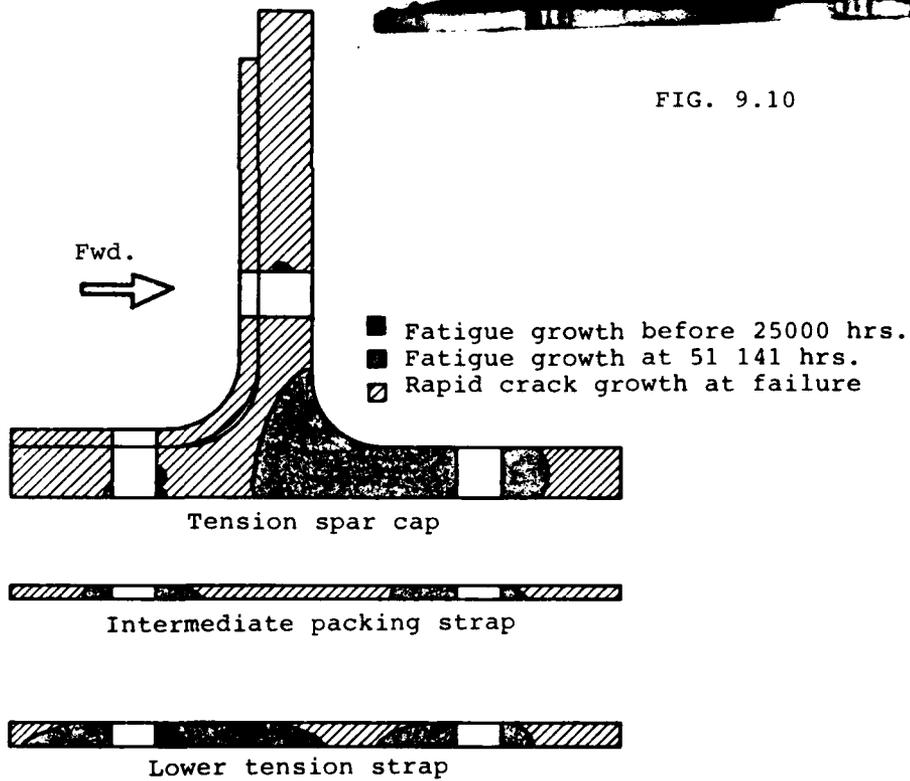
FIG. 9.11 CT4-A MAIN SPAR TENSION BOOM FAILURE

Final failure occurred at 51,141 simulated hours in the port wing main spar tension boom assembly between ribs 1 and 2 as shown in Fig. 9.9. A photograph of the failed boom is shown in Fig. 9.10. and a diagram showing the crack initiation sites and the crack growth in the boom assembly is shown in Fig. 9.11.

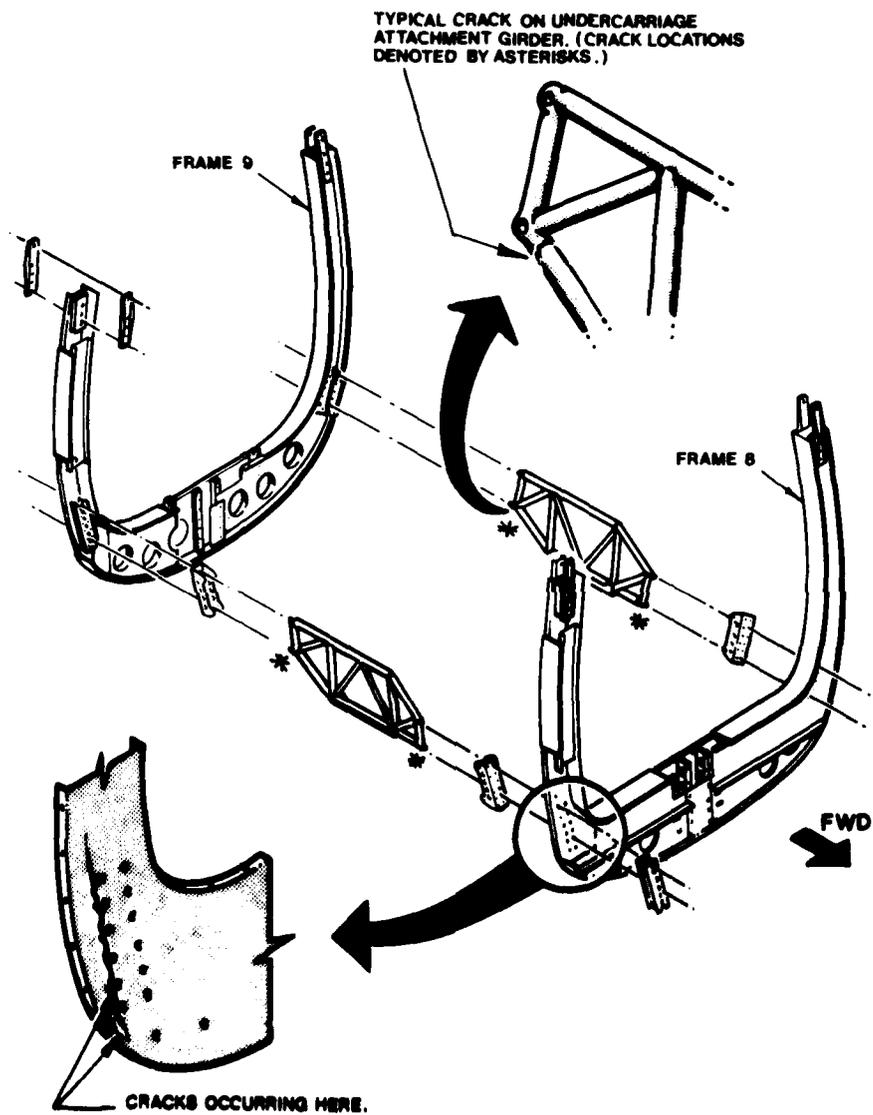
FIG. 9.12 PARTENAVIA P68 CENTRE FUSELAGE STRUCTURE SHOWING CRACKED FRAMES

The cracks were found in frame 8 and frame 9 at the landing gear girder truss attachment bracket locations shown in Fig. 9.12. The starboard side of frame 8 had cracks between the outer attachment bracket holes, running from the lower bolt hole to the frame radius in a downward and outward direction. The crack continued along the radius for approximately 25 mm. Similar cracking was observed on the port side of frame 8, but in this case the crack stopped at the frame radius. Cracking in frame 9 was similar but less severe.

The manufacturer has responded to the fuselage frame cracking by designing a repair scheme which involves the installation of a doubler over the subject area. This allows most of the undercarriage loads to be distributed away from the cracked frame area and should alleviate any further problem.

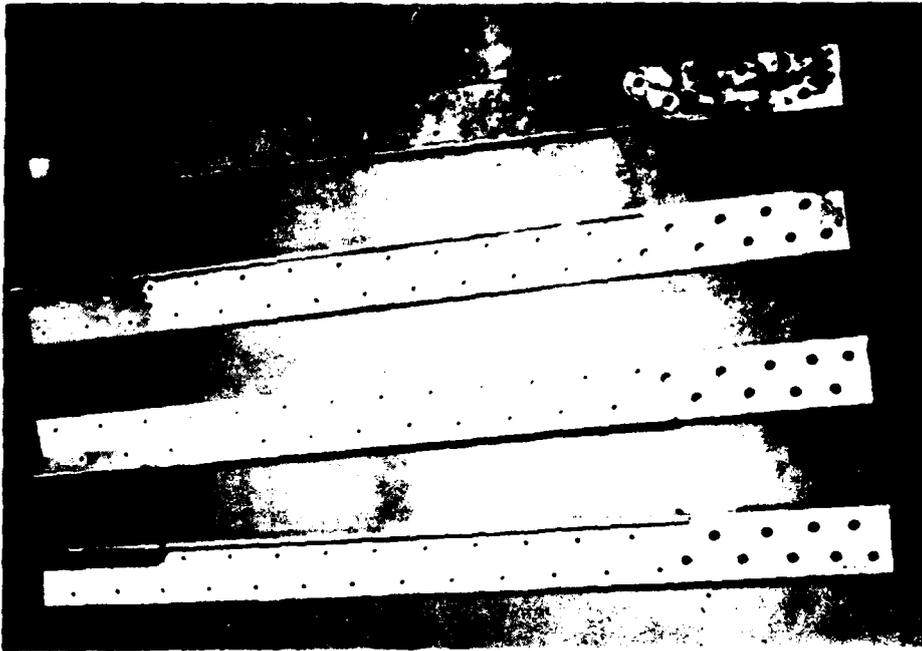
FIG. 9.13 PARTENAVIA P68 FRONT SPAR FORWARD
AND AFT LOWER CAP ANGLES, AS REMOVED

While carrying out repairs to the wing of an accident-damaged Partenavia P68 aircraft, cracks were discovered in both front and rear spars. In each case the cracks were located in the horizontal flange of the lower cap angles, at the inboard end where the horizontal flange tapers in width to enable it to pass through the wing-fuselage attachment. Fig. 9.13 shows the four front spar sections as removed from the aircraft.

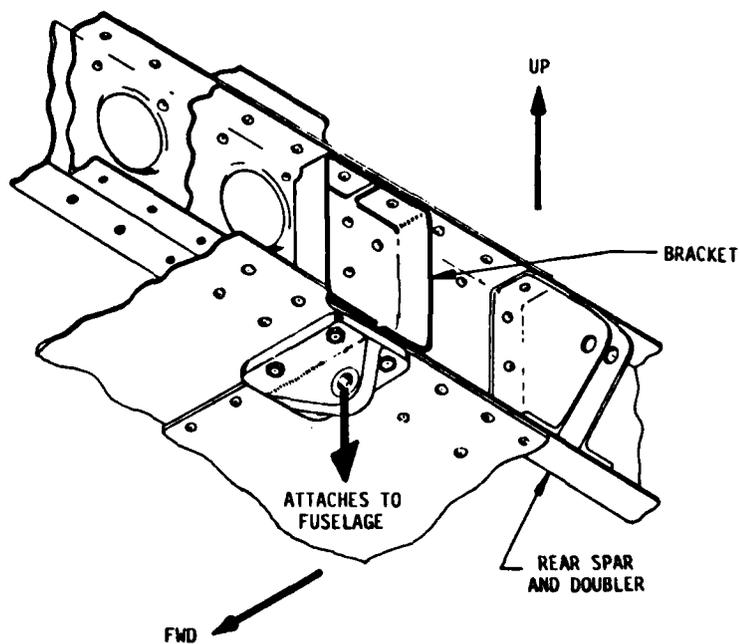
FIG. 9.16 CESSNA 210 TAILPLANE BRACKET INSTALLATION
(LEFT SIDE ONLY SHOWN)

The Australian Department of Aviation has received a number of Defect Reports concerning cracked Cessna Model 210 tailplane left hand rear spar reinforcement brackets, Fig. 9.16. All the brackets were cracked in the same location, along the bottom radius from left to right, and in the fore/aft direction through the left hand countersunk screw hole, Fig. 9.17. In one case both the rear spar and doubler reinforcement making up the spar assembly were found cracked at the flange bend radius immediately under the cracked reinforcement bracket. Another recent defect report indicated that the doubler only was cracked.

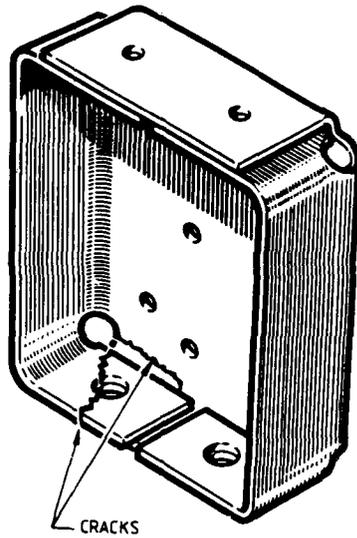
FIG. 9.17 CESSNA 210 TAILPLANE REAR SPAR REINFORCEMENT BRACKET

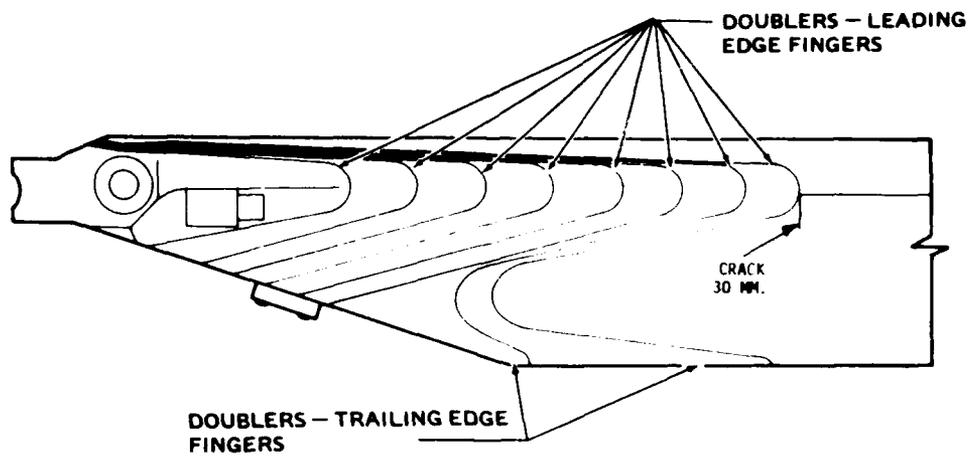
FIG. 9.24 BELL 206 B MAIN ROTOR BLADE REINFORCEMENT

The first of these involved a fatigue crack which was found in the skin of a Bell 206B main rotor blade. The root end of the blade is reinforced by a number of overlying bonded finger doublers, Fig. 9.24. Should disbonds occur under the end of a doubler, the standard repair scheme is to trim up to 50 mm from the end of the doubler. However, the repair is rather delicate in that great care is required to prevent inadvertent tool damage to the underlying skin. This point is emphasised strongly in the manufacturer's repair and overhaul instructions, and also in operational safety notices.

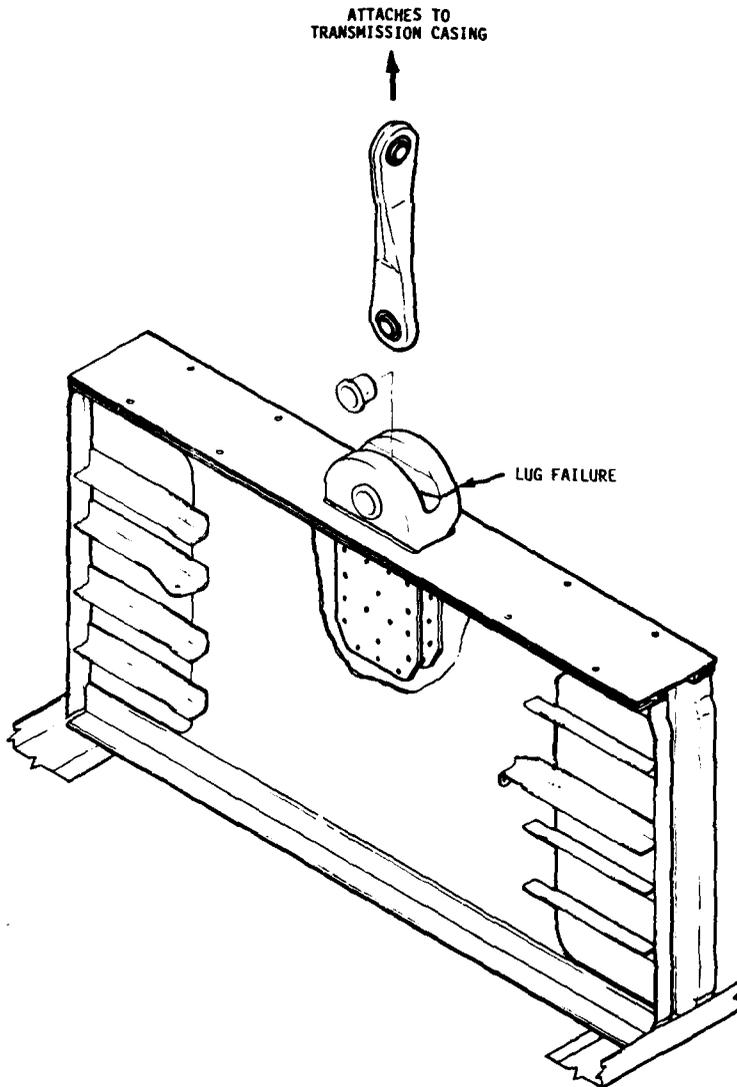
FIG. 9.29 LIFT LINK, LIFT BEAM AND ATTACHMENT FITTING - BELL 212 HELICOPTER

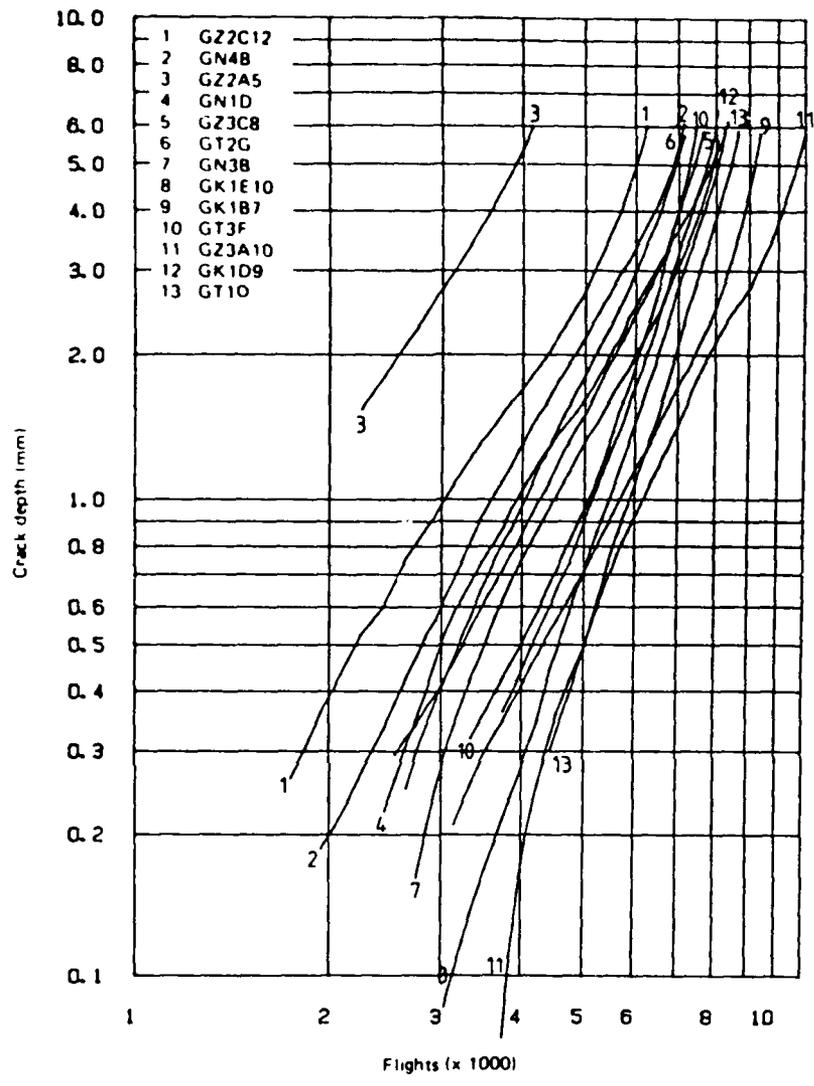
FIG. 9.31 FATIGUE CRACK GROWTH FROM 8mm BOLT HOLE
SPECIMENS WITH 0.125 INCH SLAN RIVETS, SPECTRUM TYPE 1

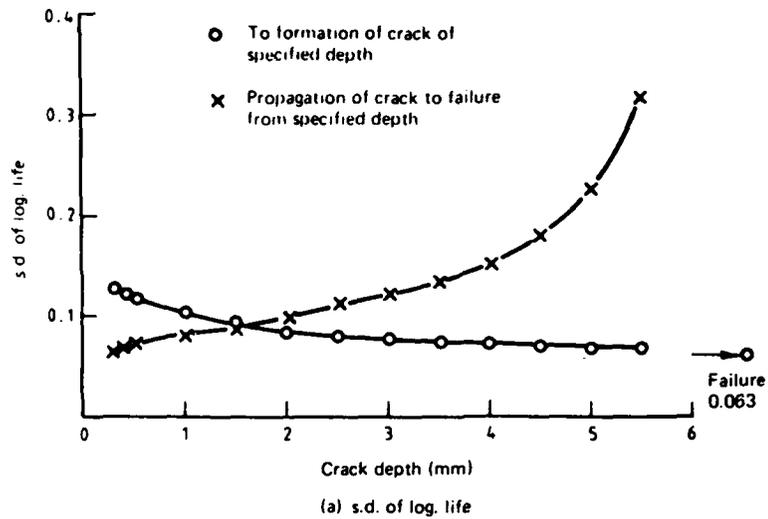
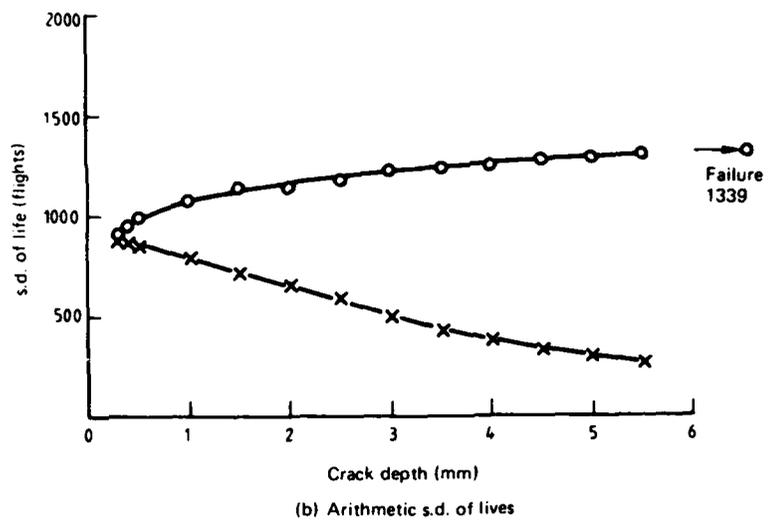
FIG. 9.32 VARIABILITY IN LIVES TO FORMATION AND PROPAGATION OF CRACKS OF SPECIFIED DEPTHS

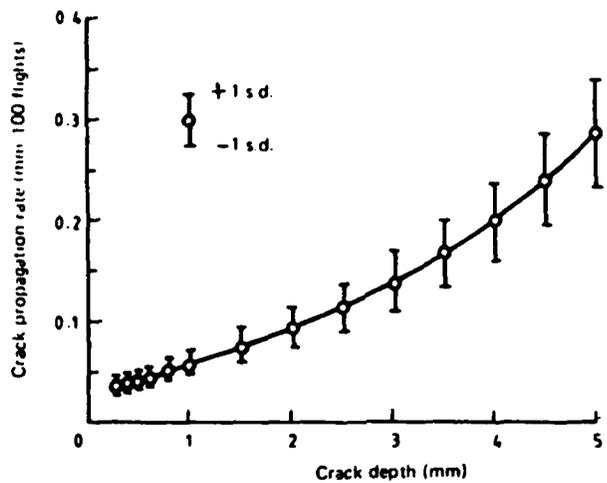
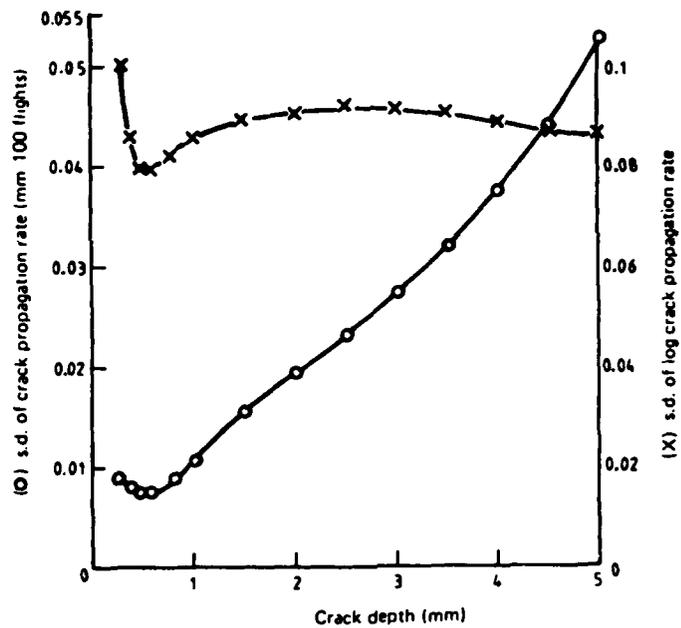
(a) Crack propagation rates

(b) s.d. of crack propagation rates

FIG. 9.33 RELATIONSHIPS BETWEEN CRACK PROPAGATION RATES AND CRACK DEPTHS

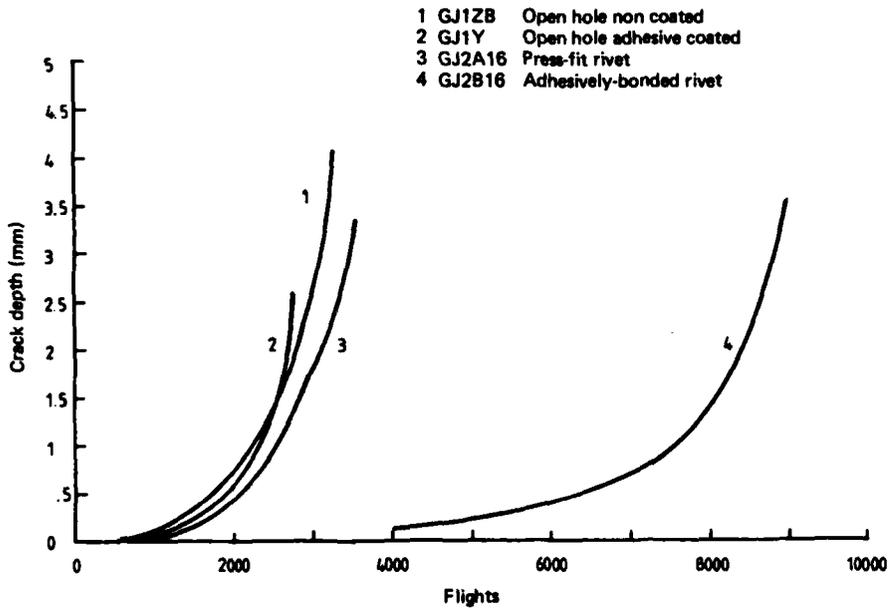
FIG. 9.34 EFFECT OF ADHESIVE BONDING ON CRACK PROPAGATION

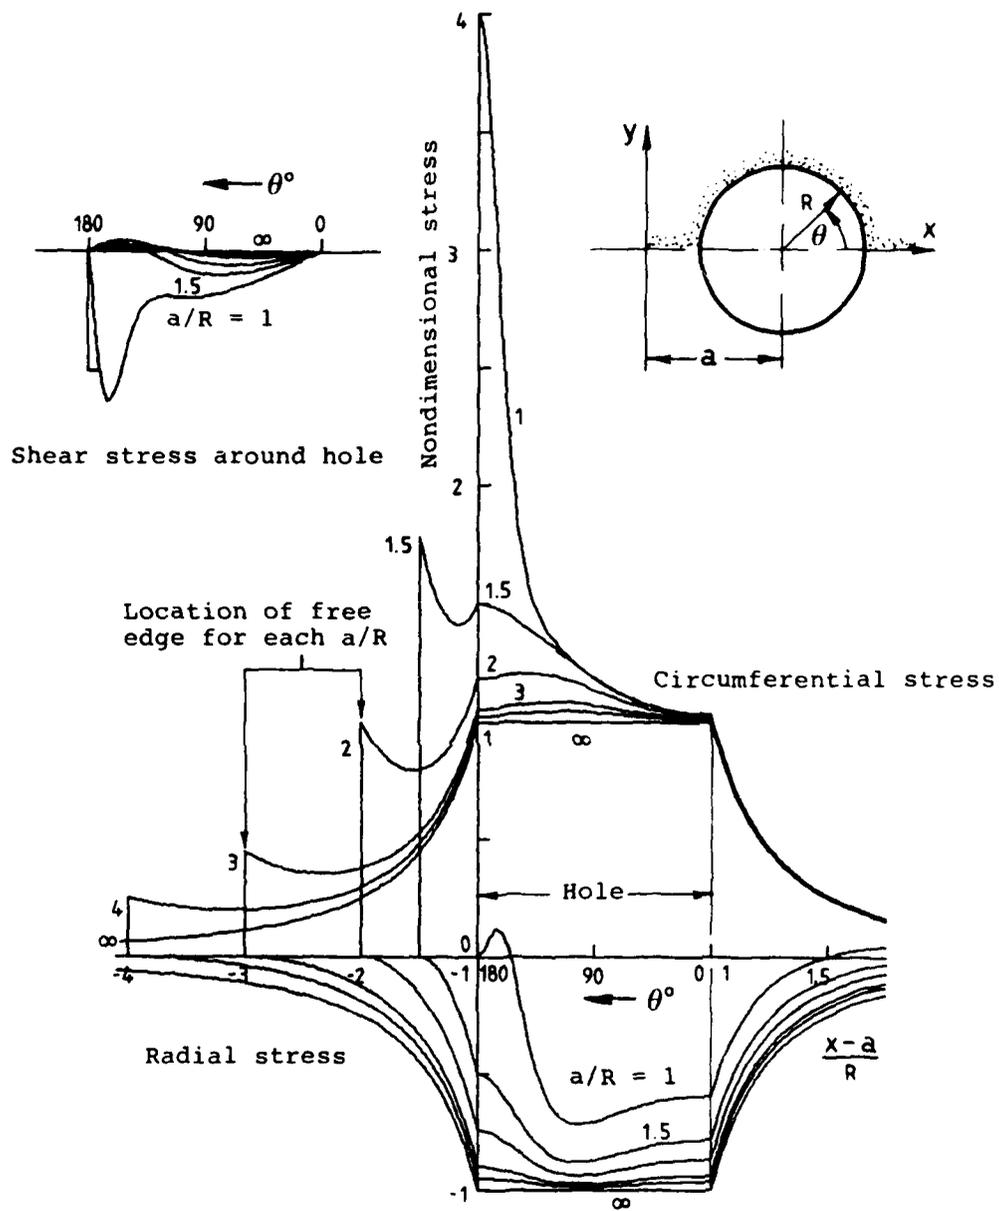
FIG. 9.35 ELASTIC INTERFERENCE-FIT STRESS DISTRIBUTION AROUND HOLE AND ALONG X AXIS - EFFECT OF EDGE DISTANCE

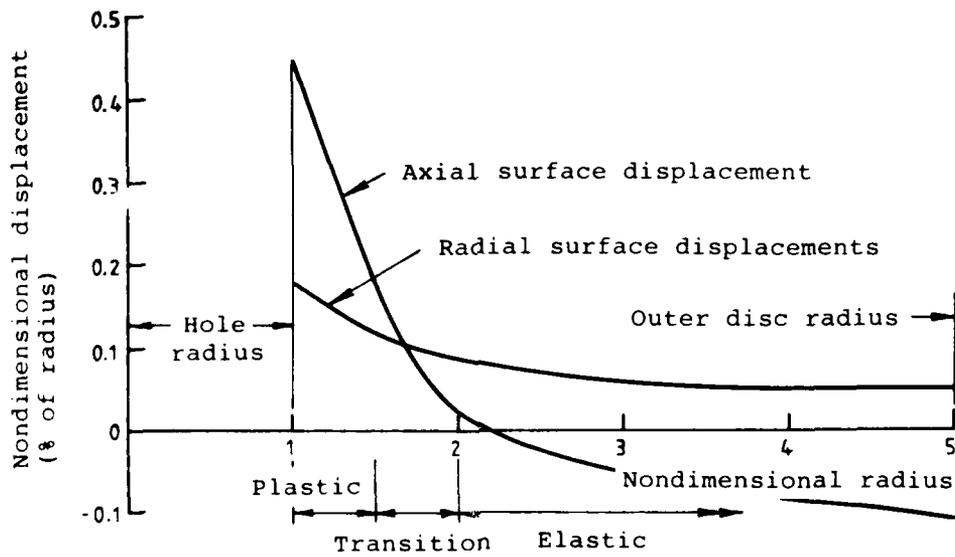
FIG. 9.36 SURFACE DISPLACEMENT OF AN ALUMINIUM ALLOY DISC CONTAINING A PRESSURIZED HOLE (NONDIMENSIONAL THICKNESS = 6.25)

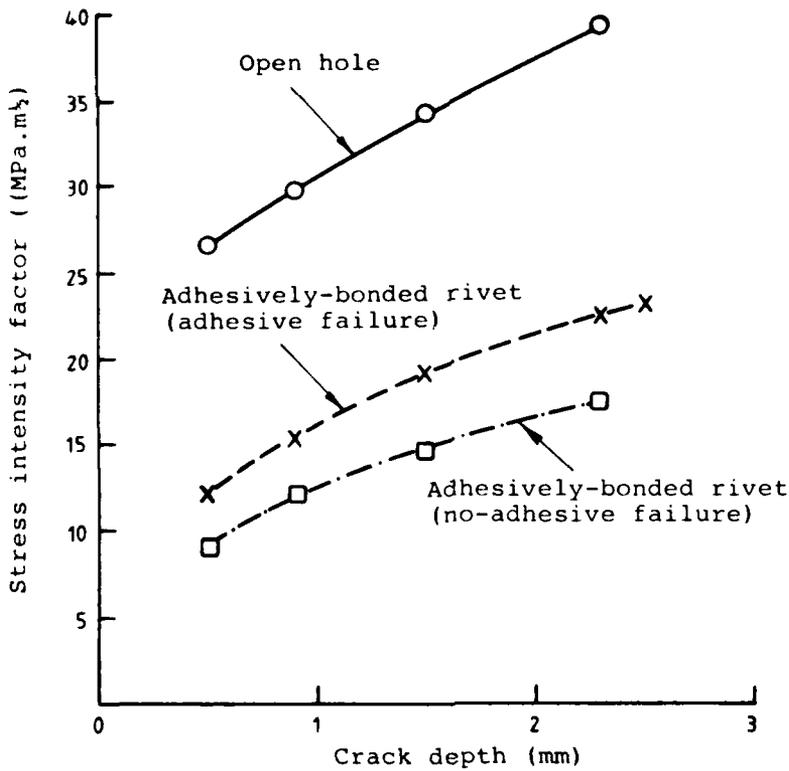
FIG. 9.37 STRESS INTENSITY FACTORS FOR HOLES WITH CRACKS ON BOTH SIDES

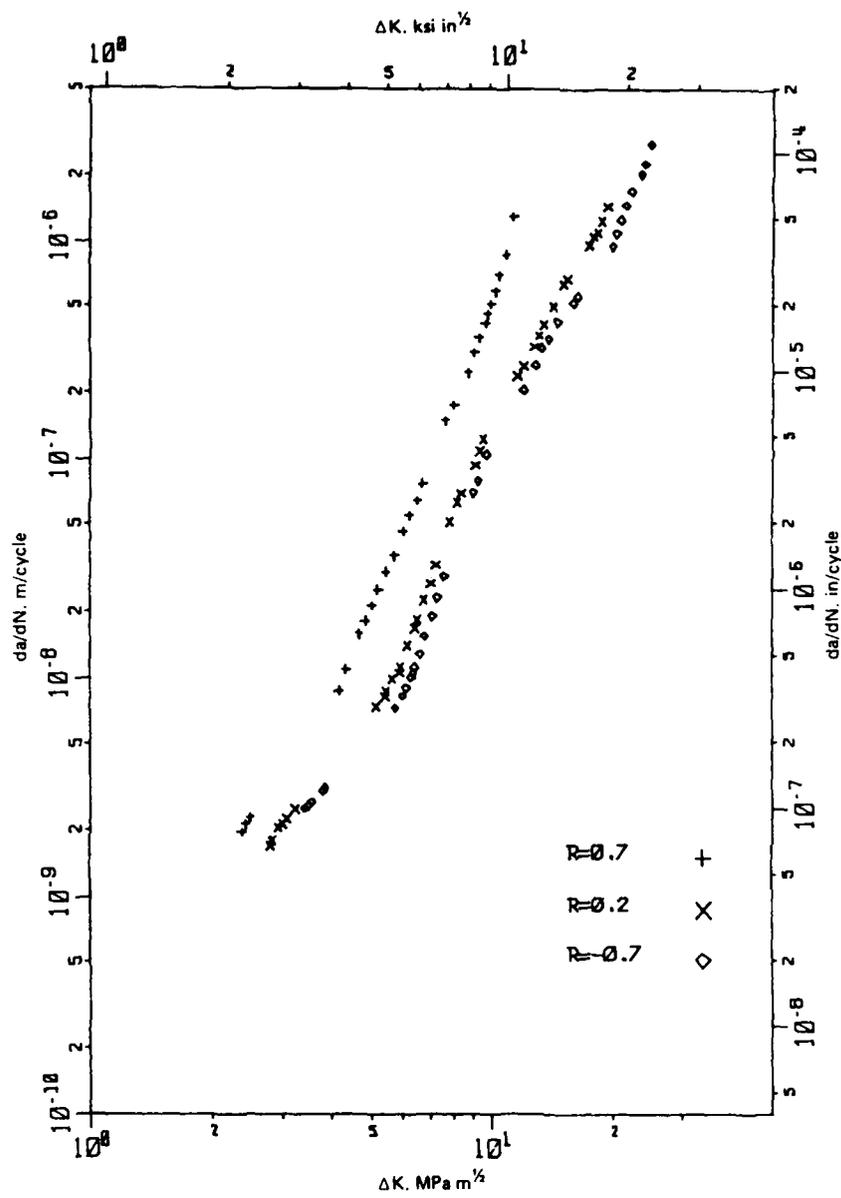
FIG. 9.39 CRACK GROWTH DATA FOR 20mm THICK CCT SPECIMENS

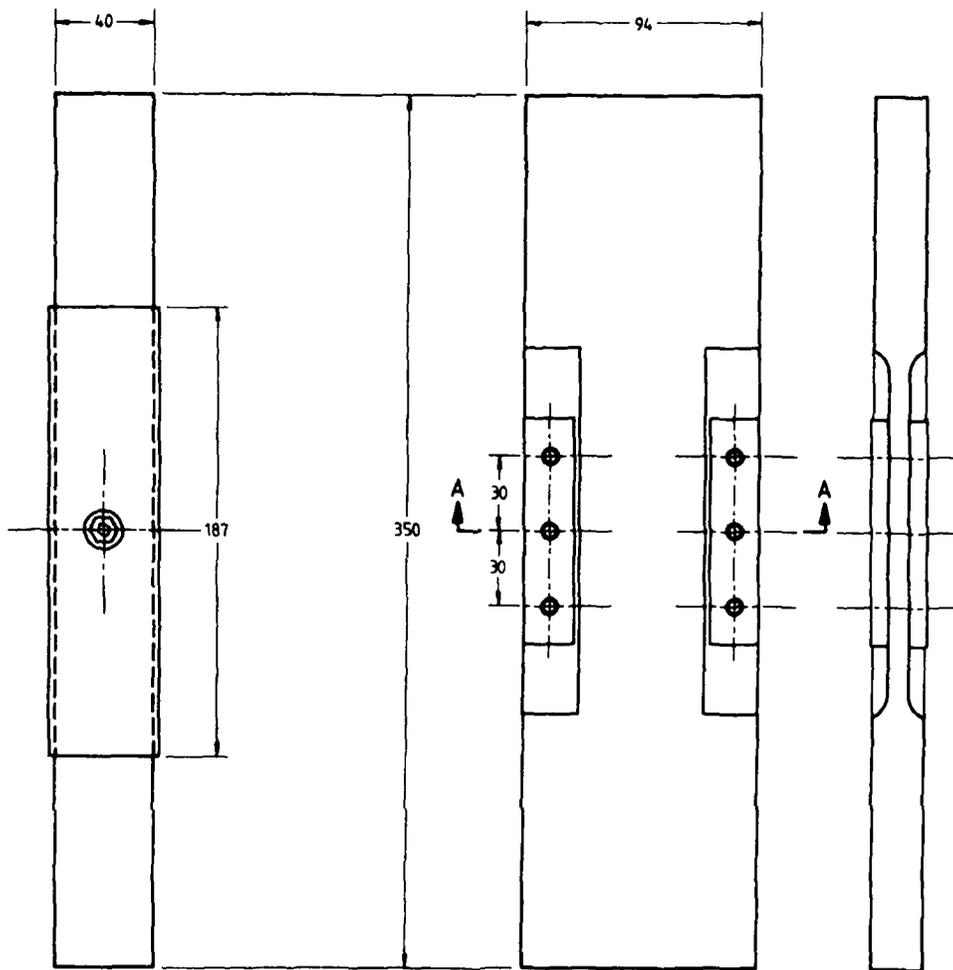
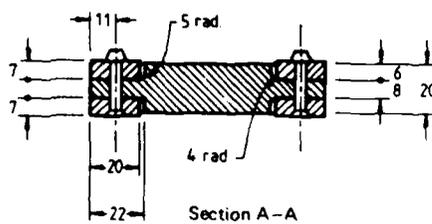
FIG. 9.40 HOLE 18

FIG. 9.41 BOTTOM OF FRAME

Simulation specimens for regions of
Mirage Frame 26

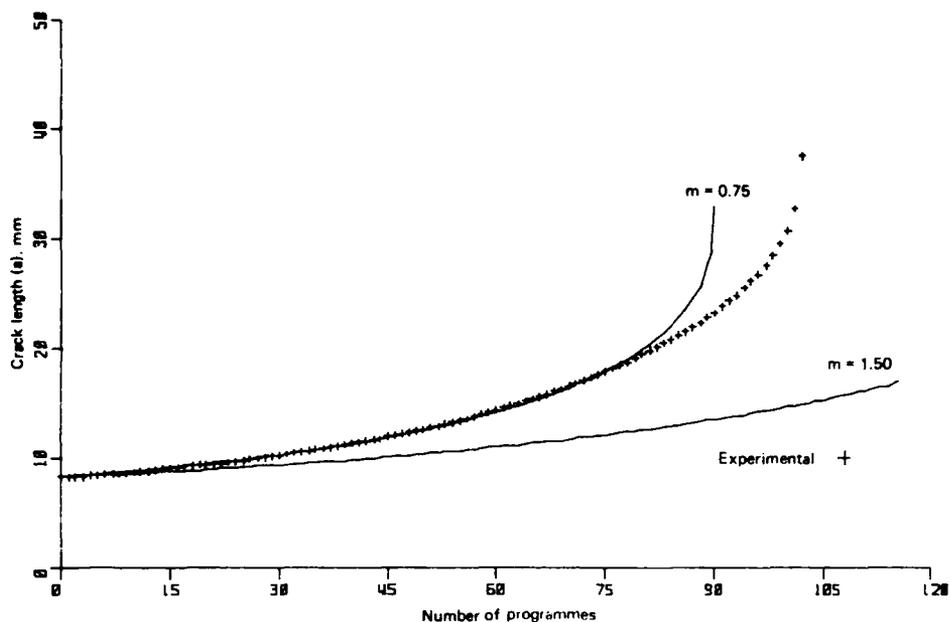
FIG. 9.42 CALIBRATION OF WHEELER EXPONENT, m .
20mm THICK CCP SPECIMEN TESTED UNDER THE
F + W SEQUENCE (13.33 MPa/g)

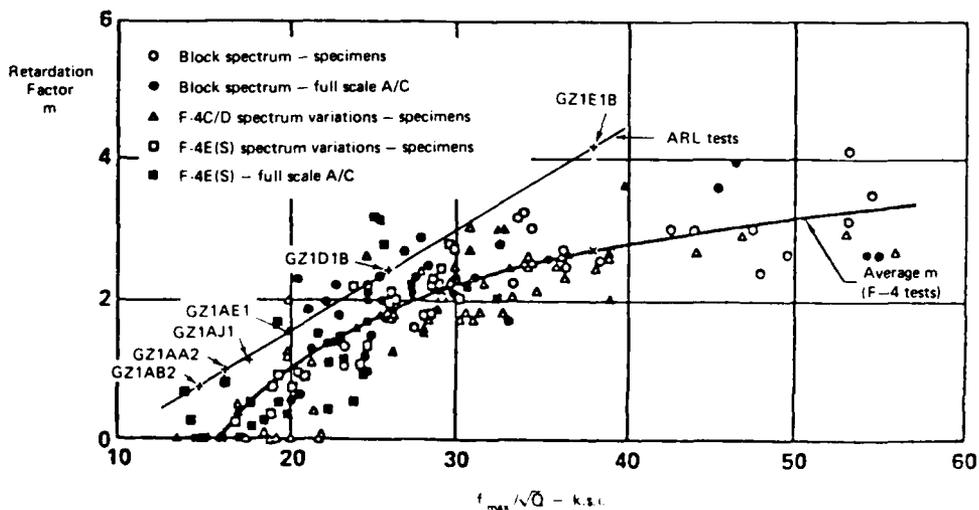
FIG. 9.43 DEPENDENCE OF WHEELER RETARDATION EXPONENT,
 m , ON MAXIMUM STRESS IN SEQUENCE AND CRACK
SHAPE

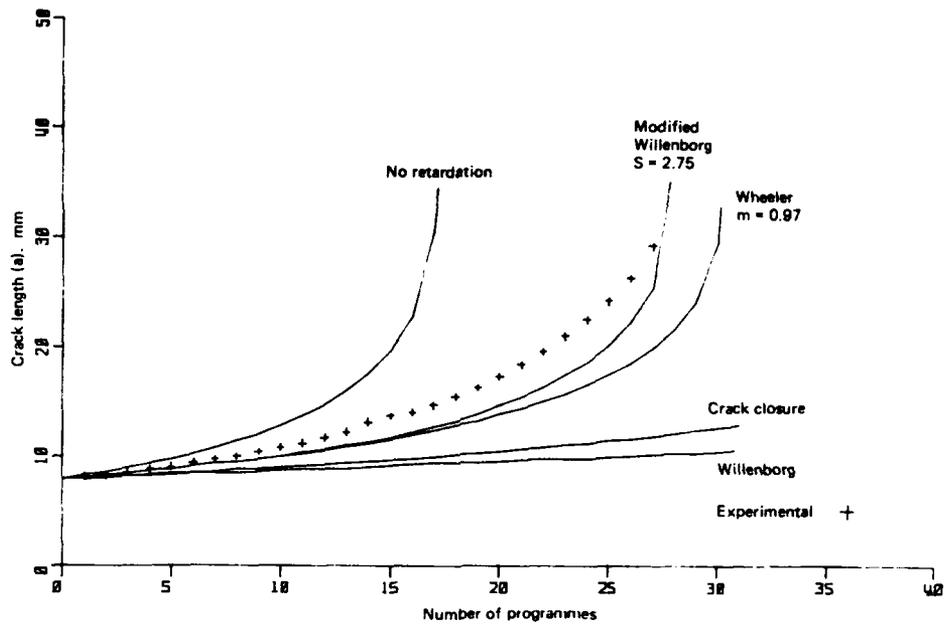
FIG. 9.44 CRACK GROWTH IN 20mm THICK CCT SPECIMEN UNDER THE RAAF 'ALL-TIME-AVERAGE' SEQUENCE (14.12 MPa/g)

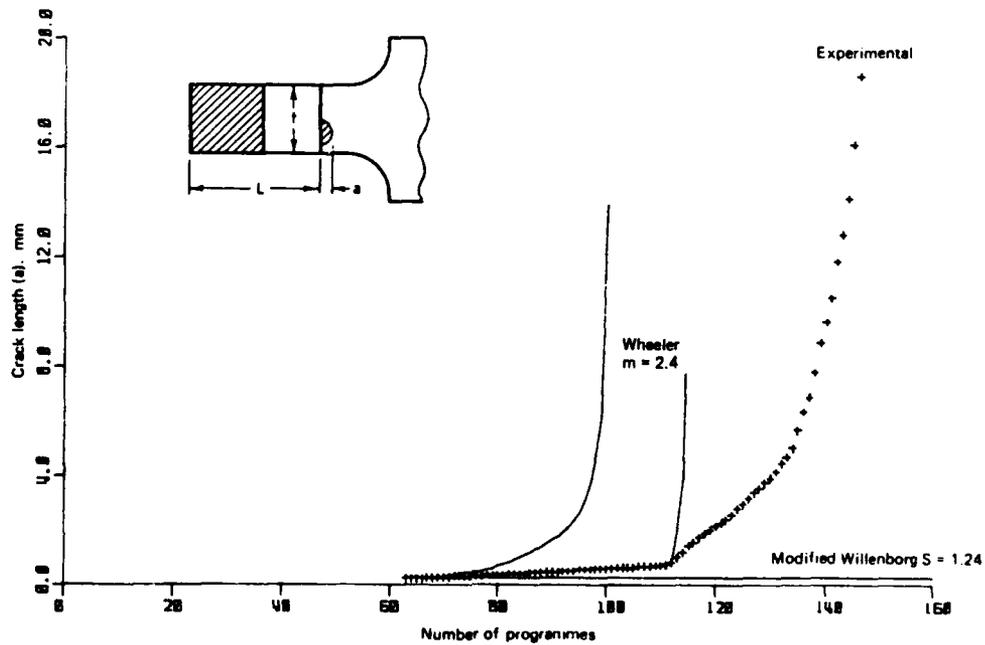
FIG. 9.45 CRACK GROWTH PREDICTION FOR FRAME-BOTTOM SIMULATION SPECIMEN TESTED UNDER THE RAAF 'ALL-TIME-AVERAGE' SEQUENCE (28.63 MPa/g)

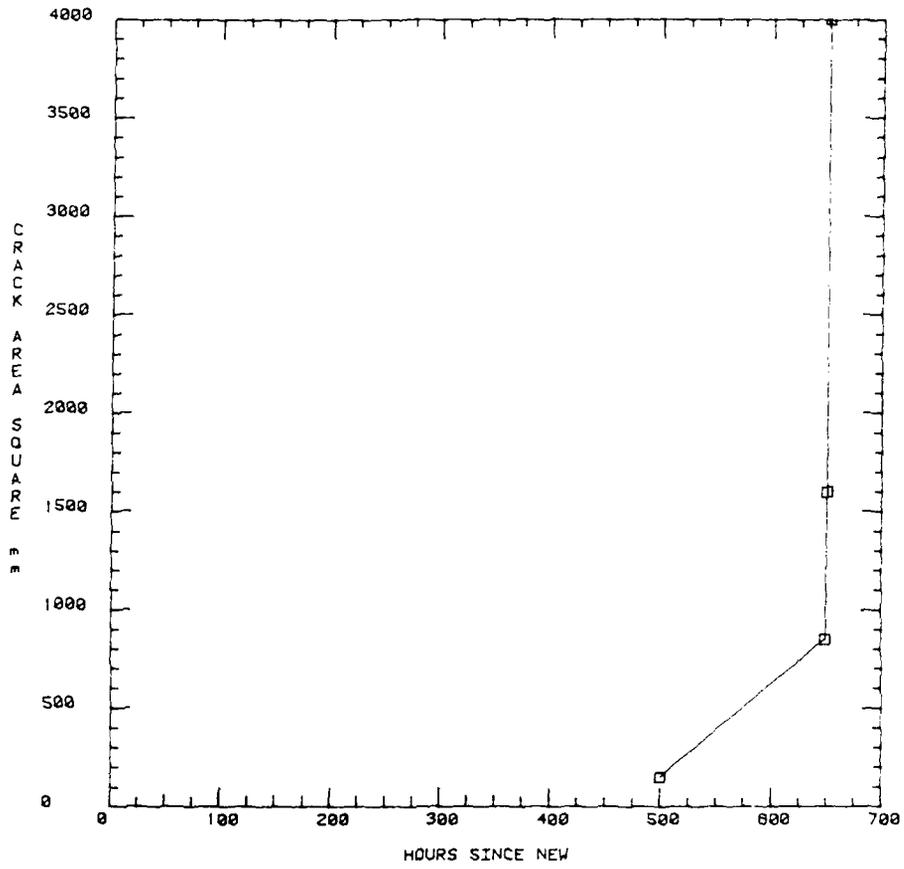
FIG. 9.48 THE PRELIMINARY PLOT OF CUMULATIVE CRACK AREA VS NUMBER OF HOURS SINCE NEW - WESTLAND WESSEX
