Structures Technical Memorandum 399

**A REVIEW OF AUSTRALIAN INVESTIGATIONS ON
AERONAUTICAL FATIGUE DURING THE PERIOD
APRIL 1983 TO MARCH 1985**

This document was prepared for presentation to the 19th Conference of the International Committee on Aeronautical Fatigue scheduled to be held in Pisa, Italy on May 20 and 21, 1985. It is being distributed within Australia as an ARL Technical Memorandum.

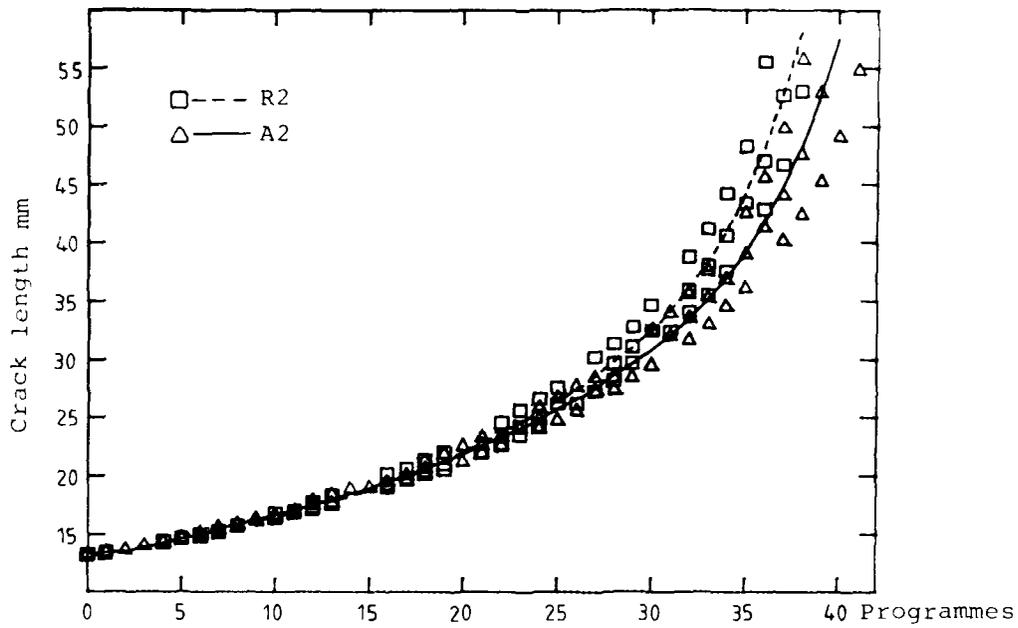
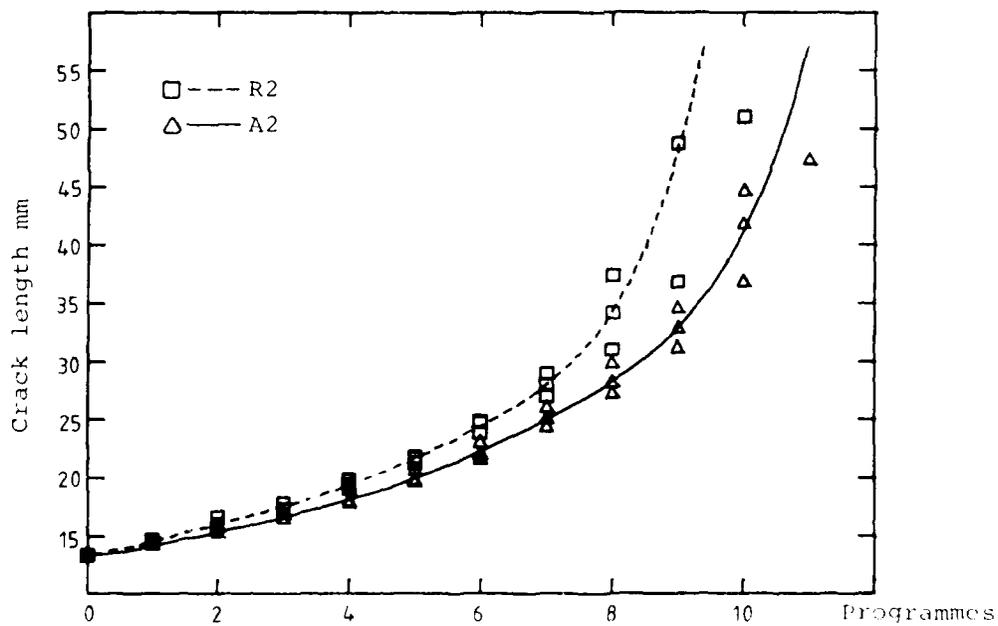
(a) Gross-area stress 11.0 MPa/g

(b) Gross-area stress 17.0 MPa/g

FIG. 9.49 CRACK GROWTH IN CCT SPECIMENS OUTER 'ACCELERATION' SEQUENCE A2, AND 'RETARDATION' SEQUENCE R2

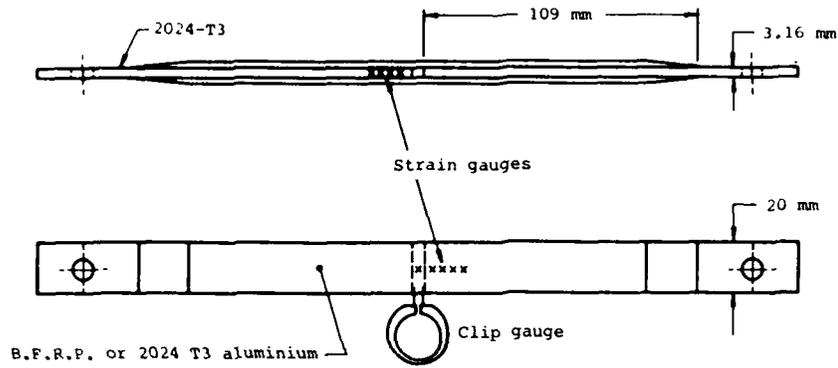
FIG. 9.51(a) ELEMENTAL JOINT SPECIMEN SHOWING POSITION OF CLIP GAUGE USED TO MEASURE DISPLACEMENT

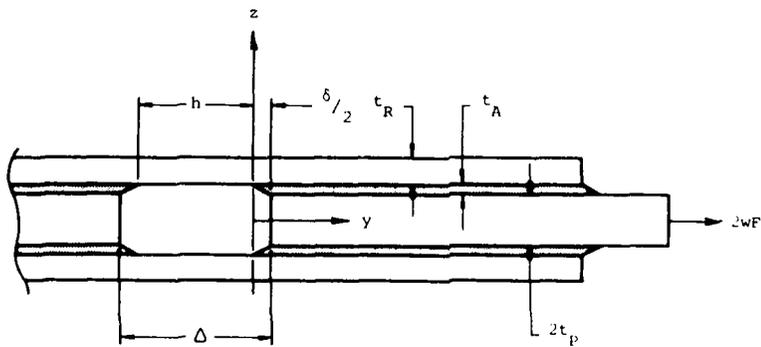
FIG. 9.51(b) NOTATION USED FOR THICKNESSES AND DISPLACEMENTS - ELEMENTAL JOINT SPECIMEN

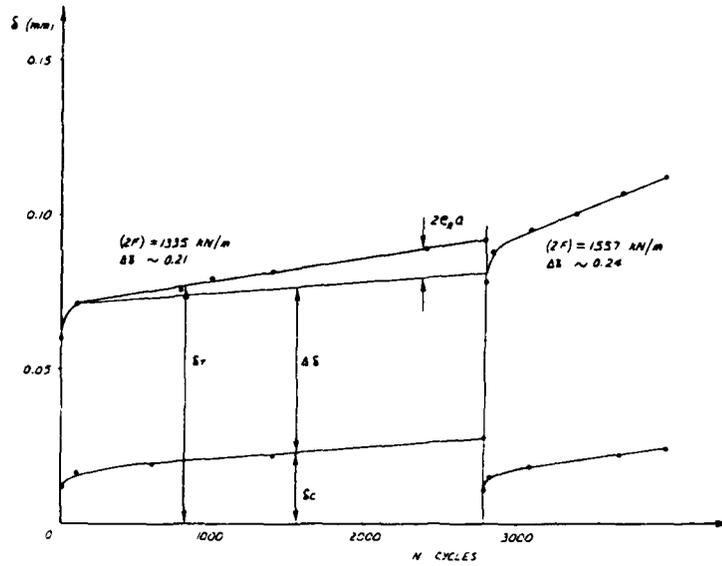
FIG. 9.52 PLOT OF DISPLACEMENT δ FOR TWO LEVELS OF LOAD INTENSITY ($2F$) VERSUS CYCLES N FOR SPECIMEN WITH BORON/EPOXY OUTER ADHERENDS

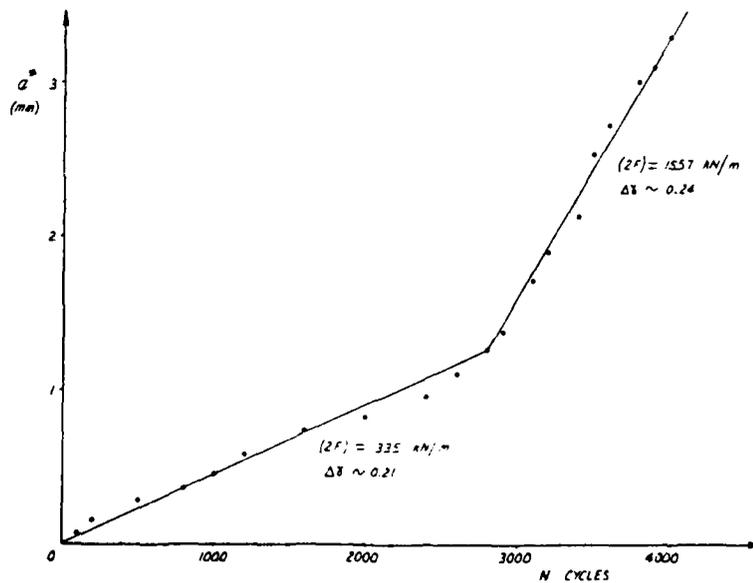
FIG. 9.53 PLOT OF APPARENT CRACK SIZE a^* IN THE ADHESIVE LAYERS VERSUS CYCLES N AT TWO LOAD INTENSITY LEVELS, DERIVED FROM FIG. 9.52

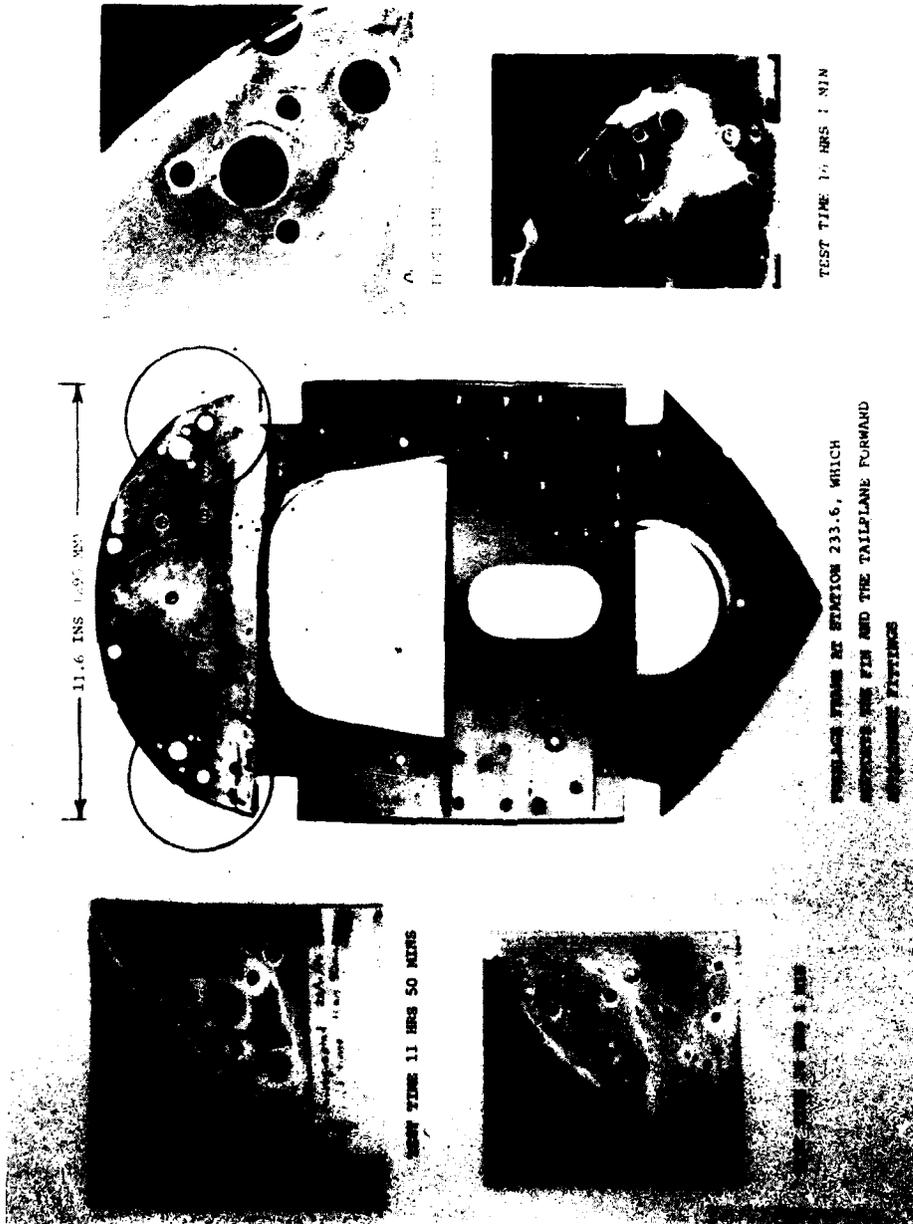
FIG. 9.56 CT4-A EMPENNAGE RESONANCE TEST - FUSELAGE FRAME DAMAGE
