## DEPLOYMENT TEST REPORT

JLOTS II  
AUGUST 1985

**JLOTS II DEPLOYMENT TEST**

JOINT TEST DIRECTOR  
JOINT LOGISTICS OVER THE SHORE (JLOTS II)  
NAVAL AMPHIBIOUS BASE  
LITTLE CREEK, NORFOLK, VA 23521

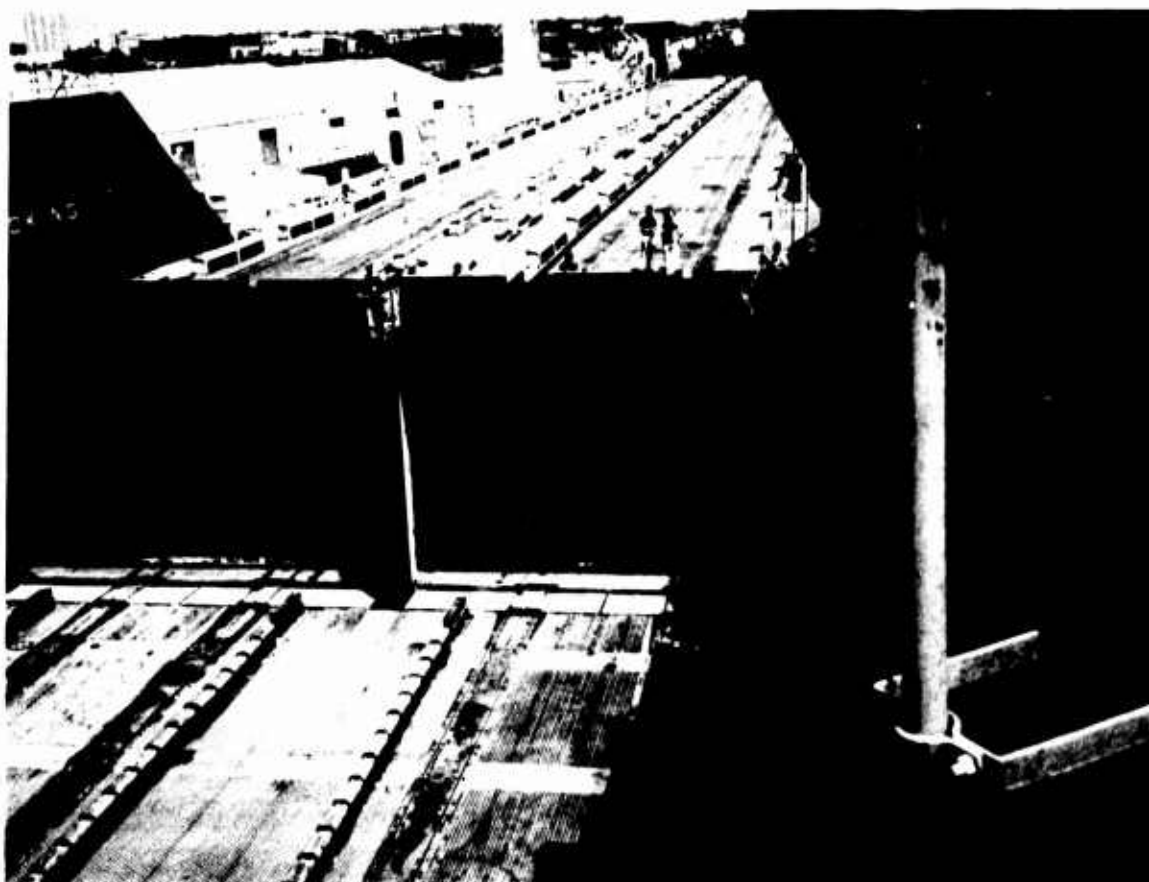
The SEABEE barge elevator is capable of lifting two SEABEE barges with a combined weight of 2000 long tons to one of three deck levels. Barges are nominally 98-ft long x 35-ft wide x 17-ft high. As the elevator is raised, the barges settle onto the elevator pedestals shown in Figure 2. The elevator is then raised to the desired deck where the barges are moved forward by transporters. There are two transporters per ship, one starboard and one port. They are electrically driven on tracks between the rows of pedestals. Figure 3 is a view looking forward on the upper deck showing the deck pedestals and transporters. Since there are only two transporters, they must be prepositioned by the elevator to the deck where barges are to be moved. When the elevator arrives at the desired deck with barges, the transporters are driven under the

Figure 2 - SEABEE Barge Elevator

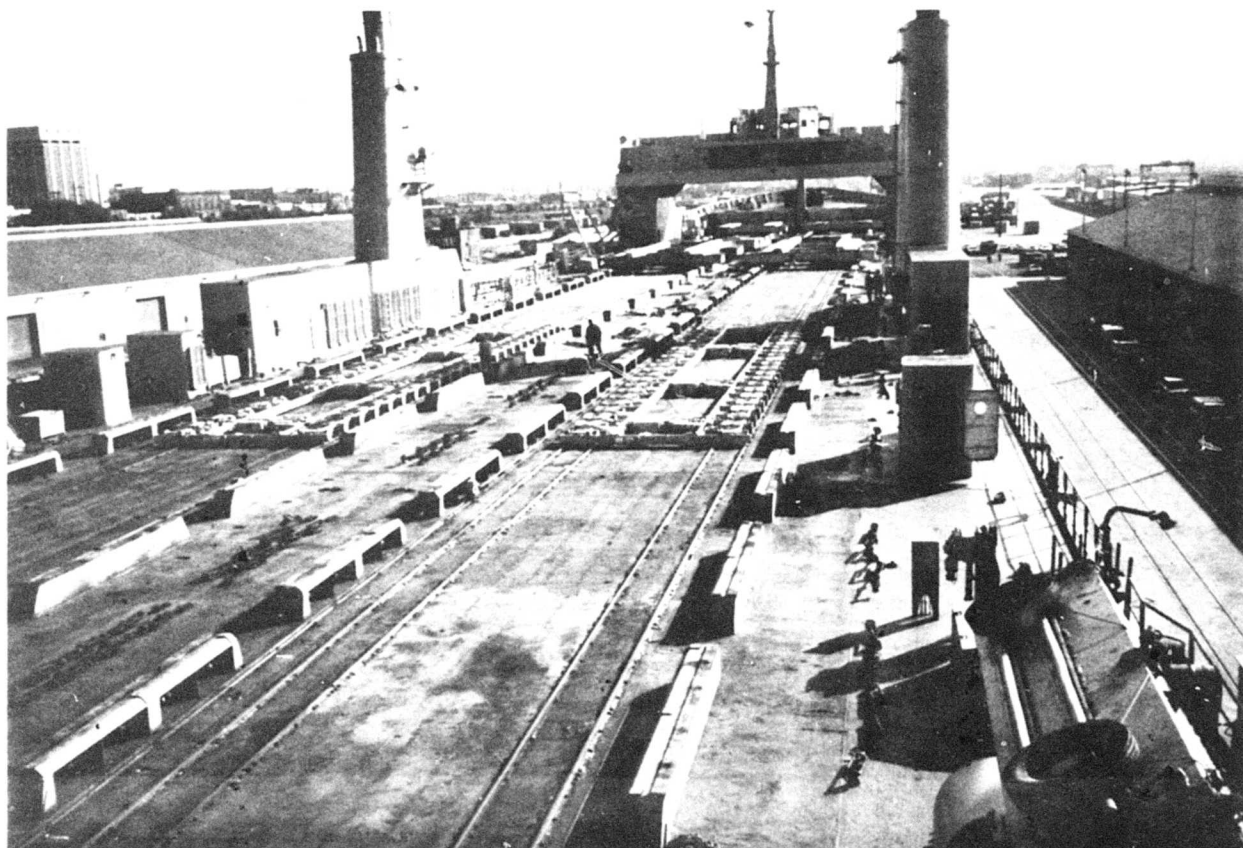
Figure 3 - Transporters and Pedestals on SEABEE Upper Deck
