CLARENCE CANNON DAM & MARK TWAIN LAKE

FOUNDATION AND EMBANKMENT COMPLETION REPORT

PART II MAIN DAM

VOLUME I — NARRATIVE SECTIONS 1 THRU 9

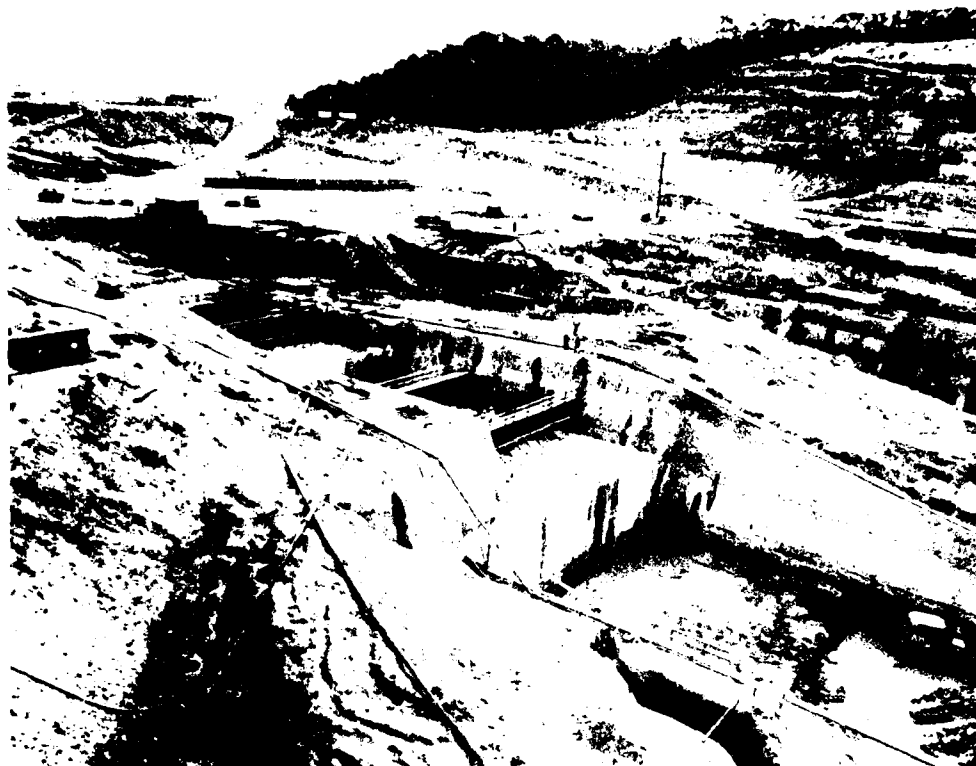
Photograph E. Picture showing dewatering operations. Note header lines used to carry water to main sump. Pooled water on floor of tailrace wall foundation was removed using small portable trash pumps.

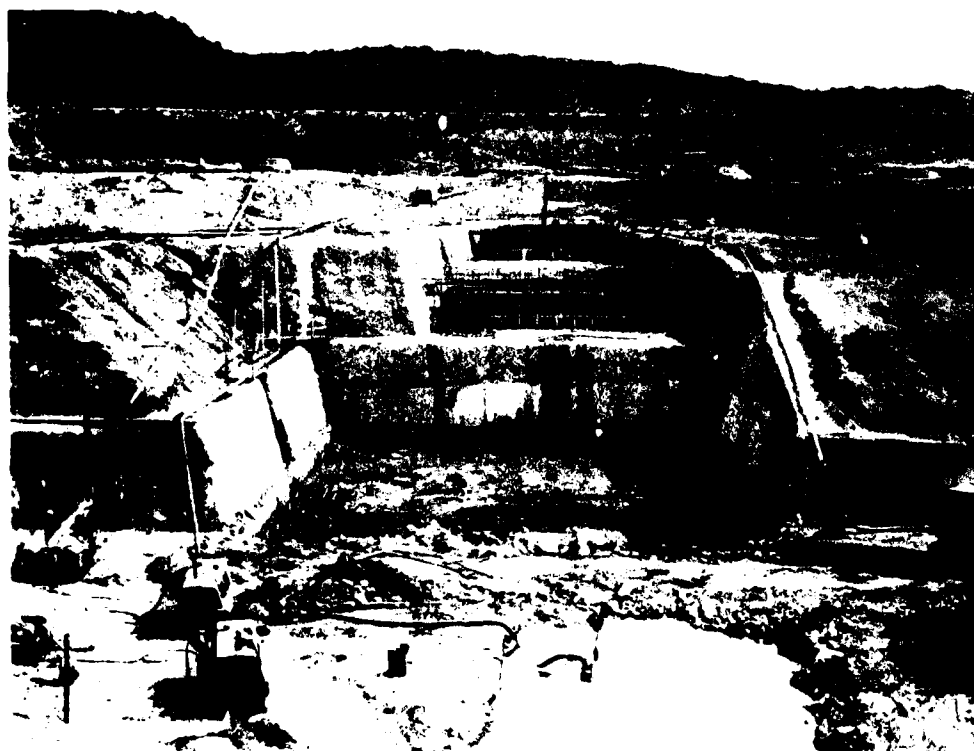
Photograph F. Picture showing dewatering operations in concrete structure. Note large dewatering pump in foreground. Second stage cofferdam in background.

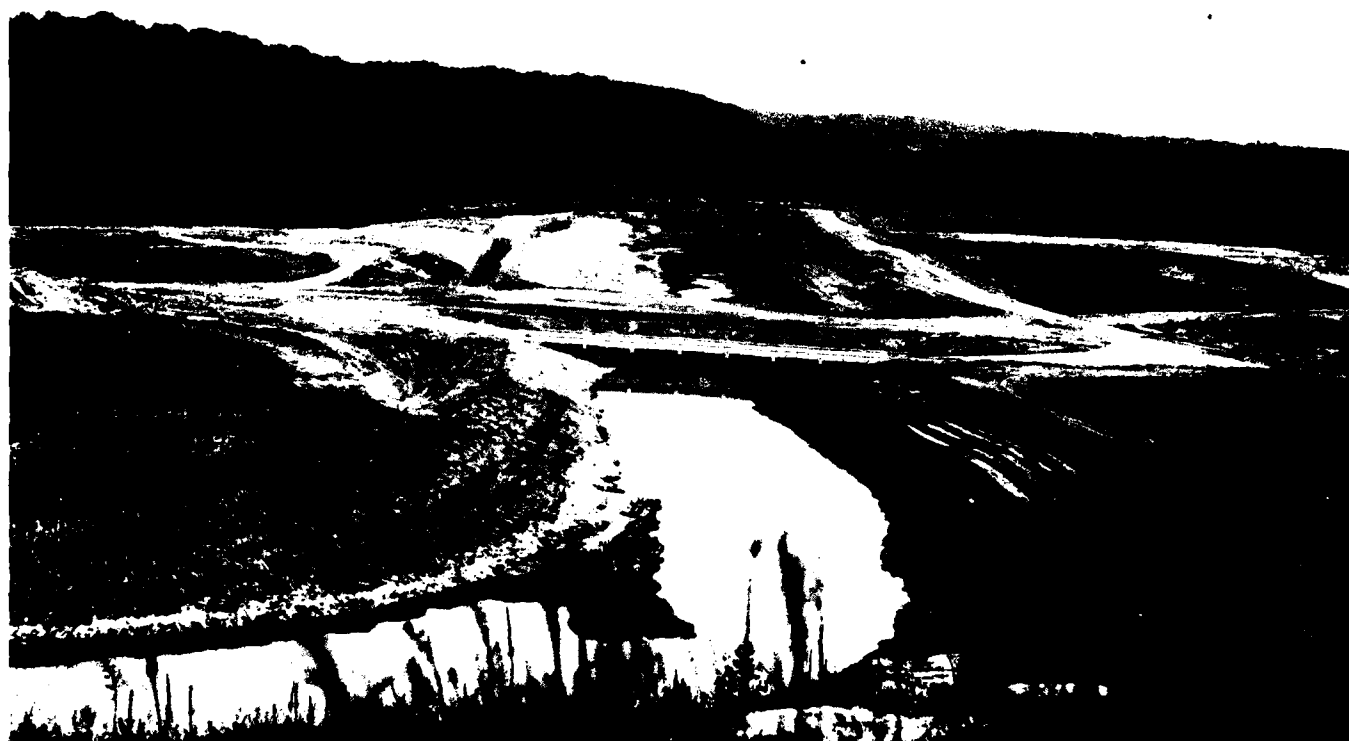
Diversion channel excavation and temporary construction bridge as viewed from north abutment.

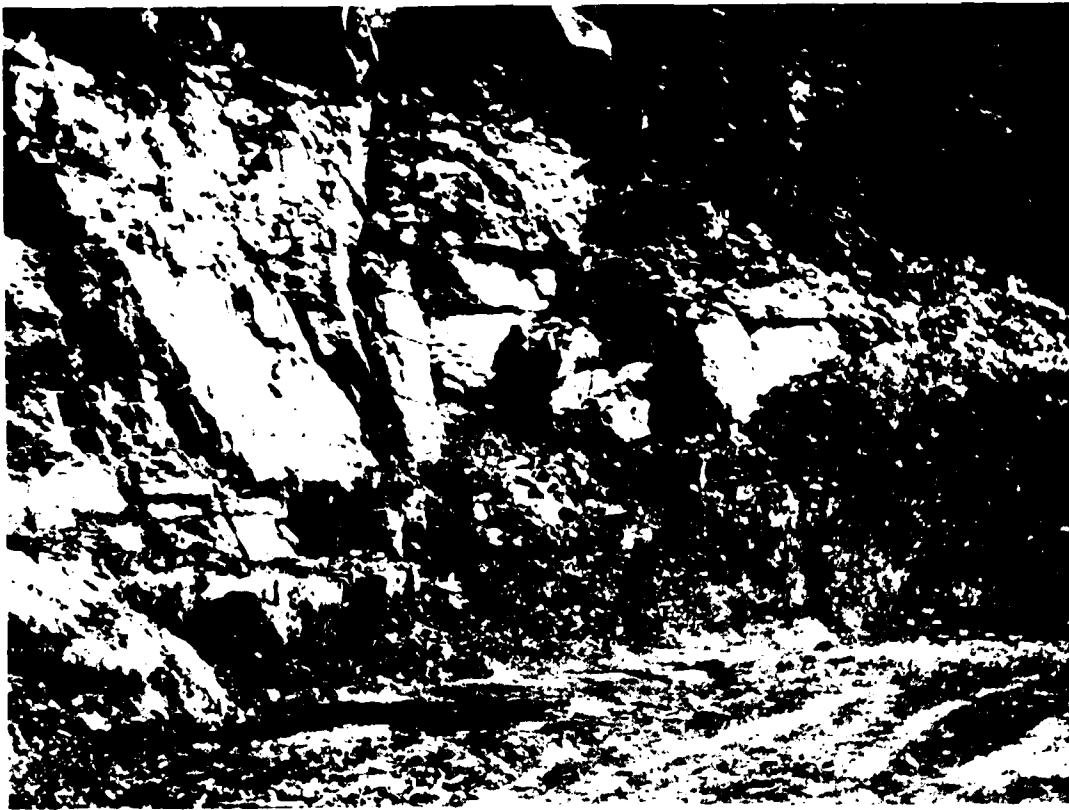
Photograph A depicting condition of rock before treatment is performed on right abutment water temperature control weir embankment/rock contact.

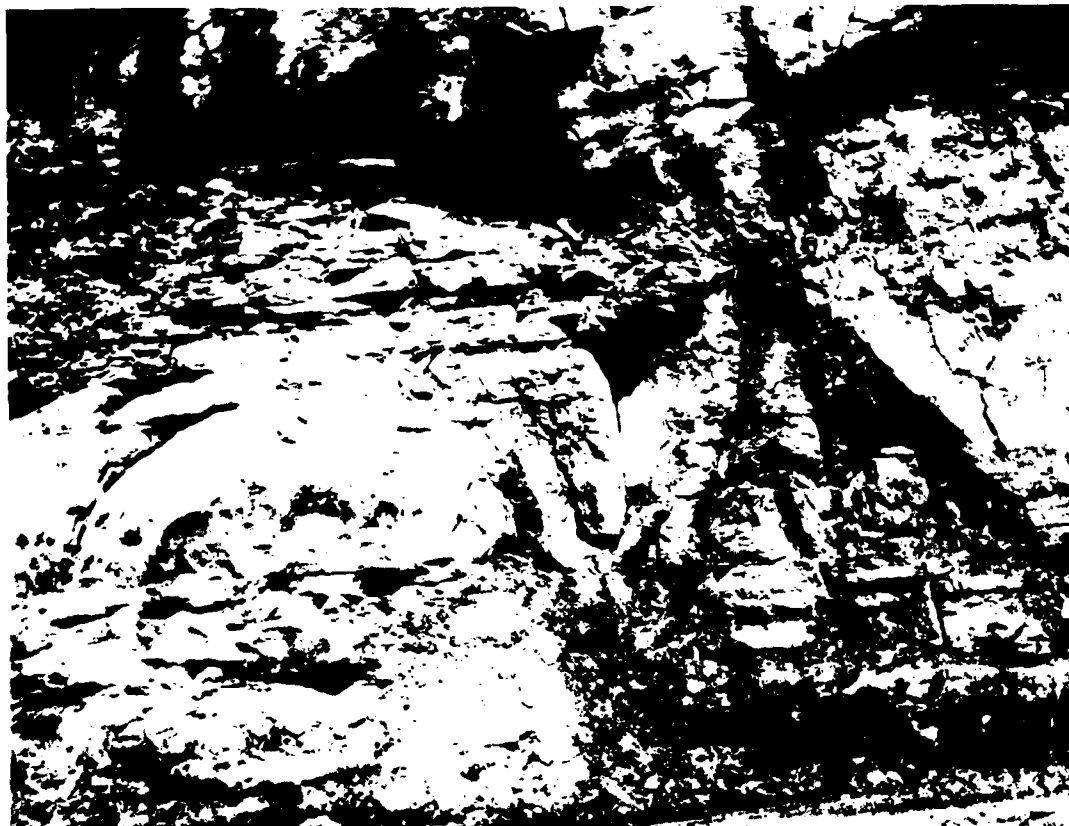
Photograph B depicting condition of rock before treatment is performed on right abutment water temperature control weir embankment/rock contact.

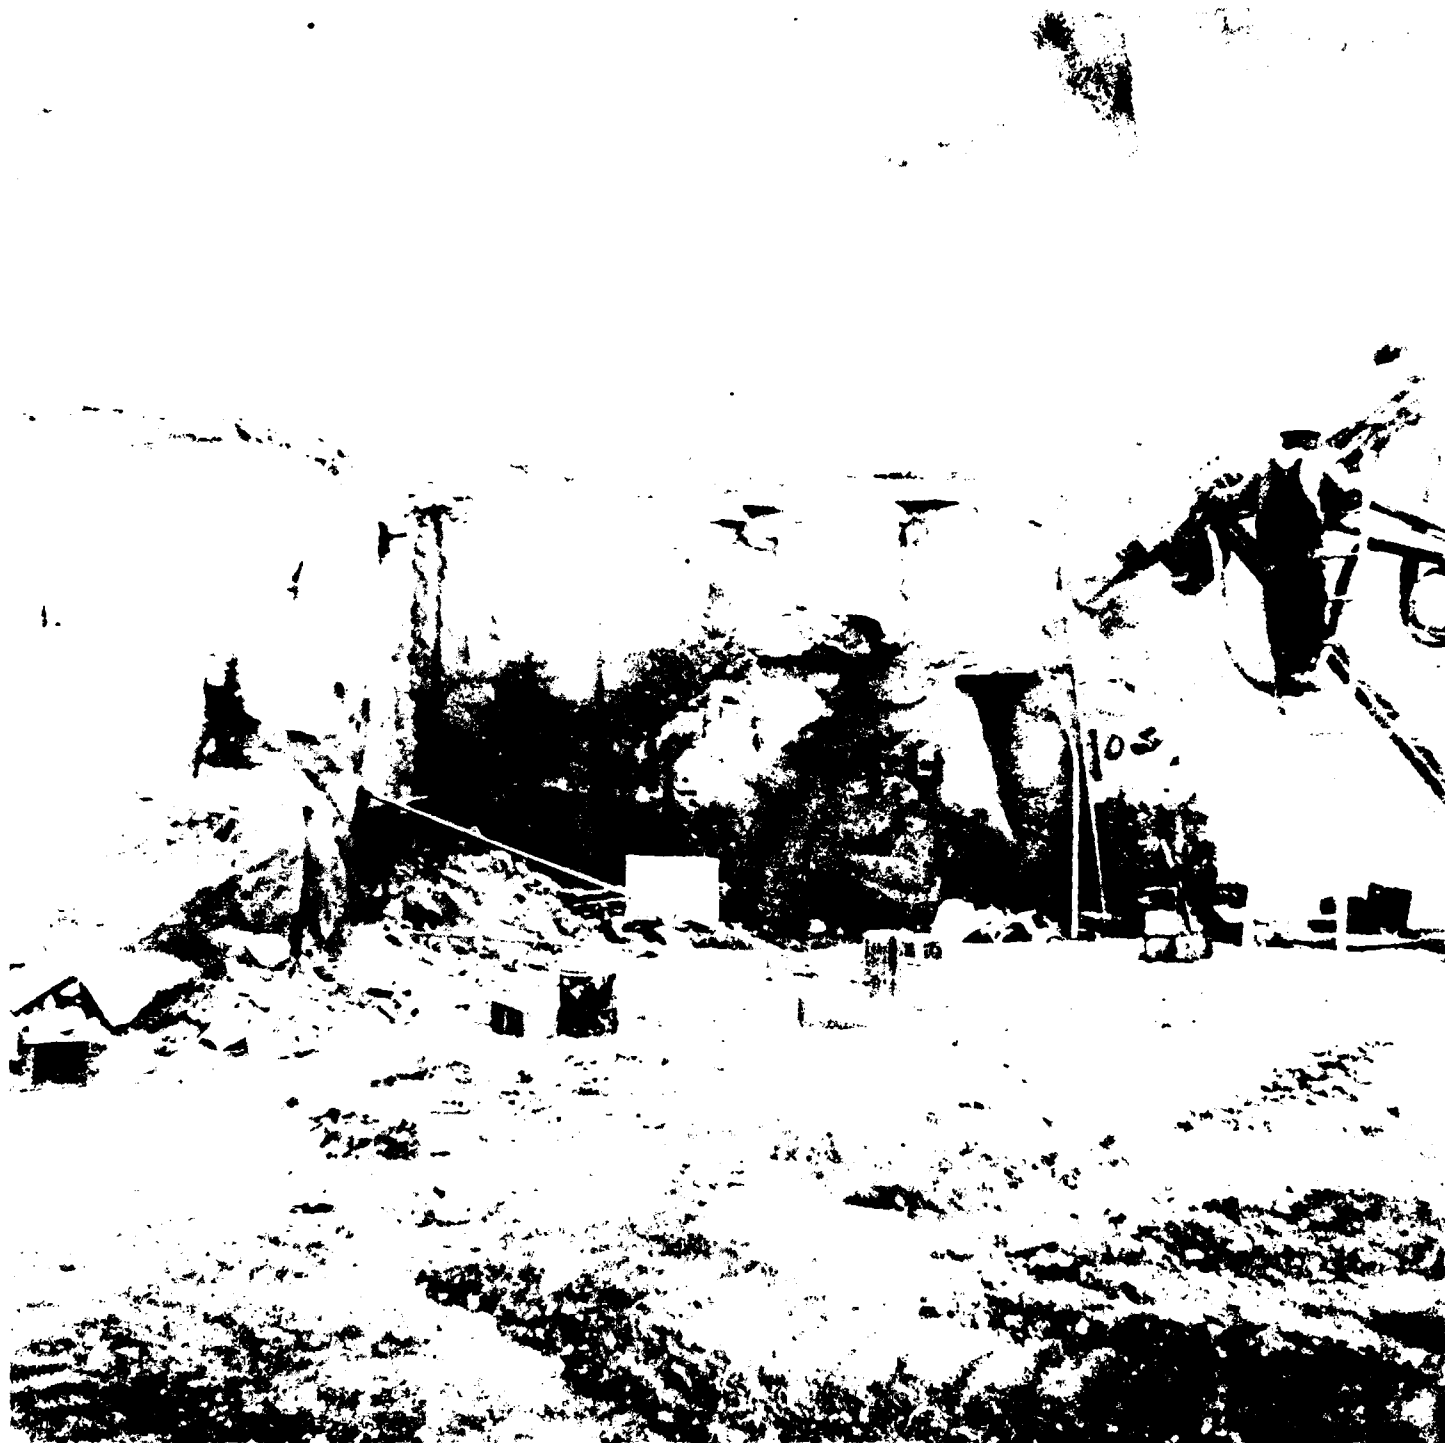
Typical rock bolt drilling operation on downstream foundation wall for Monolith D-15 with a 3700 Gardner Denver Air Track.

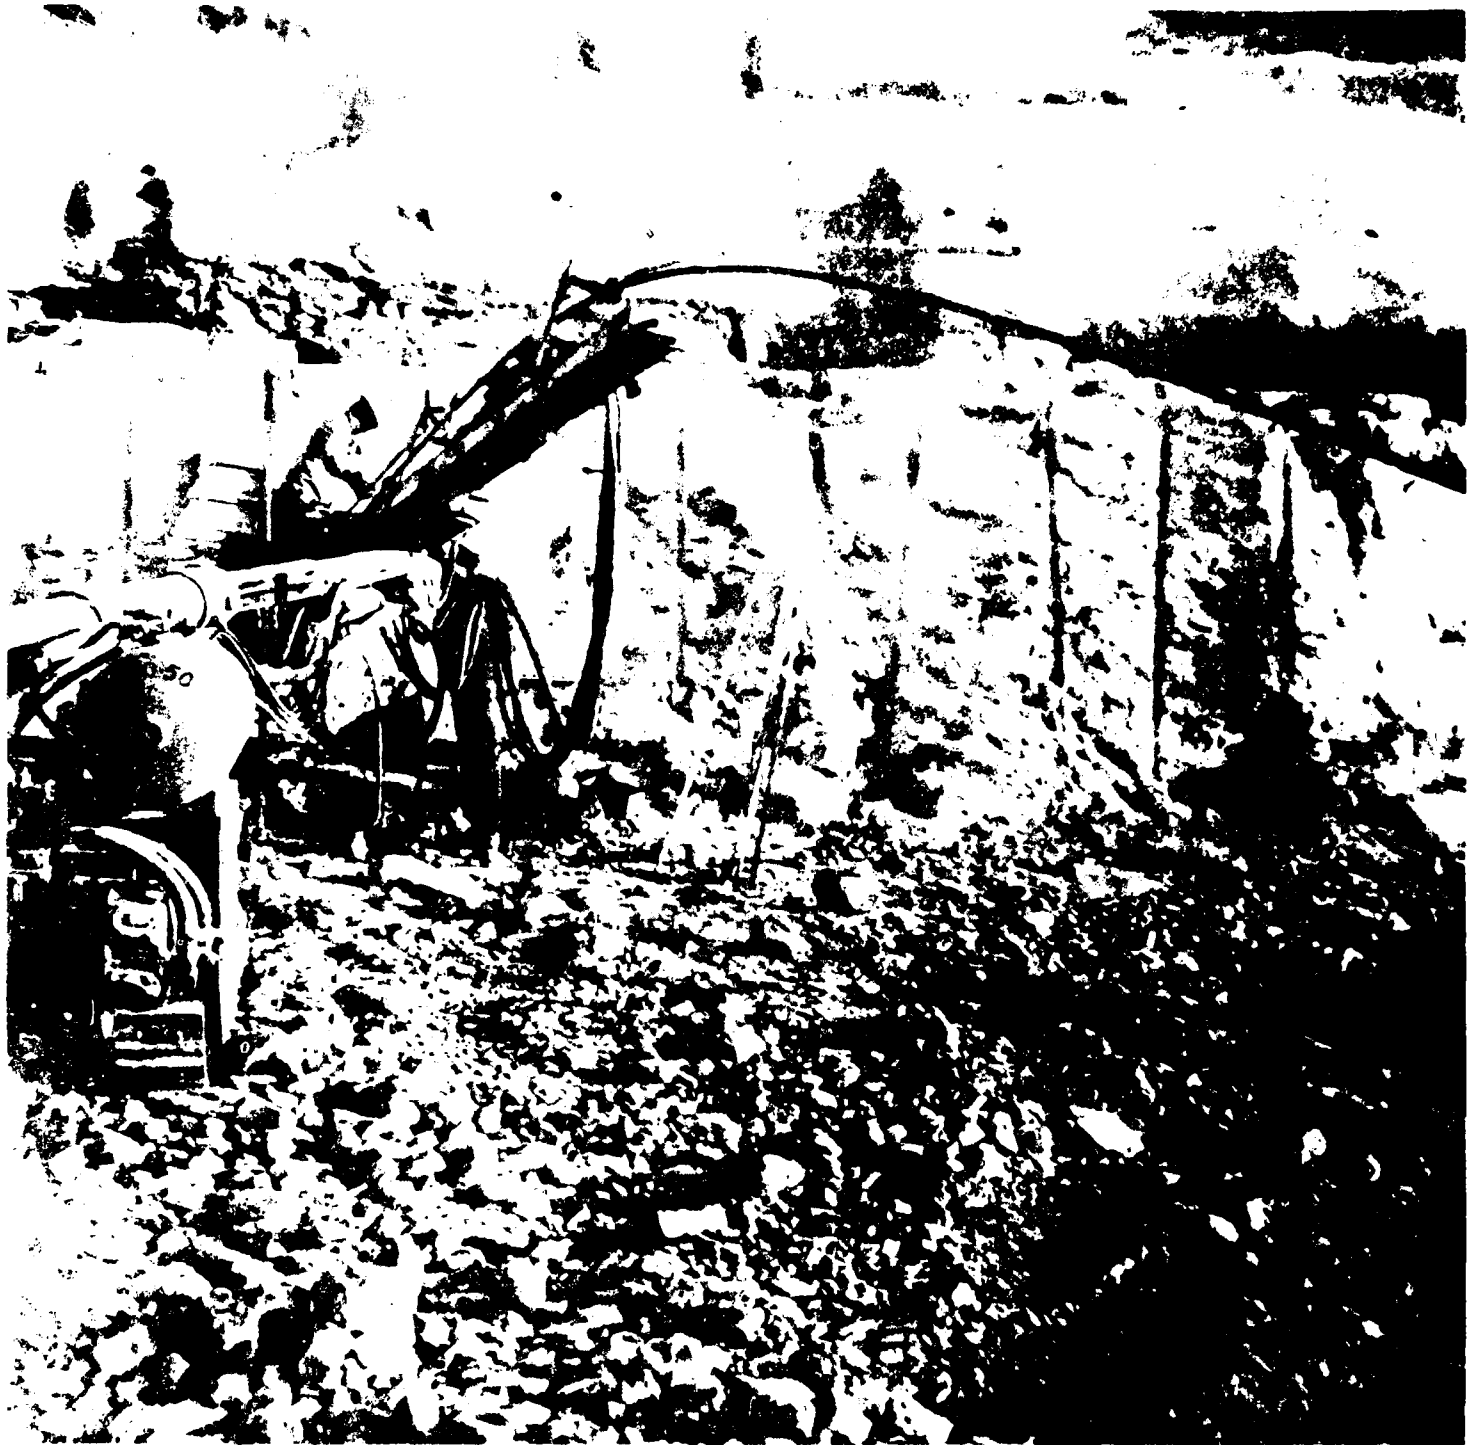
Laborer using a PVC pipe to push the Celt to resin to the back of the hole.

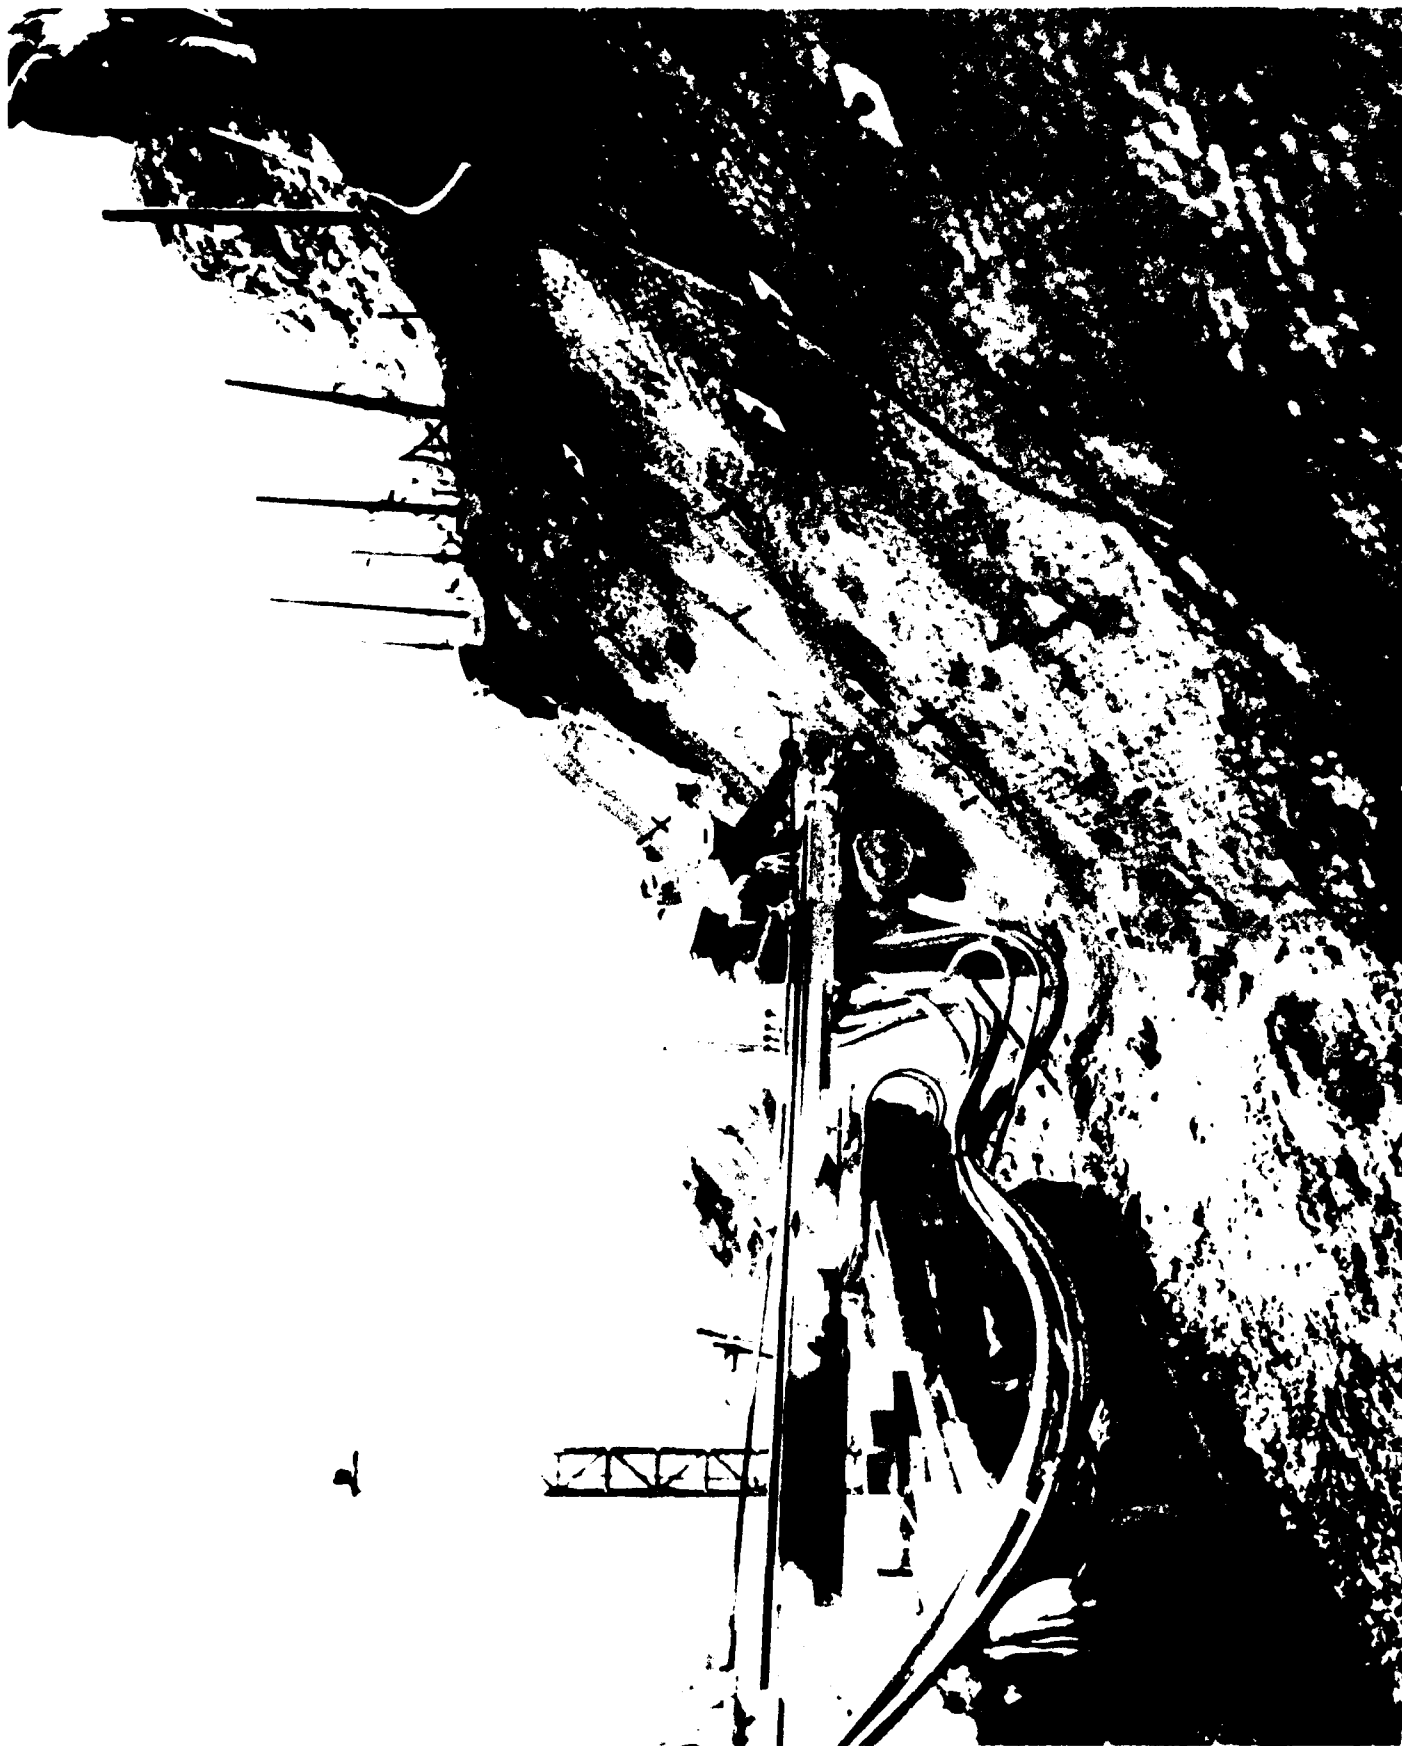
Rock bolt installation with a 3700 Gardner Denver Air Track.

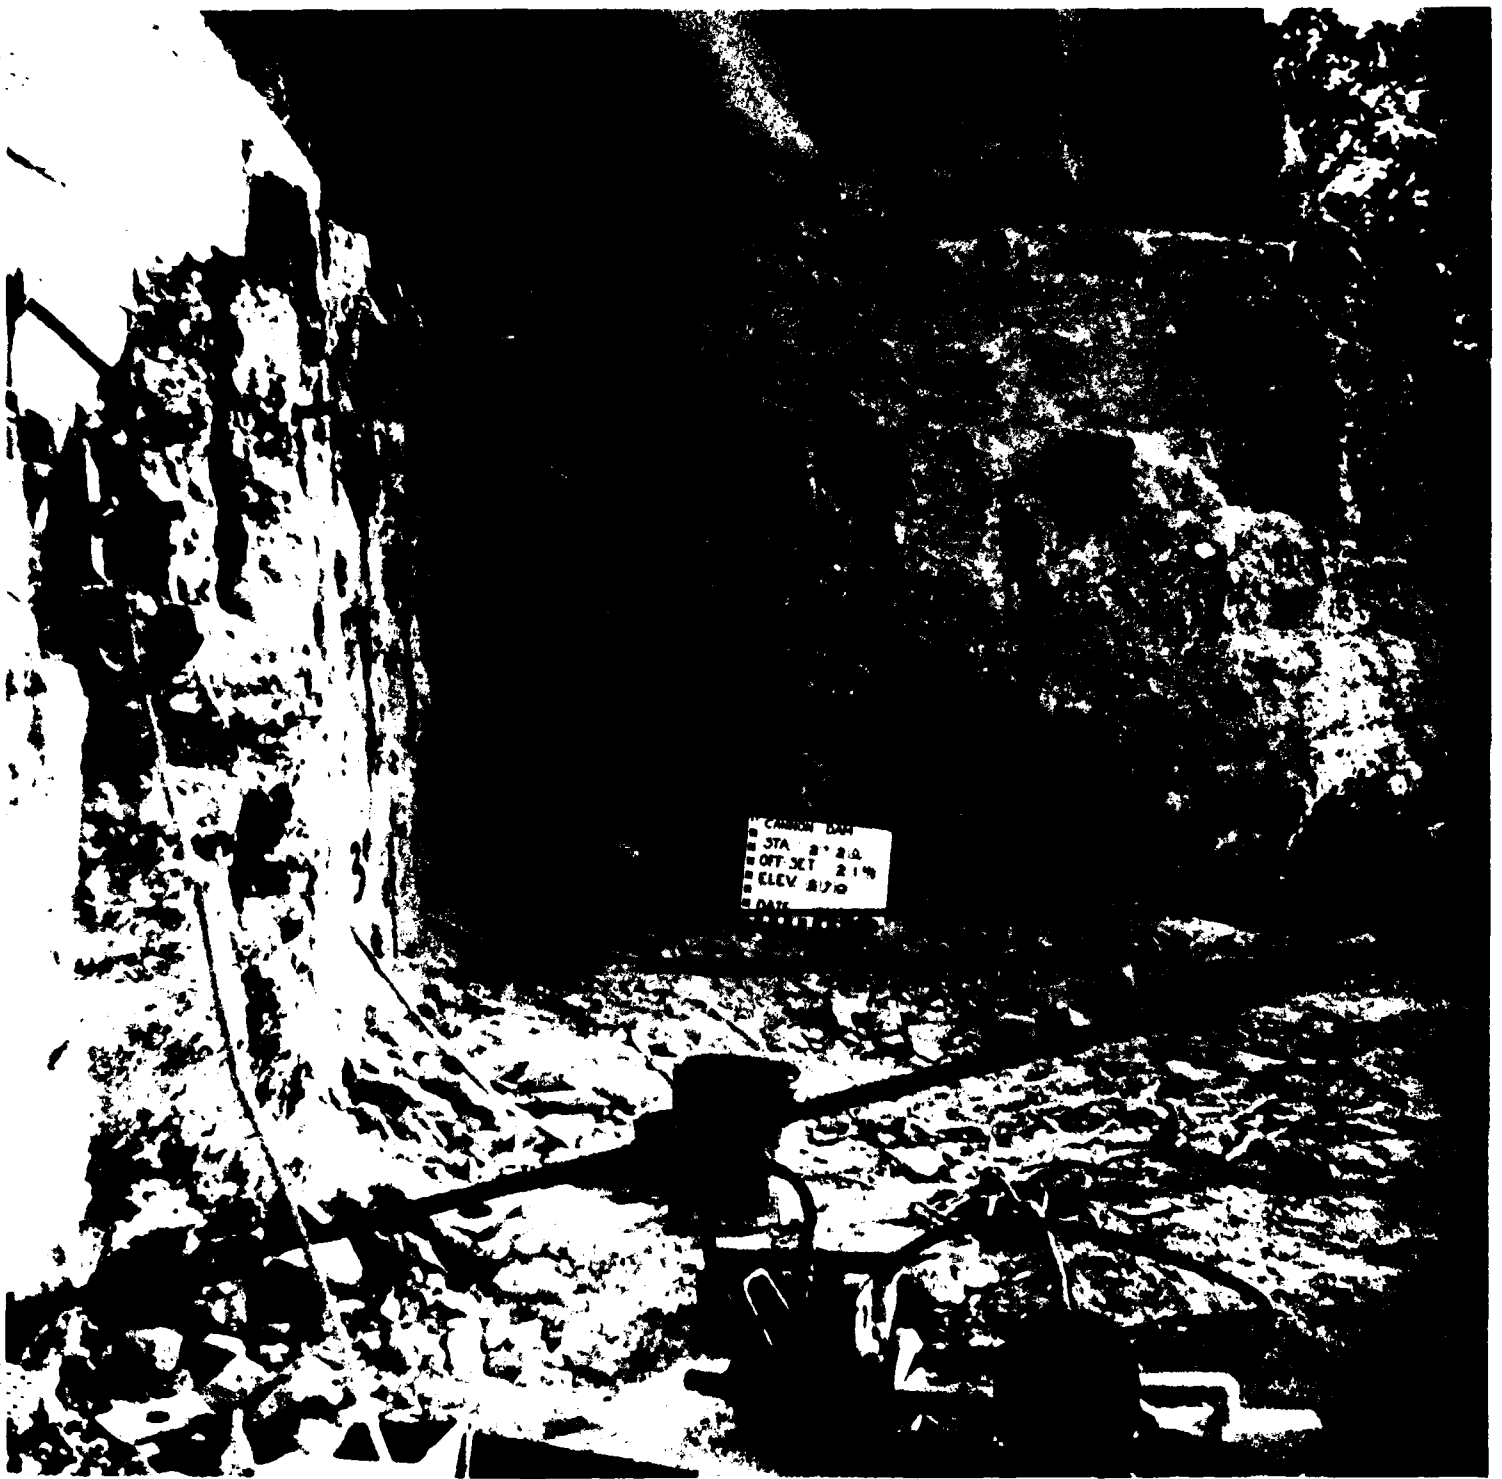
Typical Production Bolting Pattern in Monolith D-15 Foundation Walls

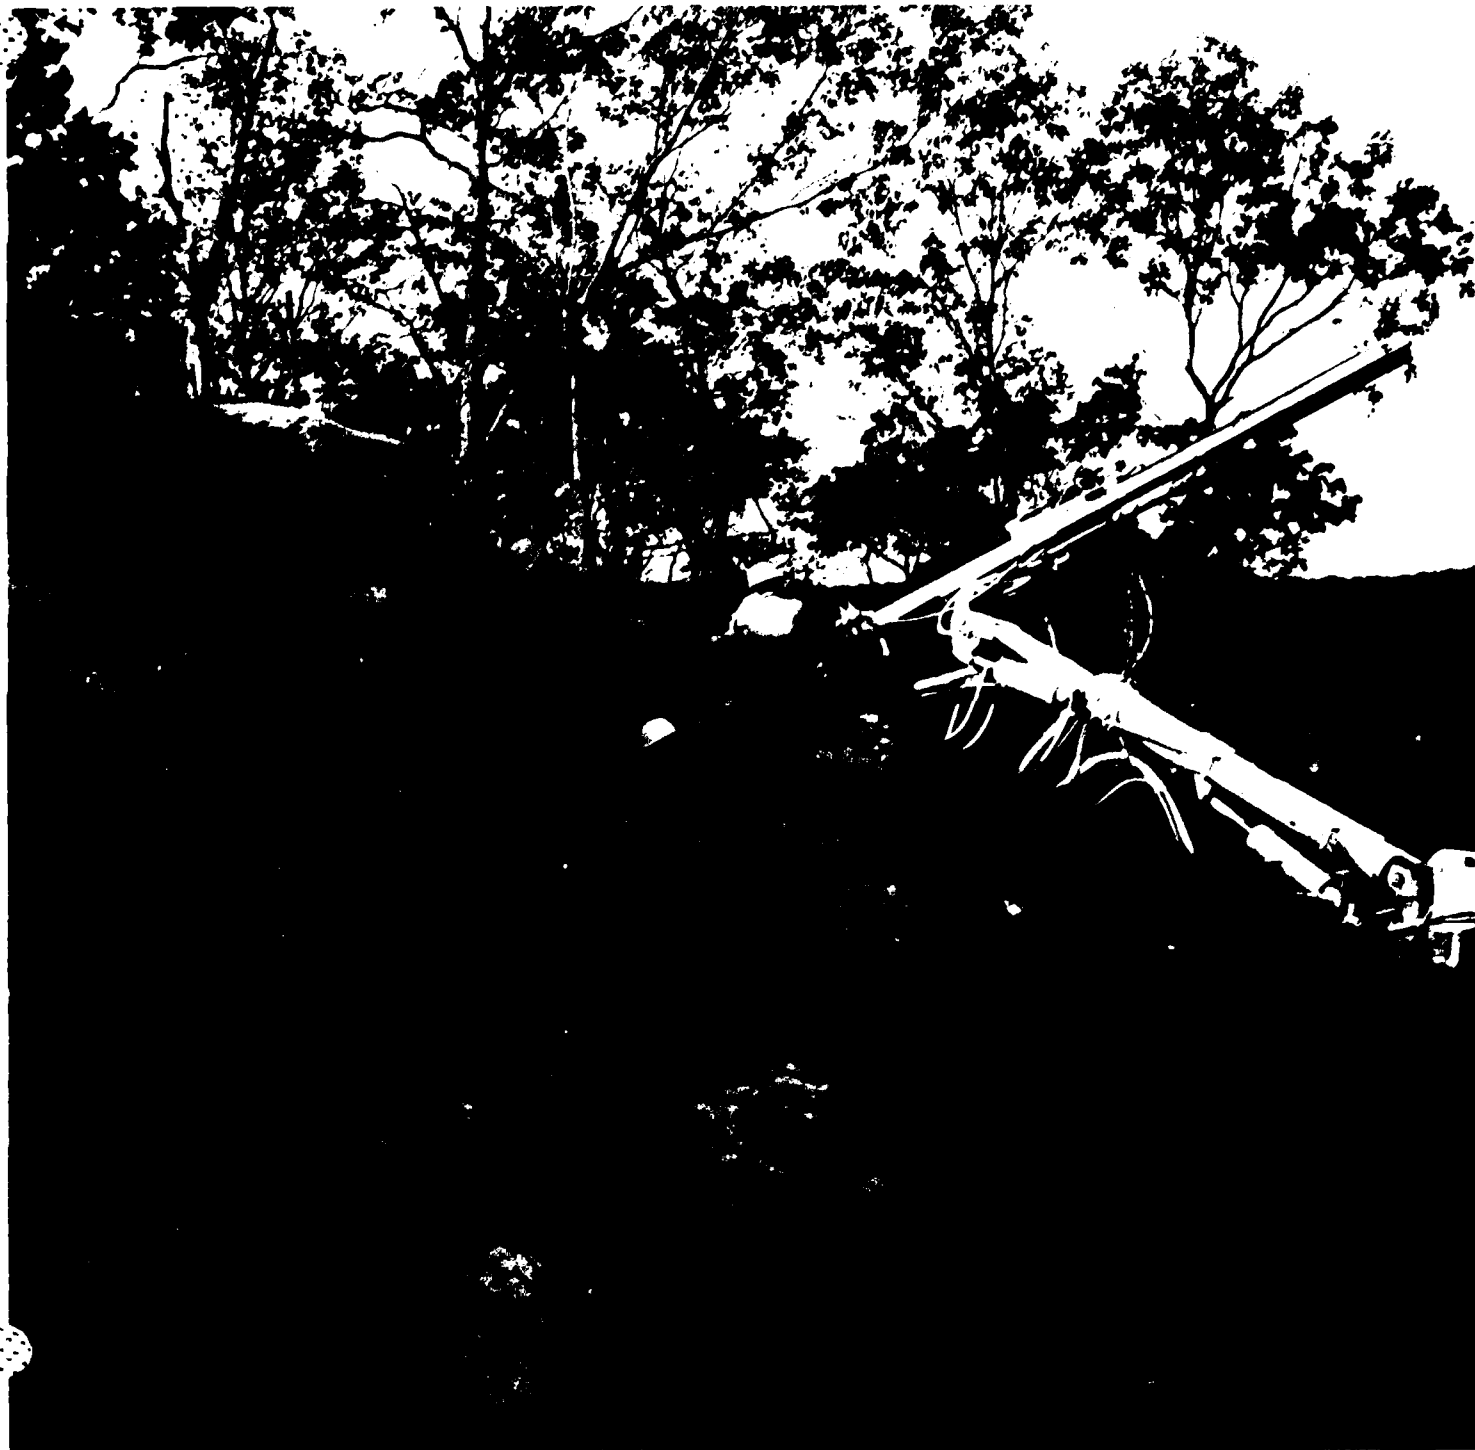
Installing rock anchors for safety curtain on right abutment upstream
1V:1H slope. Note laborer with tool in hand to tighten hexagonal nut.
