**CLARENCE CANNON DAM
& MARK TWAIN LAKE**

FOUNDATION AND EMBANKMENT COMPLETION REPORT

PART II MAIN DAM

VOLUME III — PHOTOGRAPHS

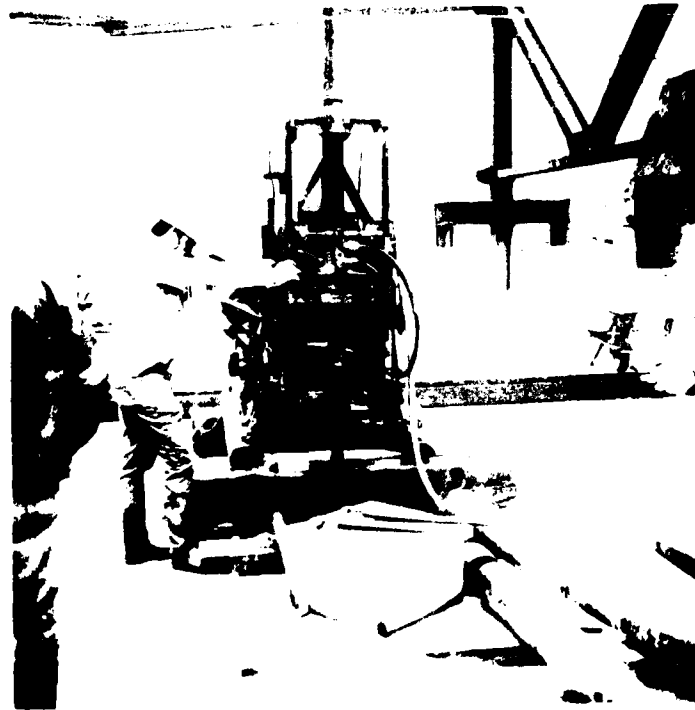
Drilling operations for the installation of Inclinator no. DT-05 in Monolith SB-3. Wooden box with pipe wrenches on top is the storage box for the leads from the Carlson electrical resistance piezometer and soil pressure meter installed in the foundation of SB-3.

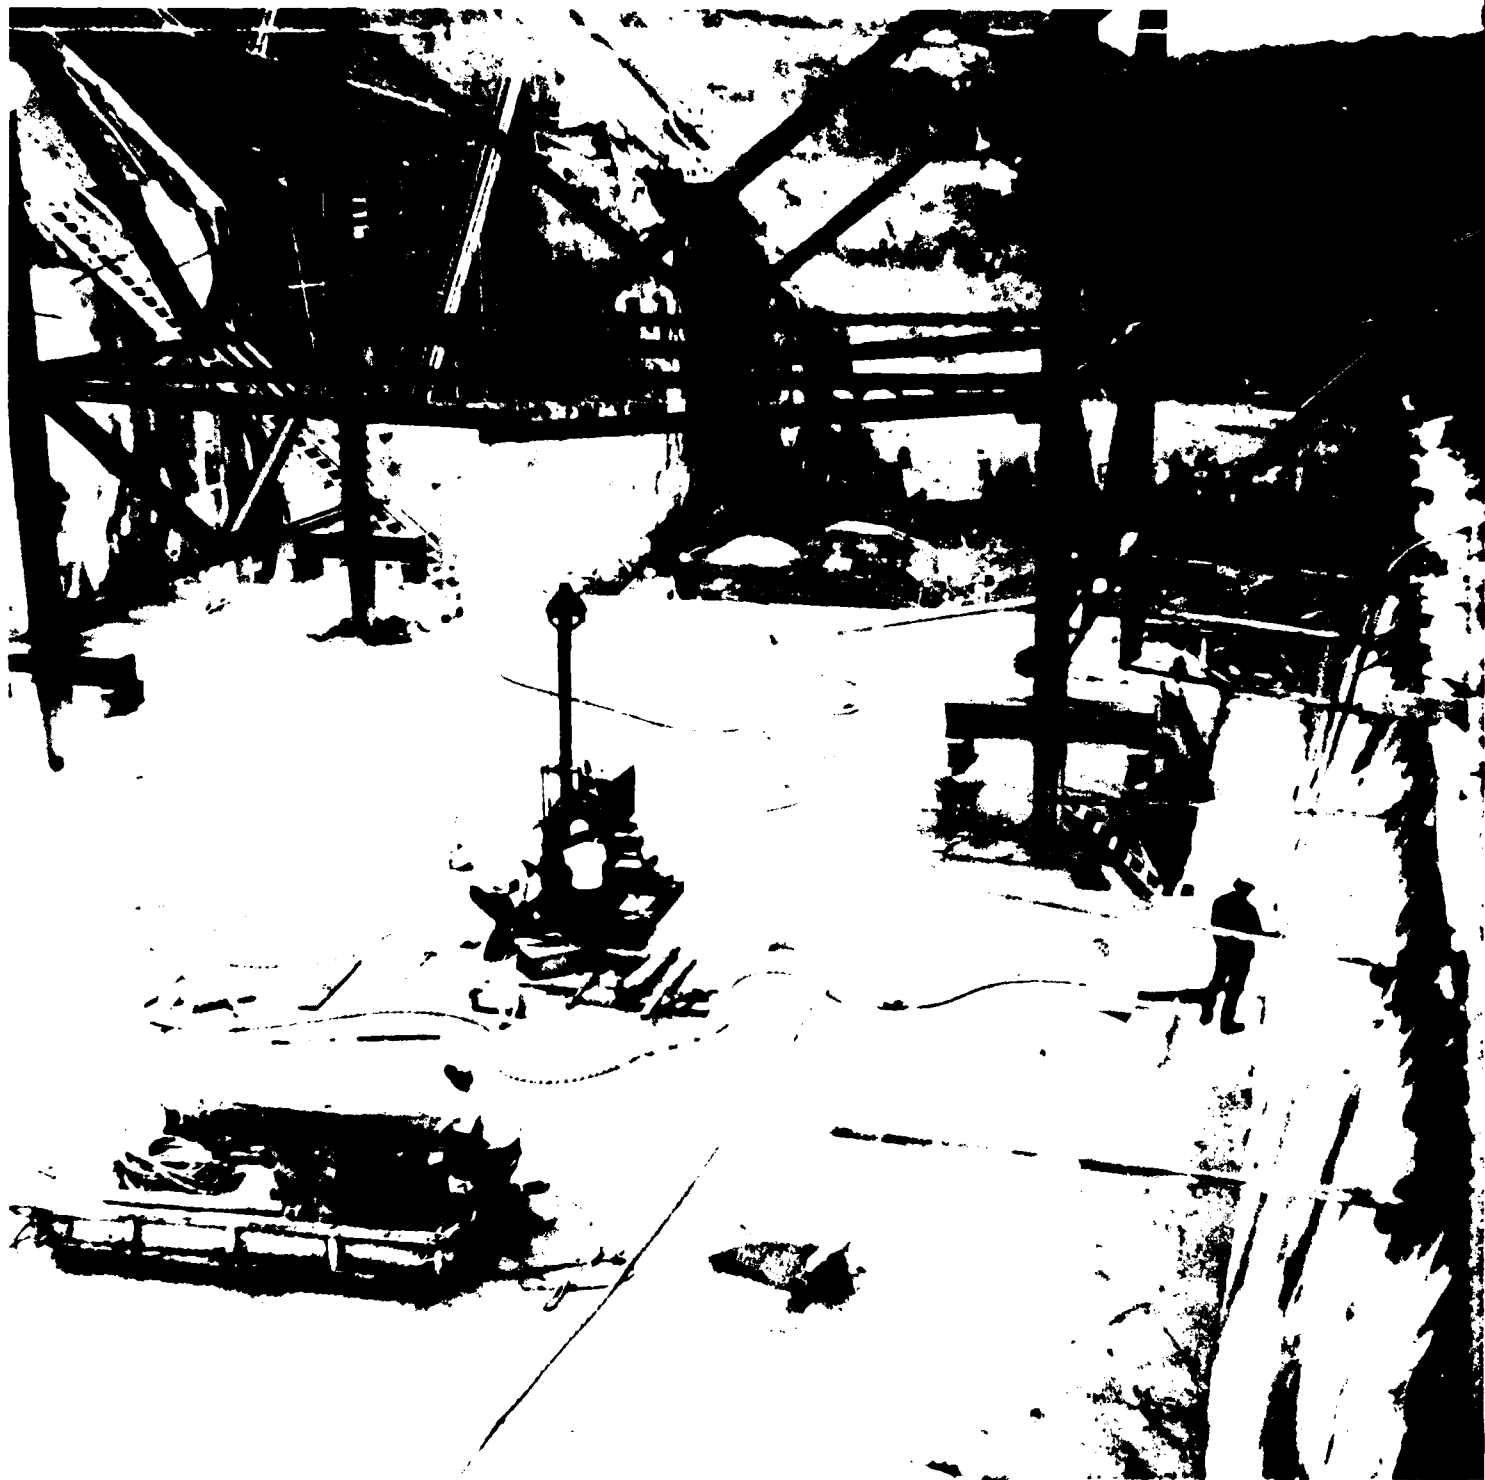
Overall view of Monolith SB-3 foundation showing drilling operation for Inclinator no. DT-05 core hole.

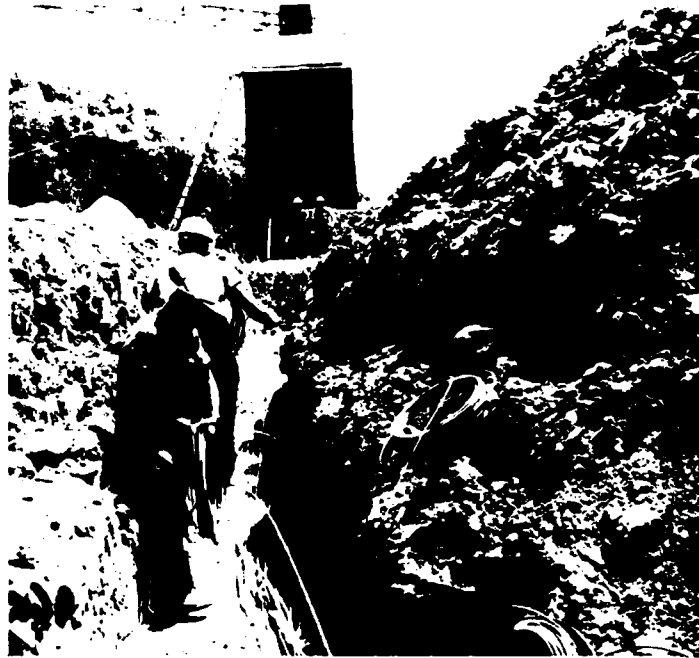
Station 12+75 U.S.B.R. piezometer tubing being unrolled in trench prior to spacing and placement of select material.

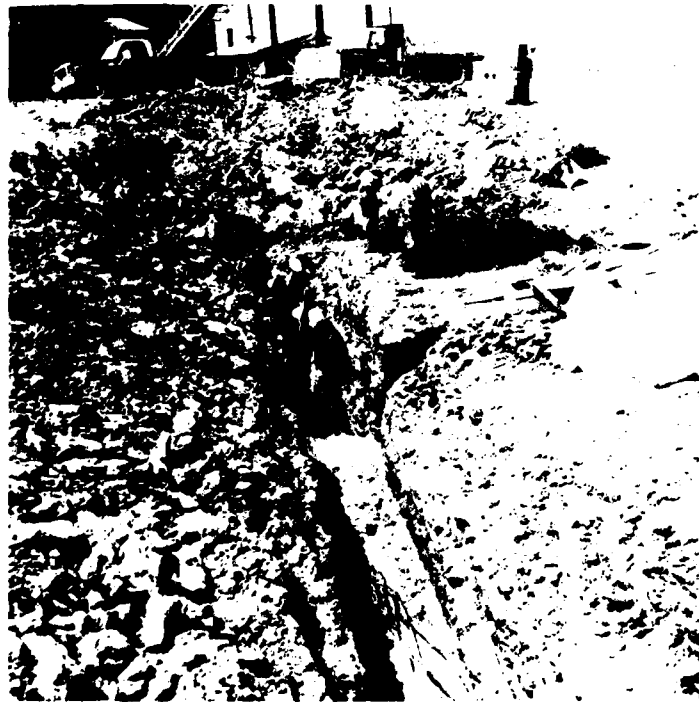
Station 12+75 U.S.B.R. piezometer tubing. Note the leveling of the select material cushion in trench.

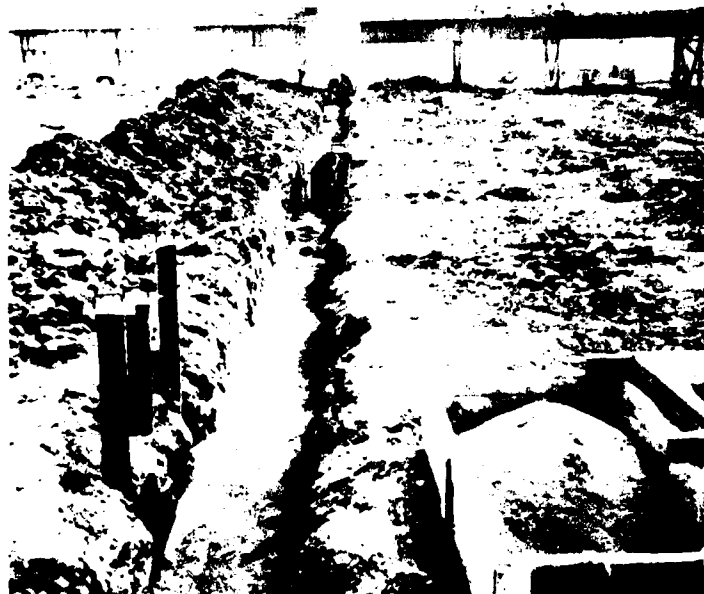
Piezometer test program trench in temperature control weir embankment. Metal pipes in the edge of the trench are protection for the drill holes for three different types of foundation tips.

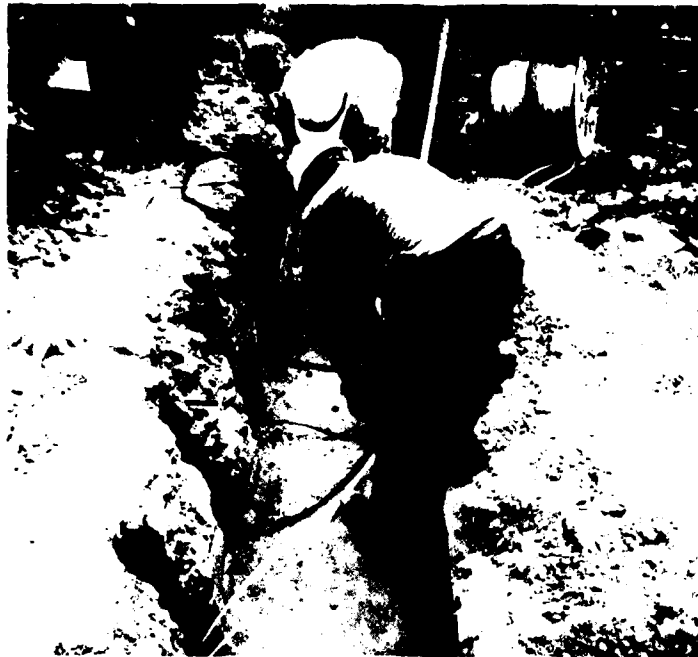
Leads of three different types of foundation piezometers extending into the trench. The pair of white leads is the tubes from the U.S.B.R. tip; the heavy black cable is the Carlson lead wire; and the small black lead is the SINCO pneumatic tubing.

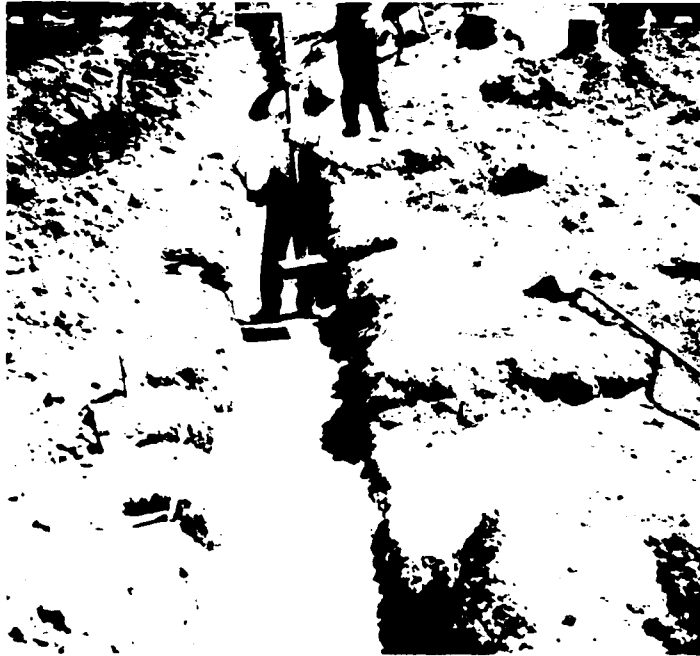
Select material (cushion) being compacted with a 1 square foot, tamper.

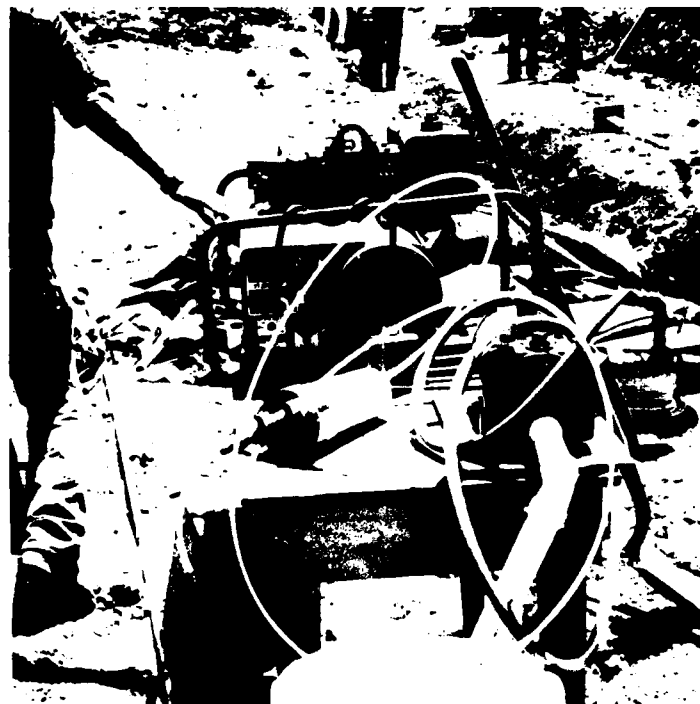
Typical testing setup for the replacement line of U.S.B.R. piezometer at Station 11+43.

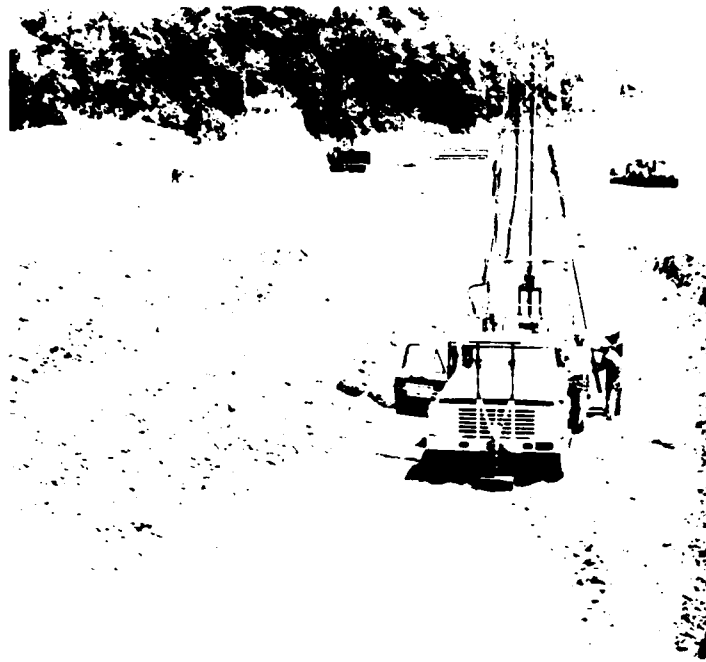
Shelby tube sample being removed from drill rods. Sample is for piezometer no. FBF-04 replacement, Station 11+45, 130' downstream.

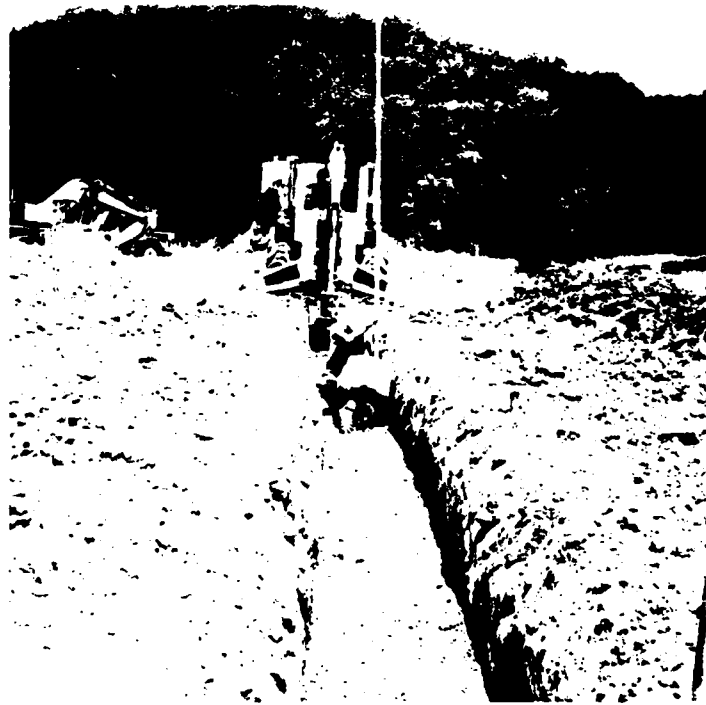
Piezometer trench excavation and setting of nails into trench walls. The lower nail was used to establish the top elevation of the cushion of select material while the upper nail established the top elevation of select material placed over the piezometer tubes.

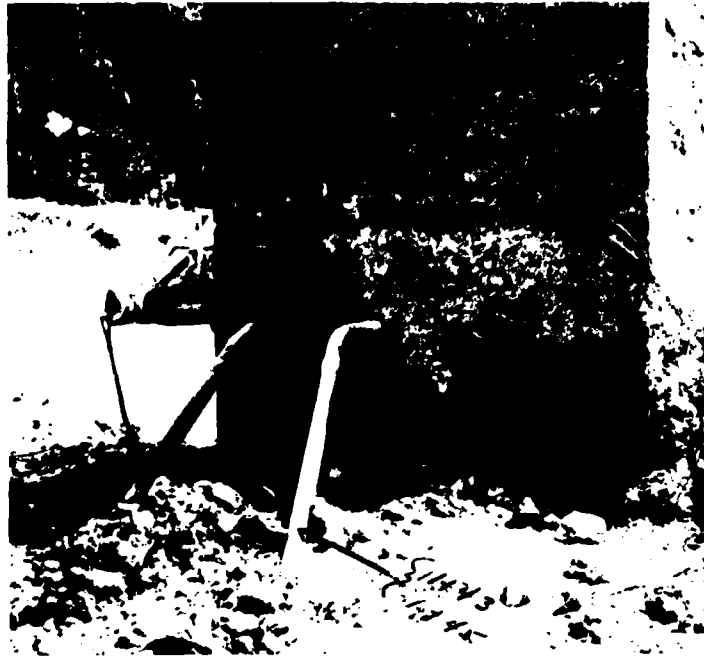
Terminal Well No. 1, entrance conduit for U.S.B.R. piezometer tubes (Stations 11+43, 11+45 and 12+75). The location of the shovel point represents the approximate top elevation of the sand blanket.

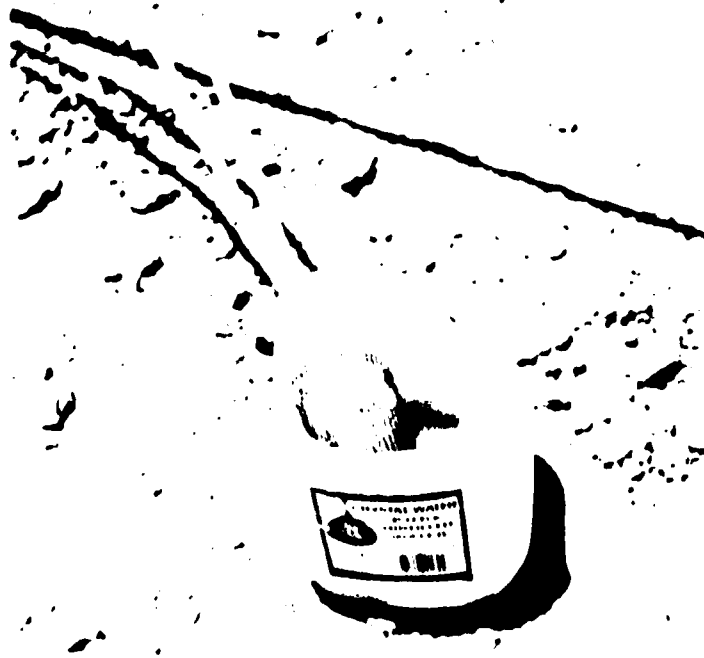
U.S.B.R. foundation piezometer tip just prior to installation.

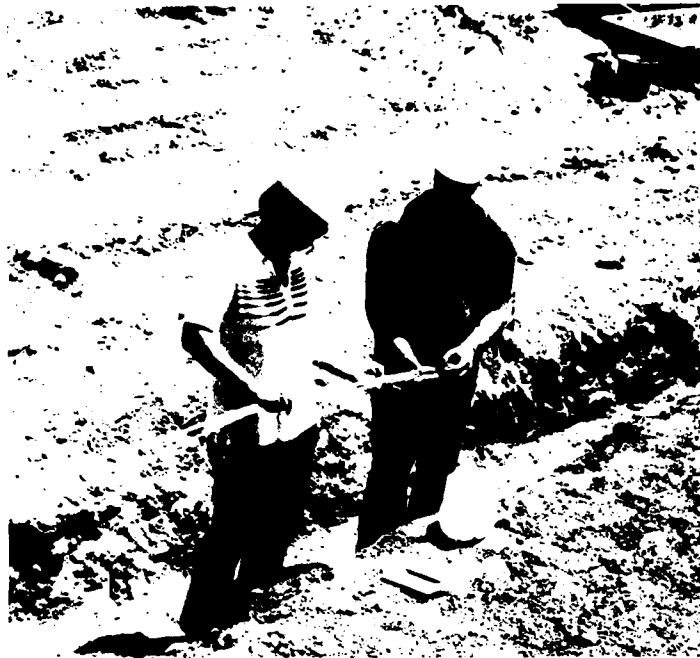
Depth being measured and marked on the piezometer tubing to facilitate installation in the bore hole.

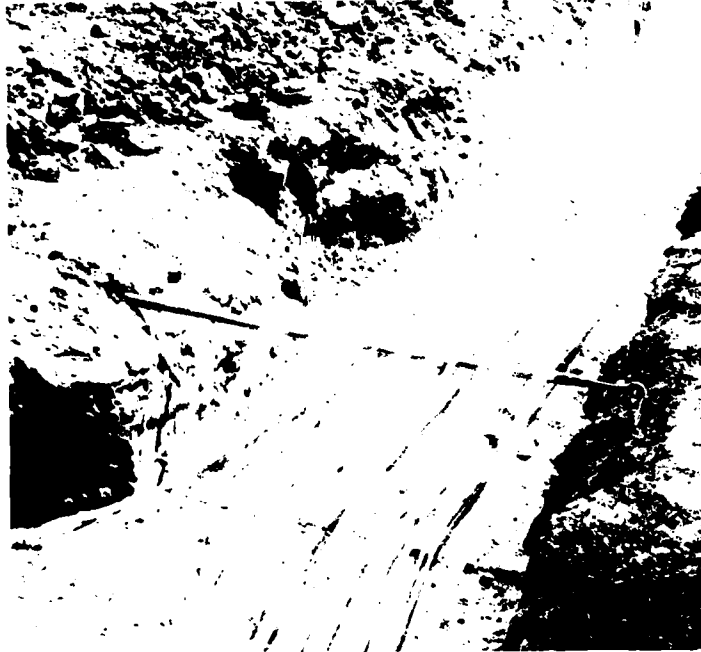
Station 16+60 U.S.B.R. foundation piezometer trench at the point where the last pair of piezometer tubes enters the trench.

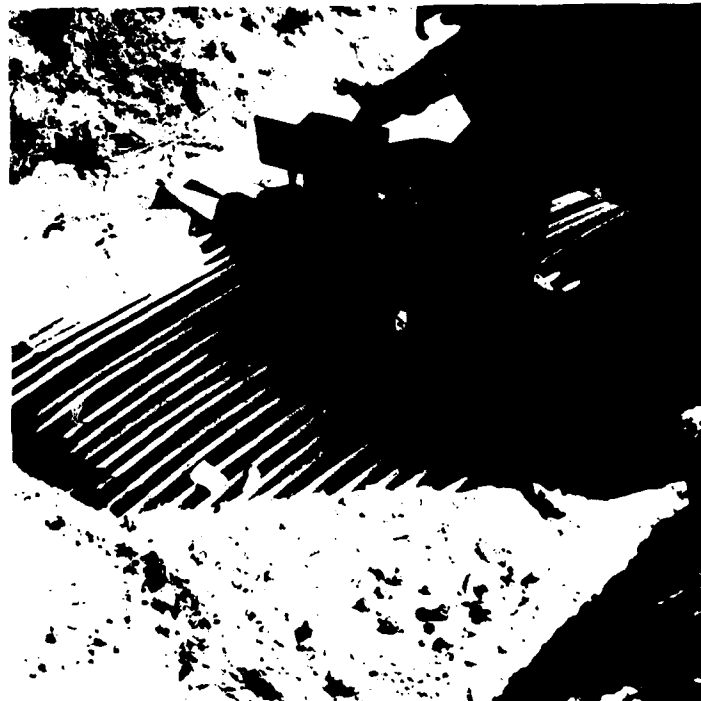
Technique and tools used for spacing the piezometer tubes in the trench.

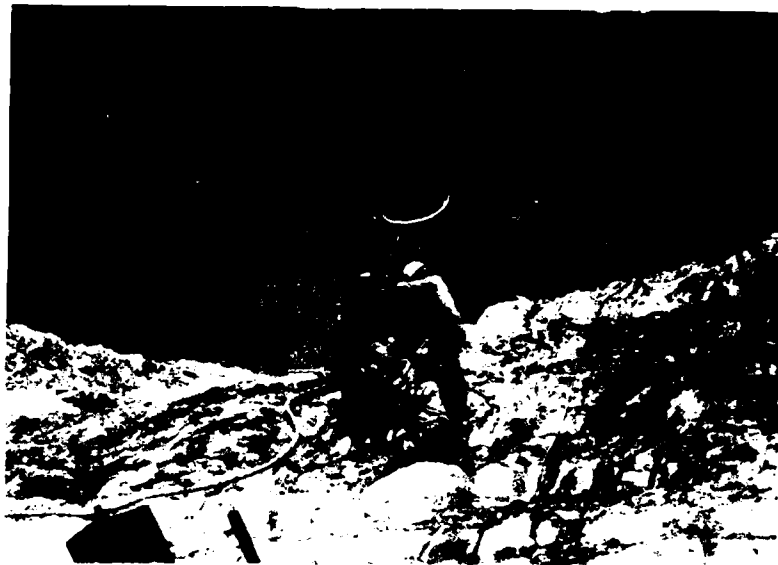
Main dam abutment and uplands grouting contract. Left abutment, drilling with C.P. 65 on rear cutoff trench slope.

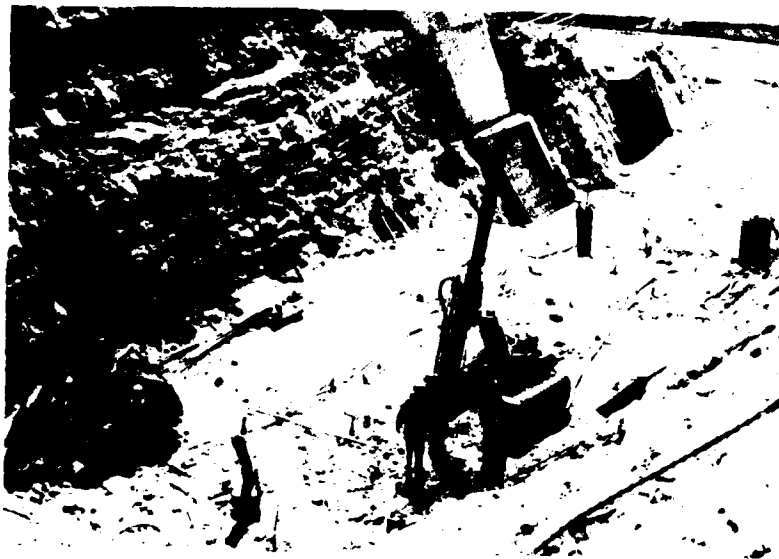
Main dam abutment and uplands grouting contract. Left abutment cutoff trench, El. 620 bench. Drilling upstream primary grout holes with air track.

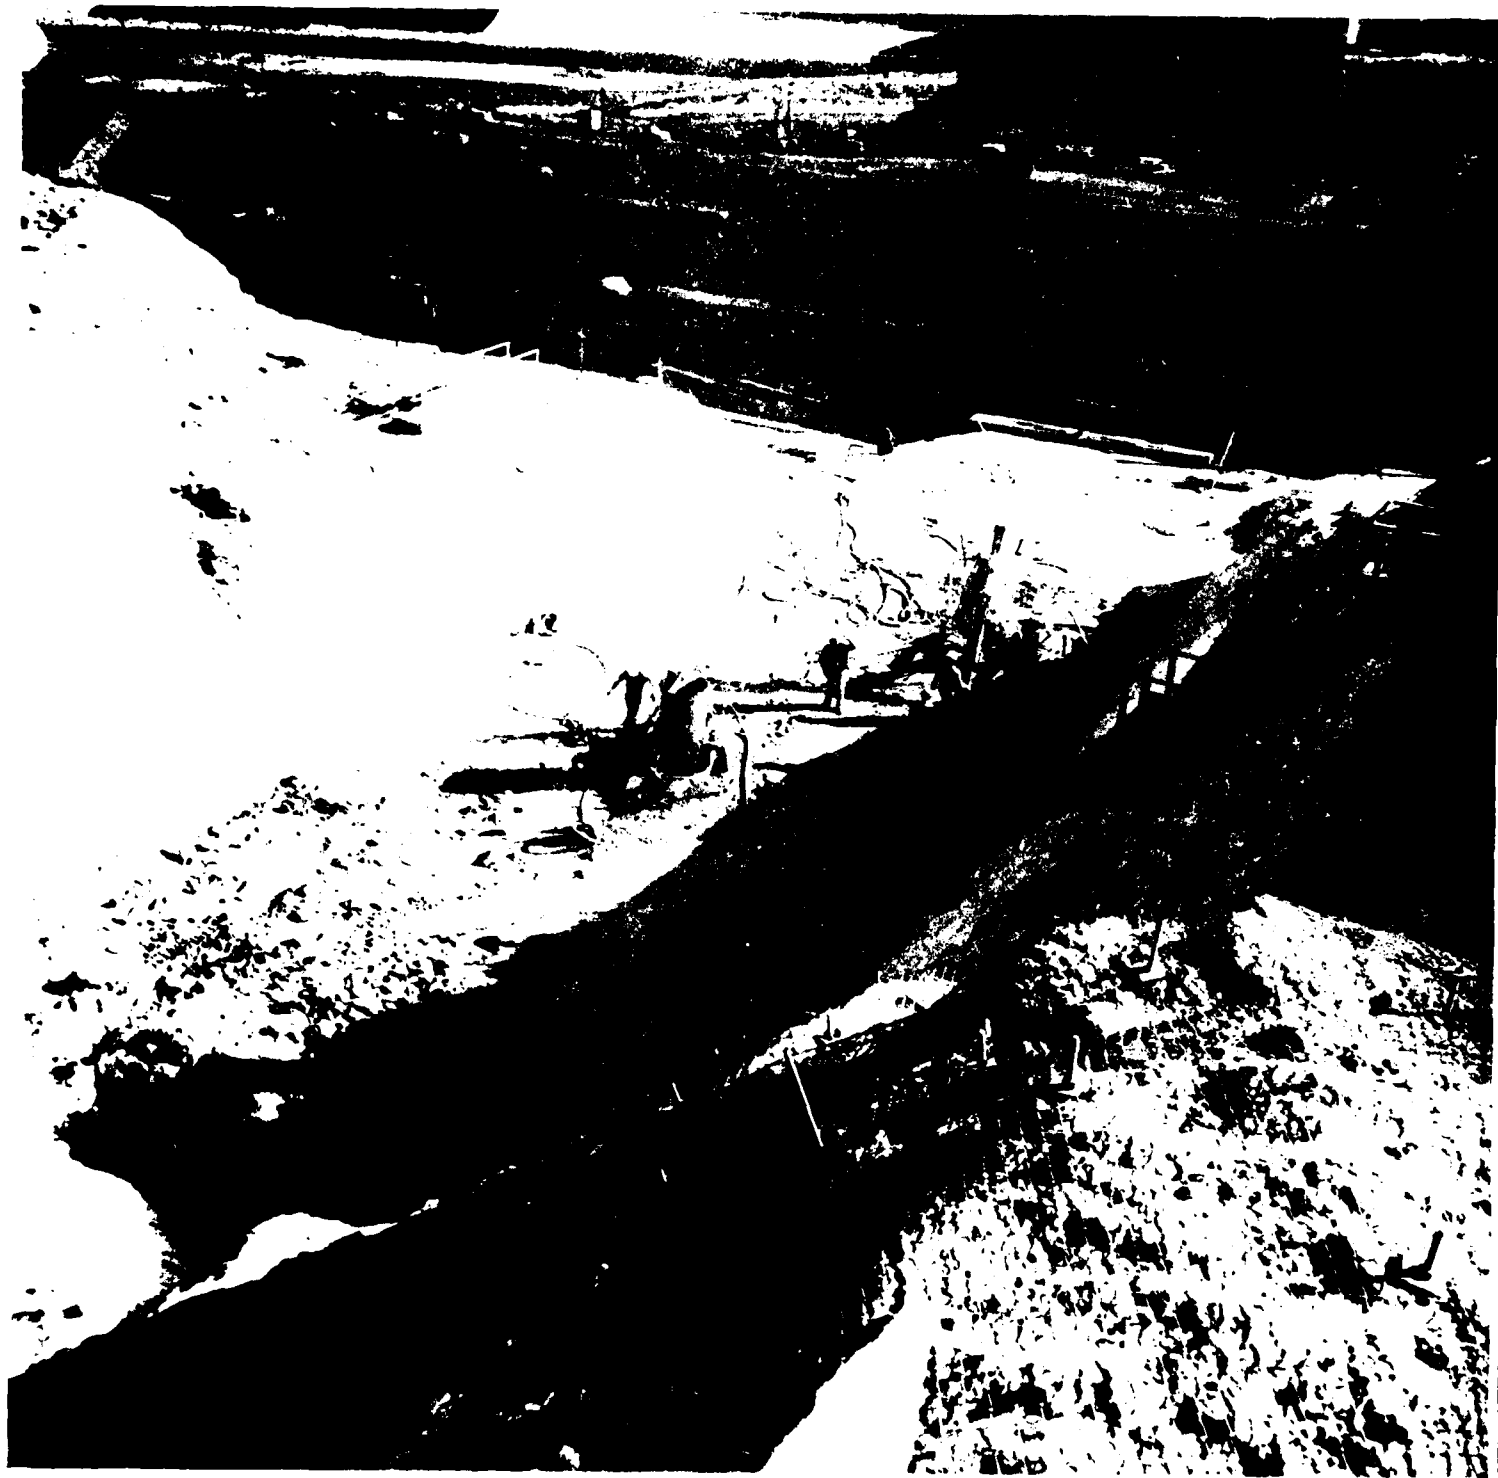
Main dam abutment and uplands grouting contract. Left abutment cutoff trench, El. 610 bench. Typical setup for drilling and grouting operations on consolidation borings.

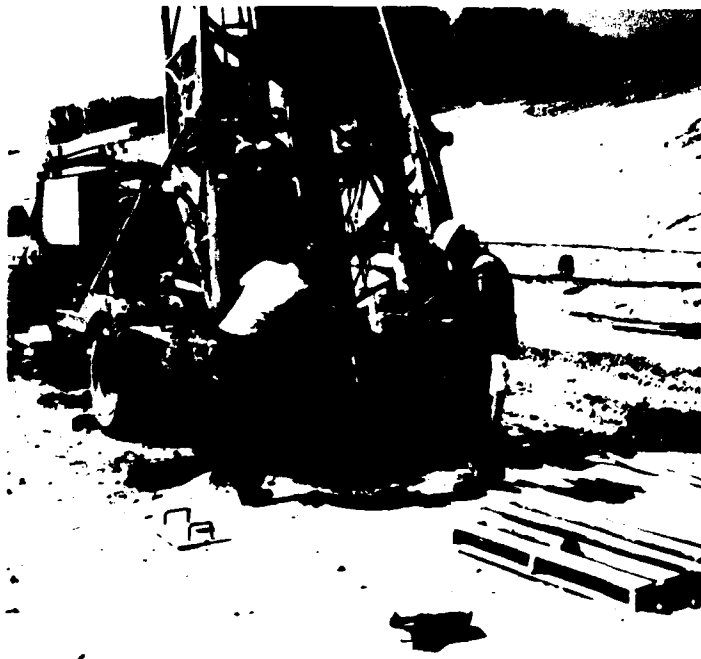
Main dam abutment and uplands grouting contract. HC-150 drill rig.

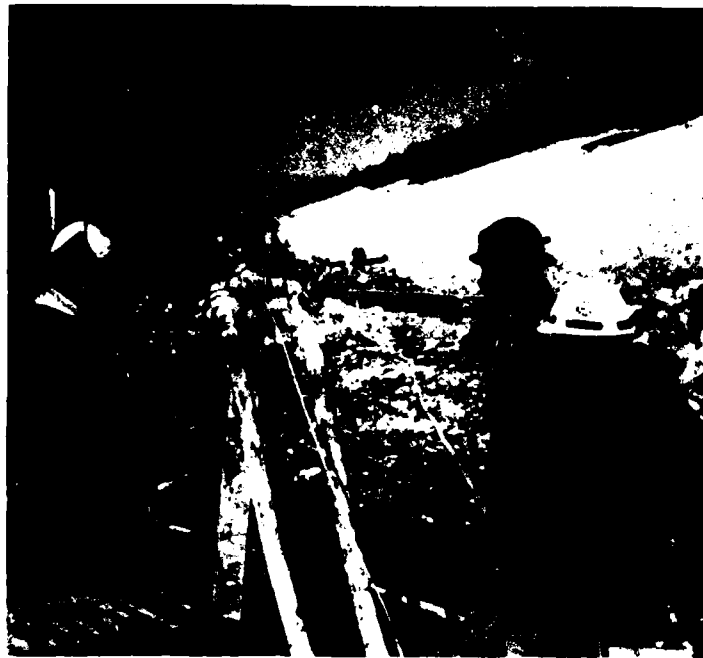
Main dam abutment and uplands grouting contract. Typical grout header arrangement.

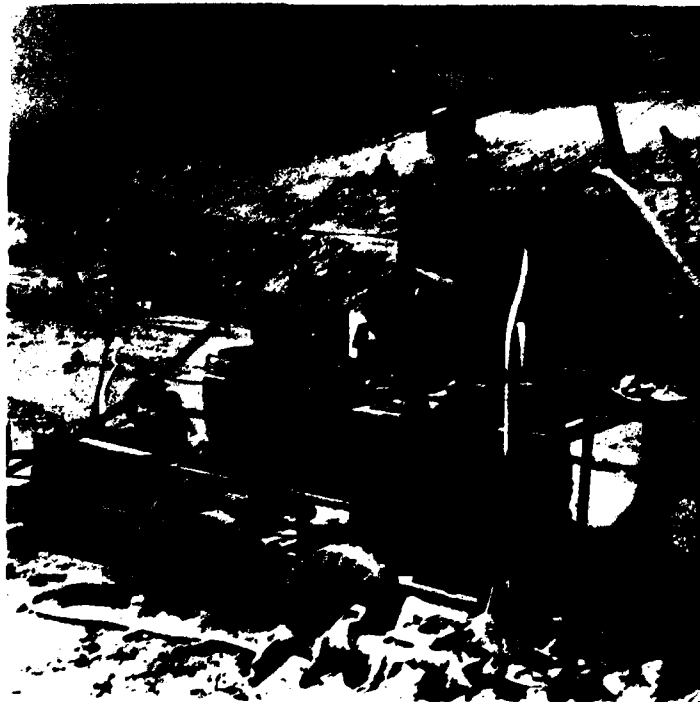
Main dam abutment and uplands grouting contract. Grouting plant assembly.

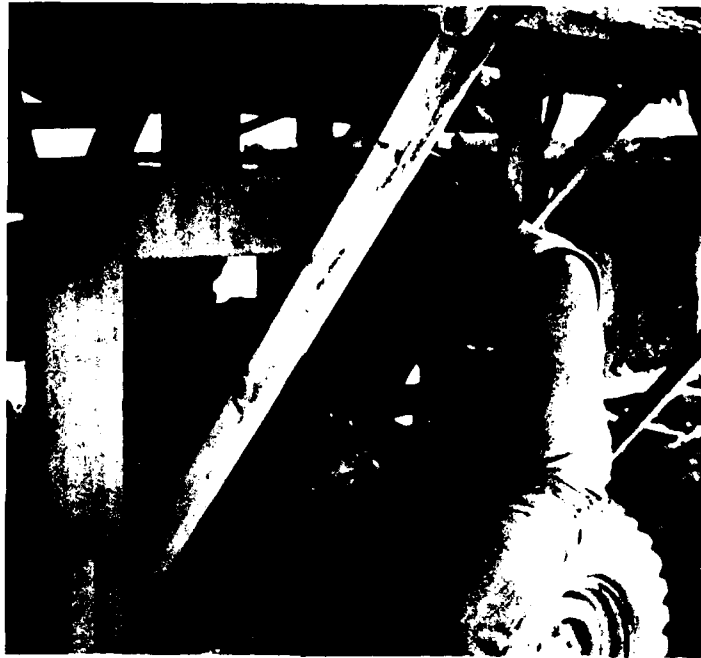
Main dam abutment and uplands grouting contract. Laborer cleaning out vacuum seal pump on a grout plant.
