**Joint Test Director
Joint Logistics Over-the-Shore II
Test and Evaluation**

**ANALYSIS AND EVALUATION
REPORT**

**JLOTS II
Throughput Test
AUGUST 1985**

Prepared by the
JLOTS II Test Directorate
Little Creek Naval Amphibious Base
Norfolk, Virginia 23521

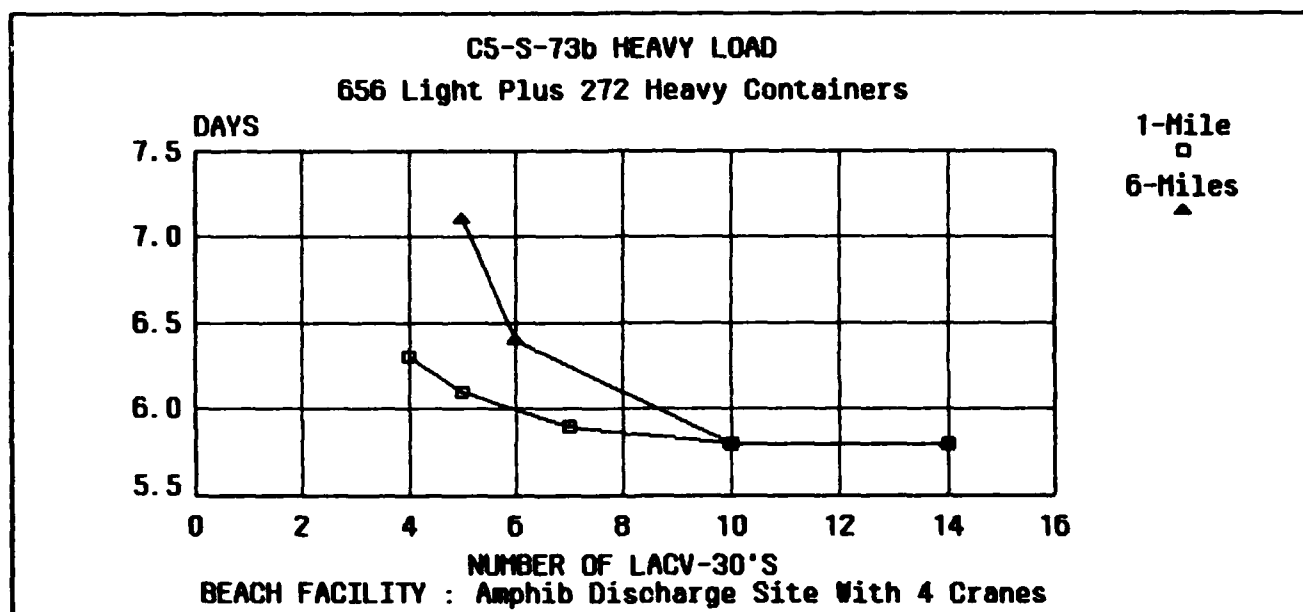
Figure 4 - T-ACS : LACV-30 : Crane System Productivity

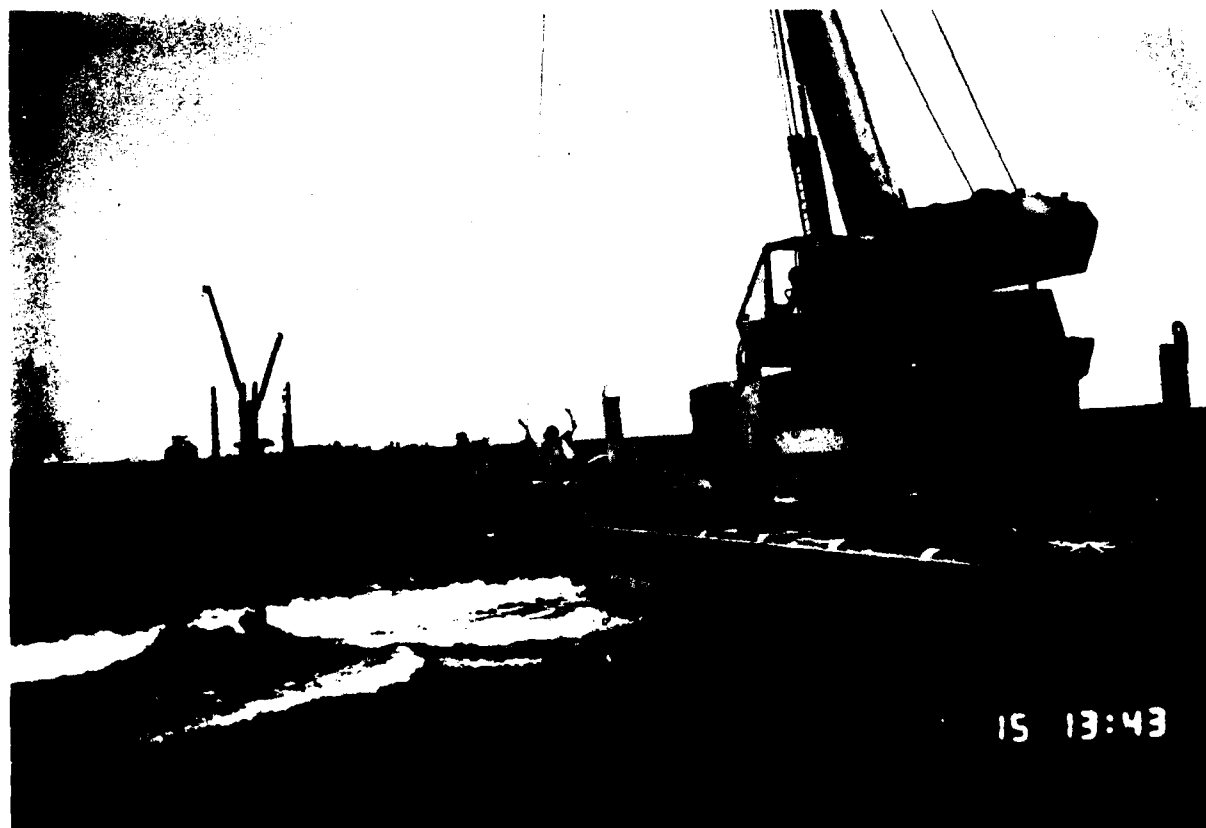
Figure 3-14 - Installation of External Spudwells

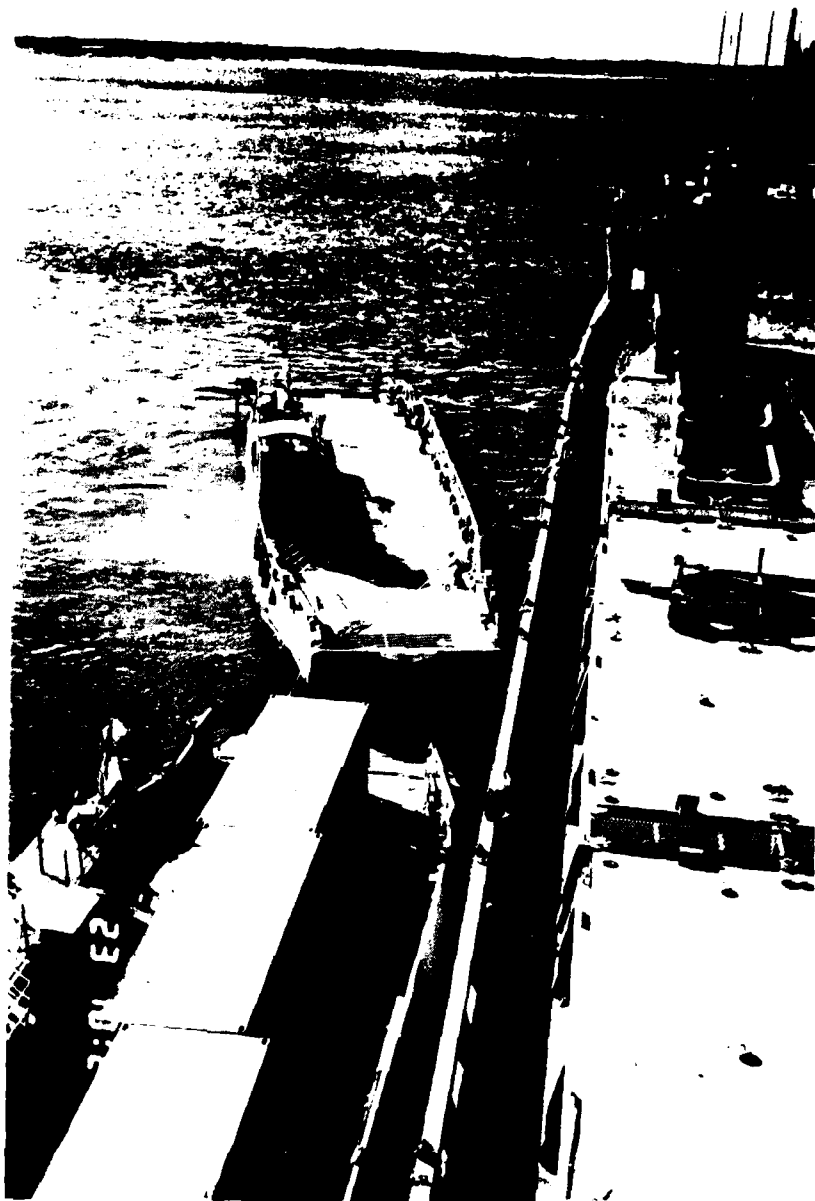
Figure 3-24 - Outboard Causeway Ferry Departs
While Inboard Ferry Receives Containers

(Note - Close proximity of craft and mooring
line caught on LCU's bow ramp)

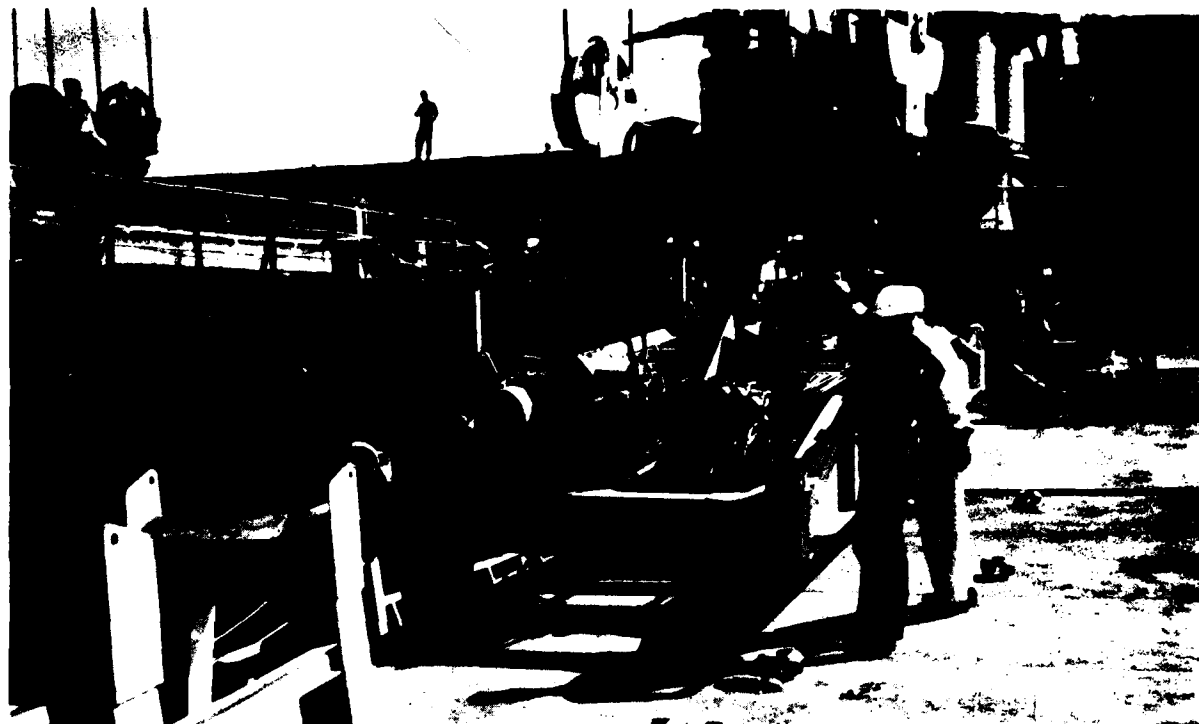
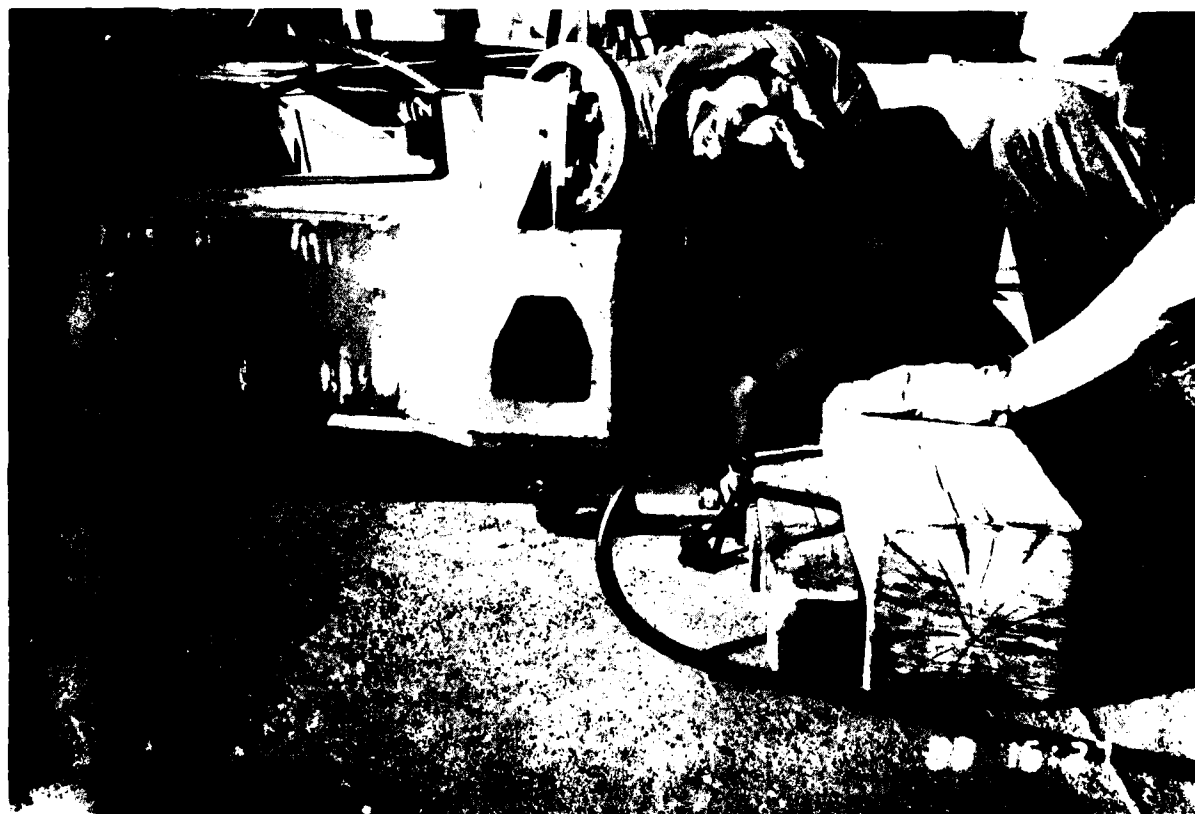
Figure 3-29 - Automatic and Manual Container Spreader Bars

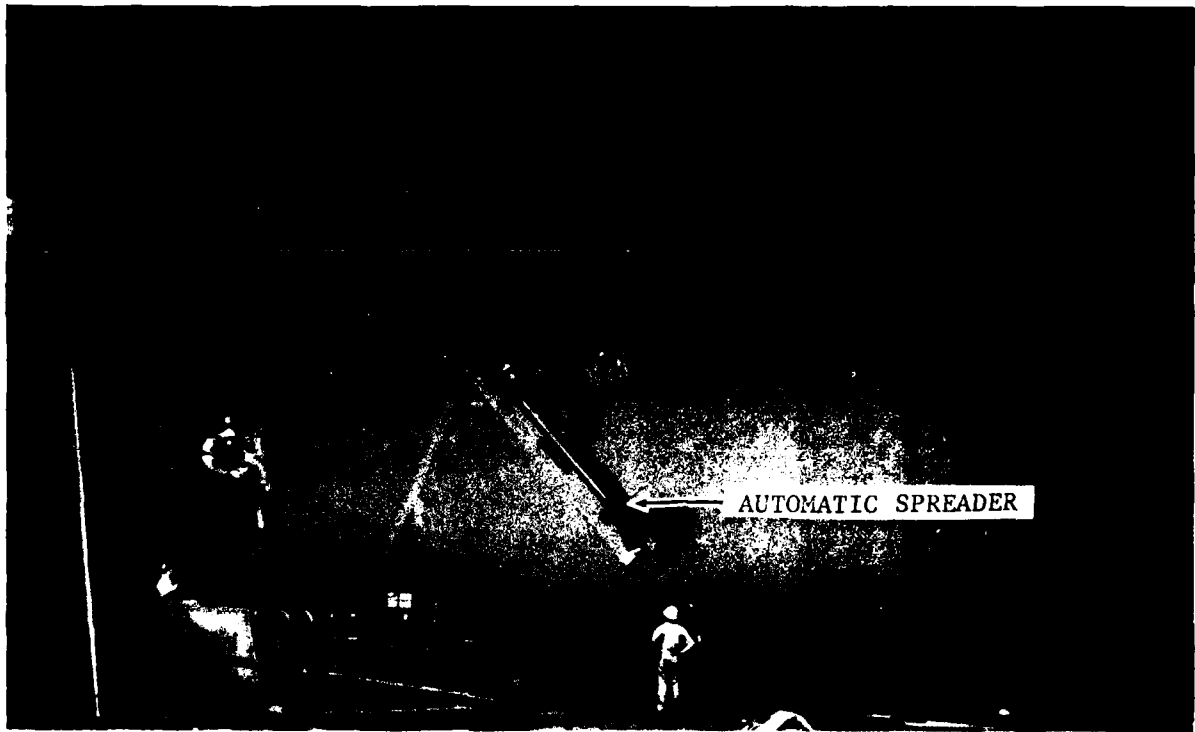
Figure 3-32 - Pendulation Problems on T-ACS

The Rider Block Tagline System installed on T-ACS cannot be used when the crane booms are used in combination. This is considered a deficiency since pendulation control is essential when handling heavy loads as well as when handling containers.

The T-ACS demonstrated the capability to move containers in Sea State 3 as long as the sea conditions consisted of small period waves, i.e., wave/chop rather than long period ground swells. Navy lighterage did not demonstrate a Sea State 3 capability. Whenever the T-ACS became exposed to ground swells on her beam she would begin to roll slightly, about 1 deg, which induced spreader bar pendulation as shown in Figure 3-32. The Rider Block Tagline System on T-ACS was not effective in controlling this pendulation. The controls for the Rider Block Tagline

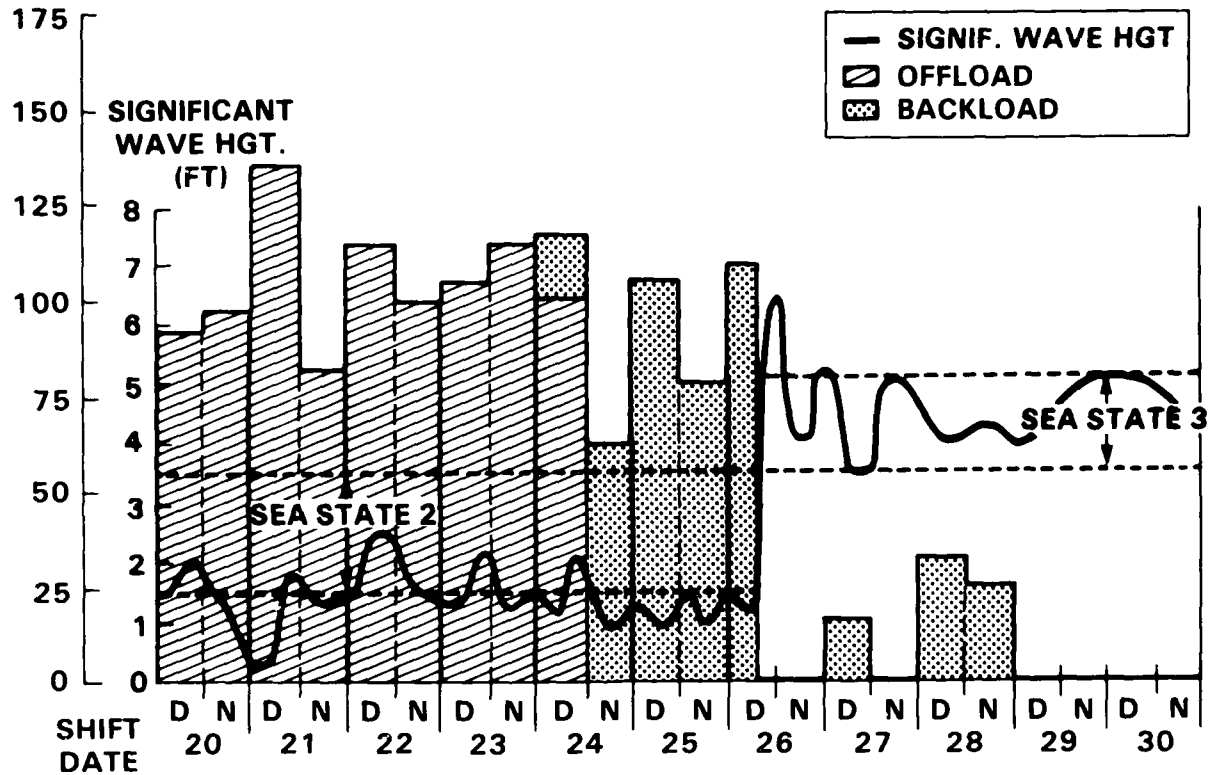
Figure 3-33 - Navy/T-ACS Operations - September 1984
