ENGINEERING ANALYSIS OF BEACH EROSION AT HOMER SPIT
ALASKA(U) COASTAL ENGINEERING RESEARCH CENTER VICKSBURG
MS O P SMITH ET AL. SEP 85 CERC-85-13

ENGINEERING ANALYSIS OF BEACH EROSION AT HOMER SPIT, ALASKA

Coastal Engineering Research Center

September 1985
Final Report

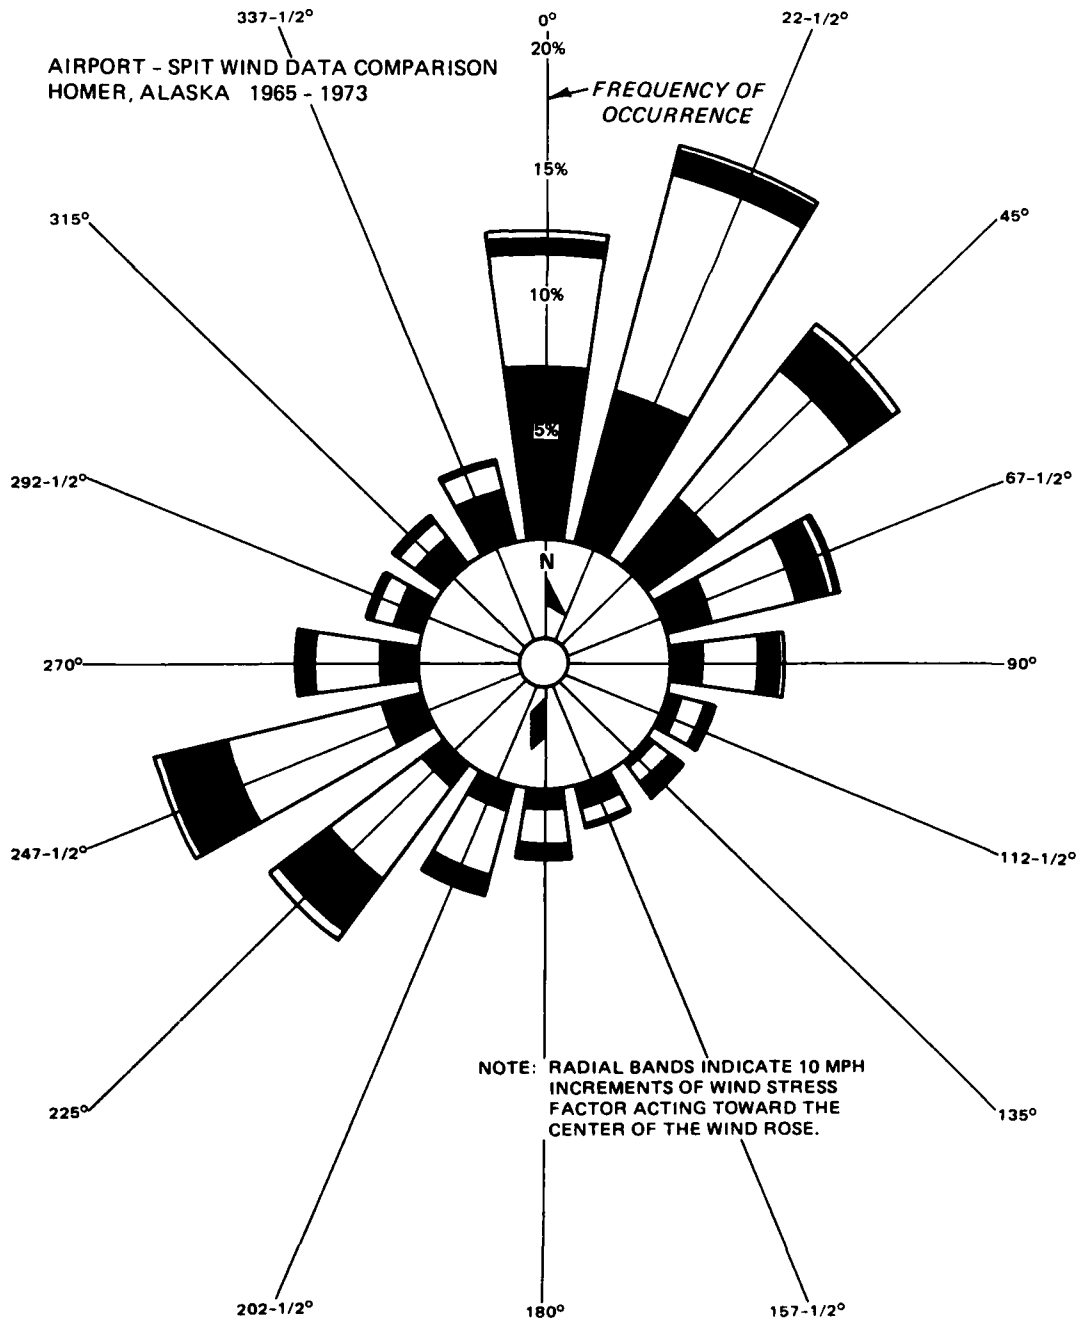
Figure A-5. Wind rose of airport anemometer data for which there were concurrent data from the Spit anemometer, Homer Alaska

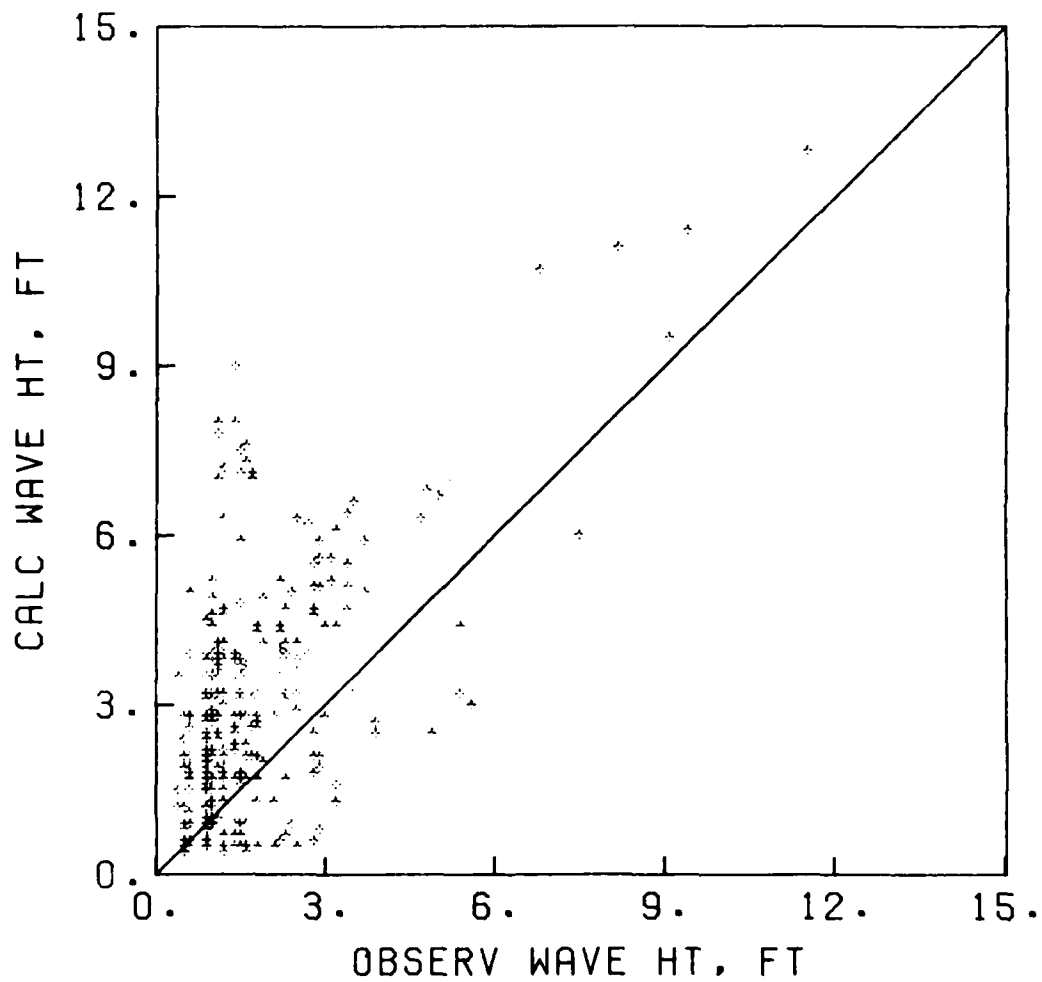
Figure A-15. Scatter plot of calculated versus measured waves

MEAN	STD DEV
CALCULATED WAVE HEIGHT (feet)	3.03	2.07
OBSERVED WAVE HEIGHT (feet)	1.71	1.39

A linear regression analysis with the observed wave height as the independent variable (X) and the calculated wave height as the dependent variable (Y) gave the following results:

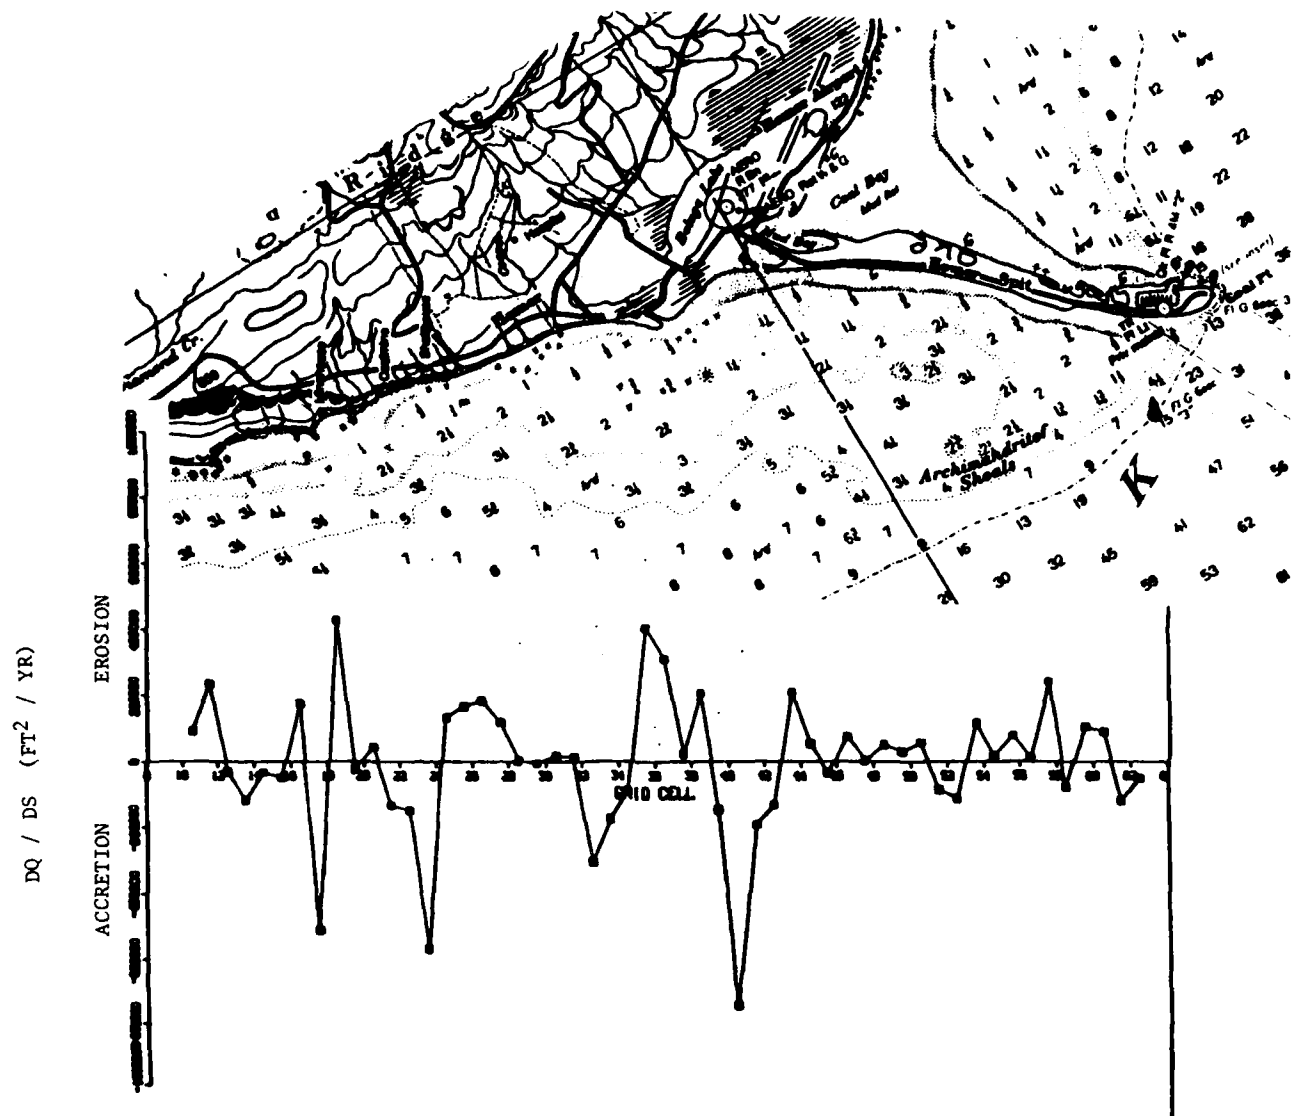
Figure B-7 - Change in sediment transport rate per increment of shoreline (airport wind distribution)

dQ/dS indicates an area of local accretion. The erratic variation of dQ/dS illustrates the need for more accurate hydrographic data in the wave model and additional wind and wave data for improved confidence. Visual smoothing reveals a rough correspondence between major variations and the known areas of erosion, however.
