Technical Report-85-E-2

VHF-FM COMMUNICATIONS ANTENNAS FOR PROJECT SINGARS
(UH-1 TAIL WHIP ANTENNA EVALUATION)

VIBRATION SURVEY OF THE DAYTON-GRANGER
FM 10-360 QUAD POD ANTENNA

DELSD-E REPORT NO. 76

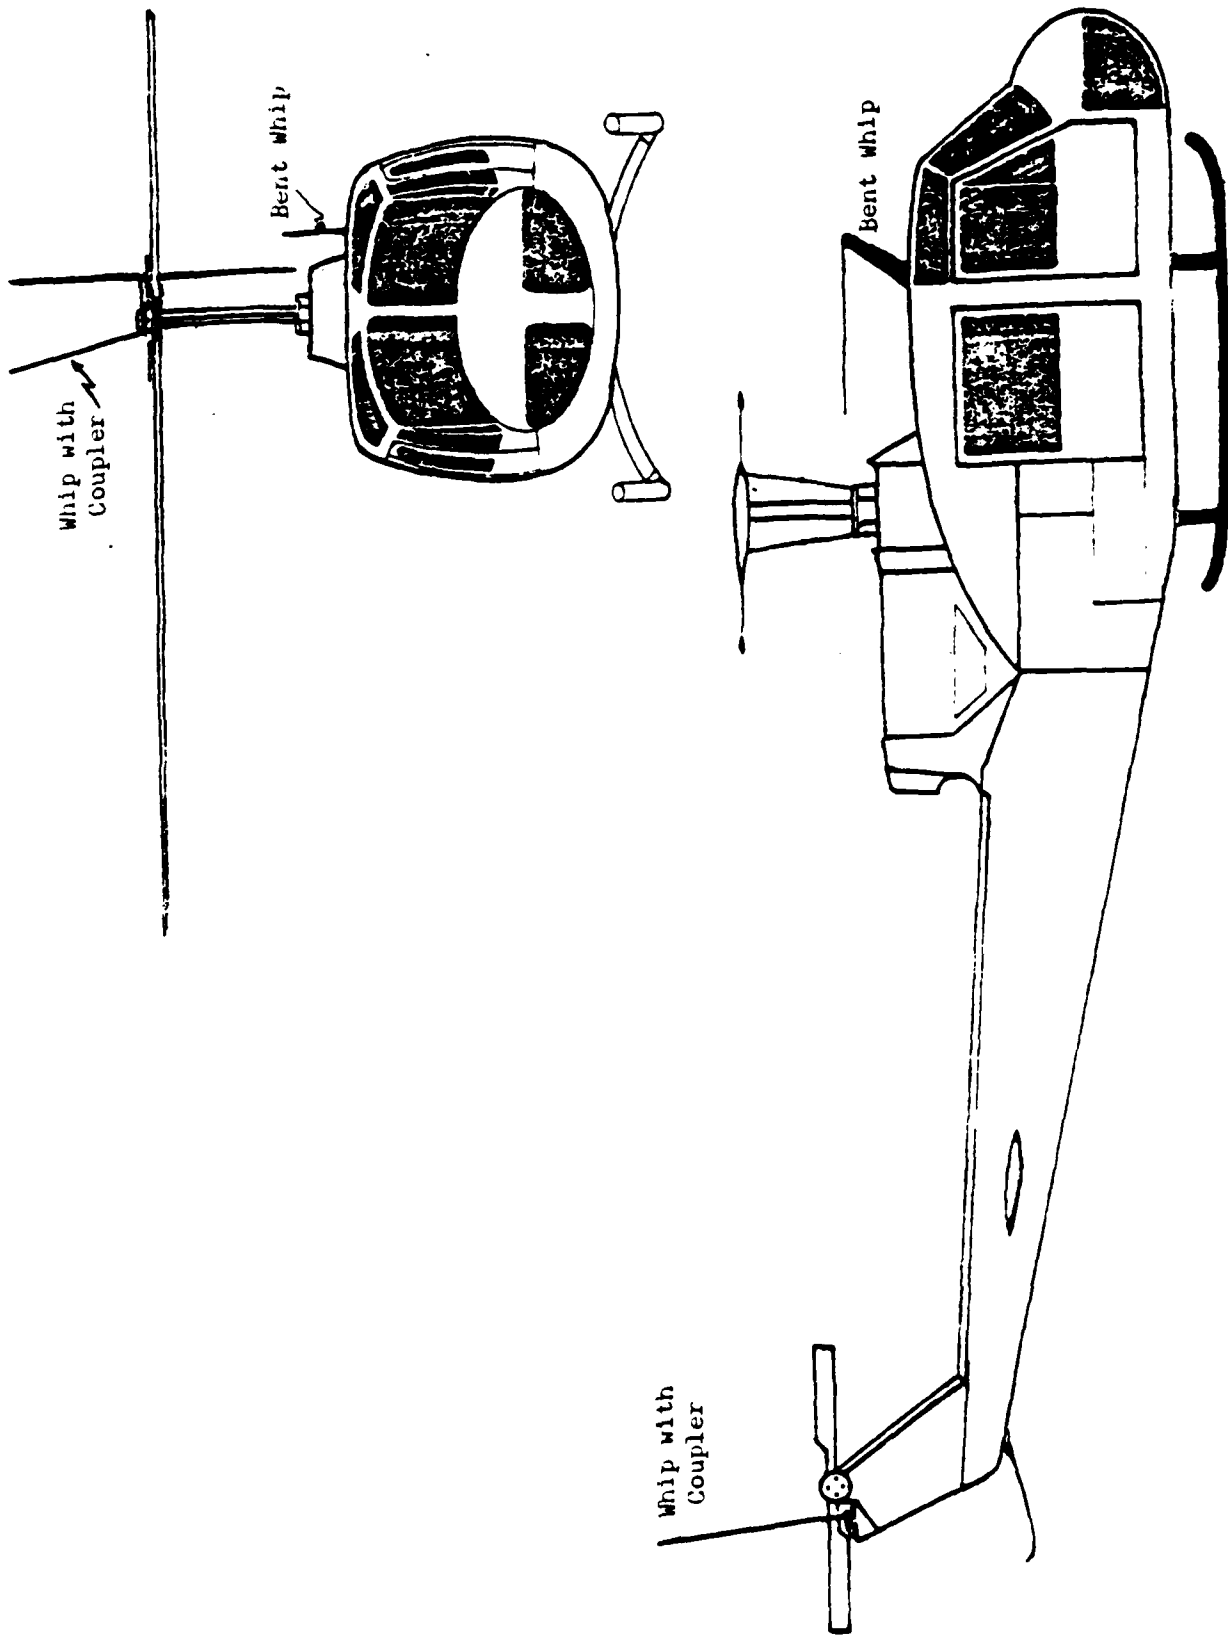
Figure 1. Test Range Setup.

The test measurements were conducted at the Naval Air Development Center Antenna Test Facility located in Warminster, PA. A UH-1B Army Helicopter was transported to the test facility and placed on a 20 by 24-foot cement pad located 500 feet from Building 115. Figure 1 shows how the test range was set up for these measurements.

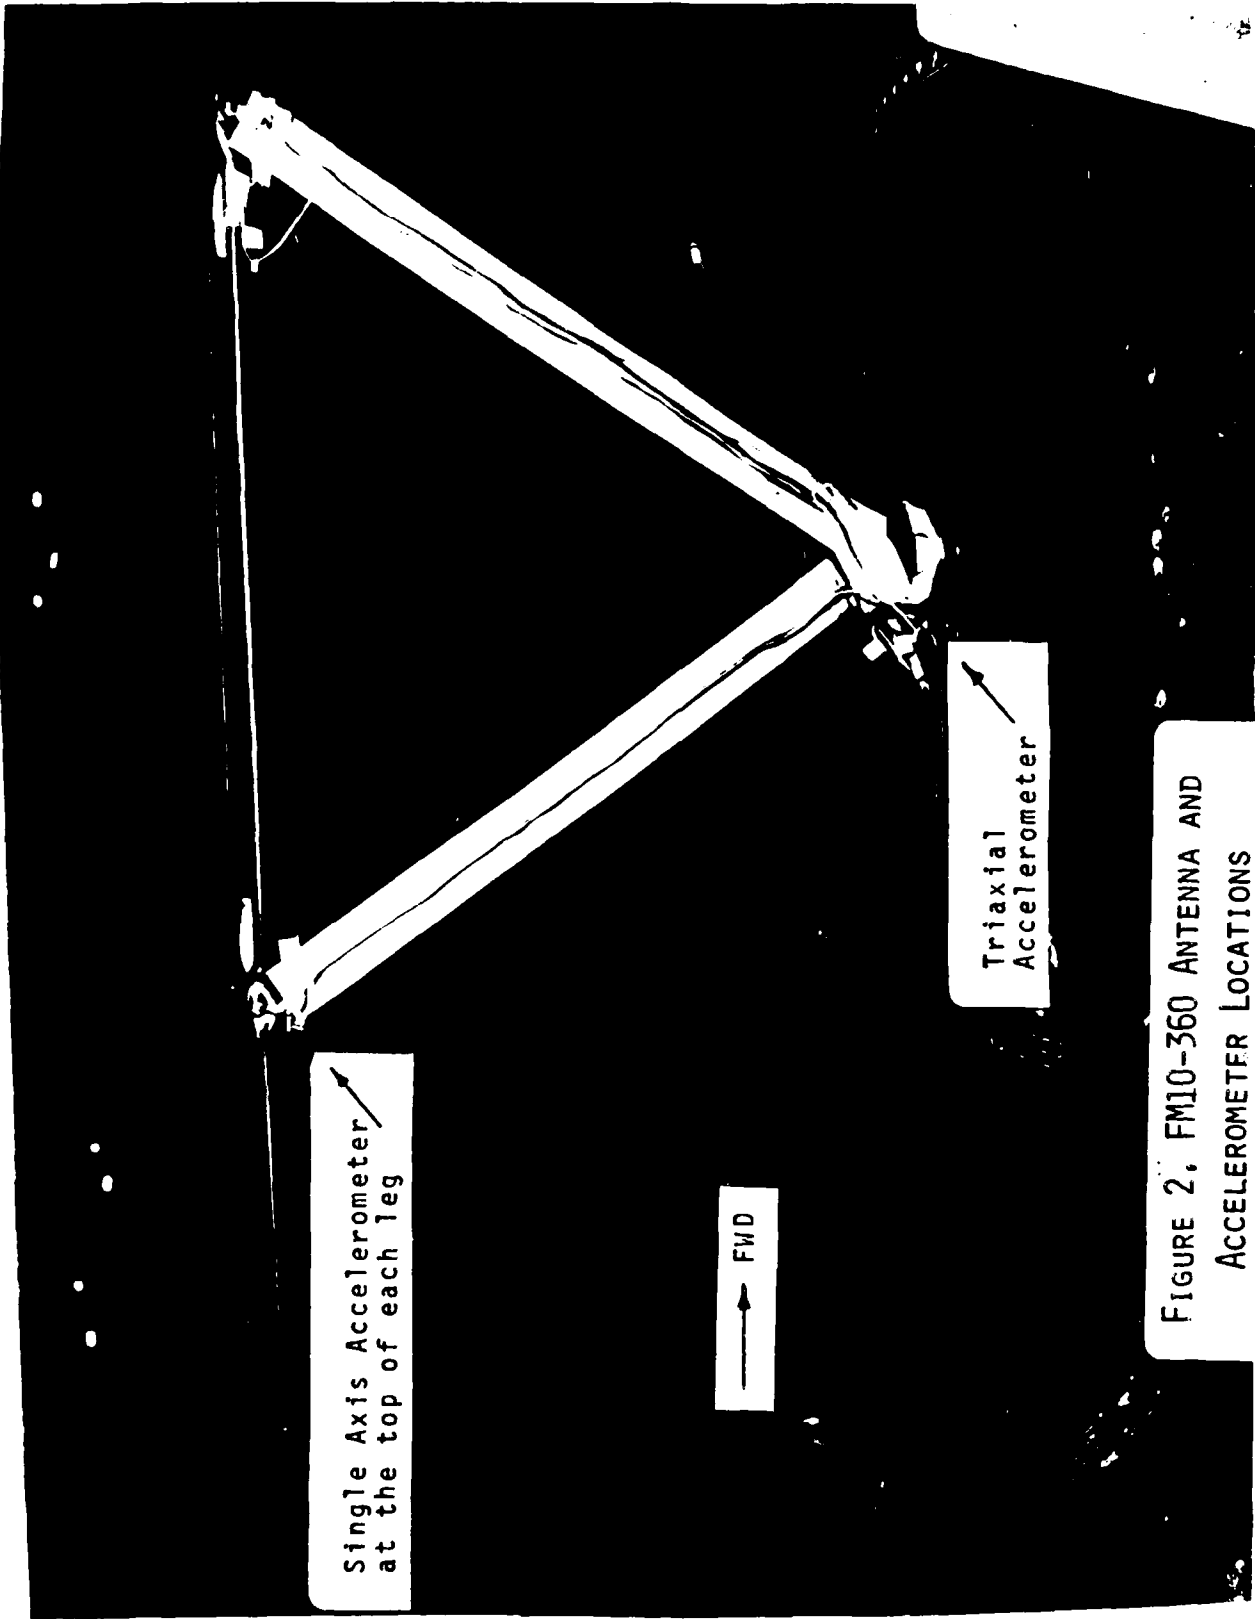
Single Axis Accelerometer
at the top of each leg

Triaxial
Accelerometer

FIGURE 2. FM10-360 ANTENNA AND
ACCELEROMETER LOCATIONS

b. Single axis accelerometers were secured, using epoxy, at the top of each of the four (4) vertical support members. These recorded output in the y direction, i.e., side to side. Another single axis accelerometer was mounted on the horizontal element to record output in the x direction, i.e., fore and aft. The triaxial accelerometer was mounted on the base of the antenna near the aircraft skin to measure the input levels (Figures 2 and 3).

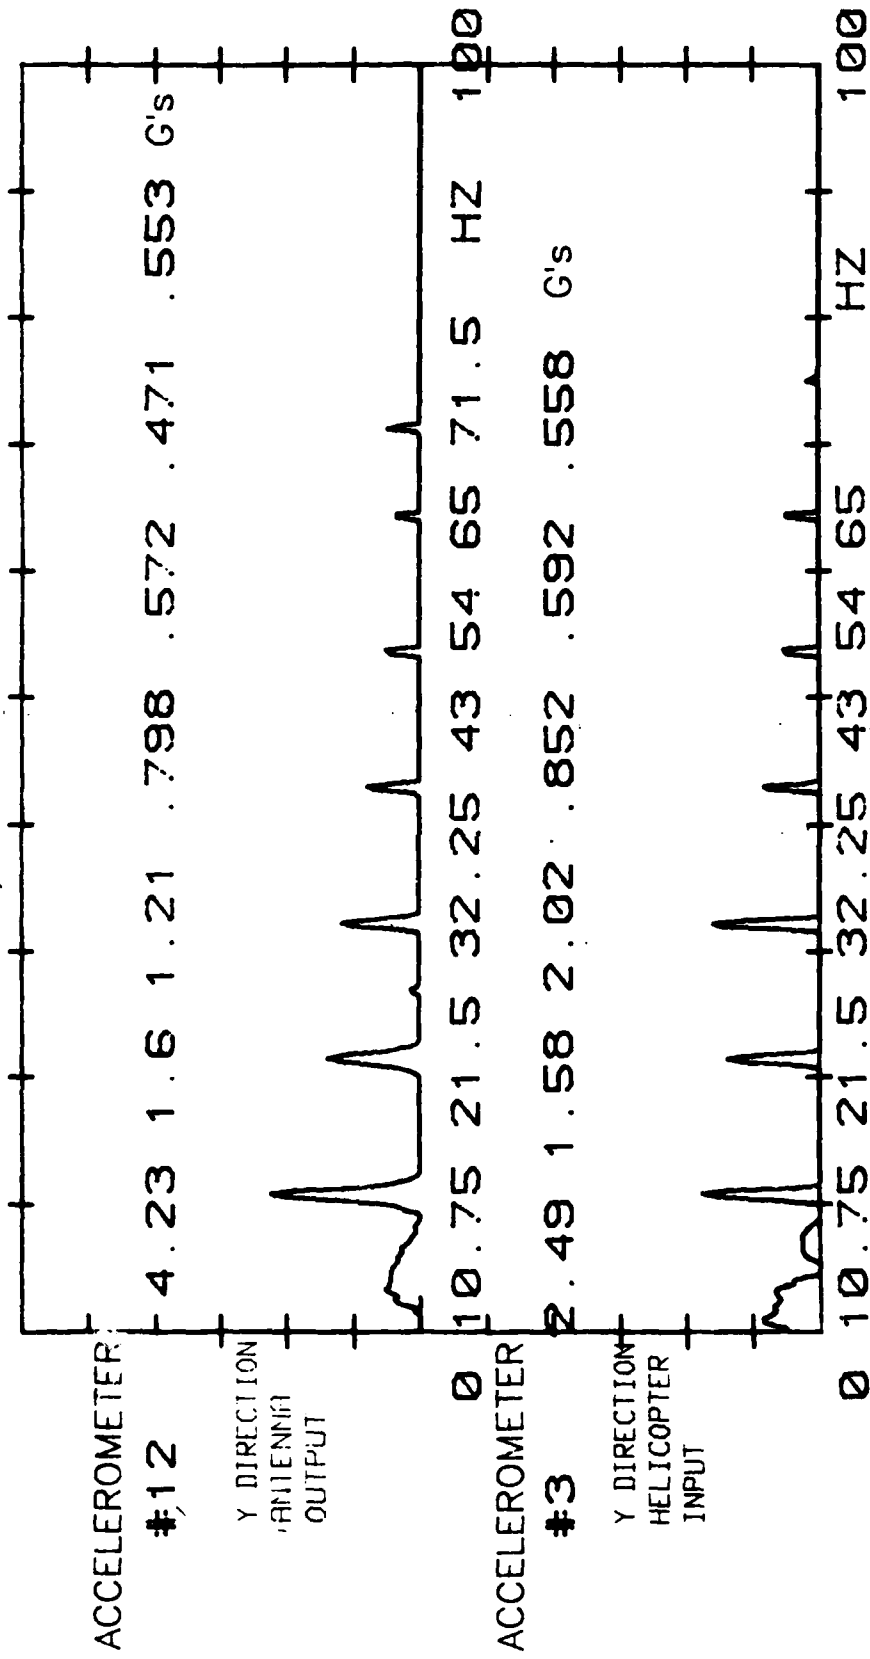
F10-360 ANTENNA VIBRATION SURVEY ON UH-1H HELICOPTER 73-21684
 AVERAGE G LEVELS VS FREQUENCY
 PERFORMED ON AUGUST 9, 1984 AT NAS LAKEHURST NJ

FIGURE 10. GROUND RUNUP 324 RPM; ACCELEROMETERS 3 AND 12

b. The results of the flight survey are presented in Figures 10 thru 41. Figures 10 thru 20 present the output measured by accelerometer #12, and the helicopter input measured in the y direction by accelerometer #3. Figures 21 thru 31 present the output measured by accelerometer #8, and the helicopter input measured in the z direction by accelerometer #5. Figures 32 thru 41 present the x direction helicopter input measured by accelerometer #6. The data in the graphs is an average of all data taken during the particular flight maneuver listed. Accelerometers 8 and 12 were identified in modal analysis as being in locations that would reveal significant amplification. The other accelerometers measured similar data.

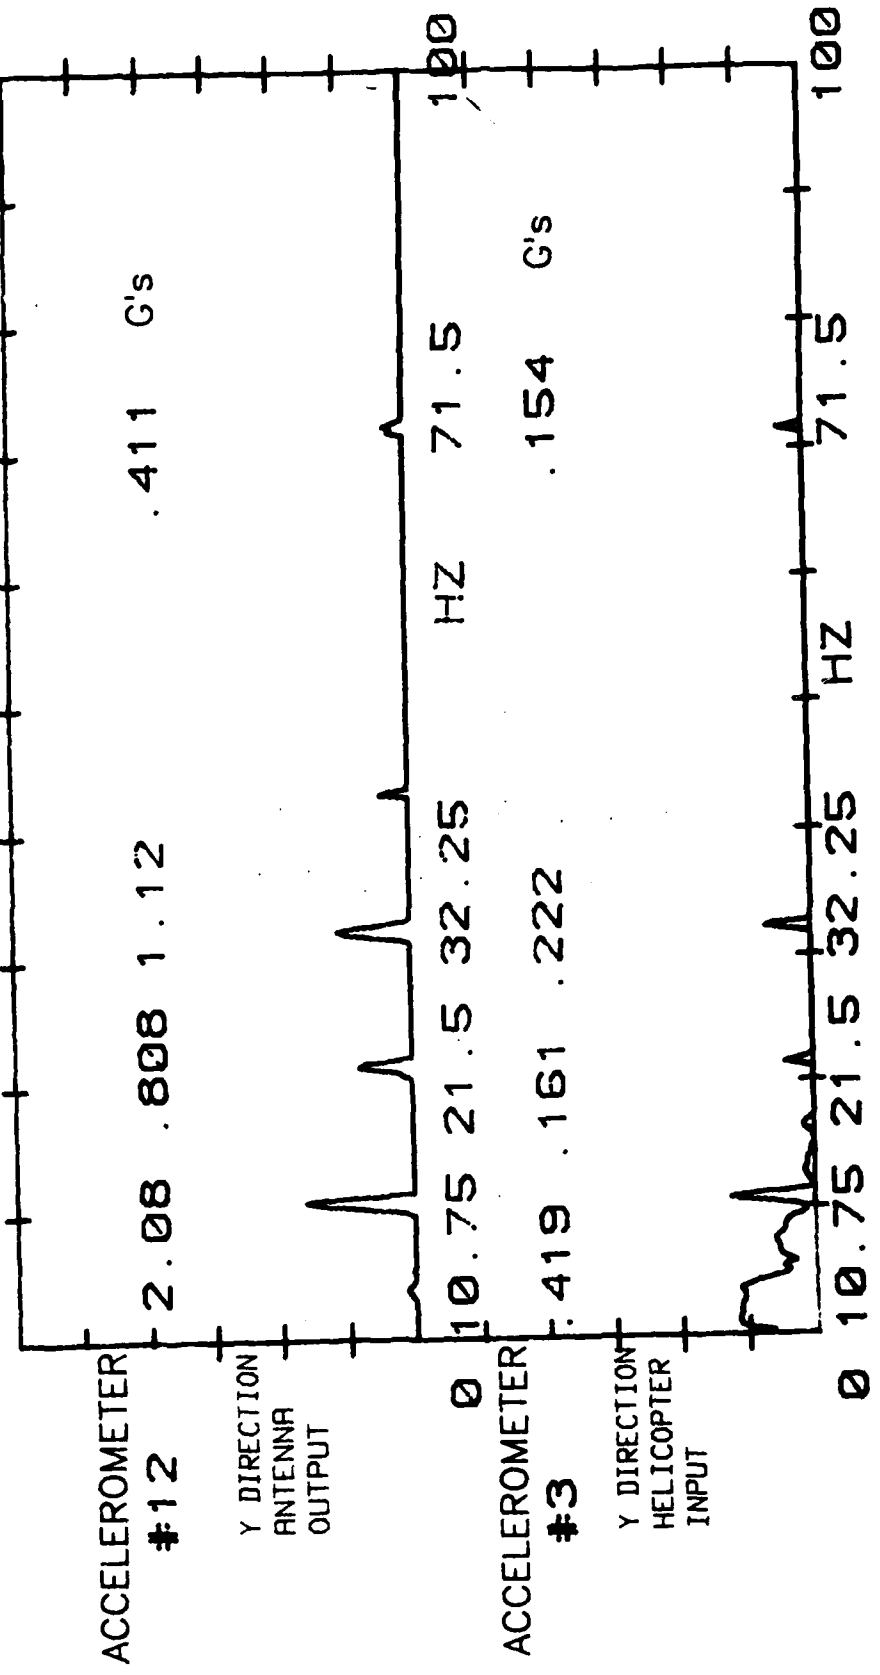
FIGURE 11. TAXI AND TAKEOFF: ACCELEROMETERS 3 AND 12

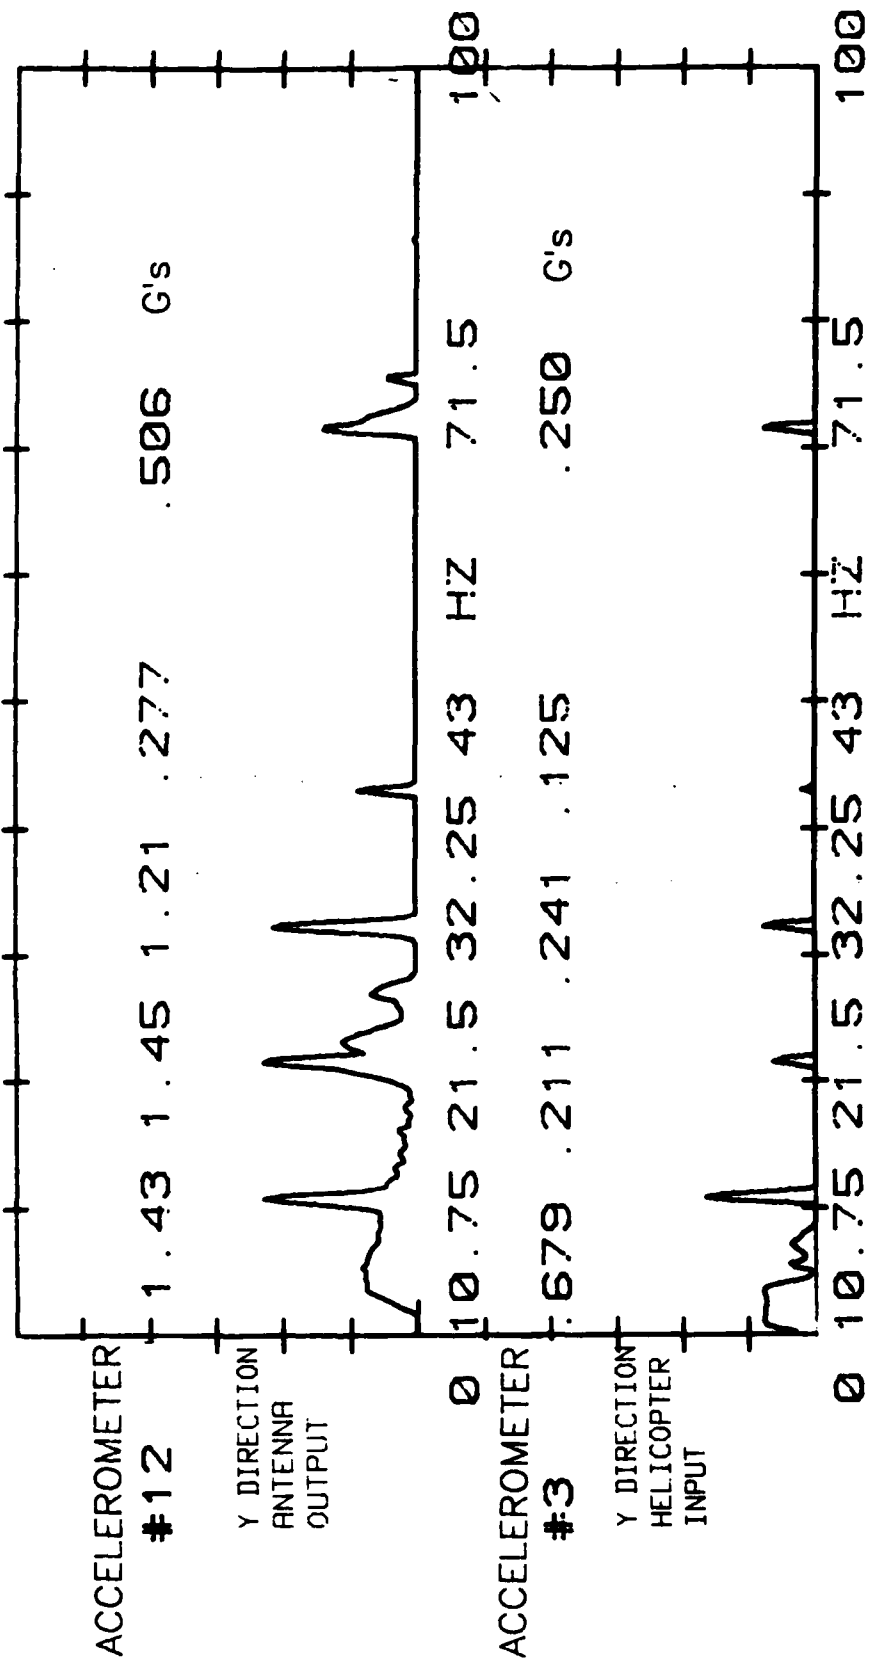
FIGURE 12. LEVEL FLIGHT 70-80 KNOTS, 100-3000 FT: ACCELEROMETERS 3 AND 12

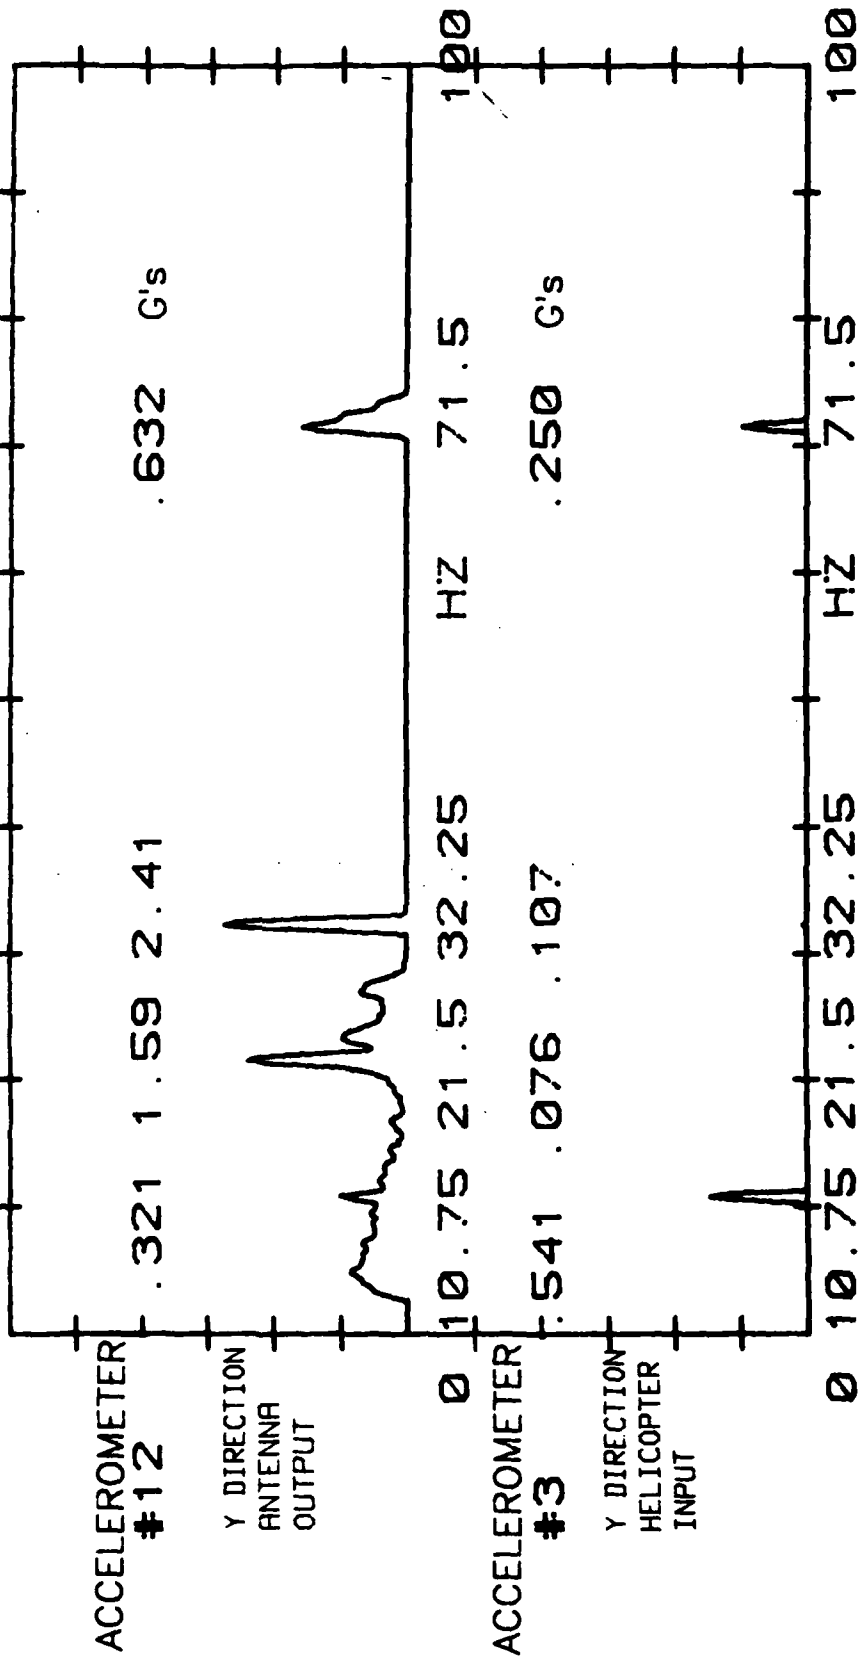
FIGURE 13. LEVEL FLIGHT 90-95 KNOTS, 3000 FT: ACCELEROMETERS 3 AND 12

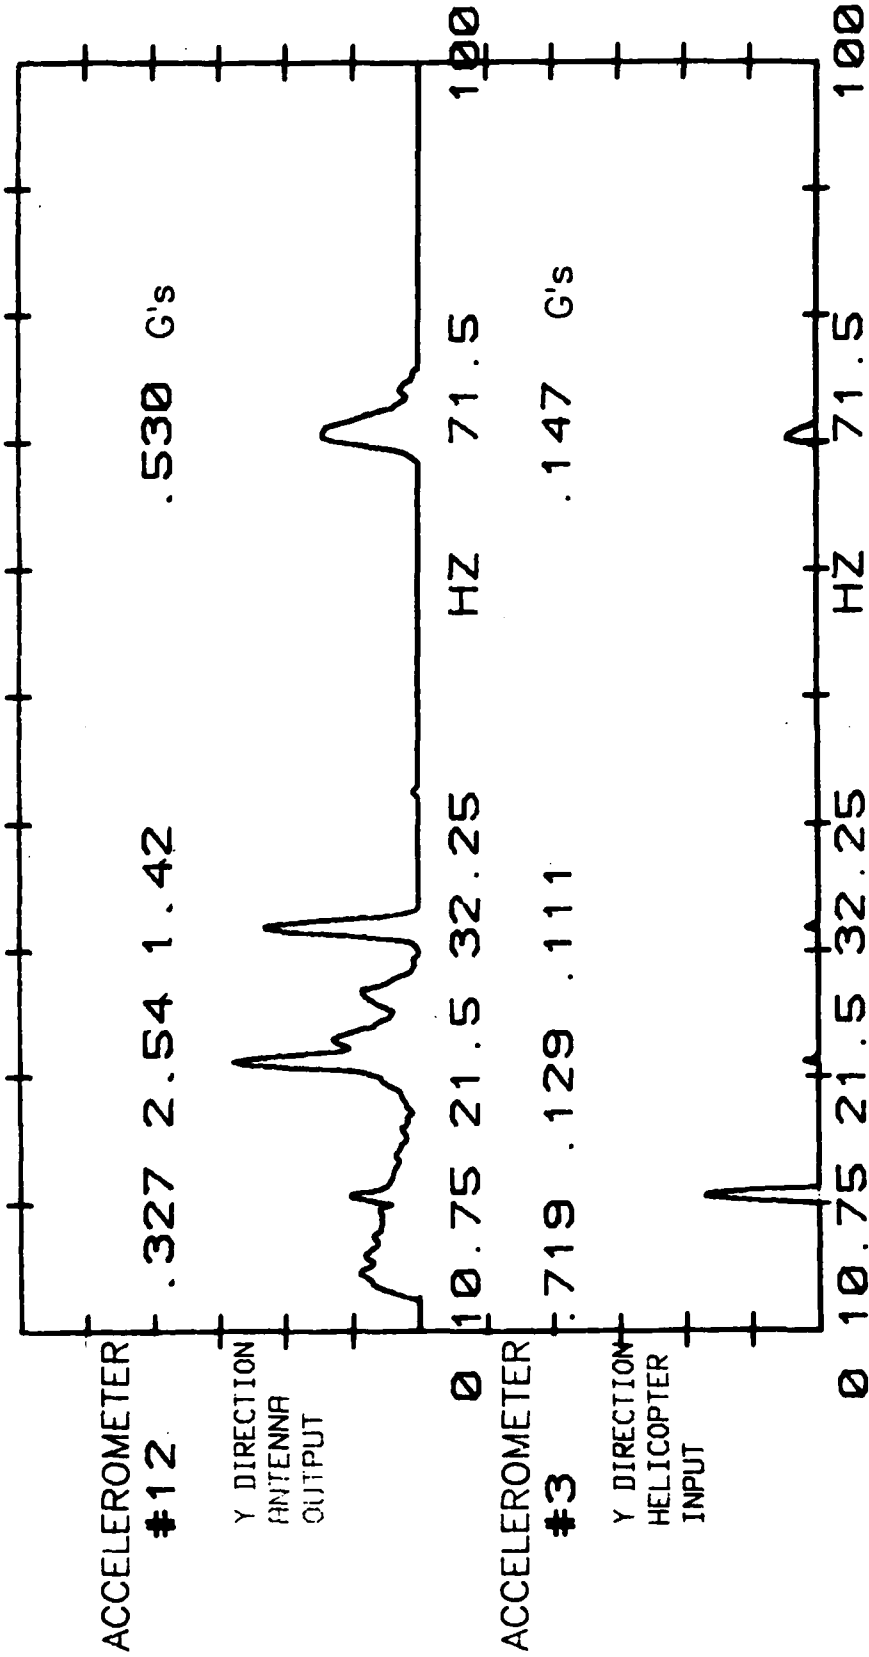
FIGURE 14. LEVEL FLIGHT 105--110 KNOTS, 3000 FT: ACCELEROMETERS 3 AND 12

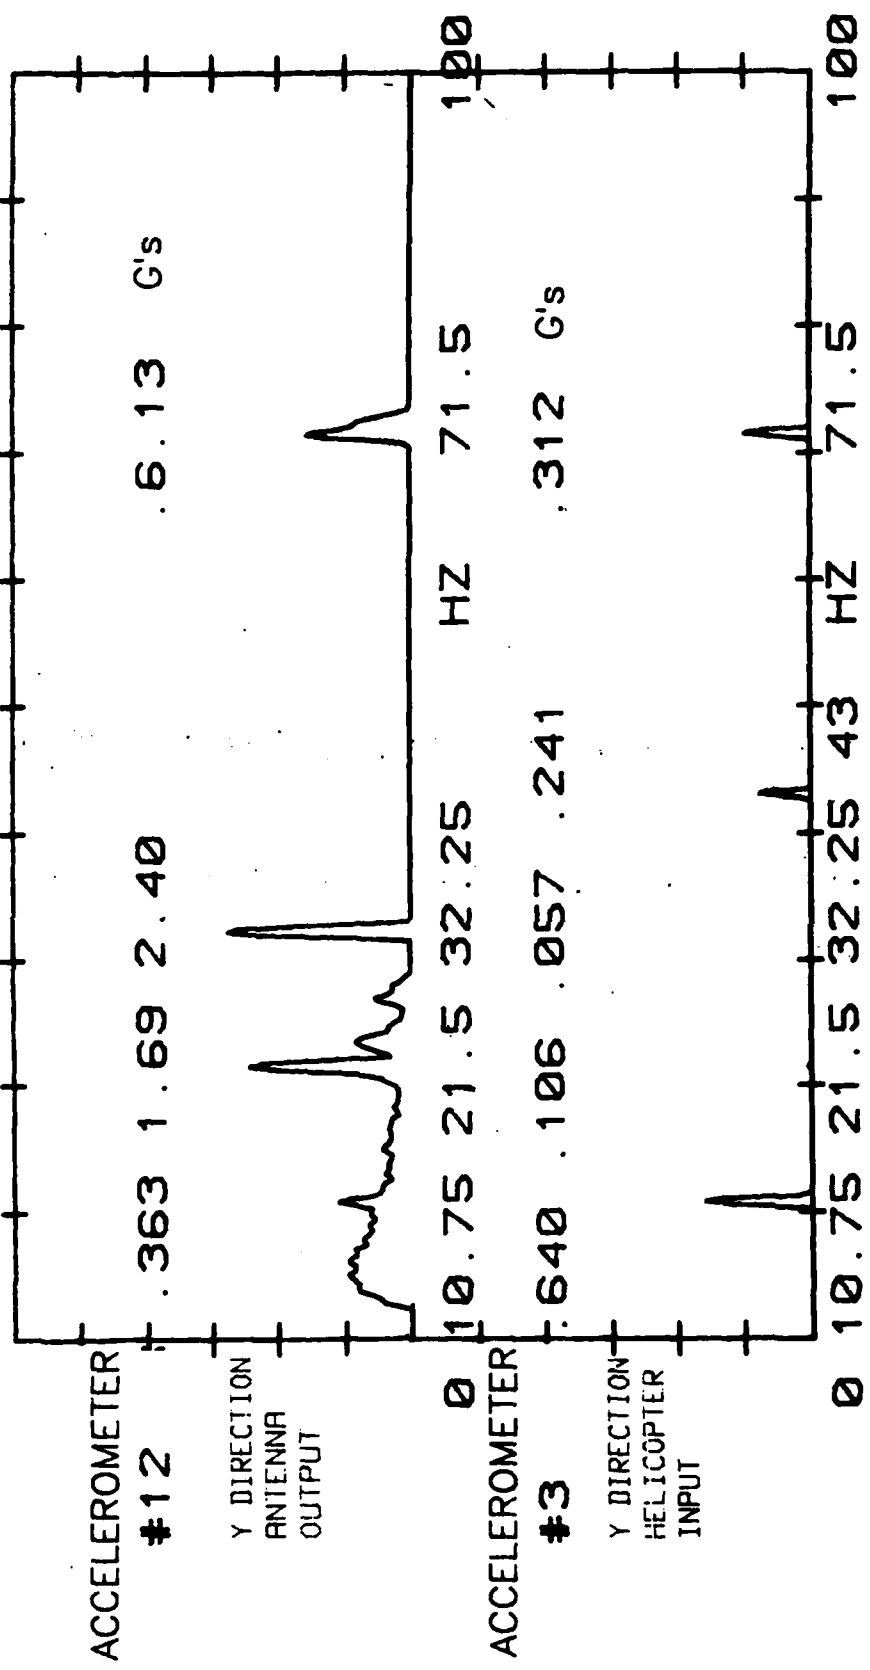
FIGURE 15. 45 LEFT BANK 70-75 KNOTS, 2800 FT: ACCELEROMETERS 3 AND 12

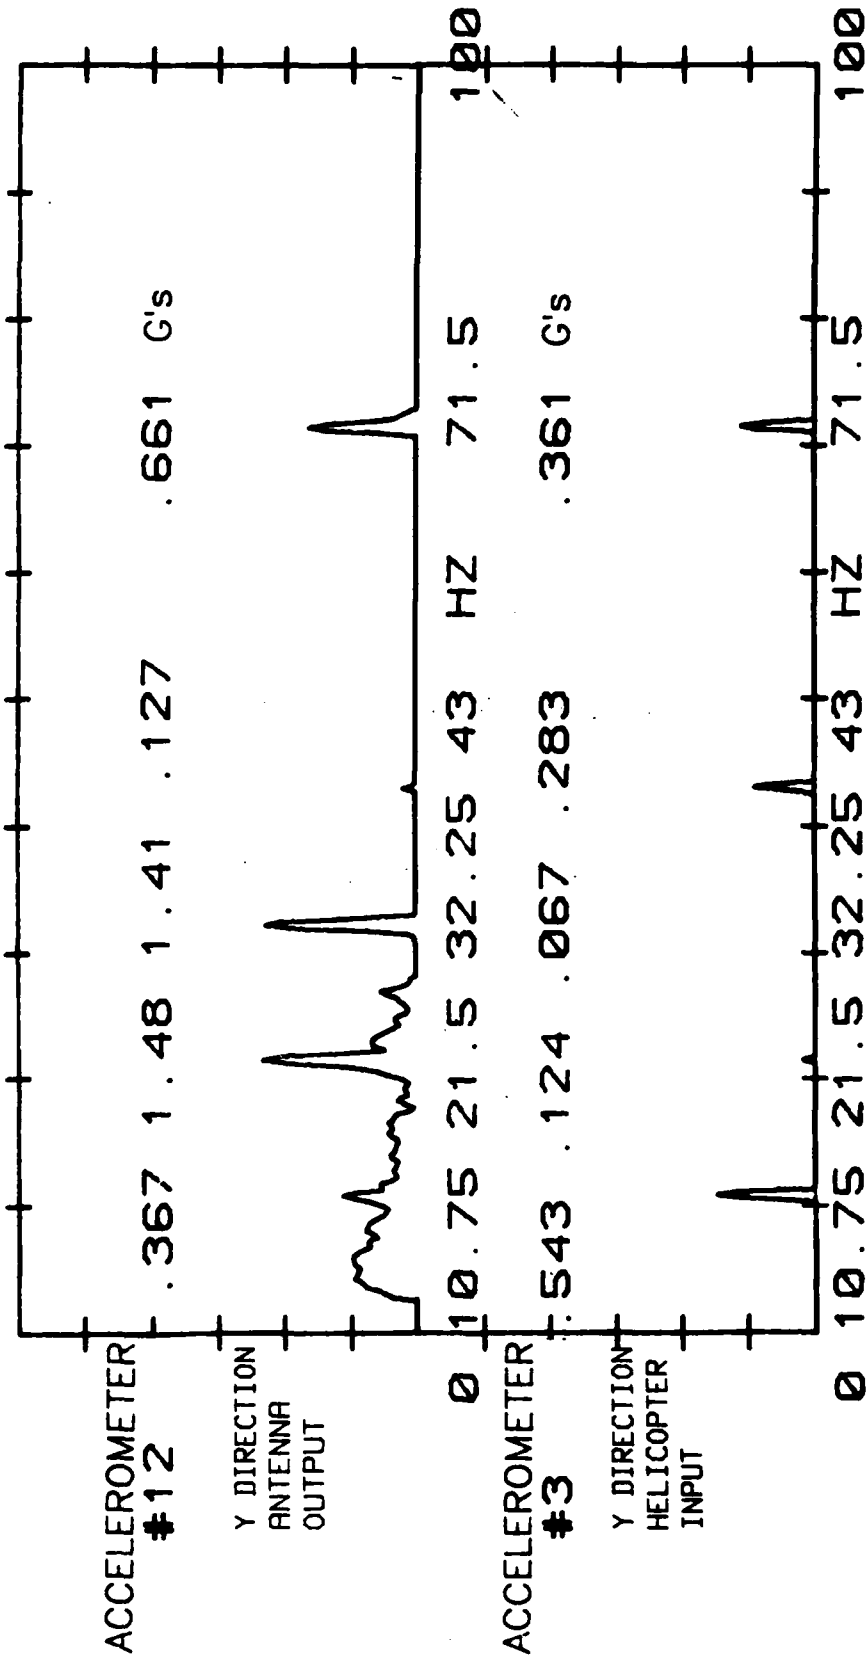
FIGURE 16. 45 RIGHT BANK 70-75 KNOTS, 2800 FT: ACCELEROMETERS 3 AND 12

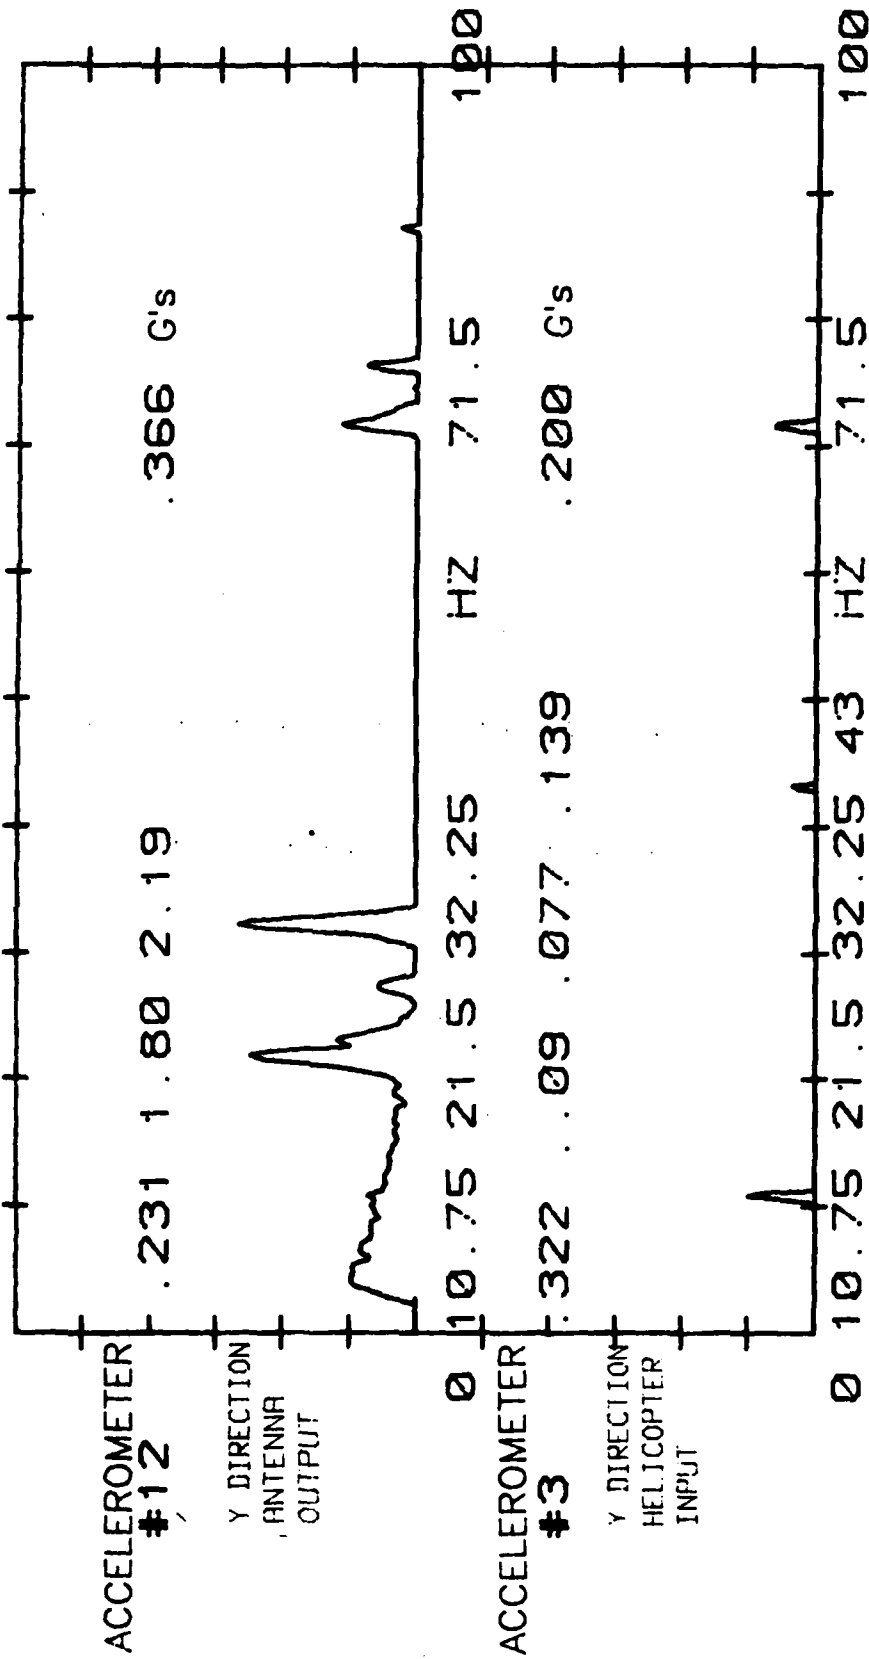
FIGURE 17. HOVER 1000 FEET: ACCELEROMETERS 3 AND 12

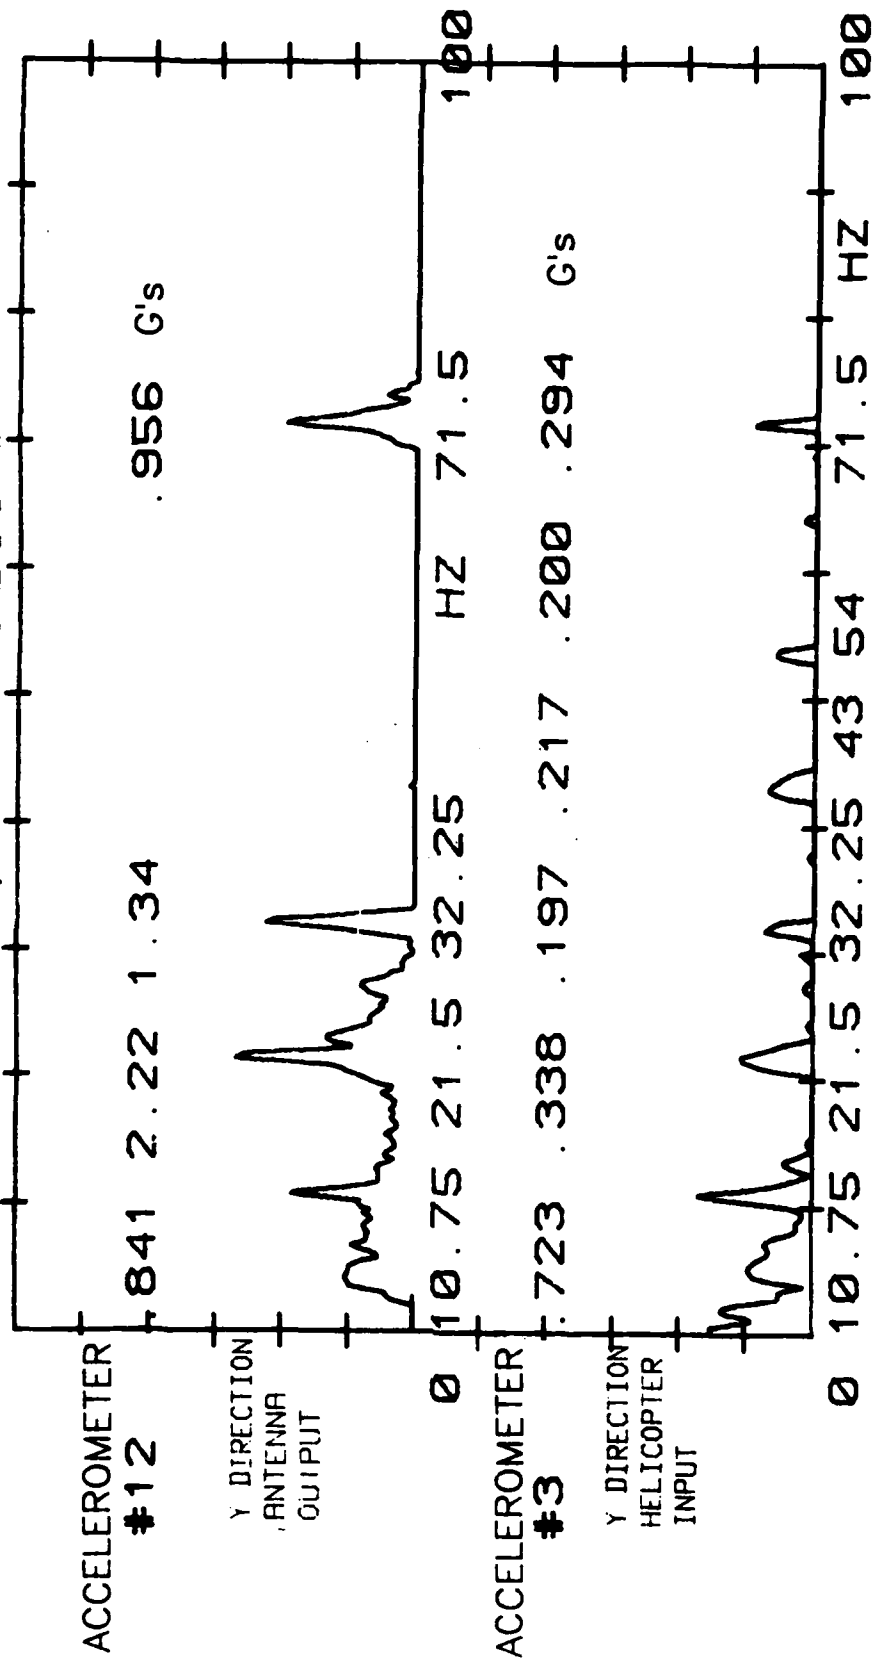
FIGURE 18. LOW LEVEL FLIGHT 70-75 KNOTS, UNDER 50 FT: ACCELEROMETERS 3 AND 12

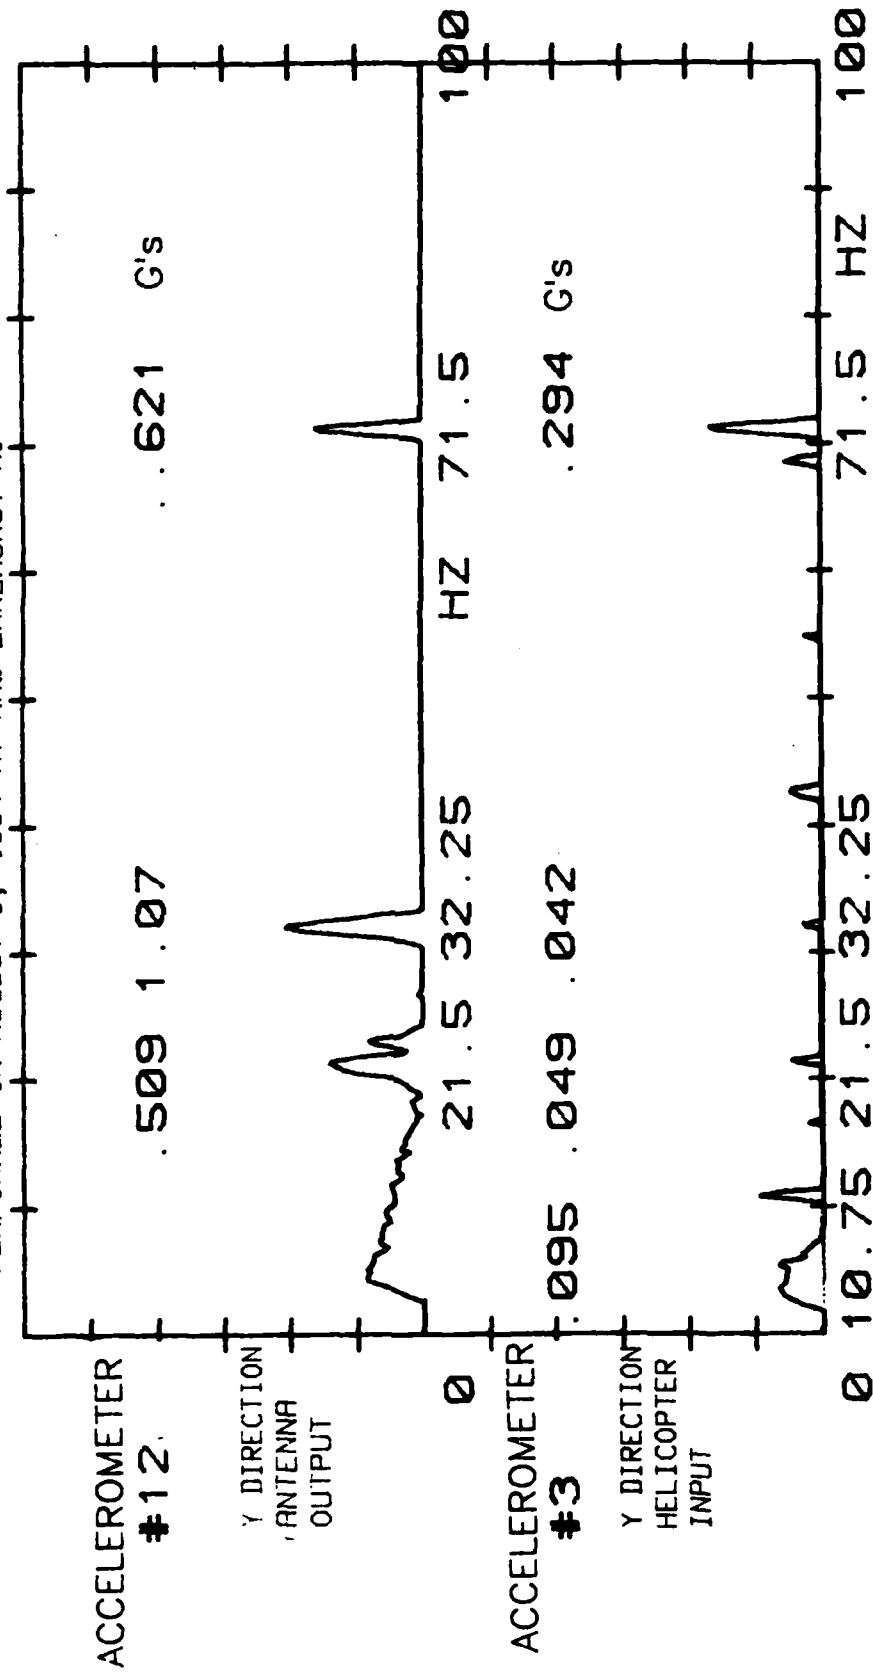
FIGURE 19. IN GROUND EFFECT (IGE) HOVER 10-15 FT: ACCELEROMETERS 3 AND 12

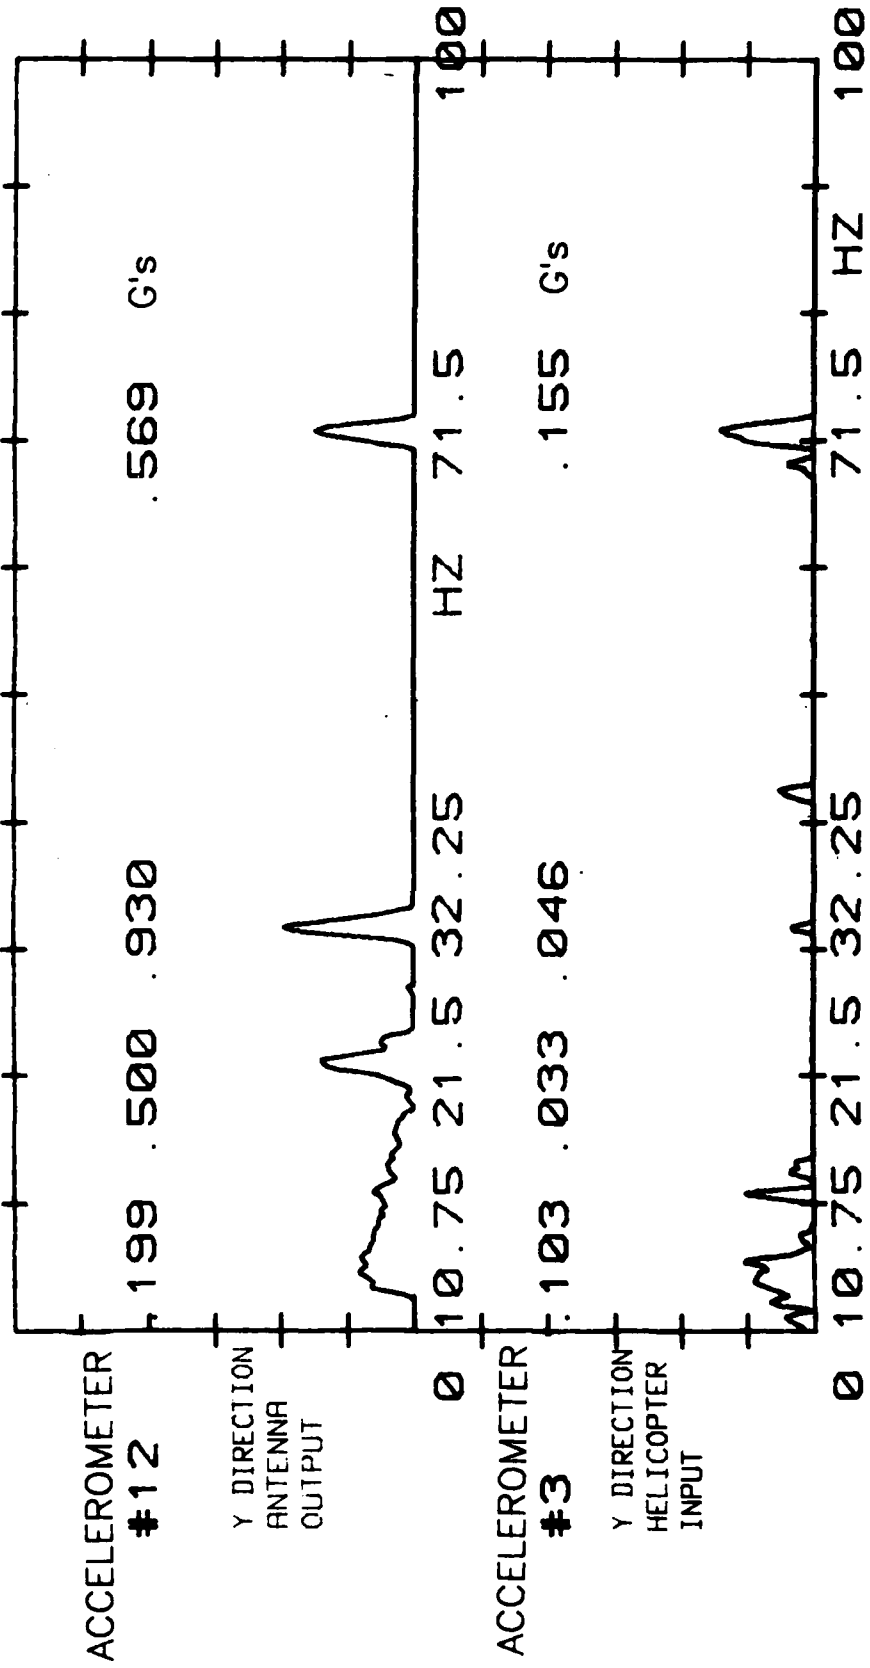
FIGURE 20. LANDING AND ENGINE SHUTDOWN: ACCELEROMETERS 3 AND 12

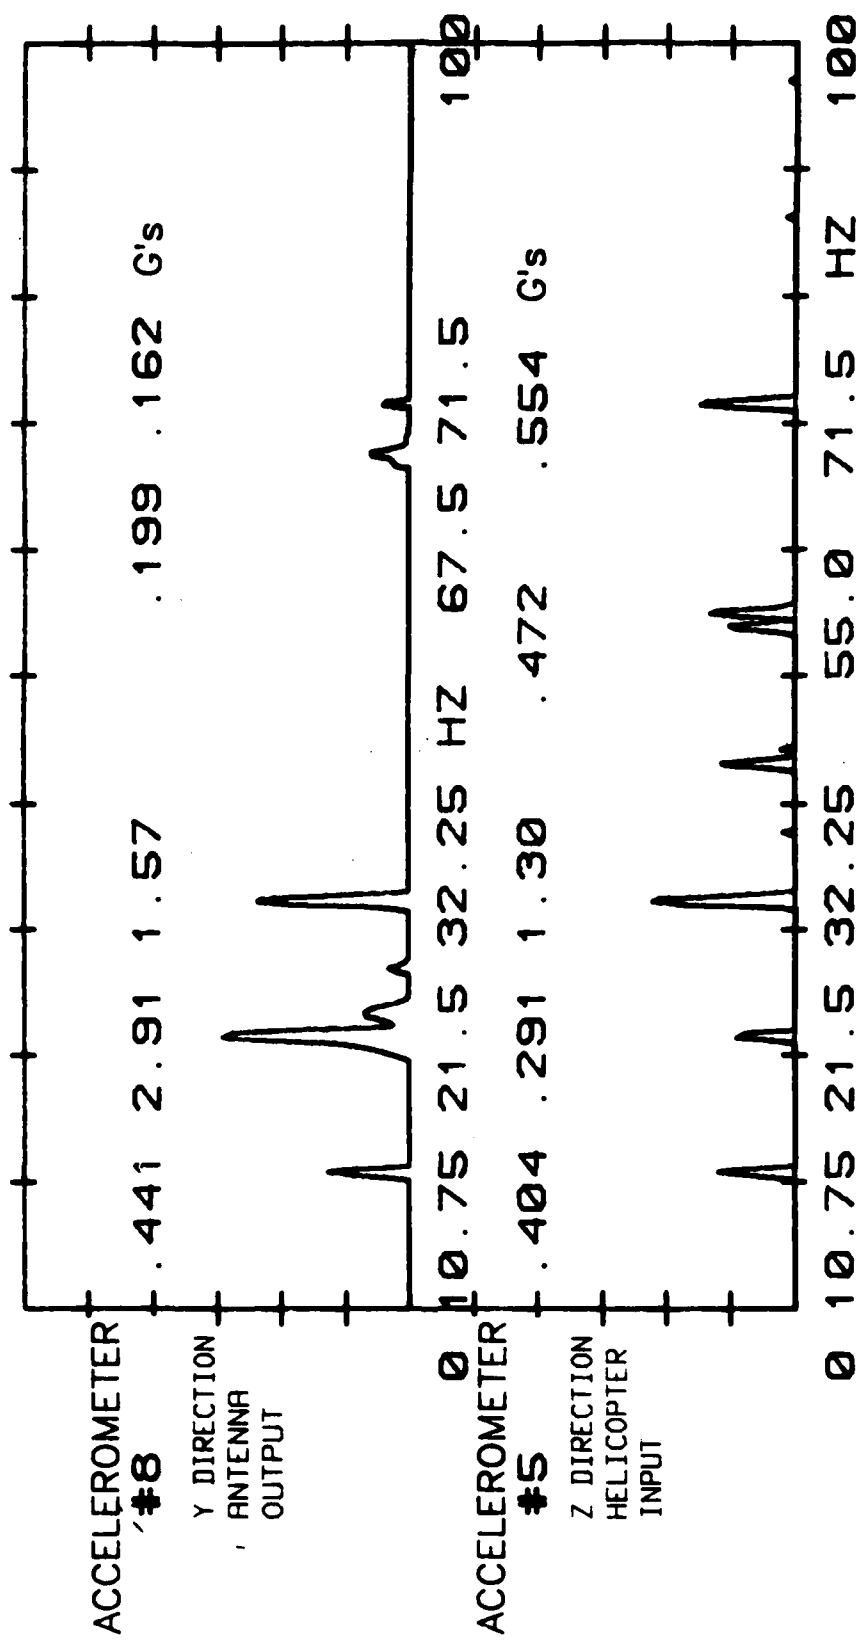
FIGURE 26, 45 LEFT BANK 70-75 KNOTS, 2800 FT: ACCELEROMETERS 5 AND 8
