Technical Report-85-E-2

VHF-FM COMMUNICATIONS ANTENNAS FOR PROJECT SINGARS
(UH-1 TAIL WHIP ANTENNA EVALUATION)

VIBRATION SURVEY OF THE DAYTON-GRANGER
FM 10-360 QUAD POD ANTENNA

DELSD-E REPORT NO. 76

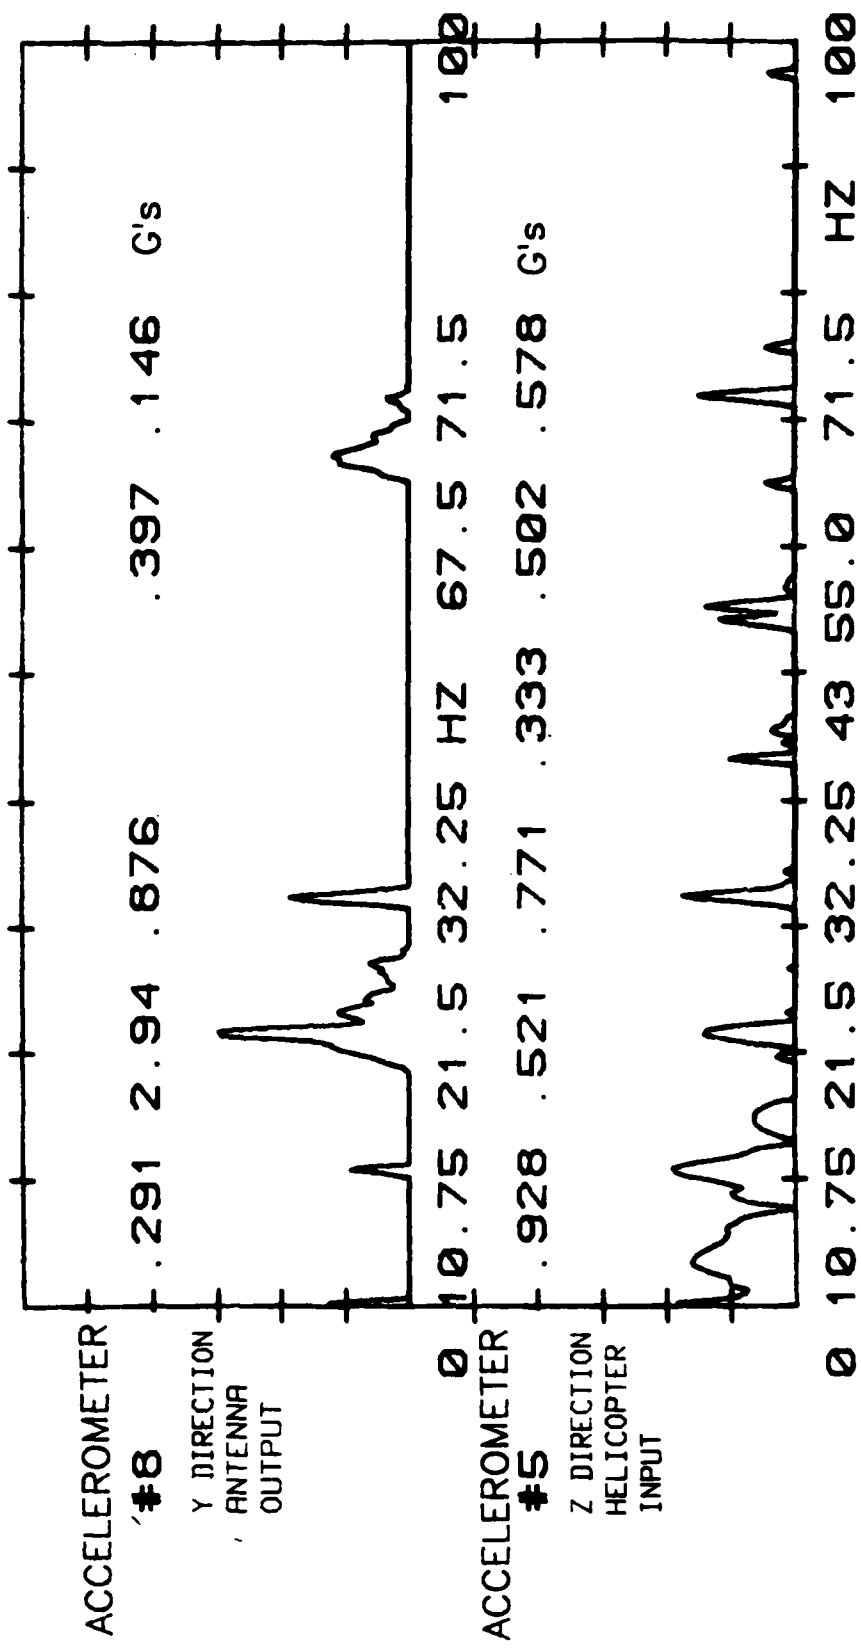
FIGURE 29. LOW LEVEL FLIGHT 70-75 KNOTS, UNDER 50 FT: ACCELEROMETERS 5 AND 8

b. The results of the flight survey are presented in Figures 10 thru 41. Figures 10 thru 20 present the output measured by accelerometer #12, and the helicopter input measured in the y direction by accelerometer #3. Figures 21 thru 31 present the output measured by accelerometer #8, and the helicopter input measured in the z direction by accelerometer #5. Figures 32 thru 41 present the x direction helicopter input measured by accelerometer #6. The data in the graphs is an average of all data taken during the particular flight maneuver listed. Accelerometers 8 and 12 were identified in modal analysis as being in locations that would reveal significant amplification. The other accelerometers measured similar data.

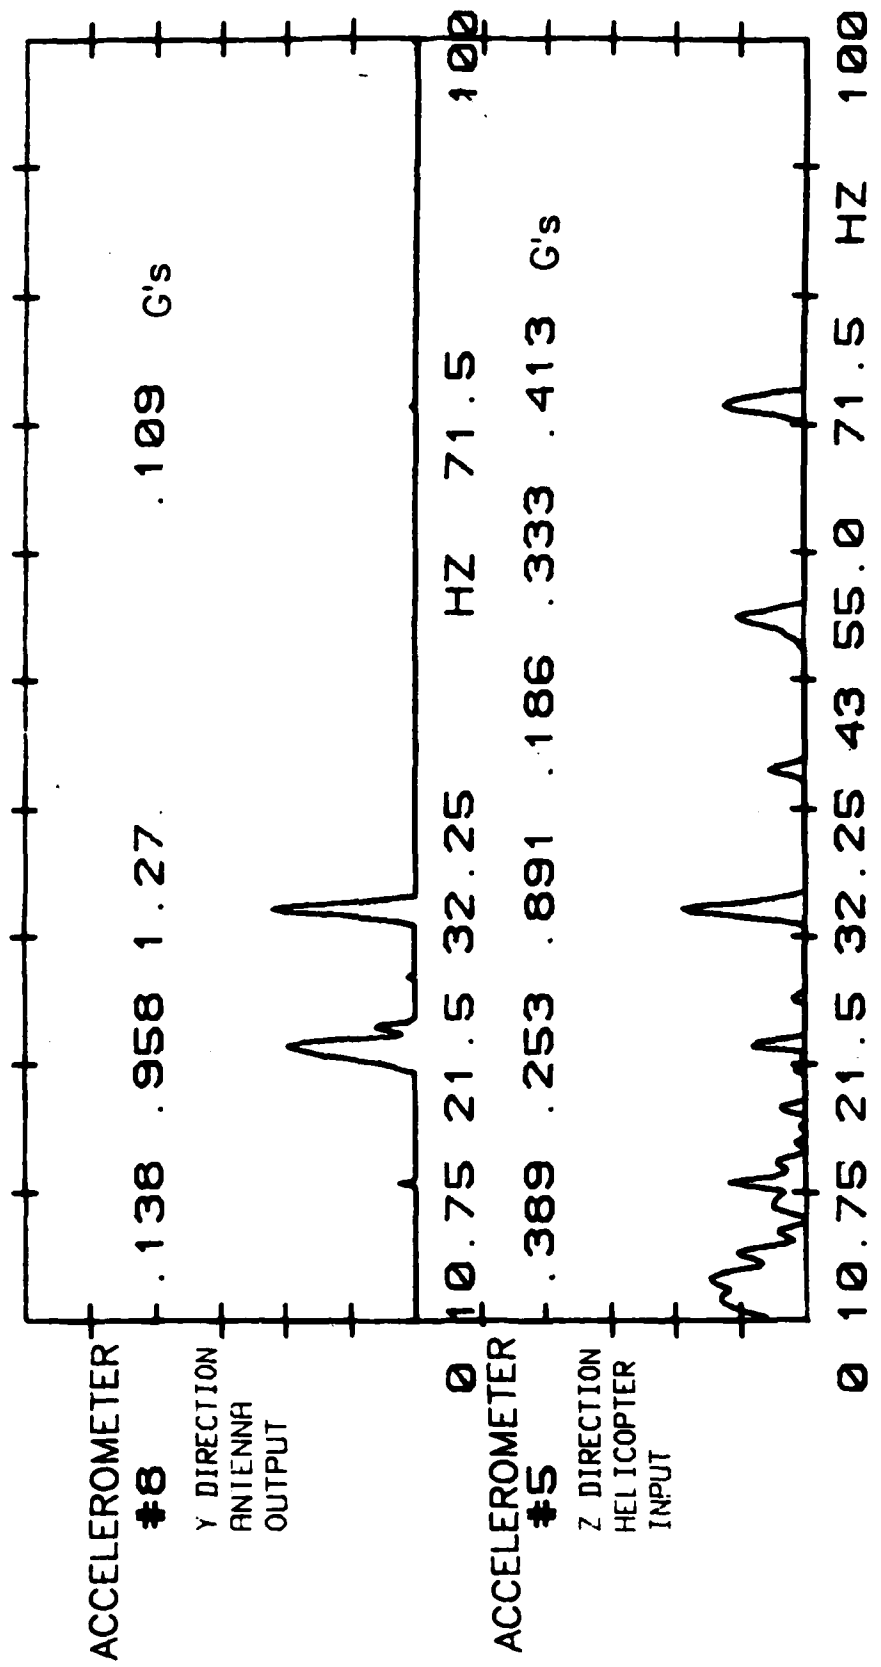
FIGURE 31. LANDING AND ENGINE SHUTDOWN: ACCELEROMETERS 5 AND 8

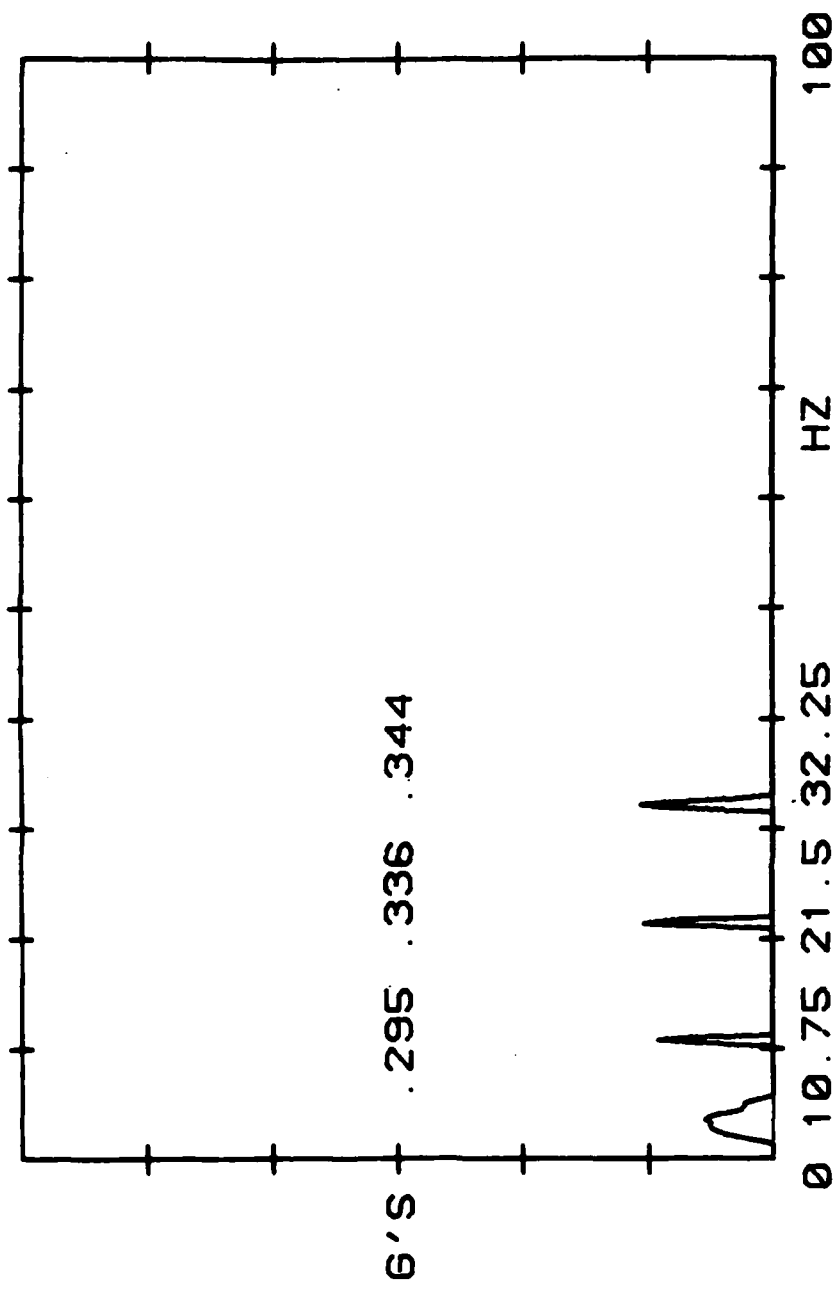
FIGURE 2. X DIR HELICOPTER INPUTS
CONDITION. GROUND RUNUP 324 RPMS

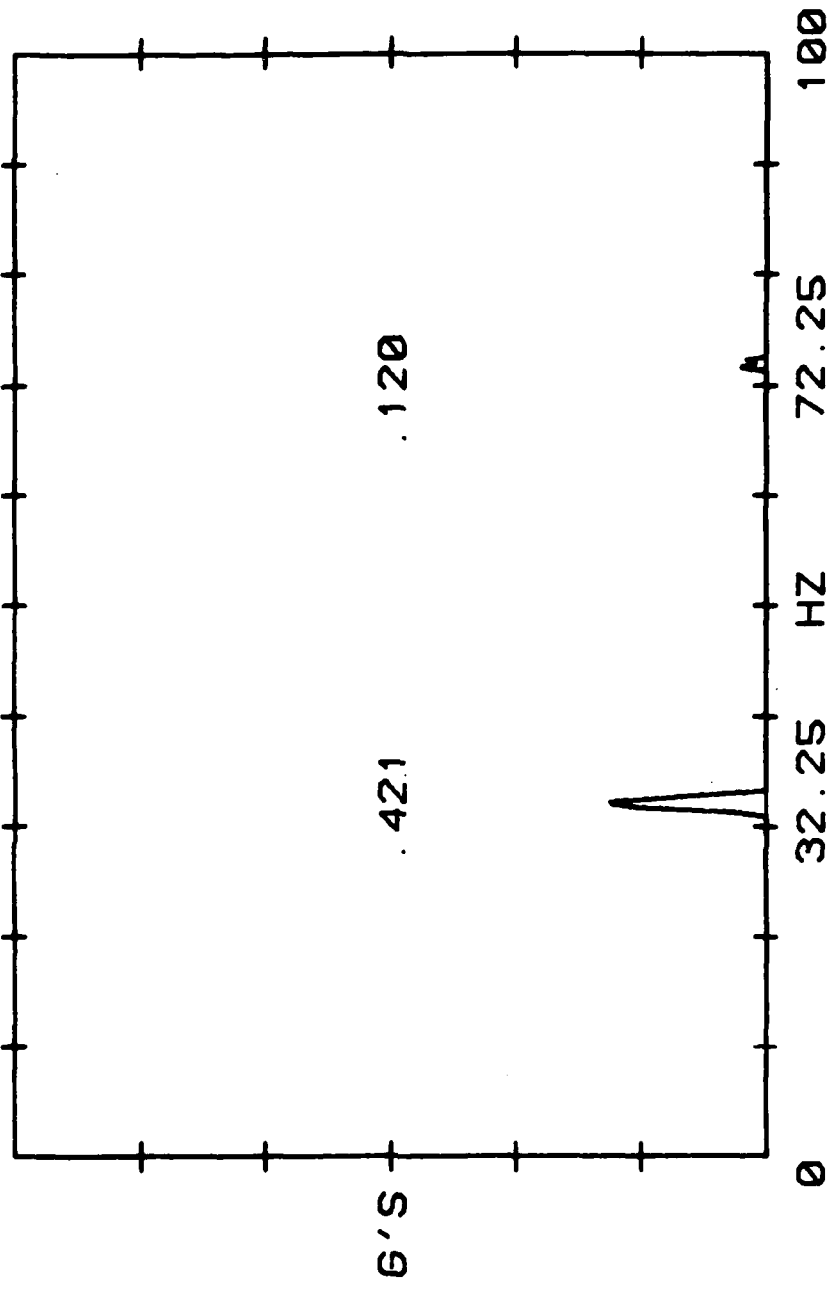
FIGURE 3, X DIR HELICOPTER INPUTS
CONDITION: TAKEOFF AND TAXI

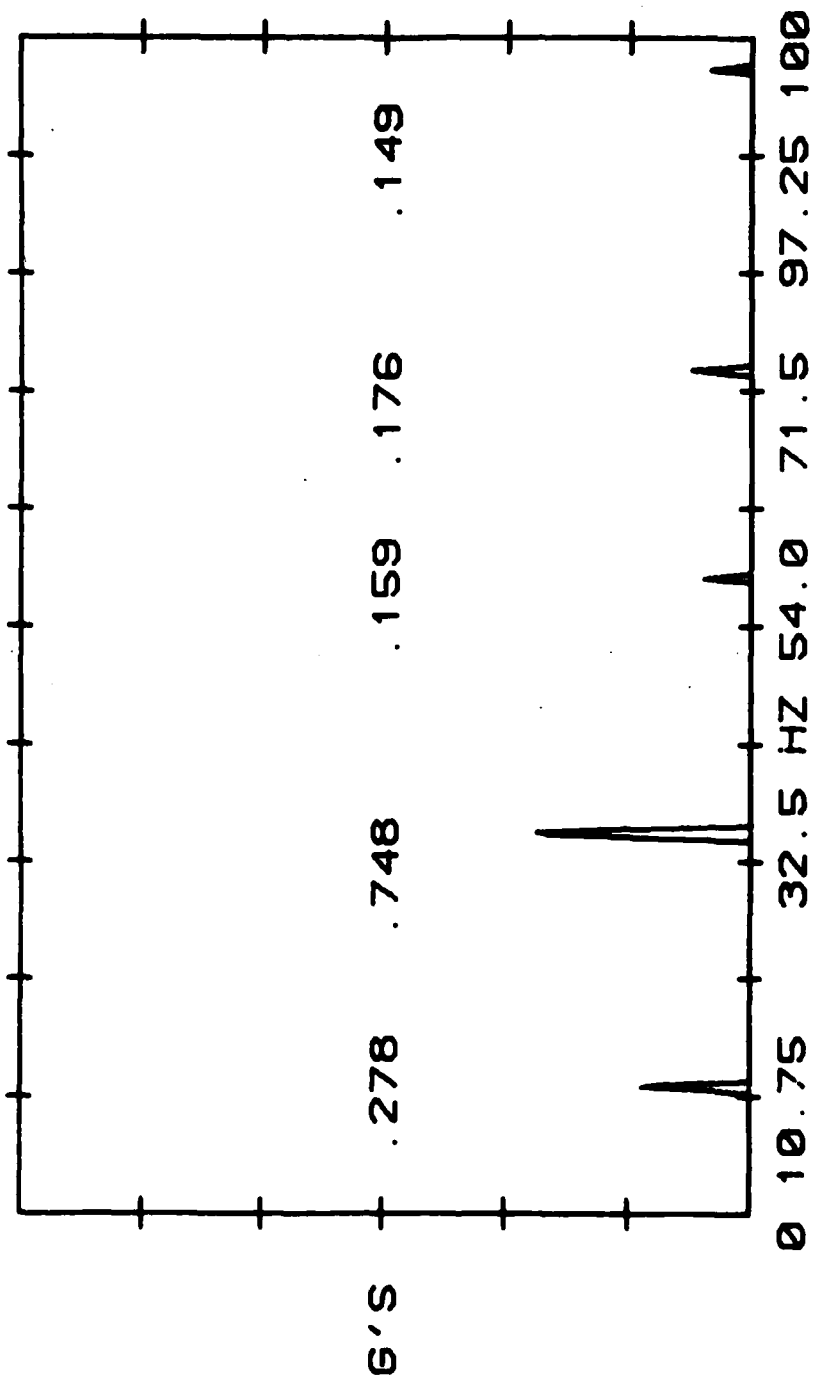
FIGURE 3. X DIR HELICOPTER INPUTS
 CONDITION: LEVEL FLIGHT 110 KNOTS

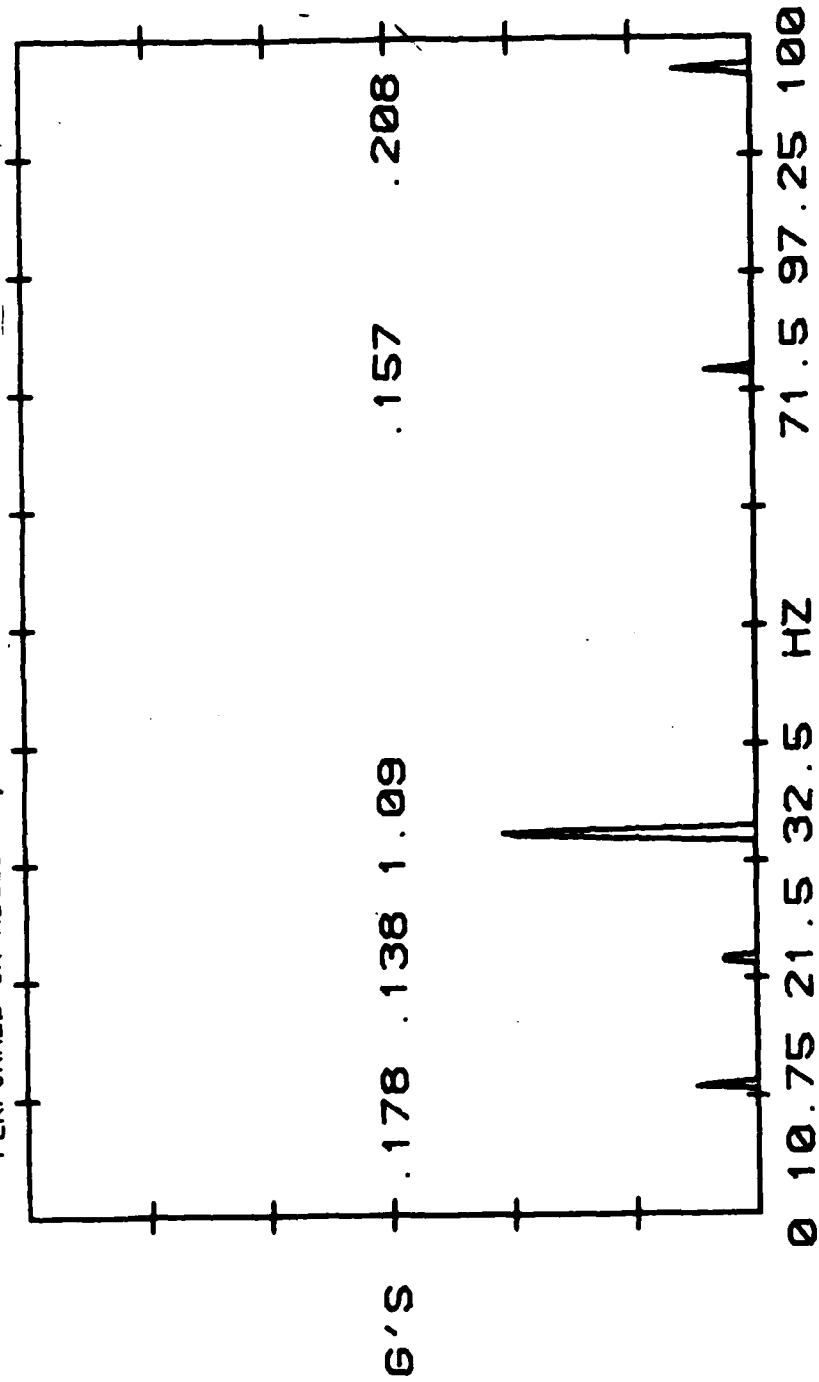
FIGURE 36. X DIR HELICOPTER INPUTS
 CONDITION: 45 DEG LEFT BANK TURN

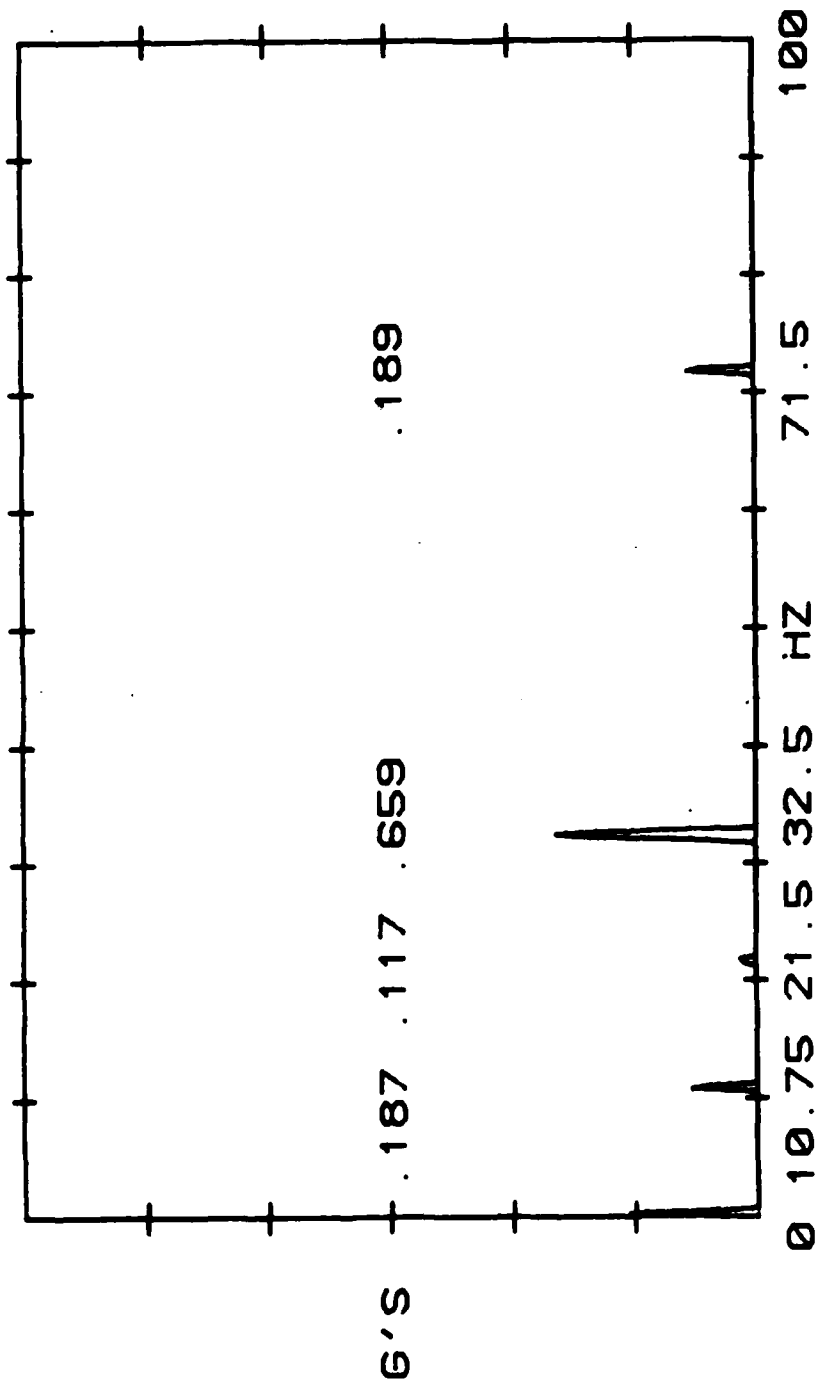
FIGURE 3. X DIR HELICOPTER INPUTS
 CONDITION: 45 DEG RIGHT BANK TURN

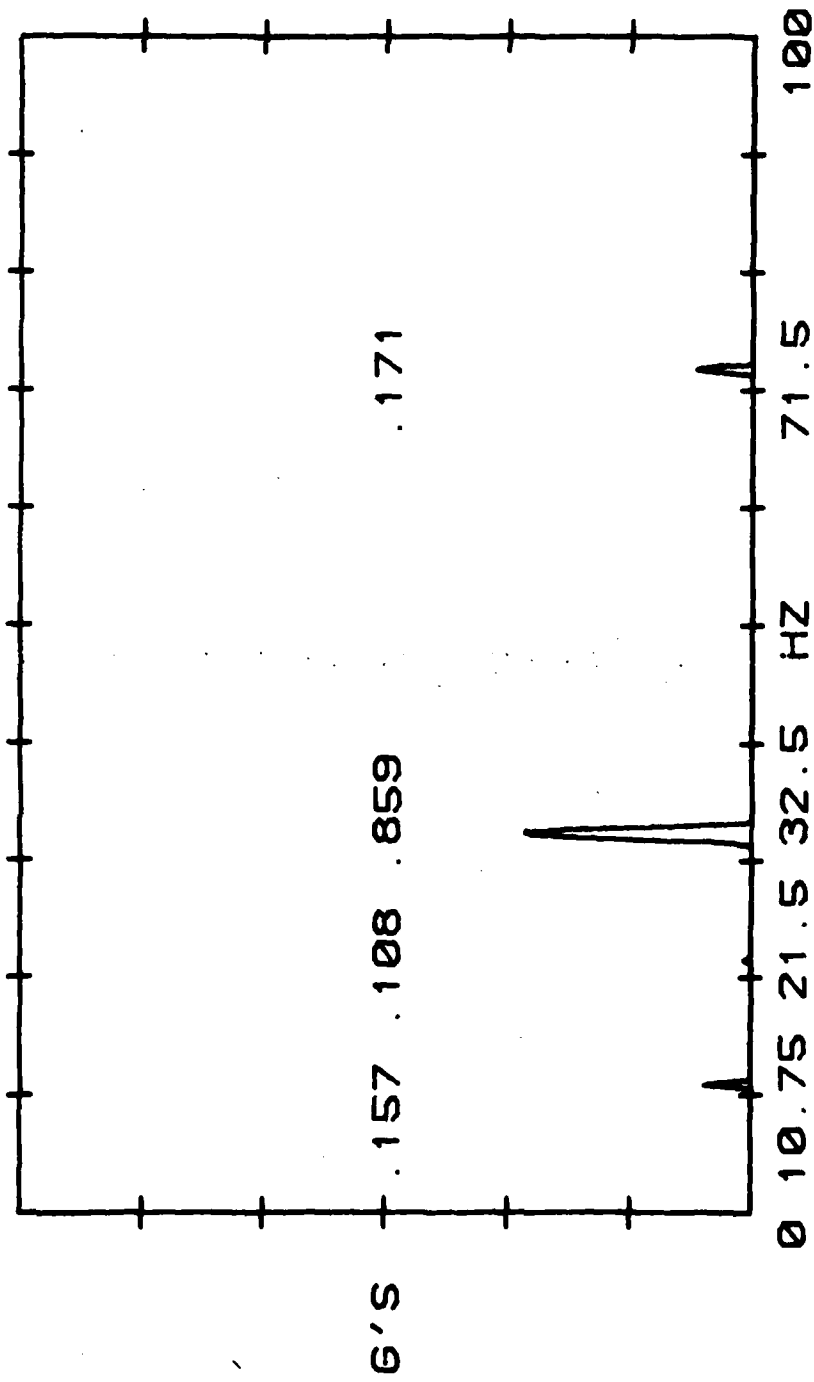
FIGURE 8. X DIR HELICOPTER INPUTS
CONDITION: HOVER AT 1000 FEET

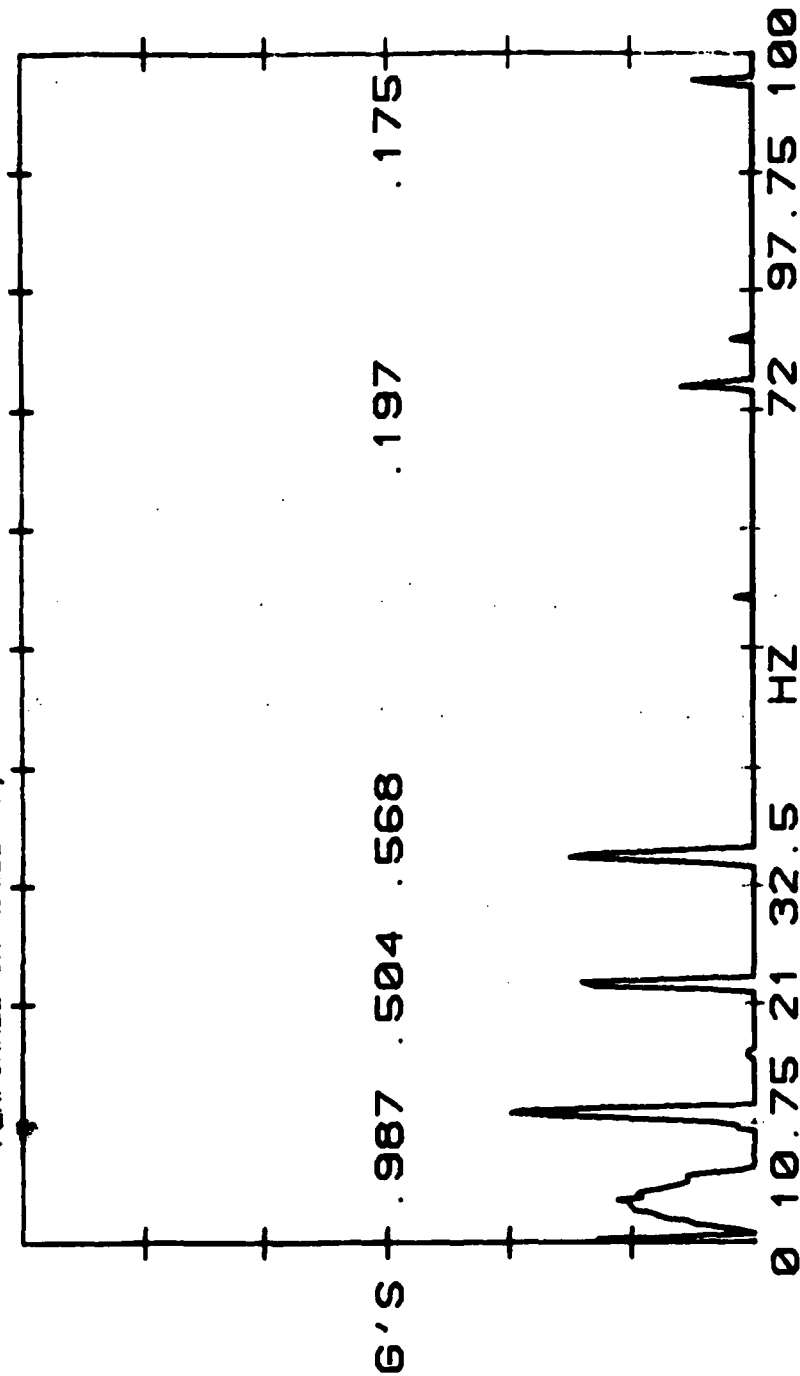
FIGURE 3. X DIR HELICOPTER INPUTS
 CONDITTON: 30 FT ALT LEVEL FLIGHT

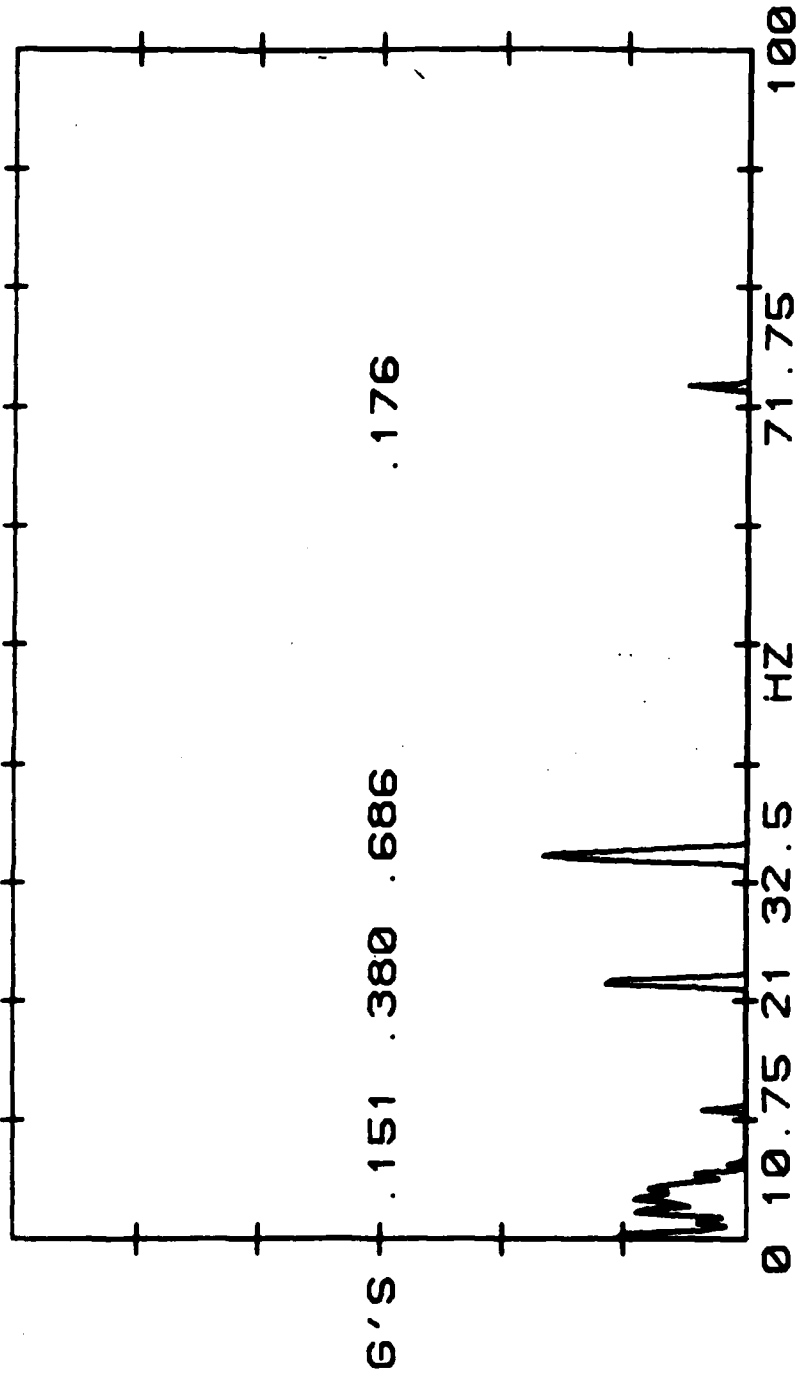
FIGURE 40. X DIR HELICOPTER INPUTS
CONDITION: GROUND EFFECT HOVER

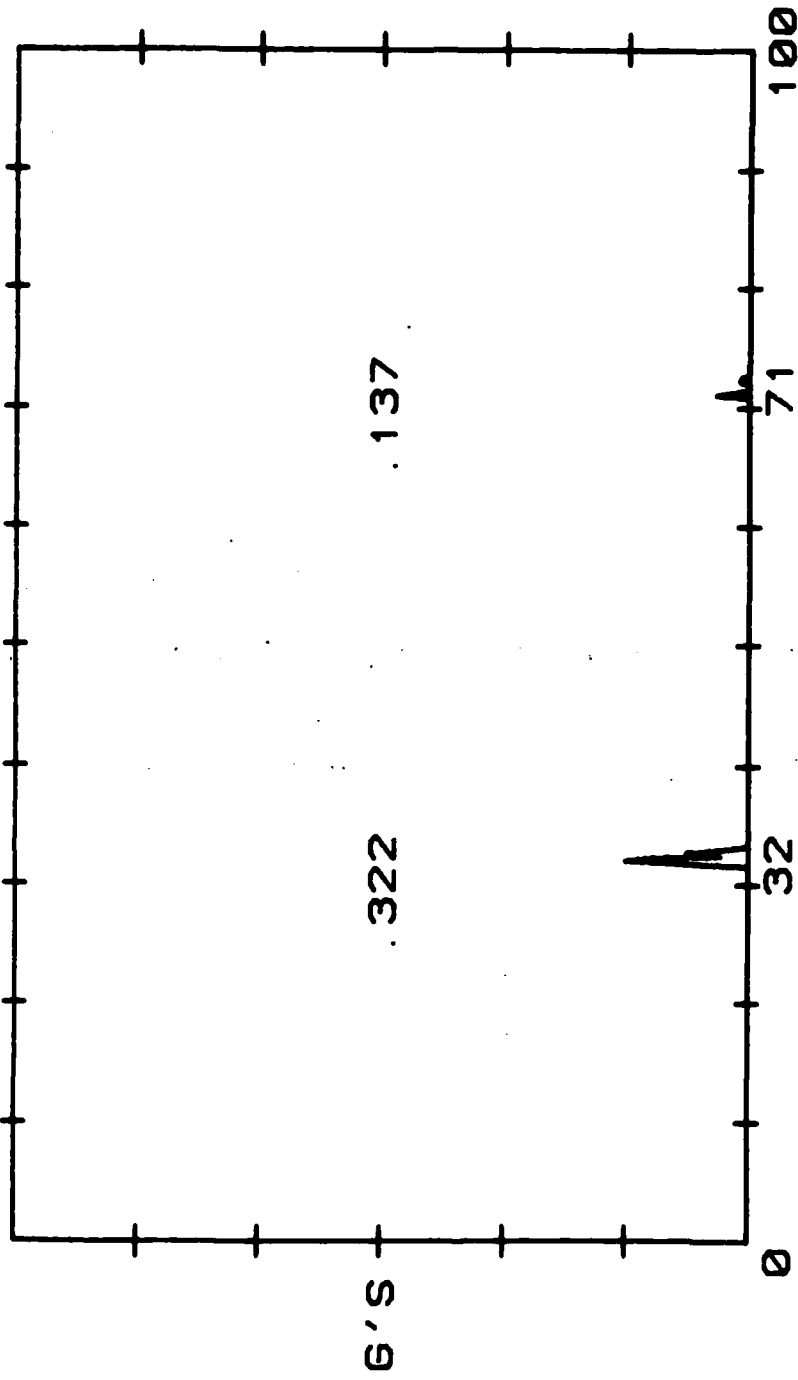
FIGURE 41. X DIR HELICOPTER INPUTS
CONDITION: LANDING
