11. TITLE (Including Security Classification)  
Norfolk Z-Loop Repair Project Completion Report

19. ABSTRACT (Continue on reverse if necessary & identify by block number)  
This report describes the repairs to the Z-loop in Slip #2 at the Norfolk Deperming Facility, Naval Station, Norfolk, Virginia. The repair design and installation were the responsibility of the Ocean Engineering & Construction Project Office of the Chesapeake Division, Naval Facilities Engineering (Con't)

**NORFOLK Z-LOOP REPAIR  
PROJECT COMPLETION REPORT**

**FPO-1-83(27)  
AUGUST 1983**

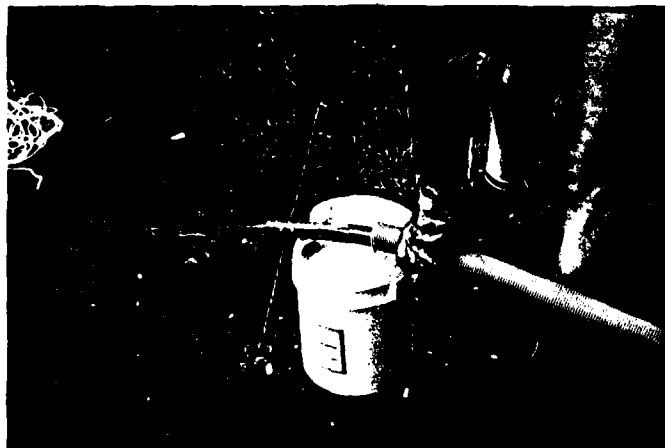
**FIGURE 4-1C**

**LUBRICATING CABLE  
AS IT IS PULLED  
THROUGH CONDUIT**

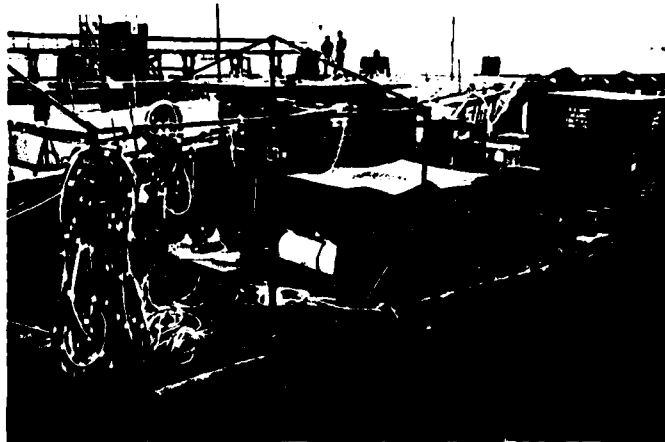
**FIGURE 4-3A**

**PROFILE OF WORK BARGE  
SHOWING CABLES AND  
DECK INSTALLATIONS**

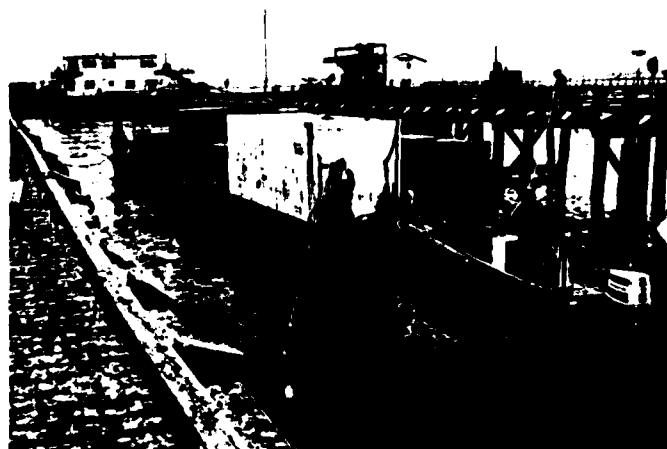
**FIGURE 4-3C**

**BARGE BEING PUSHED  
INTO SLIP #2 TOWARD  
DS-9 CONTROL BUILDING**

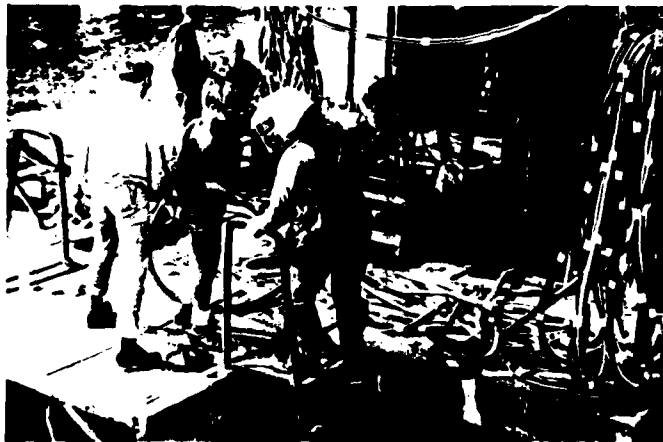
FIGURE 4-5B

DIVER IN MK 12 GEAR  
ENTERING WATER  
FROM BARGE

On 10 September 1982, the construction platform was towed to the Deperming Facility and moored in Slip #2. Diving operations began at once, the first step being a detailed inspection of the area where the cable troughs were to be installed. Visibility at the bottom proved to be very poor, so that the inspection and many of the subsequent installation operations were carried out by touch. The MK 12 diving system was used for this inspection and for all underwater construction operations up to the cable/conduit installation phase. A diver, outfitted with this system is shown in Figure 4-5A, B, and C.

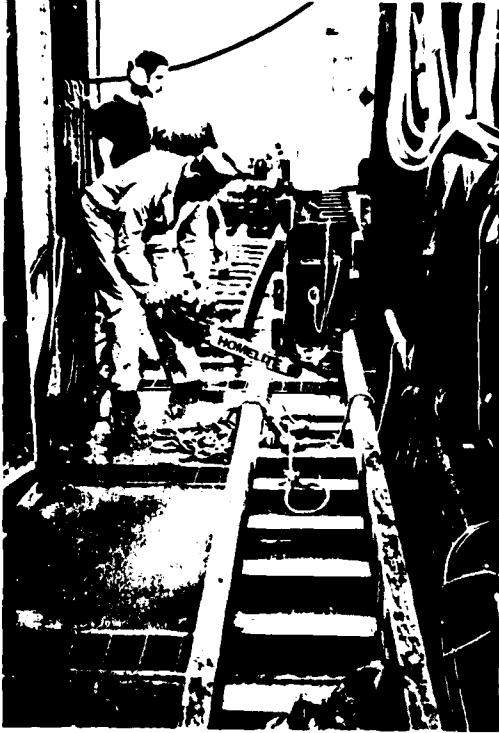
FIGURE 4-8

On 27 September 1982, the installation of trough sections began. Because of barge space and transportation limitations, it was decided that the trough sections would be fabricated on site. Timber side sections of 3 by 8 inches by 22 feet long and precut 2 by 6 by 22-inch crossbattens were stacked on deck; the trough sections were assembled from these, in the shape of a ladder, with crossbattens bolted at 3-foot intervals, Figure 4-8. It was found that the spacing between bents in the catwalks varied enough from the nominal 20 feet that it was necessary to measure each space and cut the trough to fit. The stringers had been procured in 22-foot lengths with this possibility in mind.

FABRICATING CABLE TROUGH  
FROM 3 x 8 SIDE MEMBERS  
AND 2 x 6 CROSS MEMBERS.  
END CUT TO LENGTH MEASURED  
BY DIVERS TO FIT BETWEEN  
PIER BENTS.

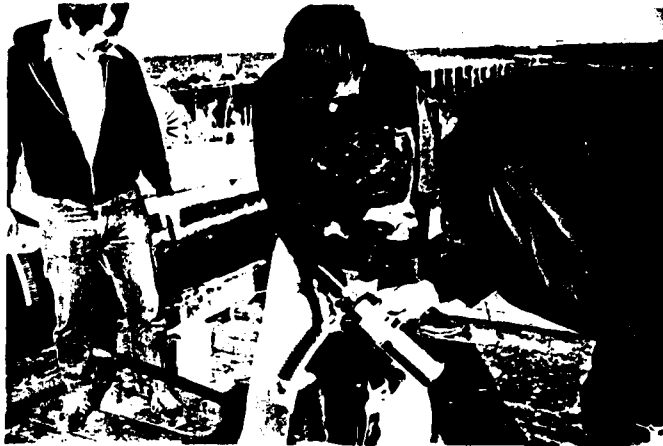
**FIGURE 4-12A**

**STRIPPING CABLE END FOR  
CLAMP BY HEATING  
INSULATION**

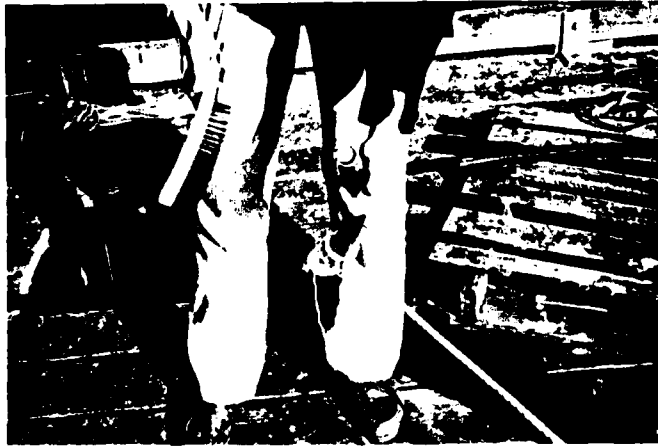
**FIGURE 4-12B**

**CLEANING CABLE END**

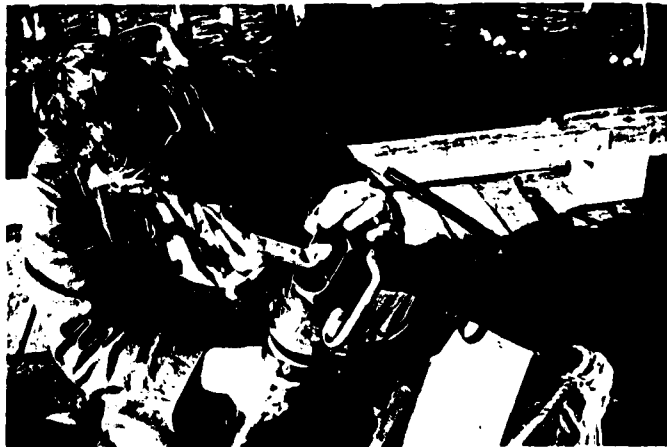
**FIGURE 4-12C**

**SECURING CLAMP  
FITTING TO CABLE END**
