USAAVSCOM TR-86-D-2

**FULL-SCALE CRASH TEST (T-41) OF THE YAH-63 ATTACK
HELICOPTER**

Kent F. Smith

April 1986

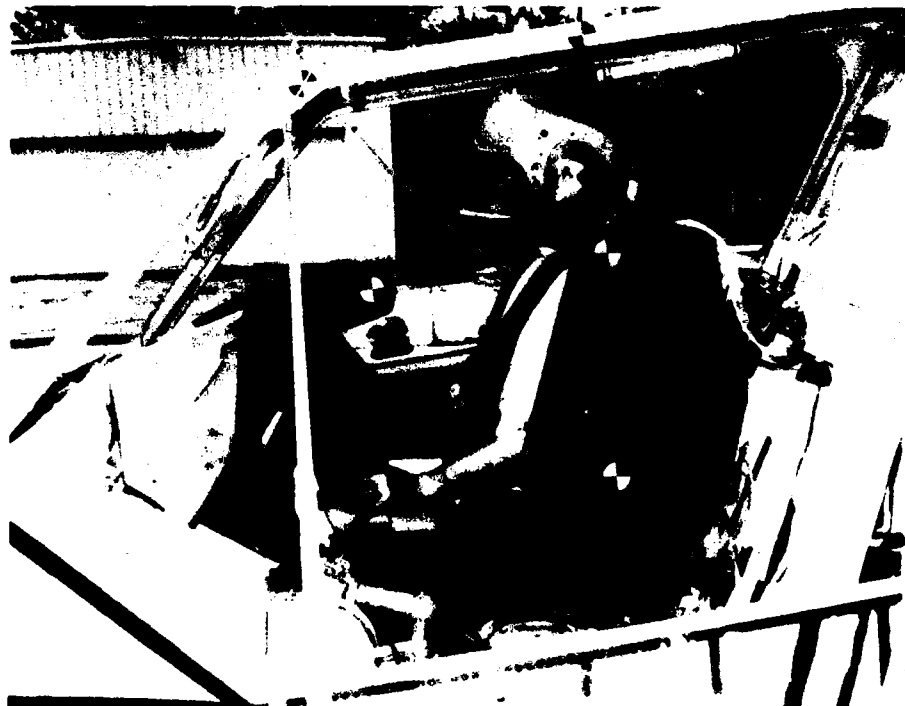
Figure 6. T-41 test installation at CPG crew station.

The YAH-63 forward CPG cockpit was modified in a manner so as to more closely represent that of an AH-64 Apache copilot/gunner (forward) cockpit. Figure 6 shows the test configuration for this crew station. The standard YAH-63 crew seat was removed and replaced with a production AH-64 crashworthy crew seat (Figure 7). The seat is bulkhead mounted and armored with boron carbide tile bonded to laminated Kevlar and has a total weight of 136.6 pounds, including cushions and restraint system. The armored bucket is designed to stroke up to 12.3 inches in the vertical direction to absorb crash impact loads using two inversion tube energy attenuators. The fixed-load attenuators are sized for a 14.5 G stroking load based on the weight of an equipped 50th percentile Army aviator. The bucket is supported by roller bearings engaging steel guide tubes to restrict its stroking to the vertical direction only. This is very important in limiting the aviator's forward/lateral strike envelope within the cramped confines of the AH-64 cockpit. This seat was designed to meet the requirements of the Army's crashworthy crew seat specification, MIL-S-58095(AV) (Reference 4).

The AH-64 incorporates a weapon's sighting device termed an optical relay tube (ORT) in the forward cockpit. Figure 10 is a photo of the actual AH-64 installation. The close proximity of the ORT to the CPG places it within the potential head and upper torso strike envelope of this crewman. A dummy ORT, constructed of lightweight styrofoam, was fabricated and sized to the overall ORT dimensions. It was mounted in the forward YAH-63 cockpit at the same relative distance from the seat reference point as found in the AH-64. The intent of the dummy ORT was twofold: (1) to determine whether or not the CPG restrained with an IBAHRS would contact the ORT in a 95th percentile potentially survivable crash, and (2) if contact was made, to establish, through high-speed photography, the approximate relative striking velocity. The test installation of the dummy ORT is shown in Figure 6.

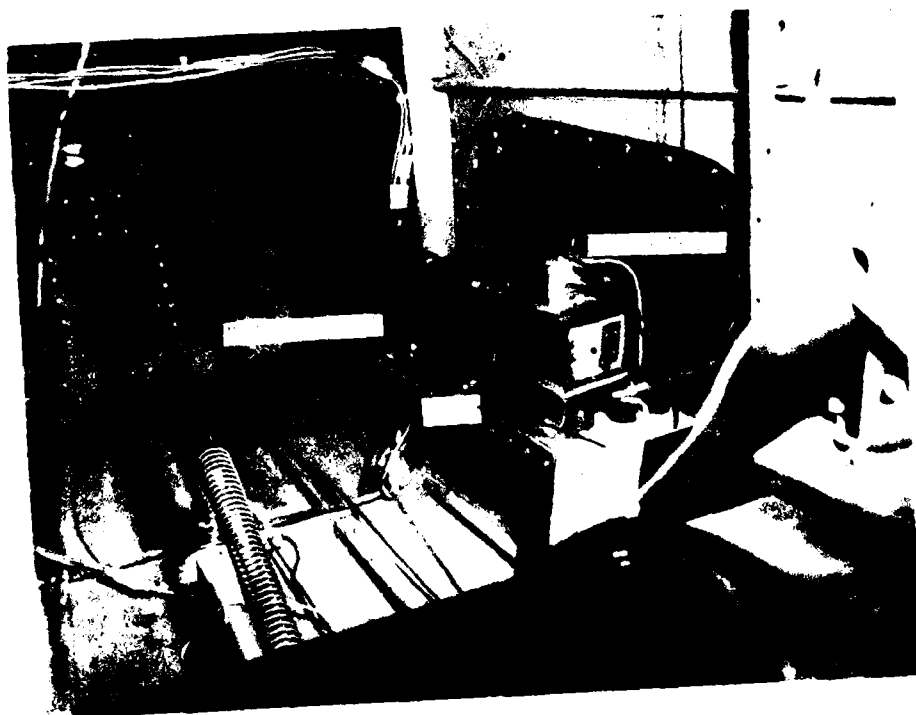
Figure 16. Typical NASA-Langley Research Center emergency locator transmitter (ELT) installation.

ELTs, required on most general aviation aircraft since 1974, are small, lightweight radio transmitters with a self-contained power supply designed to activate in the event of a crash and to transmit a characteristic signal for search and rescue homing. Unfortunately, these units are experiencing reliability problems with both false alarms (over 95 percent of all signals are false) and failure to activate after an actual crash. Redesign of ELT switching devices to eliminate these problems has been an ongoing effort by NASA-LRC. Three complete ELTs as well as a bank of 16 switches of various designs were installed on the left inboard fuselage structure at FS 204. In addition to strict accelerometer-type switches, experimental types sensing velocity change as well as peak accelerations were a part of this experiment. A self-contained on-board instrumentation system developed by NASA-LRC monitored performance of the switches throughout the crash sequence. Figure 16 shows a typical ELT test installation.

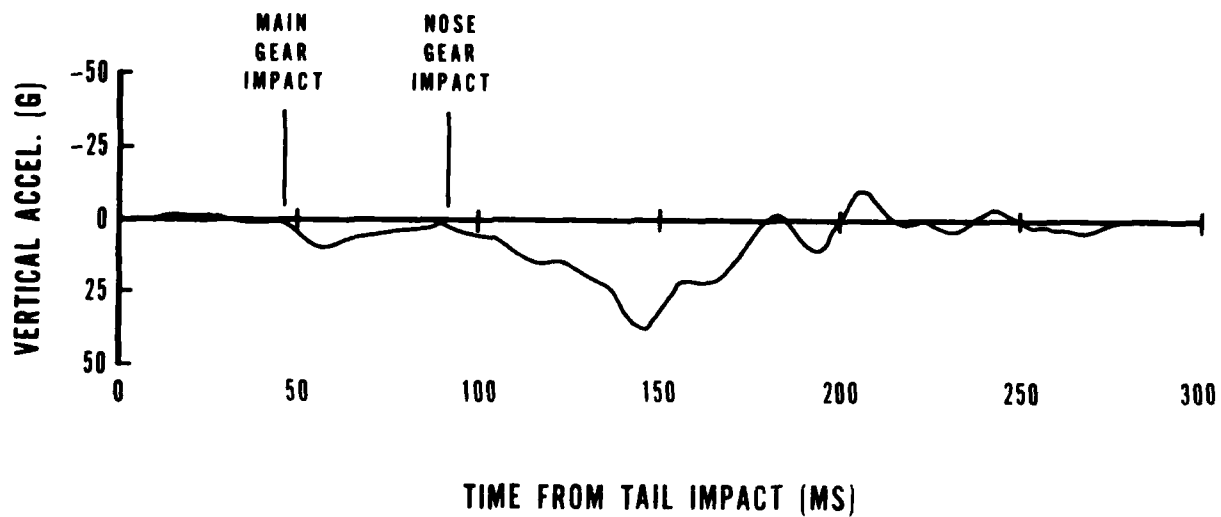
Figure 50. Vertical acceleration at aircraft center of gravity.

A similar analysis was performed for this report, except that the vertical acceleration of the aircraft CG was selected as the parameter most representative of landing gear loads. Figure 50 clearly shows the triangular deceleration pulse produced by the main landing gear stroking from 46 through 91 milliseconds. The pulse is well-defined and, when integrated, yields a vertical velocity change. Since all deceleration during this period is caused solely by main gear stroking, there are no other interactions to clutter the results. Figure 51 shows the vertical velocity decay resulting from the above integration. The final velocity of 42.0 ft/sec occurs at nose gear impact. The nose gear contribution to overall energy absorption is masked by other events as mentioned earlier in this discussion. For this reason, the nose gear energy absorption was derived using a fairly straightforward ratio process described in the following paragraphs.

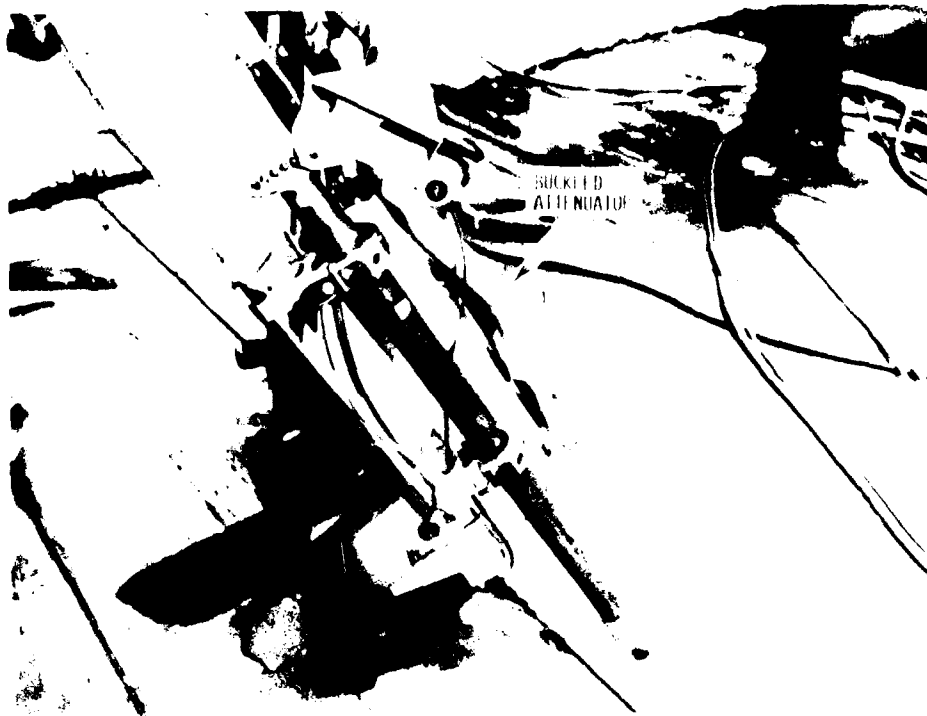
Both of the pilot's seat energy attenuators buckled in compression after stroking only 2.5 inches. Figure 59 is a close-up of the buckled right-side attenuator. In spite of this failure, the seat appeared to continue absorbing energy during this buckling event. Figure 60 is an overlay of the pilot's seat pan vertical acceleration and the crew seat bulkhead (input) acceleration. Peak seat bucket vertical acceleration was 17 G. Also, the pilot's seat began stroking at 139 milliseconds after tail impact, 13 milliseconds after the CPG seat began stroking. As these vertical loads do not exceed the 23 G Eiband criterion, the pilot should have survived this impact with no spinal injury. As was the case with the CPG, the pilot's lateral and longitudinal loads were well within noninjurious tolerance for a properly restrained human.

Figure 59. Posttest view of pilot (aft) crew seat showing buckled attenuator.

5. The YAH-63 crew seat (aft cockpit) failed to stroke in its prescribed manner due to malfunctioning inversion tube attenuators of an obsolete design.

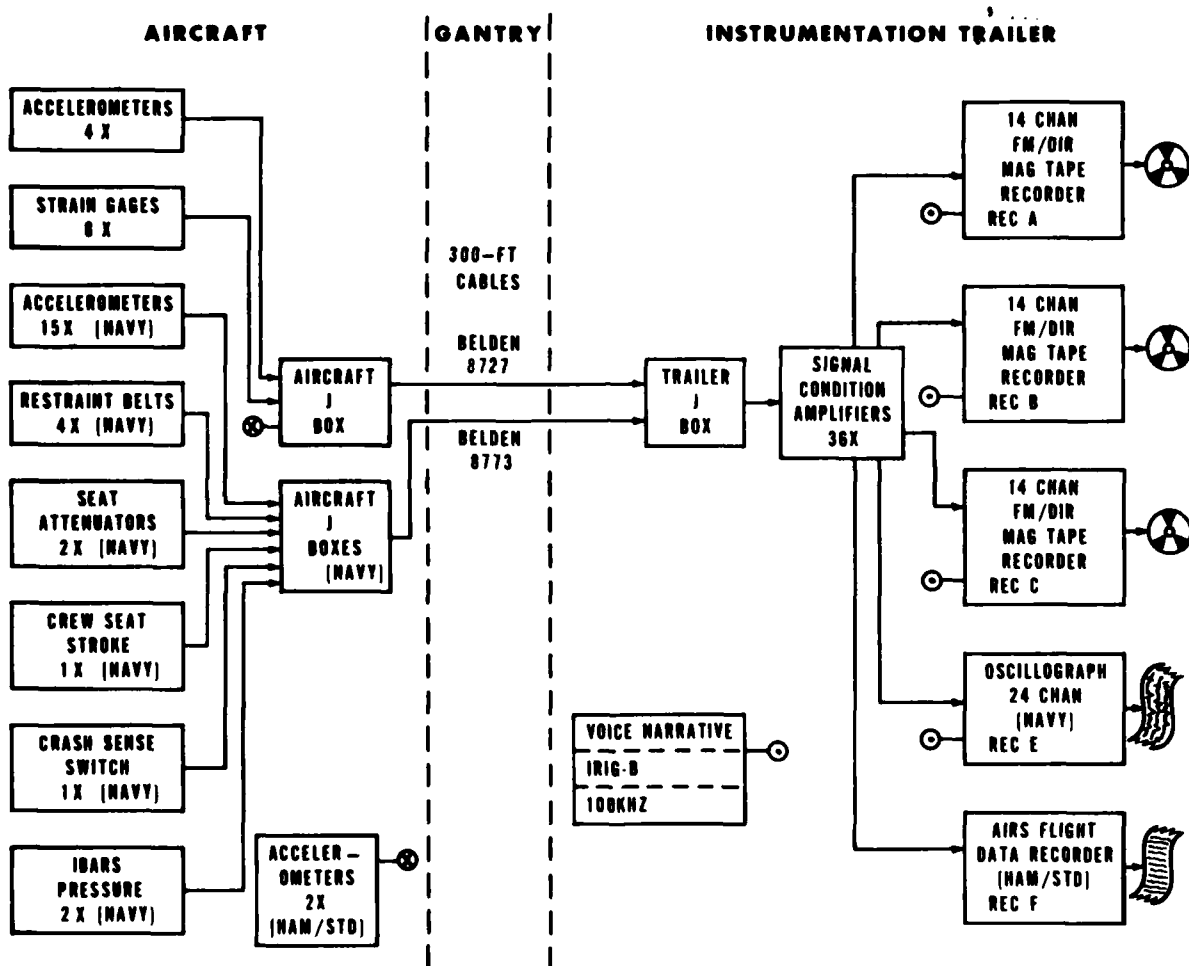
Figure A-1. AATD recorded data.

The AATD data recording system is graphically depicted in Figure A-1. Data was recorded from accelerometers, load cells, pressure, strain gage and displacement type sensors, using designated tape recorders A, B, and C plus an oscillograph designated recorder E. IRIG-B Time Code 100 kHz tape speed compensation and voice narrative data was also placed on all magnetic tape machines which were configured to IRIG intermediate band standards. All circuits were individual four-wire plus shield and drain, and excitation was provided to each individual channel by each channel's bridge conditioning/amplifier unit. Recorder E measured selected on-line NADC channels plus Channels 77 through 80.

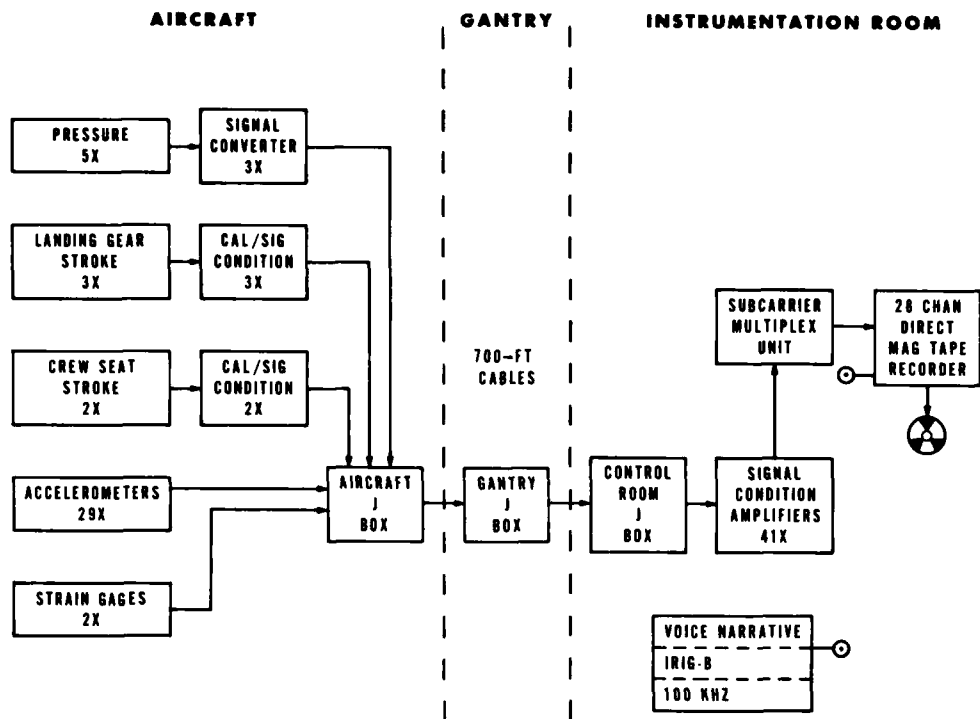
Figure A-2. NASA recorded data.

Figure A-2 generally depicts the NASA recording system. Four types of transducers representing 41 channels of Army data were recorded (accelerometers, strain gage, pressure and displacement sensors) on magnetic tape recorder D. The NASA control room equipment used for this test was that which is normally used to support all test site activities. The permanently installed system had been reconfigured prior to T-41 to include a Honeywell model 96, 28-channel IRIG standardized magnetic tape recording system. All umbilical cable incoming data is conditioned by NASA designed/built adjustable gain (1 to 1000) signal conditioning amplifiers and fed into a metroplex 100 series standard multiplex system which resulted in five data channels and one tape compensation subcarrier being placed on one direct record tape channel. The NASA multiplex subcarrier frequencies are 25, 40, 55, 70, 85, and 100 kHz (compensation). Data recorded under this system is limited to 720 Hz band pass. The power for 33 on-board sensors is fed down the umbilical cable to a 10 VDC regulator mounted within the J-box and then buss fed to each of 33 sensors requiring 10 VDC. Another J-box regulator that was fed from a second DC source via the umbilical cable provided 12 VDC for eight pressure and displacement sensors.
