Technical Note

February 1986

By A.P. Smith

## UNDERWATER NONDESTRUCTIVE TESTING OF CONCRETE: AN EVALUATION OF TECHNIQUES

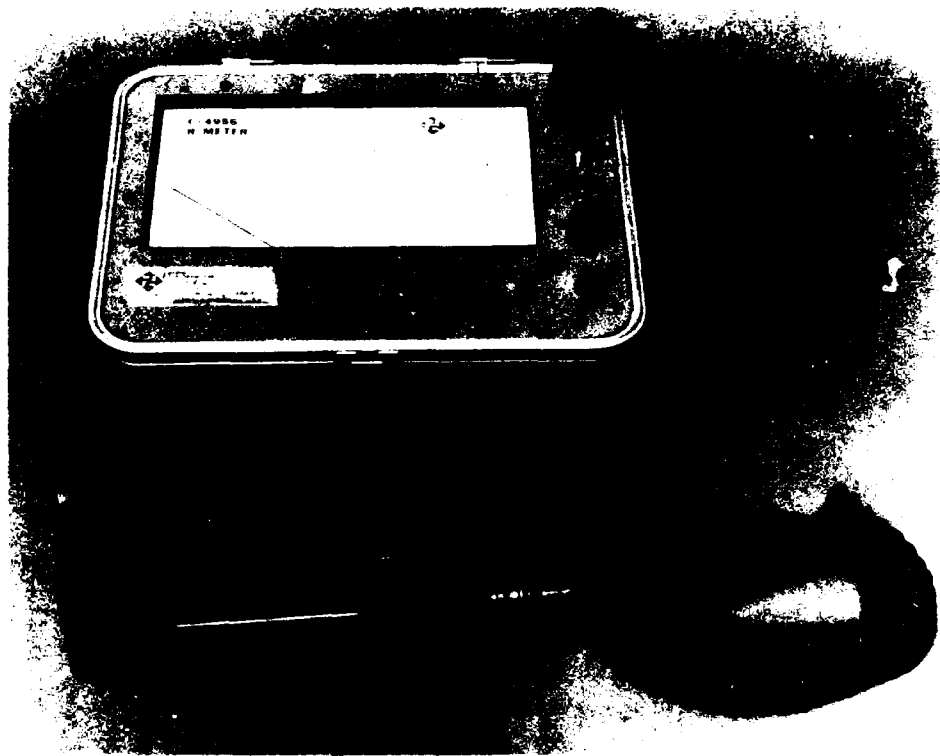
Figure 1. R-Meter, Model C-4956.

(a) General view of R-Meter.

(b) Closeup view of meter readout.

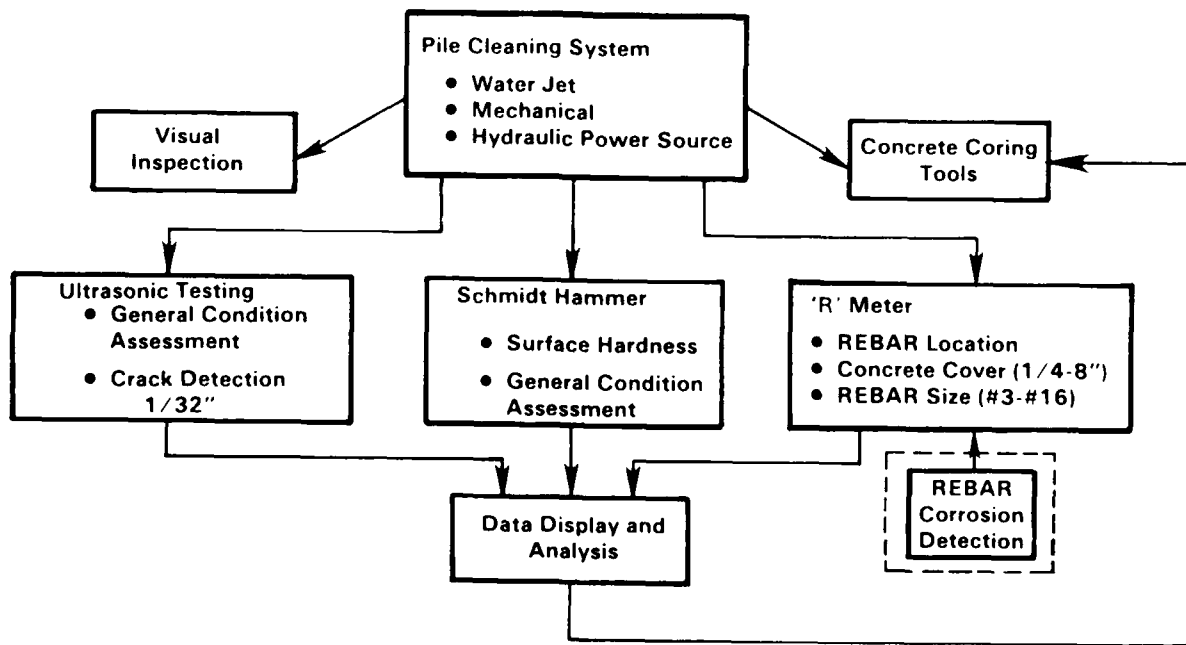
Figure 21. Integrated Systems Approach to Underwater Concrete Inspection.

5. An integrated systems approach for the underwater inspection of concrete structures, as shown in Figure 21, is further recommended. This approach uses the underwater cleaning system developed by NCEL (Ref 15) as a key element, in addition to the three instruments discussed in this report. The cleaning system is used to clean the concrete for Level II and Level III inspections and provide a hydraulic power source to take core samples if required. The three instrumentation systems utilize a common data output and analysis system. Information from the inspection would indicate if concrete cores were required to complete the analysis of the structure. A rebar corrosion detection system, under development by NCEL (Ref 16), should be integrated into the underwater inspection system and, if possible, included as part of the R-Meter design.
