Project Report
ATC-136

Pilot Evaluation of TCAS in the Long Ranger Helicopter

J. W. Andrews

3 June 1986

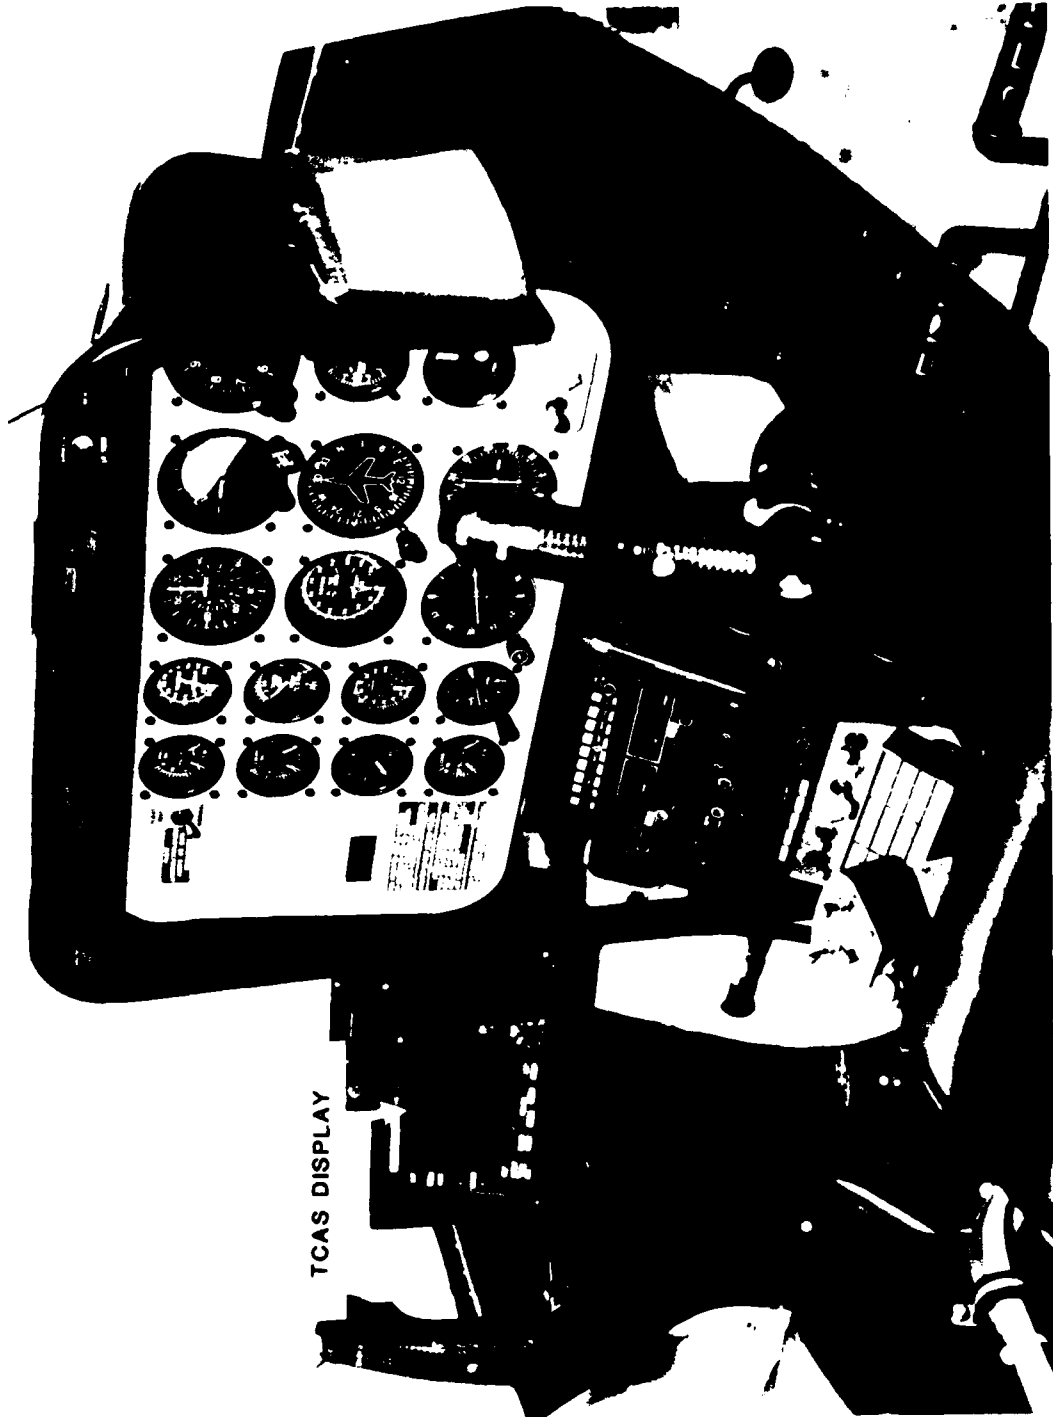
Figure 1.2 shows the TCAS traffic advisory display mounted in the Long Ranger cockpit. The display consisted of a Bendix IN-2027A color weather radar indicator operated as part of a special display unit known as the Airborne Intelligent Display (AID). This display unit was built at Lincoln Laboratory and used previously in TCAS testing in a Cessna 421 fixed-wing aircraft. The dimensions of the face of the indicator were 4.25 inches by 3.25 inches. The resolution was 256 pixels by 256 pixels. Alphanumeric characters were a maximum of 5 pixels in width and 14 pixels in height (approximately 0.08 by 0.17 inches). The display was mounted on a special bracket installed in the left-hand side of the cockpit. In an actual rotorcraft installation, it is likely that a lightweight, monochrome display would be employed and that it would be mounted on the center console. However, the information content of the AID display was identical to that anticipated for actual rotorcraft implementations and display characteristics peculiar to the experimental installation are not thought to have had any significant influence on test results.

Fig. 1.2 TCAS display installed in the Long Ranger cockpit.
