TECHNICAL REPORT SL-86-8

TESTS AND ANALYSES OF THE PANAMA CANAL LOCKS TOW TRACK SYSTEM

V. T. Cost

Panama Canal Commission
Engineering Division
APO Miami, Florida 34011

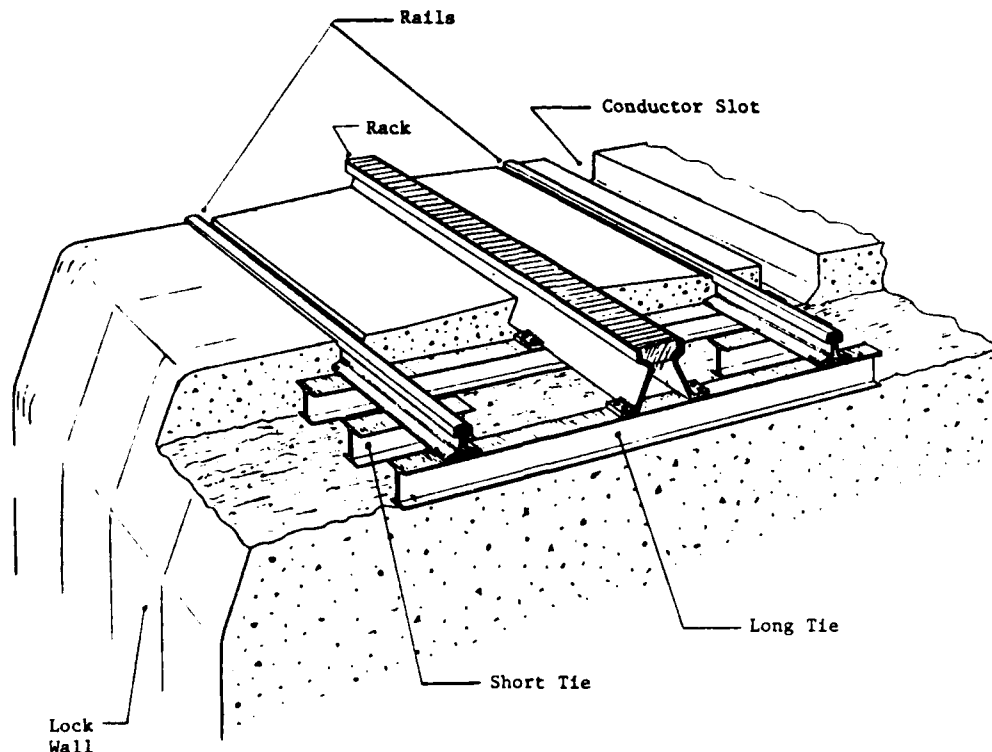
Figure 1. Cutaway sketch of typical concrete foundation tow track section

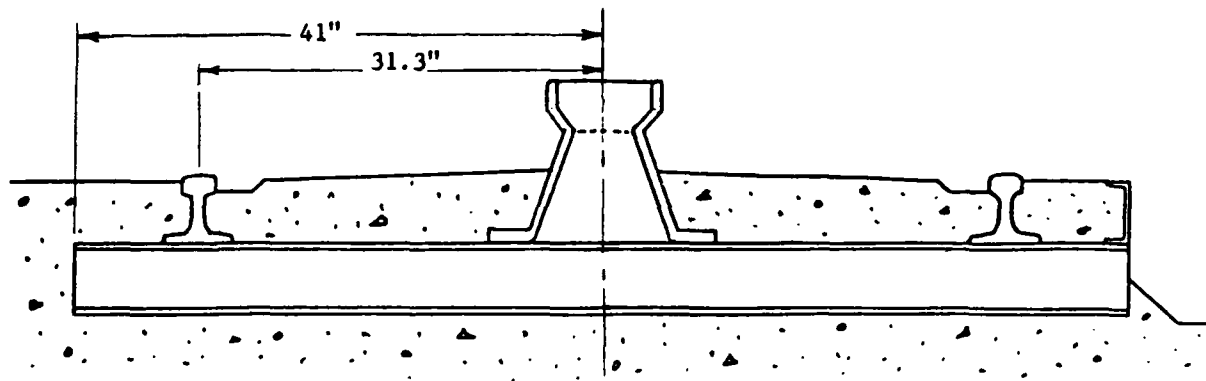
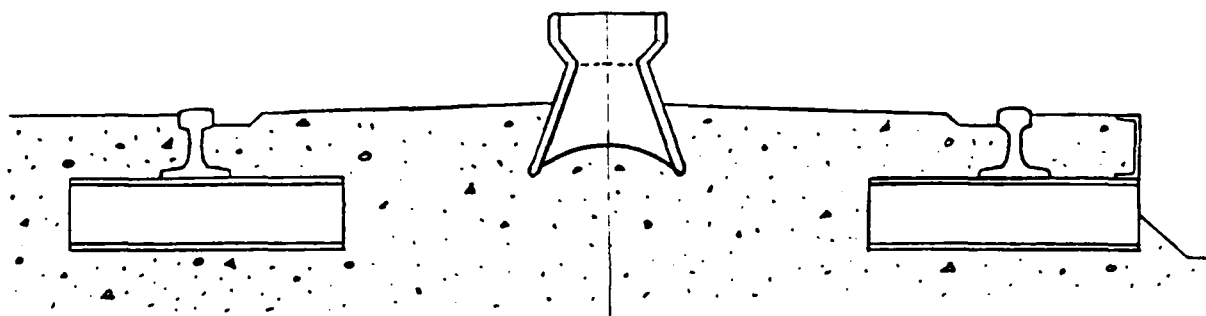
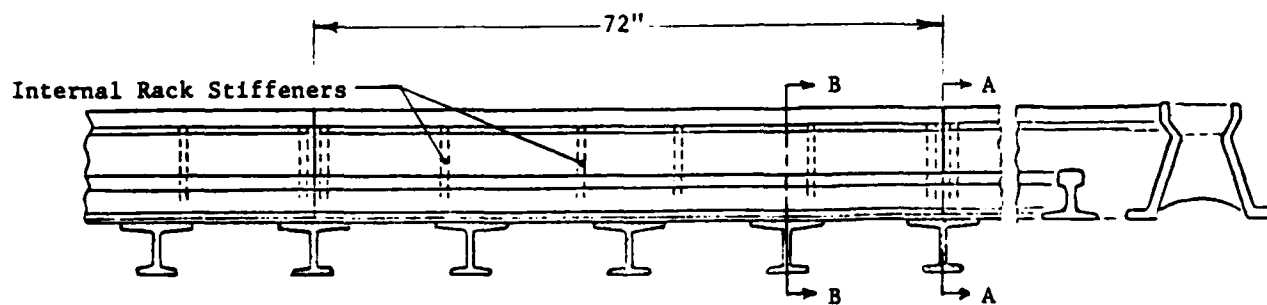
Figure 2. Construction details of the concrete foundation tow track

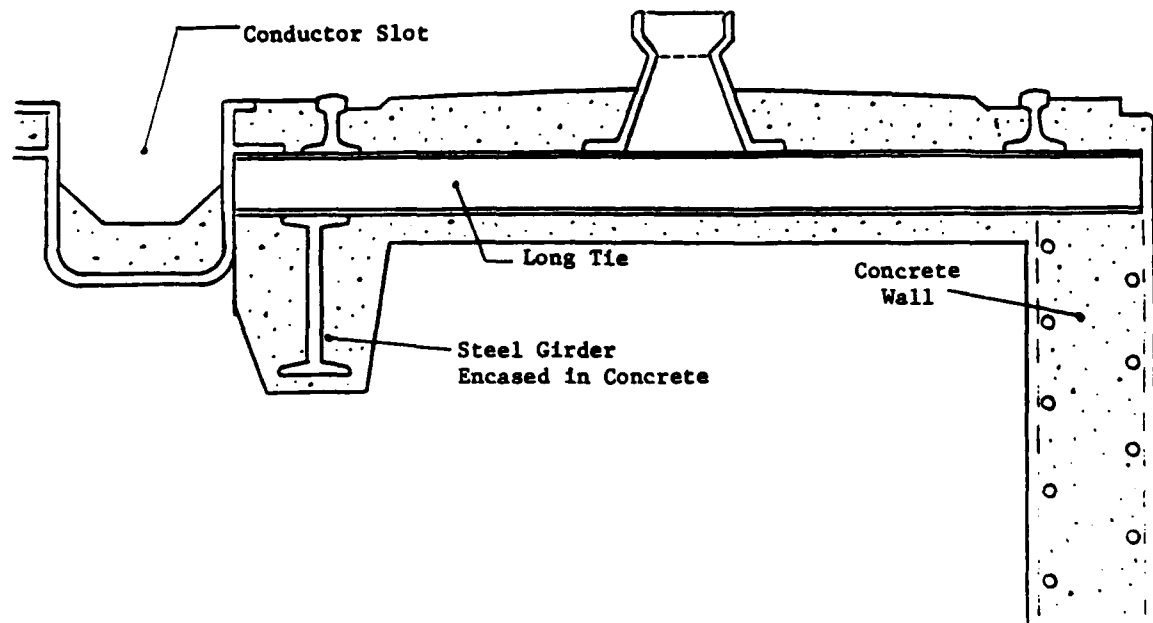
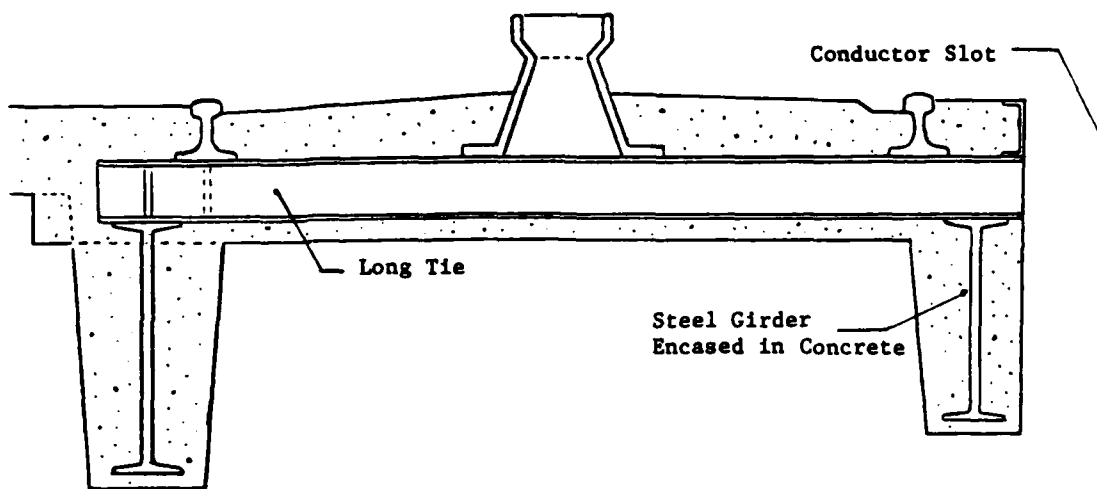
Figure 3. Section details of two typical construction types in areas where tow track spans below-deck rooms

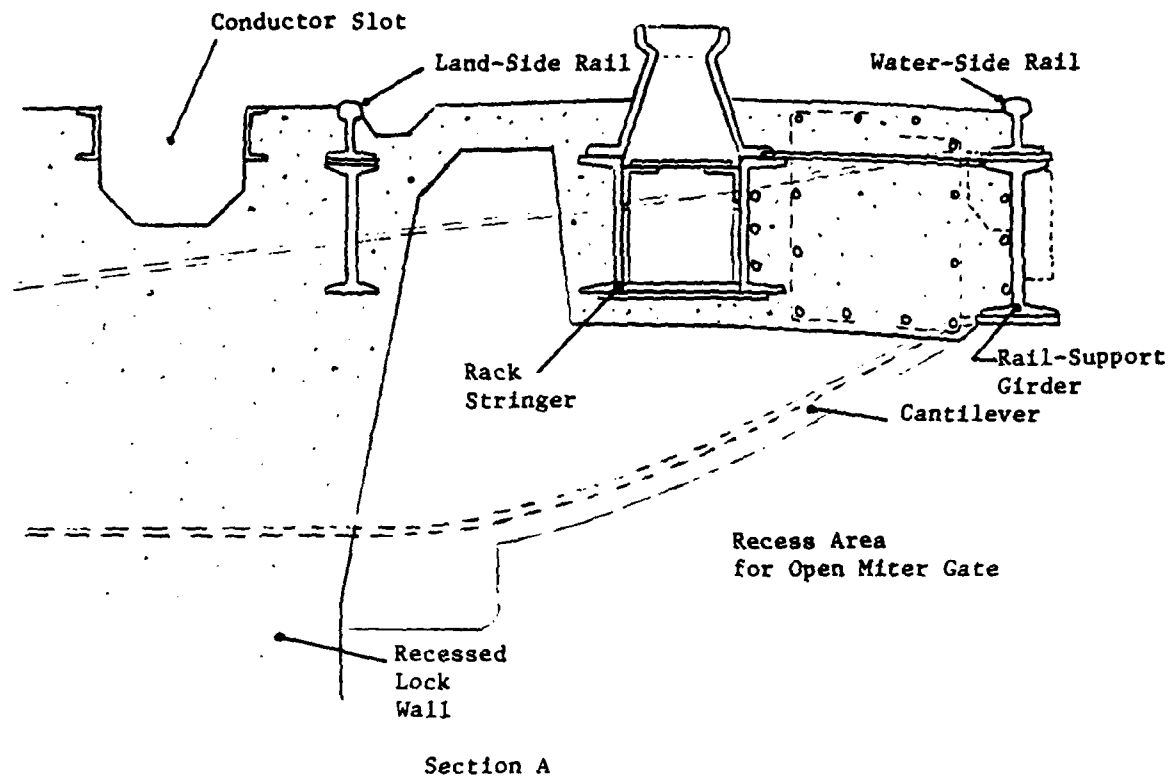
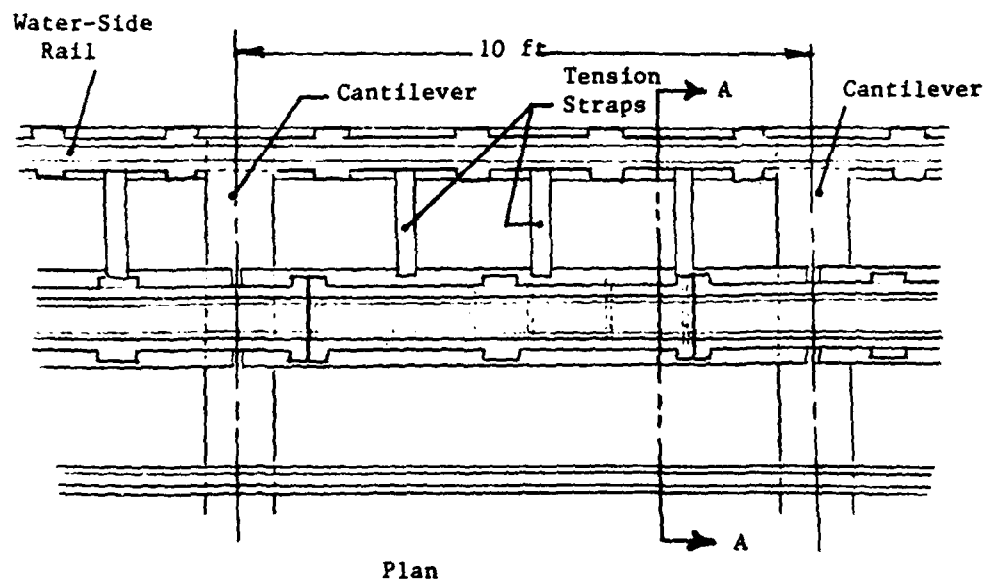
Figure 4. Plan and section views of gate recess tow track construction

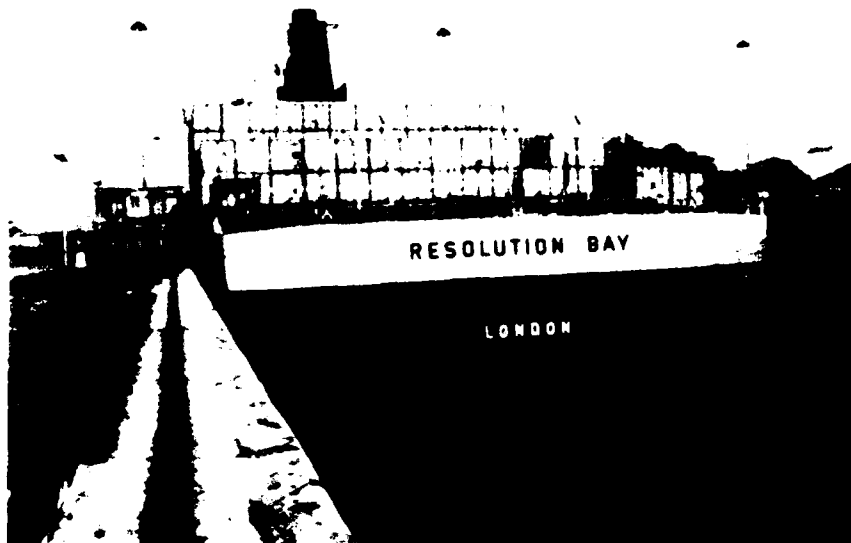
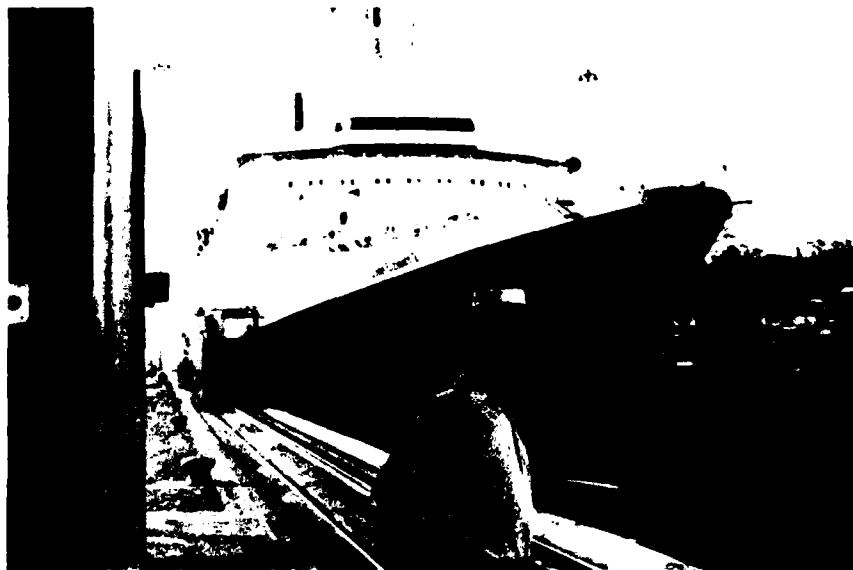
a. Locomotive cable angles vary considerably

b. Cable angles such as this cause the most severe loadings of the waterside rail

Figure 5. Typical towing operations (Continued)

c. Many of the larger vessels have only inches of clearance in the 110-ft-wide chambers

the larger vessels. The horizontal angles of the windlass cables during towing and braking may vary as much as 70 to 80 deg either side of normal (right angle to the ship's side). Vertical angles are influenced by the height above water of the cable attachment point, the water level in the lock chamber, and tide conditions, and vary between extremes of about 80 deg above or below horizontal. Figure 5 shows photographs of towing and braking operations in the chambers of the Miraflores Locks.

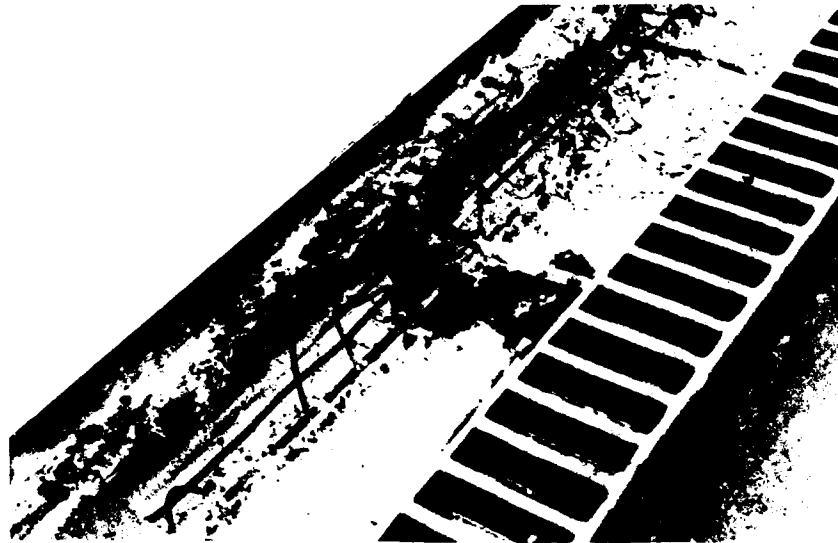
Figure 10. Gate recess area after removal of concrete between waterside rail and rack. Note the rods which serve as lateral stiffeners of the rail-support girder

12. Damage in gate recess areas seems to be primarily the result of lateral instability of the waterside rail and its supporting girder. Removal of concrete between the rack and the waterside rail often shows that the intermittent tension rods which serve as stiffeners connecting the supporting members of these components have been yielded or broken, allowing out-of-tolerance lateral deformations of the waterside structure under severe loadings. These tension rods can be seen in Figure 10.

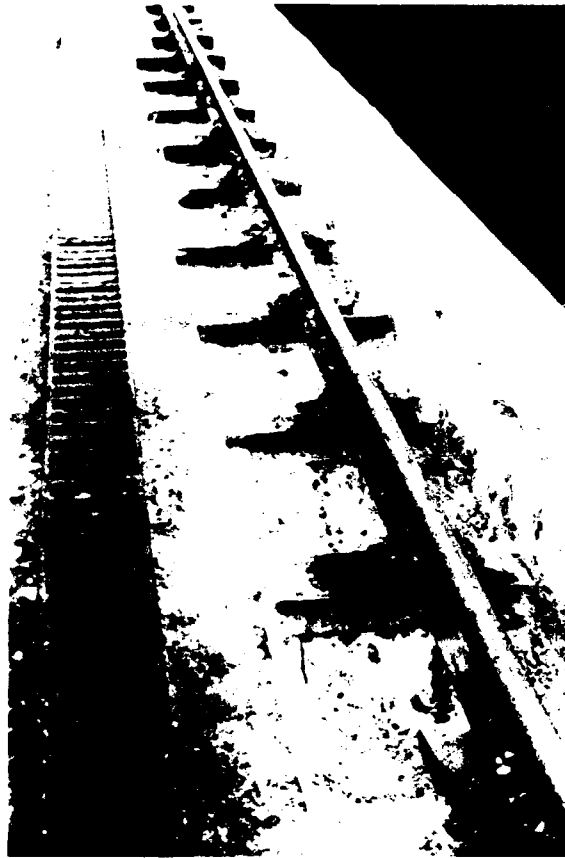
Figure 11. Repair area after the initial concrete excavation and removal of short ties

14. Repairs of a section are begun by removing the concrete around the waterside rail down to the lower flanges of the ties. All short ties in the area are then completely removed and long ties are closely inspected for damage (Figure 11). Long ties that are found to be damaged only under the waterside rail are cut off about halfway to the rack, and a new, heavier section is attached to the old using butt welds and splice plates (Figure 12). When a tie is more extensively damaged, concrete is excavated along its complete length so that it can be removed and replaced. Many of the original ties (more than half) do not appear to be damaged and are not replaced. Since sections identical to the original ties are no longer available, replacements are usually lengths of a standard W6 x 20 I-beam section. Limited supplies of a new heavier tie design are kept on hand for use where special details

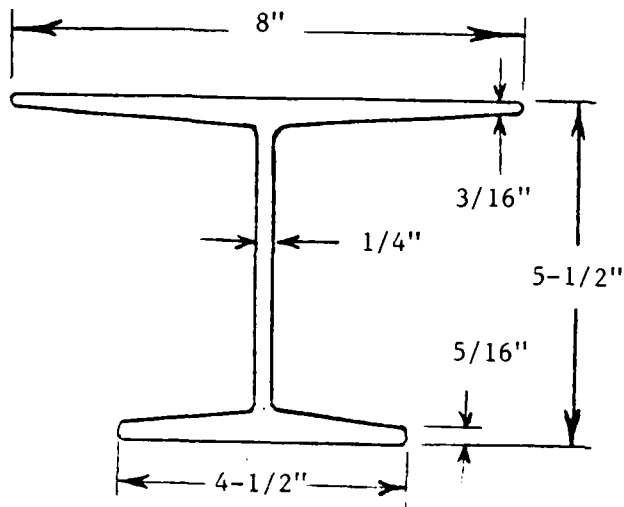
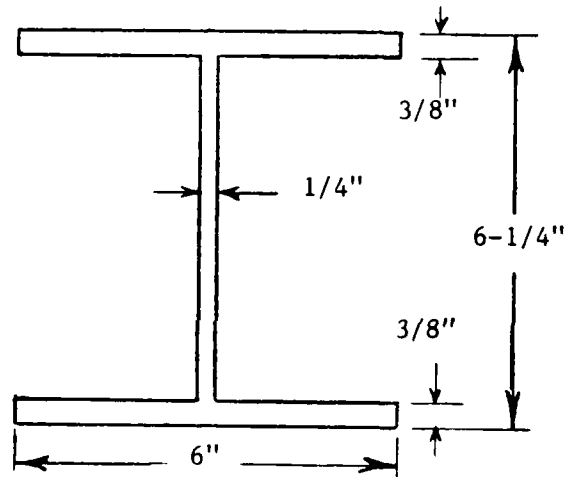
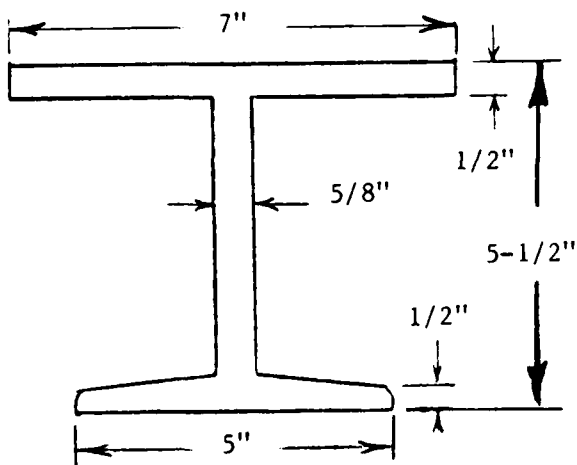
a. Original ties
(long and short)

b. Typical long tie
replacement section
(W6 x 20 I-beam)

c. Long tie replacement
section for special depth-
critical locations (in-
verted ST5 x 17.5 with
welded top flange)

Figure 13. Sectional details of crossties

require that the replacement section have exactly the same total depth as the original-style tie. Cross-sectional details of the three tie sections are shown in Figure 13. Temporary supports for the waterside ends of all long ties are made by drilling 2-ft-deep, 2-1/2-in.-diameter holes in the concrete foundation at the end of each tie, driving 2-in.-diameter extra strong steel pipes into the holes, and welding the pipes to the ties. This support condition can be seen in Figure 12. When the temporary supports are in place, additional concrete is removed below the tie bottom flanges to assure that the repair foundation is sound. The pipe supports thus carry all loads previously borne by the tie foundation (at the waterside end) for a period of at least several days, during the next steps of the repair procedure. Some additional concrete is removed when a damaged rack section must be replaced. Rack sections which show only moderate deterioration of the wear surface (landside flange) are sometimes rotated 180 deg and reinstalled.

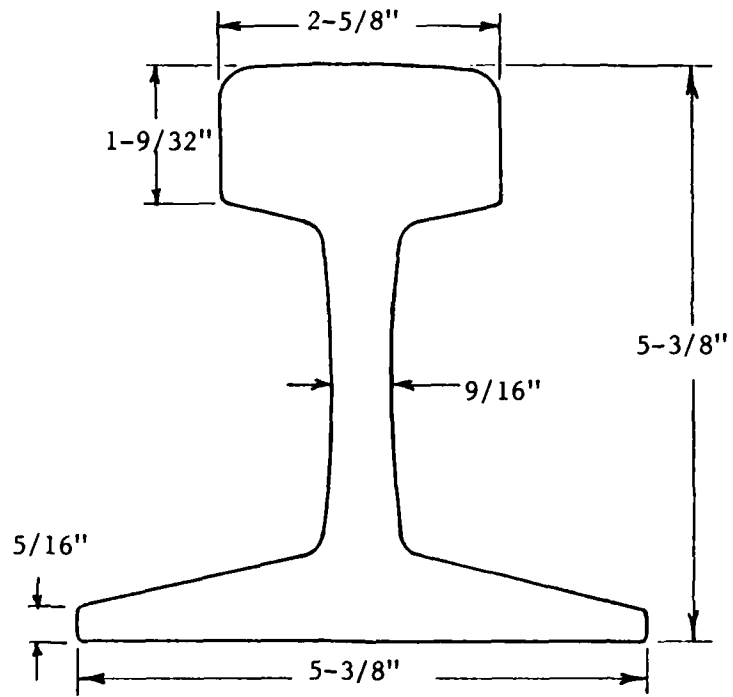
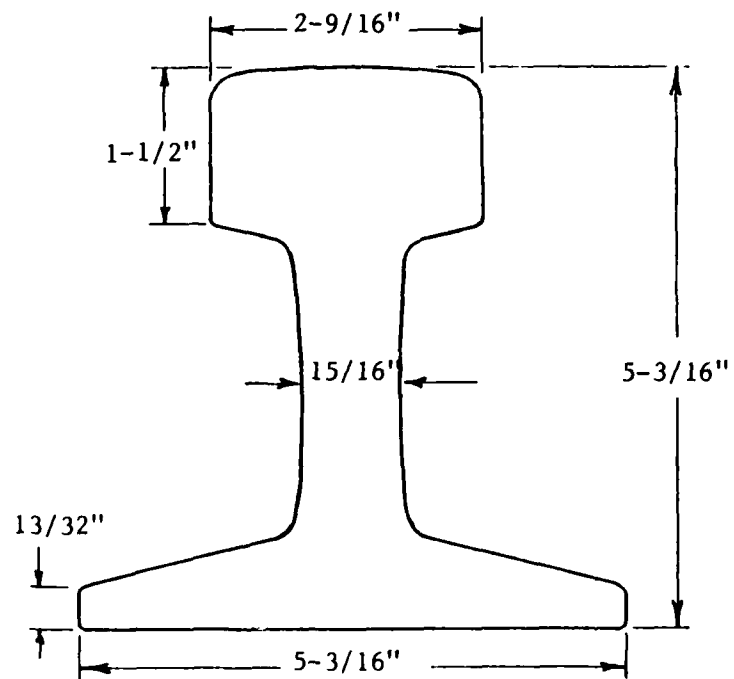
a. Original rail, 90 lb/yd

b. Replacement rail, 105 lb/yd

Figure 14. Cross-sectional details of original and replacement rails

15. When all long ties are secured by pipe supports, the waterside rails are replaced with heavier sections and upgraded connection hardware is used throughout. The new and old rail sections are detailed in Figure 14. The new rails are carefully aligned and brought to the appropriate elevation using specially designed shims. Thermit welds are used at rail joints. The original short ties are modified by welding plates on the landside ends, and are then bolted in place to the new rails, with removable spacer plates sandwiched between. Formwork is constructed around the short ties, and a 3,000-psi, high early strength concrete is cast up to the top flange of the suspended short ties only (Figure 15). After an initial set (no-traffic period), the spacer plates are removed so that no rail loads are transferred to the fresh concrete. After a 24-hr cure, all rail loads are transferred to the short ties and final connections are made; shims on the long ties are removed. Concrete is then cast and cured up to the top flanges of the long ties (Figure 16) and final connections are made. At this point all ties are encased in concrete up to the top flanges and are carrying rail loads, but the rail is still exposed. The concrete level is typically about 1/4 in. below the rail bottom flange between ties, roughly corresponding to the thickness of shims at the tie connections. No attempt is made to move concrete under the rail flange during the final placement, which is generally regarded to function only cosmetically. The repair is complete when the final concrete is cast to the original surface level and crack control joints are

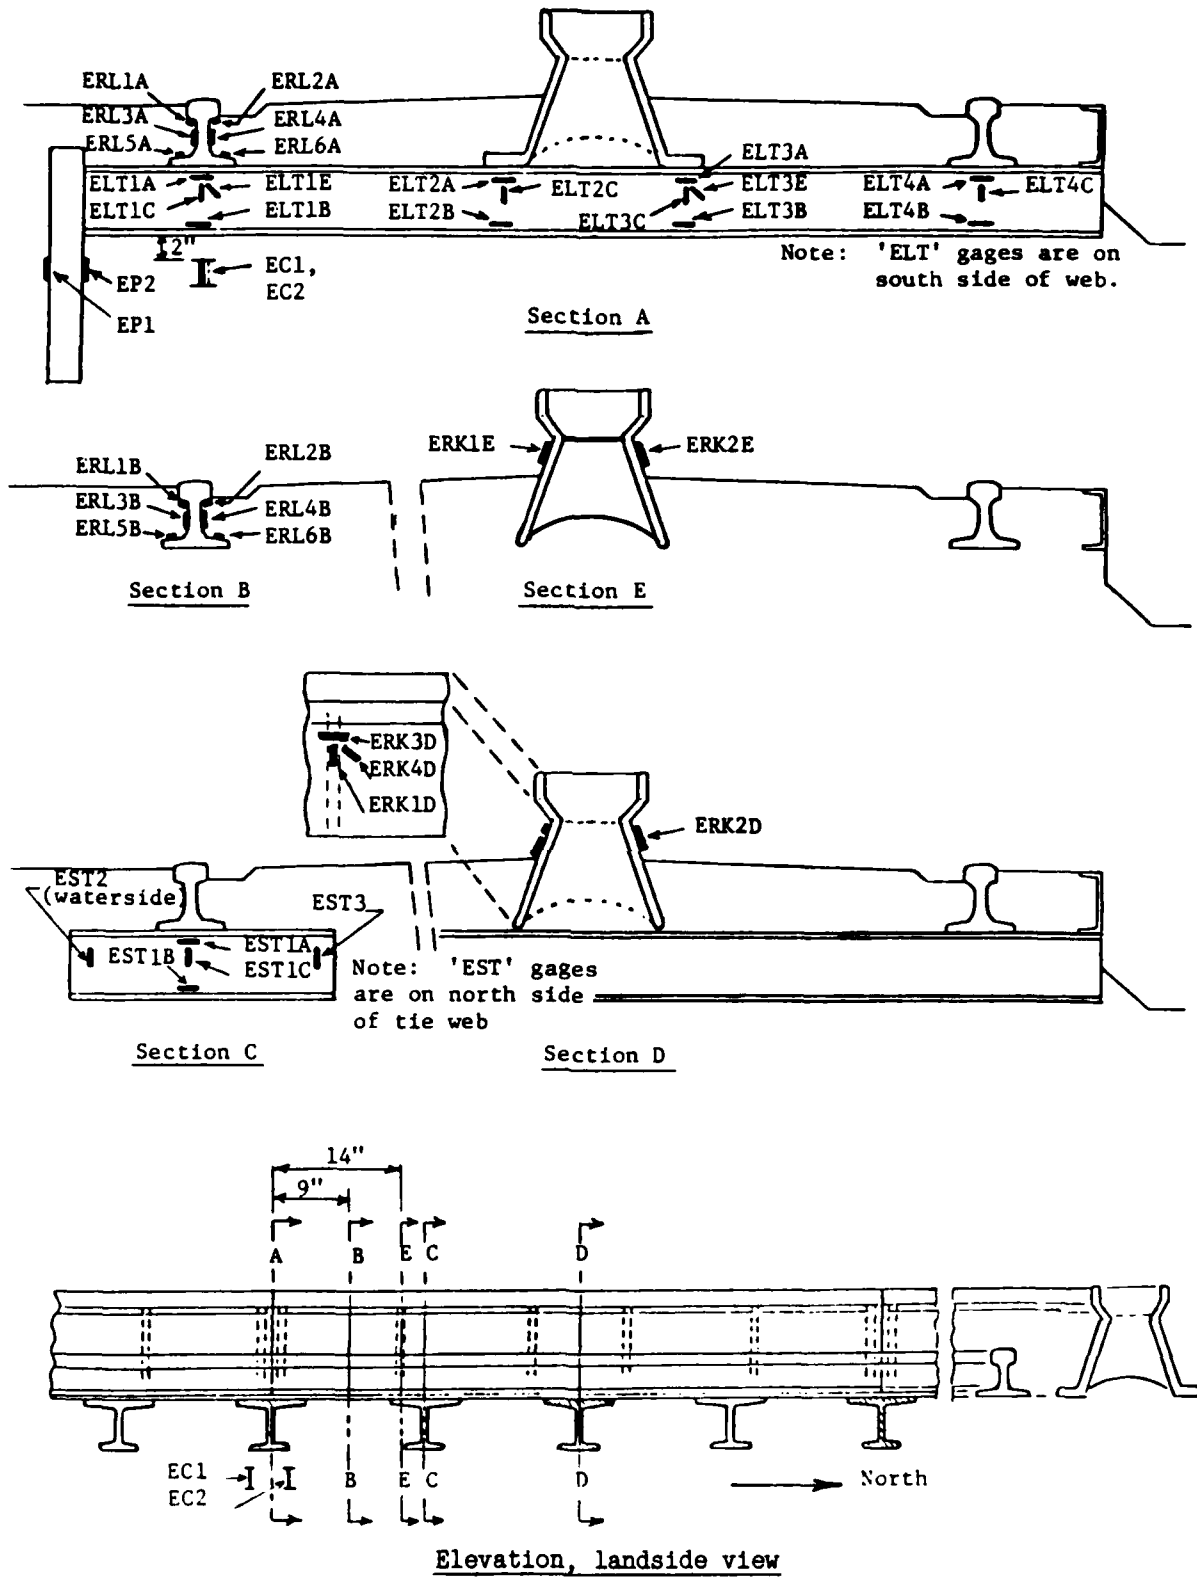
Figure 17. Gage locations, site 1

21. Gage layout details for each of the three test sites are shown in Figures 17 through 22. When new component sections were available for instrumenting prior to installation, adhesive-type strain gages were placed under controlled conditions (Figures 23 through 25). These components included the ties at sites 1 and 3 and the rail and rack at site 2. Adhesive strain gages could not be used on those components already in place due to insufficient no-load time periods and the inaccessibility and surface conditions of the gage locations. Weldable strain gages were used for these applications (Figure 26).

42. Strain gages on the long ties which were replaced at sites 1 and 3 were arranged in four groups, one under each rail and one under each rack connection point (Figures 17 and 21). All of the gages were placed on the tie webs. Each group consisted of horizontally oriented gages near the upper and lower extremes of the web and a vertical gage adjacent to the upper horizontal. In some cases, a three-gage rosette (including one at a 45-deg angle) was used at the upper location so that principal strain directions could be identified. Vertical gages under the rails were duplicated on the opposite side of the tie web at site 3, and two vertically oriented gages were used on each of the pipe supports which temporarily carry loads at the waterside ends of long ties during construction. An adjacent short tie at site 1 was gaged in a similar arrangement, while at site 3 weldable strain gages were placed on one side of the web of an in-place, original long tie (removal of concrete was done only to the extent necessary for gage placements) to facilitate comparisons of strains in the replaced tie and one which was part of previous repairs.

48. Strain gage locations on the rack were chosen so as to measure local strains caused by the locomotive safety shoes as well as those strains associated with twisting of the rack section. Other than one three-gage rosette, the orientations were vertical. All gages were on the outer surfaces of the rack sides, near the upper flanges on which safety shoes bear. Selected locations along the length of the rack sections included points both directly over and halfway between the internal stiffeners (Figures 17 and 21).

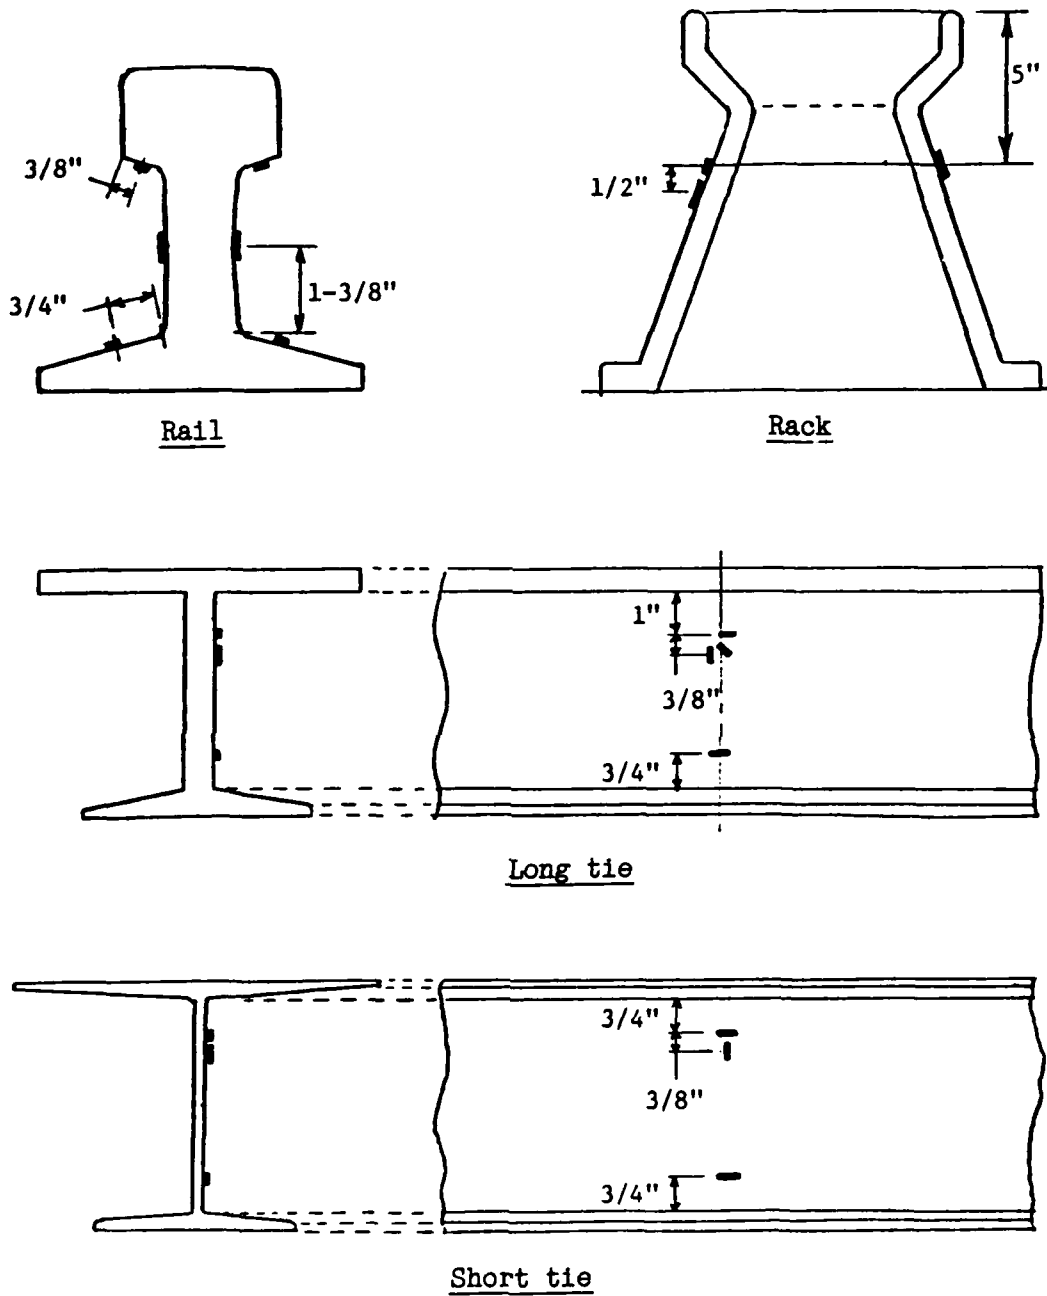
Figure 18. Strain gage location details, site 1

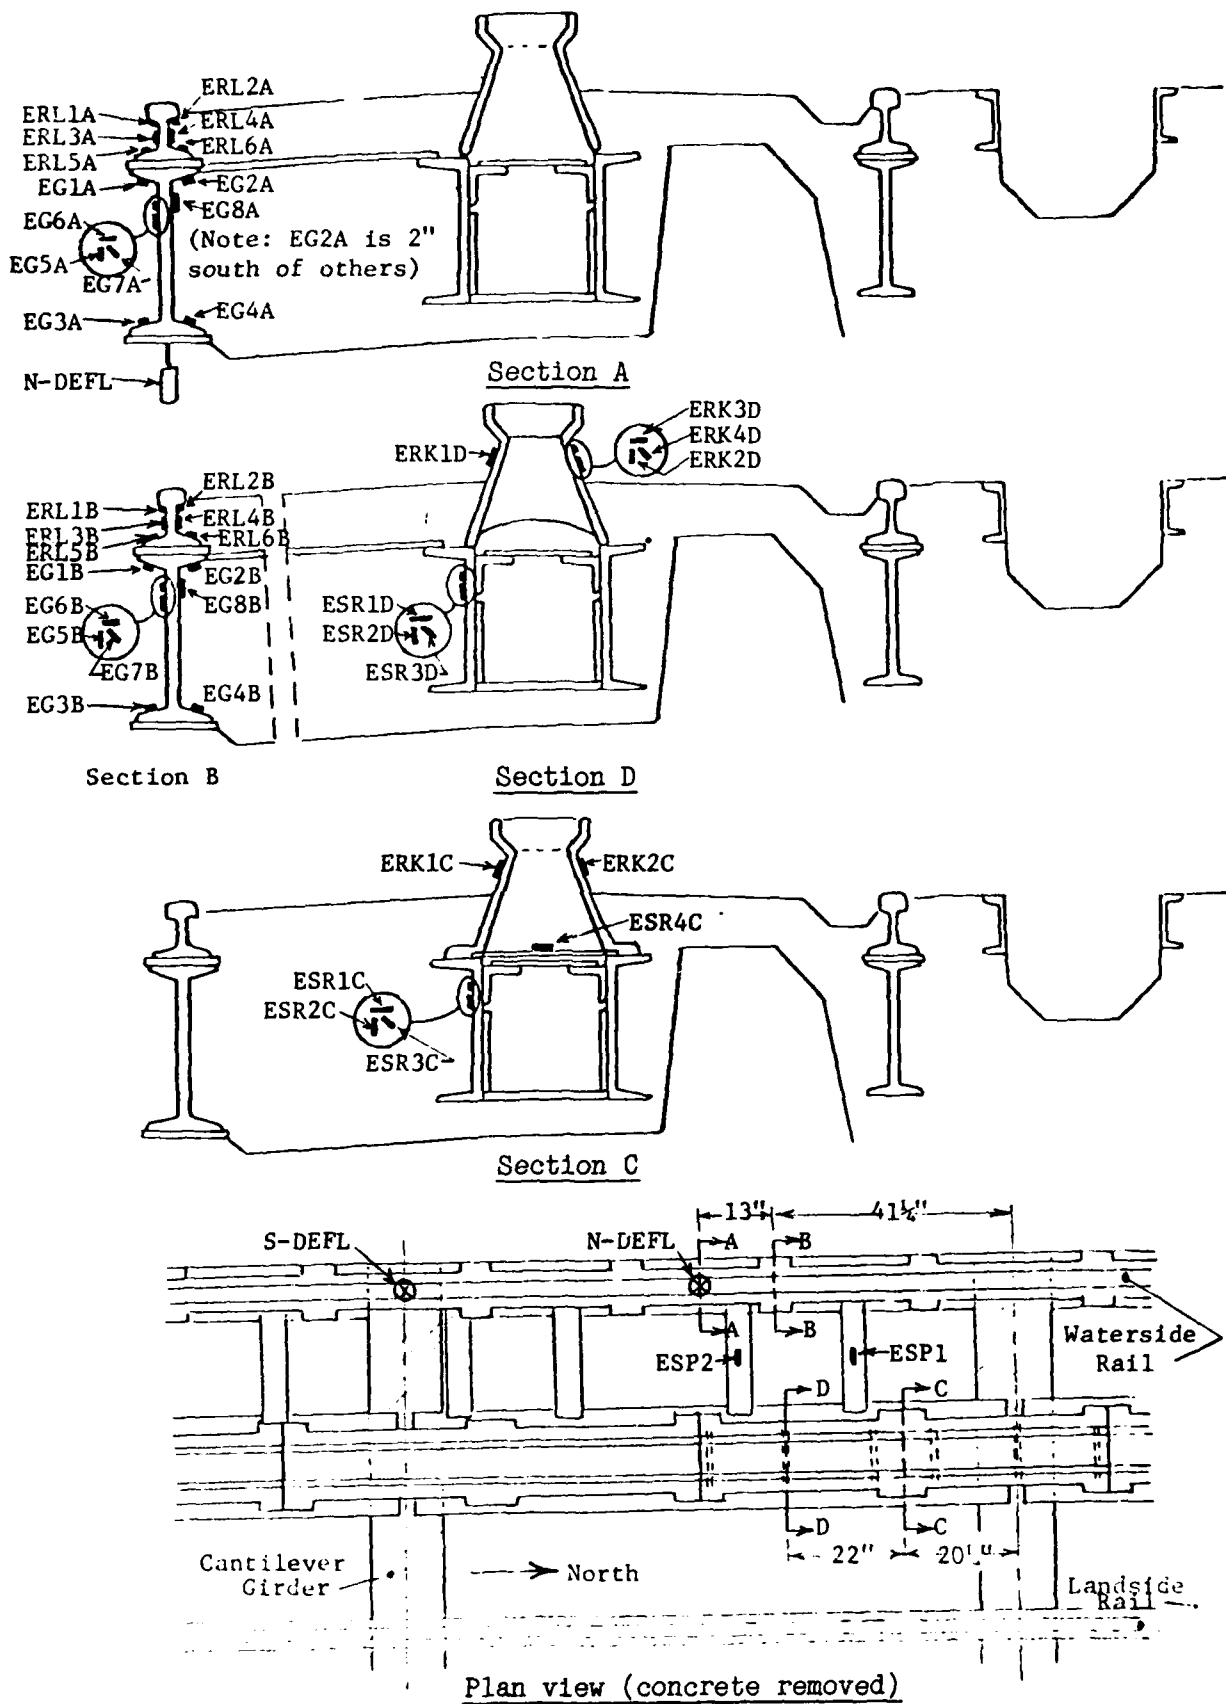
Figure 19. Gage layout, site 2

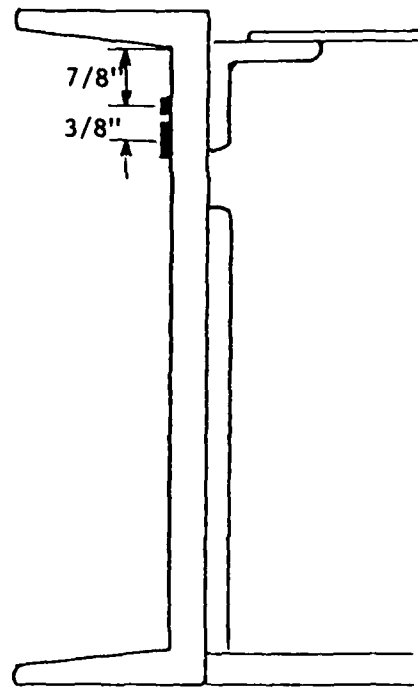
Stringer channel

Figure 20. Strain gage location details, site 2

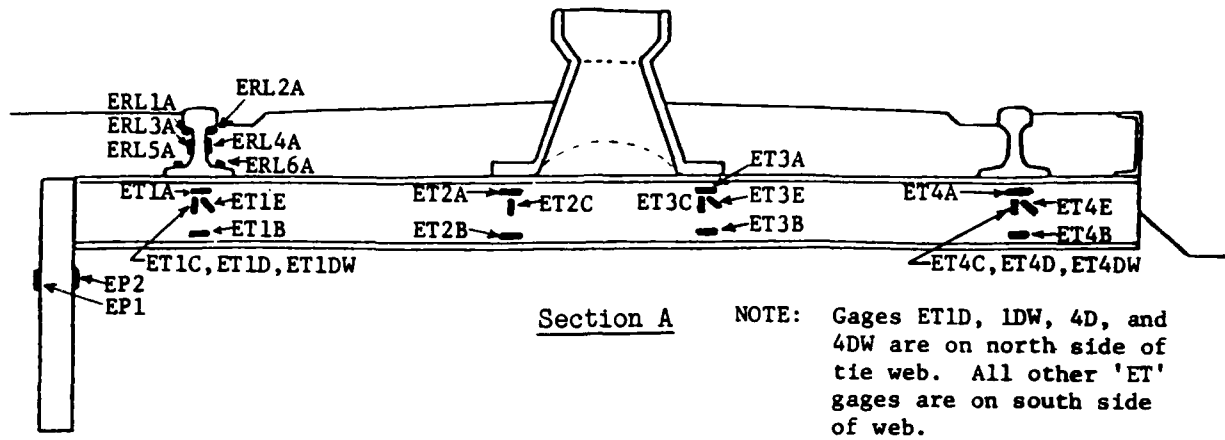
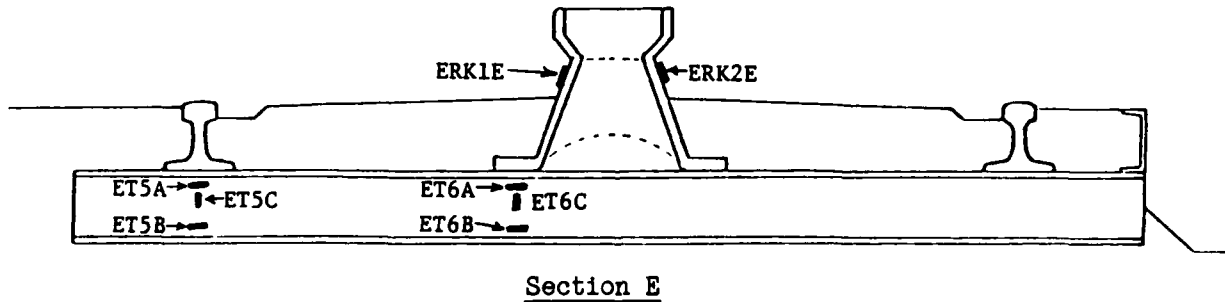
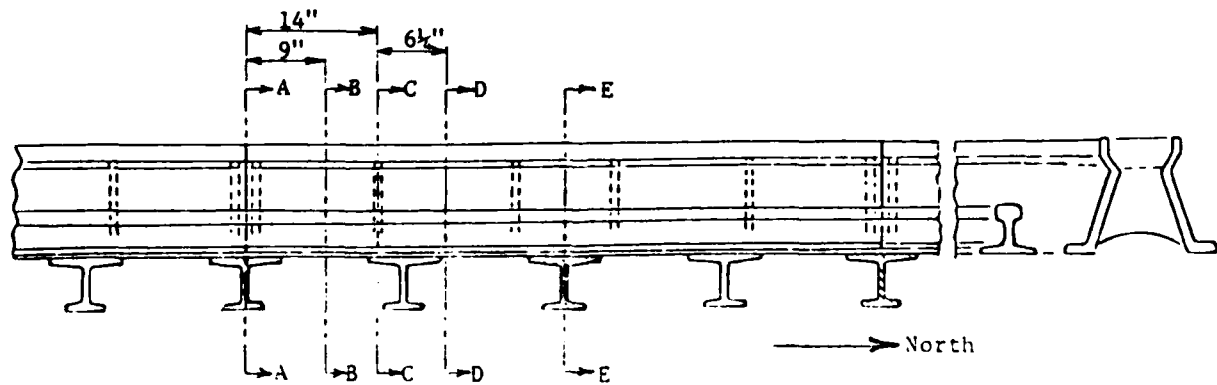
Figure 21. Gage layout, site 3

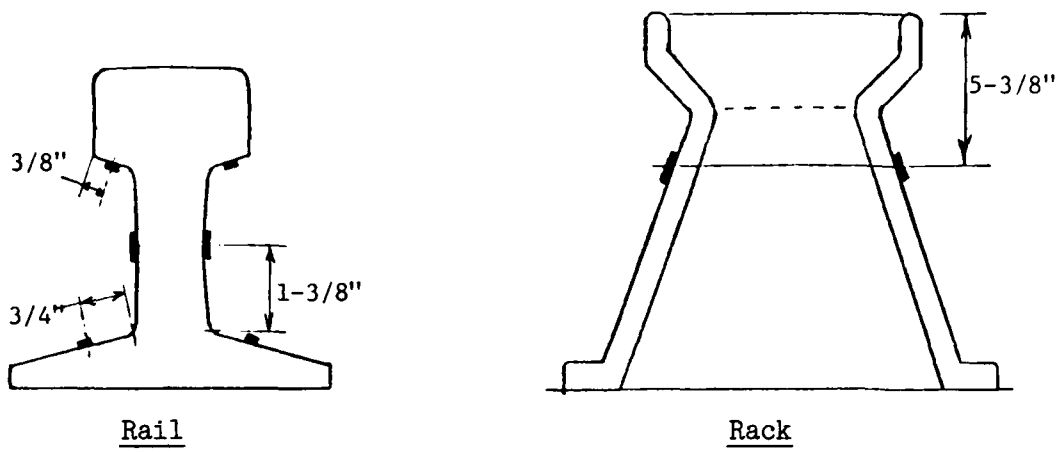
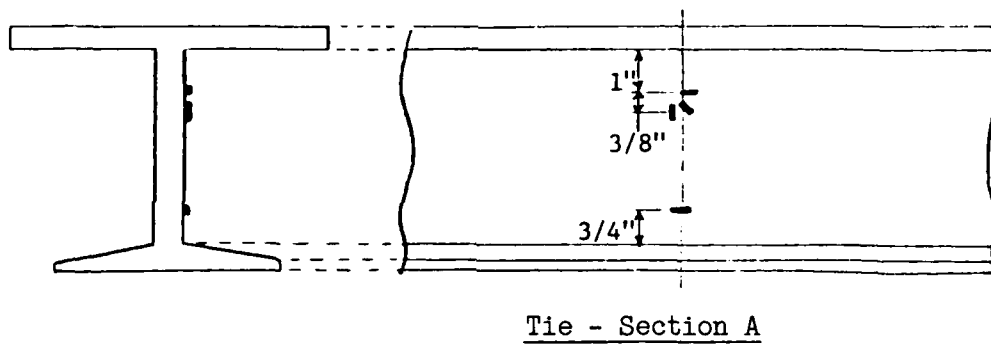
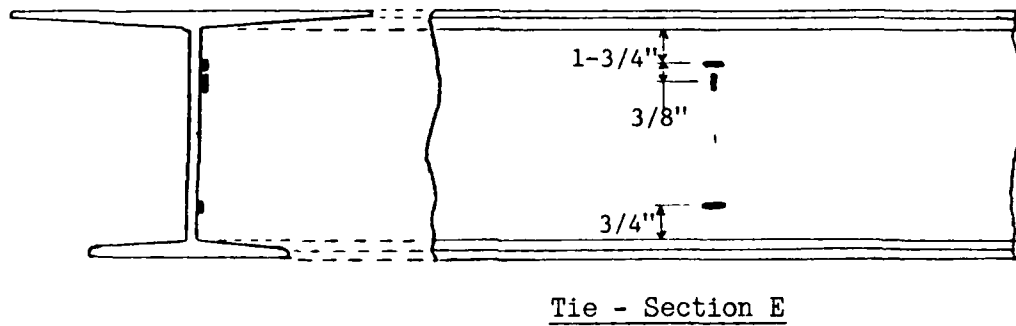
Figure 22. Strain gage location details, site 3

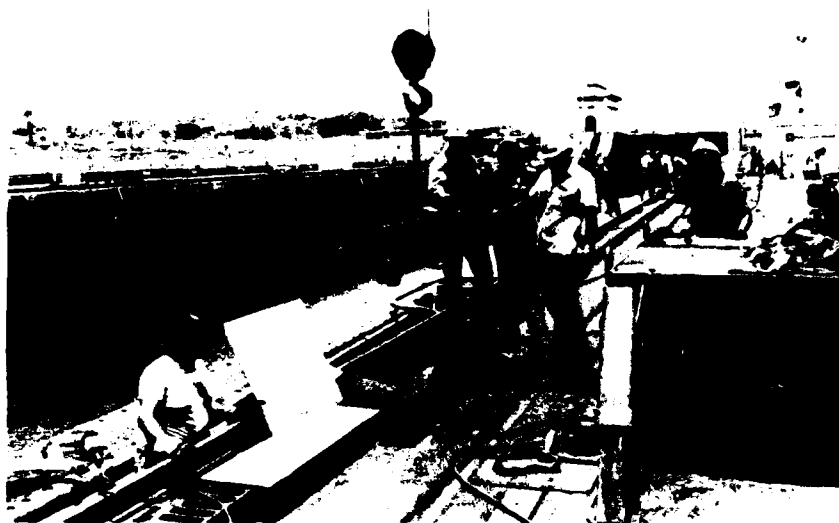
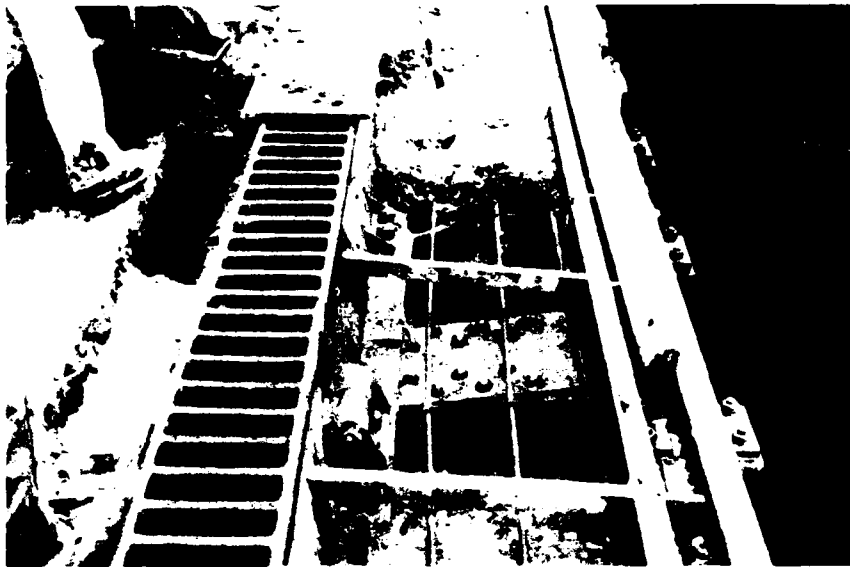
a. View of construction work from atop the closed miter gate

b. Placement of strain gages on the rail-support girder

c. Installation of a new rack section,
previously strain-gaged

d. Placement of gages and component
assembly are complete. Note the new
"tension strap" girder stiffeners

e. Concrete placement

f. Completed repair

23. Test site 2 was prepared for testing during the actual repairs of the entire gate recess section. The new waterside rail, rack section, and tension straps to be used were strain-gaged with adhesive-type gages prior to installation. Weldable strain gages were placed on the rail-supporting girder and stringer channel (part of the built-up structure which supports the rack) after the confining concrete was removed. Deflection gages for monitoring any movement of the cantilever girders were attached to specially constructed steel supports which were anchored into the lock wall. All new concrete in the gate recess section was cast at one time, completing the repair. Figure 29 shows views of the gate recess repairs and test site preparation.

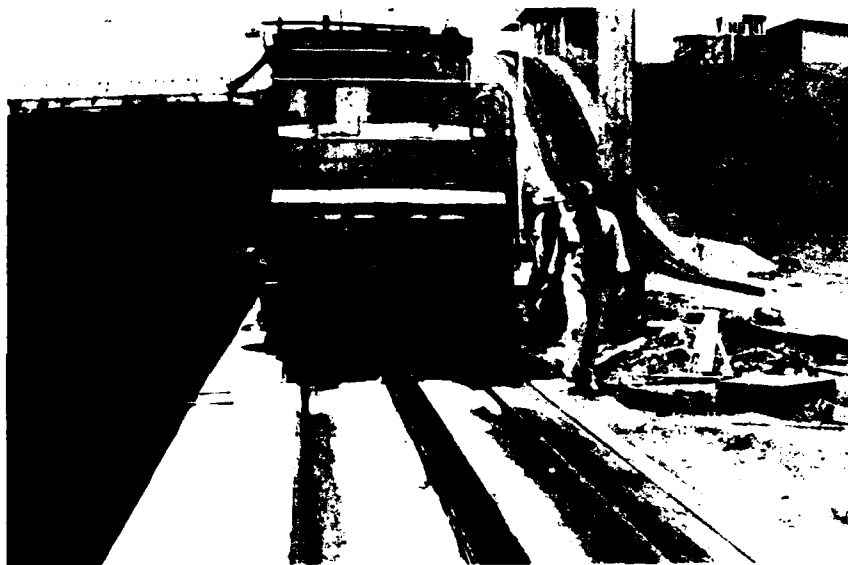
Figure 30. Controlled tow simulation tests were made by moving the locomotive over the test site with windlass cables anchored to the opposite lock wall

25. The tests conducted at each site included both actual towing situations and controlled tow simulations. The simulations were made by securing the locomotive windlass cables to stationary anchors on the opposite lock wall. Locomotives then moved across the test area at the desired speed with one or both of the windlasses exerting a prearranged (usually maximum) cable tension. The simulation conditions allowed more precise measurement of loadings over a limited range of cable angles. Data which reflected effects of the most extreme cable angles had to be obtained in actual towing tests. Since locomotives were not always fully loaded when passing a given section and extremely severe cable angles occurred only occasionally, a large number of tests were conducted in hopes of obtaining data from a representative variety of severe loading conditions. One test in which windlass cables were completely unloaded was conducted at each test site for reference purposes.

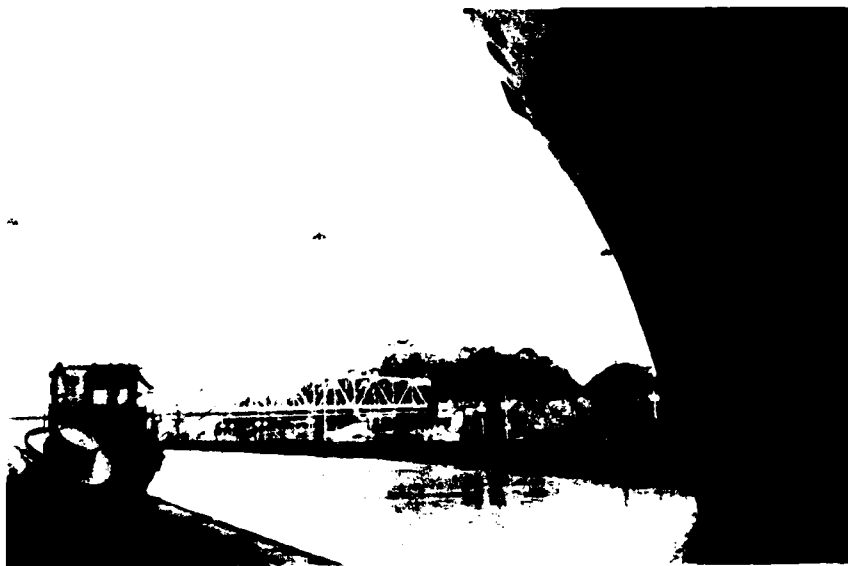
Figure 31. Tests which involved actual towing or braking of ships were made during normal operations

26. In addition to electronic instrumentation measurements, other information collected from each test included ship name, length, beam, and draft (for towing tests), measured horizontal and vertical angles of windlass cables, readings of locomotive cable tension meters, and position and function (towing, braking, or guiding) of the locomotive. Summaries of the individual tests can be found in the draft data report referred to in paragraph 3. Photography was used to document many of the test configurations (Figures 30 and 31).
