TECHNICAL REPORT SL-86-8

TESTS AND ANALYSES OF THE PANAMA CANAL LOCKS TOW TRACK SYSTEM

V. T. Cost

Panama Canal Commission
Engineering Division
APO Miami, Florida 34011

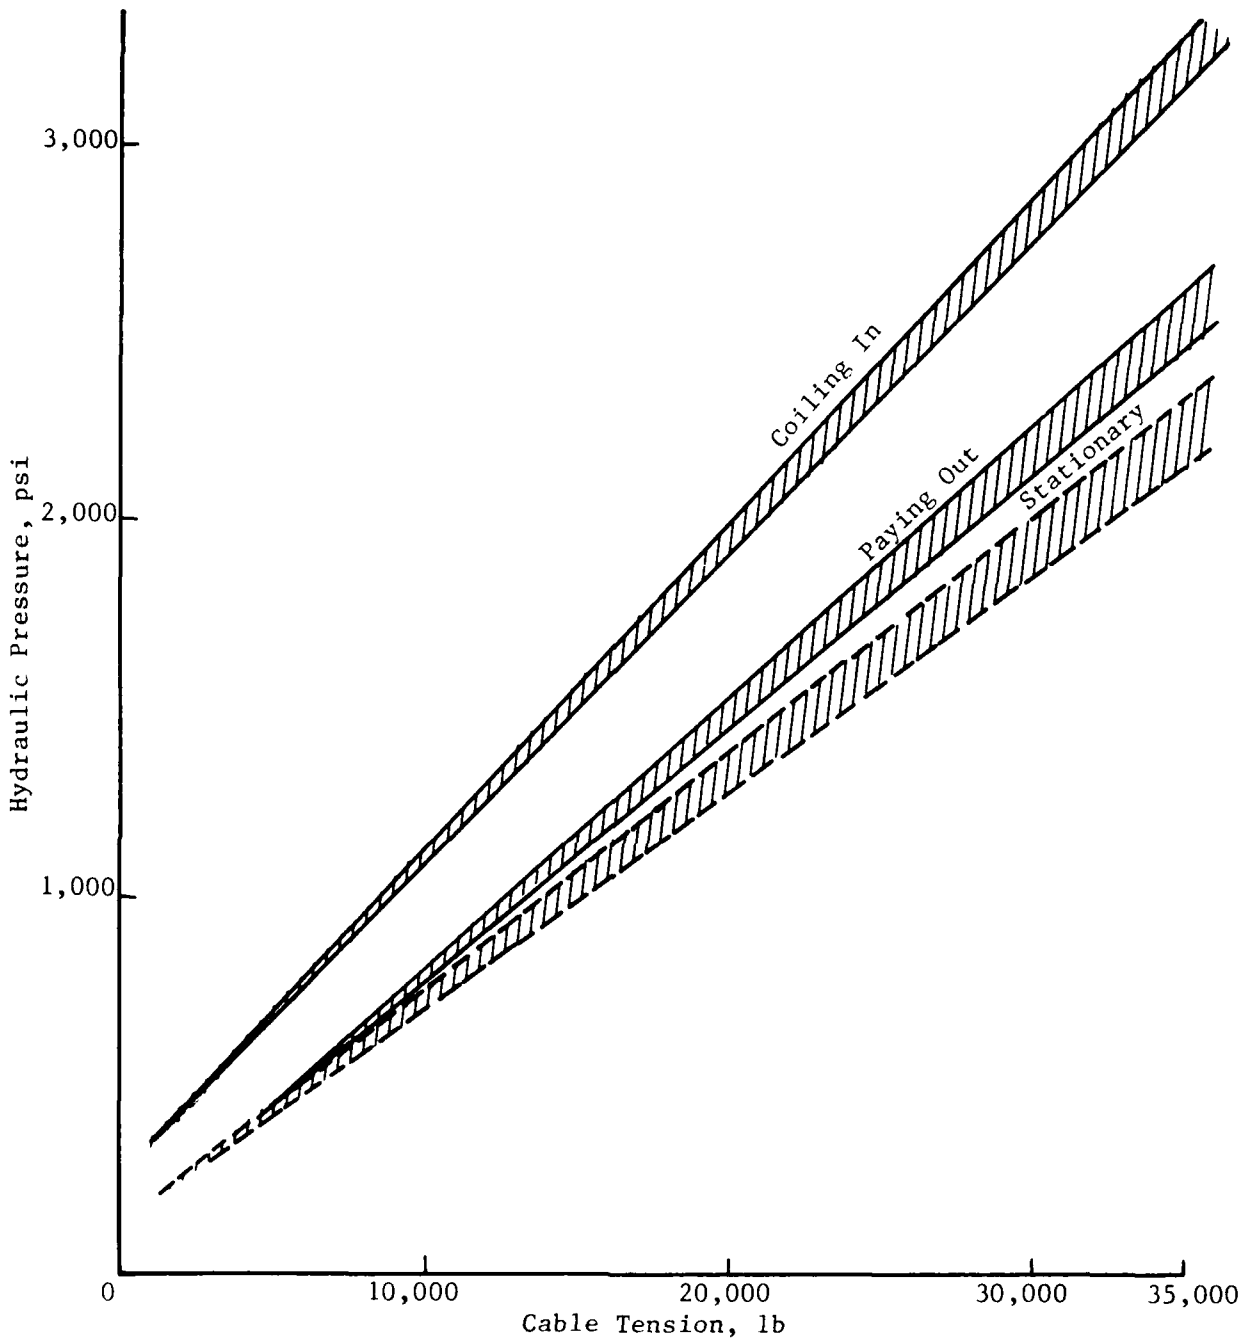
Figure 32. Relationships between cable tensions and windlass hydraulic pressures

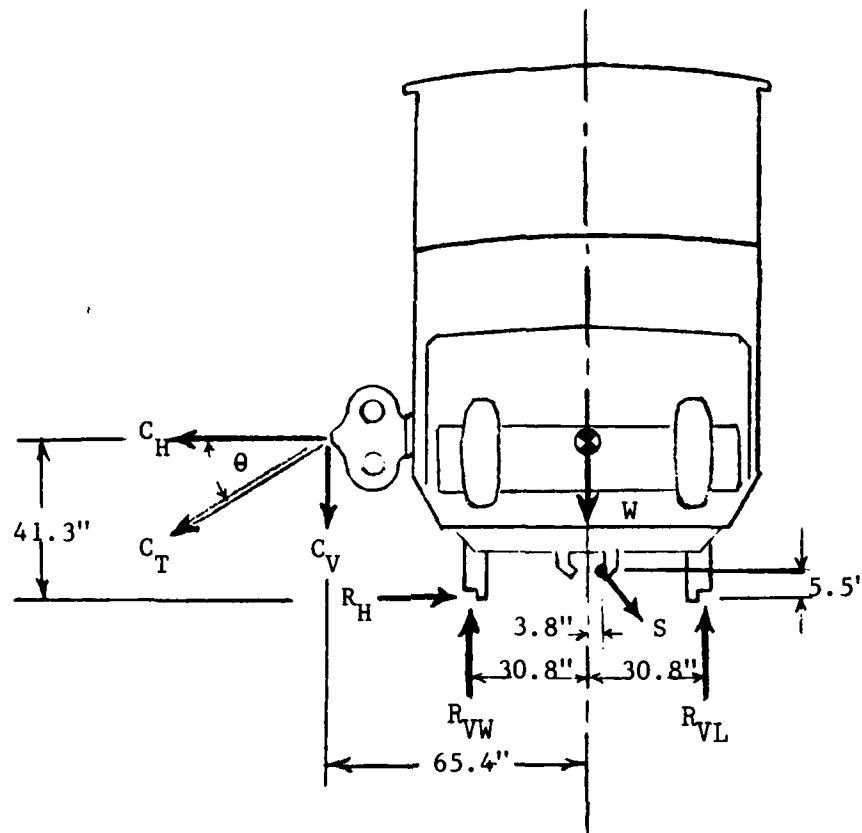
- W = locomotive weight (55 kips per axle)
- θ = cable angle with respect to horizontal
- C_T = cable tension (35 kips maximum, each)
- C_H = cable tension, horizontal component = $C_T \cos \theta$
- C_V = cable tension, vertical component = $C_T \sin \theta$
- R_H = horizontal rail load (waterside only)
- R_{VW} = vertical rail load, waterside
- R_{VL} = vertical rail load, landside
- S = safety shoe load

Figure 33. Free-body diagram of a locomotive showing all loads associated with one axle

58. Precise definition of the magnitudes, directions, and points of application of all loads imparted to the tow track system by locomotives is necessary in beginning the analytical investigation. Since locomotive weight and geometry, maximum cable tension, and the general range of cable angles are known, theoretical determinations of loads on the rails and rack can easily be made using the principles of statics, assuming the locomotive acts as a rigid body. Figure 33 is a free-body diagram of a locomotive showing all of the loads associated with one axle. When windlass cables are slack, loads to the tow track system include only the uniform distribution of the locomotive weight (vertical loads of 27.5 kips at each wheel). Since this dead-load-only case is easily defined in testing, it provides a basis for data-versus-analysis comparisons. When cable loads are applied, rail loads can be determined by summing moments about the safety shoe bearing point. Loads on the waterside rail are greatest when the cable angle is below horizontal. As the angle θ (Figure 33) increases, the vertical component of cable tension C_V becomes larger, as does the vertical resultant on the waterside rail R_{VW} . Load on the landside rail R_{VL} decreases. As θ increases with maximum cable tensions, R_{VL} eventually becomes zero. This is the point at which the locomotive safety shoes first engage to resist overturning moment. By summing moments and forces and setting $R_{VL} = 0$, this θ is found to be about 14 deg below horizontal. At this point, $R_{VW} = 63.4$ kips. Cable angles, however, often become more severe than this. By varying θ and solving for the corresponding rail loads, it can be shown that the most severe case for vertical

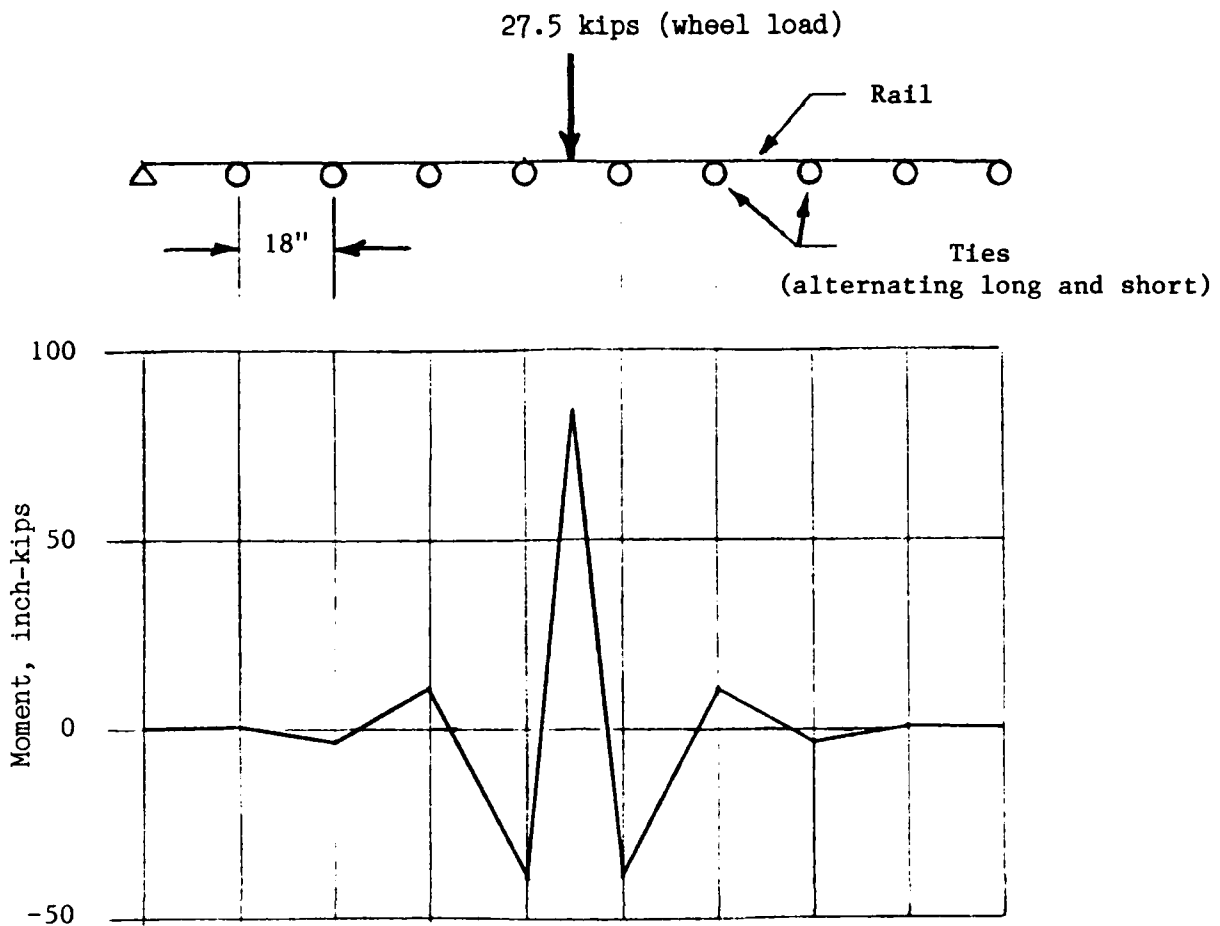
Figure 34. Moment diagram for a beam on multiple simple supports

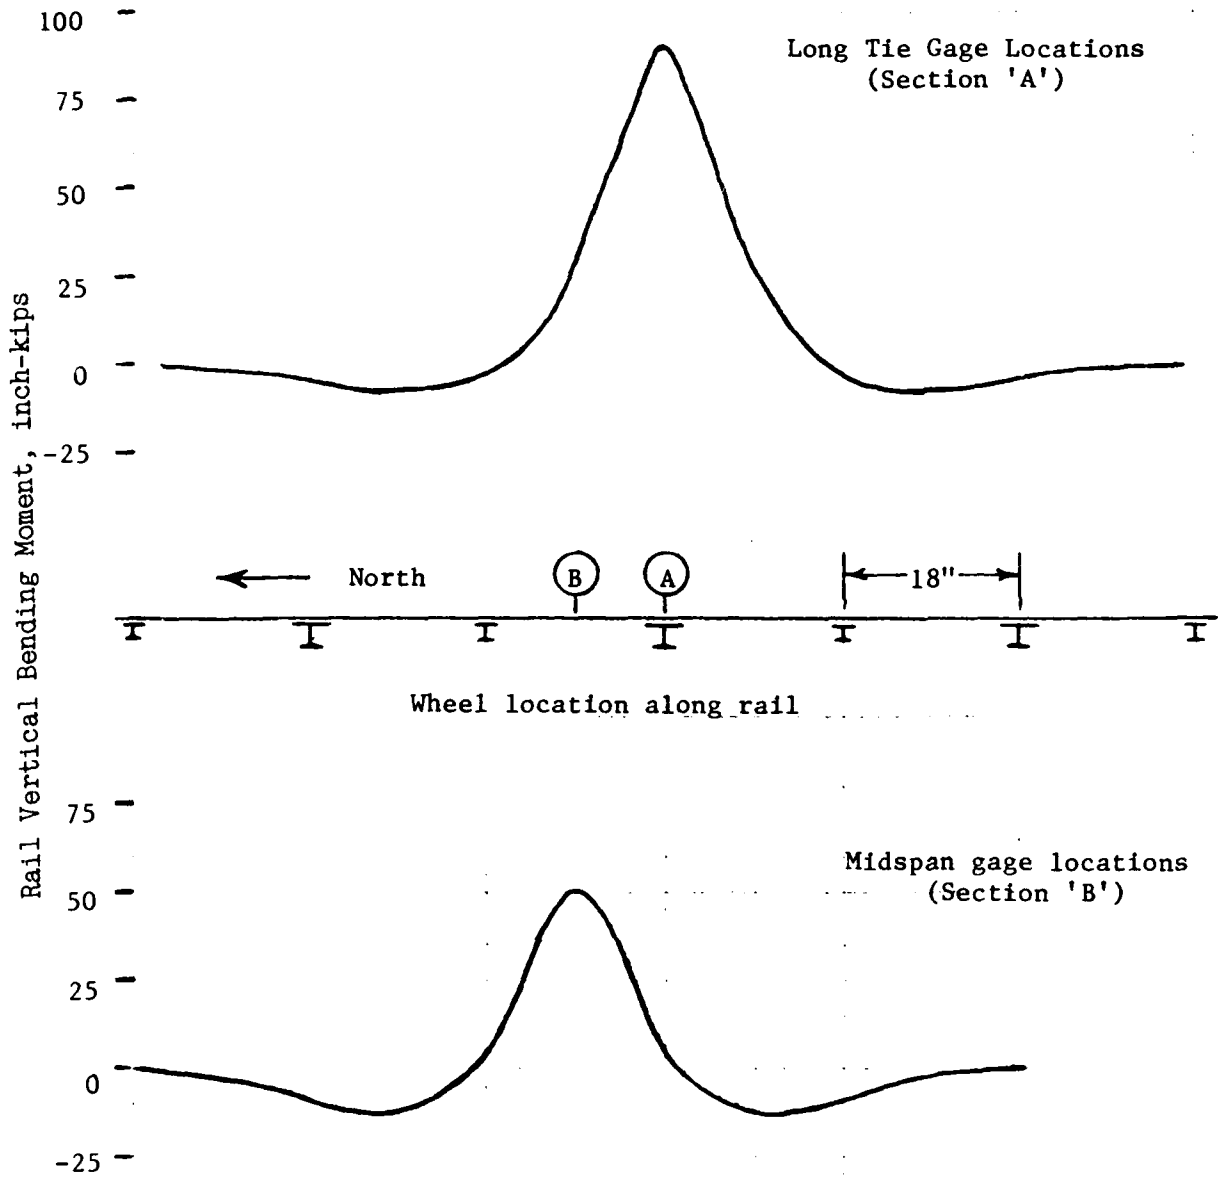
Figure 35. Influence diagrams for rail vertical bending moment induced by a single locomotive wheel (dead load only), as derived from test data

Figure 35 shows influence diagrams for vertical bending moment in the rail at tie and midspan sections, derived in this manner from the strain data of dead-load-only tests.

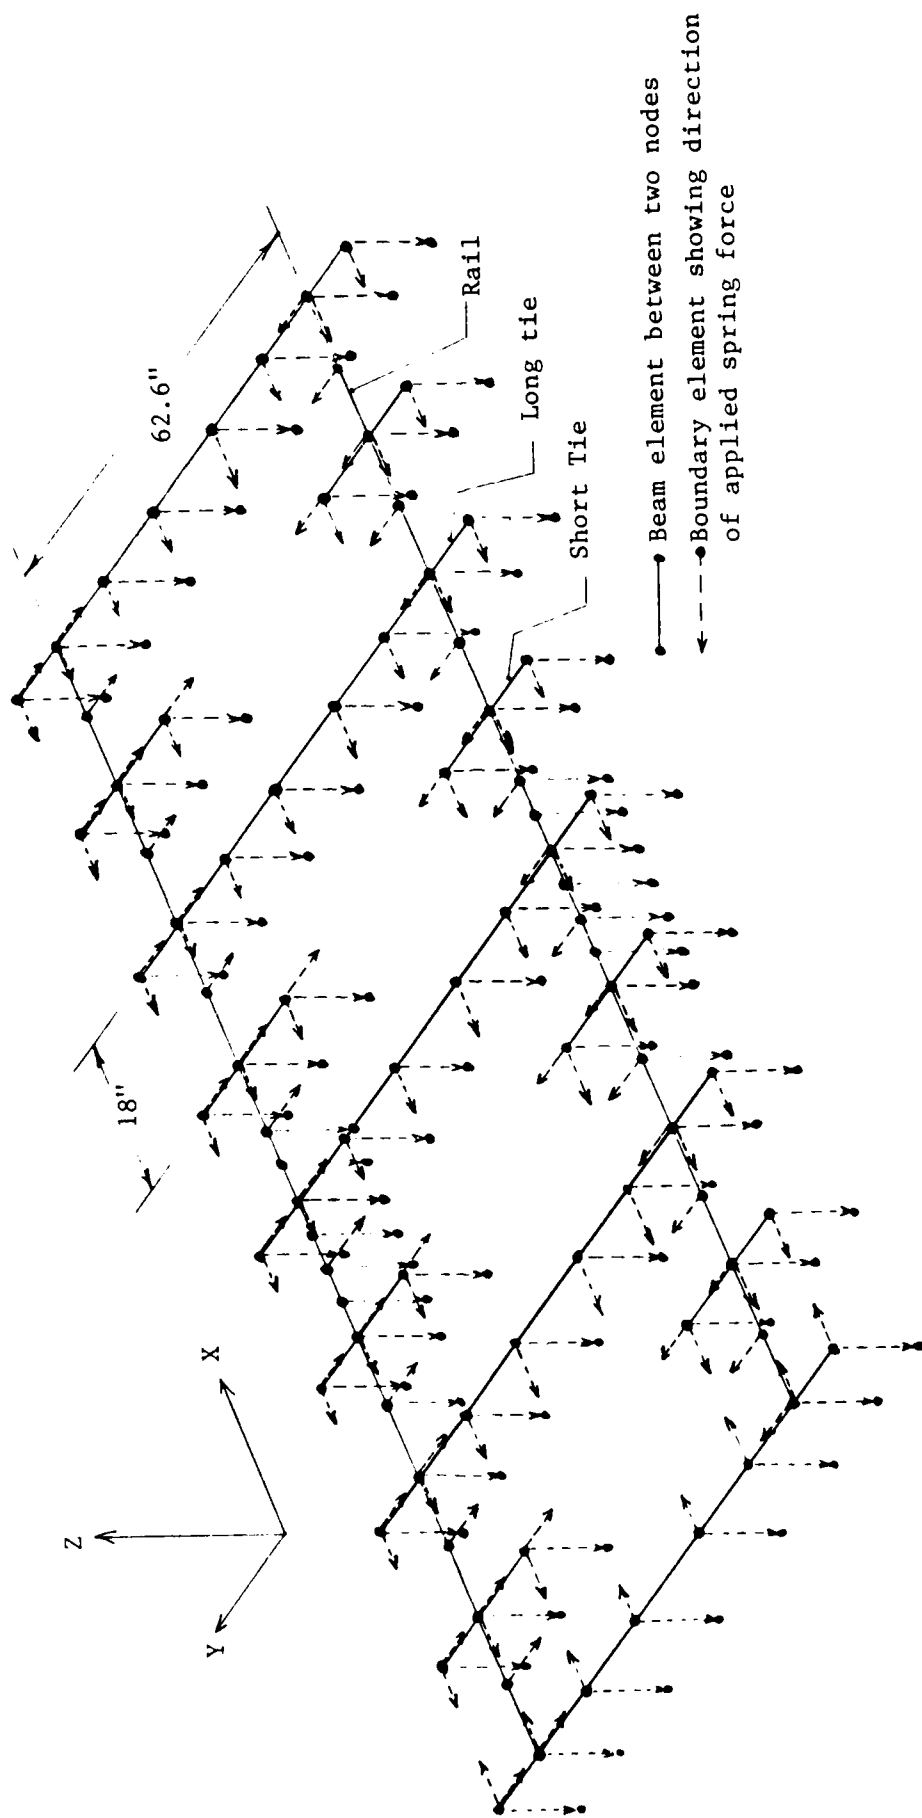
Figure 36. Sketch of the three-dimensional FE grid showing all nodes, beam elements, and boundary elements

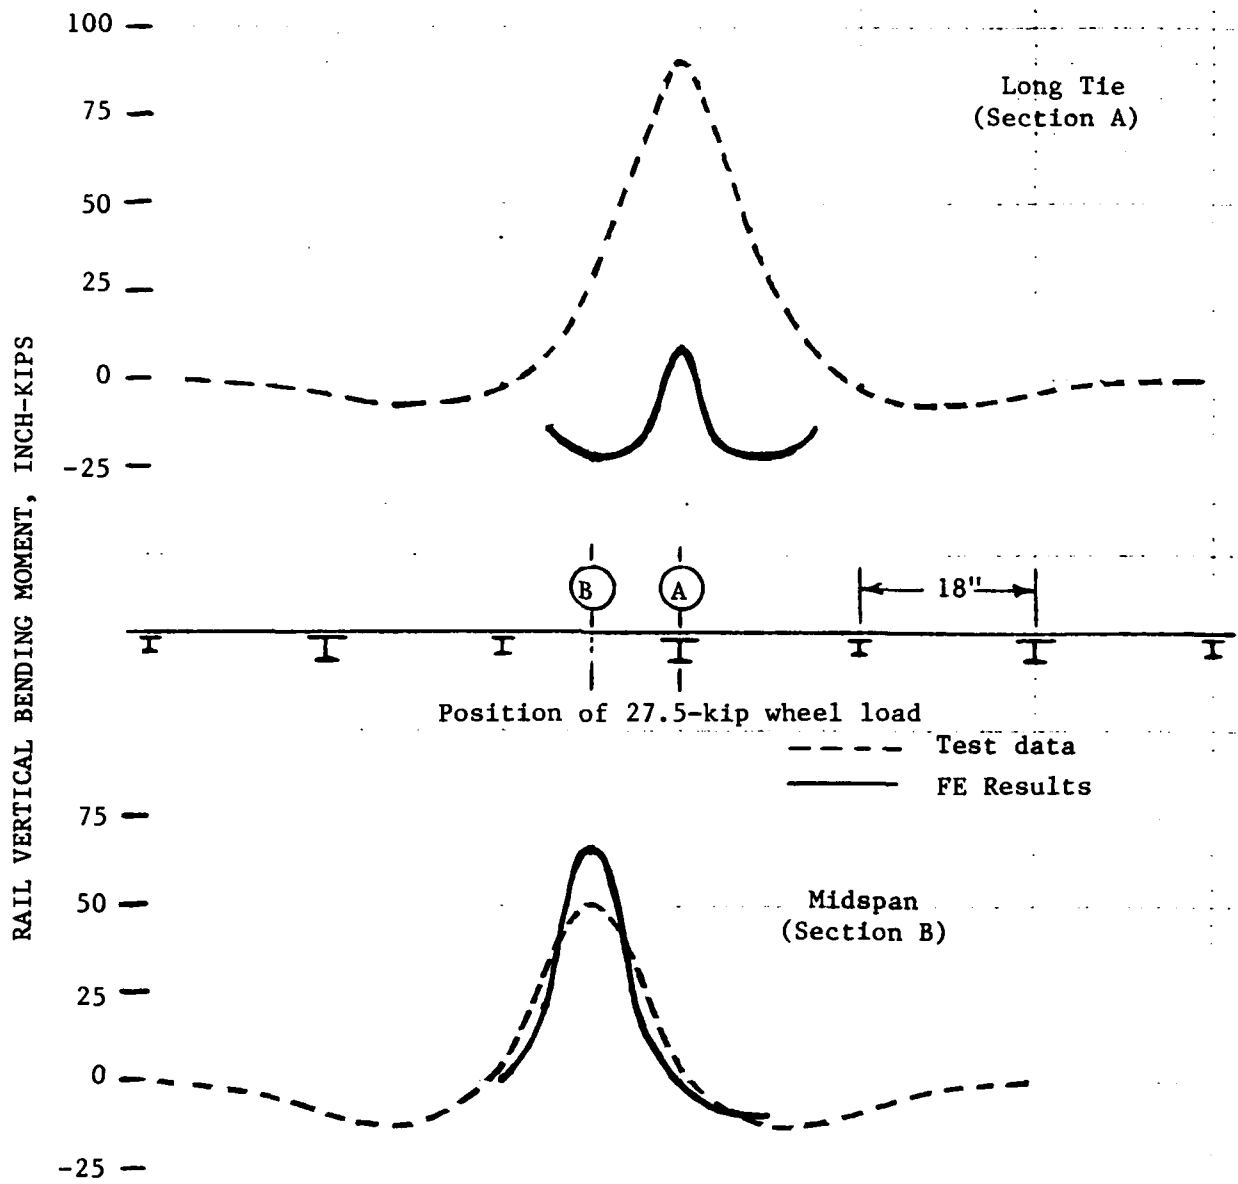
Figure 40. Influence diagram comparisons of test results and FE analyses using calculated boundary element spring constants and uniform support conditions

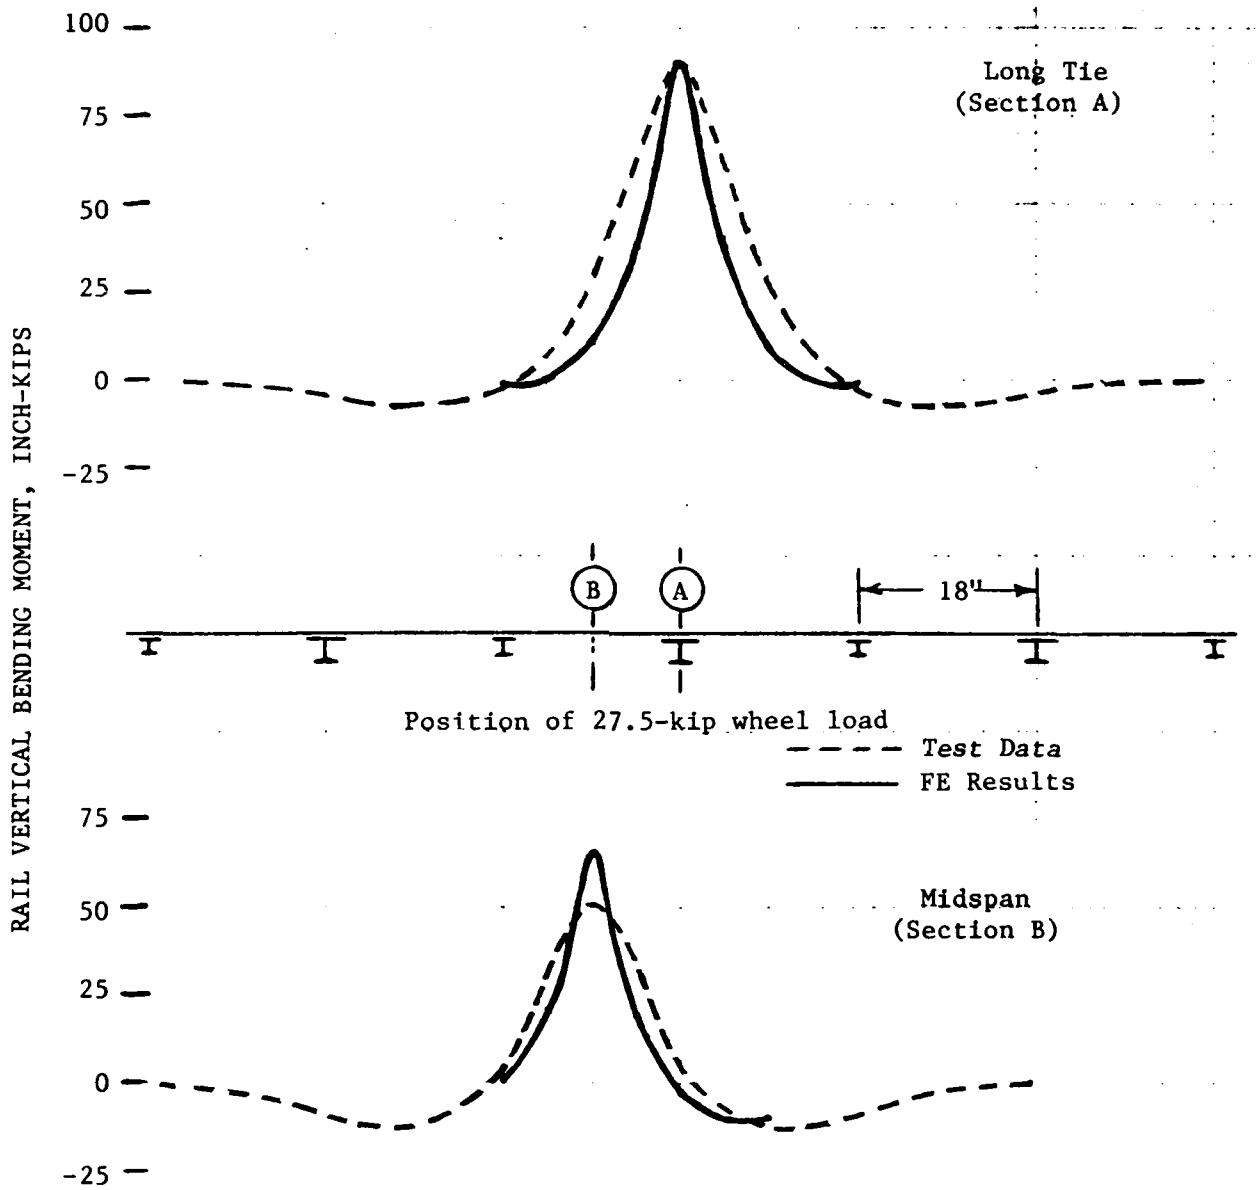
Figure 41. Influence diagram comparisons of test results and FE analyses after removal of long tie (Section A) vertical supports

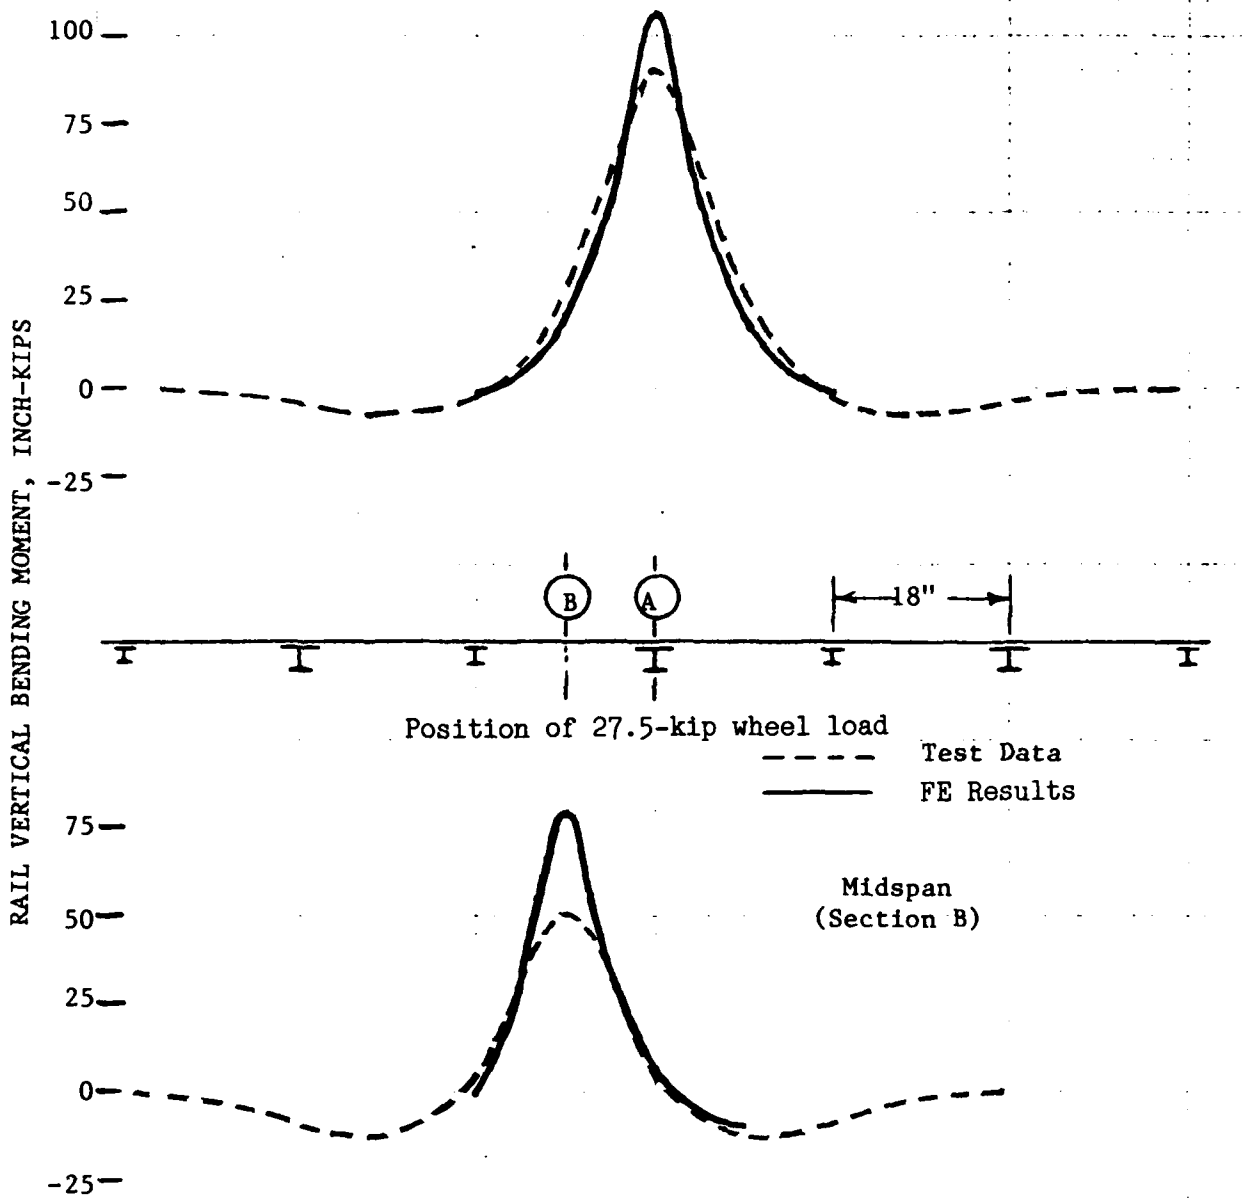
Figure 42. Influence diagram comparisons of test results and FE analyses after iterative refinement of boundary element spring constants

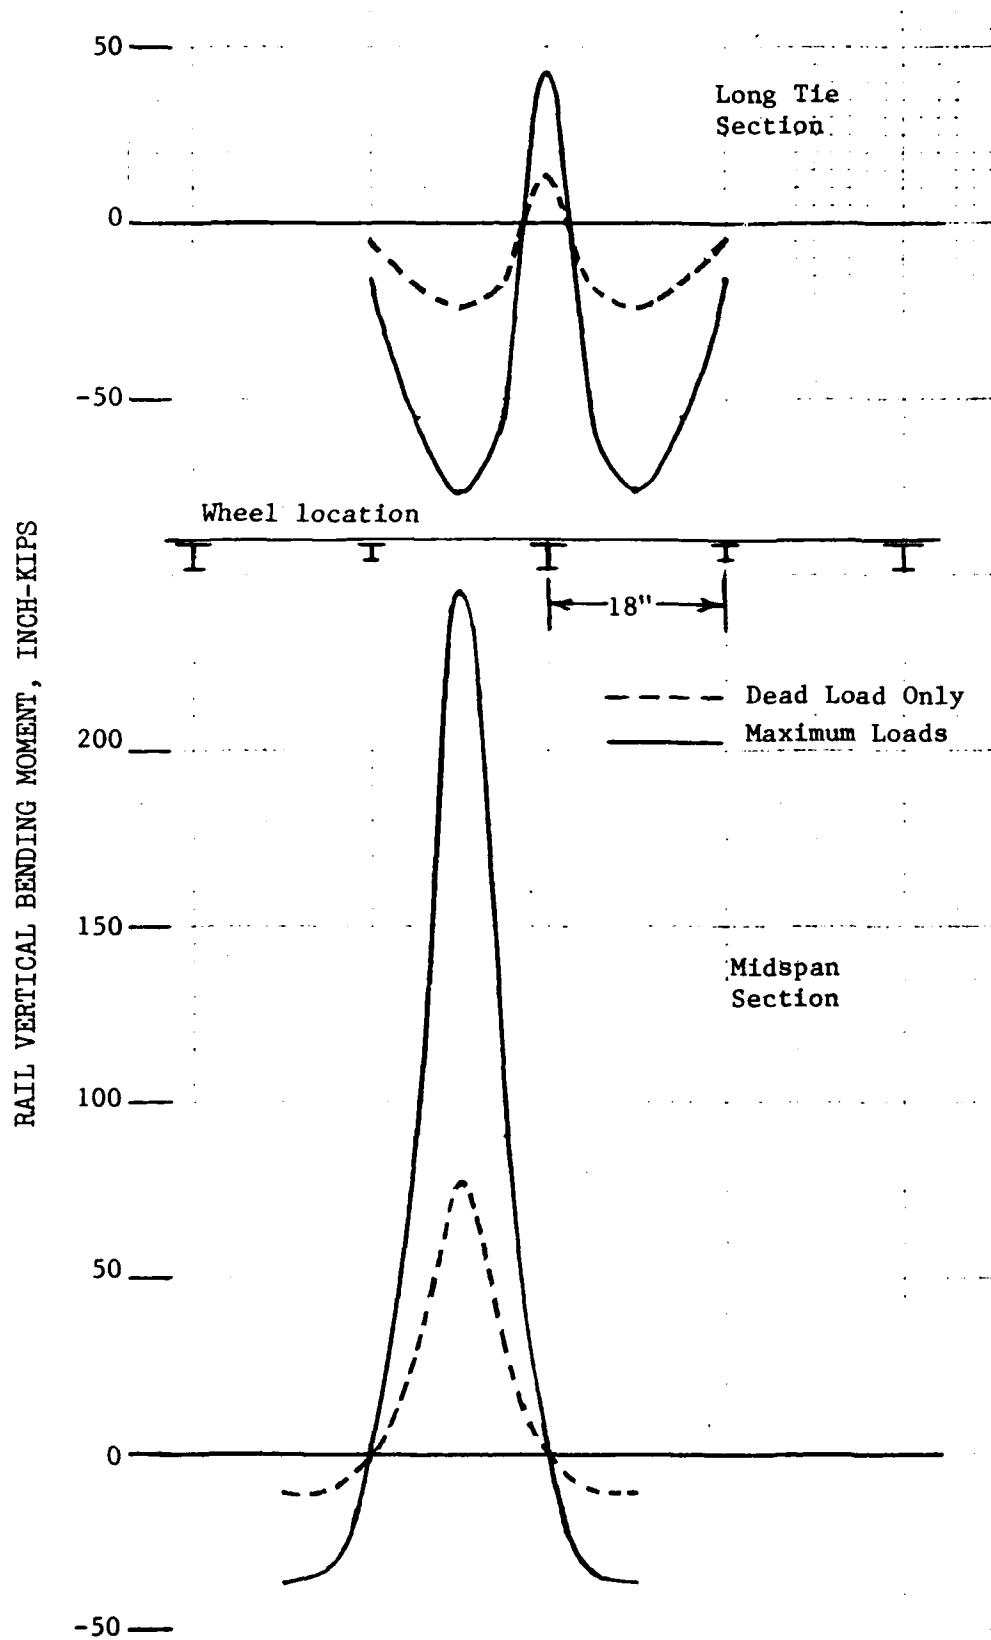
Figure 43. Influence diagrams for FE predictions of waterside rail response to dead-load-only and worst-case wheel loads at tie and midspan sections
