# HELICOPTER ICING SPRAY SYSTEM (HISS) EVALUATION AND IMPROVEMENTS

APRIL 1986

FINAL REPORT

UNITED STATES ARMY AVIATION ENGINEERING FLIGHT ACTIVITY  
EDWARDS AIR FORCE BASE, CALIFORNIA 93523

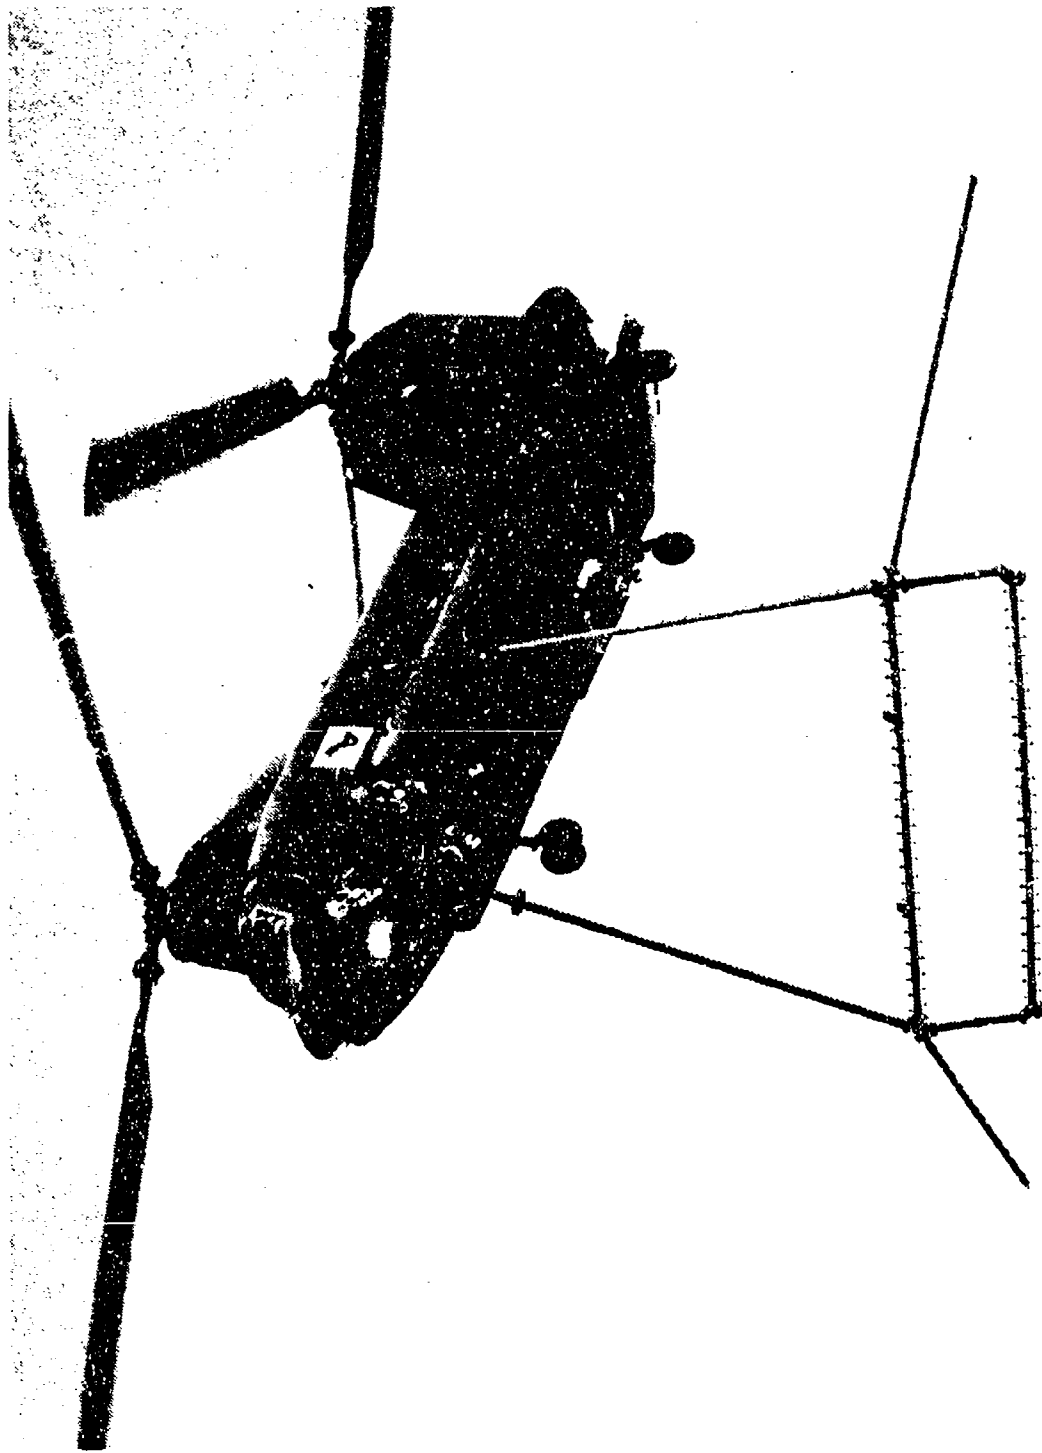
Photo A. JCH-47C Helicopter with HISS Installation

3. The HISS, shown in photo A and further described in appendix B, is installed in a modified CH-47C helicopter (US Army S/N 68-15814). It consists of an internal water tank and an external spray boom assembly suspended beneath the aircraft from a torque tube through the cargo compartment. Hydraulic actuators rotate the torque tube to raise and lower the boom assembly. The boom is constructed of concentric metal pipe, forming an upper and lower trapeze located between two outrigger sections, with an overall tip-to-tip width of 60 ft. The outer pipe is the structural trapeze and boom assembly, and is pressurized with bleed air from the aircraft engines and an auxiliary power unit (APU). The inner pipe acts as the water passage. Water and bleed air are supplied to spray nozzles spaced along the boom to atomize the water and form the spray cloud. Water flow rate is controlled to vary the cloud liquid water content (LWC).

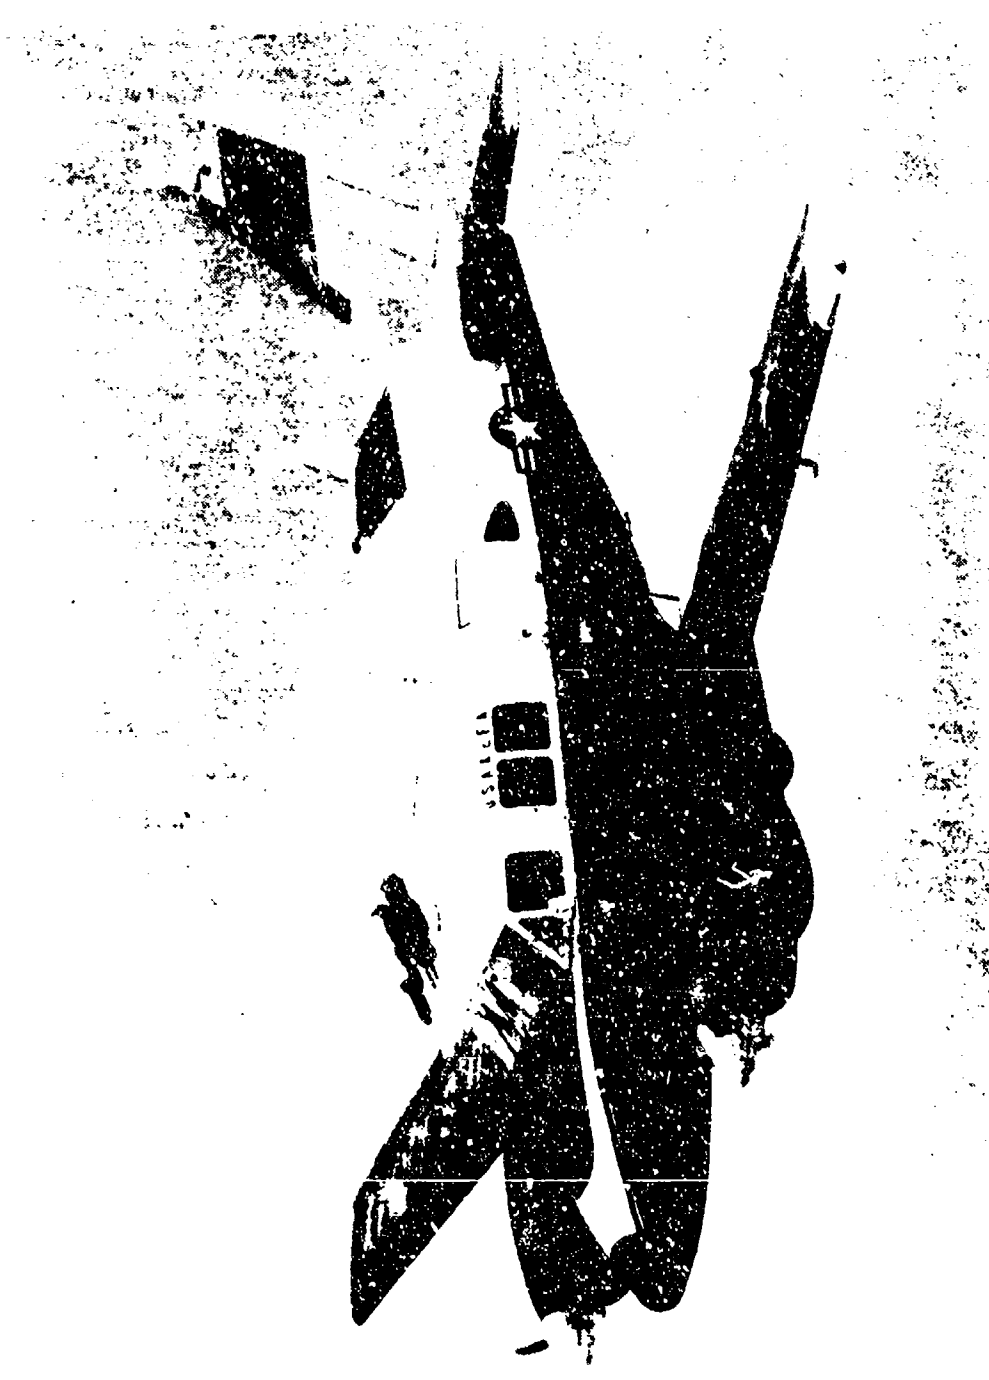
Photo B. JU-21A Aircraft with Cloud Measuring Equipment

7. The calibration aircraft used to sample the spray cloud was a JU-21A fixed wing aircraft (US Army S/N 66-18008) shown in photo B. Onboard instrumentation included two Particle Measuring Systems, Inc. (PMS) laser spectrometers (models FSSP-100 and OAP-200X), a Leigh MK 10 ice detector, a Cloud Technology, Inc. LWC sensor, a Rosemount total air temperature probe, and a Cambridge dew point hygrometer. The data acquisition system installed was a Small Intelligent Icing Data System for recording and processing the instrumentation signals. The particle counting and sizing capabilities of the PMS laser spectrometers provided a description of drop size distributions for diameters between 2 and 300 microns, and allowed a calculation of median volumetric diameter and LWC. A more detailed description of the aircraft and cloud measurement system is contained in appendix C, and the data analysis techniques are described in appendix D.

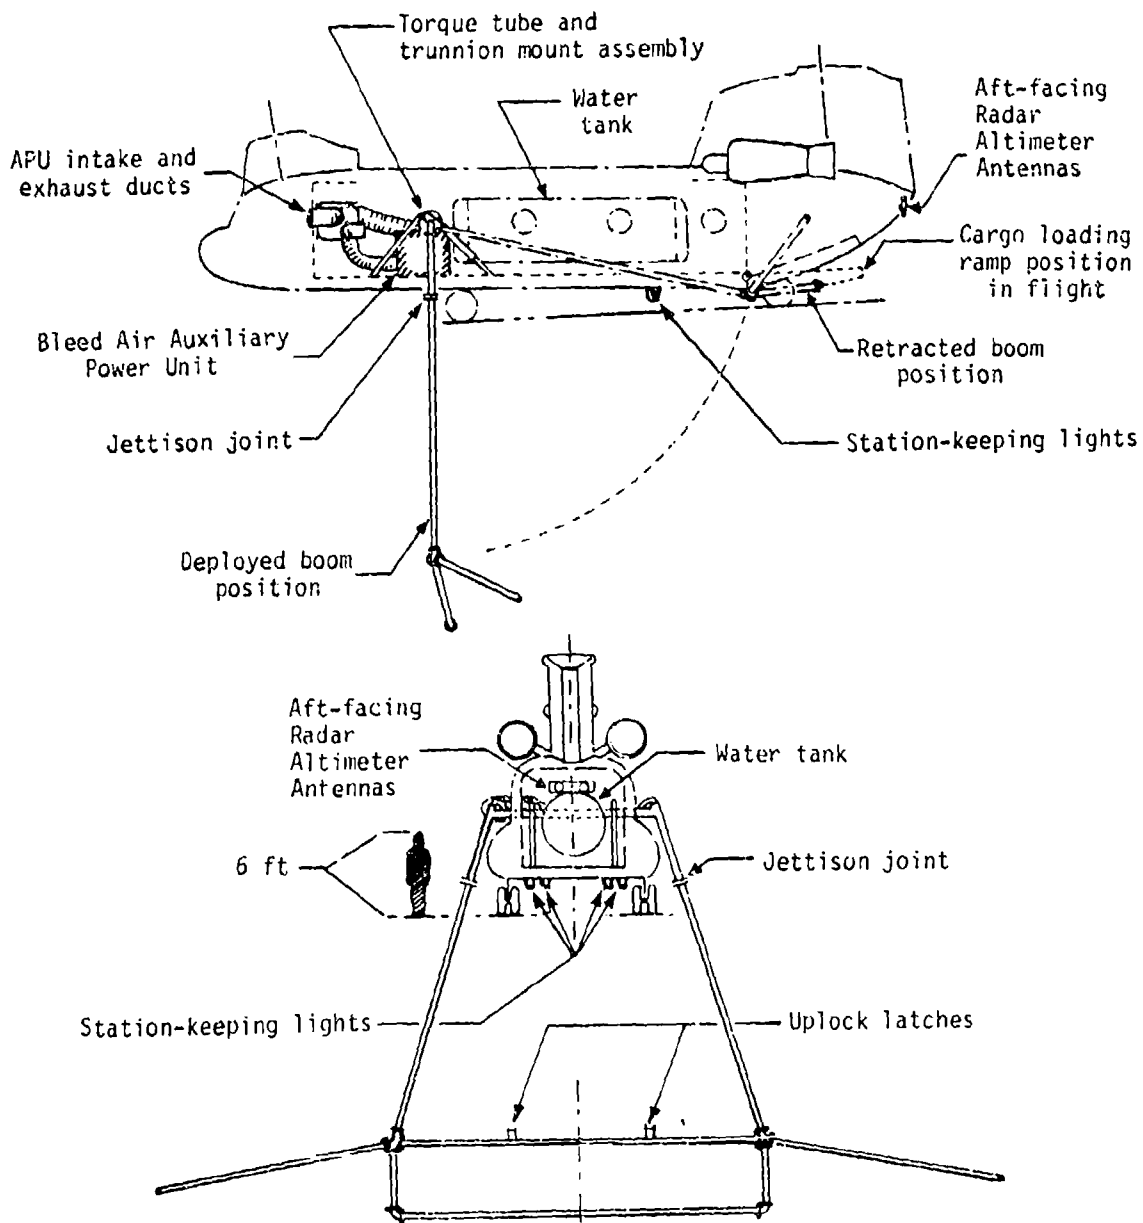
Figure A. Helicopter Icing Spray System Side and Rear View Schematic

2. The HISS installation was initially developed under contract by the All American Engineering Co. in 1972, and is described in reference 19, appendix A. Side and rear view schematics of the present overall arrangement are shown in figure A. The aluminum water tank has an 1800 gallon capacity, and the deployed spray boom assembly is suspended 19 ft beneath the aircraft from a torque tube through the cargo compartment. Hydraulic actuators rotate the torque tube to raise and lower the boom assembly, and mechanical latches hold the boom assembly locked in either the fully deployed or retracted positions. The external boom assembly can be jettisoned from any position by explosive bolts at two joints on the boom support members. The internal water supply can be jettisoned by a cable-cutter cartridge arrangement which opens trap doors in the water tank over the aircraft cargo hook hatch. Controls for water jettison and boom deployment, retraction, and jettison are located in the cockpit.

3. The boom assembly consists of two parallel 27 ft trapeze sections with 5 ft vertical separators, and two 17.6 ft outriggers attached by 4-way junctions to the upper trapeze. When lowered, the outriggers are swept aft 20° and angled down 10° giving a tip to tip boom width of 60 ft. Skid plates at each corner of the lower trapeze allow a forward hover landing without damage to the boom or nozzles if the boom fails to retract. The boom is constructed of concentric metal pipe. The outer pipe (4 in. diameter) is the structural trapeze and outrigger assembly and provides a passage for bleed air. Water is pumped through the inner pipe at selected flow rates from the tank to the nozzles on the boom assembly. The water passages originally had a 1-1/2 inch diameter throughout. Between the 1984 and 1985 icing seasons, the water tube sections within the upper and lower trapeze were changed to one inch diameter. After the 1985 season, the remaining sections in the boom supports and cabin interior were also modified, converting the entire water system to one inch diameter. Thirty manifolds for distributing water to the nozzles are spaced approximately three ft apart along the boom exterior. Aircraft

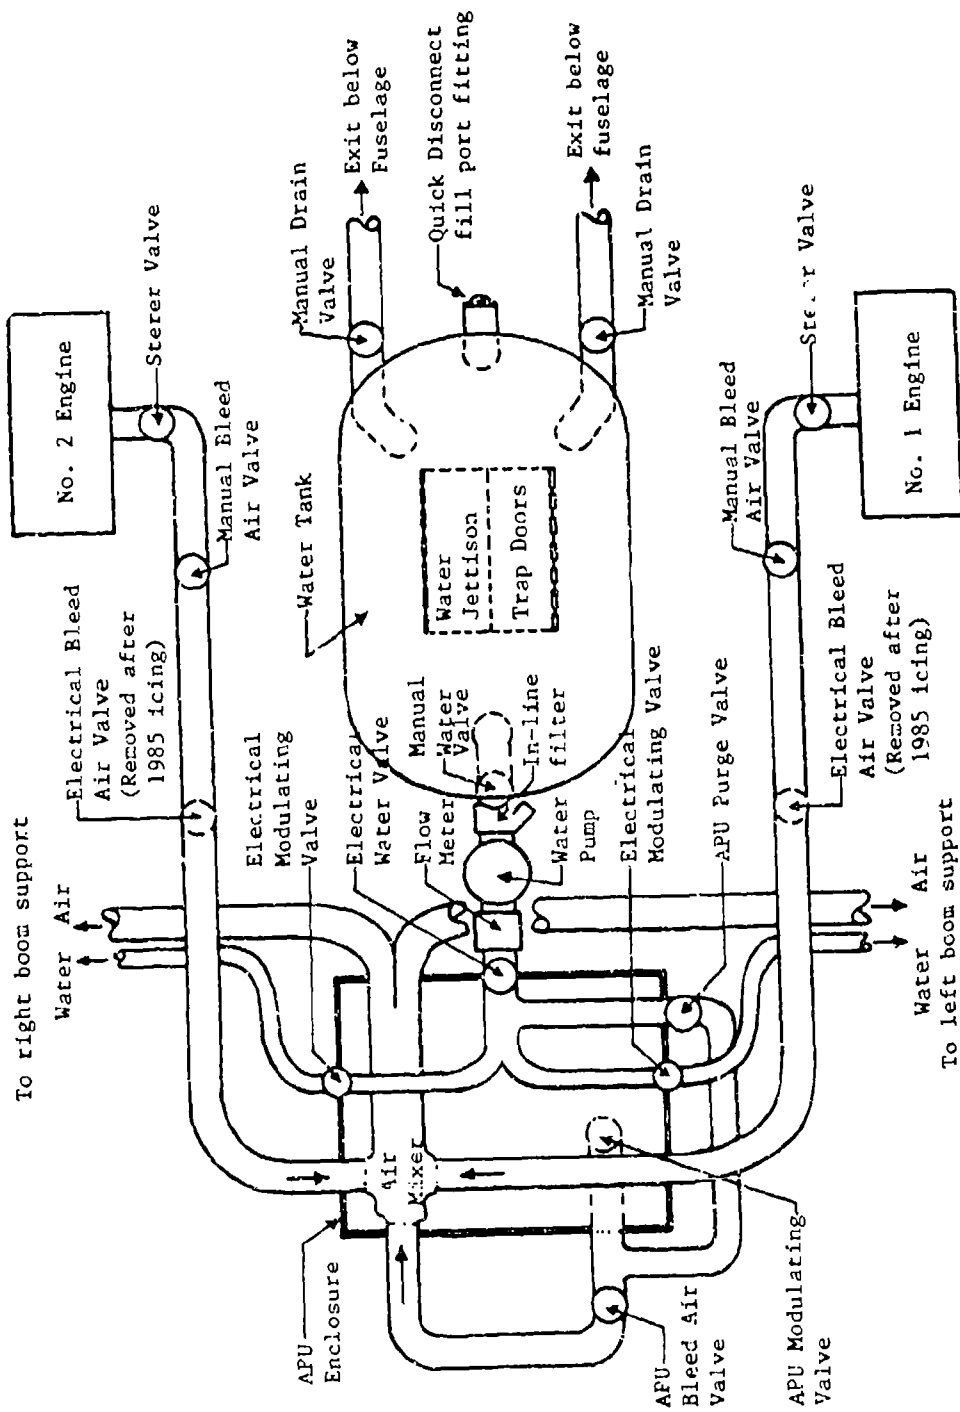
Figure B. Helicopter Icing Spray System Air and Water Distribution System

engine compressor bleed air and bleed air from a Solar T-62T-40C2 auxiliary power unit (APU) are supplied through the outer pipe to the nozzles for atomization. Figure B shows a schematic of the current air and water distribution system.

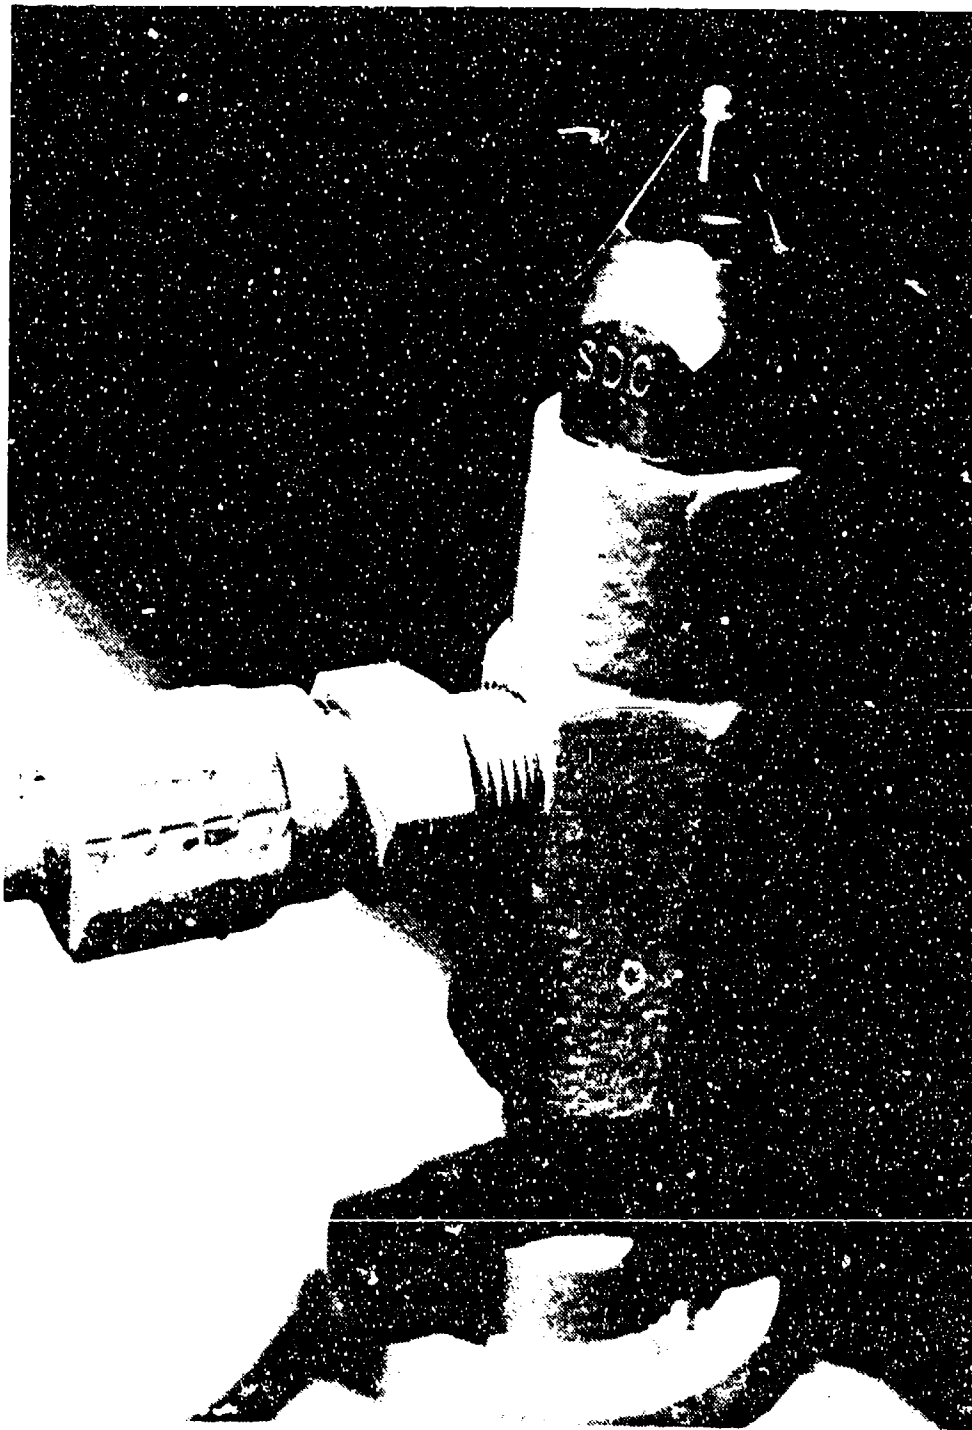
Photo 1. Soaic Development Corporation, Model 125-II  
"Soaicore" Spray Nozzle

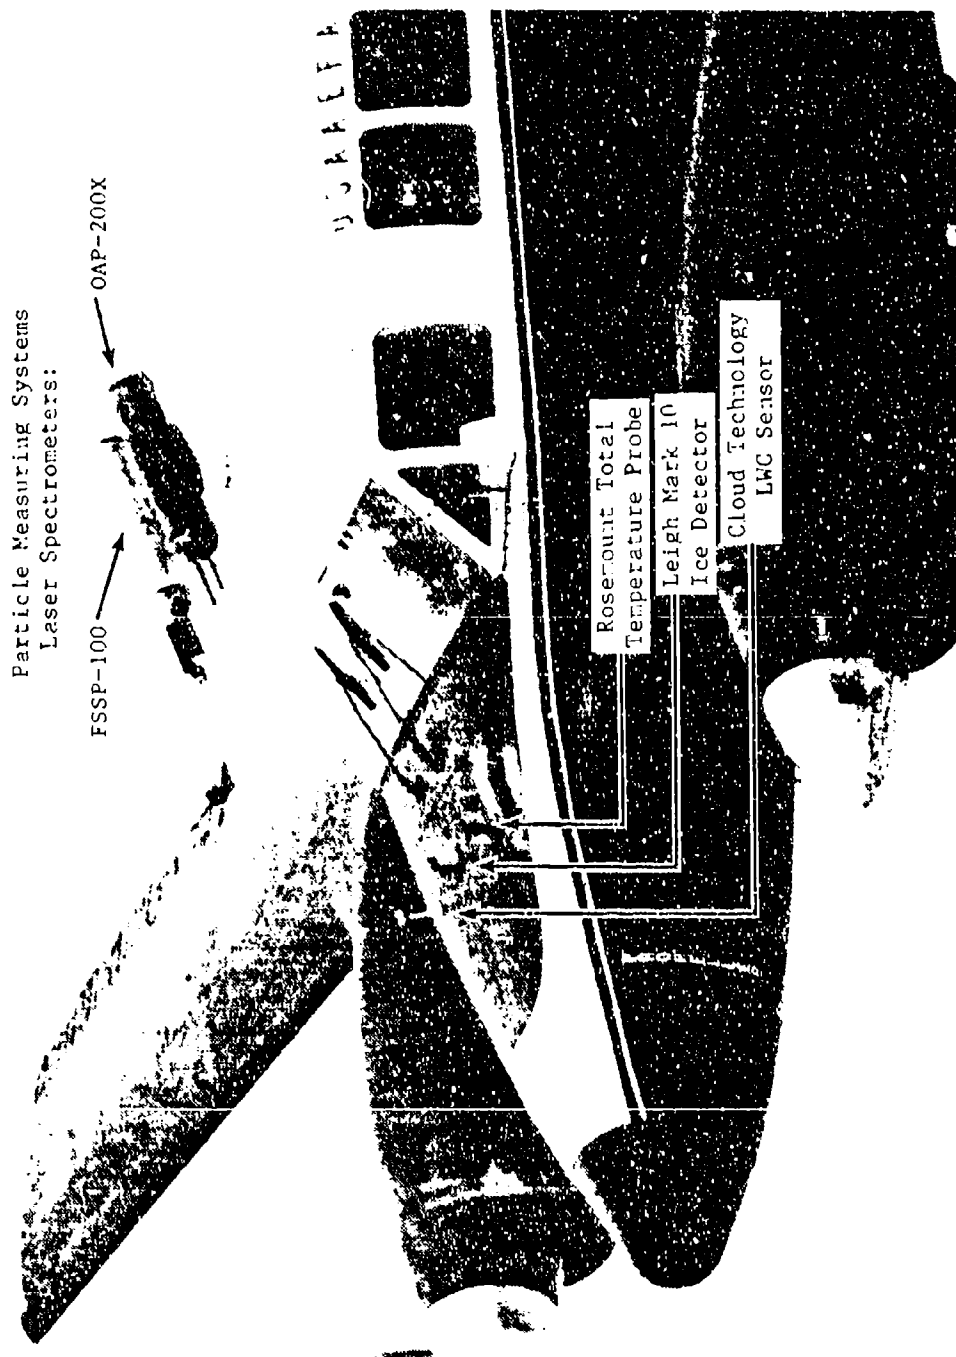
Photo 1. Cloud Measuring Instrumentation on JU-21A

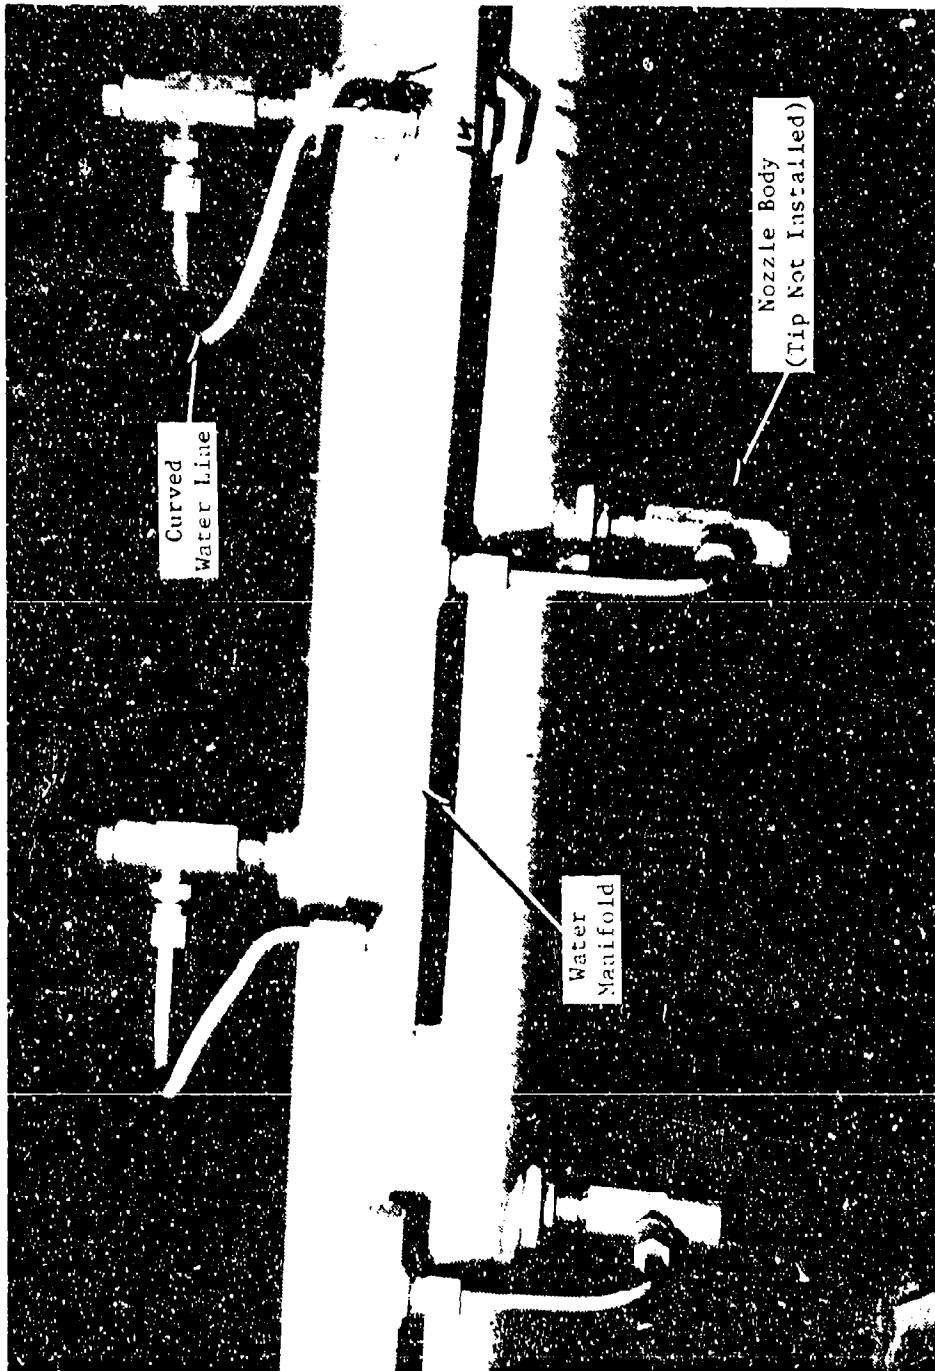
Photo 1. Curved Water Feed Lines Installed For Upward-Facing Nozzles

11. The initial 1984 icing flights with the "T" shaped water manifolds resulted in formation of ice on the upward facing rows of nozzles. As described in paragraph 17, the downward facing nozzles were not affected because of orientation differences and local airflow effects. The water feed lines for all nozzles on both upper rows were replaced with aluminum tubing curved to one side as shown in photo 1, appendix E. This curved tubing no longer projected directly behind the top row nozzle bodies, and ice formation on the water lines was eliminated.

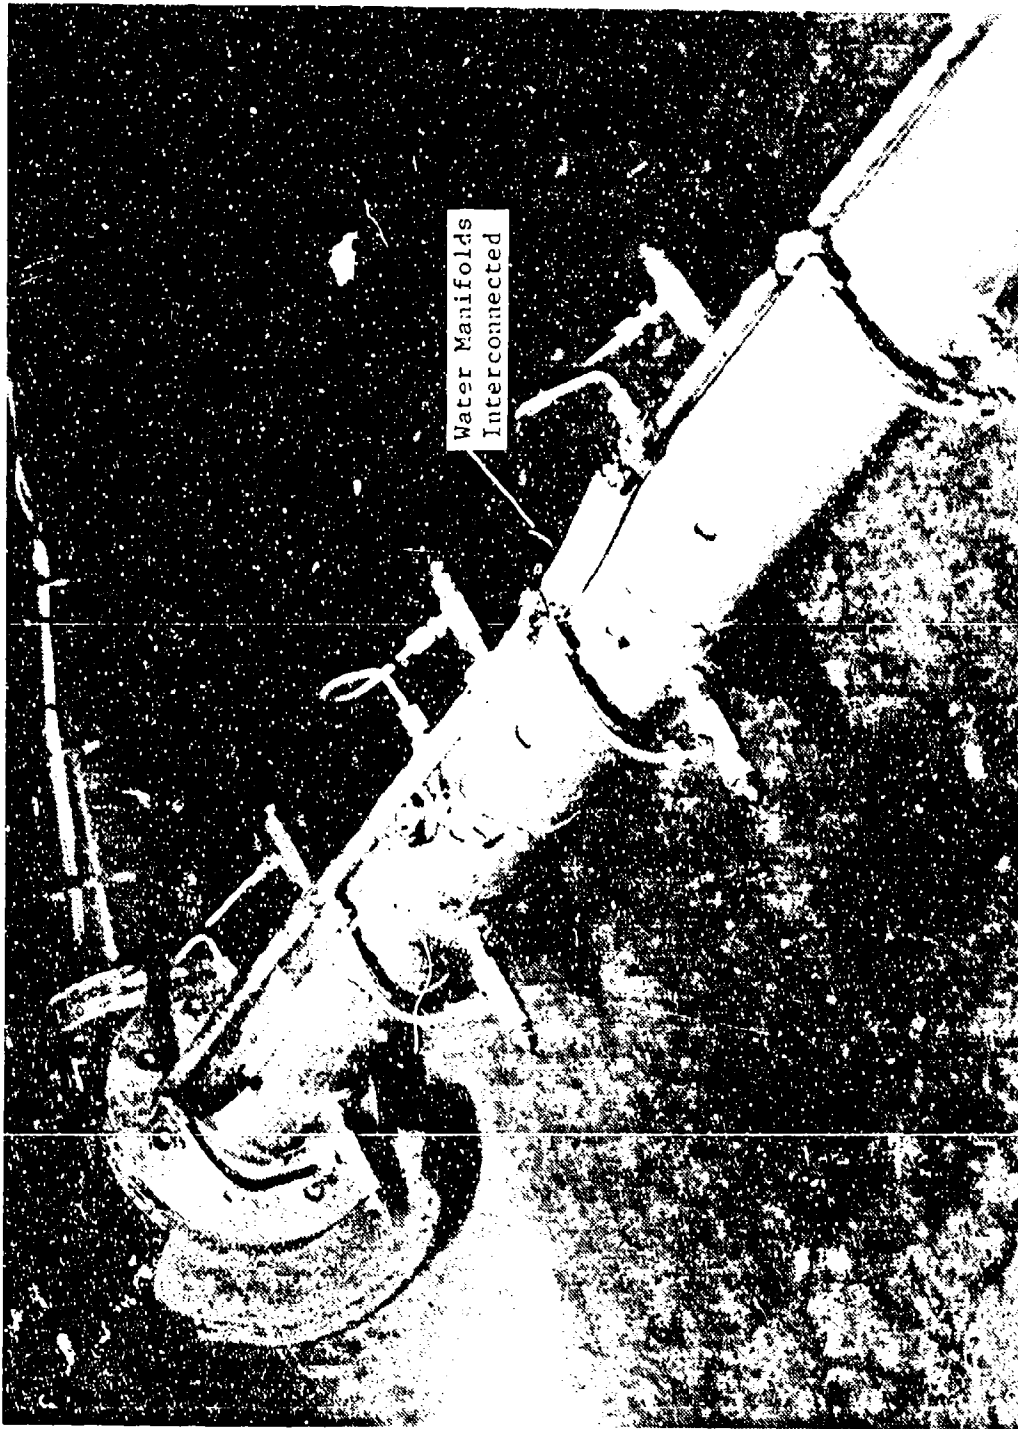
Photo 2. Interconnected Water Manifolds on Left End of Lower Trapeze

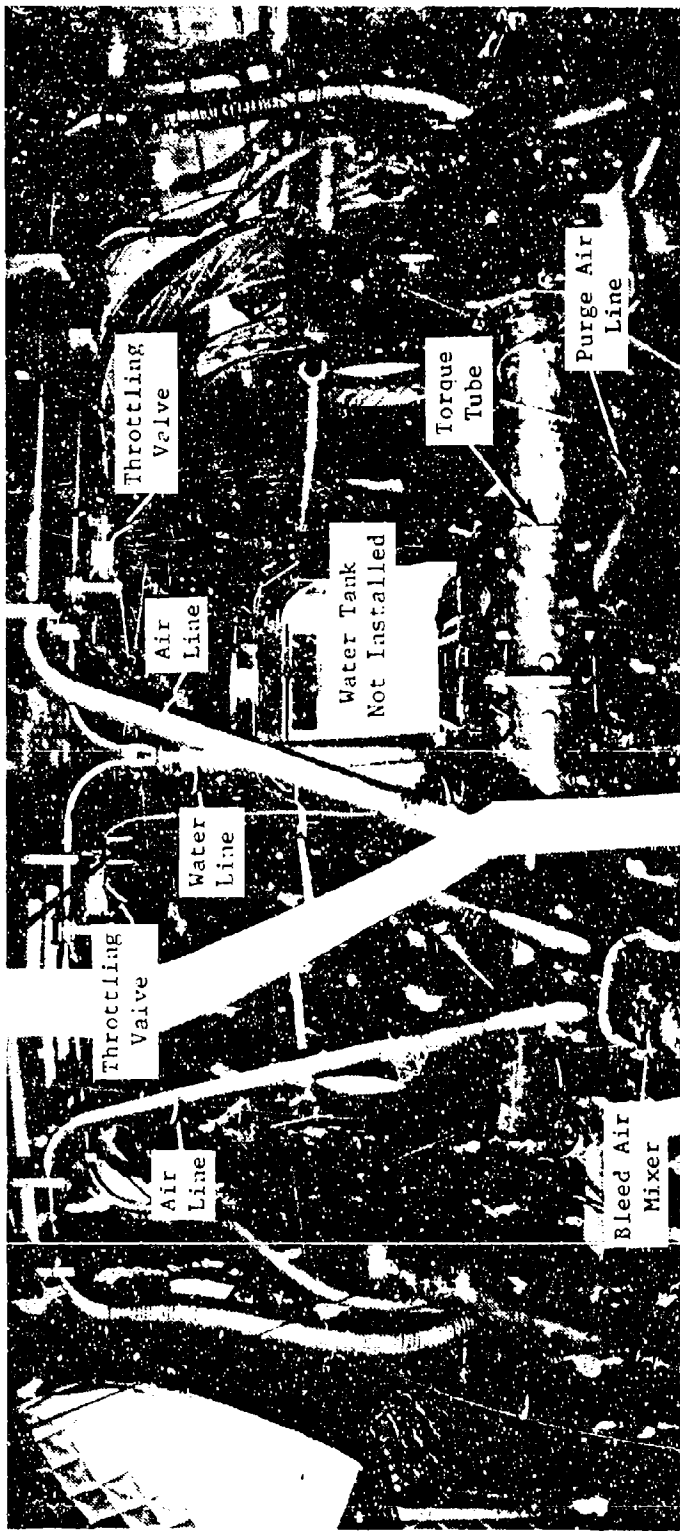
Photo 4. Stainless Steel Air Line Installation

15. Rupture of bleed air hoses and malfunction of the water pump caused recurring difficulties during operation (para 16). To reduce incidence of such problems, these systems were modified after completion of the 1985 icing tests. The long sections of 2 inch flexible hose connecting the bleed air mixer assembly outlets with each of the boom entry points were replaced by 2 inch diameter stainless steel tubing, as shown in photo 4, appendix E. Short hose sections remained to connect the tubing gaps and accommodate line movement caused by rotation of the torque tube when raising and lowering the boom. The hydraulic motor driving the water pump was replaced with a larger unit better suited for sustained operation. A thicker mounting baseplate was installed to improve alignment, and the type of coupling between motor and pump was changed from one with press-fit neoprene bushings to one with sprockets and a roller chain connection. The replacement motor unit and coupling installation are shown in photos 5 and 6, appendix E. For comparison, the original assembly can be seen in photo 2, appendix H.

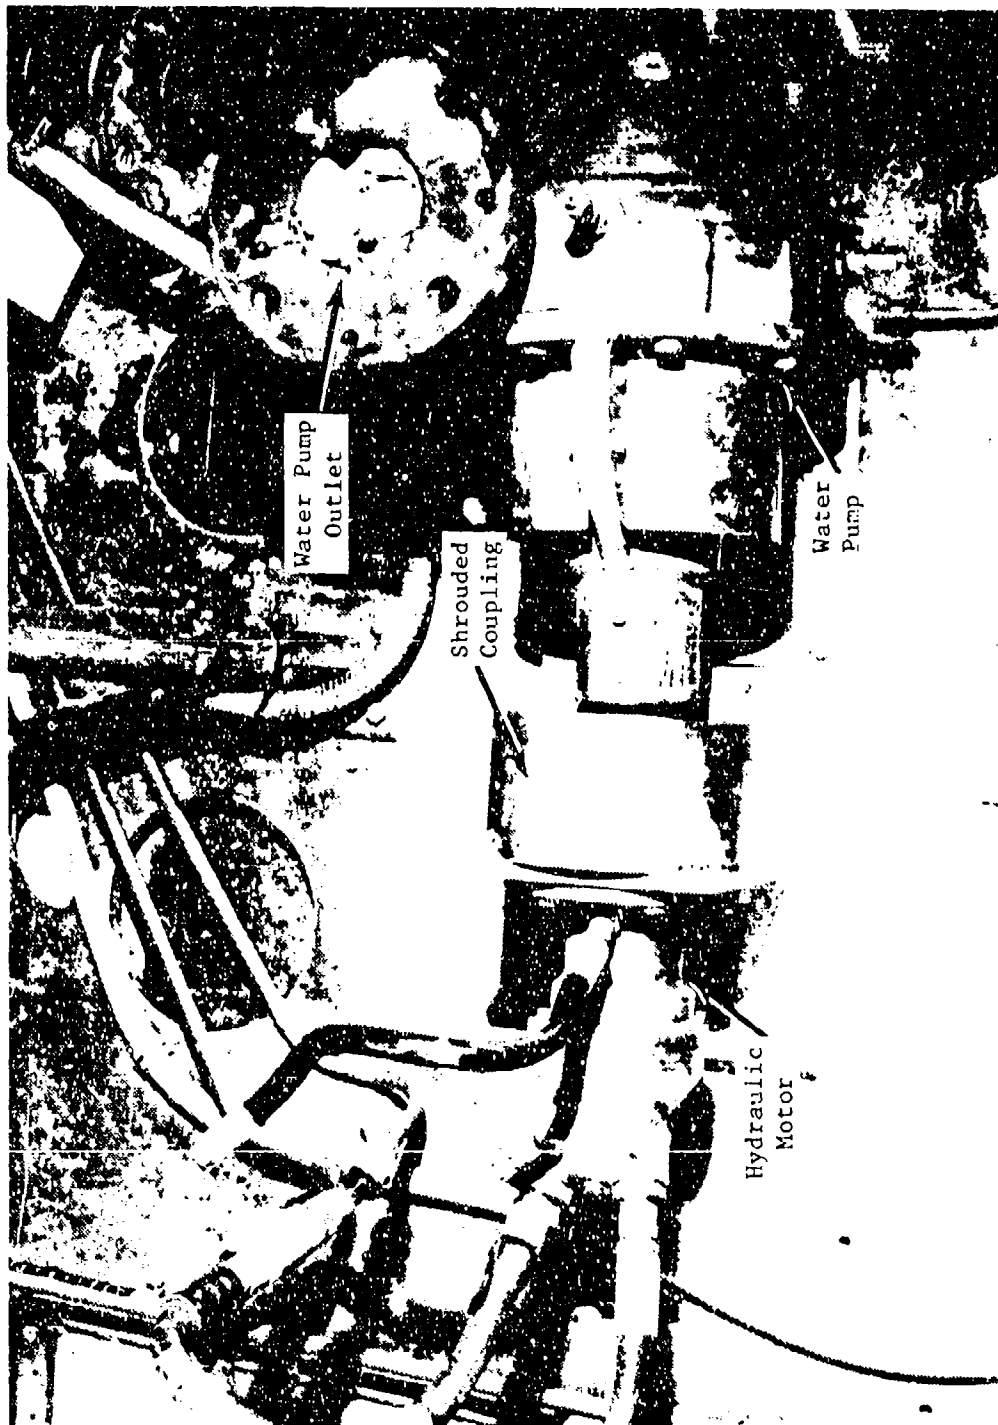
Photo 5. Hydraulic Motor and Water Pump Assembly

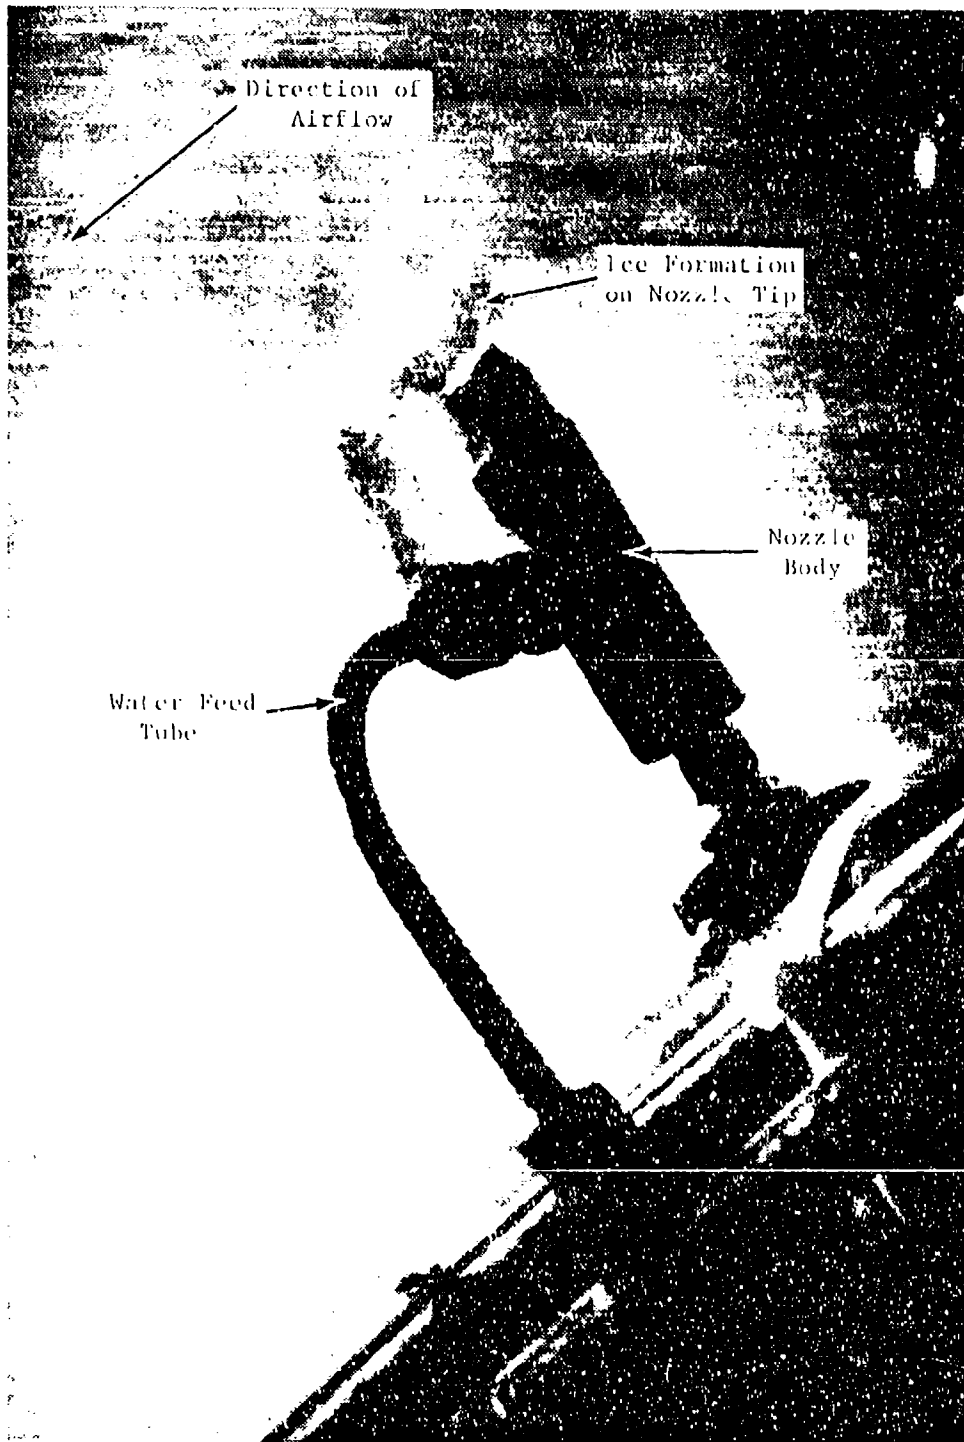
Photo 9. Ice Formation Between Atomizer Tip and Water Feed Tube

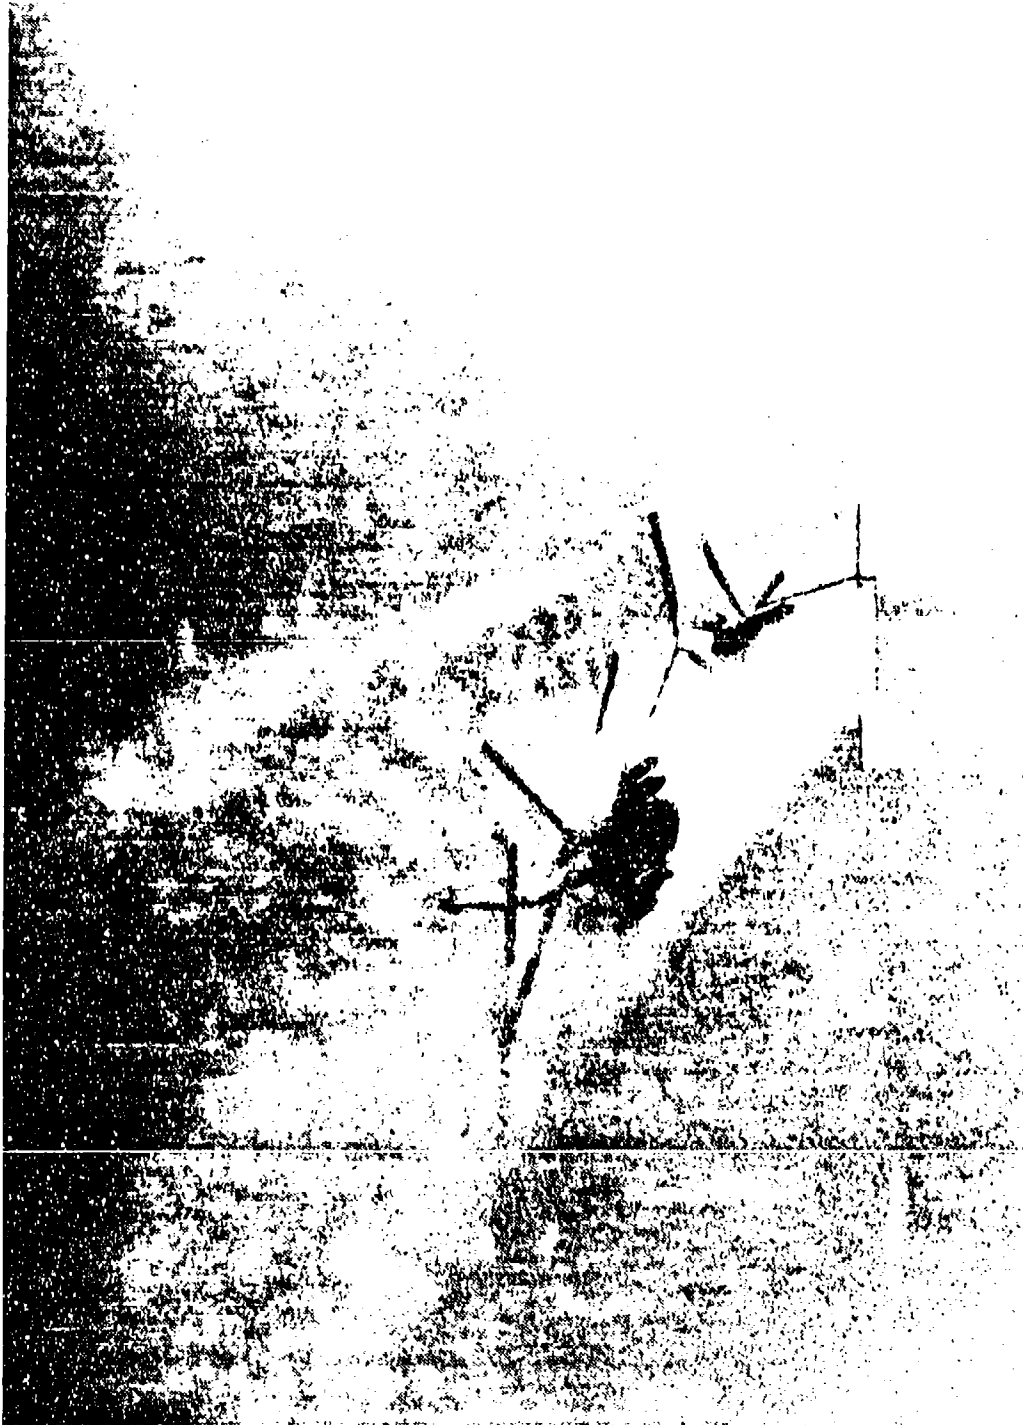
Photo 12. Condensation Trails Forming From HISS  
Blade Tips at High Humidity (>95%)

35. High humidity conditions (above 95%) produced visible effects during spray operations. The appearance of the generated cloud became more dense and noticeably restricted forward visibility from the test aircraft. This was attributed to a large increase in the number of very small drops, which was also indicated by an increase in formation of frost-like coatings on the test aircraft (para 38). In such conditions, condensation trails frequently appeared in the rotor systems of both the HISS and the test aircraft (photos 12 through 14, app E). The visible vortices from the blade tips of the HISS passed well above the test aircraft, and the condensation trails could assume dimensions and appearance comparable to the spray cloud. The spray cloud did not dissipate as quickly as at low humidity and sometimes persisted in the form of parallel rows of clouds remaining from earlier passes back and forth through the test area. On a few such occasions, an undersun reflection could be observed in the previous trails, an optical effect indicating that the supercooled water drops had glaciated and turned to ice crystals (ref 16, app A). Photos 15 and 16, appendix E show a HISS cloud trail (as observed from the ground) that persisted, increased in size, and acted as a catalyst for natural cloud growth.

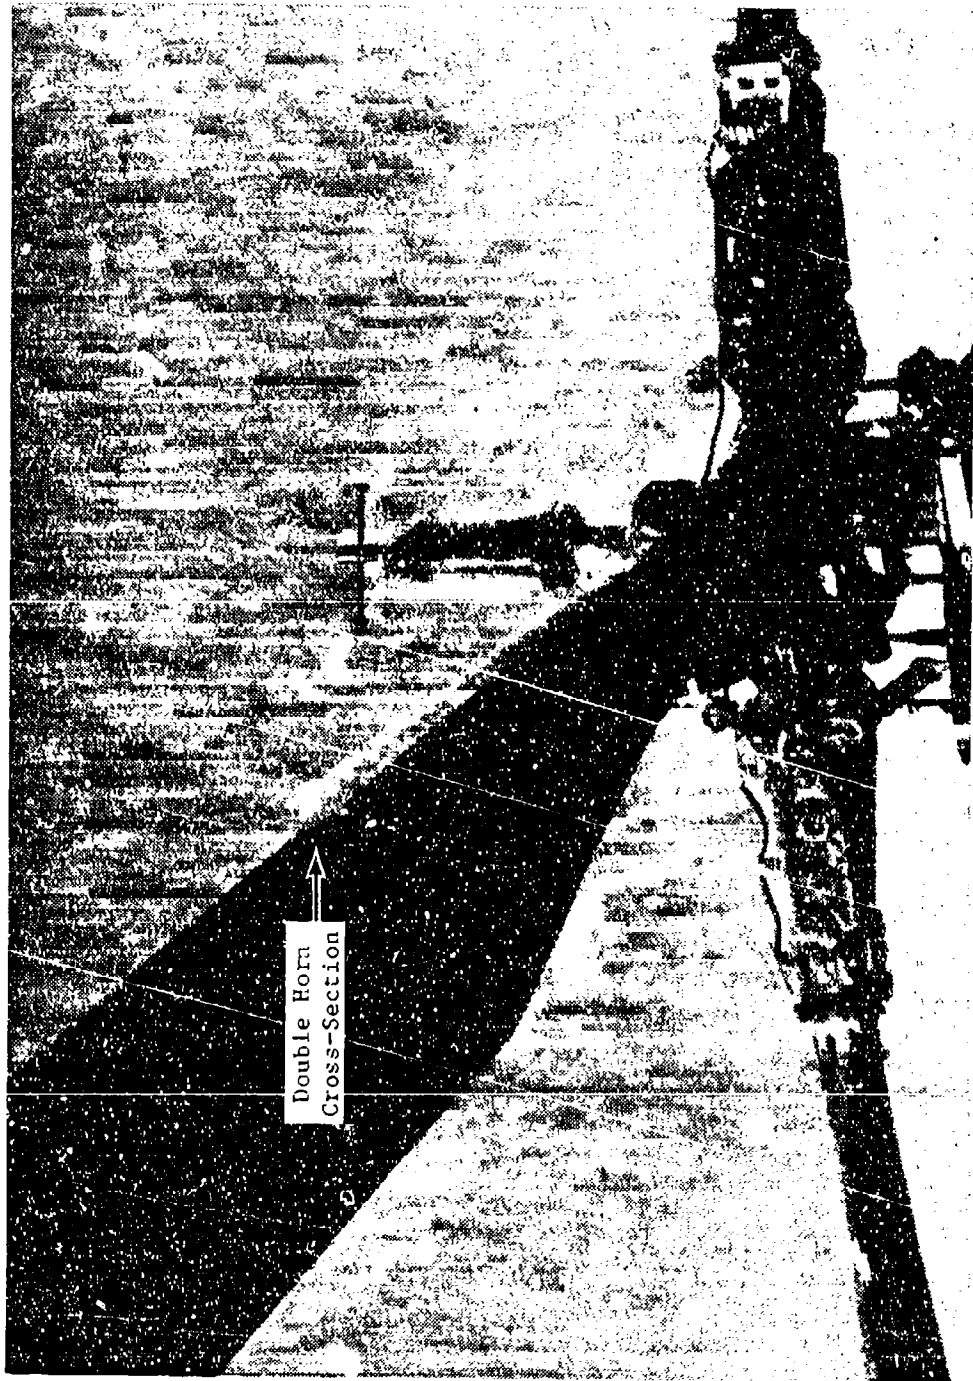
Photo 17. Artificial (HISS) Ice. "Double Horn" Shape on AH-64A Main Rotor After 22 Minutes at  $1\text{gm}/\text{m}^3$ ,  $-5^\circ\text{C}$  Ambient Temperature

9. Operational performance of the HISS as an airborne icing simulator and characteristics of the spray cloud were evaluated during the 1984 and 1985 icing seasons. These flights demonstrated that previous spray system problems of water leakage, freezing, and non-uniform flow patterns from the trapeze had been reduced. No substantial change was measured in drop size distribution of the spray. While the cloud produced peak drop concentrations in the desired range, it also contained a number of larger drops that do not normally occur in natural stratiform clouds. As a result, ice formations on test aircraft showed accordingly varied characteristics. Many aspects were quite realistic and compared favorably with natural accretions, to include formation of "double-horned" non-streamlined ice shapes on main rotor blades at  $-5^{\circ}\text{C}$ .

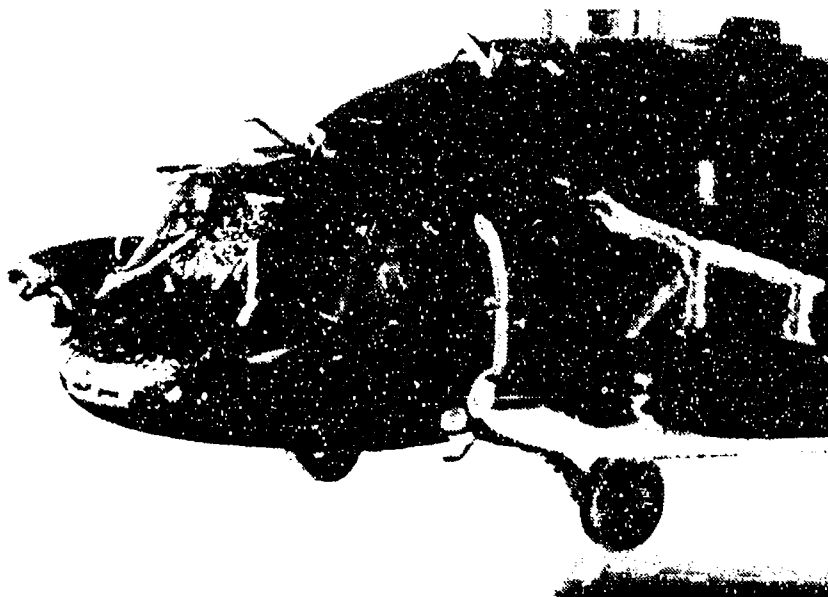
Photo 21. Natural Ice. Temperature  $-5.5^{\circ}\text{C}$ ,  
LWC  $0.25\text{gm}/\text{m}^3$  at  $26\ \mu\text{m}$  MVD, 107 KTAS

39. Photos 21 and 22 compare natural and artificial ice formations on forward areas. While the artificial formations on the nose and drop tanks cover larger areas than in natural conditions (attributed to the presence of larger drops), the general shapes and locations of accretions are comparable. The sharply defined cutoff of ice formation below a horizontal hinge-line on the nose is evident in both photos. Ice had already shed from the FM antenna (aft of the cockpit door) in photo 22; a closer view with ice present is shown in photo 23. The feathery, forward growing formations seen here and in photos 24 and 25 are characteristic of desirable drop sizes. The outward-expanding formations from exposed fastener heads in photo 23 and scalloped formations on the angled strut in photo 24 are realistic shapes also indicating presence of small drops. Additional discussion comparing natural and artificial ice formations is given in reference 18, appendix A, which was a 1985 program to photographically document ice accretions on various test airfoil sections mounted in a fixture attached to the JU-21A.

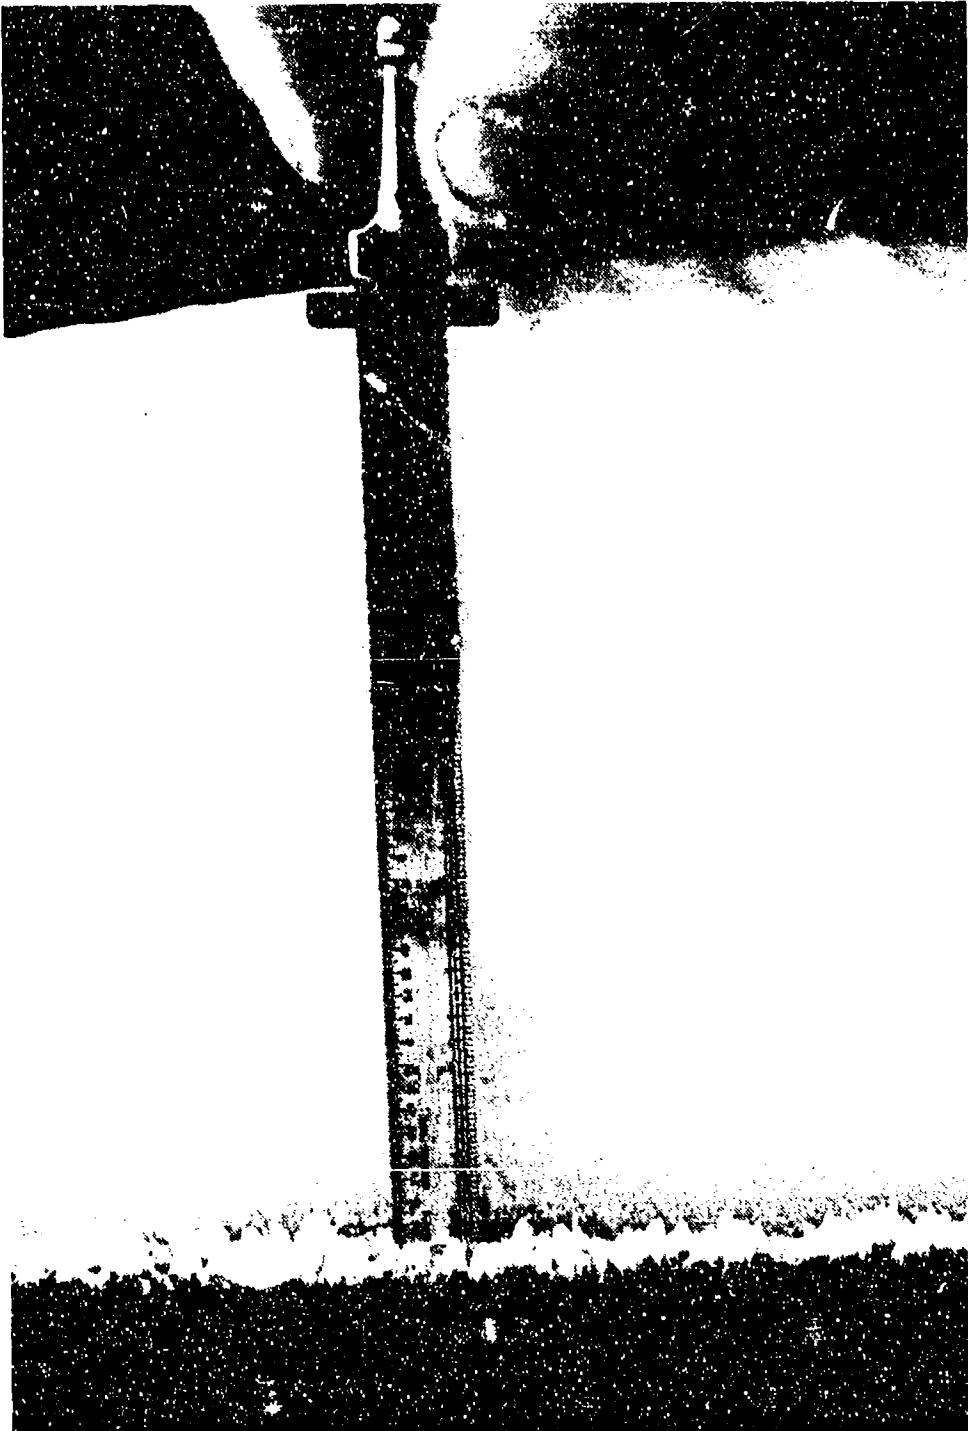
Photo 23. Artificial (HISS) Ice. Formation on FM Antenna of UH-60 Helicopter
