# HELICOPTER ICING SPRAY SYSTEM (HISS) EVALUATION AND IMPROVEMENTS

APRIL 1986

FINAL REPORT

UNITED STATES ARMY AVIATION ENGINEERING FLIGHT ACTIVITY  
EDWARDS AIR FORCE BASE, CALIFORNIA 93523

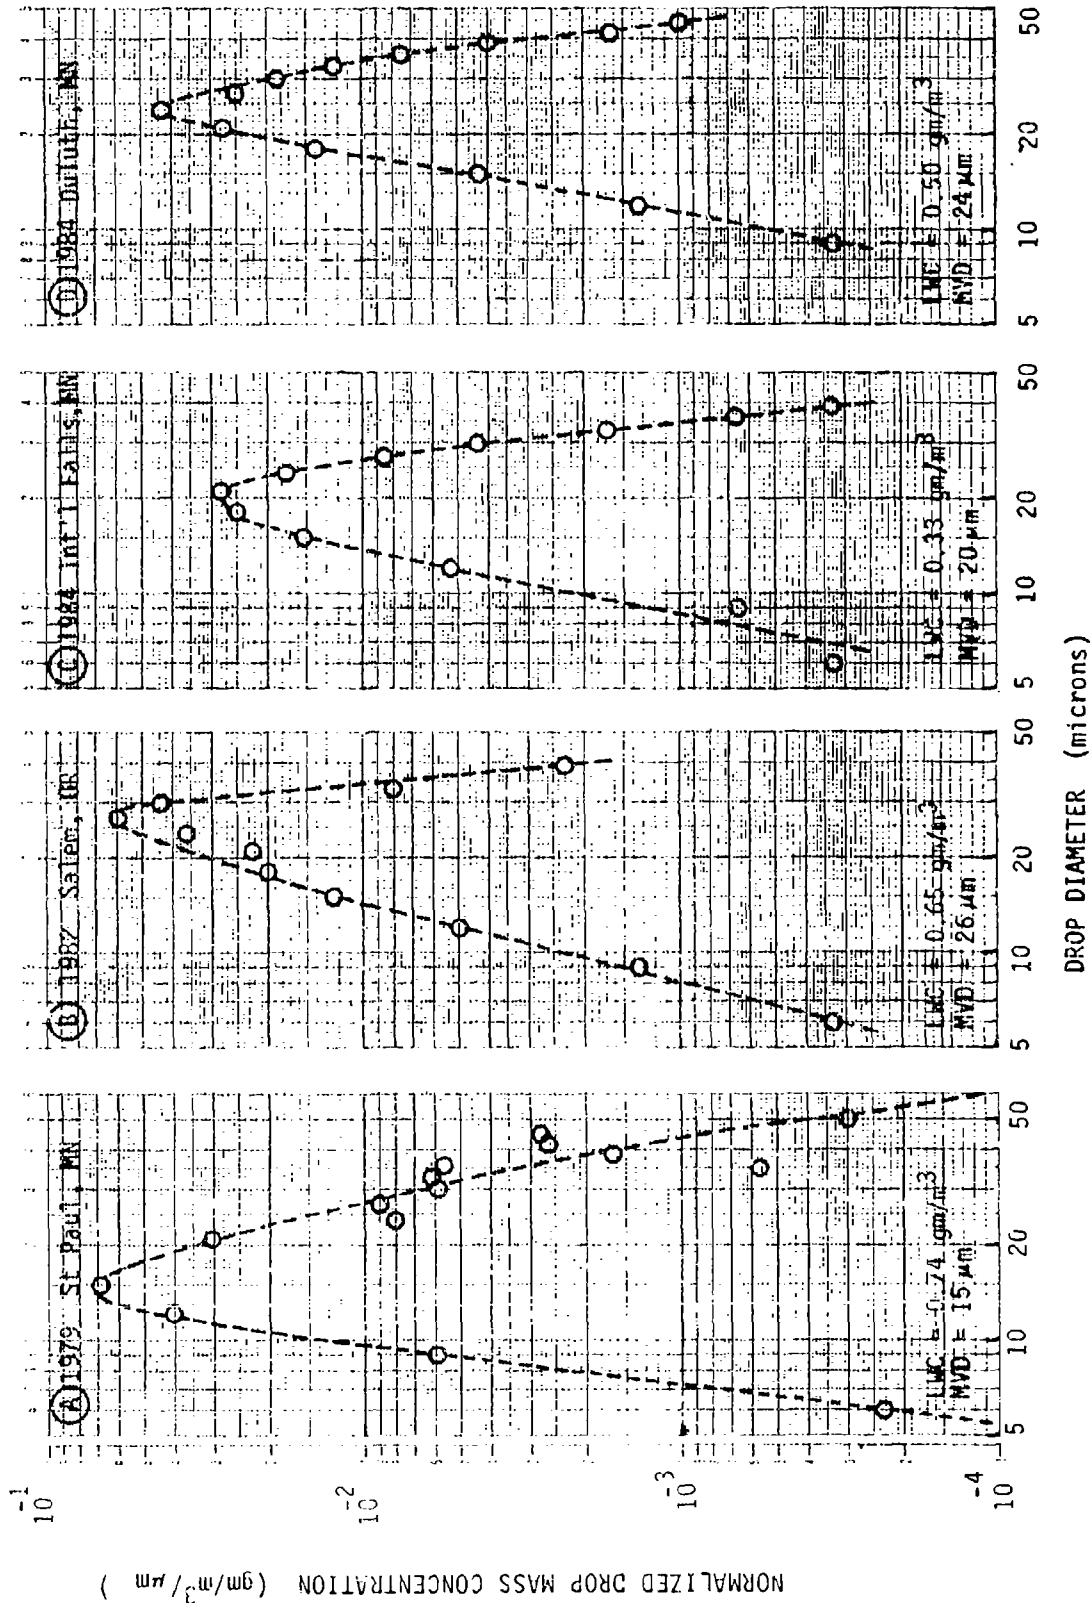
FIGURE 1  
 NATURAL STRATIFORM CLOUD  
 DROP MASS DISTRIBUTIONS

NOTE: Data obtained using Particle Measuring Systems, Inc. laser spectrometers

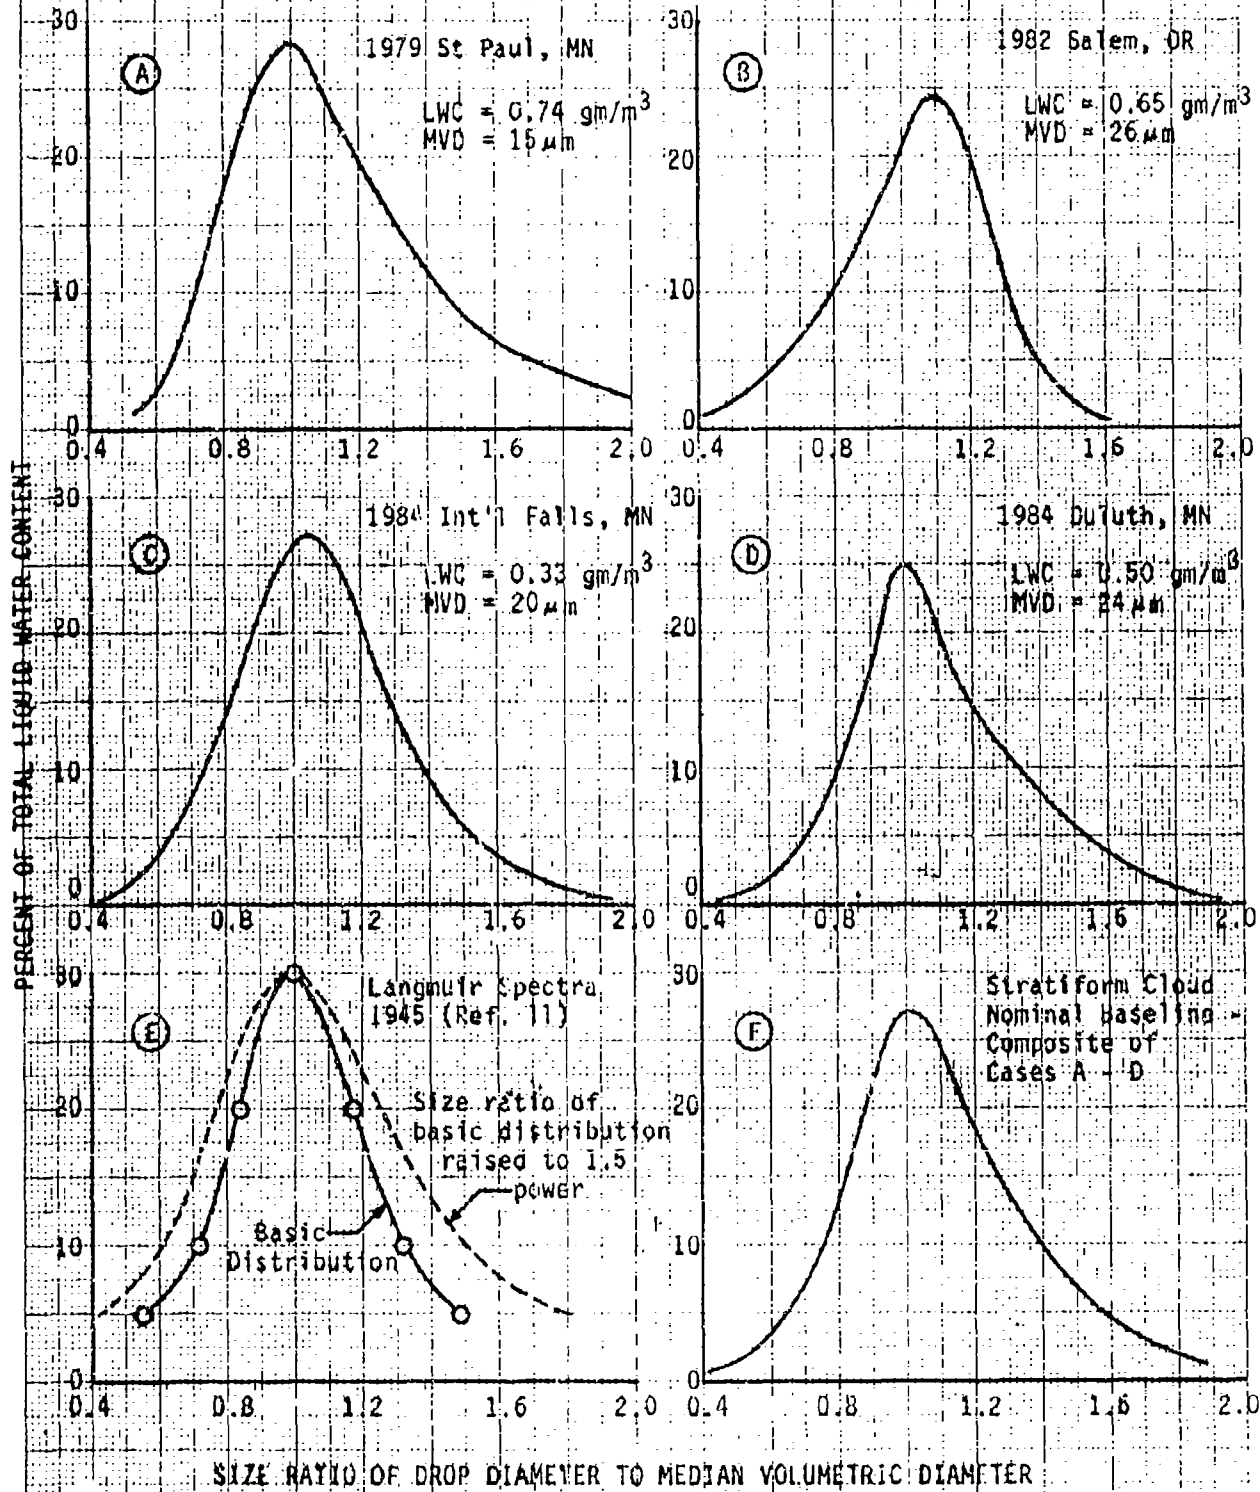
FIGURE 2  
 NATURAL STRATIFORM CLOUD  
 NONDIMENSIONAL DROP  
 MASS DISTRIBUTIONS

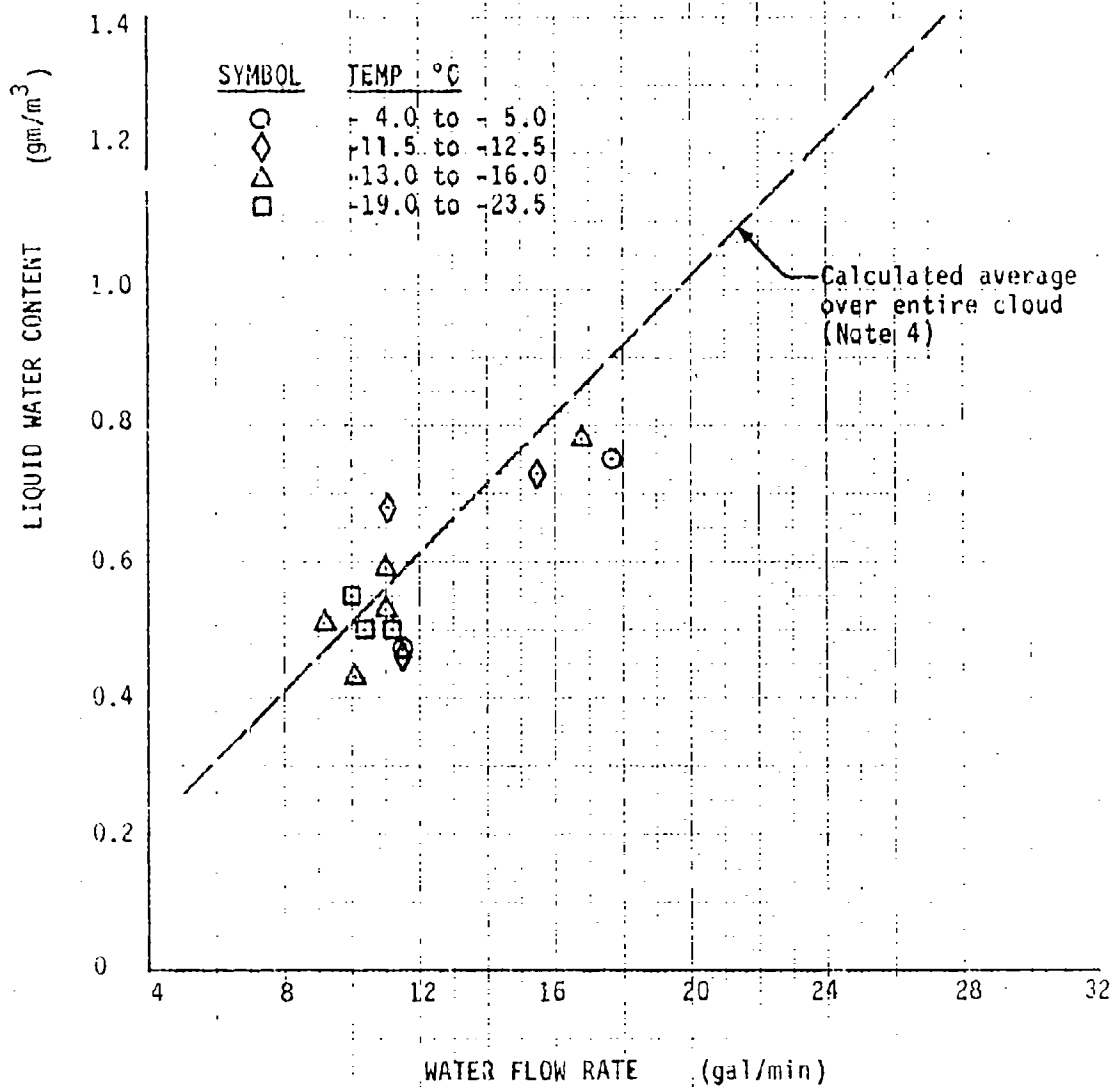
FIGURE 3  
 WATER FLOW RATE AND LIQUID  
 WATER CONTENT OF HISS SPRAY CLOUD

- NOTES: 1. 97 Sonicore nozzles installed on trapeze sections only  
 2. Data obtained using Particle Measuring Systems, Inc laser spectrometers  
 3. Measurements taken during stable immersions centered in spray cloud 180 ft behind spray boom  
 4. Line shows calculated average for 8 x 36 ft cloud cross section at 90 KTAS (Para 21)  
 5. Airspeed = 90 KTAS

over intervals lasting from 10 to 20 seconds selected from approximately one minute long stable immersions in the spray cloud. The LWC measurements (figs. 3 and 4) can be compared with the "calculated average" linear function (para 22) shown for each airspeed. The degree of agreement with the calculated line and the range of scatter are typical of those observed previously (refs 3 and 4, app A). The MVD data (figs. 5 and 6, app F) are taken from the same cloud samples and fall in a range between 34 and 75 $\mu$ m. For comparison, the 1980 results (ref 3, app A) showed a high concentration of data between 20 and 35 $\mu$ m, and the 1982 data (ref 4) ranged from 25 to 40 $\mu$ m MVD at flow rates below 13 gal/min, and 40 to 70 $\mu$ m at higher flow rates. While overlap exists with the previous range of values, the present MVD data tend to group toward the upper end of the size range. Even at low flow rates where the finest atomization should occur, no MVD's averaged below 34 $\mu$ m. This undesirable indication of larger drop sizes than seen in the past tends to shift the artificial cloud spectrum away from the nominal 15 to 25 $\mu$ m MVD range typically attributed to natural clouds. In view of the otherwise enhanced flow distribution characteristics of the spray system that were expected to improve atomization, this discrepancy cannot be readily explained. With some uncertainty in data quality introduced by instrumentation problems (para 27), substantive conclusions regarding any change of atomization performance cannot be drawn.

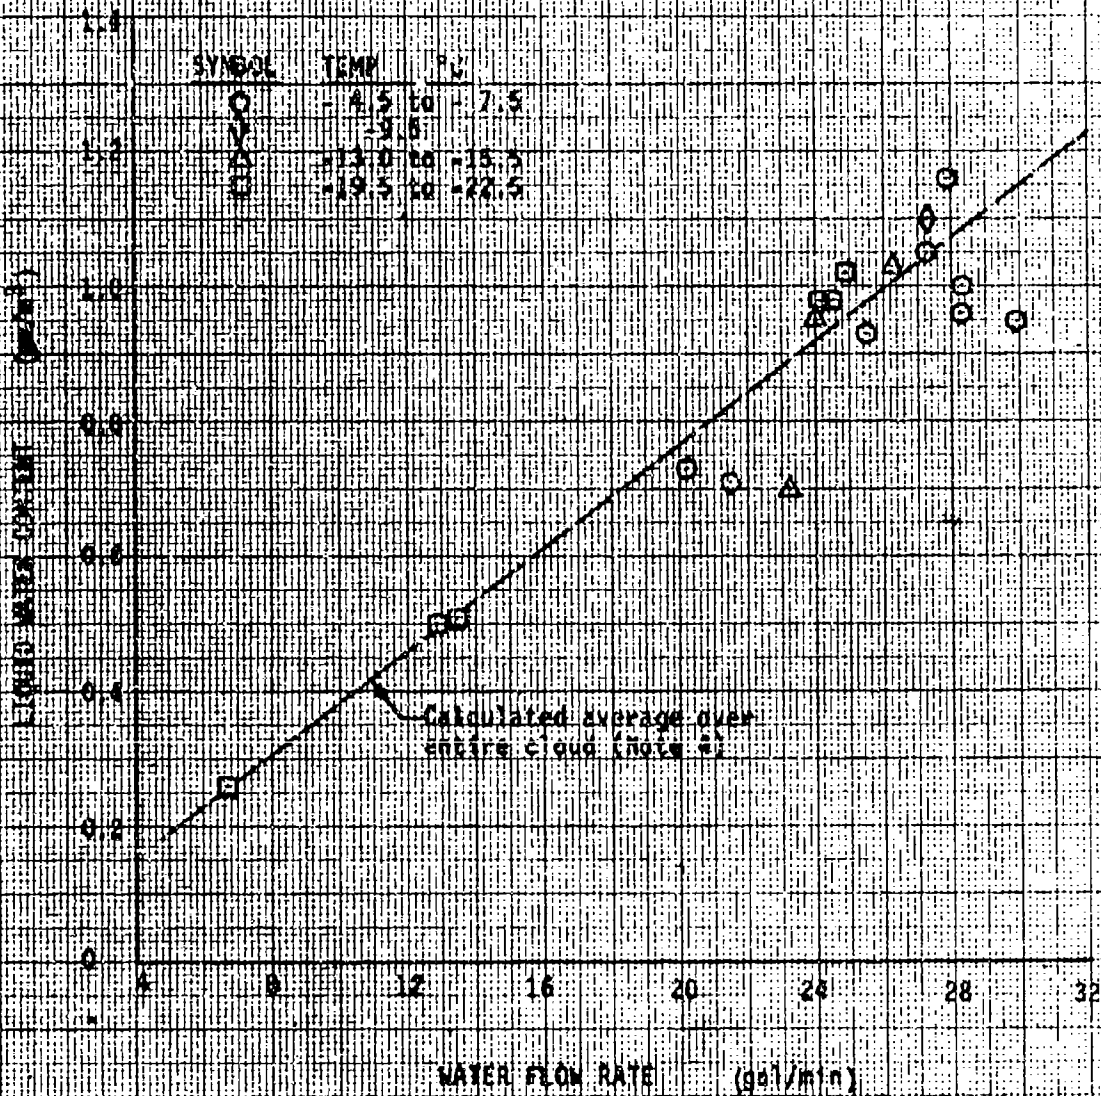
**FIGURE 4  
WATER FLOW RATE AND LIQUID  
WATER CONTENT OF HISS SPRAY CLOUD**

- NOTES: 1. 57 Sensors available installed on trapeze sections only.  
 2. Data obtained using Particle Measuring Systems, Inc. Laser spectrometers.  
 3. Measurements taken during stable immersions centered in spray cloud 180 ft behind spray booms.  
 4. Line shows calculated average for 8 x 36 ft cloud cross section at 120 KTAS (Para 21).  
 5. Airspeed = 120 KTAS.

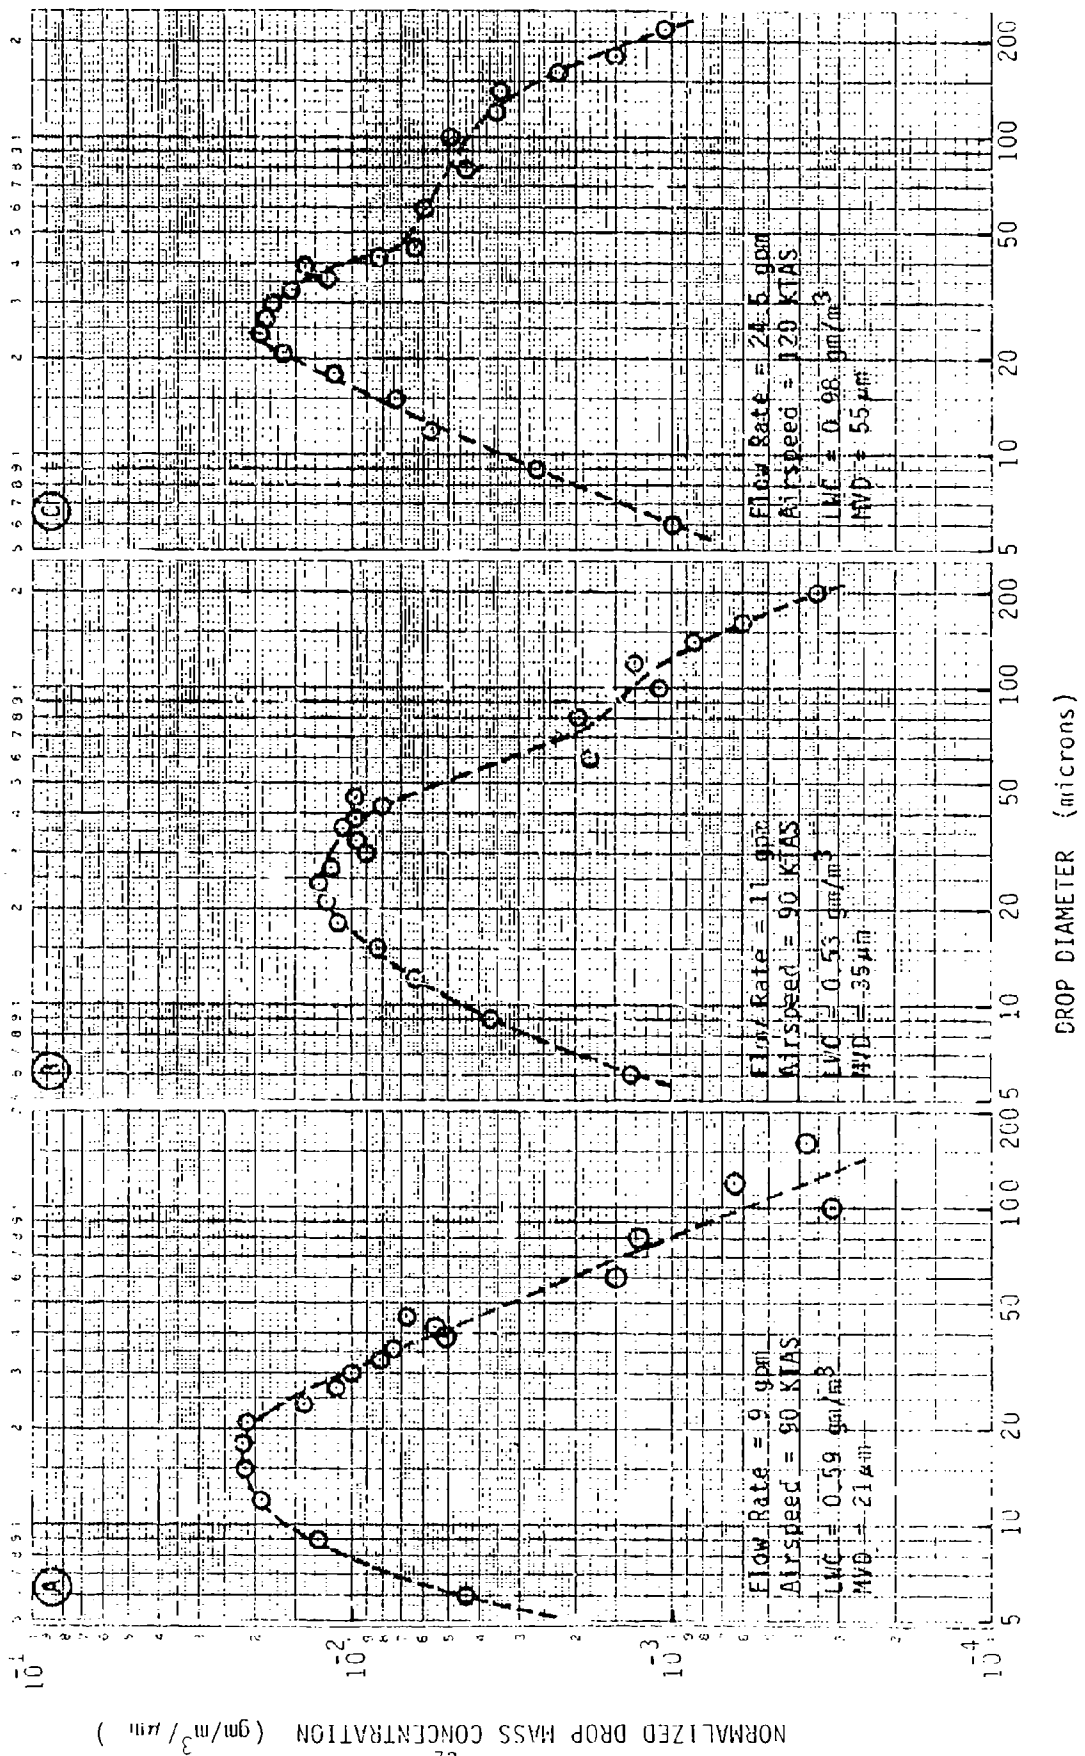
FIGURE 7  
HELICOPTER ICING SPRAY SYSTEM  
DROP MASS DISTRIBUTIONS

- NOTES: 1. 97 Sonicore nozzles installed on trapeze sections only  
2. Data obtained using Particle Measuring Systems, Inc. laser spectrometers  
3. Measurements taken 180 ft. behind spray booms

29. Examples of normalized spray cloud drop spectra are presented in figure 7, appendix F. For comparison with previous HISS data, case A is taken from reference 3, appendix A and shows a sample from 1980 with an MVD of 21 $\mu$ m. Cases B and C are from 1984 with MVD's of 35 and 55 $\mu$ m, respectively. These data were obtained from "cloud centered" samples and are one second records selected as representative of the average conditions. When compared with the natural cloud spectra of figure 1, appendix F differences are evident in slope and in shape near the apex. While the peak concentrations occur at reasonable values of drop size (15 to 25 $\mu$ m), the HISS distributions are considerably broader and include larger drop sizes above 50 $\mu$ m that do not normally occur in natural clouds. This is particularly evident at higher flow rates as in case C. Presence of these larger drops drives the MVD upward.

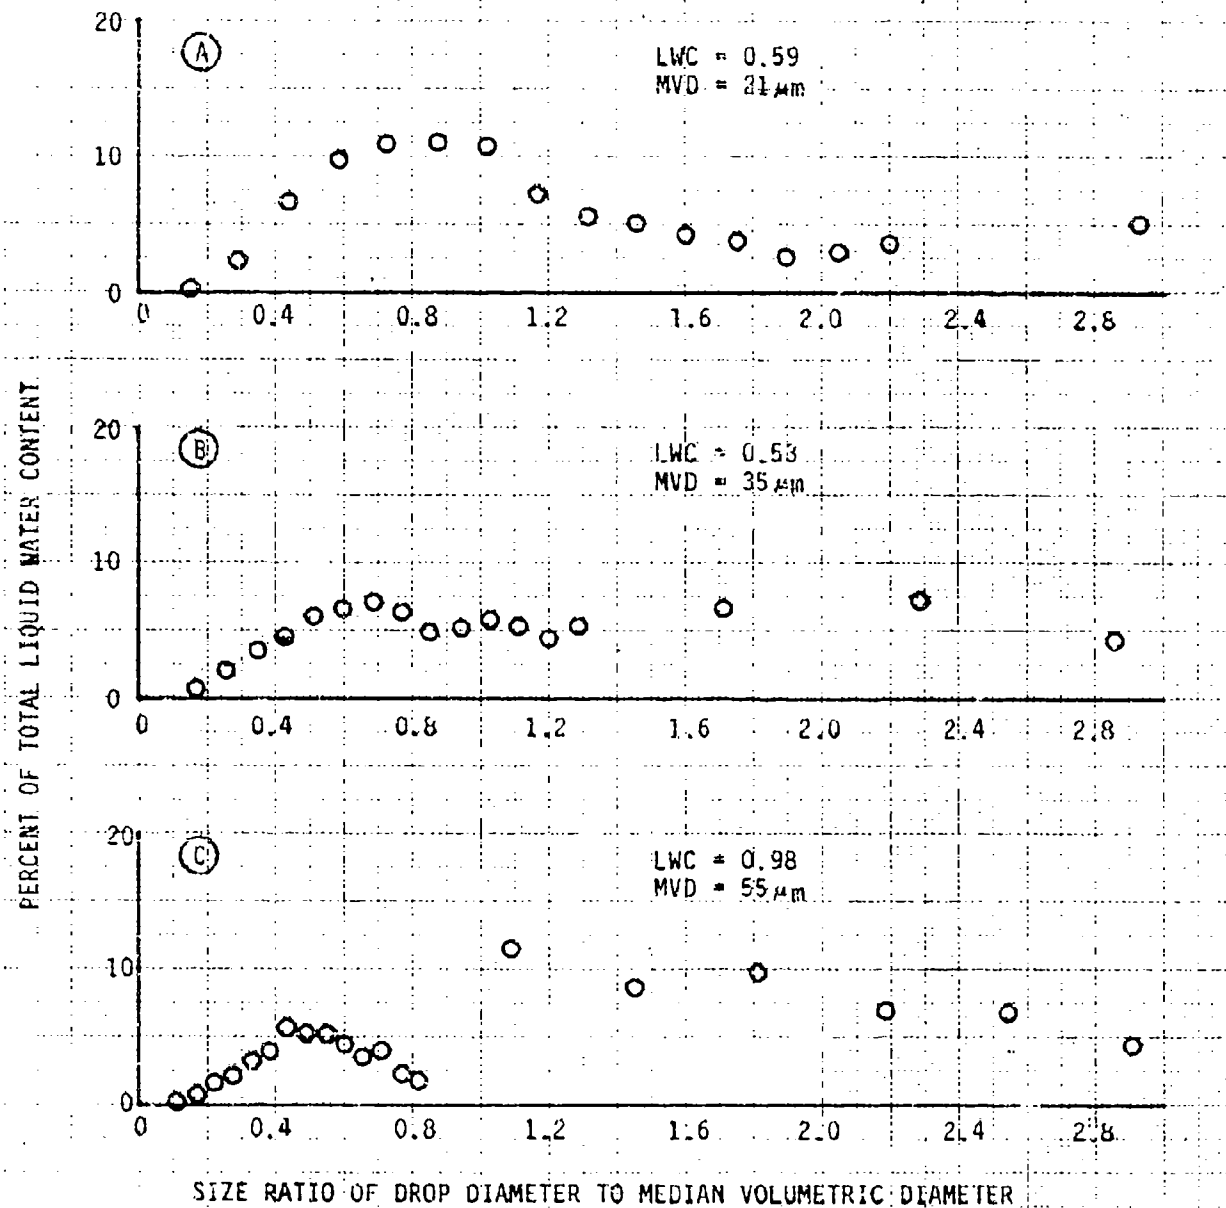
FIGURE 8  
HELICOPTER ICING SPRAY SYSTEM  
NONDIMENSIONAL DROP  
MASS DISTRIBUTIONS

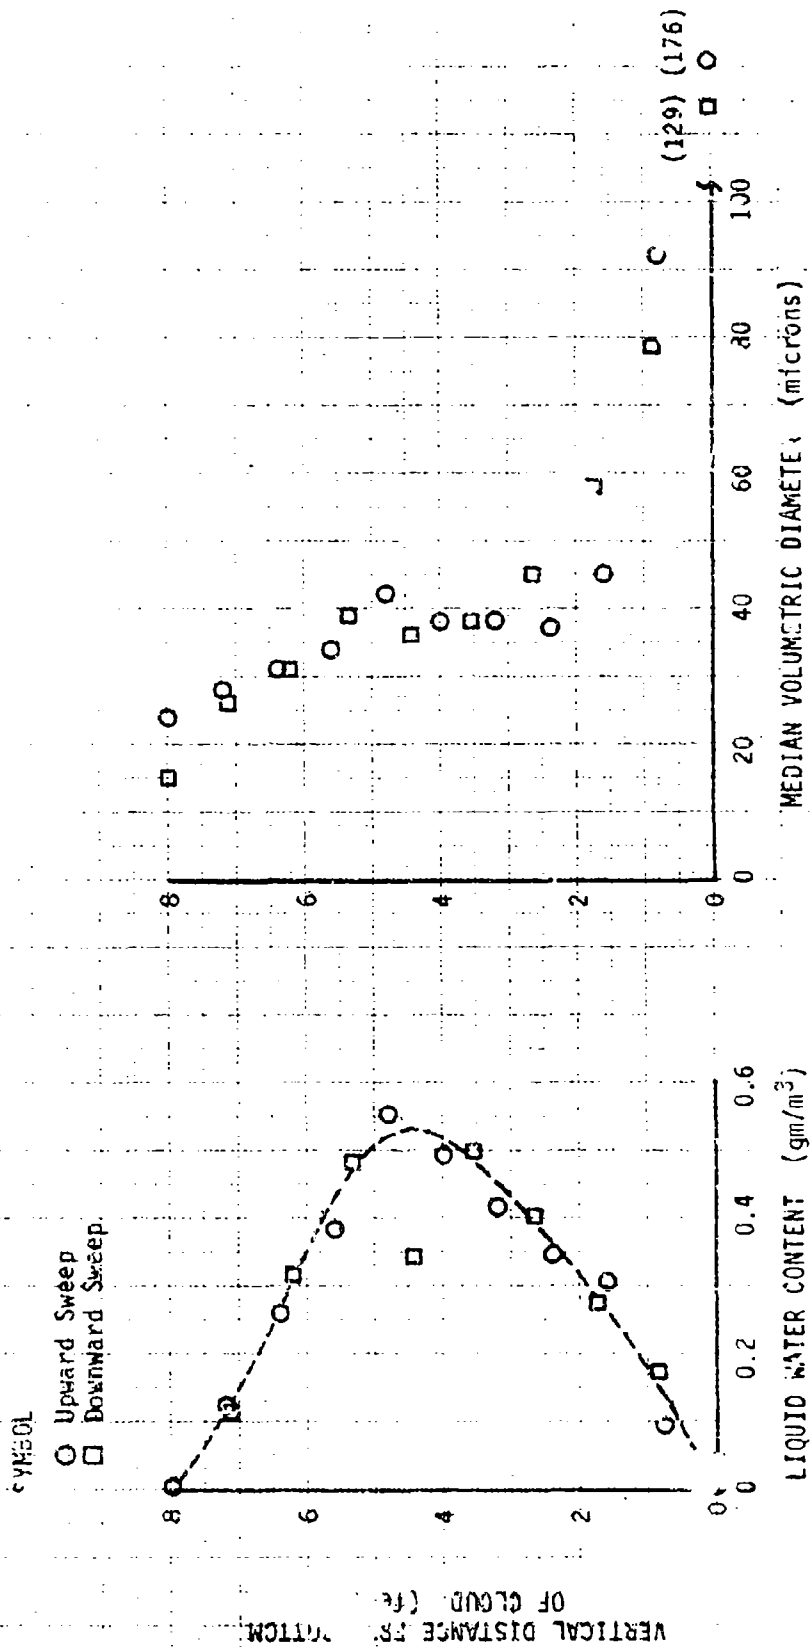
FIGURE 9  
 HELICOPTER ICING SPRAY SYSTEM  
 VERTICAL VARIATION OF CLOUD COMPOSITION

- NOTES: 1. 97 Sonicore nozzles installed on trapeze sections only  
 2. Data obtained using Particle Measuring Systems, Inc laser spectrometers  
 3. Half second sample rate during vertical sweeps  
 4. Measurements taken 180 ft behind spray booms  
 Airspeed = 120 KTAS  
 Flow rate = 13 gpm

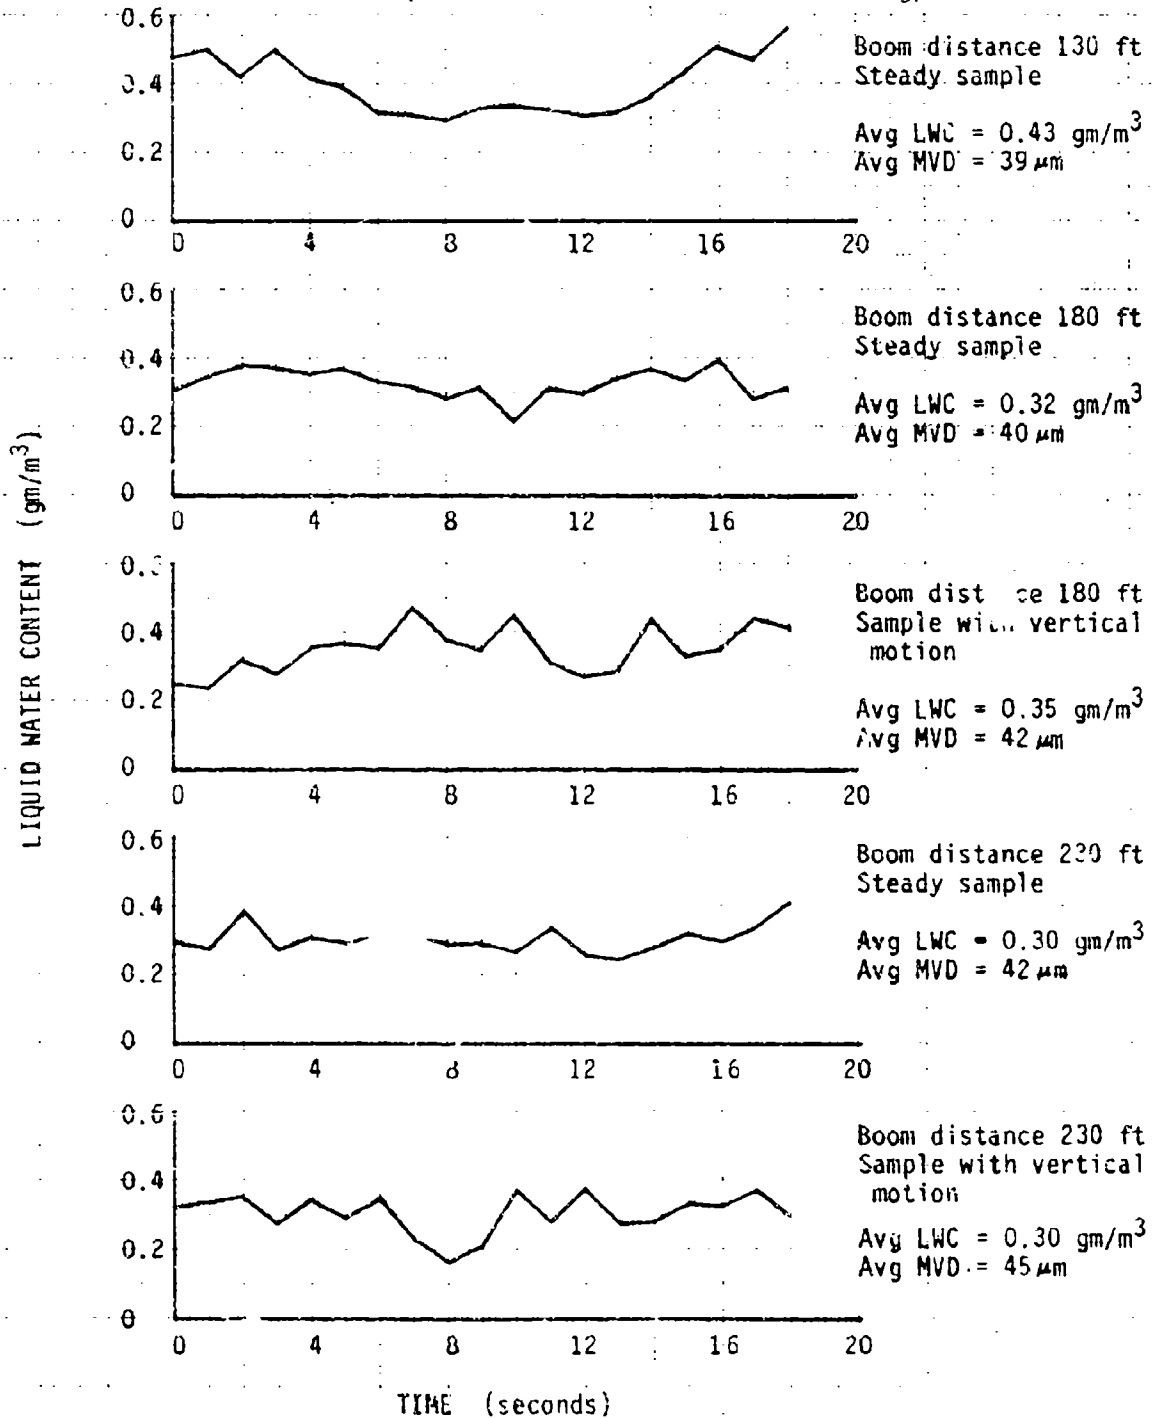
FIGURE 10  
 HELICOPTER ICING SPRAY SYSTEM  
 CLOUD SAMPLING TIME - HISTORIES

- NOTES: 1. 97 Sonicore nozzles installed on trapeze sections only  
 2. Data obtained using Particle Measuring Systems, Inc laser spectrometers  
 3. One-second sample rate during immersion  
 4. Airspeed = 120 KTAS Flow Rate = 13 gpm

32. Additional measurements taken during this same spray condition are presented in figure 10. Time histories of LWC are shown for standoff distances of 130, 180 and 230 ft from the boom. This range of distances would normally represent the limits of test aircraft movement during formation flight while attempting to

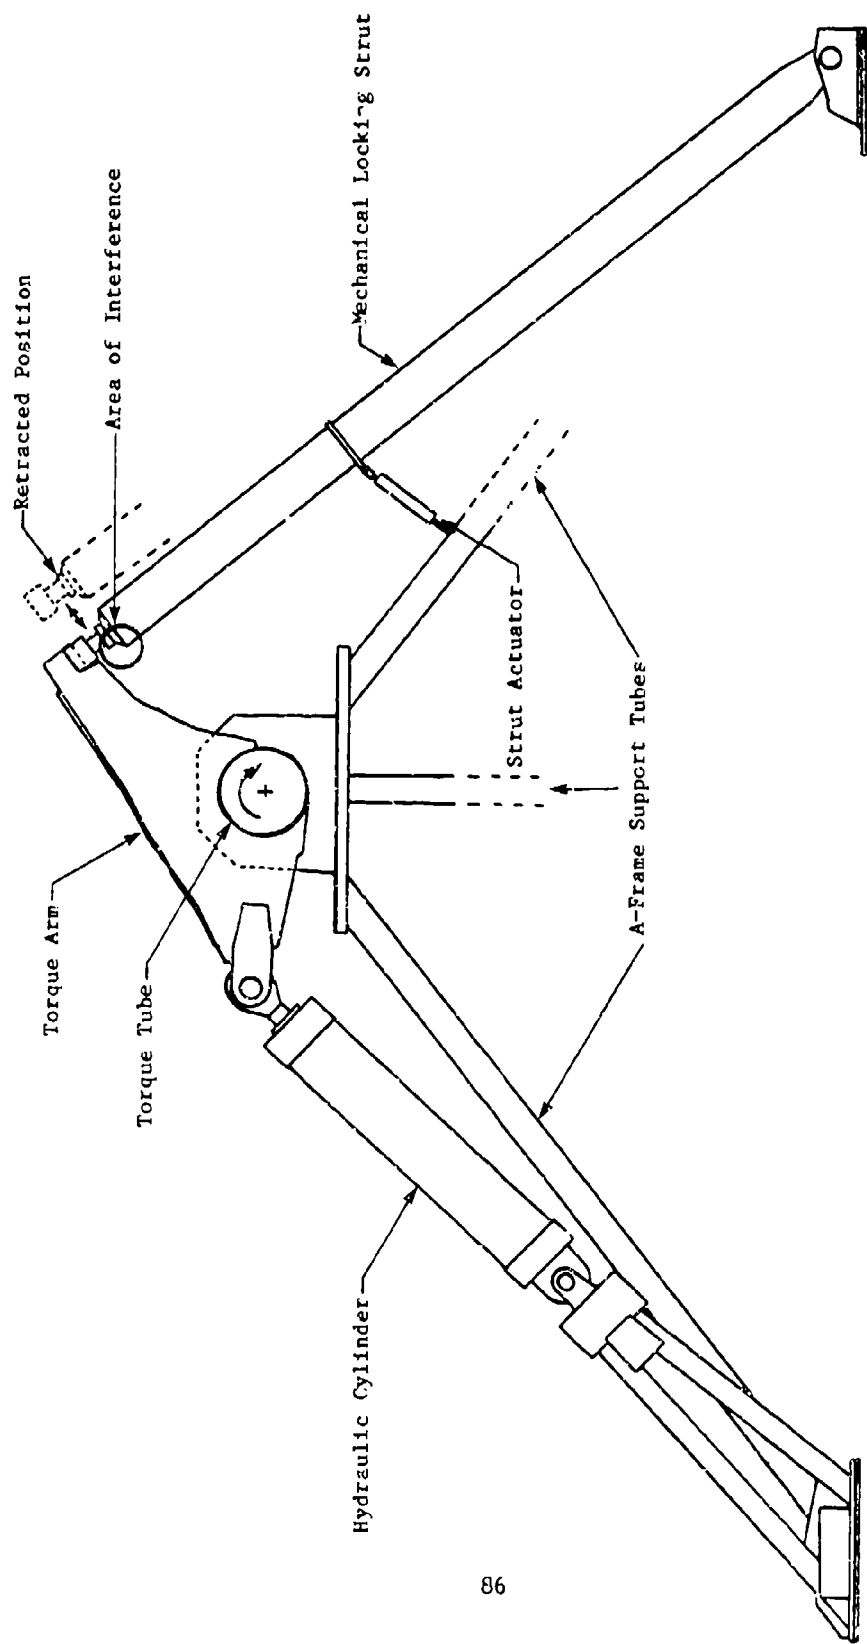
Figure 1 . Torque Tube and Trunnion Mount Assembly
