**TEST REPORT  
for the  
EVALUATION  
of the  
PIPELINE OUTFIT, PETROLEUM (POP)**

**Prepared by the  
FUELS HANDLING R&D TEAM  
BELVOIR RD&E CENTER**

**5 May 1986**

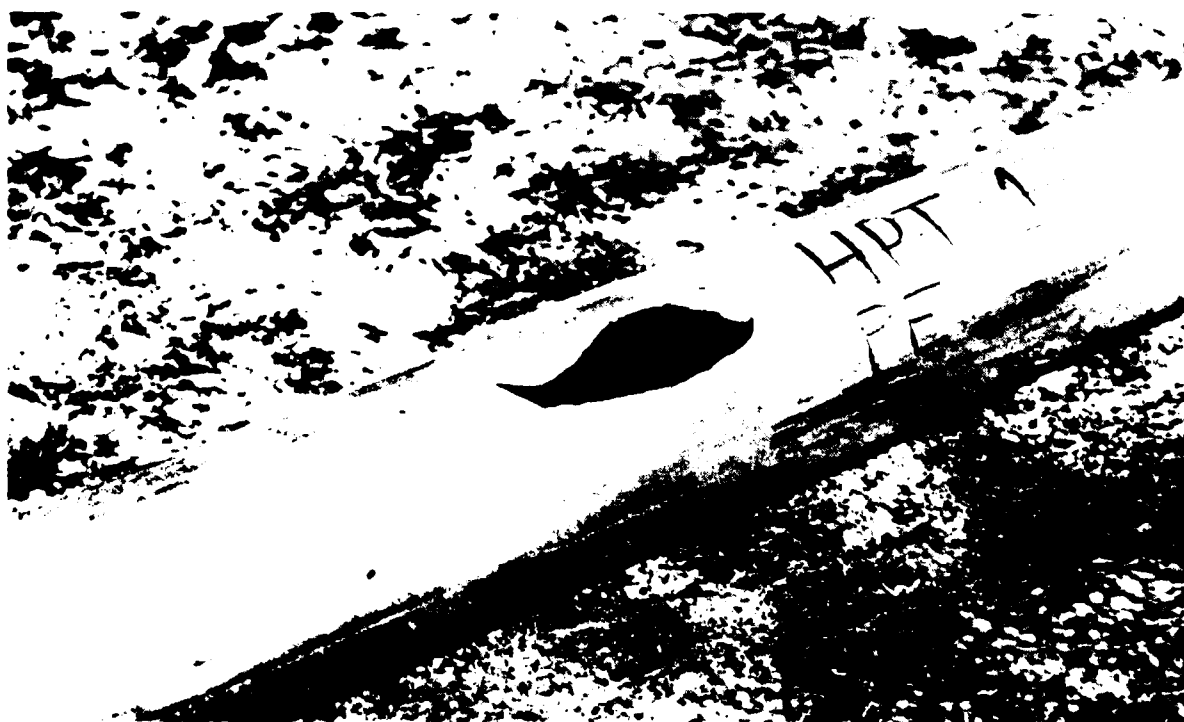
Photo #2: Hydrostatic pressure test #1. Pipe wall burst at 1,800 psi.

| Test No. | Cplg No. | Cplg Type | Pipe Type | Pipe End | Sub A Insert Depth (in) | Sub B Insert Depth (in) | 650 psi | 900 psi | 1,064 psi | Burst psi | Failure occurred at: | Remarks |
|---|---|---|---|---|---|---|---|---|---|---|---|---|
| 1 | 3 | S800 | MD261 | PE | 6.625 | 6.625 | OK | OK | OK | 1,800 | Pipe wall | See Photo 2 |

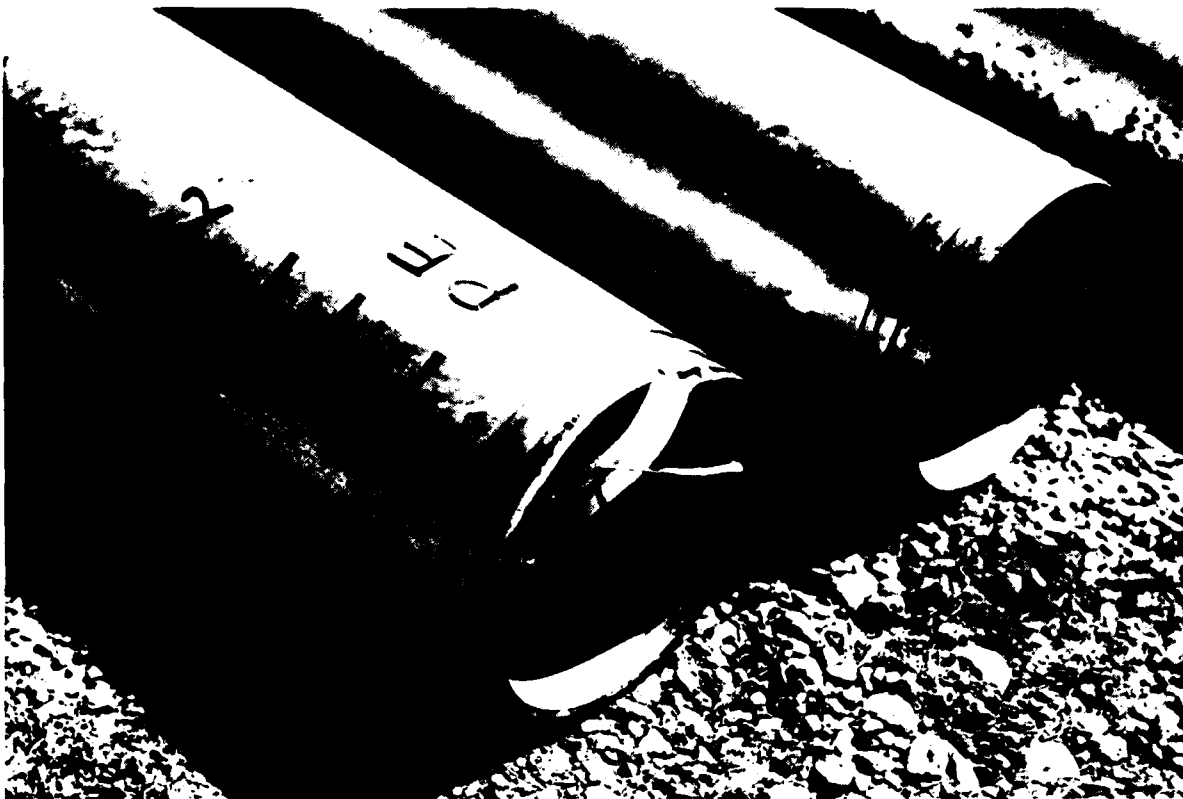
Photo #3: Hydrostatic pressure test #2. Pipe wall failure at groove at 1,800 psi.

| Test No. | Cplg No. | Cplg Type | Pipe Type | Pipe End | Sub A Insert Depth (in) | Sub B Insert Depth (in) | 650 psi | 900 psi | 1,064 psi | Burst psi | Failure occurred at: | Remarks |
|---|---|---|---|---|---|---|---|---|---|---|---|---|
| 2 | 4 | " | " | " | " | " | " | " | " | 1,800 | Pipe wall | See Photo 3. Failure at groove. |

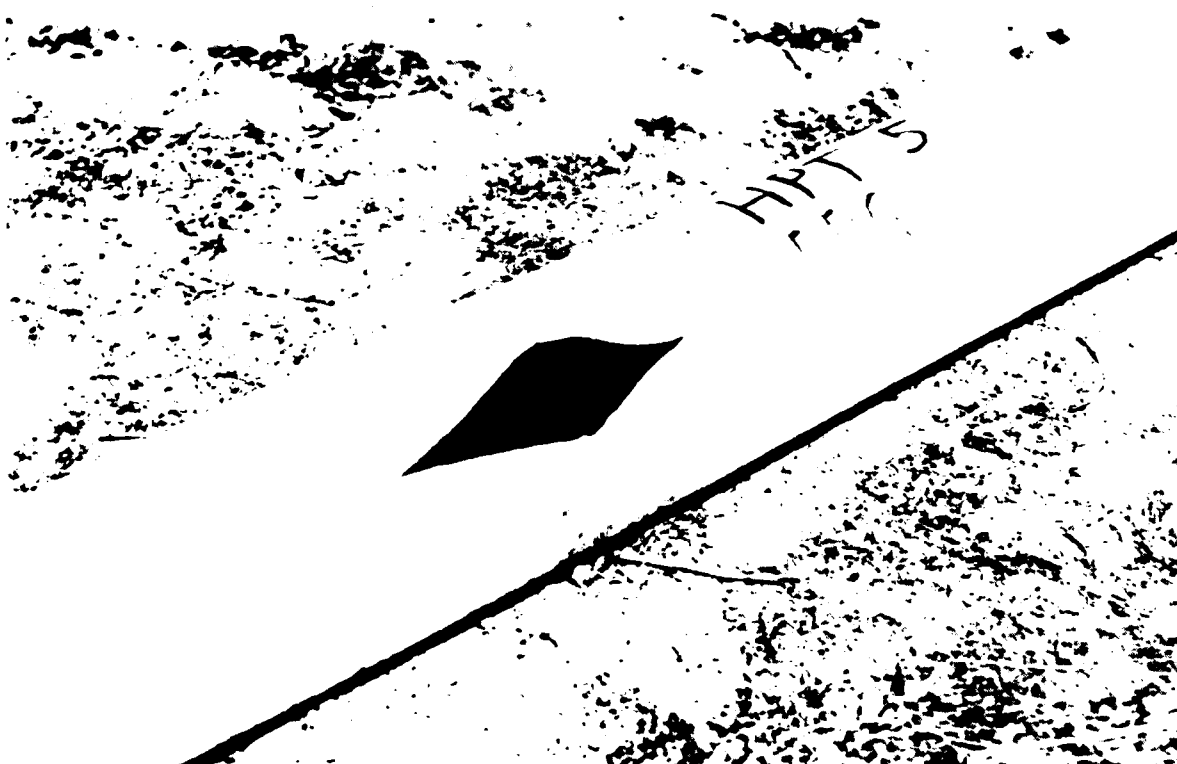
Photo#4: Hydrostatic pressure test #5. Pipe wall burst at 1,920 psi.

| Test No. | Cplg No. | Cplg Type | Pipe Type | Pipe End | Sub A Insert Depth (in) | Sub B Insert Depth (in) | 650 psi | 900 psi | 1,064 psi | Burst psi | Failure occurred at: | Remarks |
|---|---|---|---|---|---|---|---|---|---|---|---|---|
| 5 | 7 | " | " | " | " | " | " | " | " | 1,920 | Pipe wall | See Photo 4. |

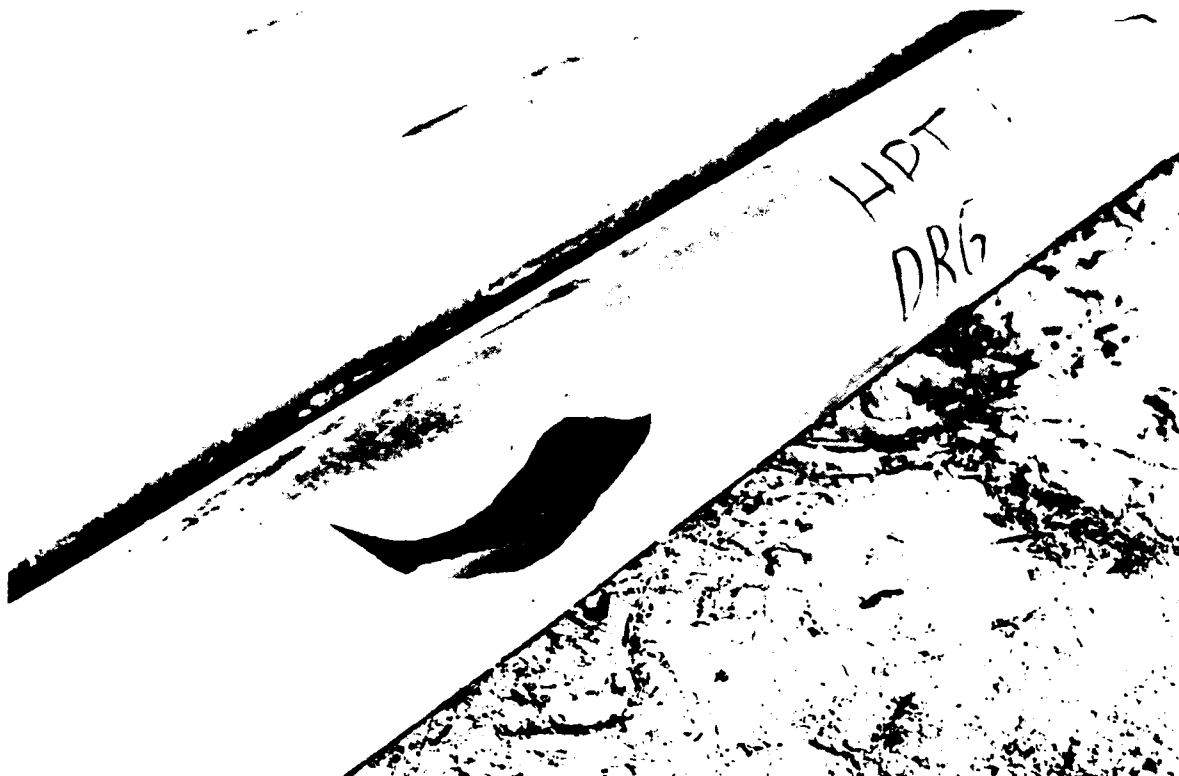
Photo #5: Hydrostatic pressure test #6. Pipe wall burst at 1,980 psi with coupling 5 failure.

| Test No. | Cplg No. | Cplg Type | Pipe Type | Pipe End | Sub A Insert Depth (in) | Sub B Insert Depth (in) | 650 psi | 900 psi | 1,064 psi | Burst psi | Failure occurred at: | Remarks |
|---|---|---|---|---|---|---|---|---|---|---|---|---|
| 6 | 6 | " | " | " | " | " | " | " | " | 1,980 | Pipe wall & Cplg | See Photo 5. Failure at pipe wall may have caused coupling failure. |

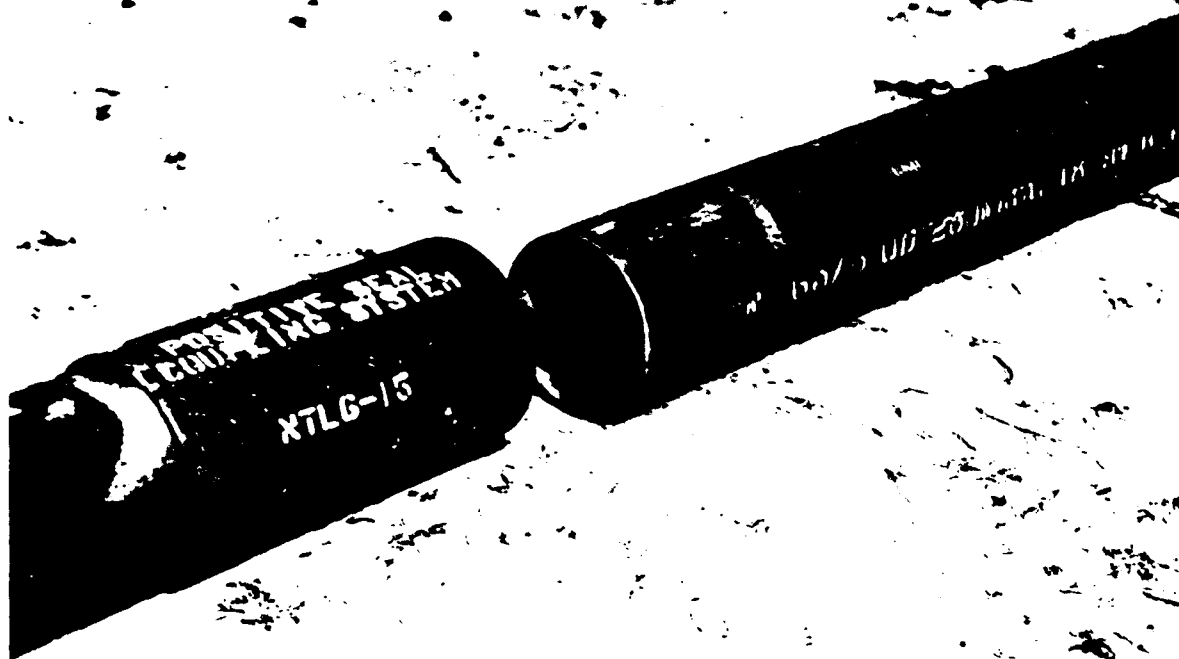
Photo#6: Hydrostatic pressure test #8. Coupling failure at 2,000 psi.

| Test No. | Cplg No. | Cplg Type | Pipe Type | Pipe End | Sub A Insert Depth (in) | Sub B Insert Depth (in) | 650 psi | 900 psi | 1,064 psi | Burst psi | Failure occurred at: | Remarks |
|---|---|---|---|---|---|---|---|---|---|---|---|---|
| 8 | 15 | " | " | " | 4.50 | 4.25 | " | " | " | 2,000 | Cplg | See Photo 6. Did not have full insertion. |

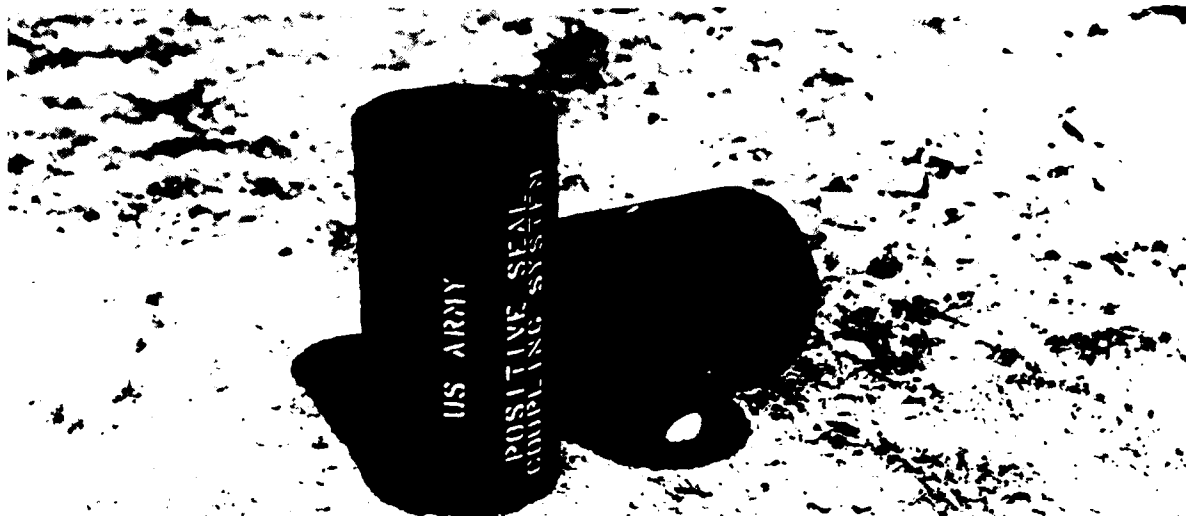
**Photo #7:** Example of end-most couplings drilled for the tensile tests.

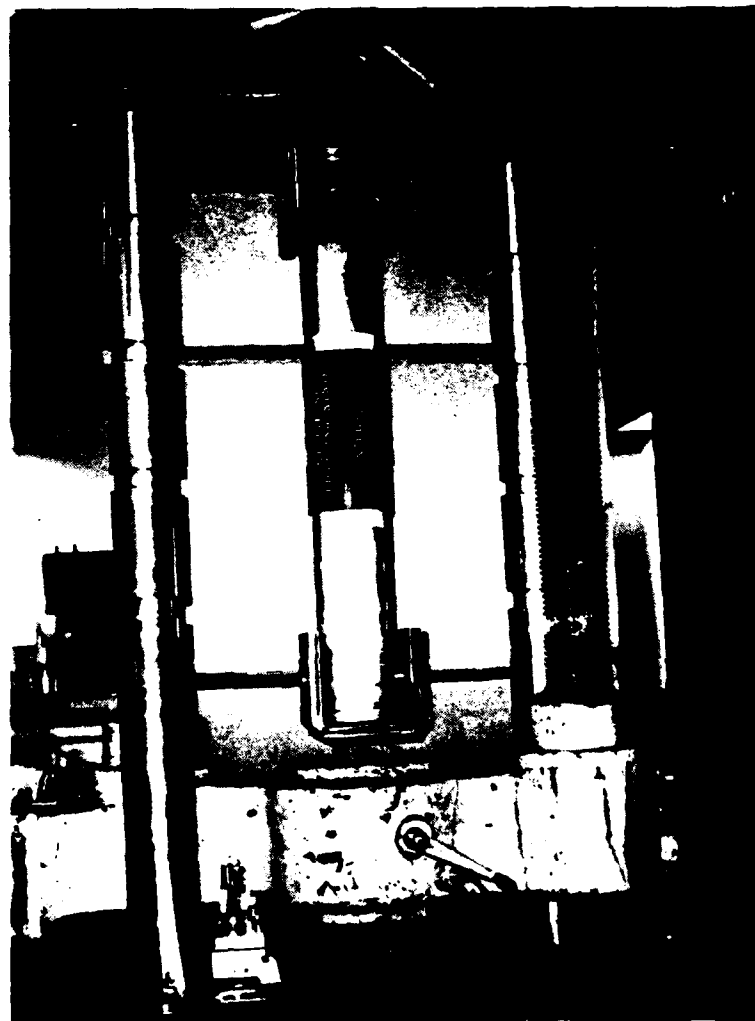
**Photo#8:** Lab tensile test sample mounted in the Baldwin tensile test machine.

The lab test will consist of two, short pipe "subs" connected by the Positive Seal coupling coated with Neutra Rust DL. The two ends will be anchored into a Baldwin tension/compression frame. The frame is equipped with a maximum force gauge and a chart recorder that plots applied stress versus strain.

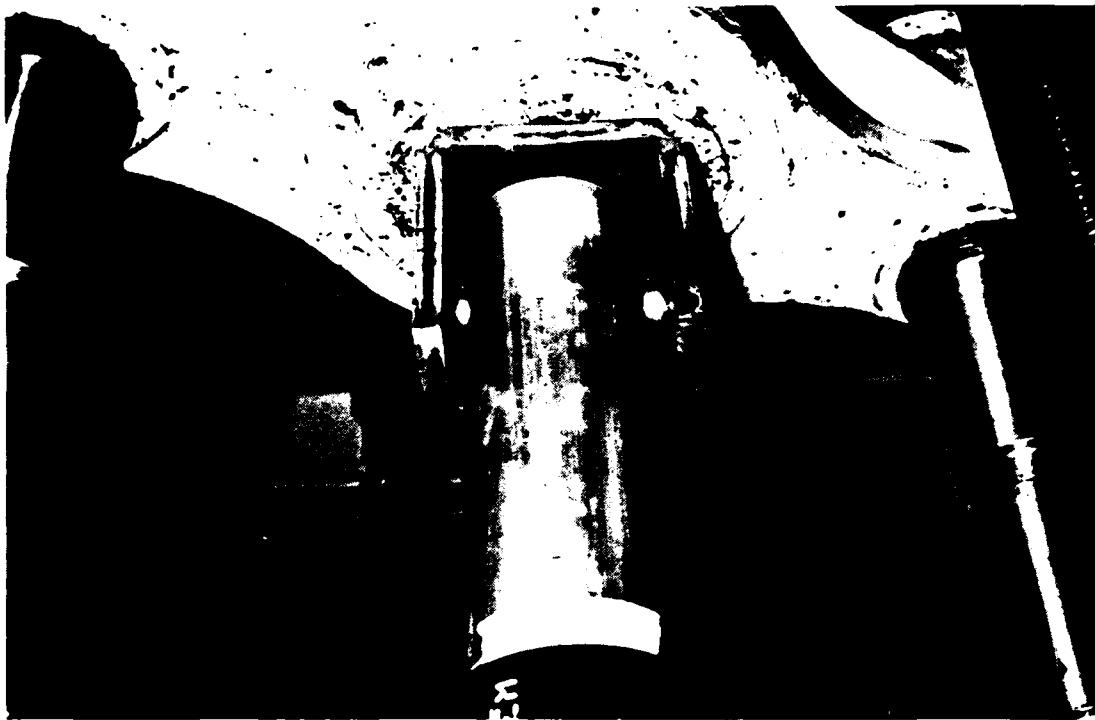
**Photo #9: Pipe wall deformation at 28,000 lb of tensile stress Test #4.**

| Test No. | Cplg No. | Cplg Type | Pipe Type | Pipe End | Sub A Insert Depth (in) | Sub B Insert Depth (in) | Pull-out Force (psi) | Slippage Occurred At: | Remarks |
|---|---|---|---|---|---|---|---|---|---|
| 4 | 2 | " | MD261 | " | 6.625 | 6.625 | 28,500 | None | Aluminum pipe wall failed at test jigs. See Photos 9 & 10. |

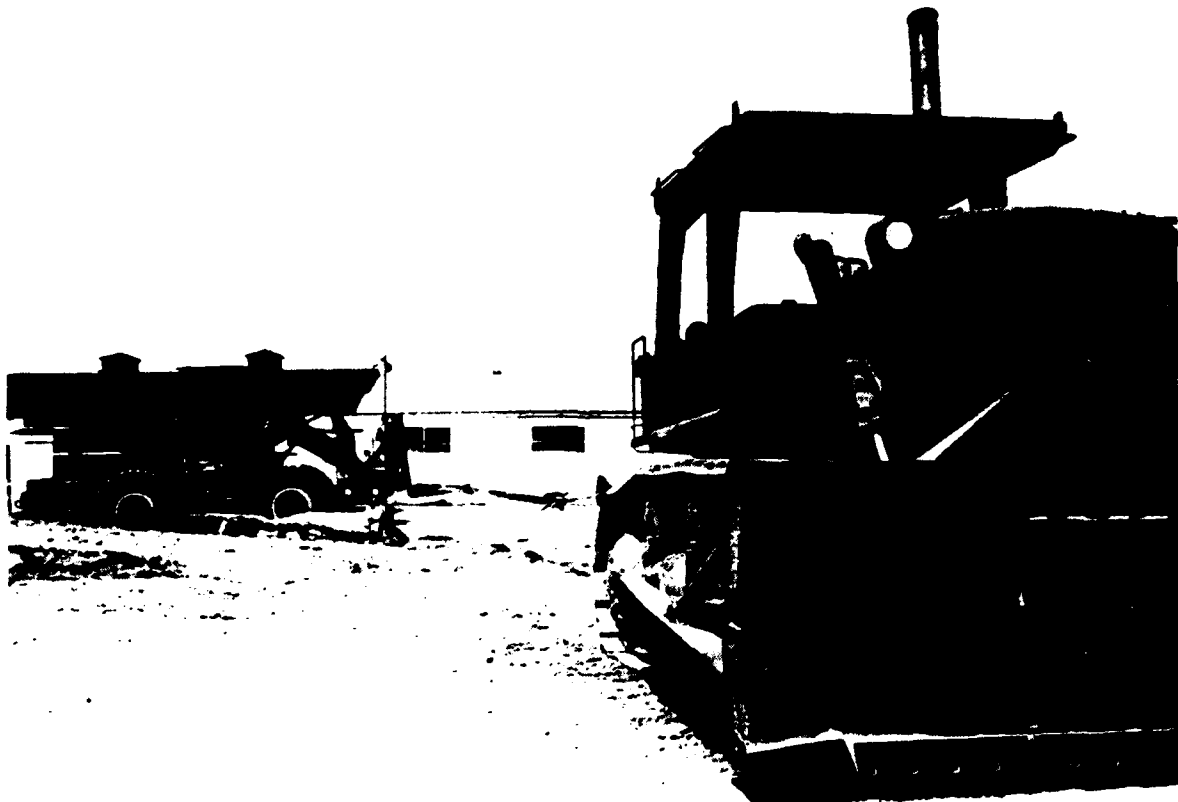
**Photo #11: Field tensile test showing setup and bending of the samples.**

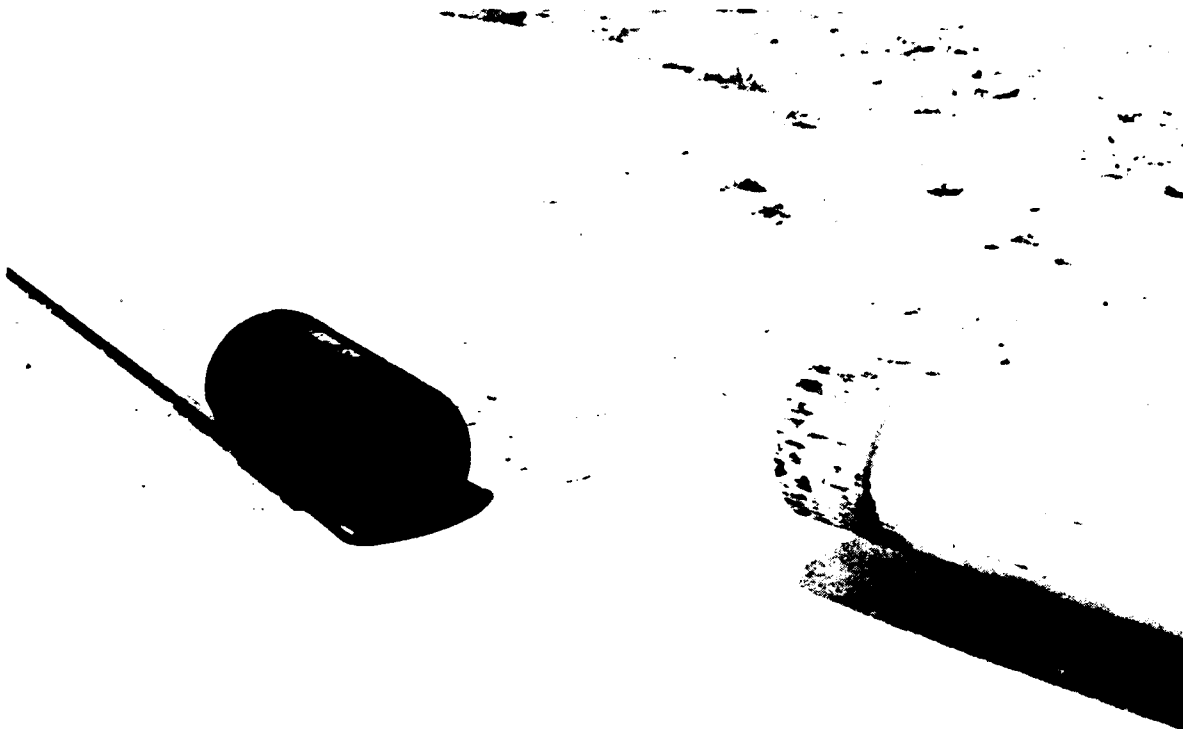
**Photo #15: Field tensile test #2. Plain end aluminum pipe. Pull out at less than 52,000 lb**

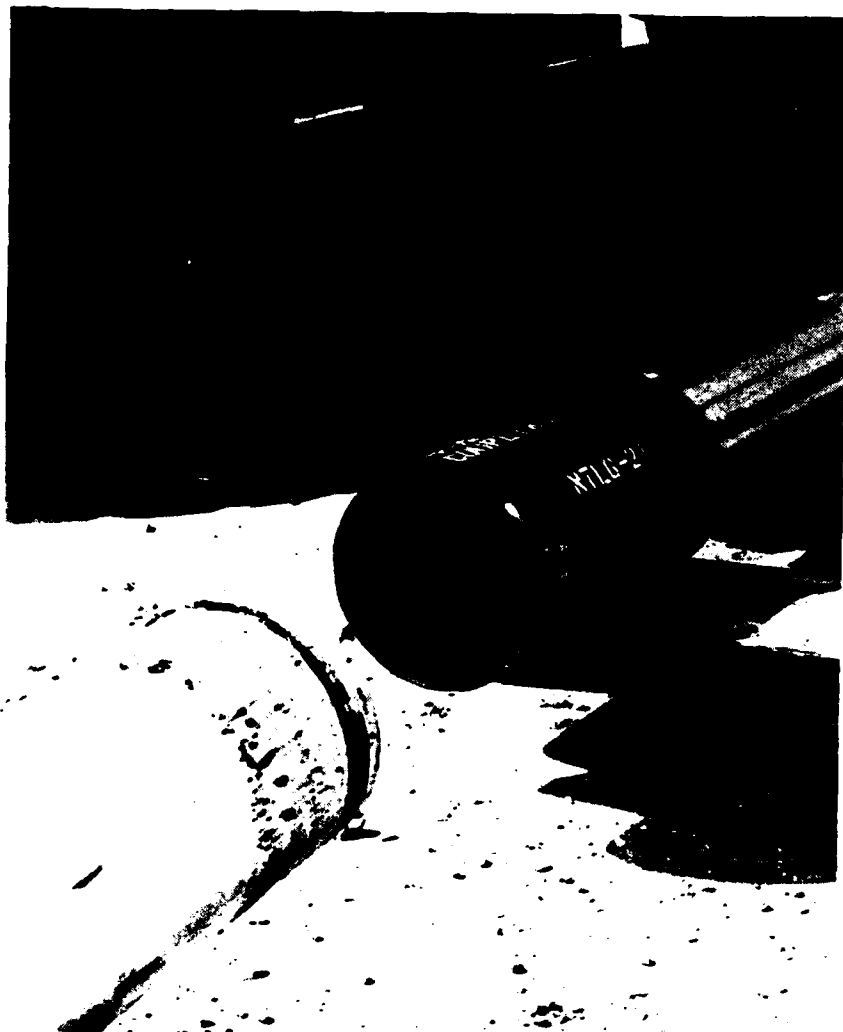
**Photo #17: Field tensile test #4. Double-rolled-groove ends pull out at less than 40,000 lb.**

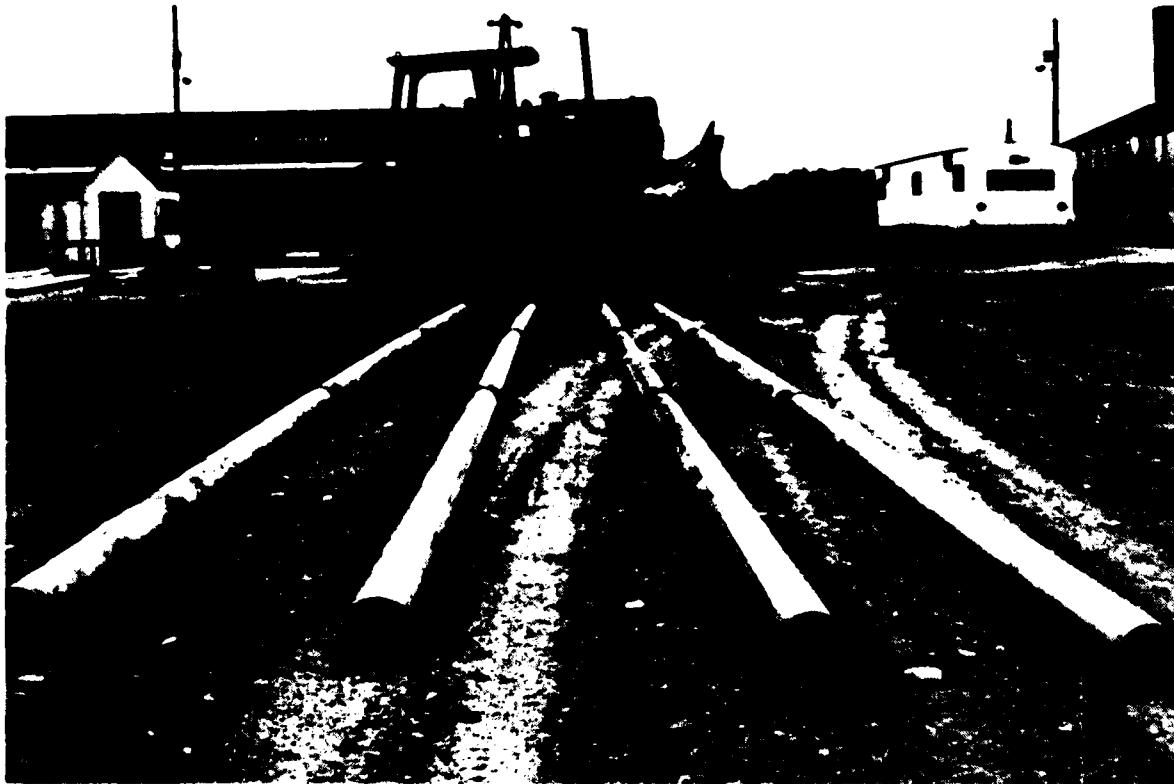
Photo #20: Flexure test setup.
