MISCELLANEOUS PAPER GL-86-19

FACILITIES TECHNOLOGY APPLICATION TESTS; FUEL-RESISTANT PAVEMENT SEALERS

James E. Shoenberger
Elton R. Brown

August 1986
Final Report

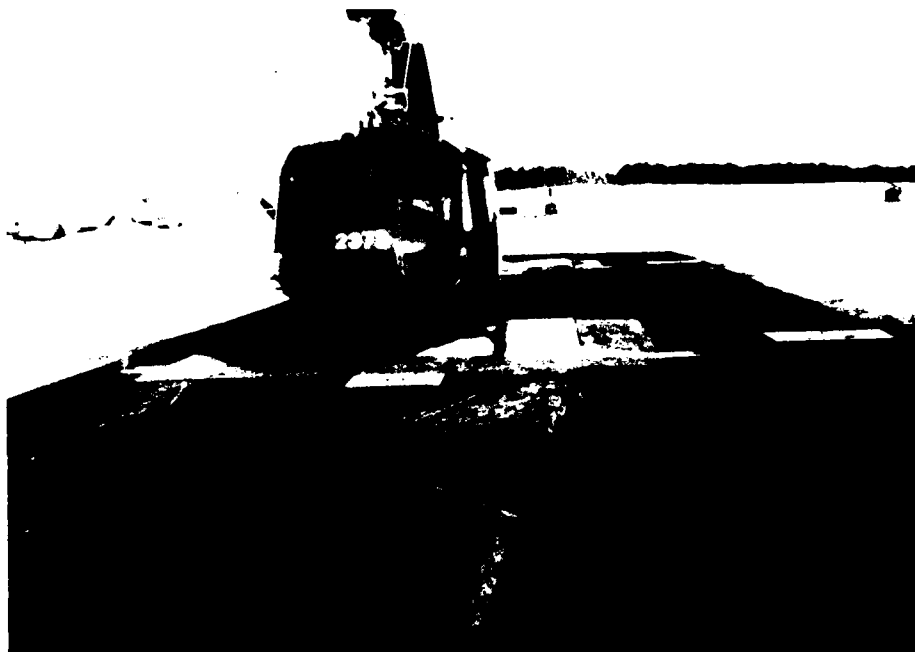
Photo 1. Concrete helipad and surrounding asphalt pavement at Ft. Rucker, Ala.

10. The asphalt concrete pavements which were sealed were located adjacent to portland cement concrete helicopter landing pads (Photo 1). The asphalt concrete pavement was in reasonably good condition and received no special preparation prior to sealing other than sweeping and cleaning with compressed air (Photo 2). The asphalt pavement adjacent to several of the concrete pads had some localized damage where fuel had flowed off the pads and onto the pavement during normal aircraft operations (Photo 3).

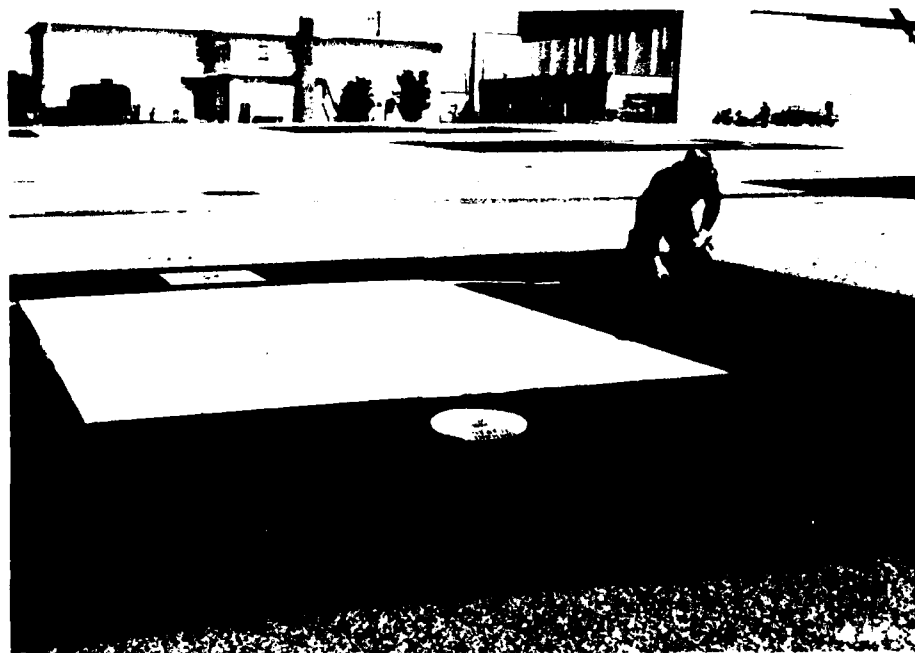
Photo 2. Cleaning with compressed air

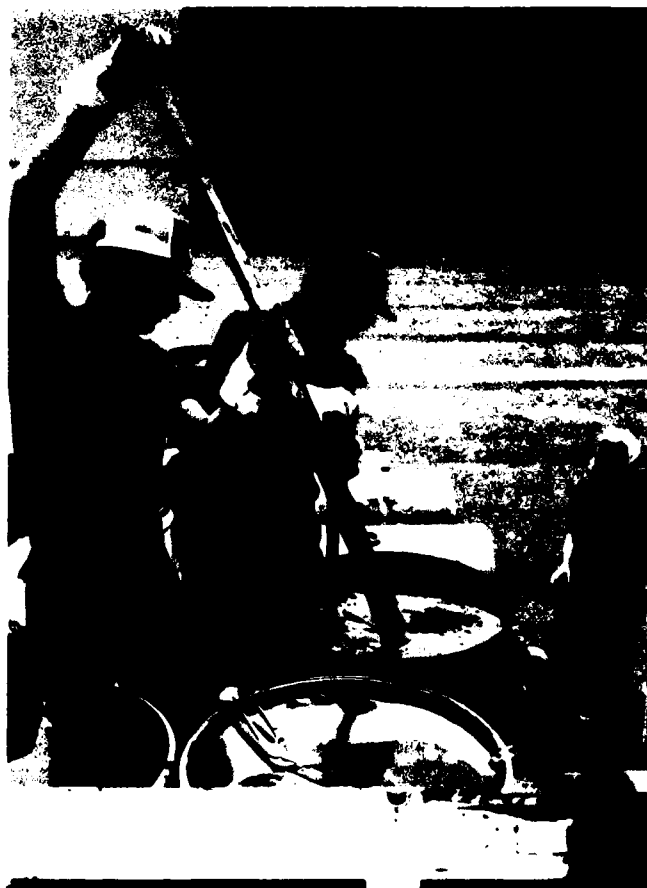
Photo 4. Premixing or stirring a sealer in its original container

11. The sealers were premixed in their own containers to help assure a uniform consistency (Photo 4). The sealers were then combined and/or thinned in accordance with manufacturers' recommendations and mixed in plastic garbage cans (Photo 5) (see Appendix A). Concrete sand was added to the mix to provide a satisfactory skid-resistant surface for traffic (Photo 6). The amount of sand added varied with the type of sealer and ranged from approximately 0.6 to 2.2 lb per gal of sealer (Table 2). Eight-quart galvanized steel buckets were used to measure and transport the various materials and sand (Photo 7). A 1/2-in. electric drill with metal stirrers was used for mixing and stirring all materials (Photo 8).

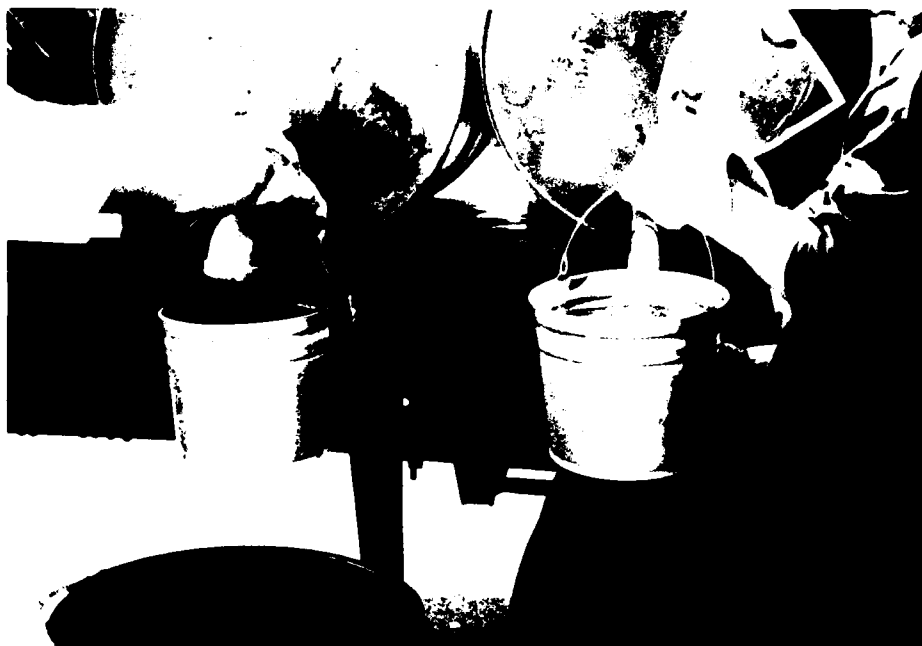
Photo 7. Galvanized steel buckets used to measure and transport sealer components

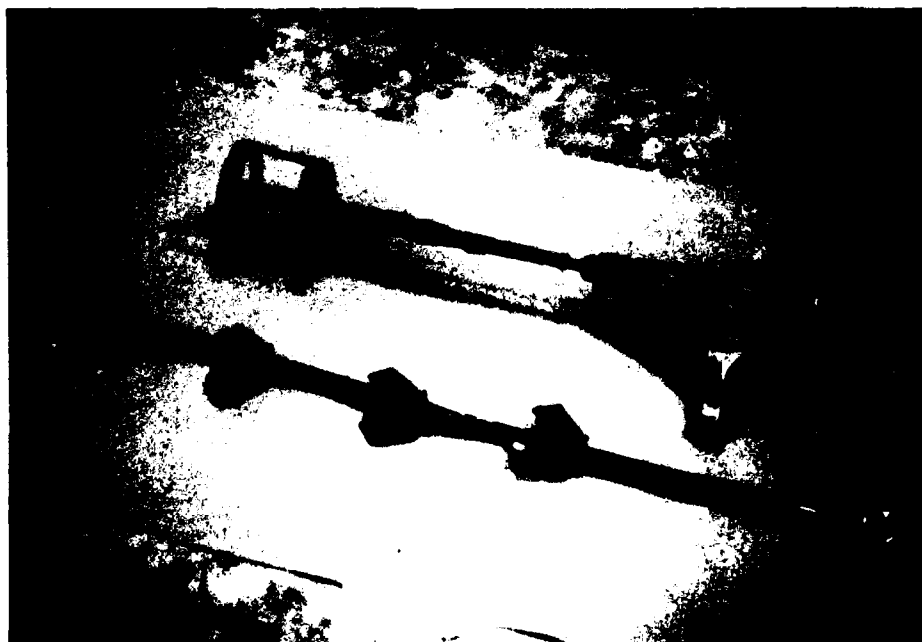
Photo 8. One-half-inch electric drill with metal stirring attachments

was used to mix the sealers and sand for application. One of the two mixing attachments (see mixing blade attached to drill in Photo 8) was designed not to splash, an important feature during mixing operations. Wooden paddles were used to mix materials that required mixing to the bottom of the barrels. The use of wooden paddles would also be advantageous when there is no electricity available (see Photo 4). A small portable generator was used to provide electrical power for the two demonstration projects. Several 10-qt galvanized buckets were used for measuring the sealers and sand and to handle the mixture. Three types of squeegees were used in the demonstrations. Two of them were rubber tipped—one with wooden support and one with metal support (Photo 20). The wooden-supported squeegees were stiffer, mainly because there was less unsupported rubber. The last type was a metal wire bristle squeegee (Photo 15). A 32-gal capacity plastic garbage can was used for mixing. Any similarly sized container will work for mixing, and one that has handles will assist in any transport.

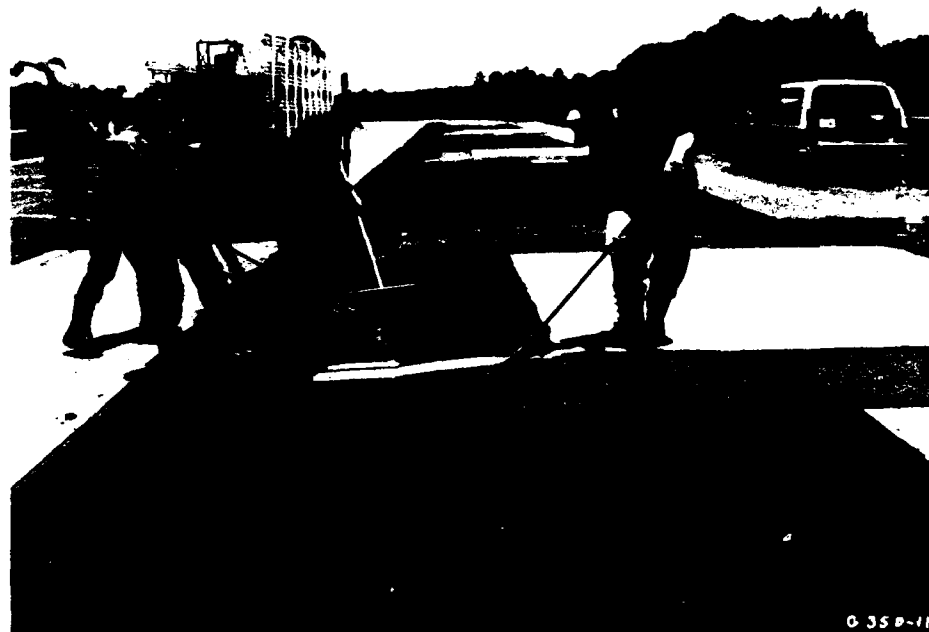
Photo 9. Applying sealer around a concrete helipad

12. The sealer mixture was poured on the asphalt pavement and squeegees were used to spread the material (Photo 9). Two types of squeegees were used—stiff wooden-supported rubber and more flexible metal-supported rubber squeegees. Two coatings of each sealer were applied to each area on successive days (Table 2).

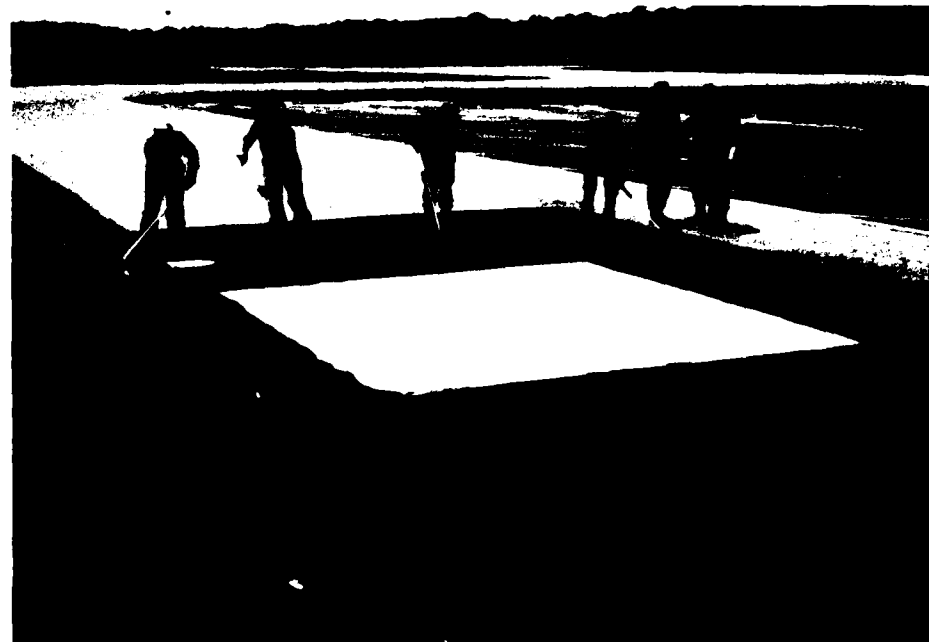
Photo 10. Nearly completed sealed helipad

13. The Ft. Rucker demonstration was conducted from 26-27 May 1984. Ten sites (landing pads) were selected for the demonstration at Lowe US Army Heliport. The first day each pad received a coating of one of the sealers followed by another coating of the same material the next day. The weather was warm and sunny during the entire demonstration period. The concrete pads measured 13 by 15 ft and the sealer application extended outward approximately 15 ft in all directions from the edge of the concrete. This resulted in a sealed area of approximately 140 sq yd around each pad (Photo 10).

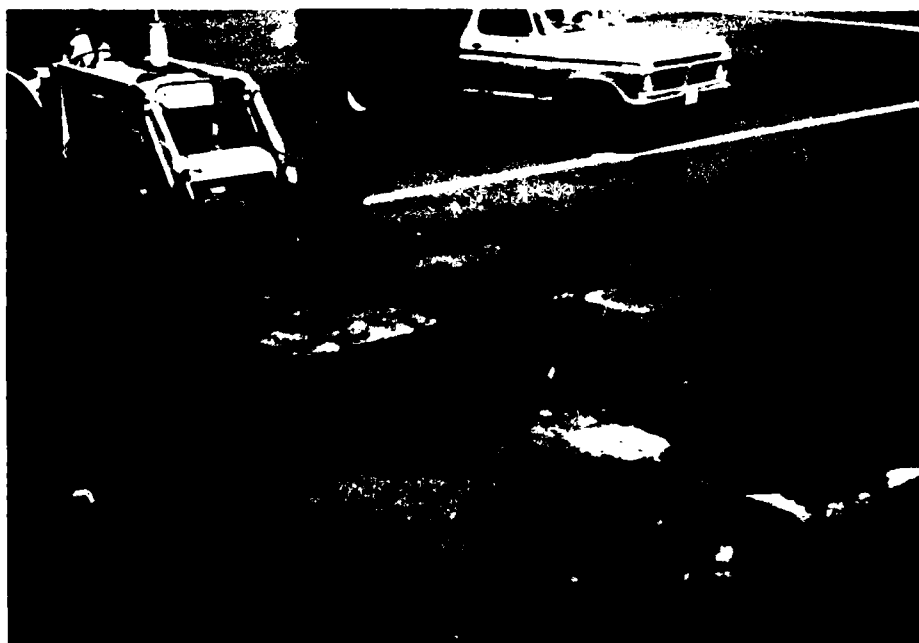
Photo 12. Removing fuel-damaged pavement prior to patching

14. The pavements sealed were parking aprons used primarily by C-12 airplanes (Photo 11). Six parking areas were selected for sealing; two of these were satisfactory for sealing without repairs. The remaining four parking areas damaged by previous fuel spillage were repaired shortly before application of the fuel-resistant sealers (Photos 12-14). Scheduling difficulties prevented allowing the recommended cure time of the asphalt patches before sealing. The areas were sealed one day after they were patched.

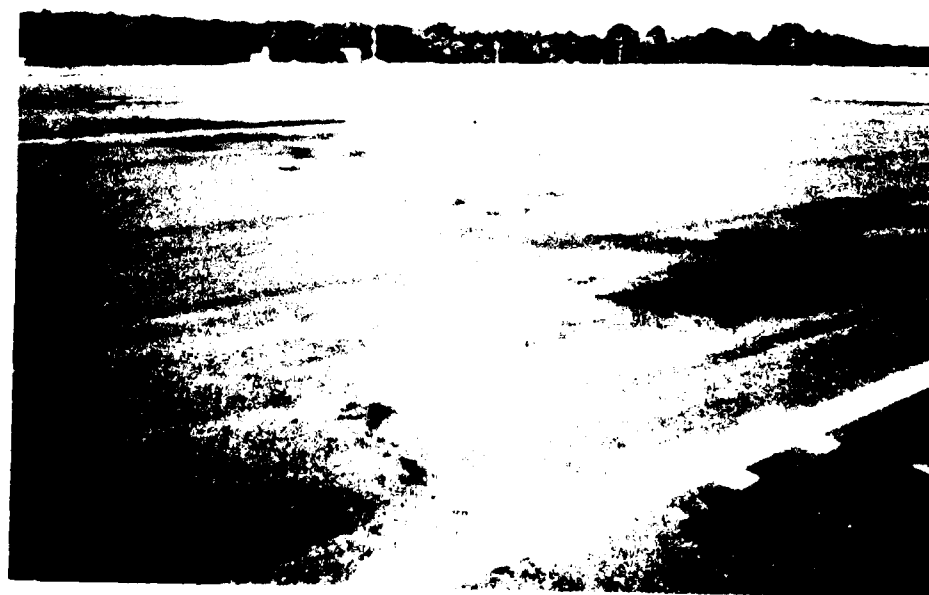
Photo 16. Apron area, lower right, before sealing with No. 21 Epoxy

17. The Ft. Belvoir demonstration was conducted from 27-30 June 1984 at Davison US Army Airfield. Two parking areas with limited minor distress from previous fuel spillage (Photo 16) were sealed with No. 21 Epoxy. The sealer was applied to these areas in a single coating (Photo 17). The manufacturer's representative advised that a single coating was satisfactory to obtain a complete seal. The remaining four products were placed in two coatings on four repaired parking areas. The individual parking areas which were sealed measured approximately 60 by 50 ft.

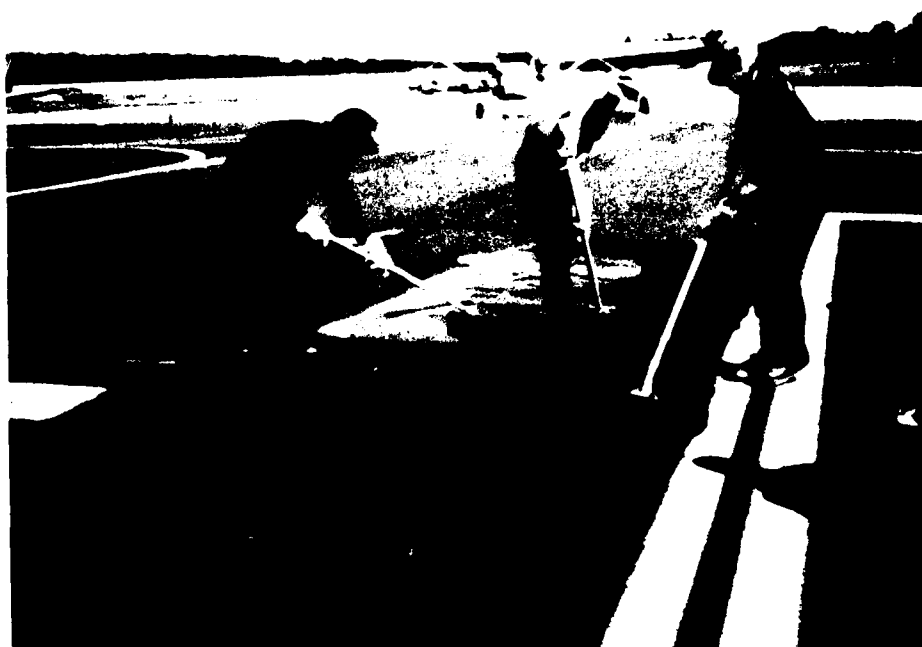
Photo 17. Applying No. 21 Epoxy

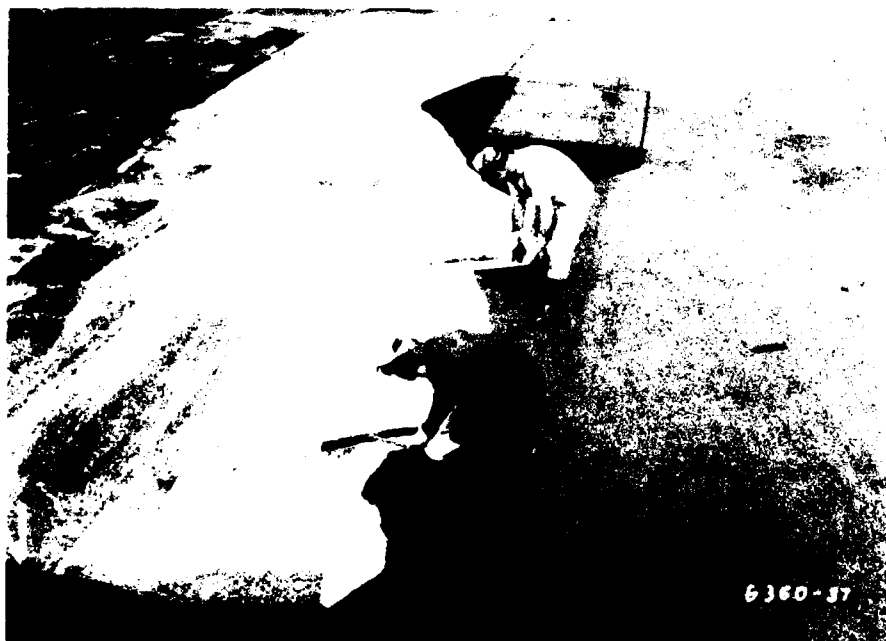
Photo 22. Applying sealer with squeegees
