EVALUATION OF FLEXMAT AS AN ASSAULT EGRESS SURFACING

TECHNICAL REPORT GL-86-12

July 1986

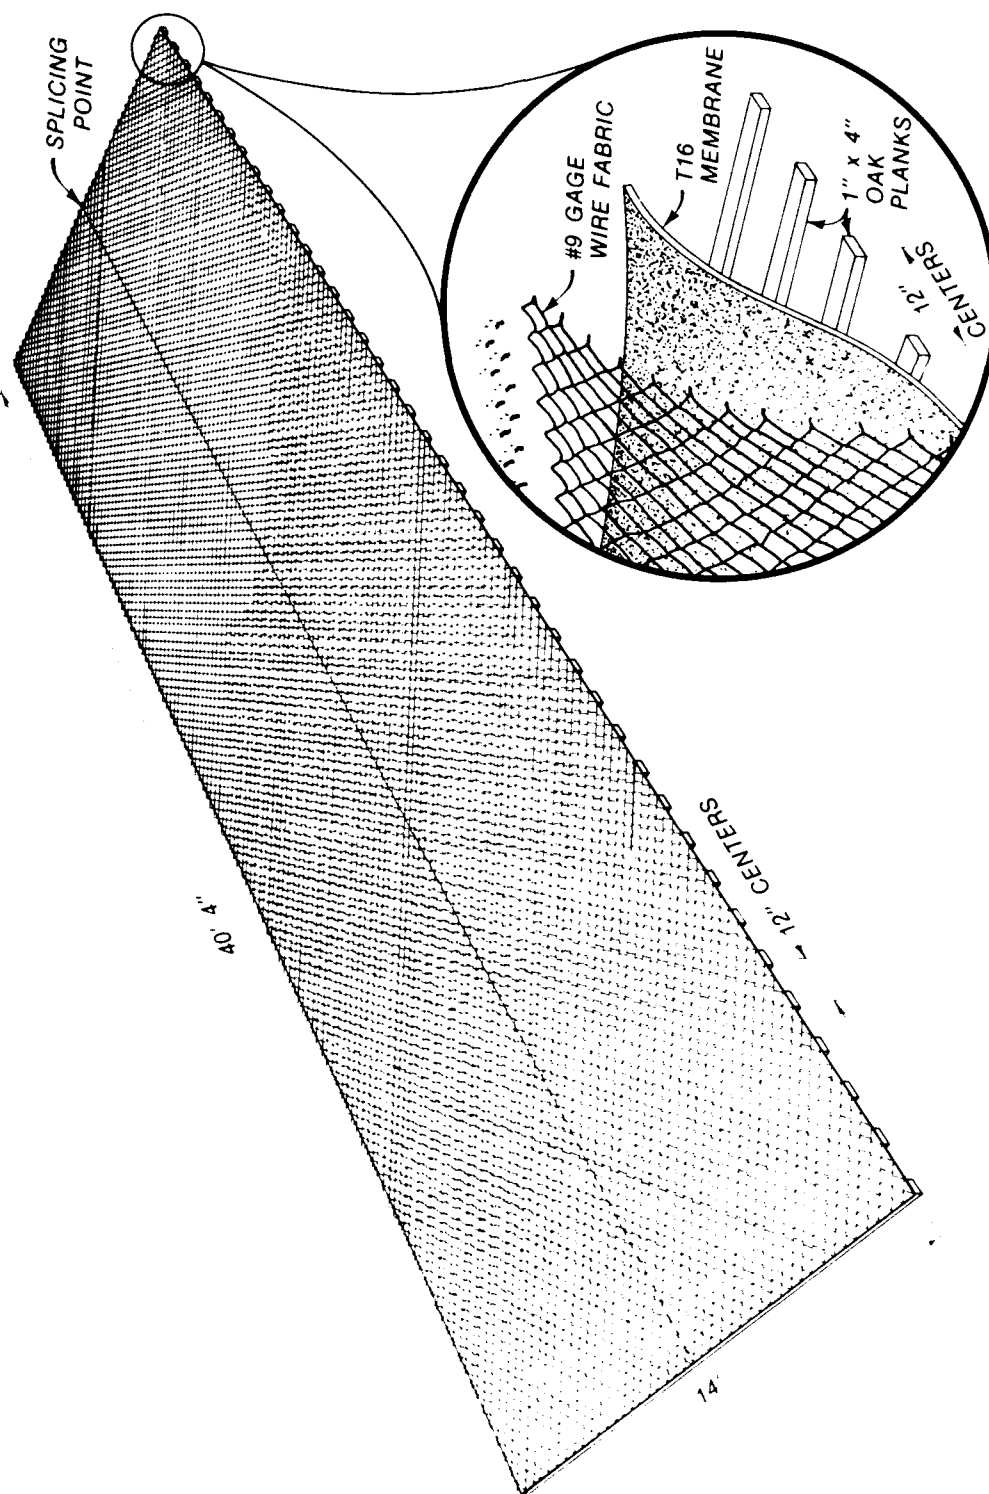
Figure 1. Graphical representation of Flexmat I

10. The initial design for the Flexmat specified that the mat be 14 ft wide by 40.33 ft long and constructed of galvanized steel wire fabric, single-ply neoprene-coated nylon membrane surfacing (T16), and oak planks. A graphic representation is shown in Figure 1. The woven-wire fabric provides traction for a tracked vehicle egressing a muddy stream, and the membrane waterproofs the existing slope and allows water tracked up the slope by the egressing vehicle to be channeled back into the stream without causing additional weakening of the soil. The 1- by 4-in. oak planks were placed on the under side of the membrane and spaced on 12-in. centers to serve as cleats to help anchor the mat on the slope. Two pieces of 9-gage wire fabric were spliced to form the 14-ft width necessary and placed over the membrane. One-inch staples were then used to fasten the T16 membrane and the wire fabric to the oak planks. To facilitate positioning into the water, weights were attached to the mat. The completed Flexmat ready for transporting and deployment is shown in Photo 4.

11. For the convenience of the reader, Table 2 identifies the various materials used in construction of the four Flexmat designs, and Figures 1-4 show each design graphically.

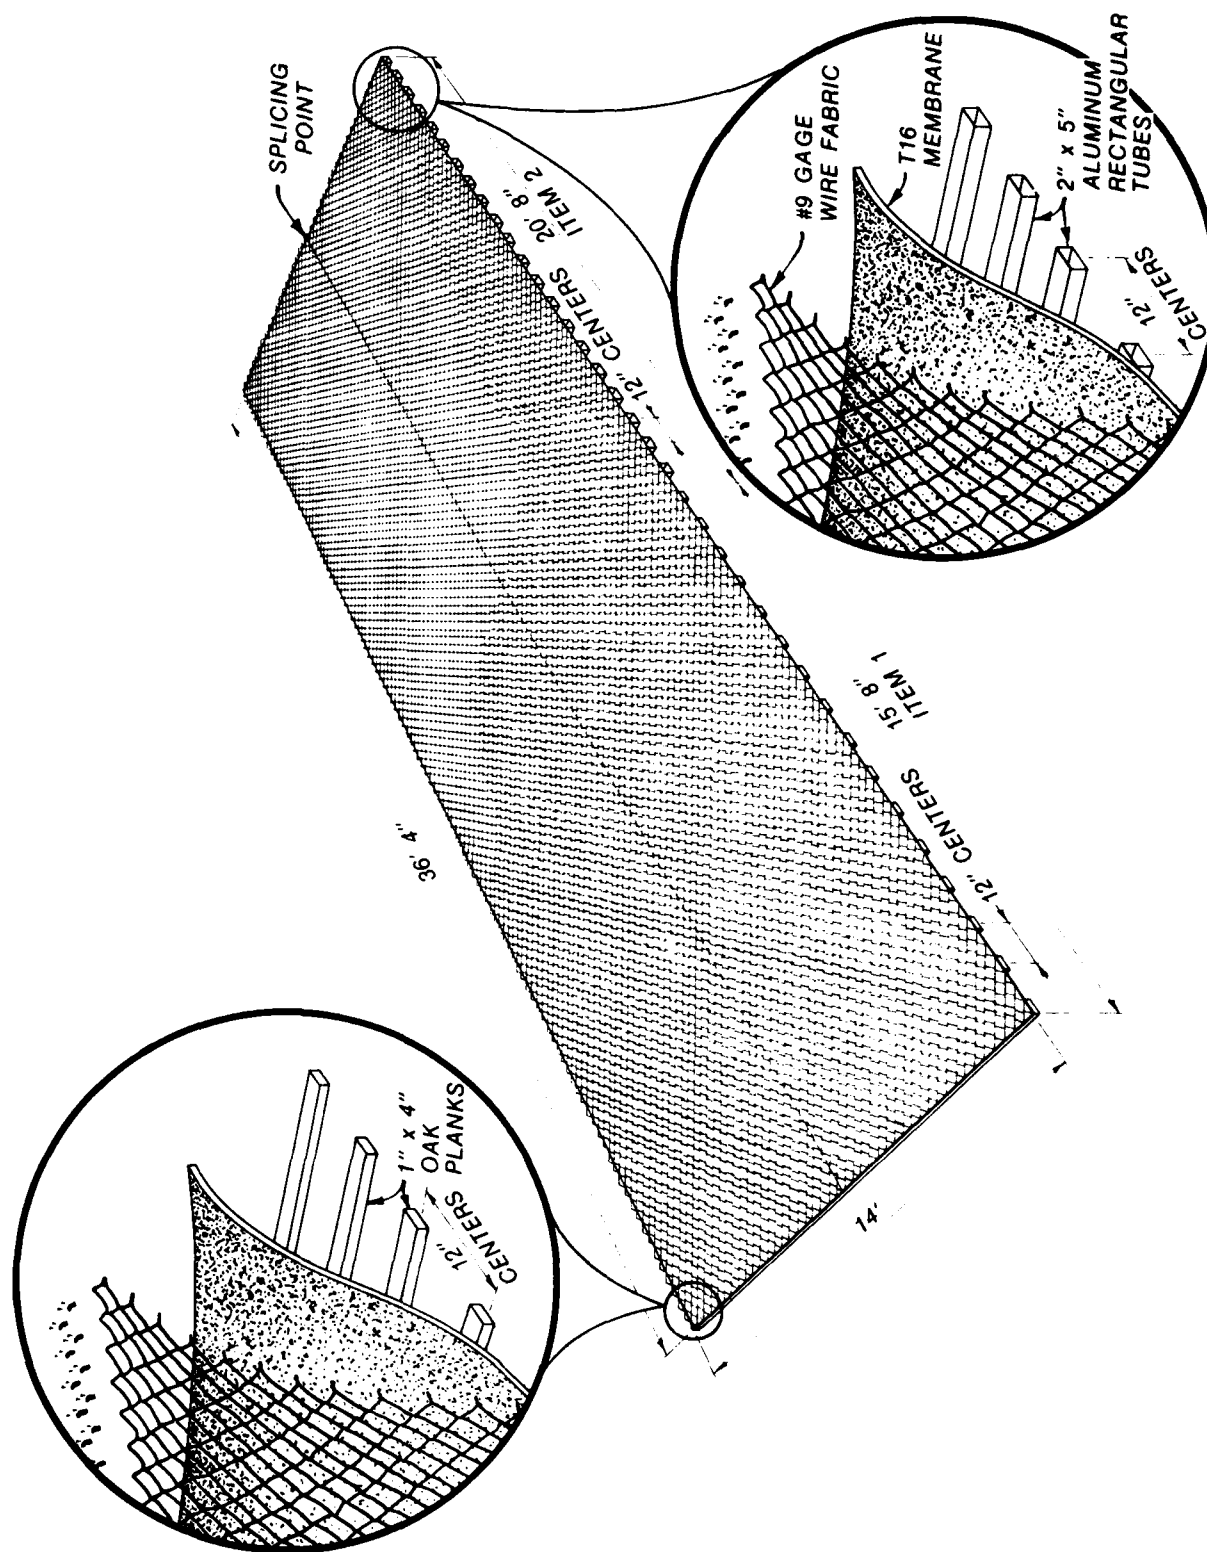
Figure 2. Graphical representation of Flexmat II

18. The Flexmat that the crew used in the second series of tests was a combination of two designs spliced to form a single unit 14 ft wide and 36.34 ft long. The first section, Item 1, was 15.67 ft long and was an undamaged portion of the Flexmat that lay above the waterline in Test I. The second section, Item 2, was 20.67 ft long and was a modified version of the original Flexmat I with the same basic design. The team replaced the oak planks originally specified with 2- by 5-in. aluminum rectangular tubes. Adhesive was used to bond the membrane to the aluminum tubes and the wire fabric was held in place by adjustable stainless steel hose clamps, as shown in Photo 7. A graphical representation of Flexmat II is shown in Figure 2. The completed Flexmat II was rolled into a single roll by the crew for transport to the test site.

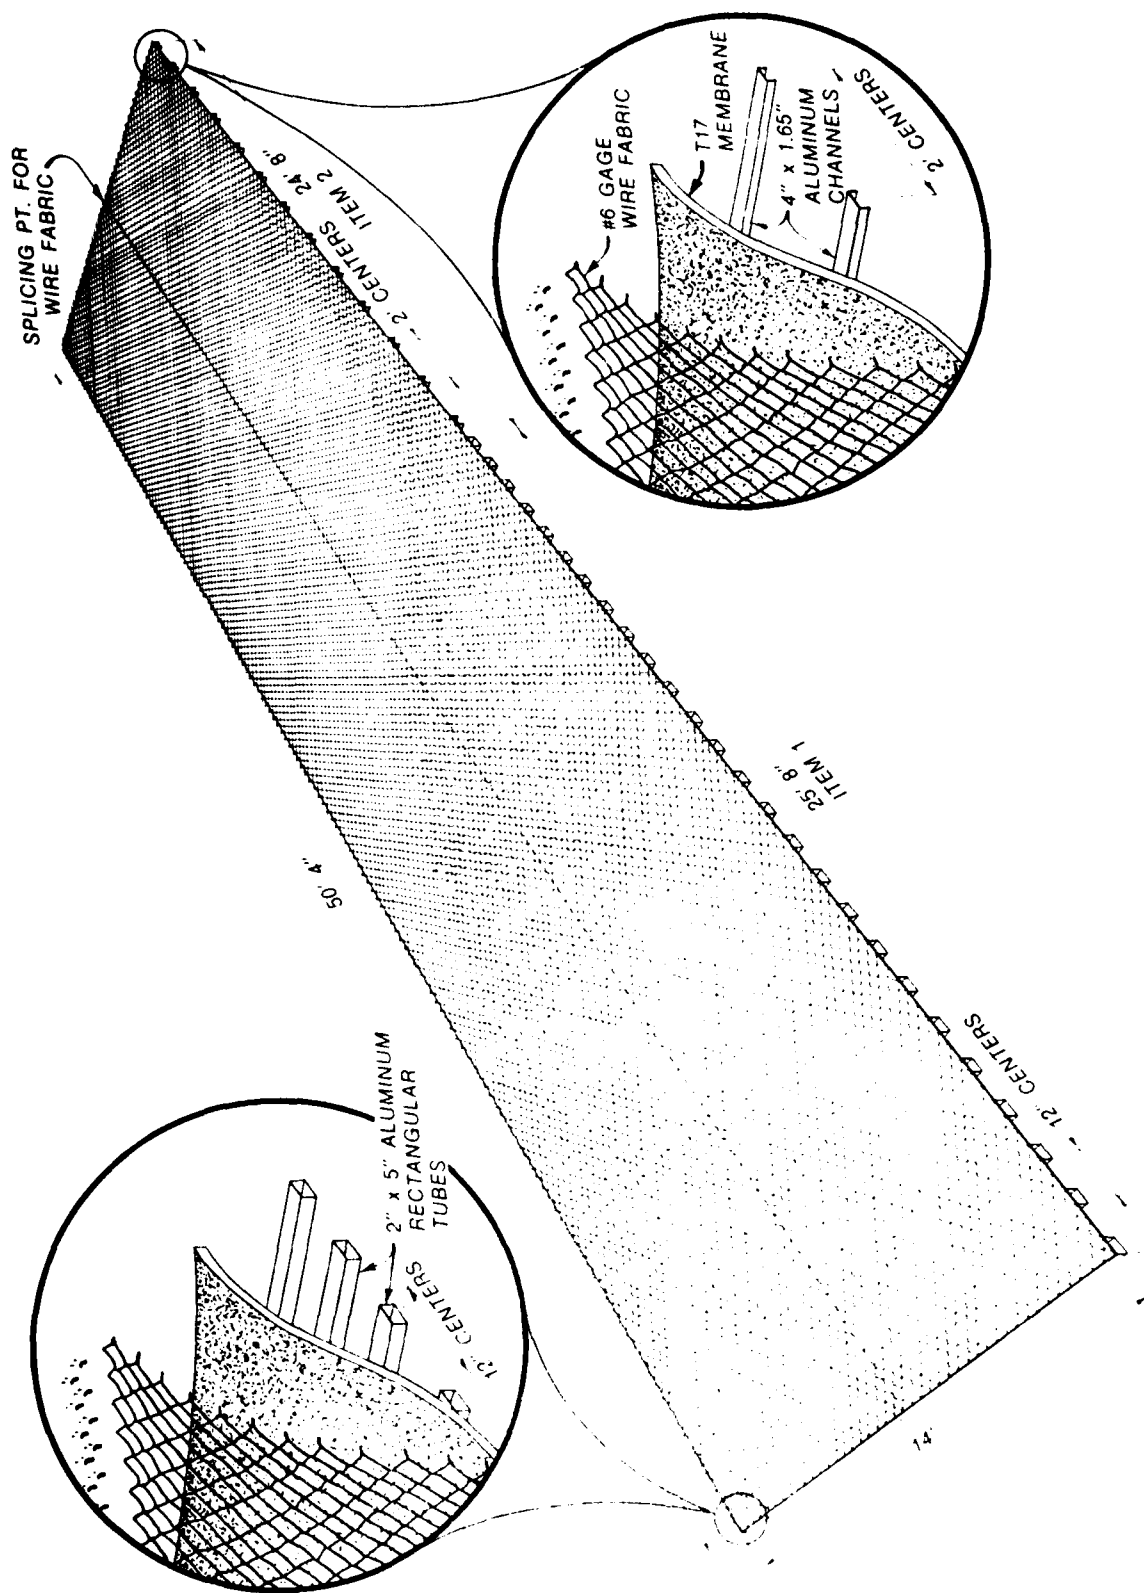
Figure 3. Graphical representation of Flexmat III

22. The Flexmat designed for the third series of tests consisted of two items that formed a single unit 14 ft wide and 50.34 ft long. The No. 6 gage galvanized wire fabric was replaced by the No. 9 gage used in the two previous designs. The membrane was also changed from single-ply T16 to a heavier two-ply version (T17). The components of Flexmat III are shown graphically in Figure 3.

23. Item 1 was 25.67 ft long and had 2- by 5-in. aluminum rectangular tubes spaced on 12-in. centers. Item 2 was 24.67 ft long, but 4- by 1.65-in. American Standard aluminum channels spaced on 2-ft centers were used to replace the rectangular tubes. Self-drilling and tapping hex head screws 1/4 by 3/4 in. were used with 2- by 3/4-in. aluminum clips in Items 1 and 2 to fasten the Flexmat III. The spacing of the aluminum clips used for Items 1 and 2, however, was different and is shown in Photos 11 and 12, respectively. After fabrication was completed, the Flexmat III was rolled into a single roll for transport to the test site.

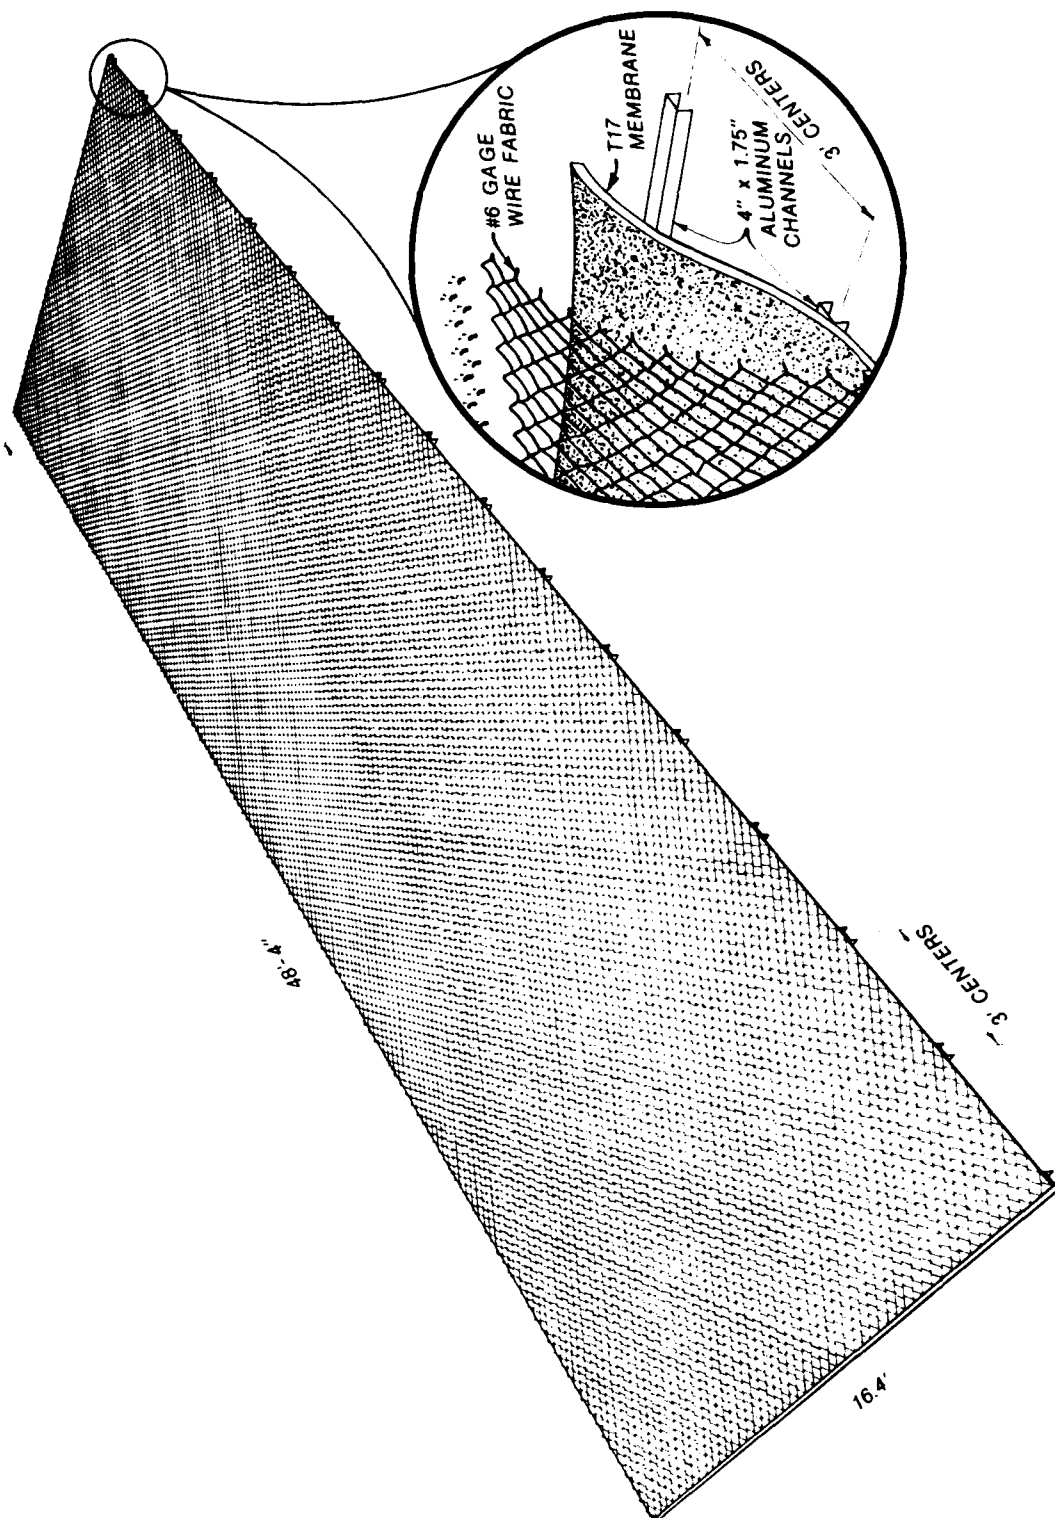
Figure 4. Graphical representation of Flexmat IV

35. The fourth design of the experimental egress surfacing, Flexmat, was 16.4 ft wide and 48.33 ft long. Nominal 4- by 1.75-in. aluminum channels spaced on 3-ft centers supported layers of T17 membrane and wire fabric. The No. 6 gage aluminum-coated wire fabric was one continuous piece with the same dimensions as Flexmat IV. The components of Flexmat IV minus the self-deploying masts are shown in Figure 4. Self-drilling and tapping Phillips pan head screws (1/4 in.-14 Unified National Coarse (UNC) by 1 in.) were used with 2- by 3/4-in aluminum clips to fasten the wire fabric and membrane to the channels. The Phillips pan head screws replaced the hex head screws used in the two previous designs to prevent the APC tracks from damaging the exposed screw heads.

36. A self-deploying visual marking system was added to the design to enable the driver of the test vehicle to align the APC with the mat. An 8-ft-long, 3/8-in.-diam fiberglass mast was threaded through an 11-in.-long, 5-in.-diam floating marker and attached to each corner of the mat that would be submerged. The system was designed so the masts would roll up inside the Flexmat IV for storage and would automatically spring up when the mat unrolled into the water.

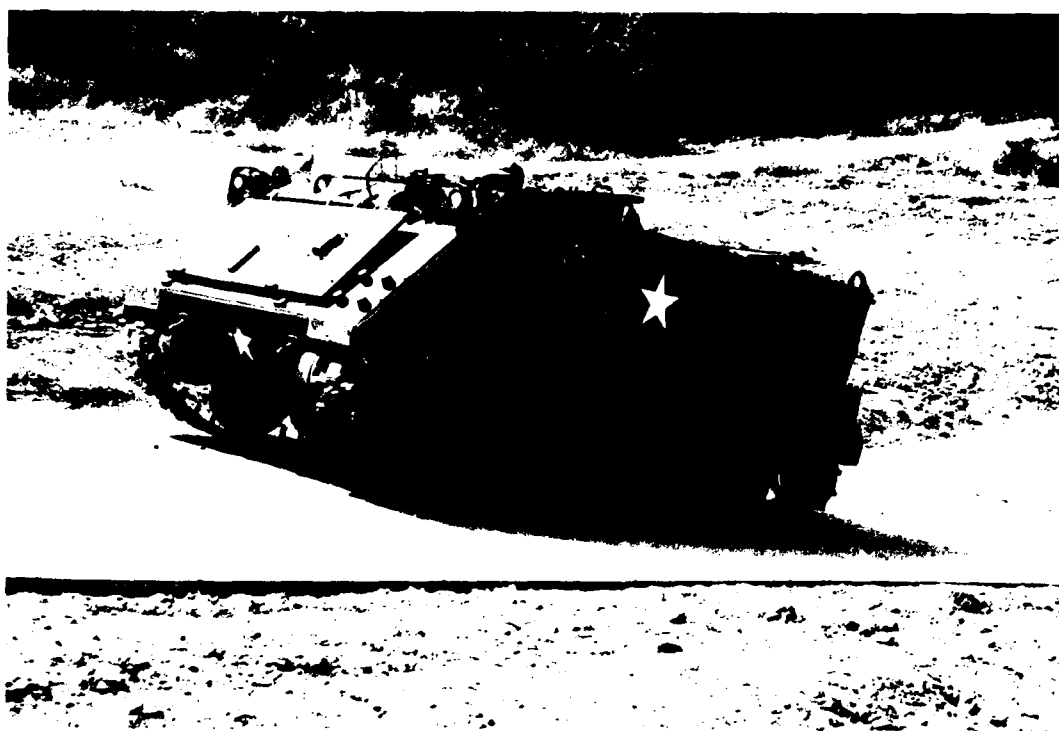
Photo 1. M113 APC

9. During this investigation, three test vehicles were used to simulate military vehicular traffic. An APC, as shown in Photo 1, was used to conduct all the slope climbing tests. The weight of the APC used for each test is given in Table 1. Traffic tests were conducted using the APC, an M48A1 tank loaded to 140,000 lb, and a ribbon bridge transporter loaded to 47,400 lb. The tank and the transporter are shown in Photos 2 and 3, respectively.

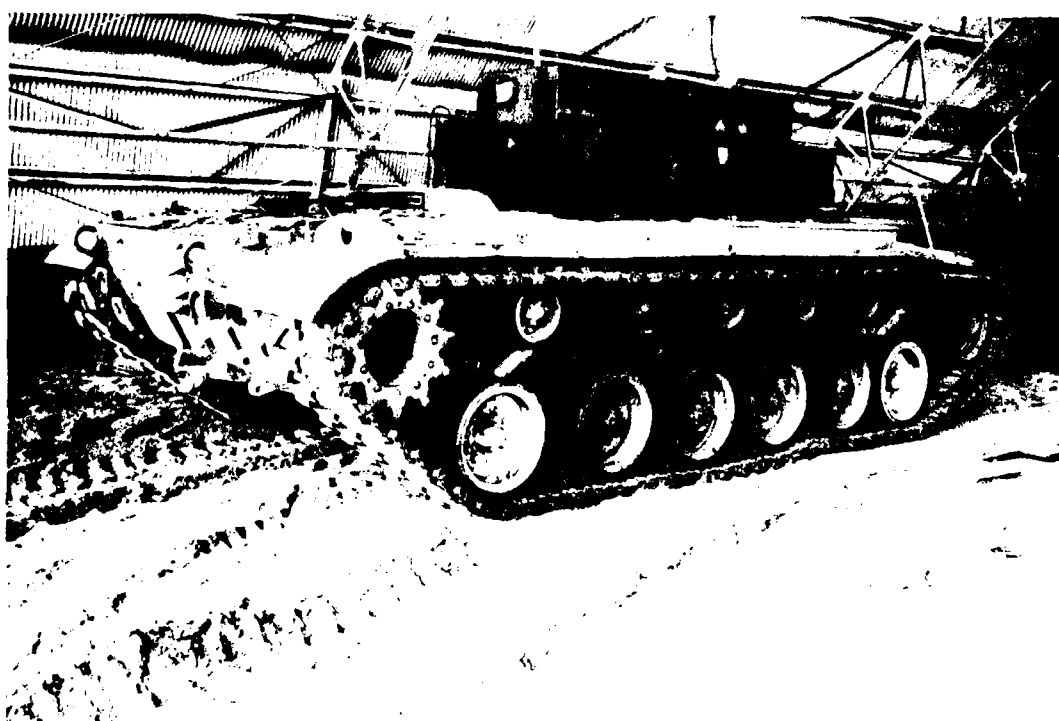
Photo 2. M48A1 tank

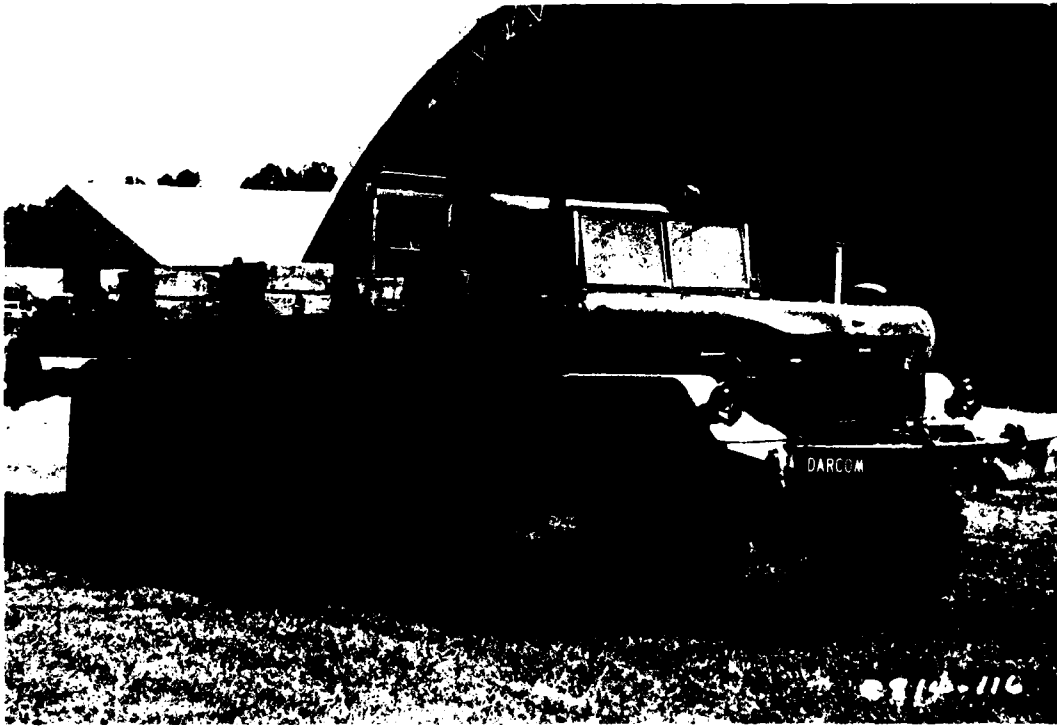
Photo 3. Ribbon bridge transporter

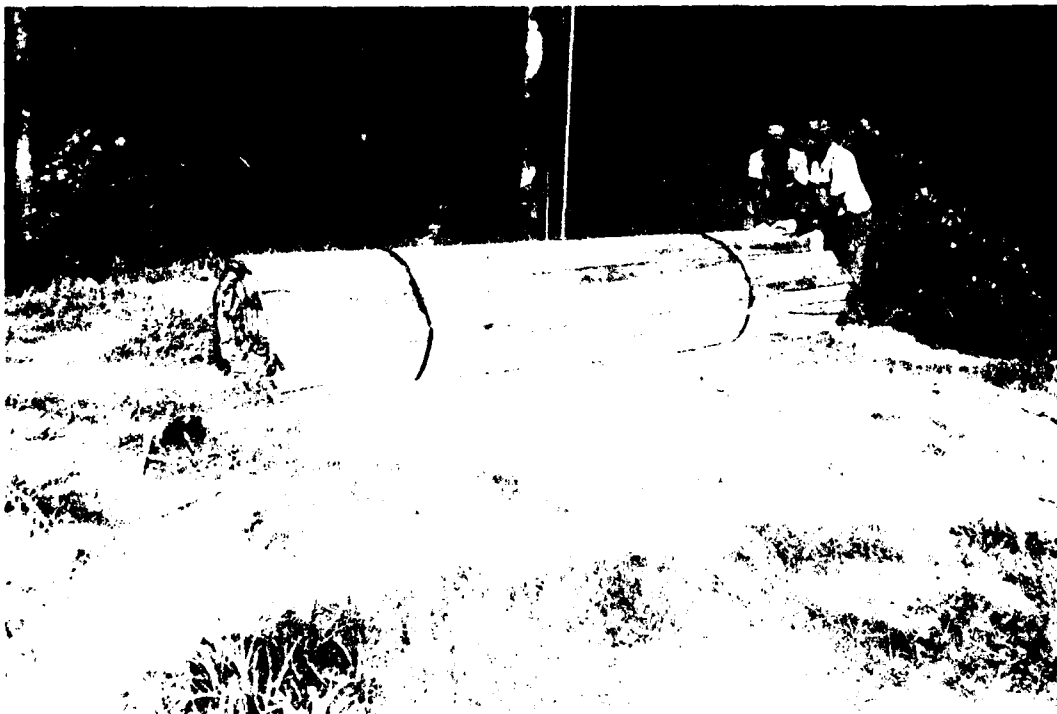
Photo 4. Flexmat I, single roll

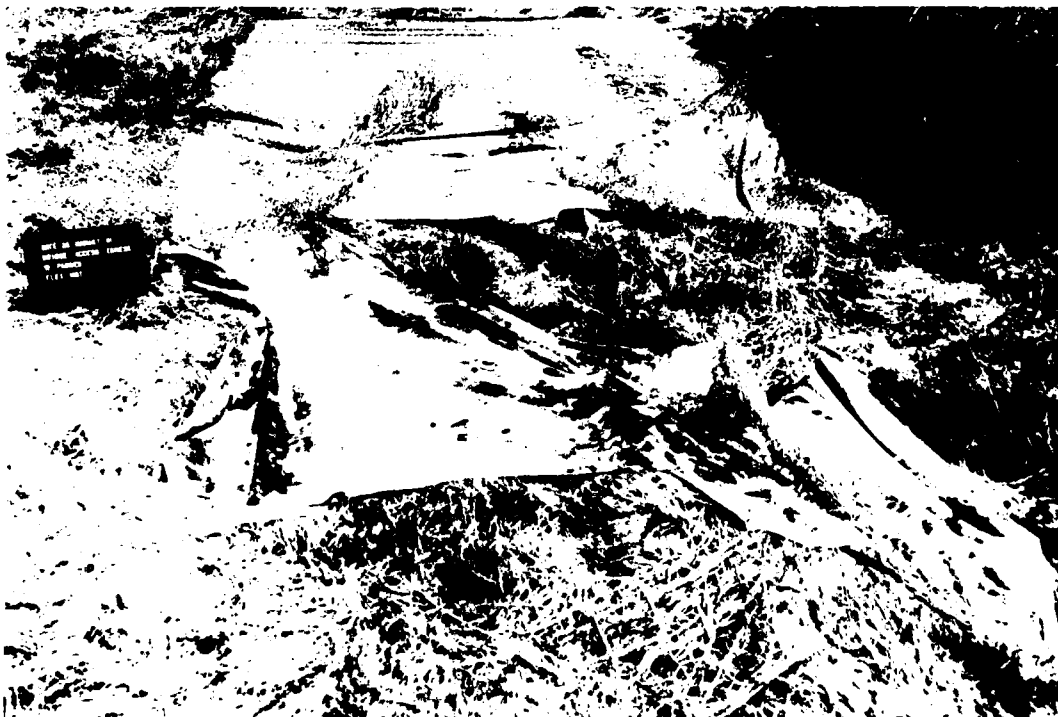
Photo 6. Flexmat I, after removal from test site

17. After the final pass was made with the test vehicle, the team found that the 20-ft long portion of the mat on the slope was in excellent condition. However, the part of the mat that had been immersed had sustained severe damage. Several staples had been pulled out or broken causing the wire fabric to separate from the oak planks along one side and down the center where it had been spliced. The membrane was also separated from the oak planks and torn in several places. A general view of the damaged mat after removal from the lake is shown in Photo 6.

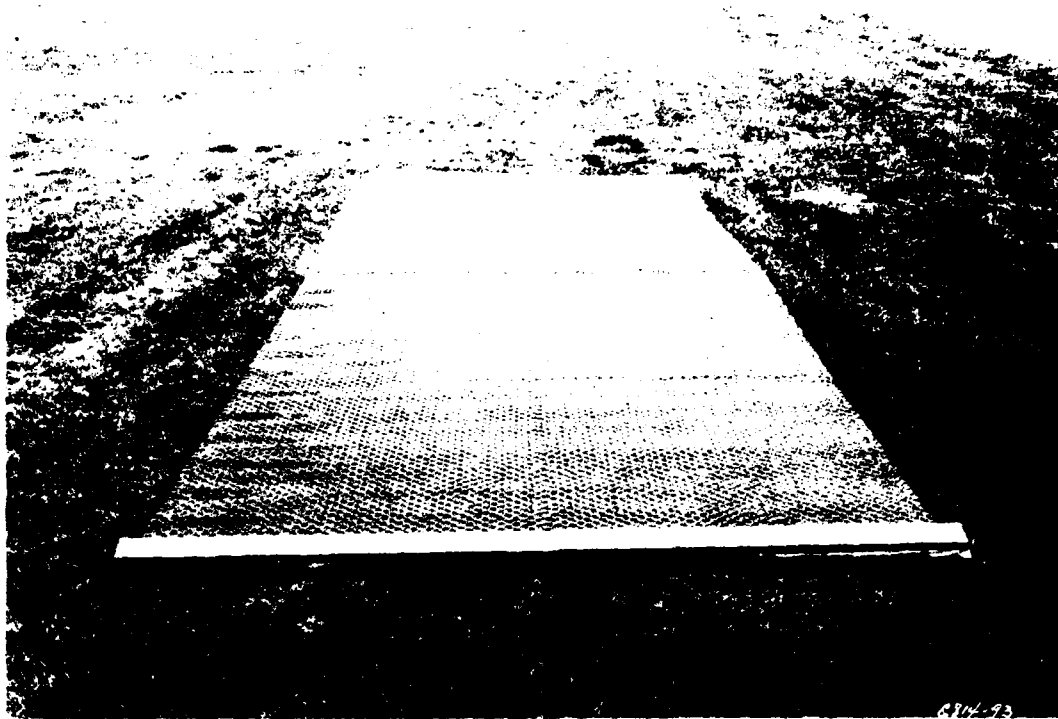
Photo 7. Flexmat II, showing aluminum tube and location of clamps

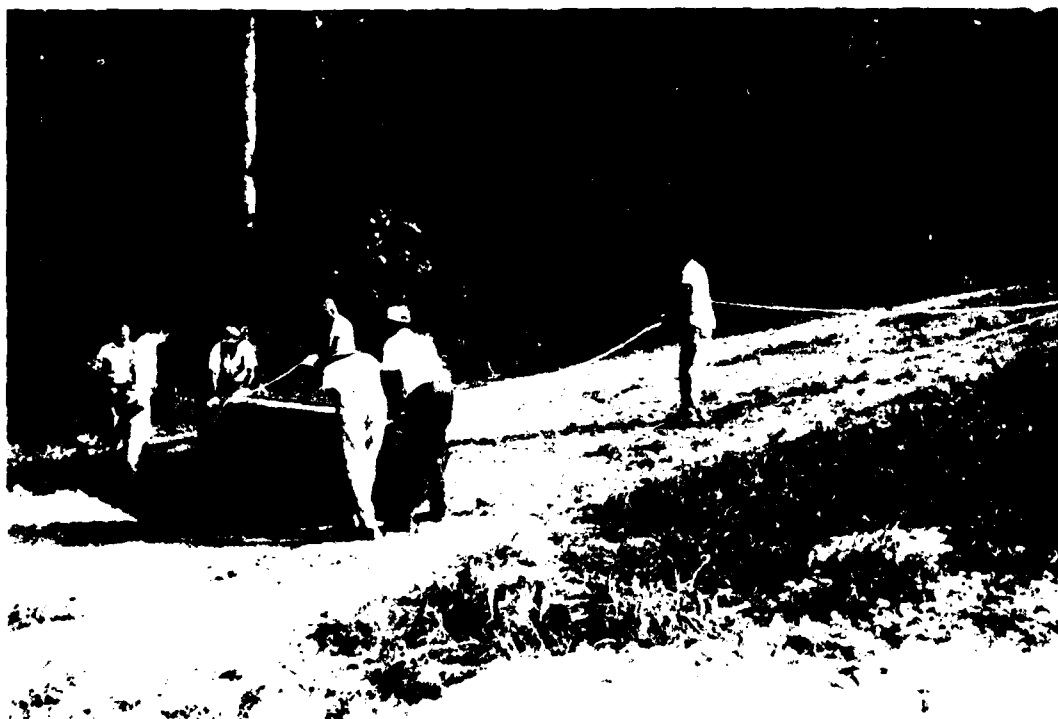
Photo 8. Flexmat II, being placed on 25 percent slope

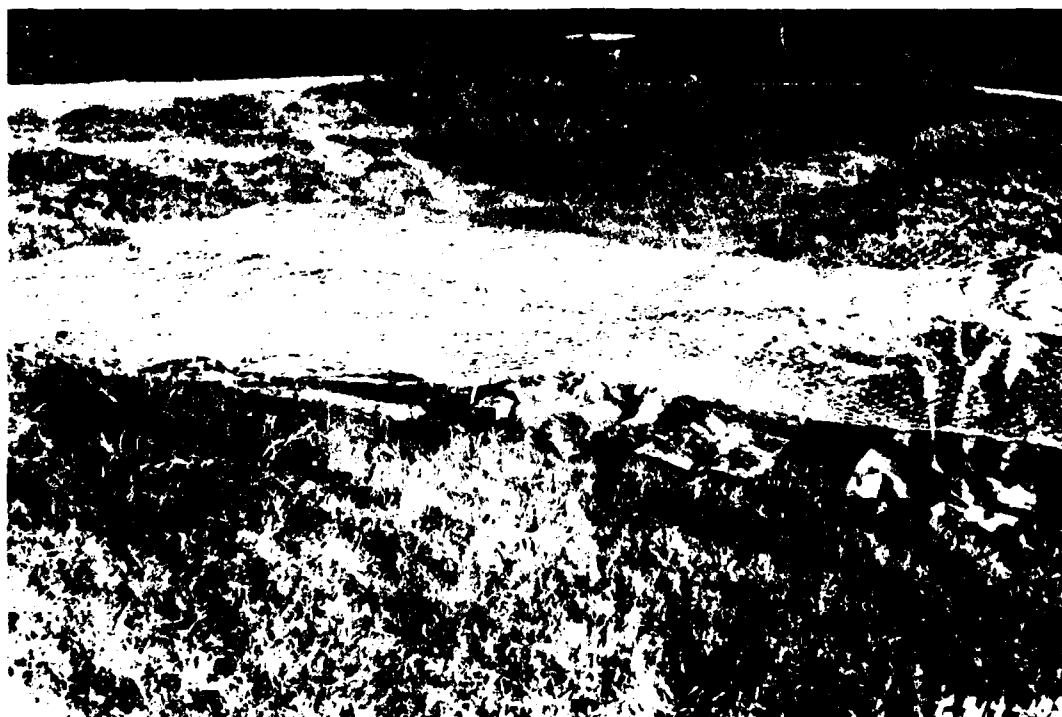
Photo 10. Close-up view of damaged Flexmat II

21. After the team completed the slope-climbing tests, they pulled the Flexmat II from the lake and examined it for damage. The 15.67-ft section of the mat from Test I that remained on the slope above the water was undamaged except for a few staples near the center line that had been pulled out (Photo 9). The section of mat near the waterline sustained severe damage including two aluminum tubes that had pulled completely away from the membrane and wire fabric, one broken tube, and numerous broken clamps. On the lower 13 ft of the mat, the membrane and the beams remained intact and even though the wire fabric was distorted and pulled loose, there were no actual breaks. Photo 10 is a close-up view of the damaged section of Flexmat II. Although the Flexmat II was damaged, it did meet the requirement of 25 egresses.

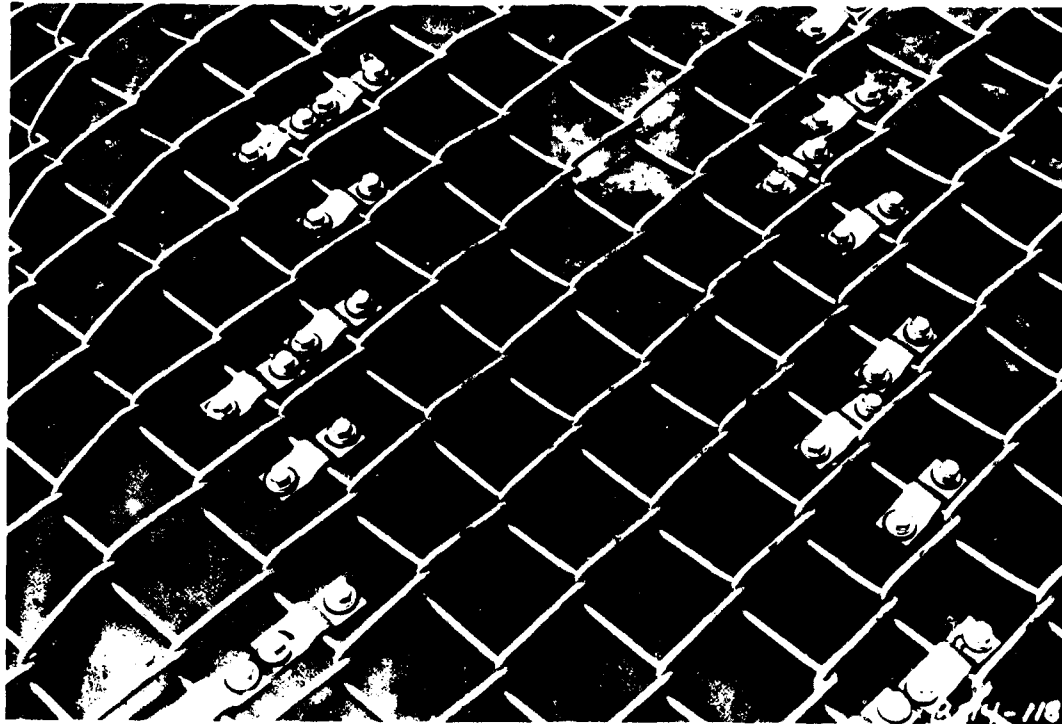
Photo 11. Close-up showing spacing of aluminum clips for Item 1, Flexmat III

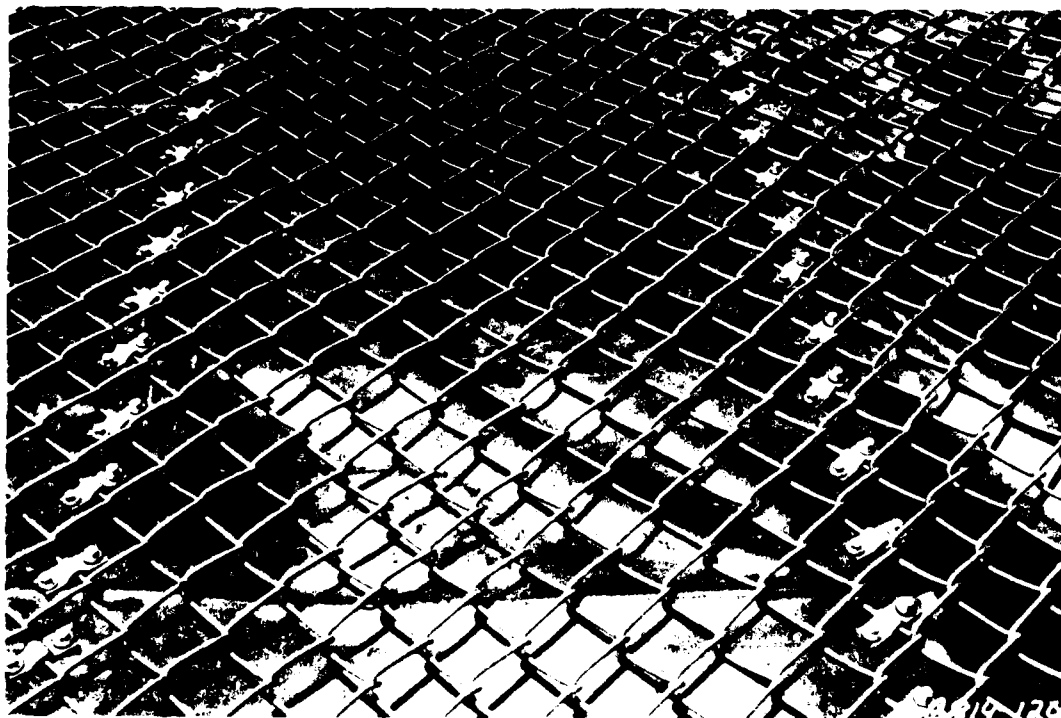
Photo 12. Close-up showing spacing of aluminum clips for Item 2, Flexmat III

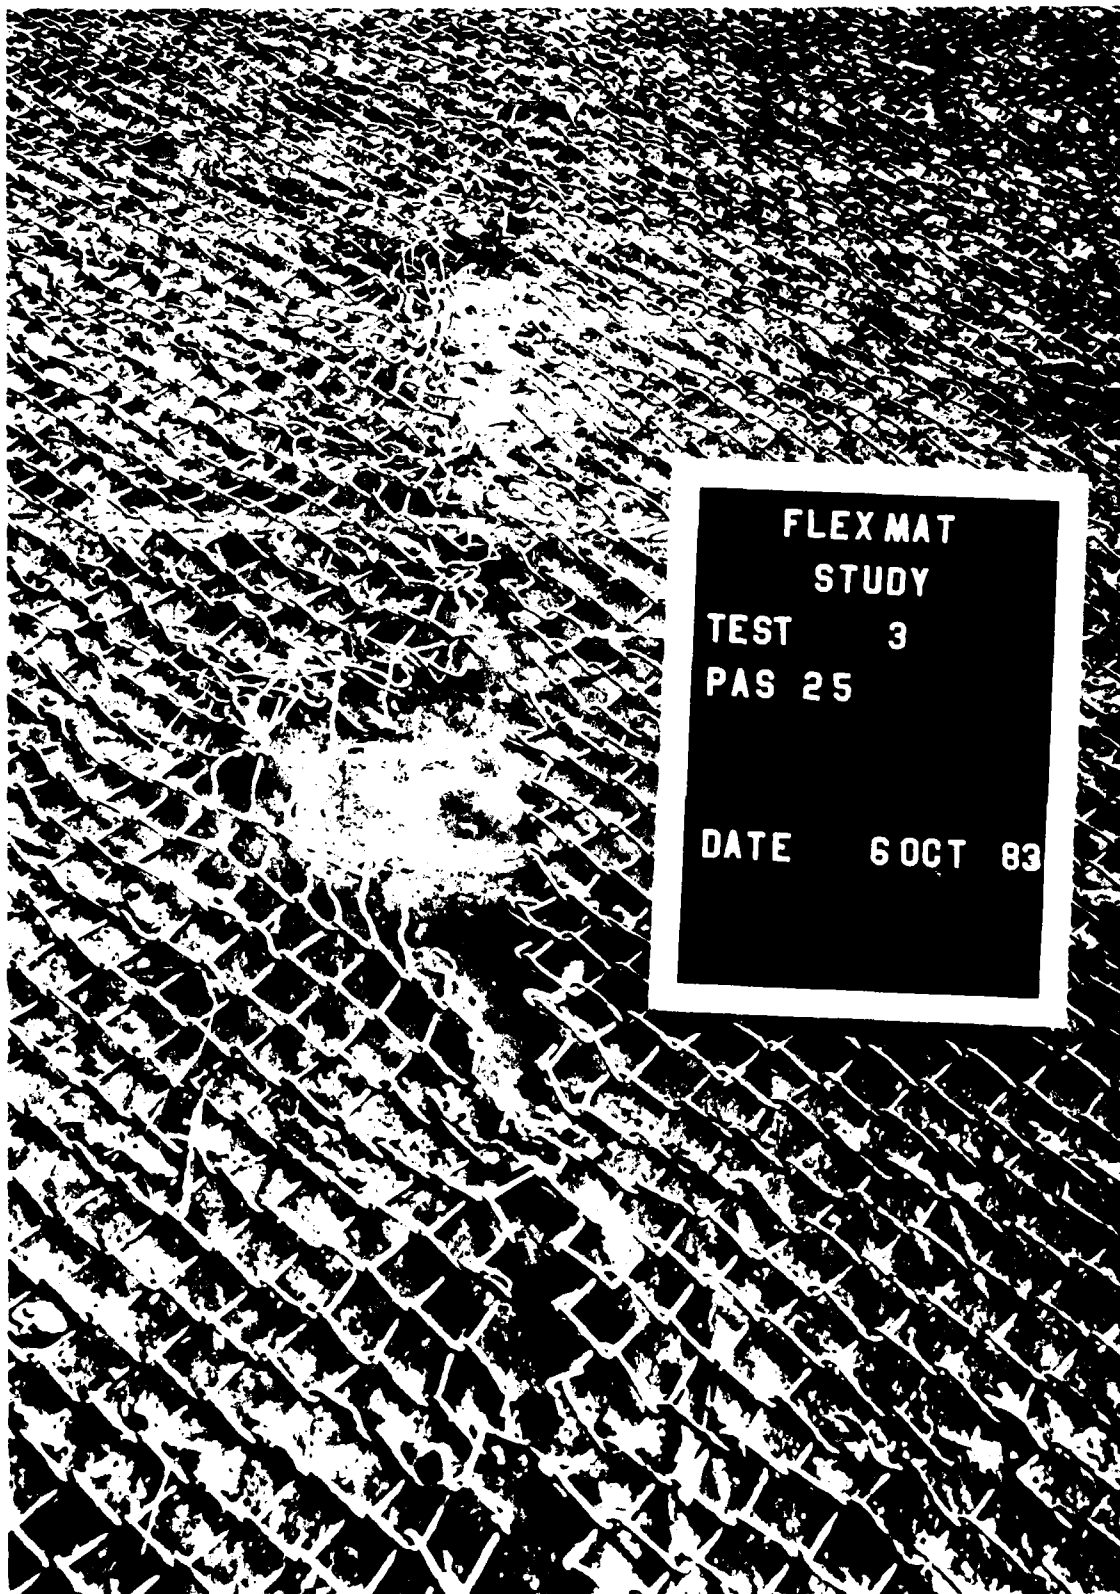
Photo 13. Close-up of damage at center line, Flexmat III

29. After 25 passes were completed in Part A of the test, the team removed Flexmat III from the lake and examined it. The only damage sustained by the mat was along the center line where the wire fabric had been pieced together. Photo 13 shows where the wire fabric had pulled apart due to the test traffic.

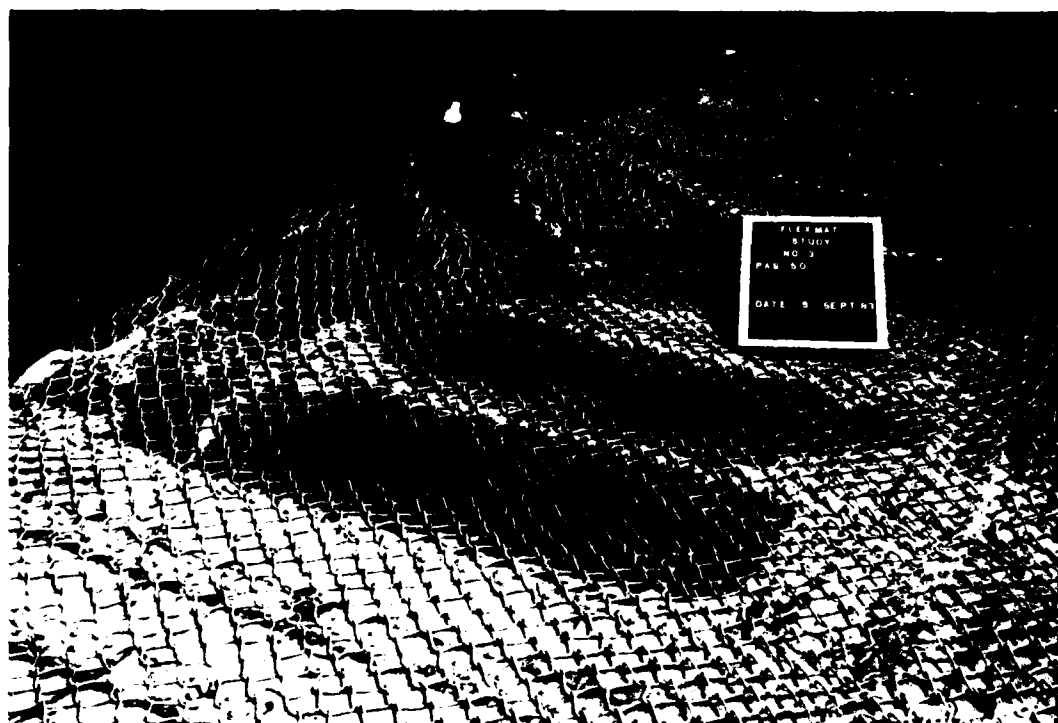
Photo 14. Damage caused by vehicle making side approach, Flexmat III

made a side approach to the mat. The vehicle's tracks became entangled underwater with the wire and beams causing a 2-ft rip in the wire fabric and membrane, shown in Photo 14. Also, two aluminum channels were deformed and one was broken. Although this damage was severe, it was limited only to a small area and did not affect the performance of Flexmat III. Photo 15 is a general view of the mat after all testing had been completed, a total of 57 passes.

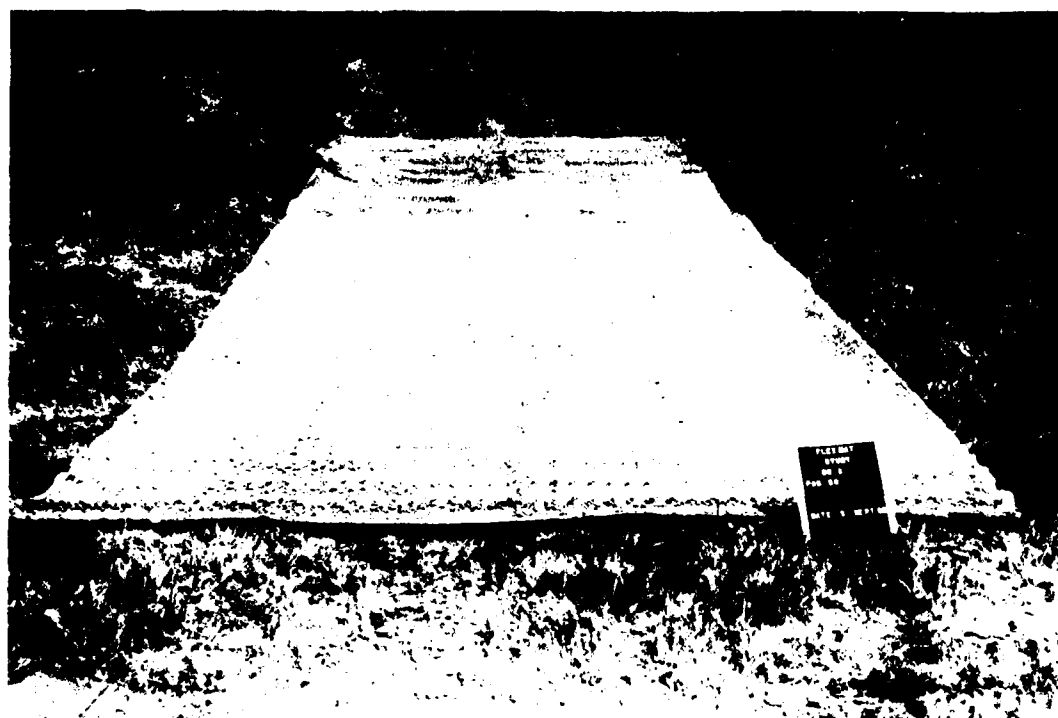
Photo 15. Flexmat III, after 57 passes with APC
