# A TRIDENT SCHOLAR PROJECT REPORT

ENVIRONMENTAL EFFECTS ON IMPACT DAMAGE  
TOLERANCE OF HYBRID COMPOSITE MATERIAL.

UNITED STATES NAVAL ACADEMY  
ANNAPOLIS, MARYLAND  
1986

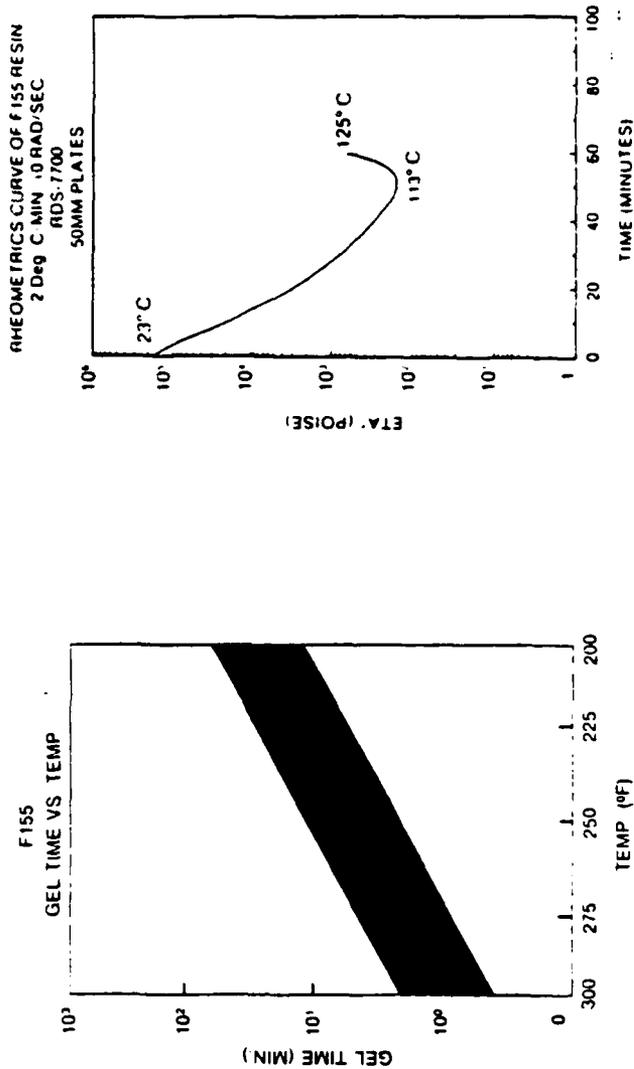
FIGURE 1

## NEAT RESIN PROPERTIES

SPECIFIC GRAVITY	1.336 g/cc
T <sub>g</sub> DRY	250 °F
EQUILIBRIUM MOISTURE ABSORPTION	9.4%
LINEAR COEFFICIENT OF THERMAL EXPANSION	2.93 x 10 <sup>-5</sup> in/in/°F
TENSILE STRENGTH	11.6 ksi
TENSILE MODULUS	0.47 msi
TENSILE STRAIN	5.2%
FRACTURE TOUGHNESS, K <sub>1c</sub>	1.50 ksi $\sqrt{\text{in}}$
	1.37 MPa $\sqrt{\text{m}}$
STRAIN ENERGY RELEASE RATE, G <sub>1c</sub>	4.18 lb/in
	0.73 KJ/m
GEL TIME @ 250 °F	4-10 min.

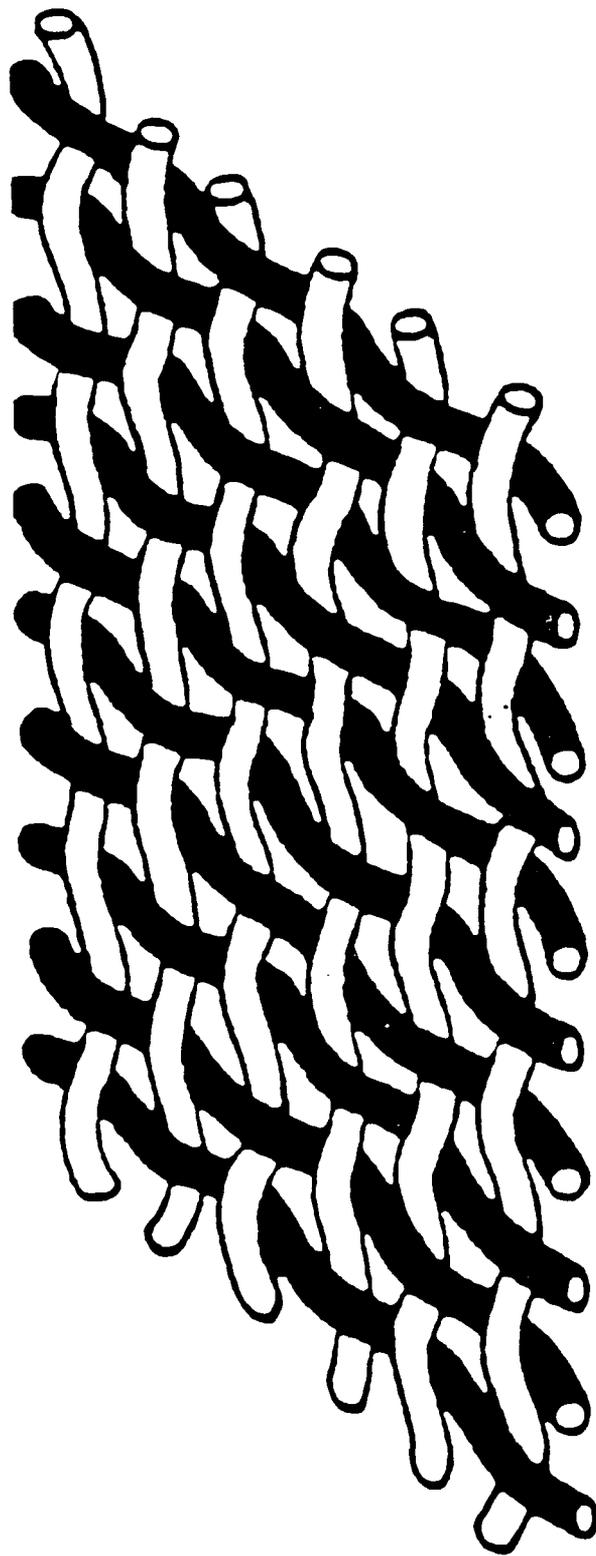
FIGURE 2

# 2-D WOVEN FABRICS

PLAIN

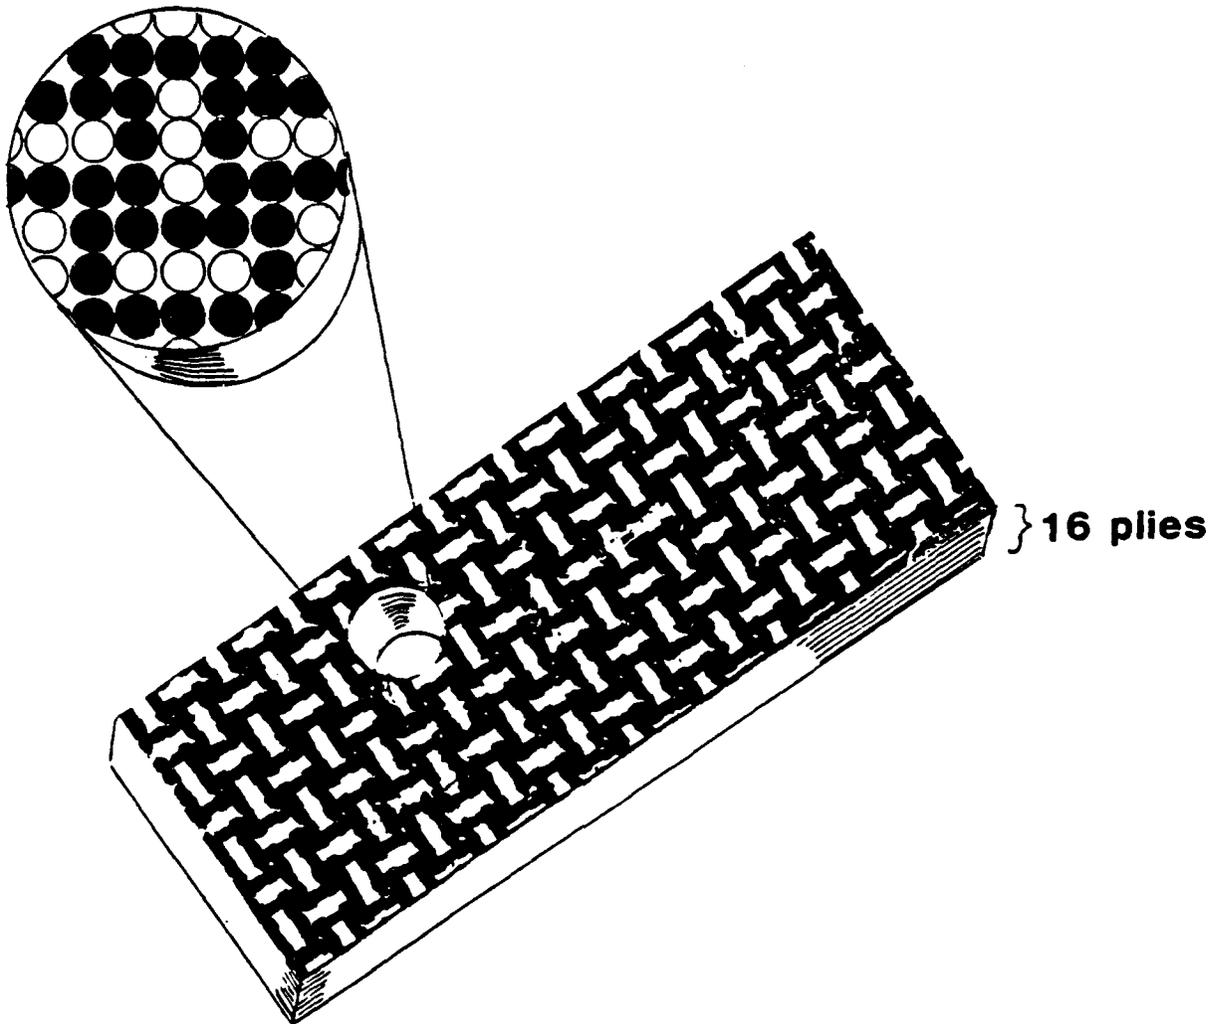
**FIGURE 3**

**Hybrid Weave Pattern**

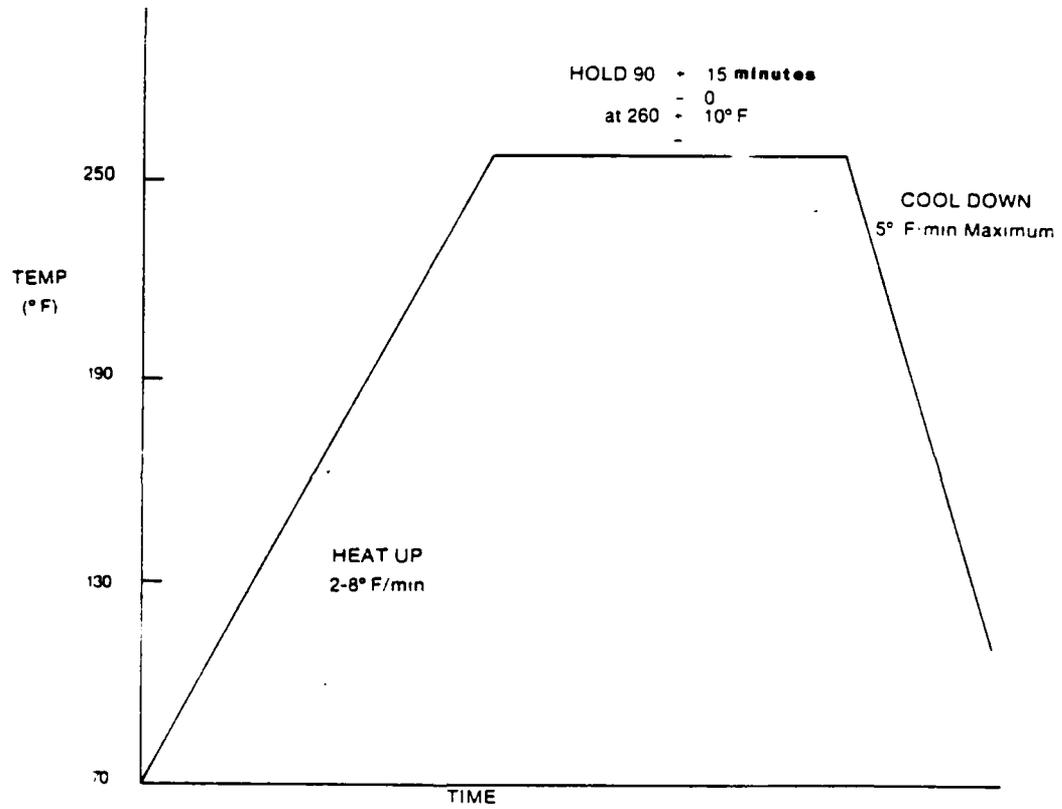
**FIGURE 4**  
CURE CYCLE

**CURE PROCEDURE.**

- A Apply vacuum of 22 in. Hg minimum
- B Apply 85 - 15 - 0 PSIG pressure for laminates.
- C Apply 45 - 15 - 0 PSIG pressure for sandwich \*
- D Vent vacuum bag to atmosphere when pressure reaches 20 PSI
- E During cool down when the part temperature falls below 140° F. pressure can be relieved and the test panel removed from the autoclave and debagged.

\*Typical for HRH 10-1.8-3.0 honeycomb

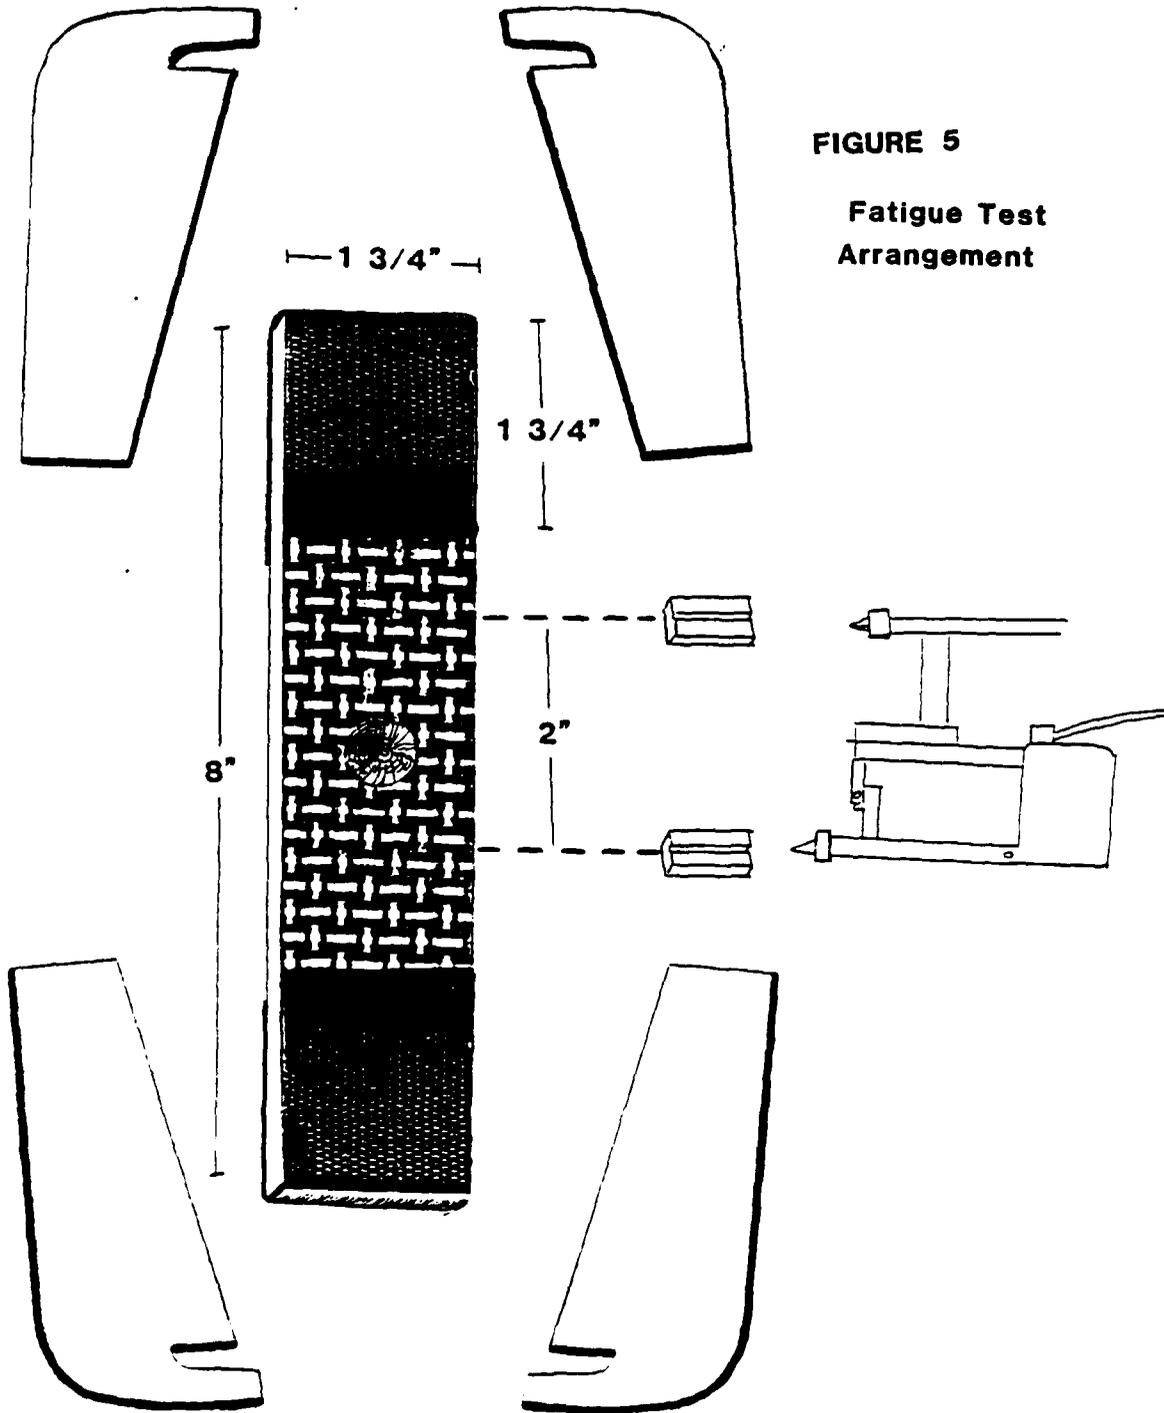
FIGURE 5

Fatigue Test  
Arrangement

The ends (approximately 1 3/4 in. (44 mm)) were coated with a thin layer of MS 907 epoxy manufactured by Miller-Stephenson Chemical Company. This coating served to consolidate the surface fibers in the 0 degree direction and provide a more uniform gripping surface for tensile loading. Emery cloth (320 grit) was interposed between the machine grips and the specimens during fatigue loading to improve the gripping efficiency. The epoxy layer served to insulate the specimen from wear induced by the fatigue loading. This preparation arrangement is shown schematically in Figure 5.

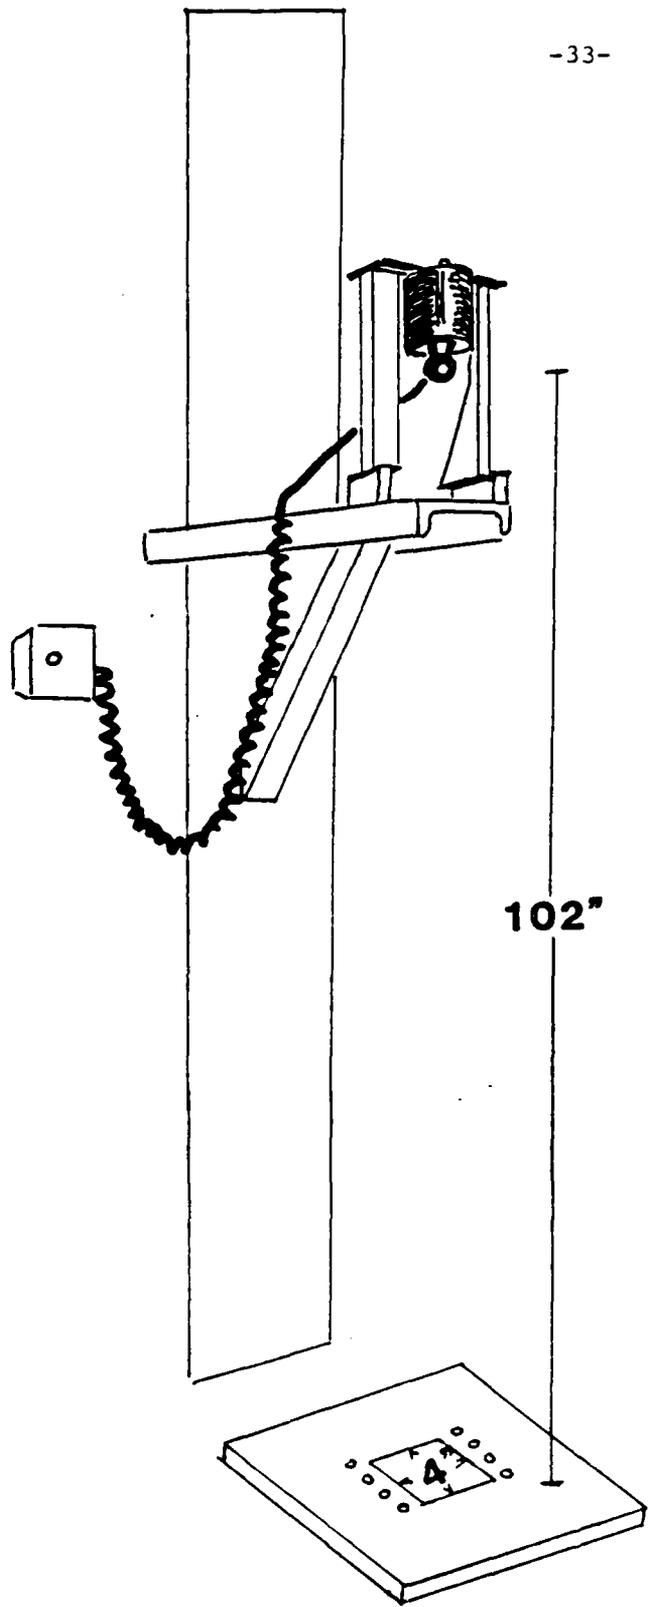
FIGURE 6

102"

Drop Tower

Approximately 75% of the remaining test specimens were subjected to low velocity impact damage prior to fatigue testing. These specimens were damaged utilizing a drop tower located in the Advanced Composite Material Lab, David Taylor Naval Ship Research and Development Center. The drop tower, having a variable-height magnetizing head and steel balls of differing weight, was used to subject each specimen to 120 lbs ( 13.85 N-m). The 2 in. (51.2 mm) diameter ball used weighed 1.18 lb. (0.534 Kg) and was dropped from a height of 102 in. (2.59 m). Figure 6 shows this arrangement. Ramkumar [9] noted that in order to obtain consistent initial damage throughout the specimens, containment of the damage to a constant area was necessary.

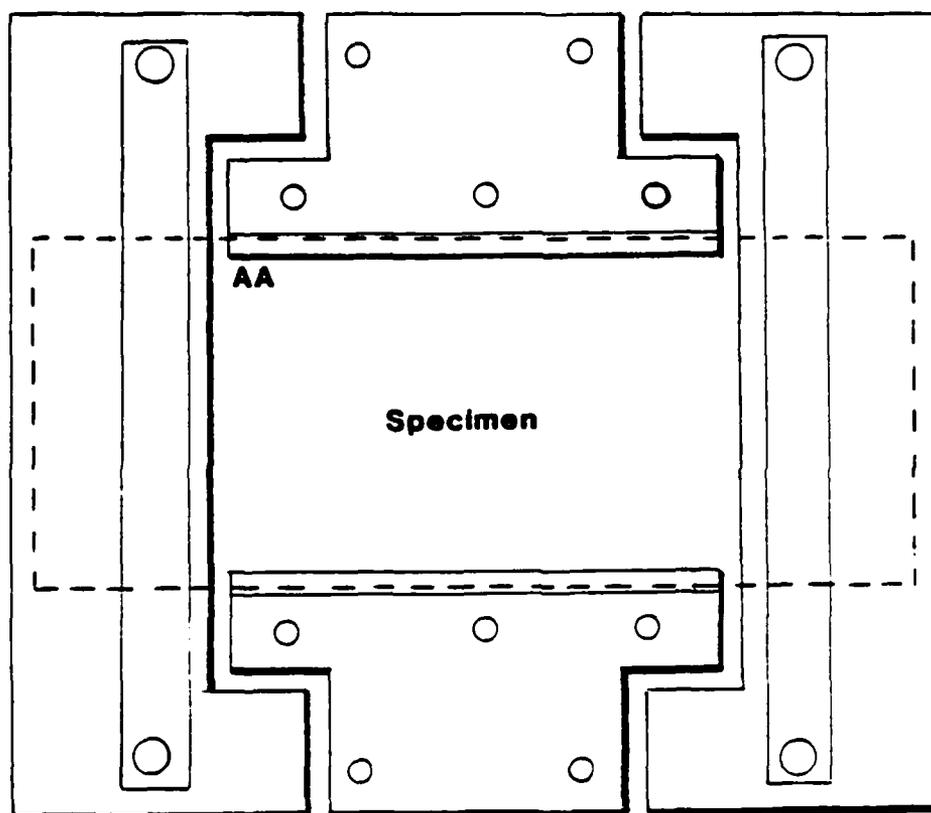
**FIGURE 7**

**Specimen Constraint Fixture**

constrained differently than those nearer to the plate center. These varying constraints would have created inconsistent initial damage. The method chosen instead involved impacting the individual specimens using the "clamped-clamped" constraint. The "clamped-clamped" constraint allowed minimal deflection of the specimen during impact by constraining all four edges. The fixture shown in Figure 7 was used to constrain each edge of the specimen during impact. The constant area containment was accomplished by placing a one inch outer diameter aluminum pipe directly under the impact location of each specimen. The impact damage zone was confirmed by radiography to be confined to a one inch diameter circle equidistant from the edges and centered on the point of impact.

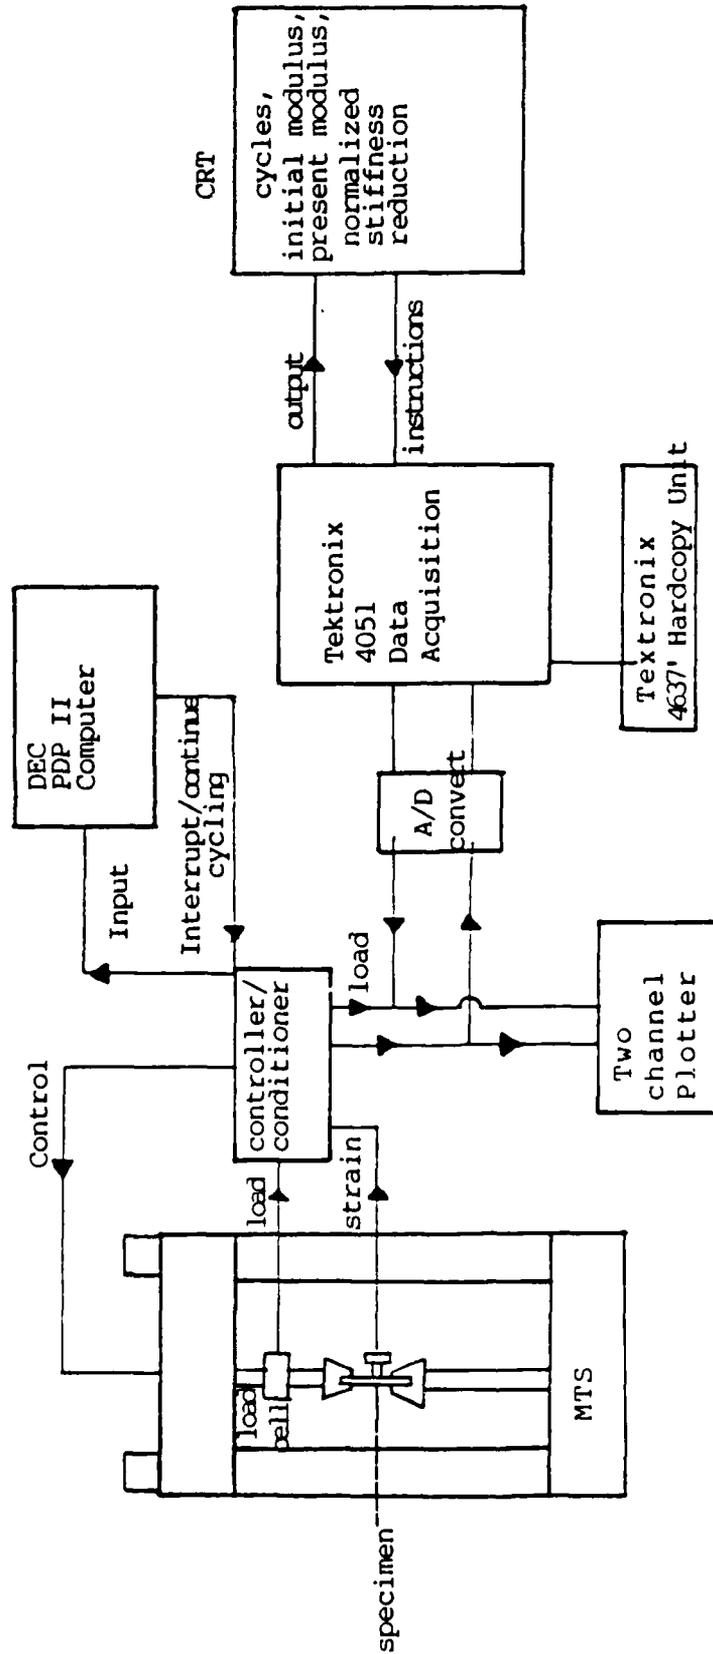
FIGURE 8

Data acquisition and control during fatigue testing.

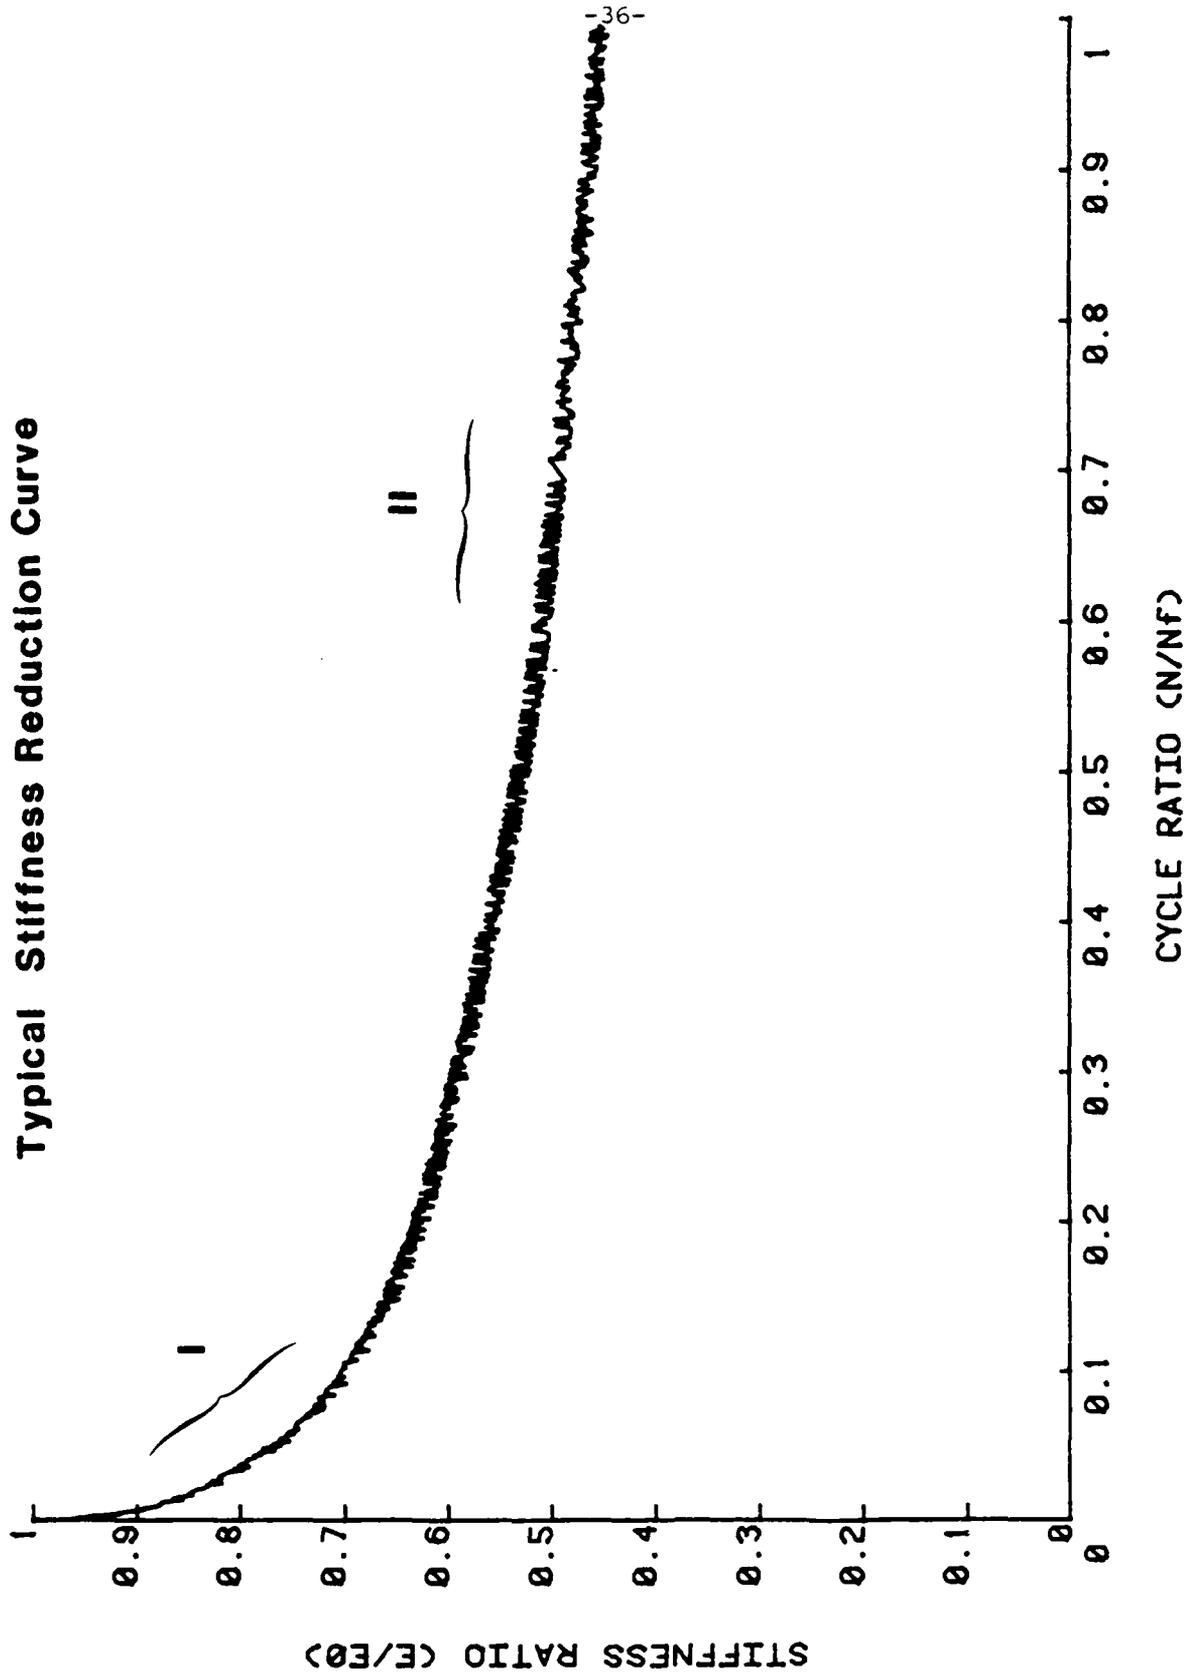
FIGURE 9

# Typical Stiffness Reduction Curve

For the stop and go series of tests, the specimen was cyclicly loaded until the stiffness reduction curve reached the apparent end of Region I. The specimen was then unloaded, and reloaded for 1/2 cycle to obtain a static stiffness measurement. Two of the four stop and go test specimens of each type were edge replicated. During edge replication the specimen was loaded to its mean cyclic load†, and a replica was made of the edge over a length of 1 in. (25 mm) near the specimen center. (The edge replication technique as well as other damage evaluation methods are described in detail in a subsequent section of this report.) Following replication, the specimen was removed from the testing machine and prepared for X-ray radiography by the introduction of an X-ray opaque enhancing agent. Following X-ray radiography and a low temperature heating cycle (1 hour at 100° F (38° C)) to drive off the enhancing agent liquid carrier, the specimen was returned to the testing machine for further fatigue testing. During the examination phase, the extensometer mounting tabs were not removed. This stop and go process typically continued until the specimen failed in fatigue. Because Region II of the stiffness versus cycle curve is horizontal (i. e. very little stiffness reduction), dynamic stiffness monitoring proved an invalid stopping point selection technique. With the exception of the first point, subsequent stopping intervals were typically selected to be 50000 cycles.

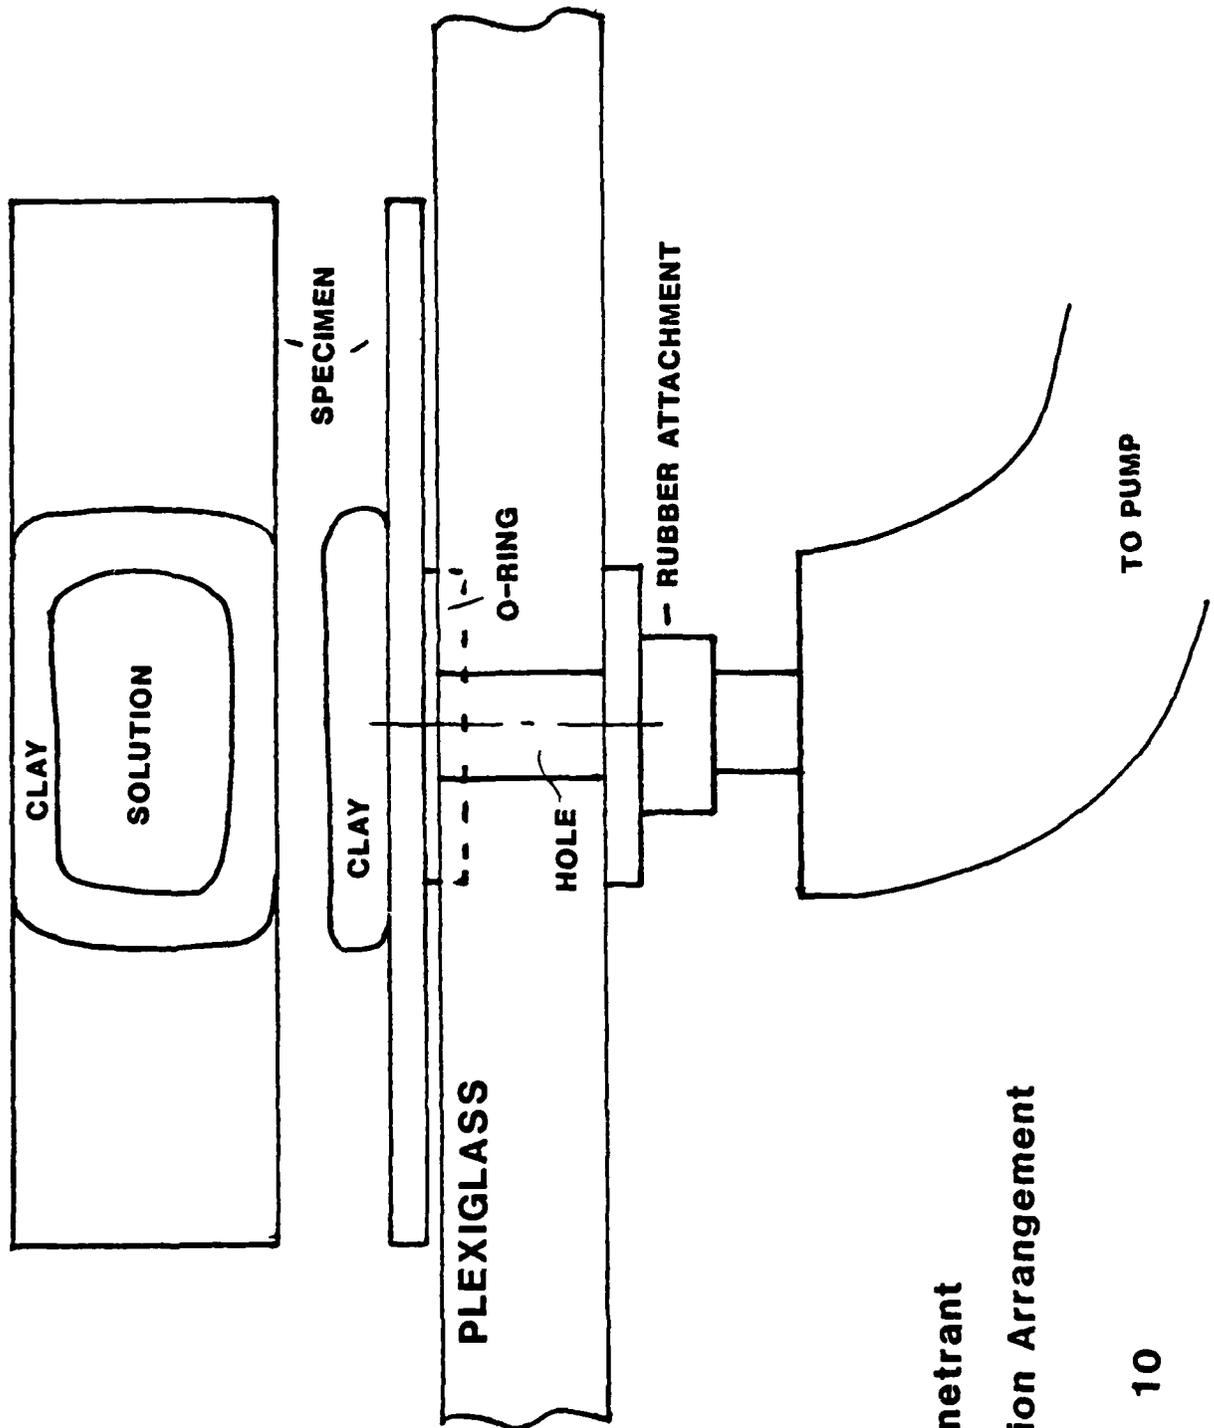
**FIGURE 10**

**Dye Penetrant  
Infiltration Arrangement**

It was therefore necessary to investigate a more effective way of enhancing agent infiltration than the present method of soaking. It was found that by subjecting one side of the specimen to a vacuum and the other side to the zinc iodide solution, the solution was pulled into the delaminations and other defects in the area of impact. Modeling clay was used to form a cup on one side of the specimen in which the zinc iodide solution was placed. This arrangement also included a plexiglass plate equipped with a recessed O-ring enclosing a 3/4 in. (19 mm) hole. The specimen was placed on the plate such that the

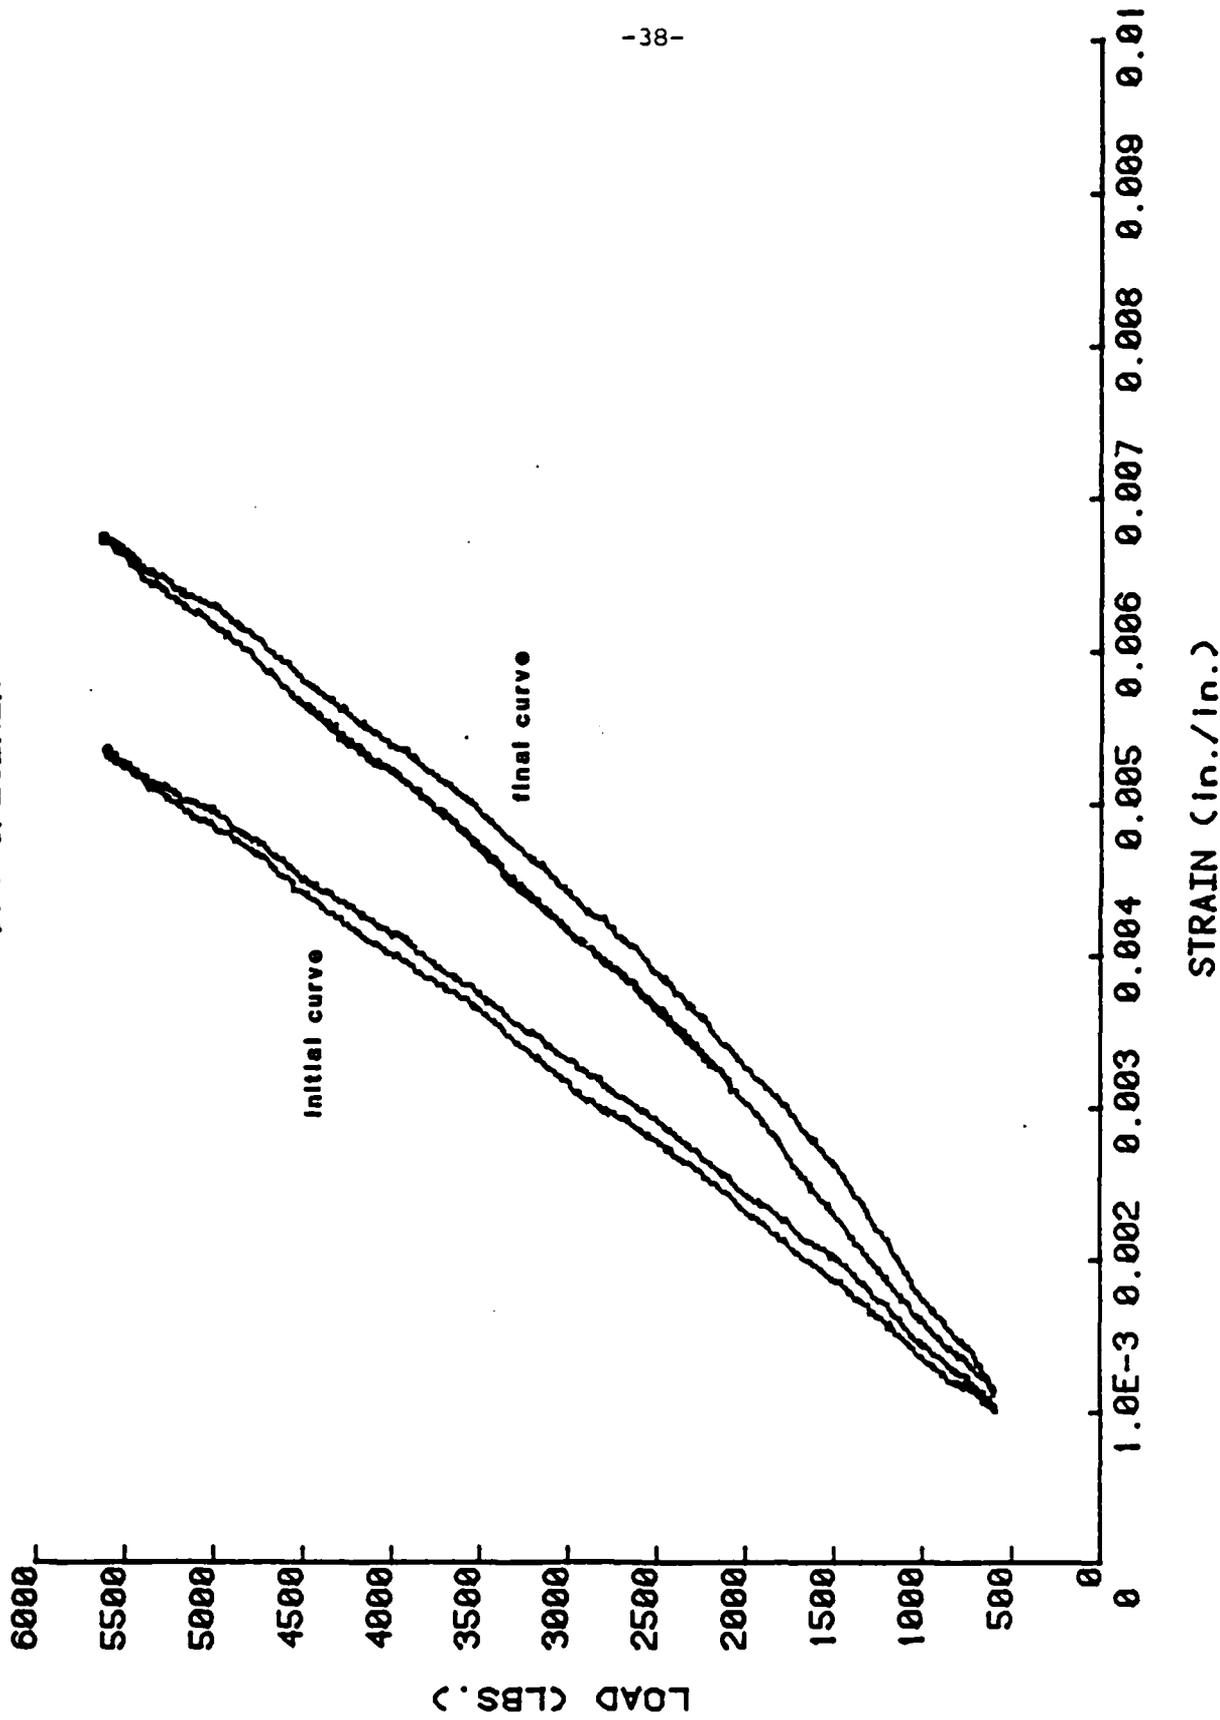
FIGURE 11

# HYSTERESIS CURVES DRY SPECIMEN

The area under the loading curves thus represents the total energy transferred to the specimen. The elastic strain energy, that energy that can be recovered as the loading is released, is represented by the area under the unloading curve. Therefore, the area of the loop depicts the strain energy absorbed by the specimen. The energy is dissipated either by hysteretic heating as discussed previously, or by damage growth. As noted by the increase in the area of the hysteresis loop, the strain energy absorbed for this material increased as life was expended by fatigue. Two possibilities exist as to by what means this additional energy was dissipated. One possibility is that hysteretic heating increased. While no significant increase in temperature was noted, this possibility can not be discounted since the surface temperature of the specimen was not monitored during this portion of the test. Another possible source of energy dissipation is internal friction and damage growth.

The curves shown in Figure 11-12 also possess varied slopes each of which represent the dynamic stiffness modulus at that point in the test. Because this stiffness modulus was used as a damage analog, it was monitored continuously by the data acquisition system described earlier. The system used the method of least squares to calculate this modulus every 71 seconds. Continuous monitoring by the system yielded stiffness reduction curves for both dry and wet specimens in Figures 13-14. It was found that the absolute value of the dynamic stiffness was slightly greater than the static stiffness which was plotted on the two channel plotter. Although the absolute stiffness measurements varied, the static and dynamic stiffness reductions varied only slightly. It was then feasible to use the dynamic stiffness reduction as a damage analog to control the fatigue tests.

The bimodal characteristic of the righthand curves of Figures 11-12 can be related to the damage mode and growth in the area of interest. During the initial cycles, the fiber-matrix interface was relatively undamaged, and the fiber weave was constrained by the matrix. As the specimen is subjected to more cycles, the fiber-matrix interface becomes damaged causing the release of the fiber weave. Allowing the weave to "unkink" gives the hysteresis loop its bimodal shape with two apparent stiffnesses. The first stiffness modulus was geometry-related, resulting from the unkinking of the weave. Once the weave reached maximum deformation, the mechanical behavior of the individual fibers dominated resulting in the second slope.

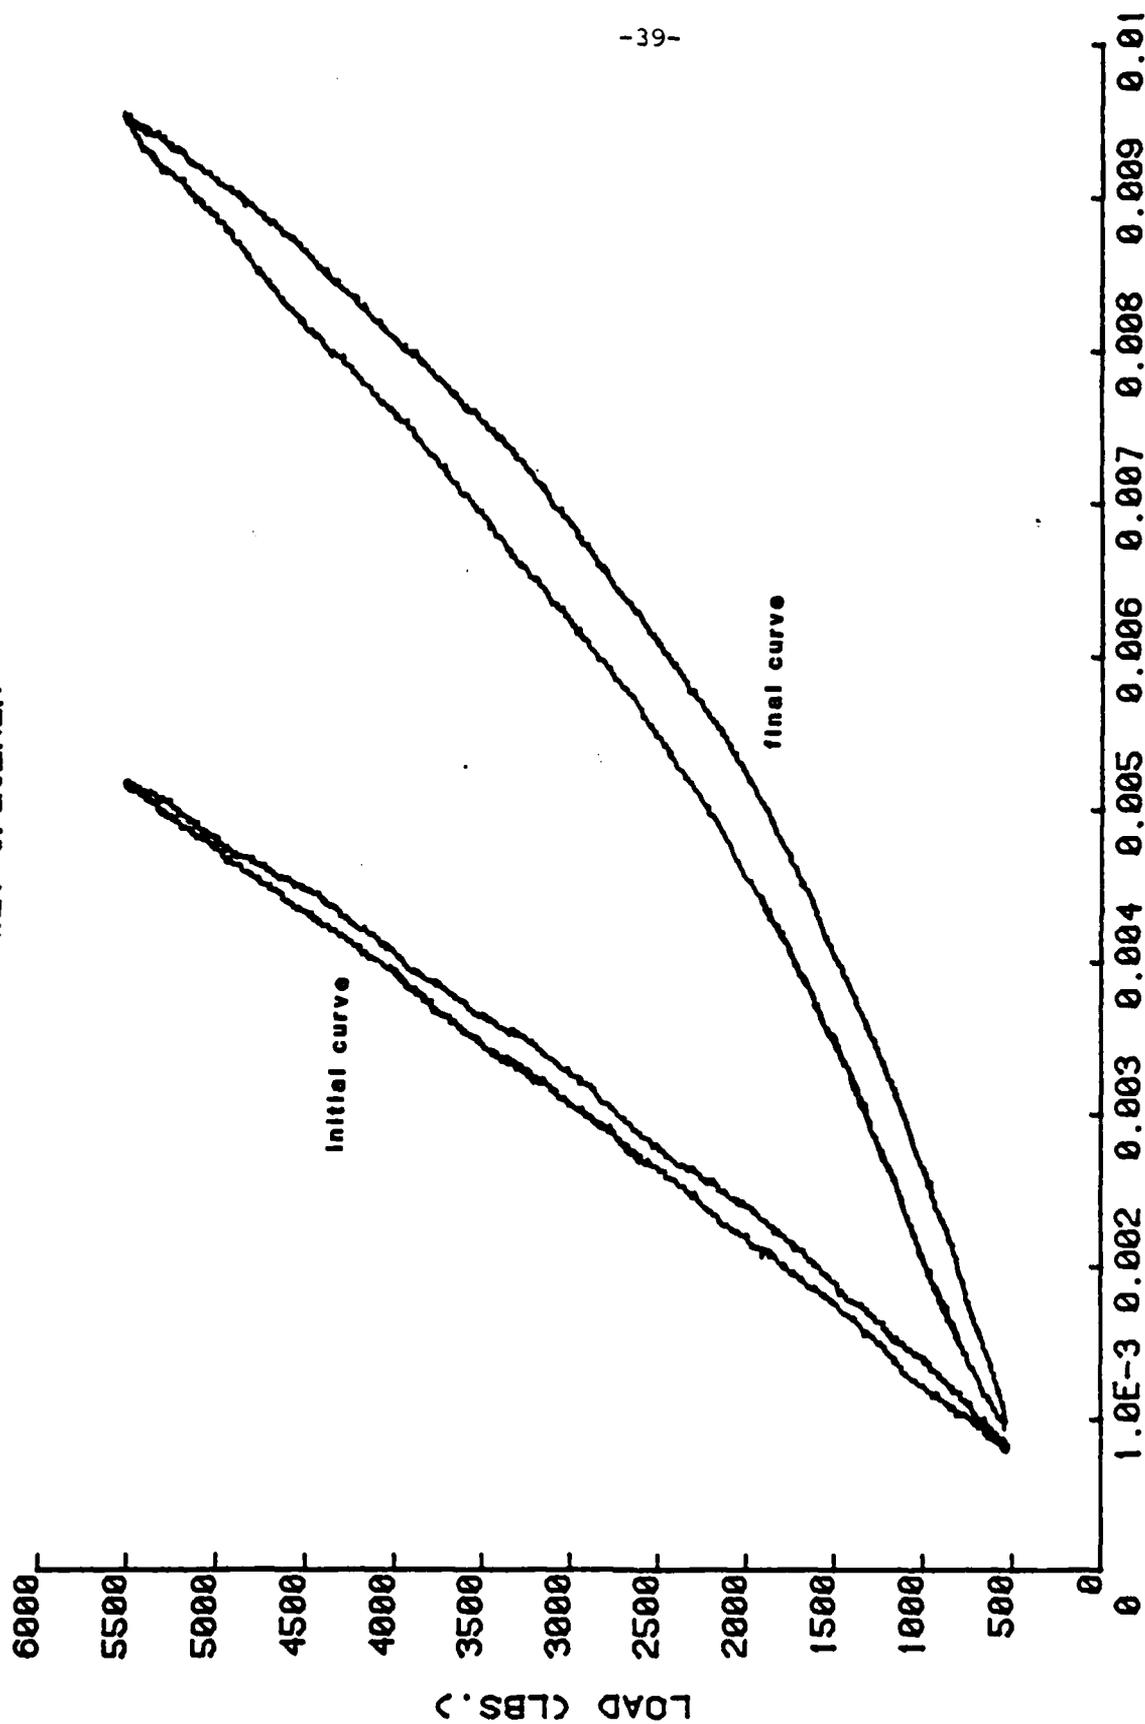
STRAIN (in./in.)  
FIGURE 12

HYSTERESIS CURVES  
WET SPECIMEN

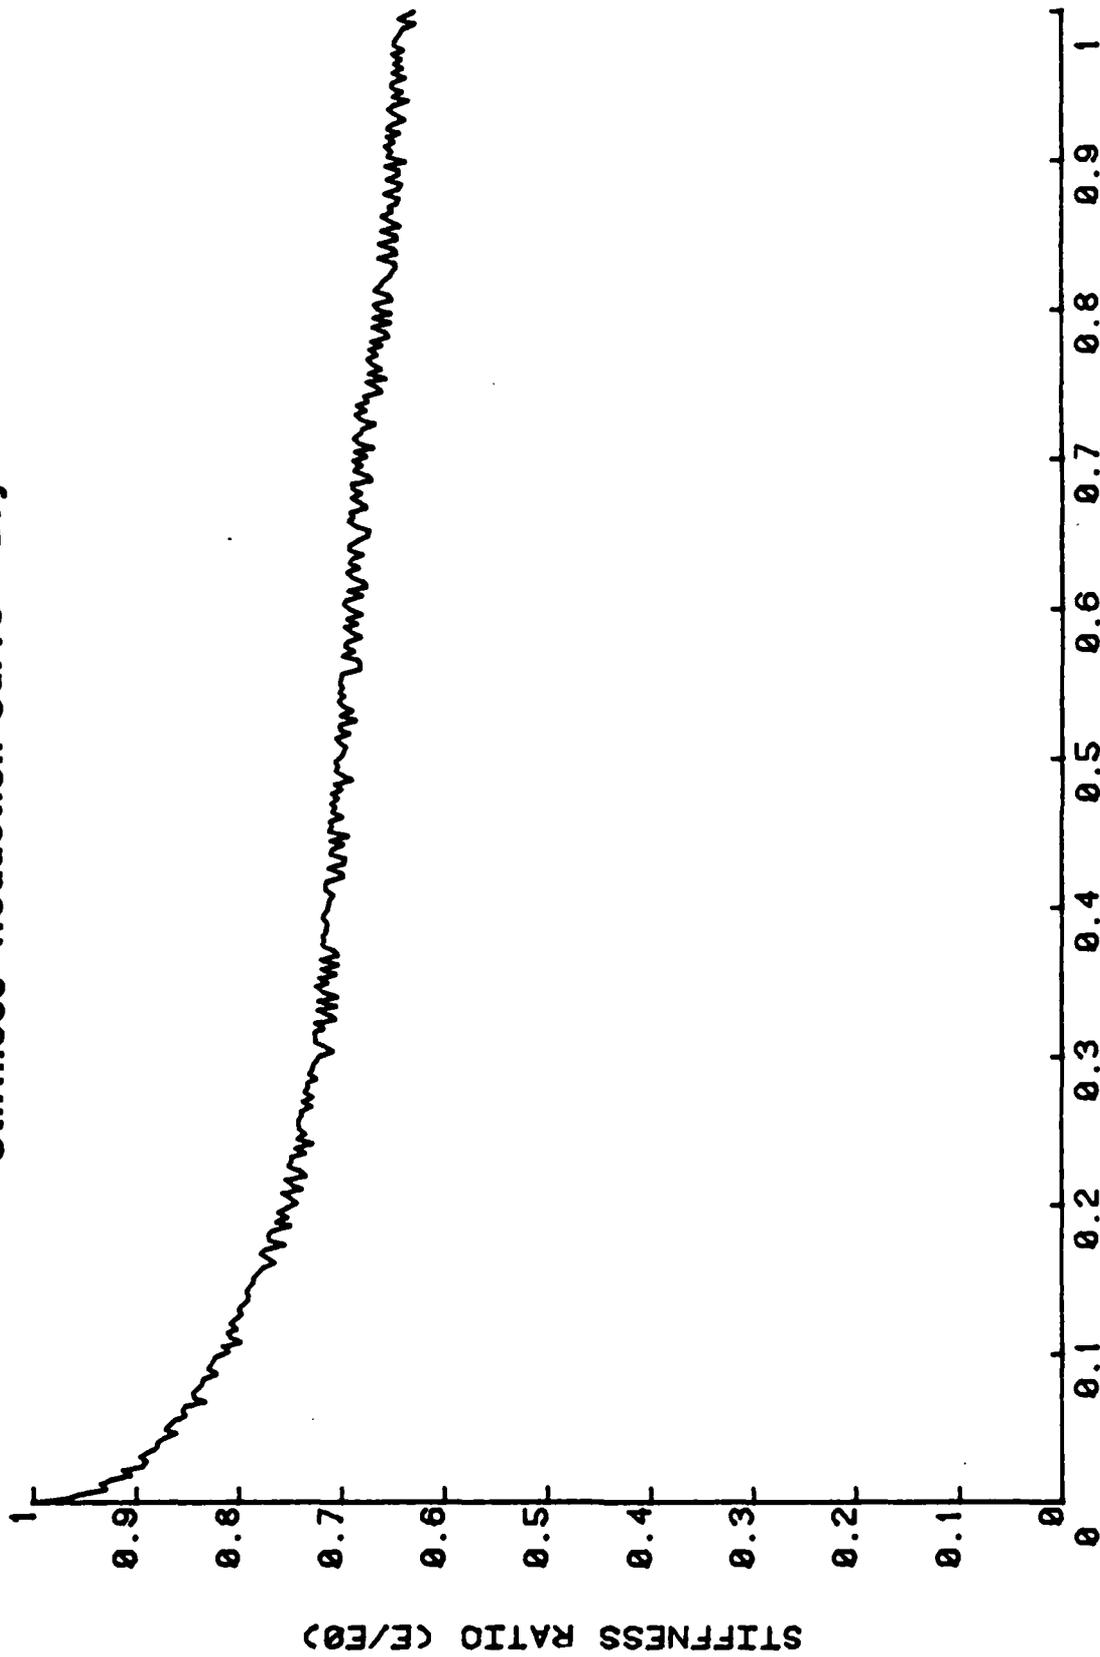
FIGURE 13

# Stiffness Reduction Curve - Dry

tion curves for the hybrid dry and wet specimens. These figures show that the overall stiffness reduction for wet specimens were on average higher than the dry specimens. This greater stiffness reduction is attributed to the moisture plasticizing the resin allowing it to flow from the fibers. The overall stiffness then is lower because it no longer has any contribution from the matrix.

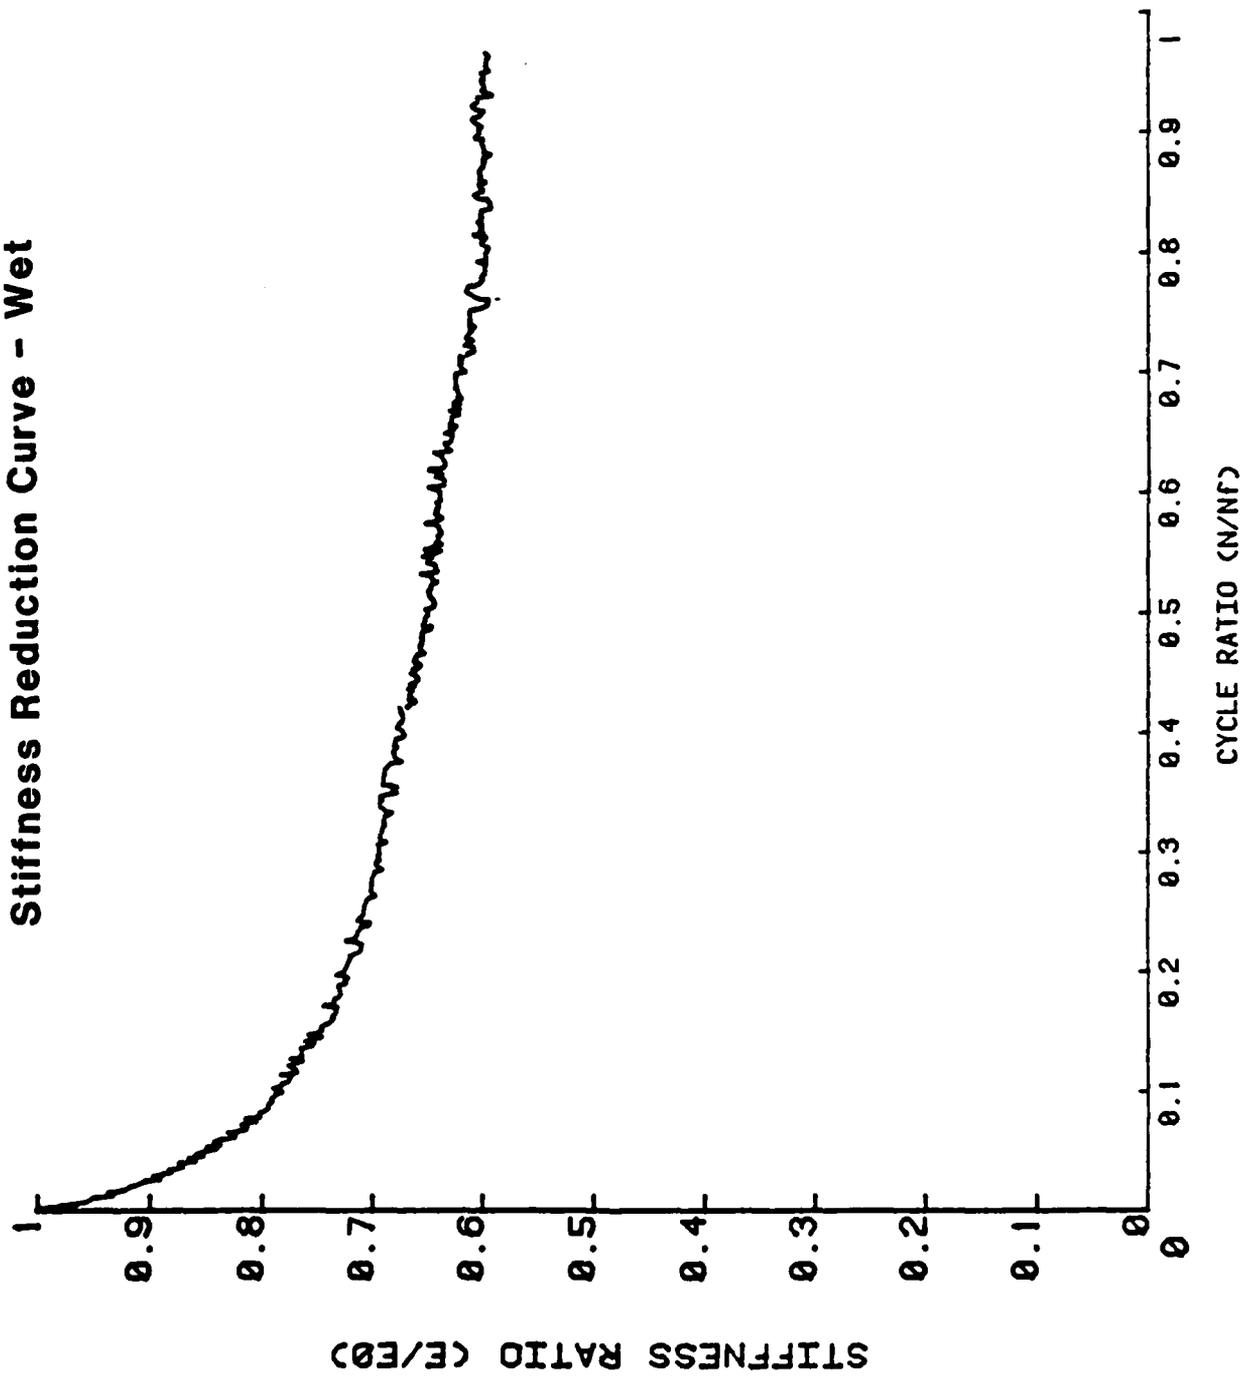
FIGURE 14

### Stiffness Reduction Curve - Wet
