# A TRIDENT SCHOLAR PROJECT REPORT

ENVIRONMENTAL EFFECTS ON IMPACT DAMAGE  
TOLERANCE OF HYBRID COMPOSITE MATERIAL.

UNITED STATES NAVAL ACADEMY  
ANNAPOLIS, MARYLAND  
1986

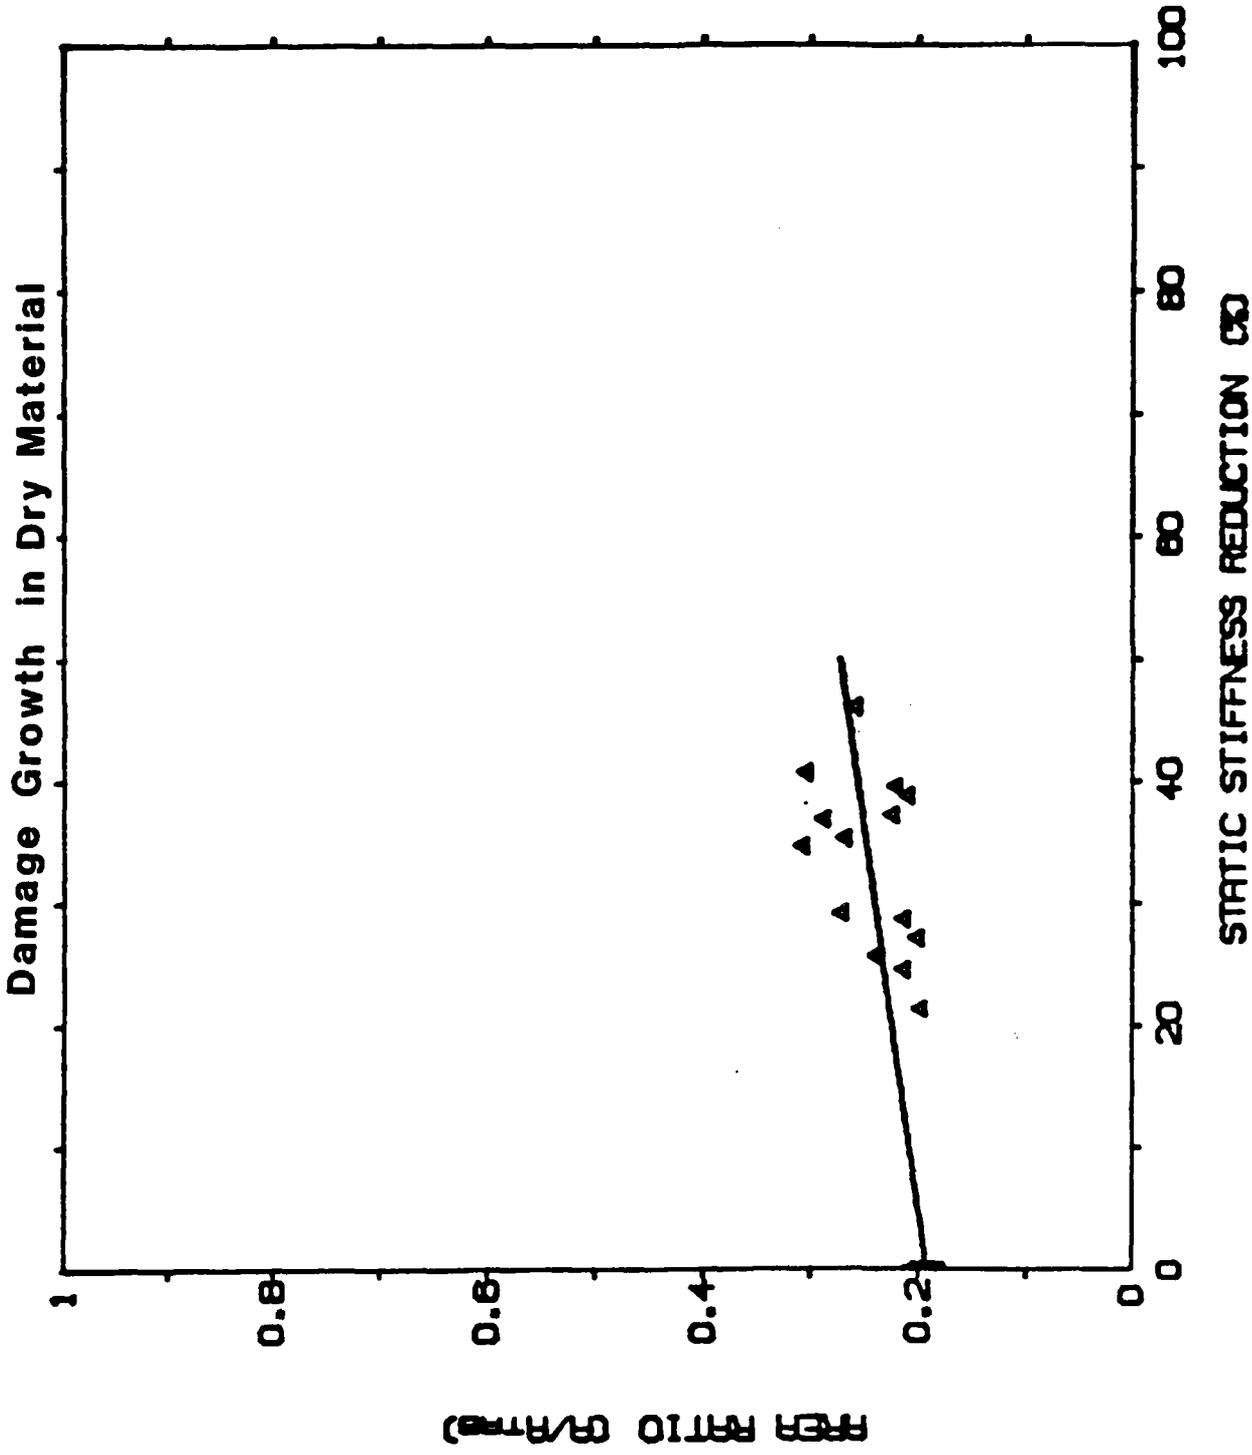
FIGURE 17

STATIC STIFFNESS REDUCTION (%)

Damage Growth in Dry Material

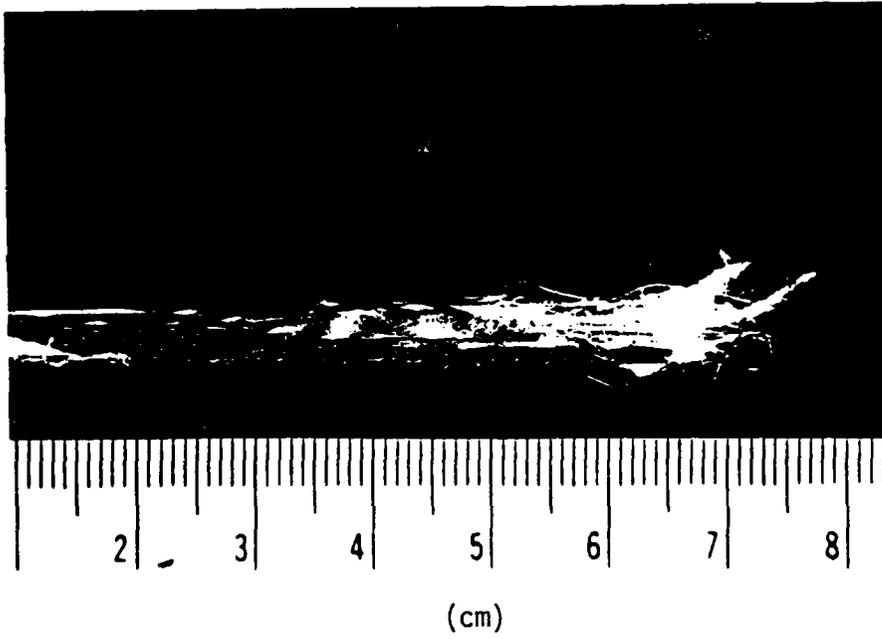
**Surface**  
**Fatigue Failure**  
**FIGURE 20**

**Edge**

The initial transverse crack on the back face became more pronounced as fatigue continued. This crack increased in size moving toward one edge. However, ultimate failure resulted more often from a crack unnoticed initially. This crack began either at the top or bottom of the initial ring of cracks. Tests concluded that most specimens which failed in fatigue, failed at a 45 degree angle as the specimen shown in Figure 20. Failure resulted in total fracture of graphite fibers. The polyethylene fibers did not break, rather they stretched and ripped.
