DNA-TR-84-362

RECOVERY OF MILL RACE GROUND MOTION CANISTERS AND EXAMINATION OF CANISTER EMPLACEMENT

31 May 1983

Technical Report

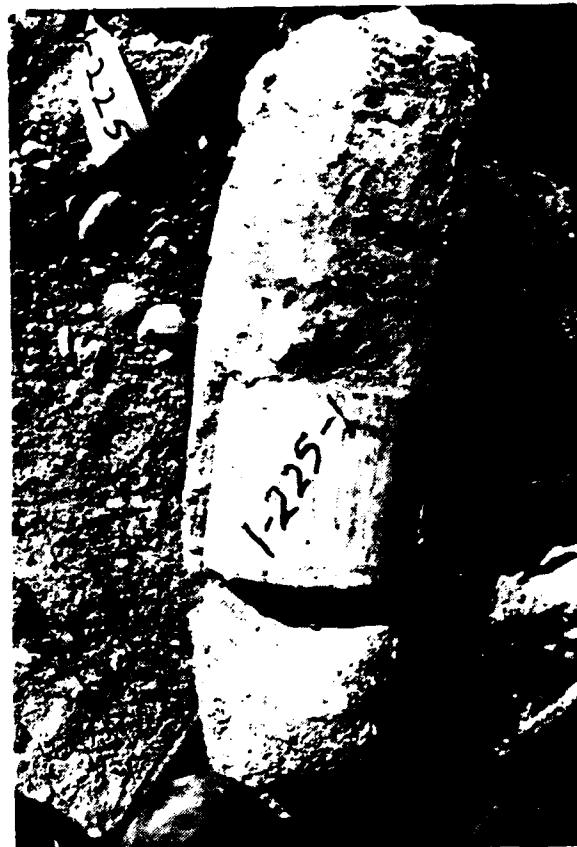
Figure 7. The 1-225-1 canister, partially and fully excavated.

1-225-1: Roughly 65% of the surface was exposed. The grout extended several inches below the bottom of the canister, yet more than $3/4$ of the canister bottom was exposed and the grout occupied only one side of the hole below the canister bottom. It is likely that a substantial amount of soil was present in the bottom of the hole and was pushed to one side by the grout. The grout continued up the same side of the canister leaving about 240 degrees of the canister wall exposed. Further, a void was observed on the top of the canister on the same side as the exposed portion of the wall, possibly due to more soil that had fallen in on top of the canister before the grout had reached that level. The grout seemed, however, to be bonded strongly to the canister wall and to the surrounding medium. The soil in contact with the canister had bonded to the canister wall. The surrounding soil also showed signs of having been compressed by the grout.

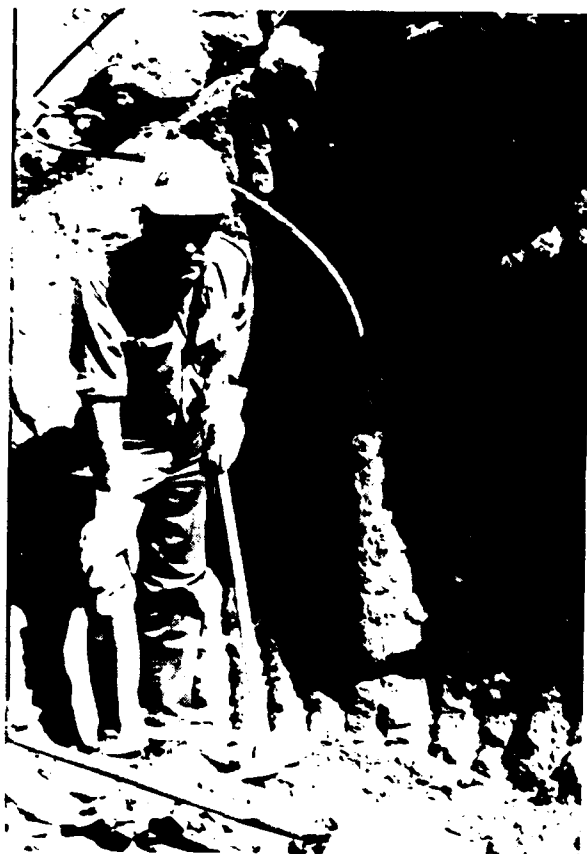
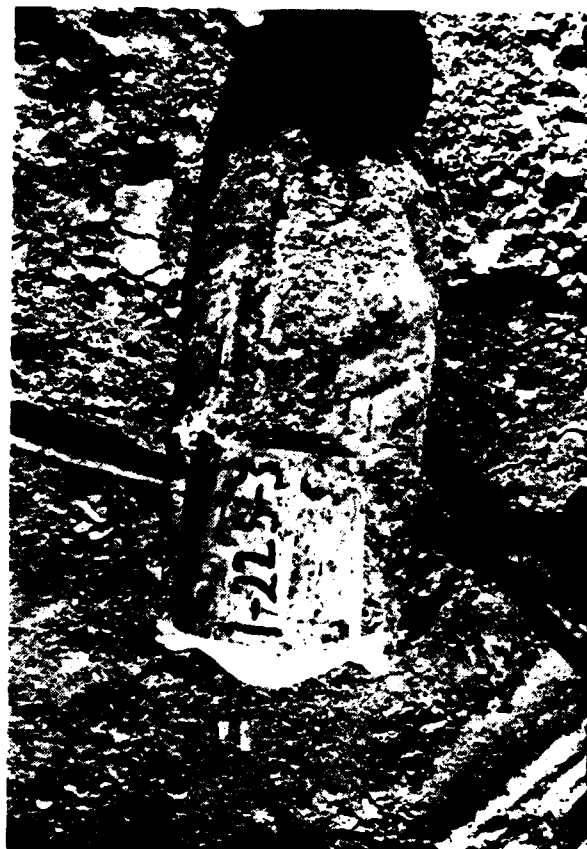
Figure 9. The 1-225-3 canister, partially and fully excavated.

1-225-3: The canister was roughly 50% exposed. Its entire bottom was exposed, indicating that a large amount of soil had fallen into the bottom of the hole partially burying the canister before the grout was pumped in. About 180 degrees of the canister wall is exposed and there was a moderate sized void on top of the canister on the same side as the exposed bottom. This would indicate that soil had fallen into the hole around the canister before the grout was being pumped in. The grout was strongly bonded to the canister wall and to the surrounding medium. The soil in contact with the canister wall had also bonded to the canister.

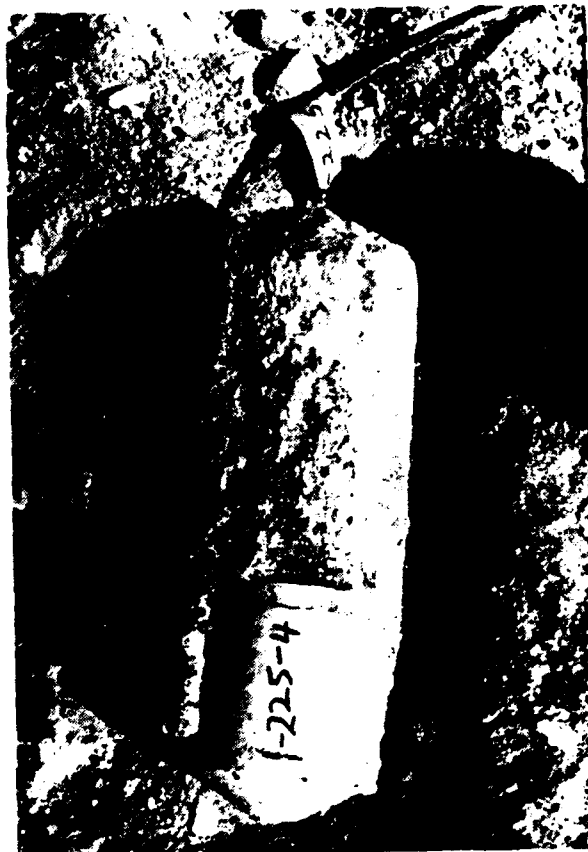
Figure 10. The 1-225-4 canister, partially and fully excavated.

1-225-4: The canister was found to be roughly 70% exposed. The entire bottom of the canister including the wall up to a height of about one inch, and 180 degrees of the canister wall were exposed. This indicates that a large amount of soil was falling to the hole bottom both below and around the canister prior to the arrival of the grouting material. The discontinuous slope of the soil/grout interface at this level suggests that soil continued to fall downhole during the grouting process. In addition, a moderate sized void was observed on the top of the canister where soil had fallen prior to the arrival of the grout. The grout was strongly bonded to the canister wall and to the surrounding medium. The surrounding soil was also bonded to the canister wall.

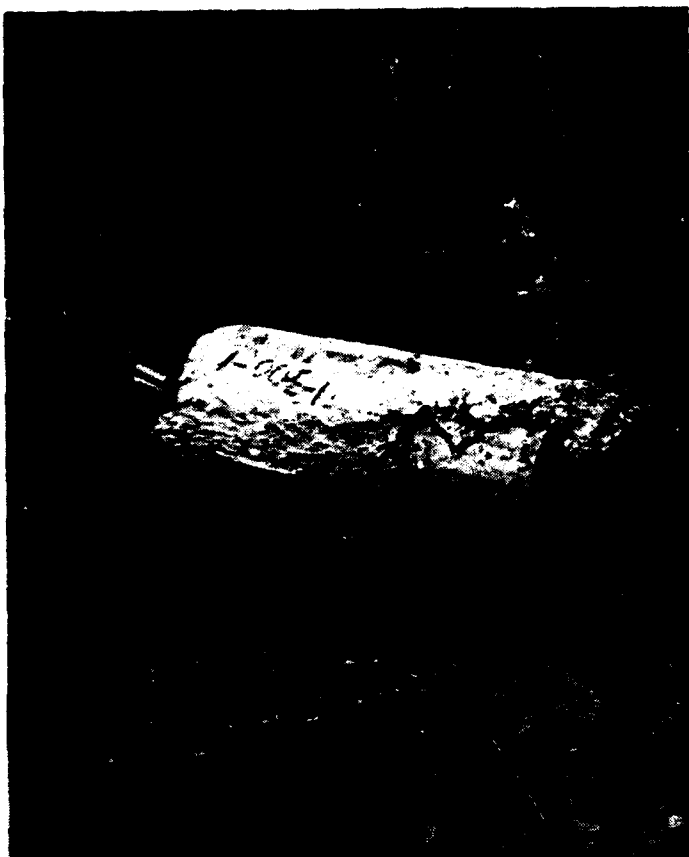
Figure 11. The 1-300-1 canister, partially and fully excavated.

1-300-1: About 40% of the surface was exposed. The bottom of the canister was about 50% exposed with the grout continuing for several inches below the canister bottom. Apparently, there was a substantial amount of soil in the hole bottom when the grout was pumped in; that soil may have been pushed to one side by the falling grout. About 180 degrees of the canister wall was exposed with a small void on the top on the same side. The grout in this case is bonded strongly to the canister wall and to the surrounding medium. The soil in contact with the canister wall is also bonded to the canister.

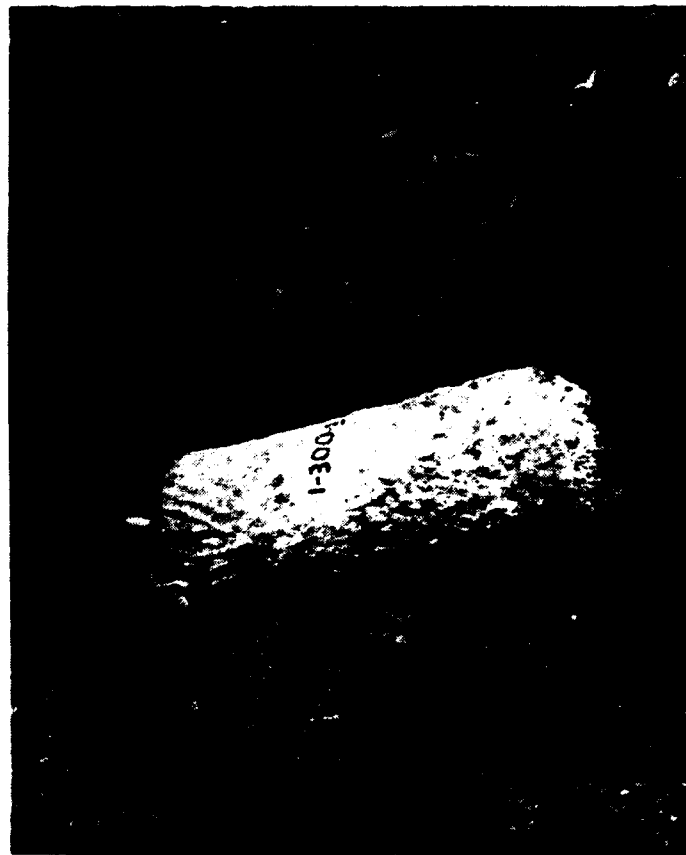
Figure 13. The 1-300-3 canister, partially and fully excavated.

1-300-3: The canister was found to be fully grouted in. There were no exposed areas or voids observed. The grout was firmly bonded to the surrounding medium.

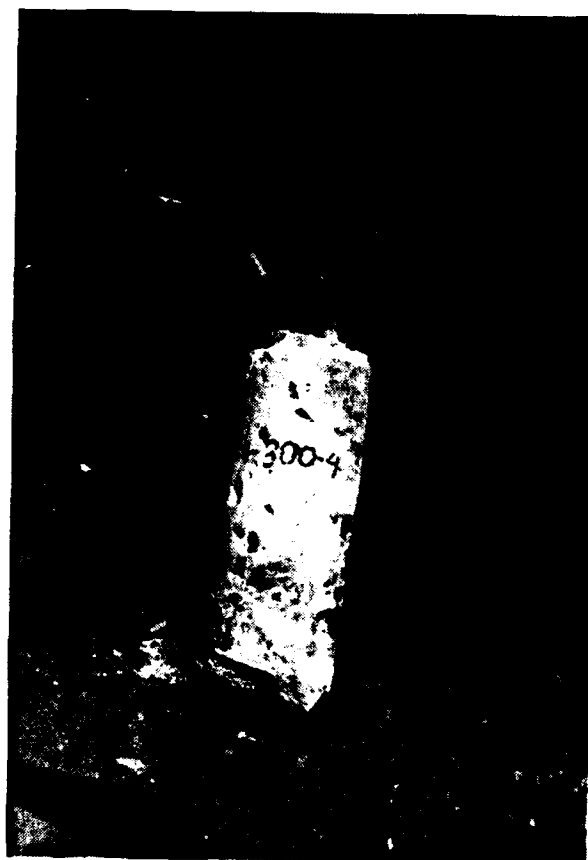
Figure 14. The 1-300-4 canister, fully excavated.

1-300-4: The canister was found to be completely covered with grout and the grout was strongly bonded to the surrounding medium.

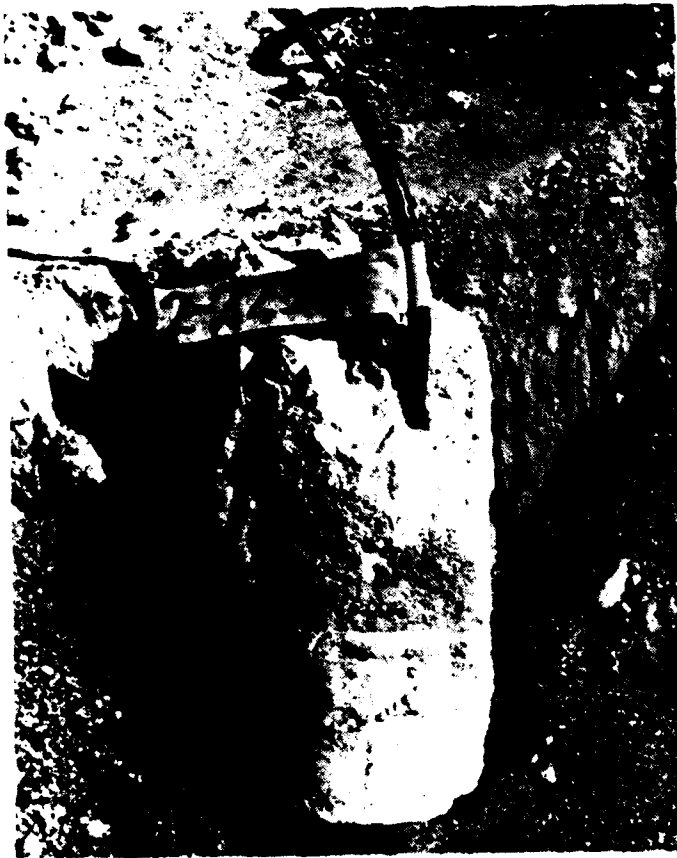
Figure 19. The 2-225-1 canister, partially and fully excavated.

2-225-1: The canister was roughly 65% exposed. The entire bottom of the canister including the canister wall up to a height of slightly less than one inch was exposed. About 180 degrees of the canister wall was also exposed and there was a moderate void on the top of the canister. Evidently there was a large amount of soil in the bottom of the hole when the canister was emplaced. The grout was found to be strongly bonded to both the canister wall and to the surrounding medium. The soil in contact with the canister wall was also bonded to it. The soil in the top void had apparently been compressed significantly by the pressure exerted by the mass and expansion of the grout.

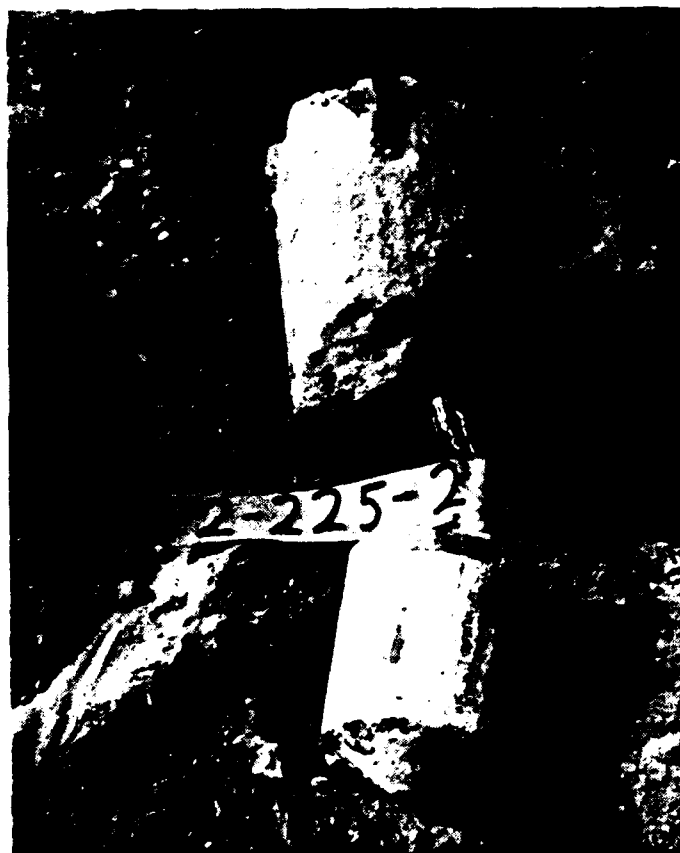
Figure 20. The 2-225-2 canister, fully excavated.

2-225-2: The canister was about 95% exposed. A small amount of grout was found in contact with the canister top surface. The result is that the canister was not grouted in.

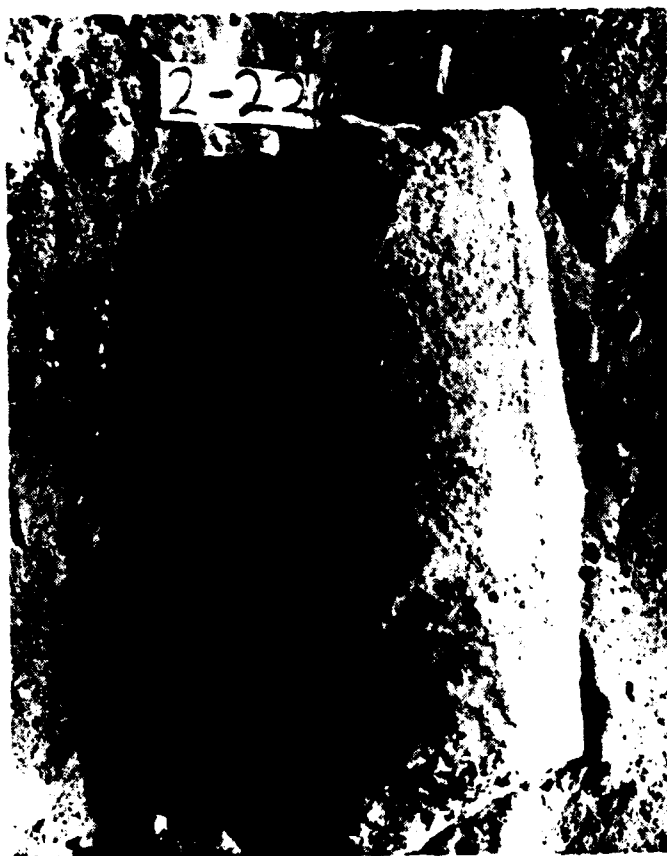
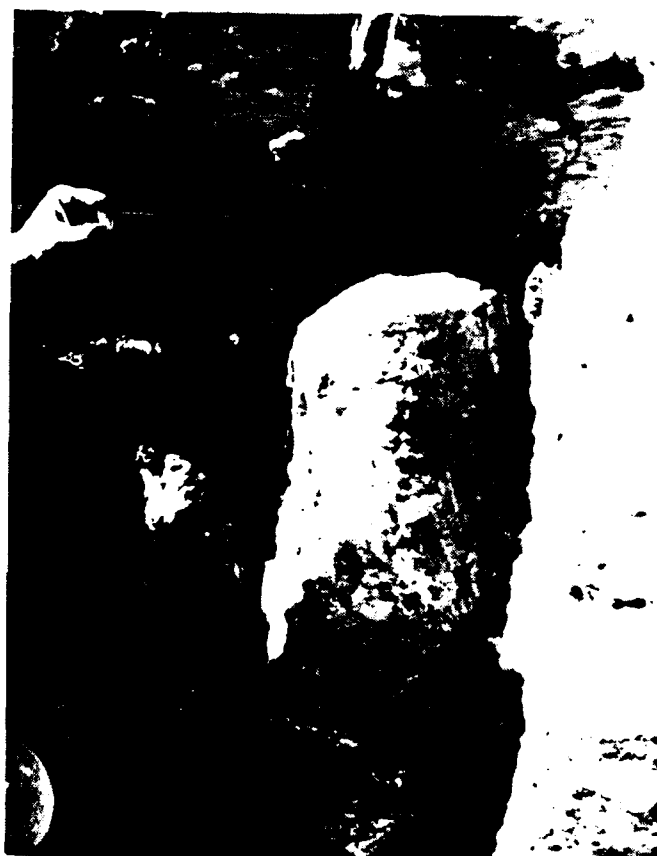
Figure 21. The 2-225-3 canister, partially and fully excavated.

2-225-3: Only about 5% of the surface was exposed. The exposed patch on the canister wall, which measured about 1-1/2 inches wide and 4 inches long, was the only exposed portion of the canister. The canister probably lay on one side of the hole when it was grouted in. The canister was well covered with grout and the grout had bonded strongly to the surrounding medium.

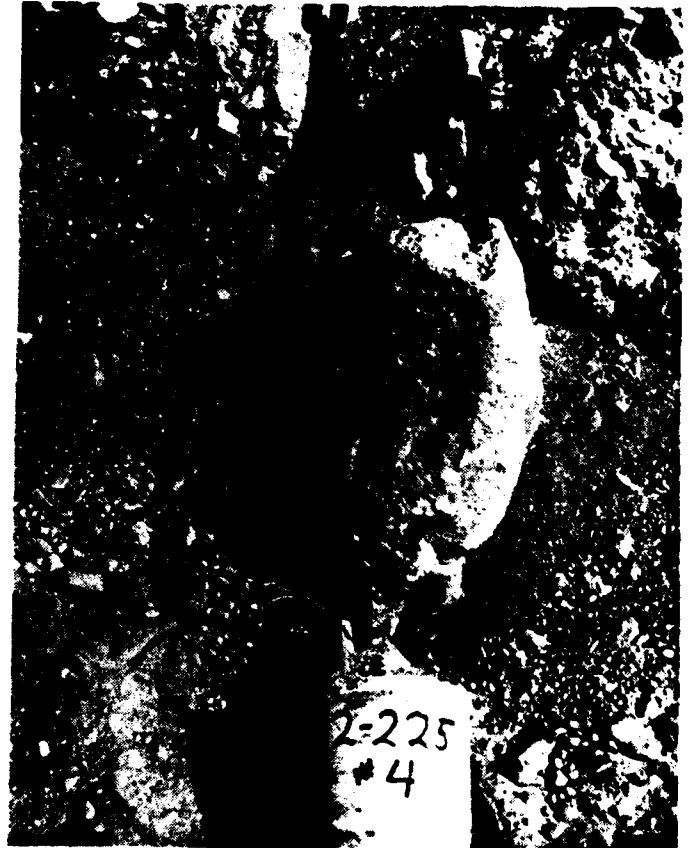
Figure 22. The 2-225-4 canister, partially and fully excavated.

2-225-4: The canister was fully exposed, indicating that soil falling to the bottom of the hole had completely buried it before grouting began.
