## Technical Report

FABRICATION AND TESTING OF A CERAMIC

TWO-CYCLE DIESEL ENGINE

CONTRACT DAAE07-83-C-R05B

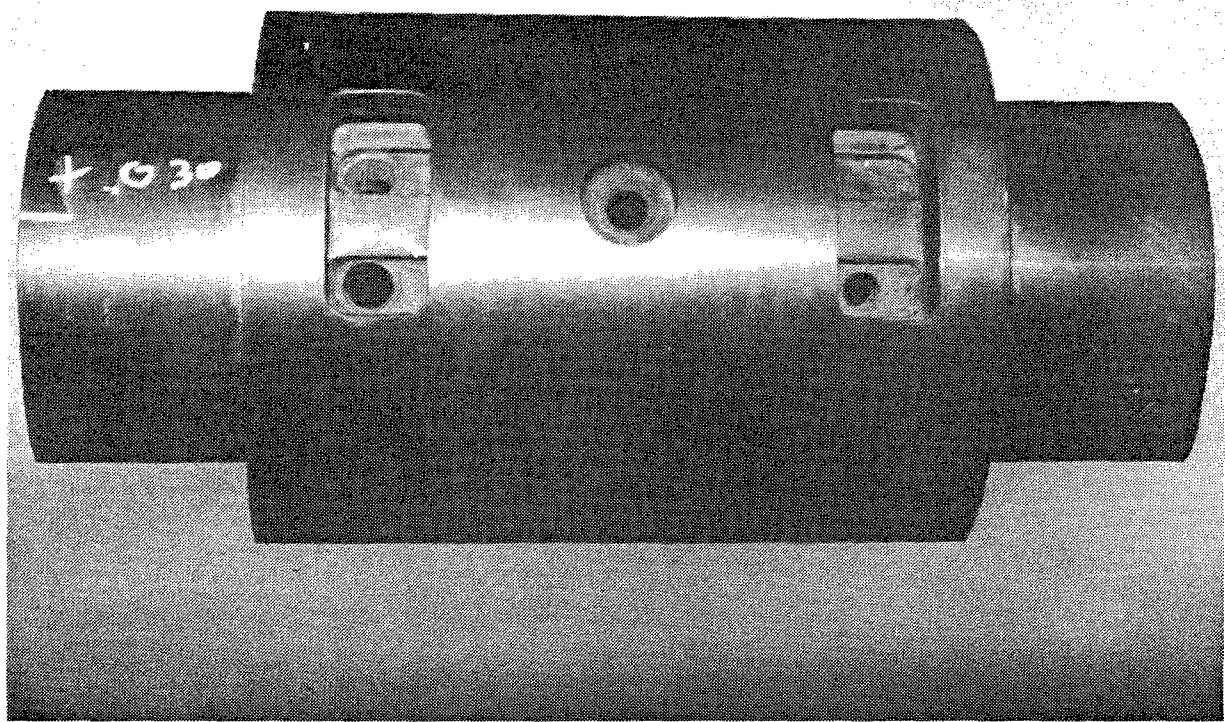
Figure 5-3. SASC Cylinder Assembly (Initial Design)

The initial SASC cylinder assembly consisted of two sintered alpha silicon carbide cylinders joined together forming an inner liner with 8 exhaust and

8 inlet ports either side of a single injector hole. Two annular cavities in the outer housing form the exhaust and inlet manifolds shown in Figure 5-3 and schematic drawings in Appendix A.

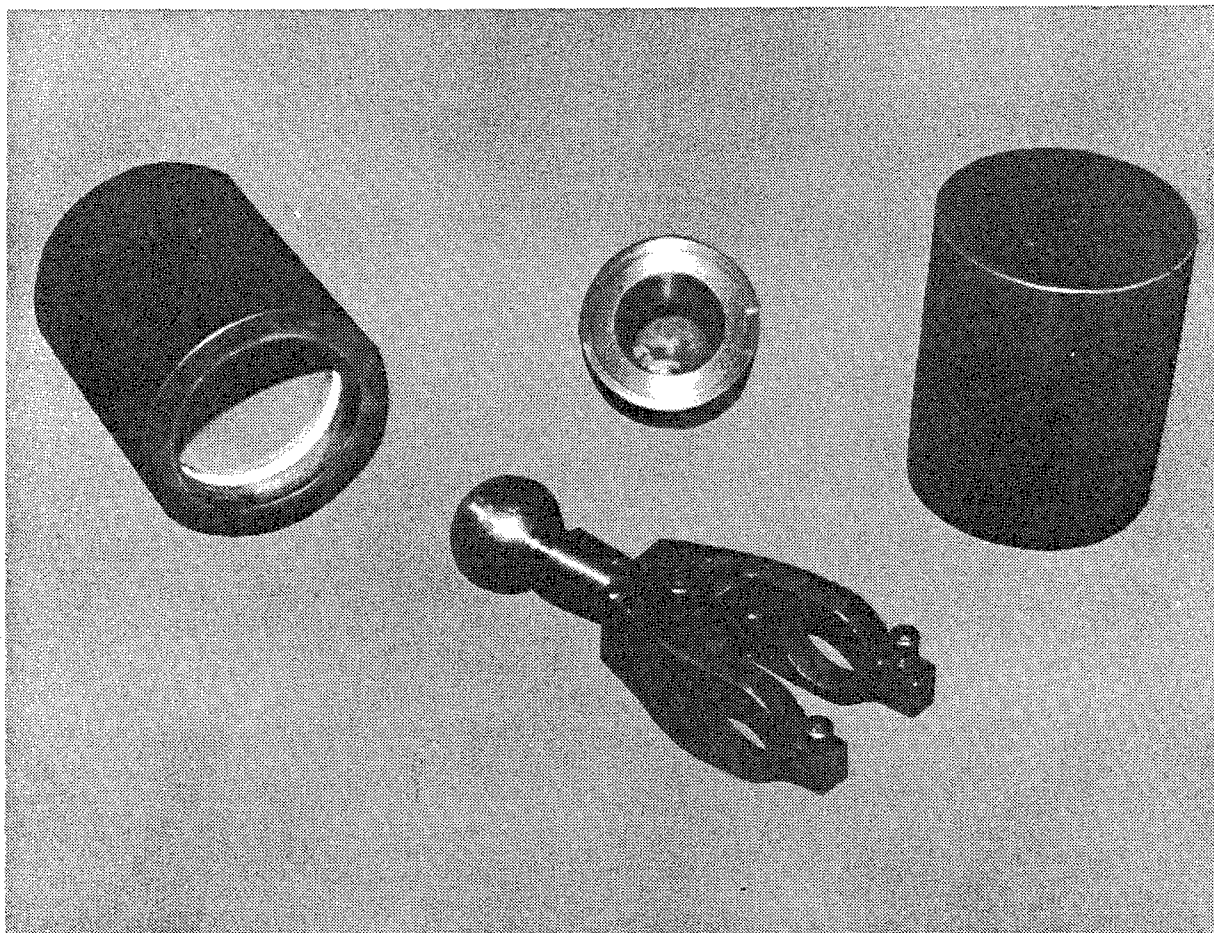
Figure 5-4. SASC Pistons with Ball and Socket Connecting Rod

The piston assembly consists of the ceramic piston fitting over a split steel carrier with spherical sockets retaining the ball end. The carrier and ball end rod assembly are held in the piston cup by a split retainer ring epoxied in the groove at the lower end of the skirt. This initial design was judged as inadequate based on two piston skirt failures from preliminary testing. An example of the piston failure is shown in Figure 5-5.

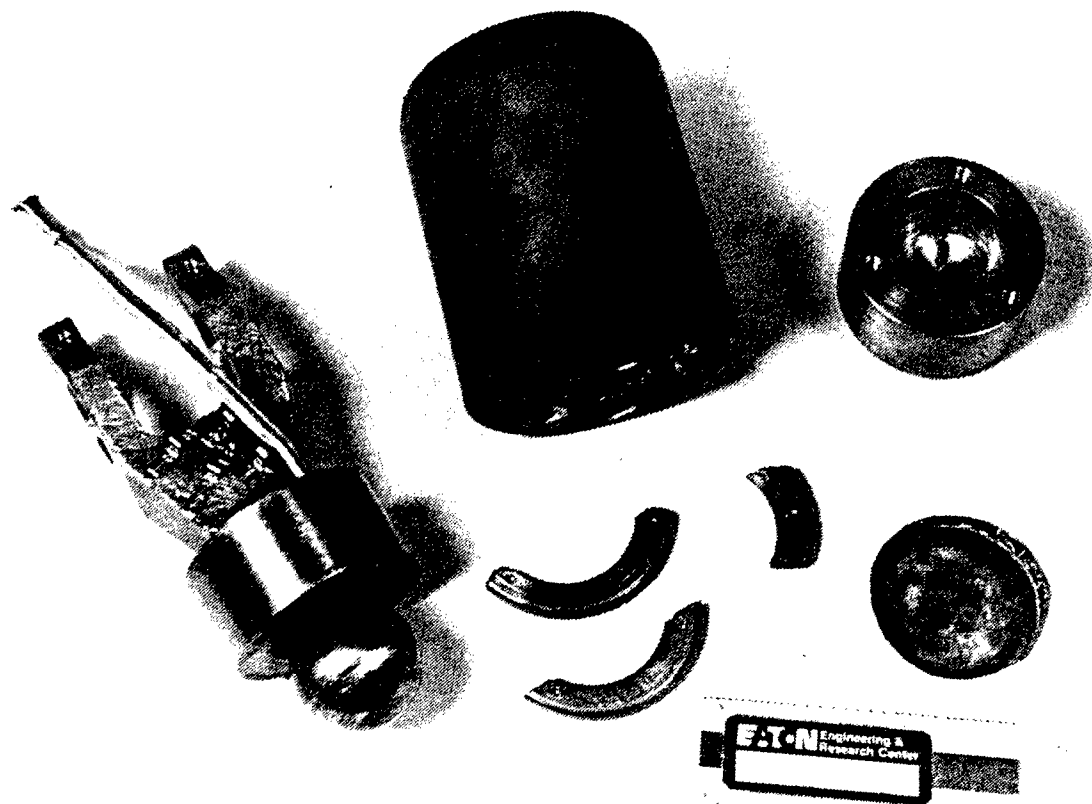
Figure 5-5. SASC Piston Skirt Fracture

Piston skirt fracture below retainer ring groove

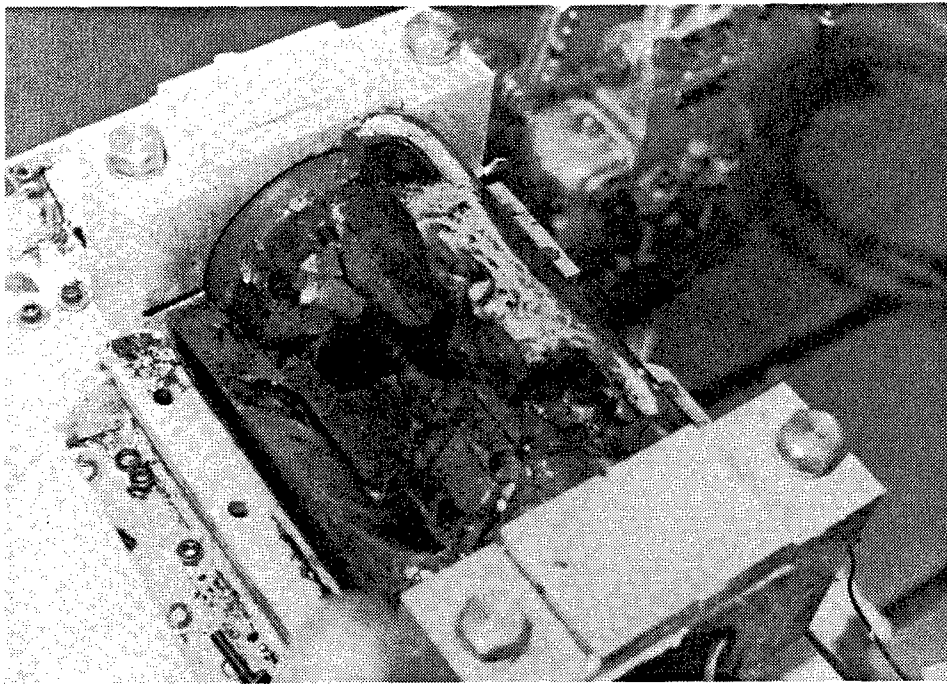
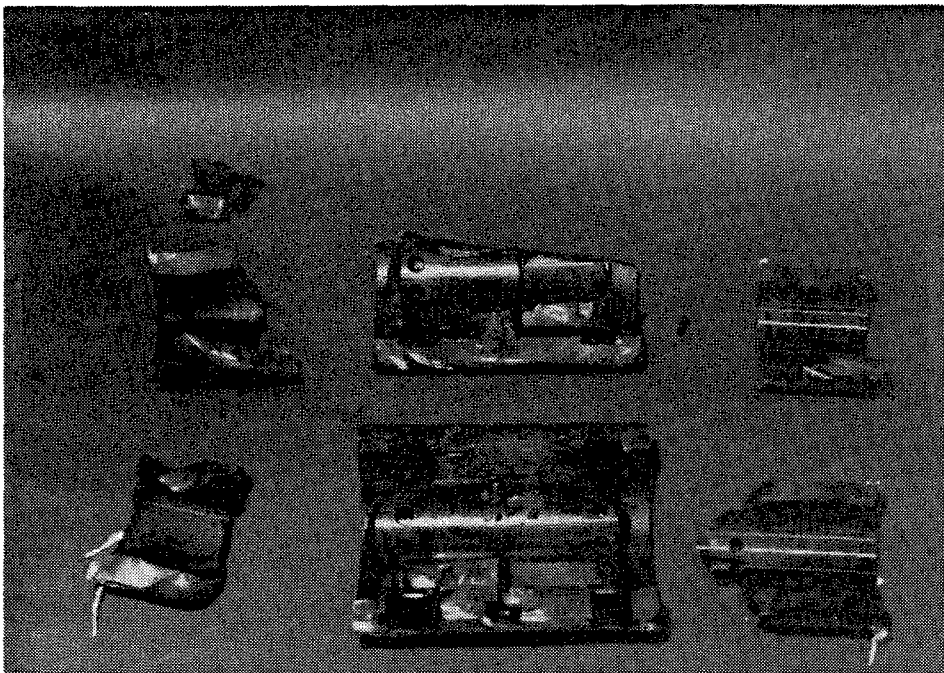
Figure 5-8. SASC Cylinder Failure (B/N-01)

Despite the failure, the engine could be turned over freely by hand, enabling the rocker pins to be removed without difficulty. The pistons suffered slight damage at the ends as shown in Figure 5-7, and both piston carriers were cracked. Further inspection revealed the cylinder had failed as shown in Figure 5-8, and the engine was completely dismantled.

Further inspection of the cylinder failure, and review of inlet air temperature data indicated the cylinder failure permitted short circuiting of exhaust gas to the inlet, accounting for the temperature rise on the intake side.

The probable failure origin was identified in the outer housing at the interface of the liner and outer housing, near the injector port. Appendix B details the fractography analysis and conclusions. The exact reason for the failure was undetermined, however, the presumed probable cause was residual tensile stresses due to the method of joining.

Cylinder liner/housing assembly fractured November 11, 1983

Based on the postmortem and at the recommendation of the project engineer, a redesign of the cylinder liner, and further modification to the piston carrier assembly was initiated.

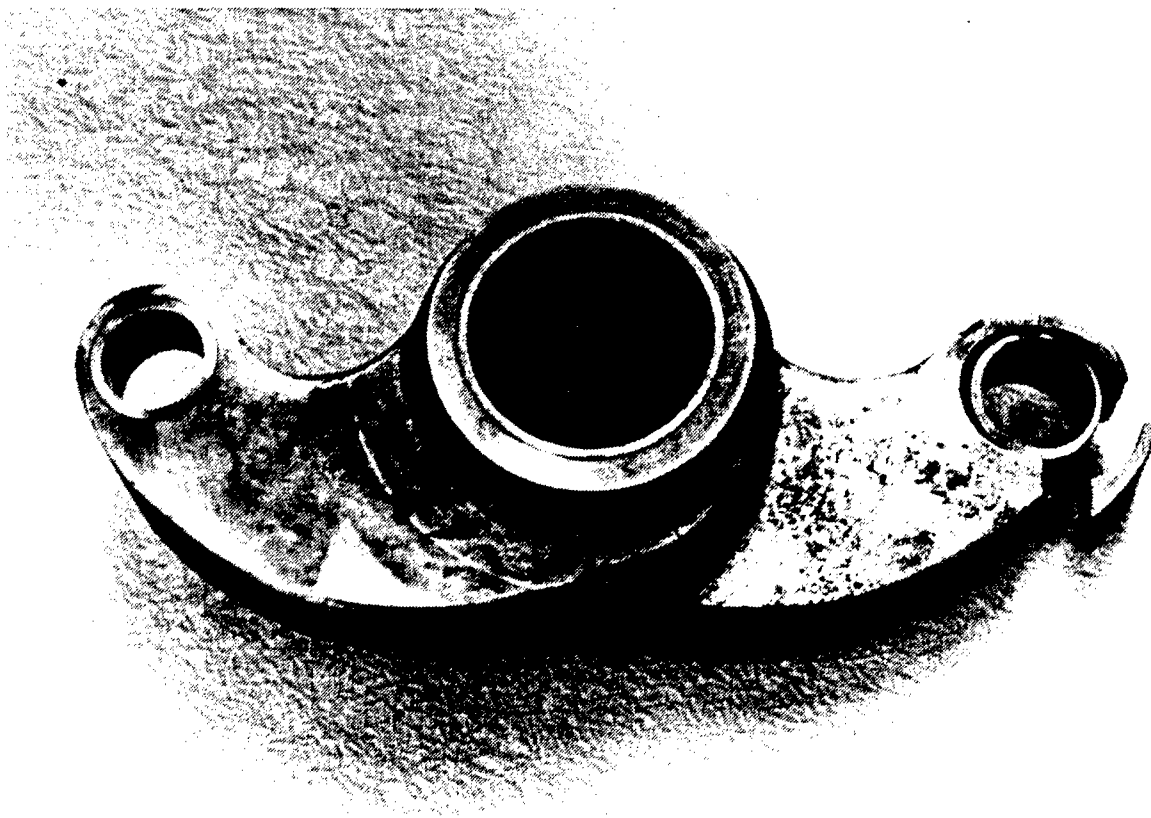
Figure 5-10. Cast Iron Rocker Arm Failure (B/N-03)

The metal engine evaluation program was initiated and operating characteristics recorded. During this testing on March 12, 1984, the engine lost power due to a failure of the intake rocker arm, shown in Figure 5-10.

The exhaust rocker and connecting rods were given a Magnaflux inspection, revealing numerous small cracks. After calculating the working stresses, fabrication of new rockers and connecting rods from steel was recommended.

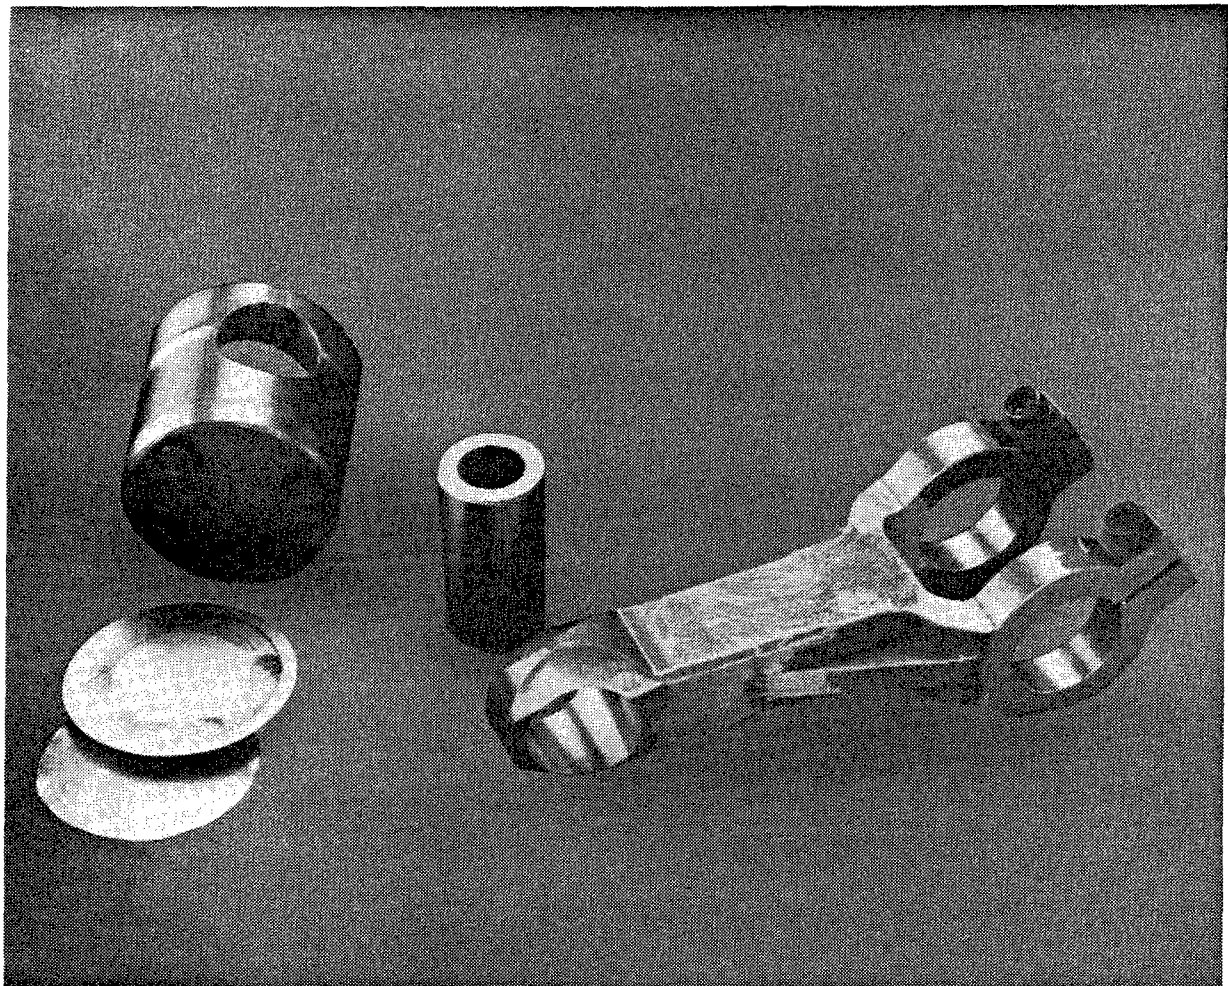
Figure 5-18. Modified Piston Carrier Assembly

Disassembly of the piston/carrier revealed the ceramic mullite spacers had cracked, increasing the clearance between the carrier and the retainer ring. A design modification to the piston carrier was made incorporating Allen-type set screws to take up any clearance between the spacer and the carrier after assembly, as shown in Figure 5-18.

As recommended by Ricardo Consulting Engineers, the ceramic mullite spacer was replaced with a steel spacer between the carrier and the underside of the piston crown. Results from the thermal analysis study showed undercrown insulation creates a severe thermal stress gradient, and should be avoided.

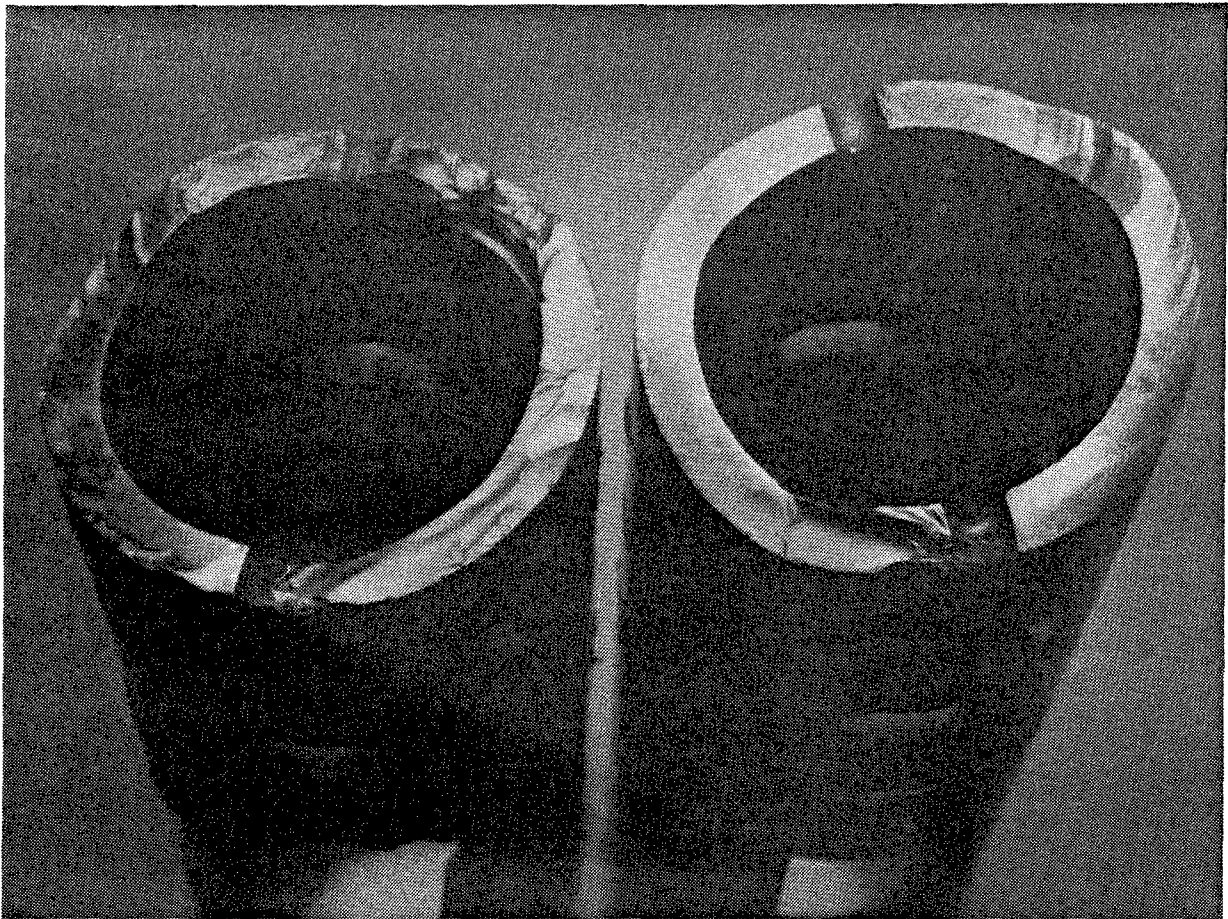
Figure 5-20. SASC Cylinder - Bending Failure (B/N-05)

After 73 hours of total motoring with the SASC hardware, engine firing was attempted over a period of 1.5 hours before terminating testing due to extremely poor combustion. Inspection after engine teardown revealed the cylinder had cracked at mid-length.

Analysis of the fracture surfaces revealed a bending failure of the cylinder shown in Figure 5-20. Abraded areas of the pistons and matching areas on the cylinder bore are shown in closeup views Figure 5-21 and 5-22. It was concluded that the stiffening ring, weighing 8 lbs., imposed a substantial cyclic bending load on the cylinder, caused by the engine vibration and rocking couple from the crankshaft. Additionally, misalignment of the piston axis and cylinder axis, as apparently evidenced by component abrasion, may have contributed further to the bending stresses.

Given the tight design clearances, it was decided the risk of piston-to-cylinder misalignment and resulting interference was too high with a wrist pin carrier/connecting rod attachment. Therefore, it was decided subsequent ceramic piston assemblies would incorporate the original ball and socket design to allow freedom of alignment. Secondly, the crankcase required further structural strengthening to reduce the lateral displacement due to the vibration problems. Thirdly, the cylinder assembly should be allowed to float in the support trunnions to avoid transmitting bending forces to the cylinder. Additionally, the cylinder and stiffening ring should be assembled with a line-to-line shrink fit to eliminate any movement of the ring on the cylinder.

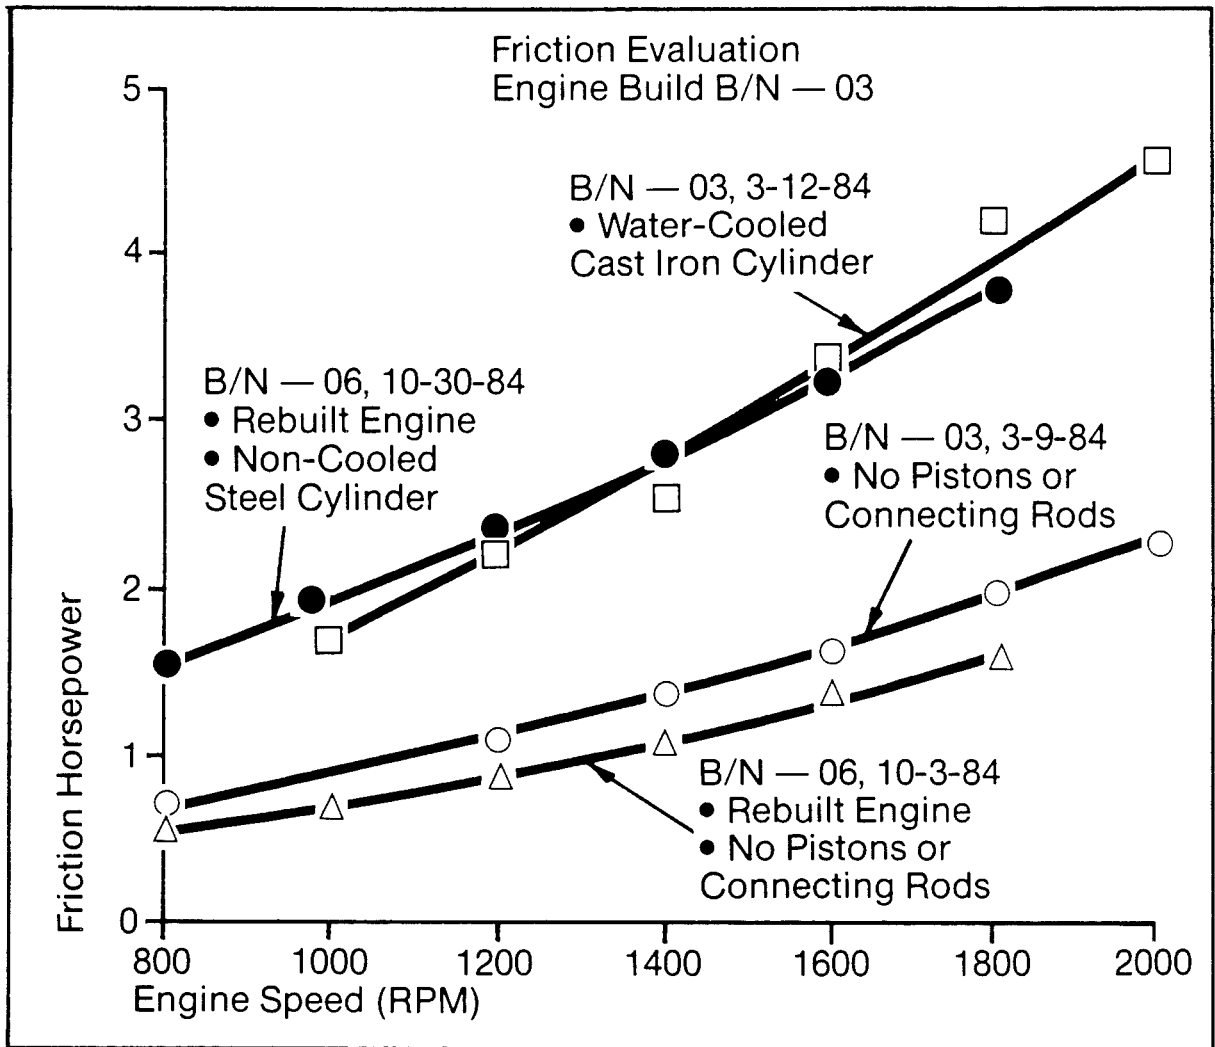
Figure 5-23. Engine Friction Comparison Between Build B/N-03 and Build B/N-06

A steel cylinder without a cooling jacket was fabricated and baseline friction horsepower measurements obtained on the lubricated metal engine. The friction horsepower curve can be seen to be essentially the same as the complete metal engine from build B/N-03 with a water-cooled cast iron cylinder. Friction results are also tabulated in Table 5-8 for the metal assembly (steel cylinder, aluminum pistons).

Friction measurements for this engine build (B/N-06) provide the baseline comparison for all subsequent ceramic engine friction evaluations.

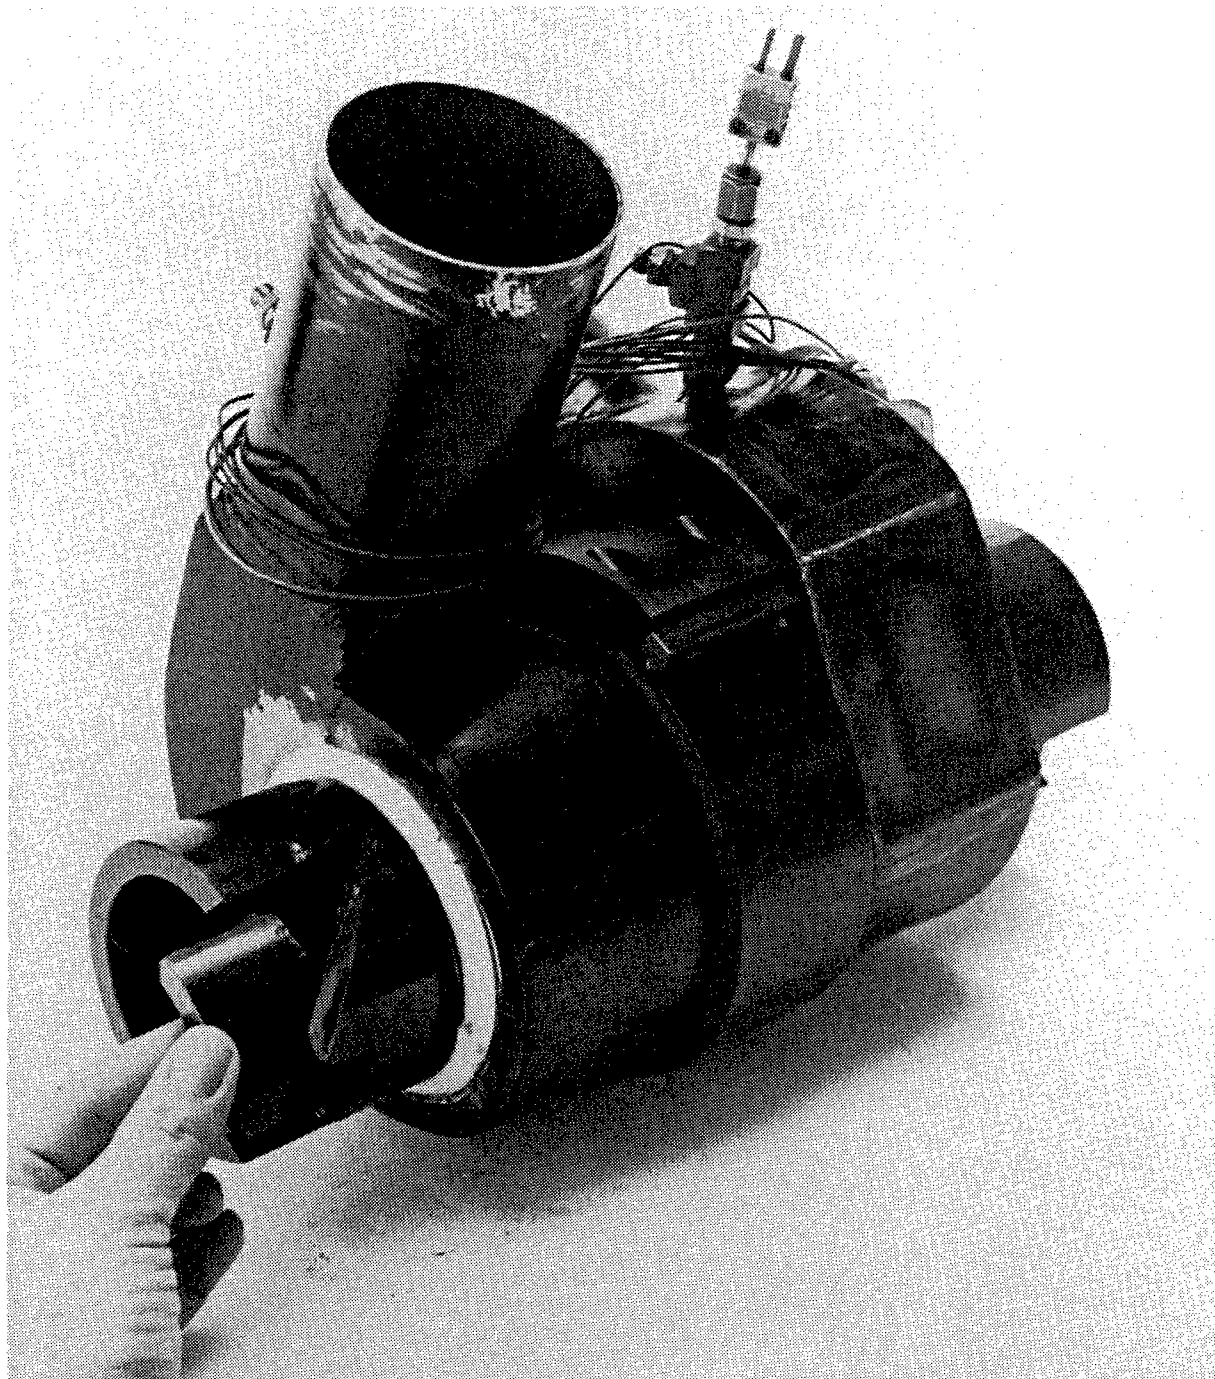
Figure 5-24. SASC Cylinder Damage (B/N-07)

The consequence of the pre-existing broken cylinder end section probably lead to the failure. Observation of white smoke through the transparent end covers, prior to the catastrophic failure, suggests the likelihood that a crack propagated to the combustion zone, allowing exhaust leakage to the crankcase.

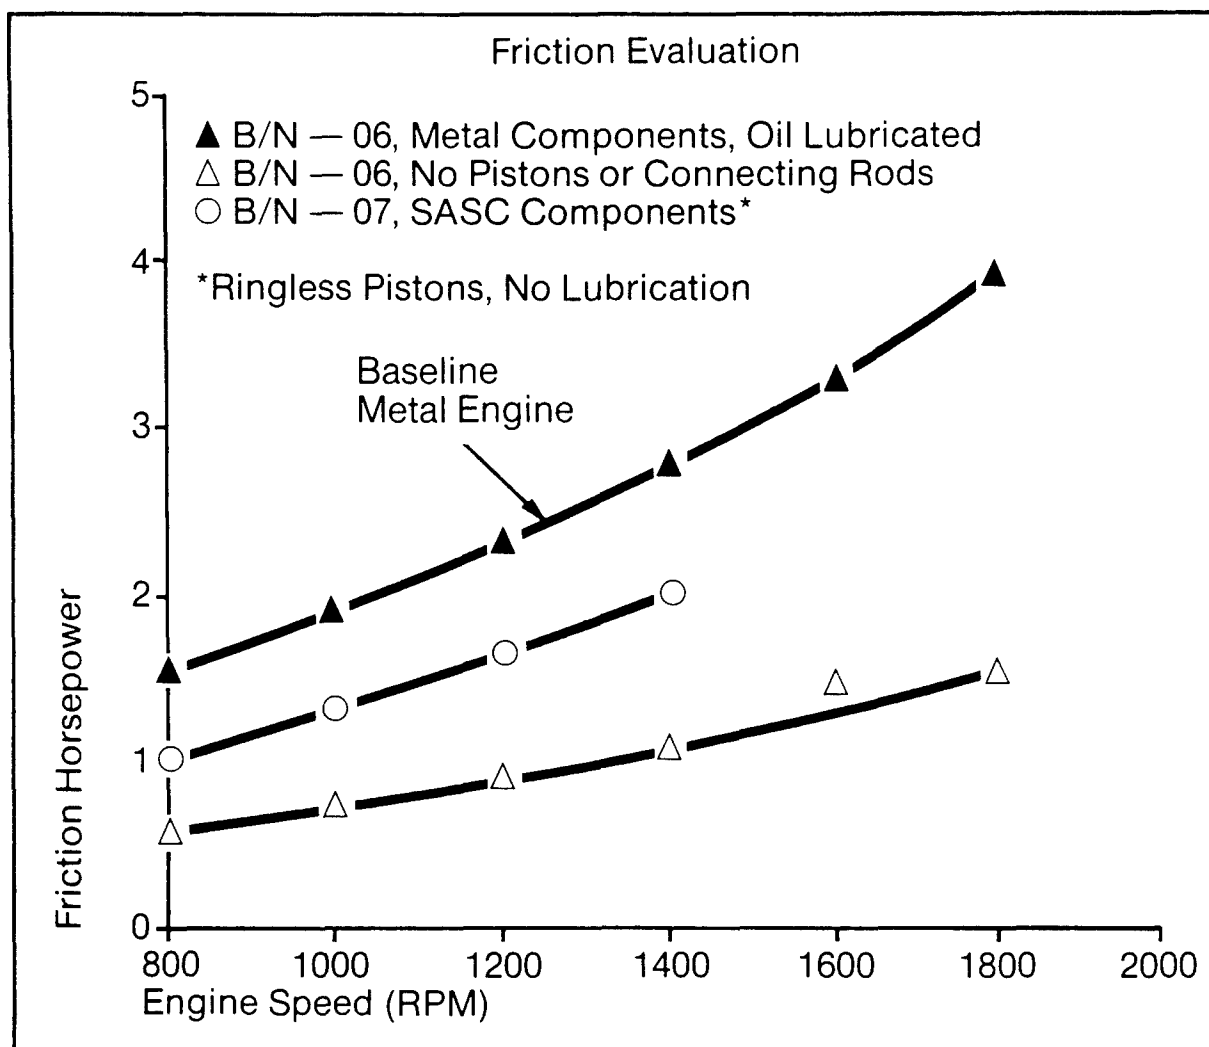
Figure 5-26. Engine Friction Comparison Between Metal Baseline B/N-06 and SASC Build B/N-07

Friction horsepower results shown in Figure 5-26 for the SASC ringless pistons show a 50 percent reduction in the contributed friction of the piston components compared to the baseline metal engine.

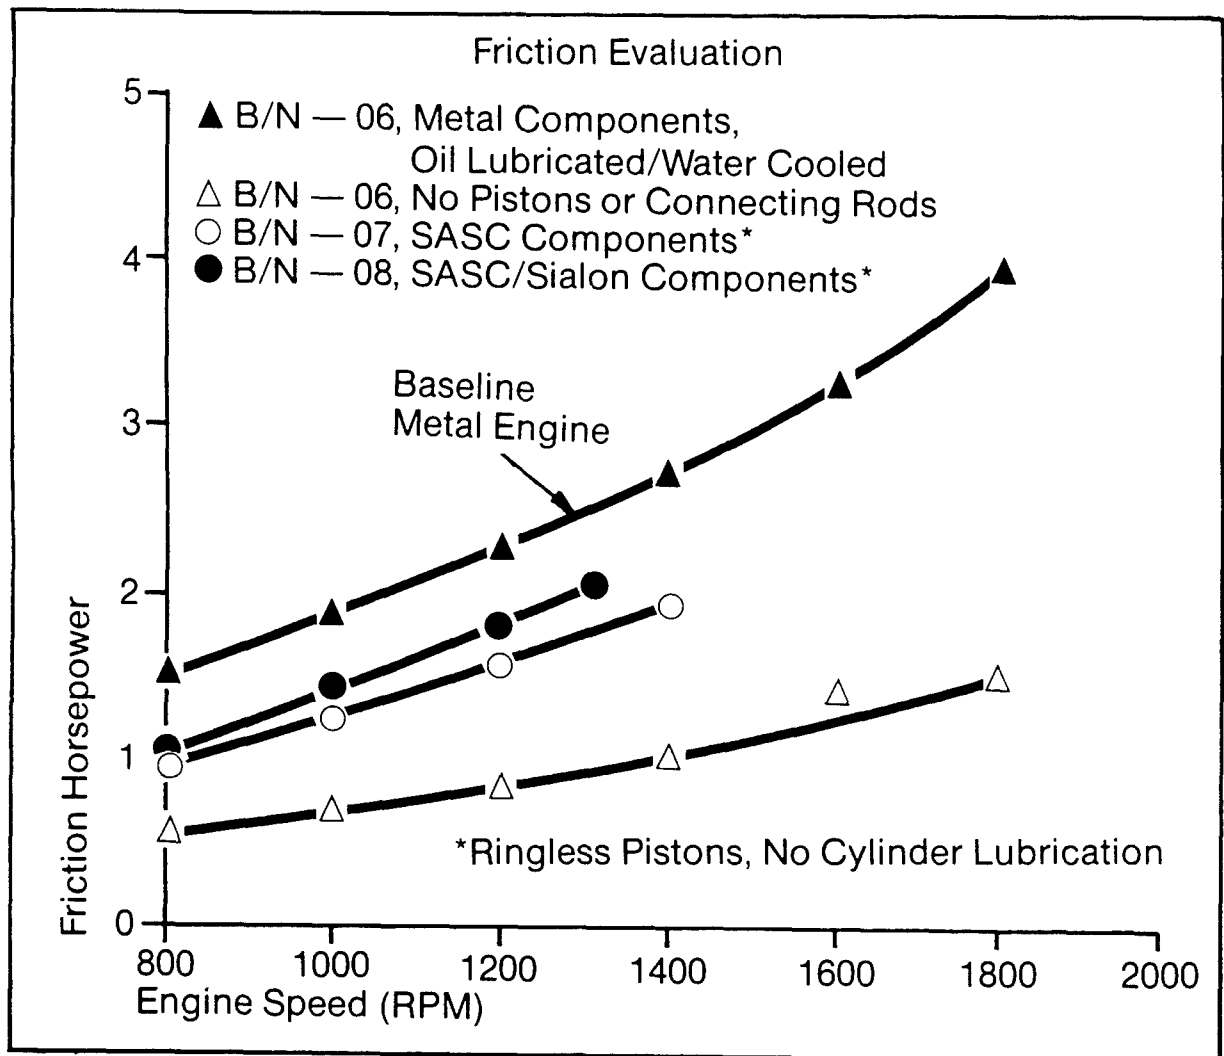
Figure 5-28. Engine Friction Comparison Between Metal Baseline B/N-06, SASC B/N-07 and Sialon/SASC B/N-08

Friction horsepower results for the ringless sialon pistons shown in Figure 5-28 exhibit a slight increase in friction over build B/N-07, but closely follow the SASC results of a 50% reduction in friction.

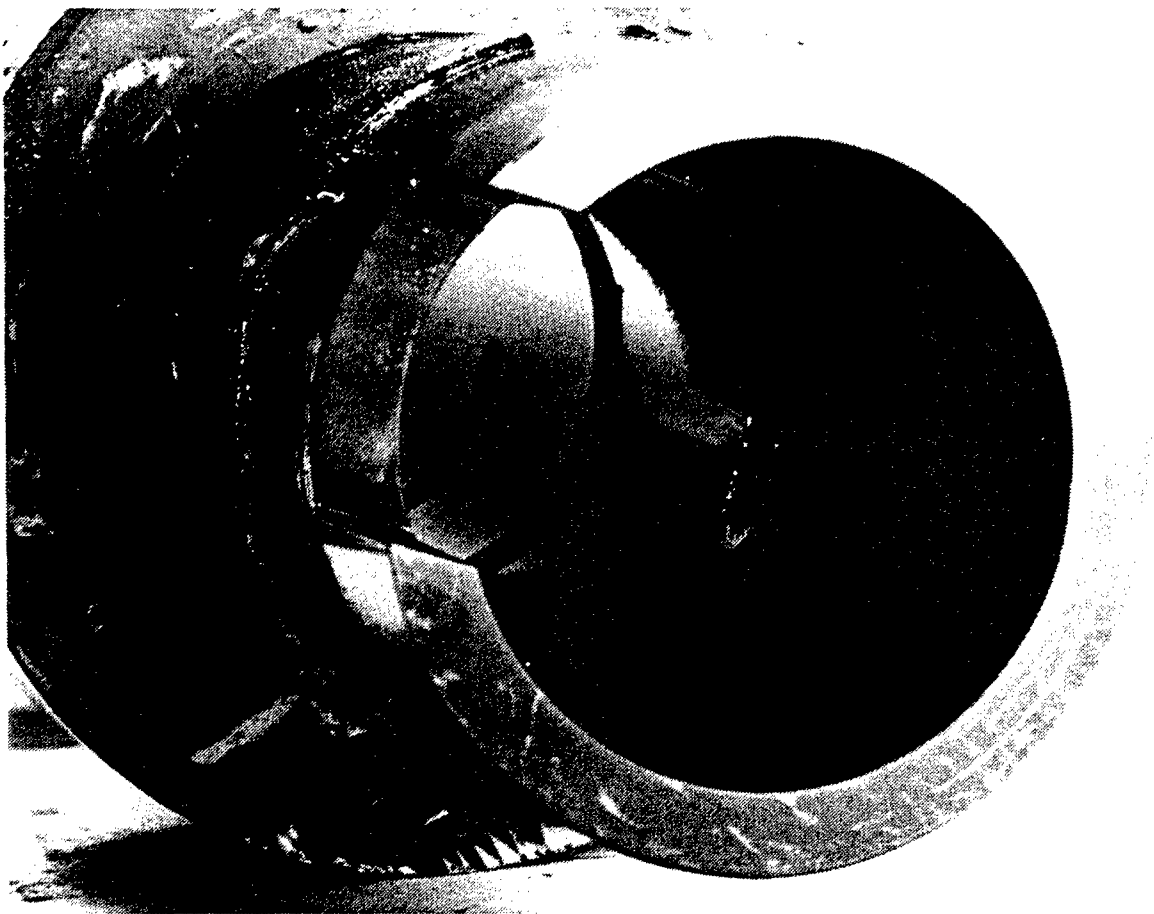
Figure 5-31. SASC Cylinder Bore After Firing with Sialon Pistons (B/N-08)

Figure 5-31 shows the silicon carbide cylinder bore, with no indications of matching piston wear. Accumulated carbon deposits can be seen in the center of the cylinder combustion zone. The ceramic components showed no other physical evidence of distress and were judged to be in excellent condition.

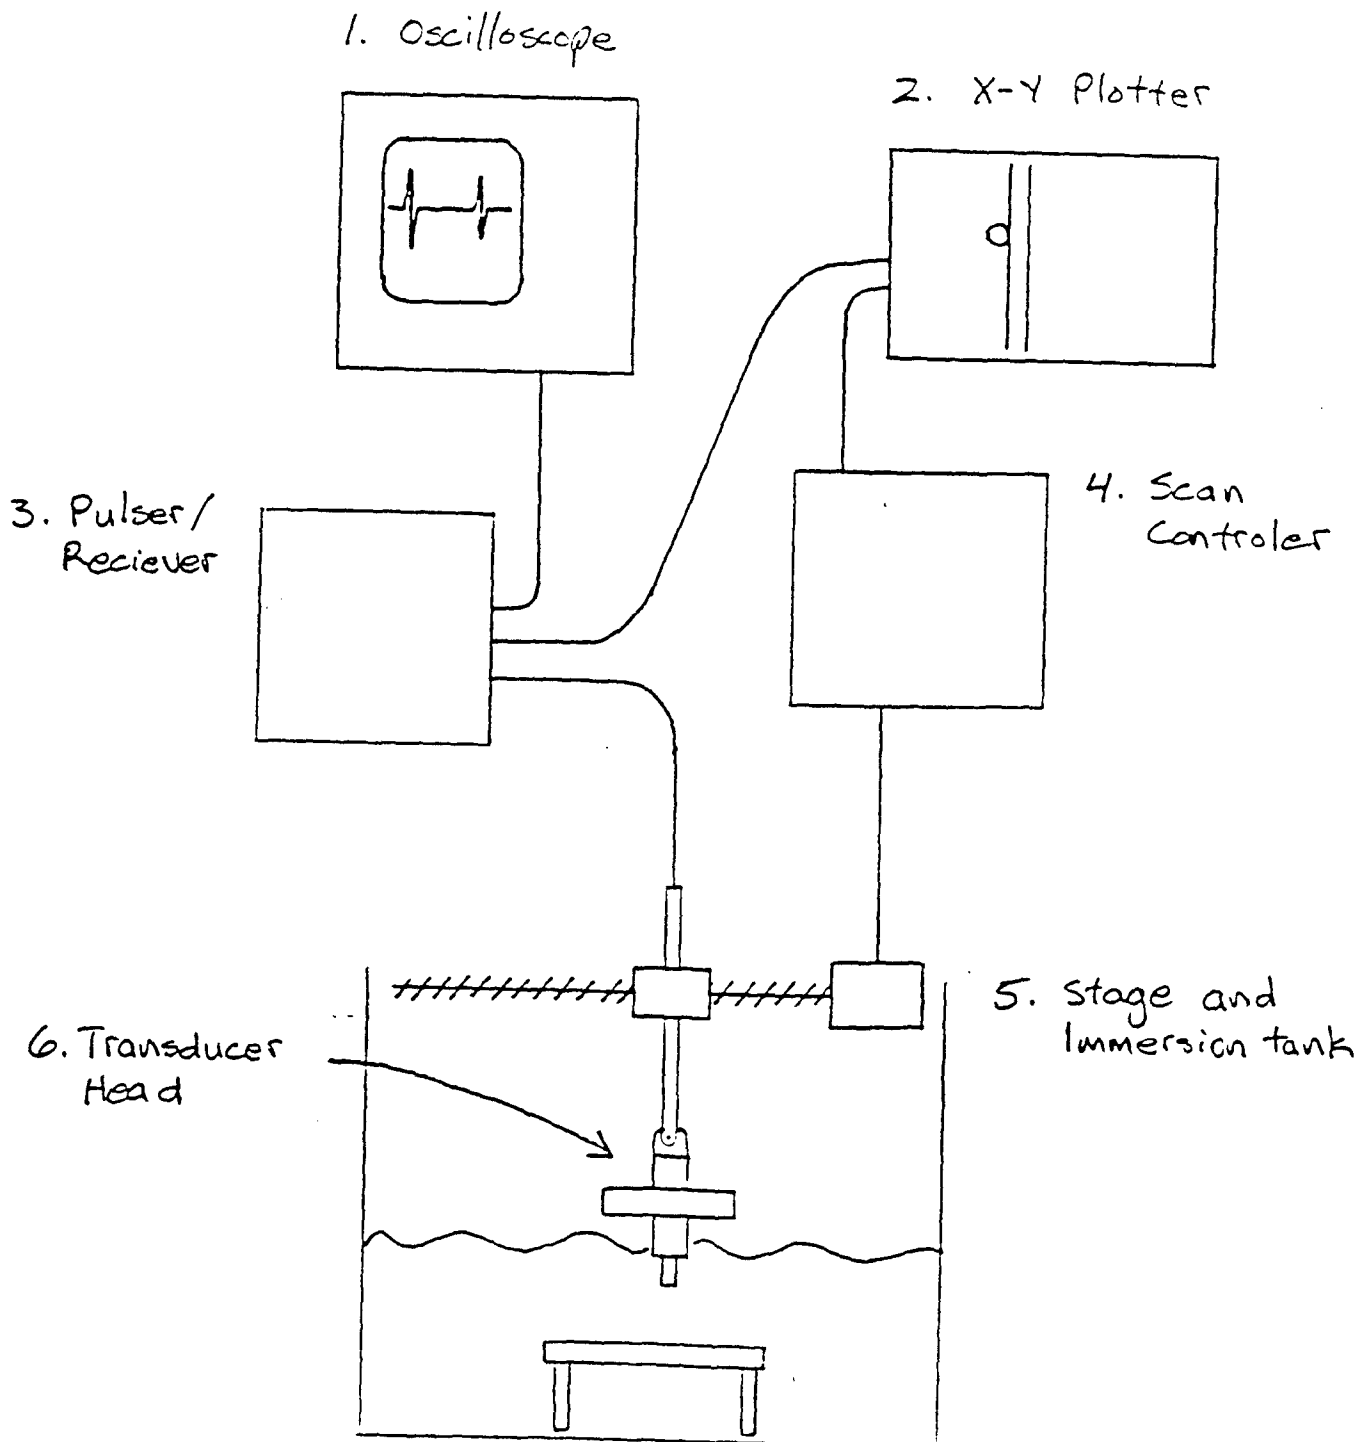
Figure 3.

Schematic Diagram of Pulser/Receiver Section
